Hayward Watershed Fish Habitat and Fish Passage Assessment FWCP Project No. COA-F22-F-3524

November 2022

Prepared by: Ciara Sharpe, M.Sc. R.P.Bio.¹ and Angela Addison²

Prepared for: Fish and Wildlife Compensation Program

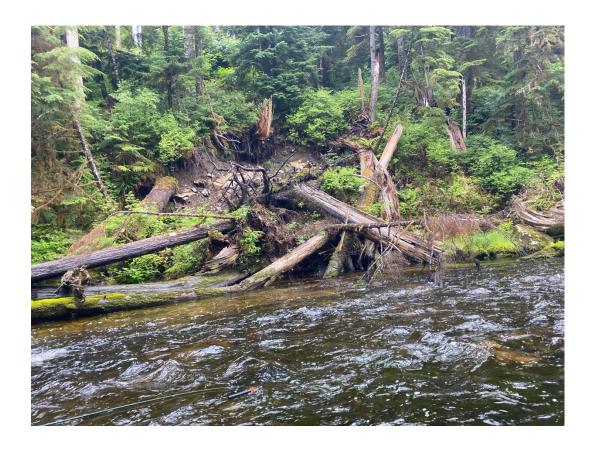
Several impacts from logging were noticed in this reach. A small bank failure was identified at 5.3km, in close proximity below the 4m falls (Figure 2). This bank failure is located where the river has steep banks and has been logged above (with a riparian buffer) on a steep slope suggesting it may be logging related. There were no signs of undercutting as it has been

stabilized by large woody debris and shrubs, however, this bank failure may provide some additional fine sediment deposition downstream. There was some evidence of blowdown, with large woody debris elevated across the river (non-functional) and one large log jam across a portion present from 5.6km – 6.6km (9 U 447538 5991230, (Appendix D: Photo 15)). A large cut block is located on the north slope of the river with a riparian buffer present at this location. Stream banks in Reach 2 were mainly undercut in shape and were heavily composed of fine sediments. Steep vertical banks were present for 200m adjacent to bedrock cascades and waterfall present at 5.4km. Banks in this reach remain stable with no evidence of eroding banks (aside from the bank failure at 5.3km).

Figure 2. Bank failure identified at 5.3km below logging on a steep slope on the north side of Hayward Creek.

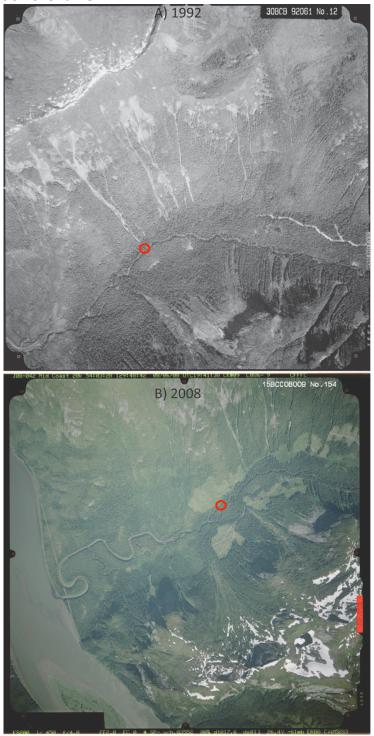
Figure 4. Air photos of lower Hayward Creek taken in A) 1992 (BC Gov Air Photo 1992a) prior to logging in Reach 2 and in B) 2008 (BC Gov Air Photo 2008), after logging of the entire watershed. Red circles denote approximate locations of bank failures and debris torrents identified in A) 1993 and B) current study.

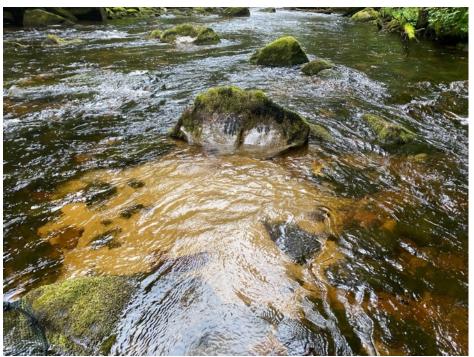
Photo 6. Illustrating sediment deposited in behind boulders documented throughout Reach 2. Photo taken in stream section above the waterfall and debris flow on Reach 2.

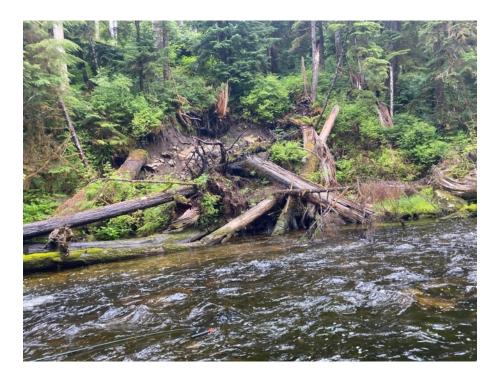
Photo 8. Bank failure identified at 5.2km downstream of the waterfall on Hayward Creek, present on steep slope below large cutblock.

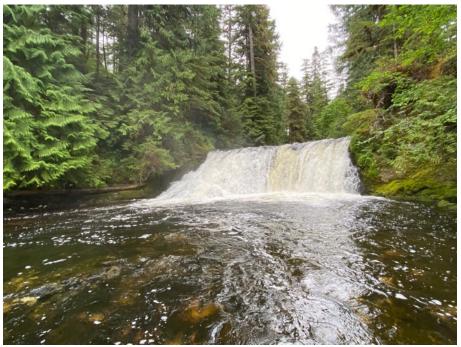
A 4.0 m high falls is located at 5.4 km upstream of the Ecstall River and is documented to be passable to Coho Salmon under certain flow conditions and impassable to Pink Salmon (DFO 1991). There is reference that these falls have been blasted in the past to improve fish access (Jyrkkanen Environmental Consulting 1996, 1997). An impassable fish barrier is located at the outlet of Hayward Lake and is recorded as a 3 – 4 m falls with water percolating through slide material (DFO 1991; FLNRORD 2005). This barrier has also been reported as a 10m drop in vertical height over a 50m stream section (Bustard 1993).

Photo 11. Viewing upstream at the 4m waterfalls on Hayward Creek. Waterfall may be passable during certain flow conditions for some anadromous salmon species, however, a side channel also provides passage around this river section.

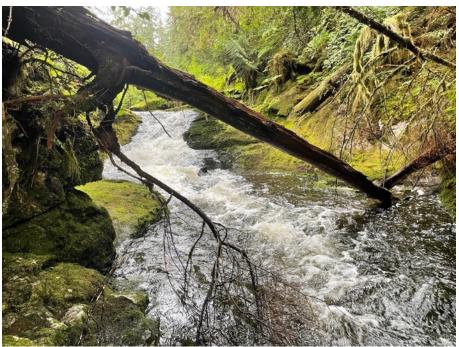
Photo 13. Viewing upstream at cascade present (16m long, 3m high) at upstream end of side channel providing passage around the falls. Several small pools available to aid fish passage.

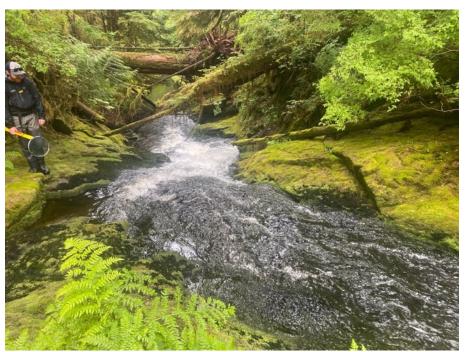
Photo 14. Viewing downstream at cascade present (16m long, 3m high) at upstream end of side channel providing passage around the falls.

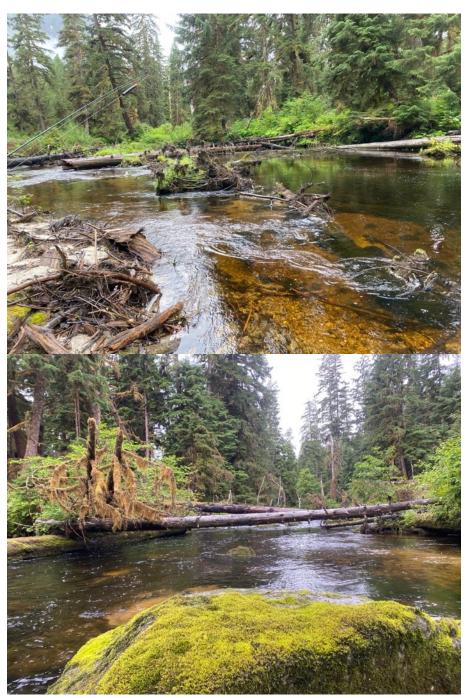
Photo 15. Non-functional LWD parallel to banks (evidence of blowdown) in stream section 5.6km to 6.6km, approximately located at 9 U 447538 5991230 with logging present on the north side of the river (with a riparian buffer present).

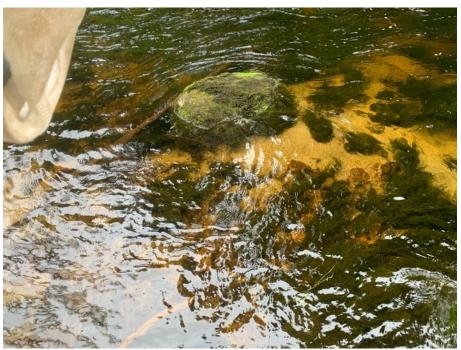
Photo 23. Fine sediment present in Reach 4. Present with boulder and large cobble, abundant of instream vegetation in certain lower gradient sections.

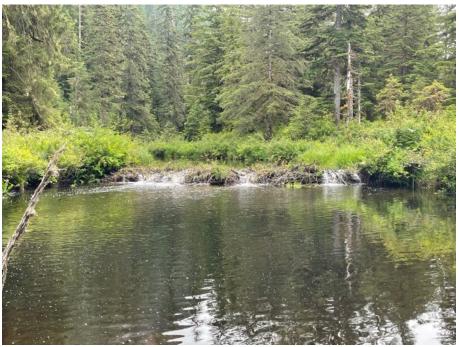
Photo 39. Beaver dam present in Reach 6. Beaver dams in reach 6 do not restrict fish passage throughout this section.

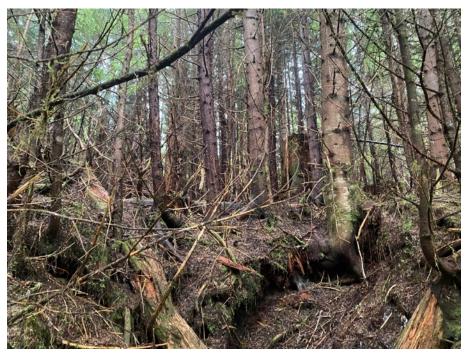
Photo 52. Eroding stream bank present in Little Beaver Creek which has been logged up to the edge (no riparian buffer remaining).

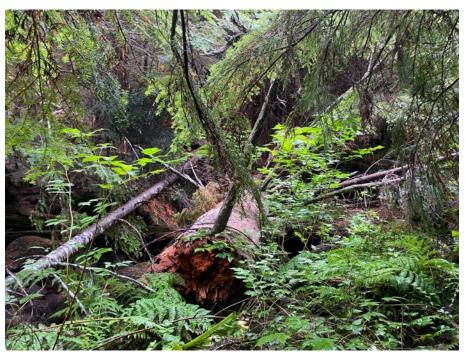
Photo 53. Abundant non-functional LWD is present within little beaver creek caused by logging close to the stream bank and subsequent windfall.

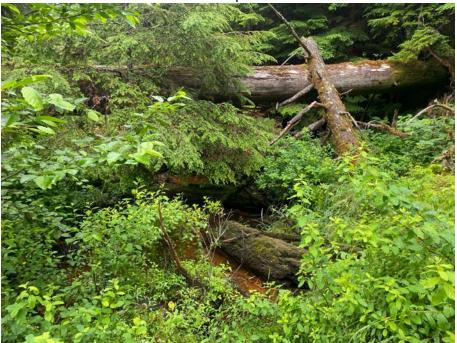
Photo 54. Abundant non-functional LWD is present within little beaver creek caused by logging close to the stream bank and subsequent windfall.

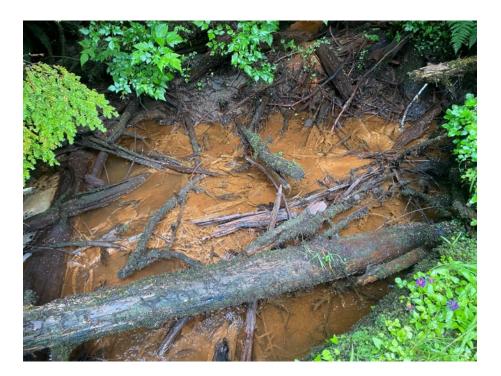
Photo 55. Abundant SWD is present within little beaver creek caused by logging close to the stream bank and subsequent windfall. SWD and LWD in creek and clogging the creek and likely limiting fish passage. Red algae was present during sampling.

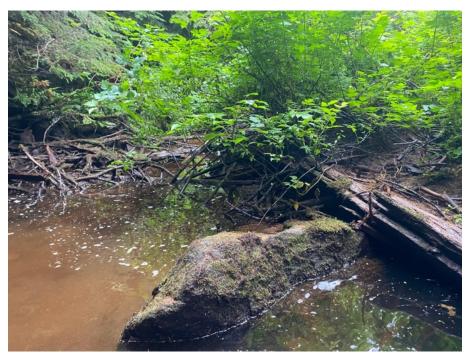
Photo 57. Abundant SWD is present within little beaver creek caused by logging close to the stream bank and subsequent windfall. SWD and LWD in creek and clogging the creek and likely limiting fish passage. Red algae was present during sampling.

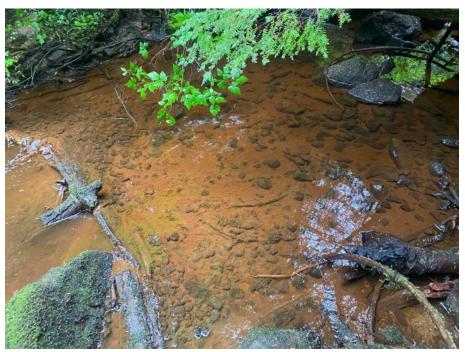
Photo 58. Fine sediments and red algae clogging stream during low flow sampling in July.

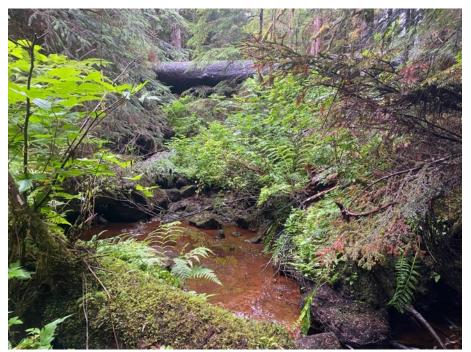
Photo 59. Abundant non-functional LWD is present within little beaver creek caused by logging close to the stream bank and subsequent windfall.

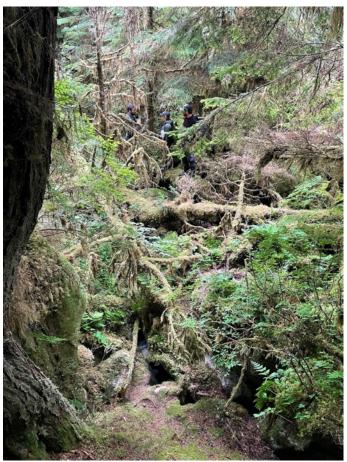
Photo 61. Viewing old landslide downstream of Hayward Lake, where water is percolating through large-boulders. Mature forest has grown over boulders and represents the limit to anadromous fish passage in the Hayward Creek watershed.

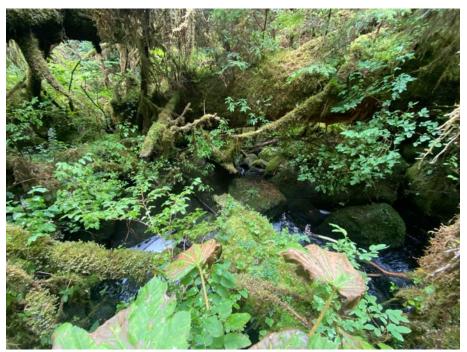
Photo 62. Viewing old landslide downstream of Hayward Lake, where water is percolating through large boulders. Mature forest has grown over boulders and represents the limit to anadromous fish passage in the Hayward Creek watershed.

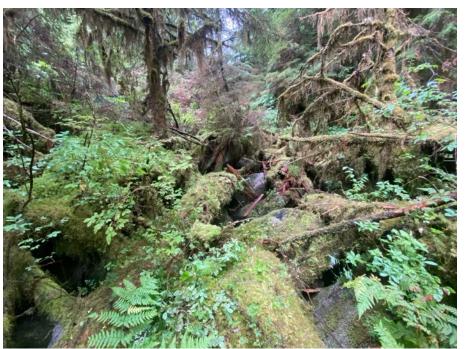
Photo 63. Viewing old landslide downstream of Hayward Lake, where water is percolating through large-boulders. Mature forest has grown over boulders and represents the limit to anadromous fish passage in the Hayward Creek watershed.

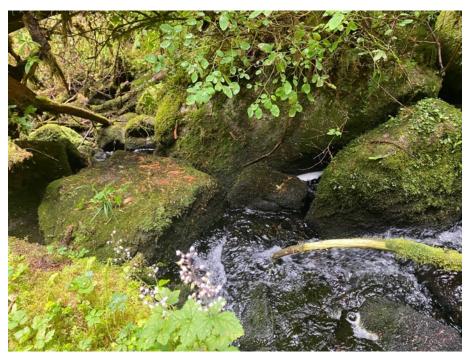
Photo 64. Viewing old landslide downstream of Hayward Lake, where water is percolating through large-boulders. Mature forest has grown over boulders and represents the limit to anadromous fish passage in the Hayward Creek watershed.

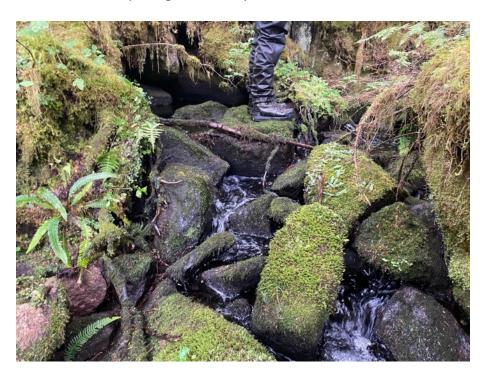
Photo 65. Viewing old landslide downstream of Hayward Lake, where water is percolating through large-boulders. Mature forest has grown over boulders and represents the limit to anadromous fish passage in the Hayward Creek watershed.
