Routine Effectiveness Evaluation

Off-channel ponds and debris structures

FRBC ACTIVITY NUMBER: 725138

MARCH 2002

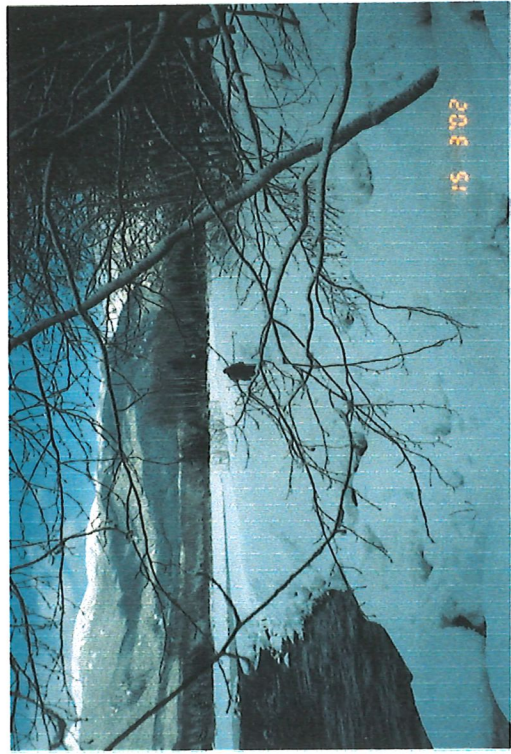
Photo 1. Looking upstream in the lower channel of Site 77 from the Photo Reference point on the bank near the mouth

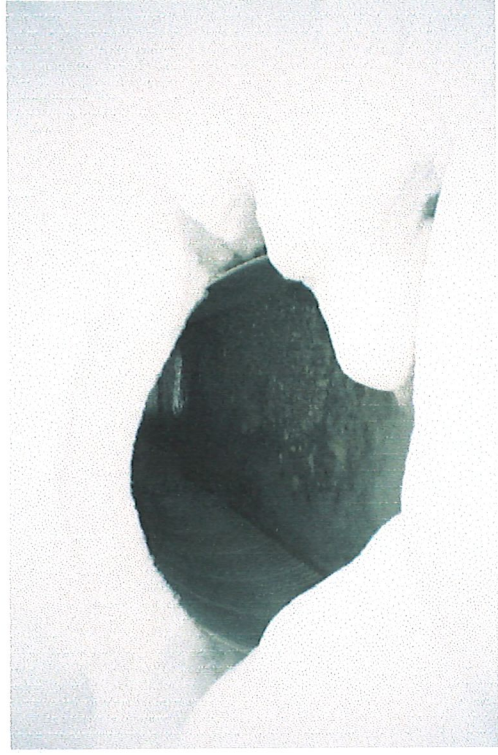
Photo 3. Looking at the culvert inlet at Site 77. Gravels have infilled the bottom of the culvert for 6m.

| Priority | Watershed | Distance | Site ID | Maintenance Score | Problem/Fix | Estimated Cost | Person Days Required | Materials and equipment Required | Prescription Required |
|---|---|---|---|---|--|---|---|--|---|
| 2 | Copper | At culvert inlet | Site 77 | 2 | Armouring 10m channel upstream of culvert | \$500 | 2 | locally available cobble | No |

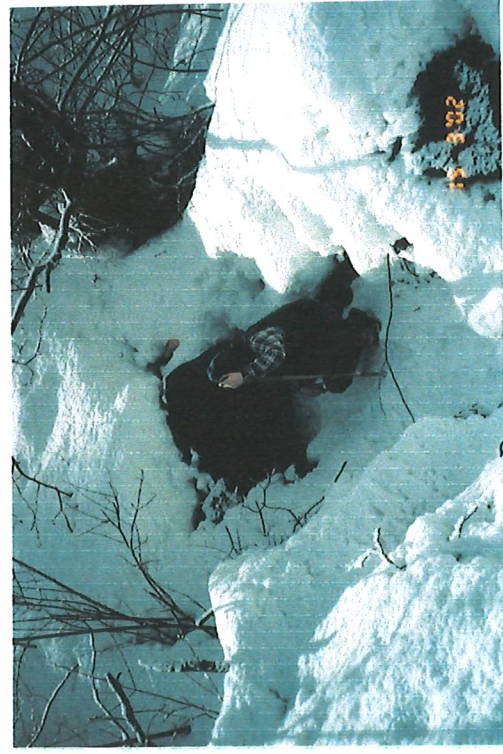
Photo 2. Looking at the outlet of the new culvert at Site 77.

| Priority | Watershed | Distance | Site ID | Maintenance Score | Problem/Fix | Estimated Cost | Person Days Required | Materials and equipment Required | Prescription Required |
|---|---|---|---|---|--|---|---|--|---|
| 4 | Copper | at culvert mouth | Site 77 | 2 | Add load of gravel to channel | \$400 | 2 | load of pea or pit run gravel | No |

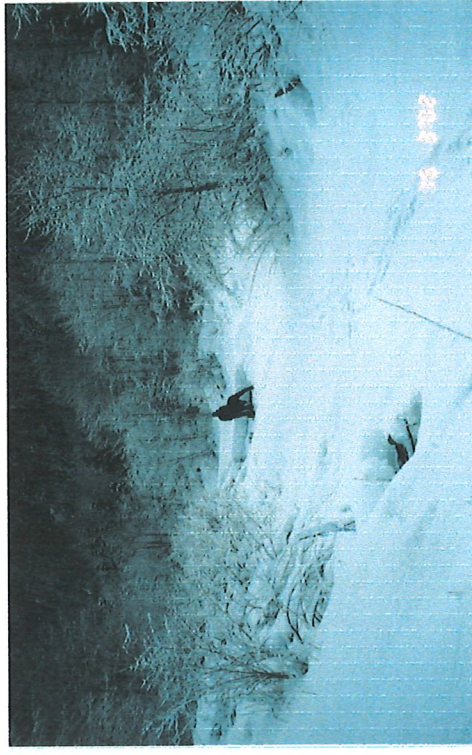
Photo 4. Looking upstream at off-channel habitat made accessible from the Copper River. Coho juveniles were capture in minnow traps under the ice.

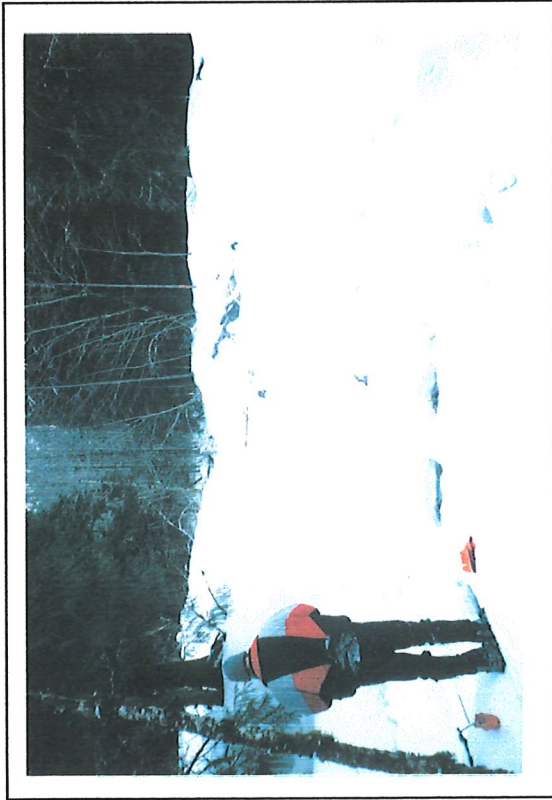
Photo 5. Looking upstream in the excavated channel at 3 km from approximately 40 m below Pool 1.

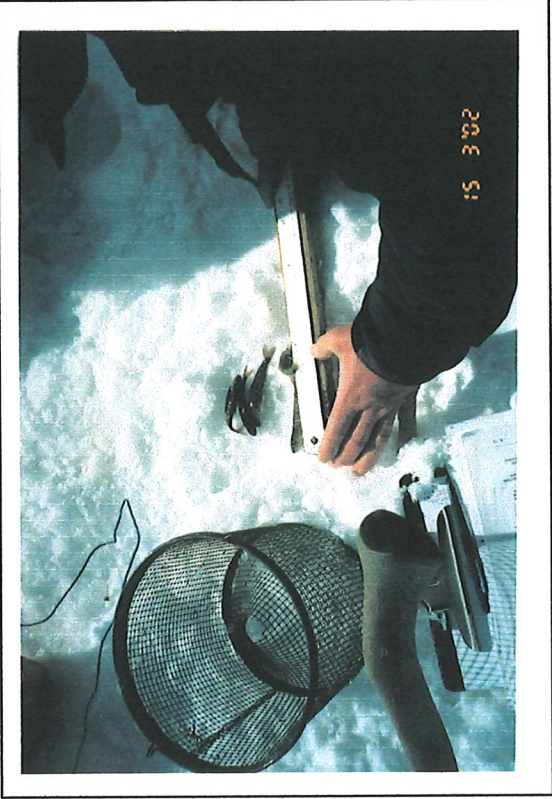
Photo 7. Some of the coho and cutthroat trout juveniles captured in Pool 4.

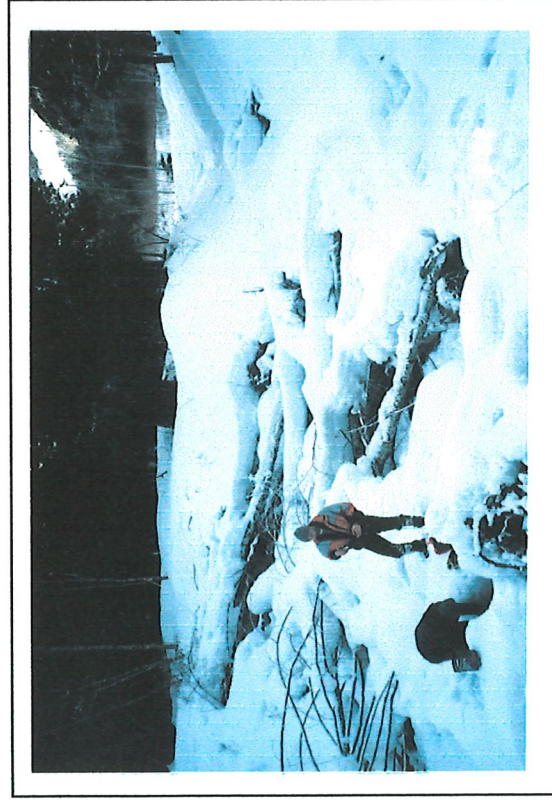
Photo 6 Looking downstream Pool 4 in the excavated off-channel development at 3 km. Note the large woody debris. Juvenile coho and cutthroat trout were captured in minnow traps under the ice in this pool.

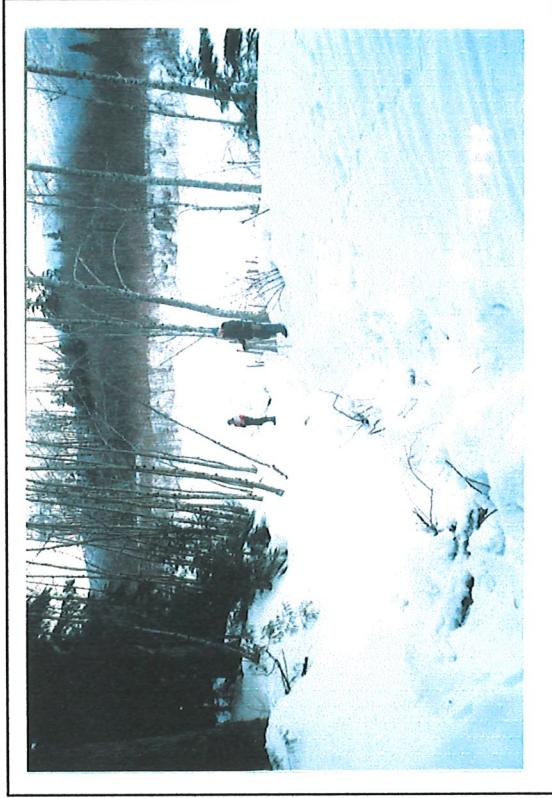
Photo 8. Looking downstream toward the mouth of the new off-channel habitat. This channel drains into a spawning channel where the person on the left is standing.

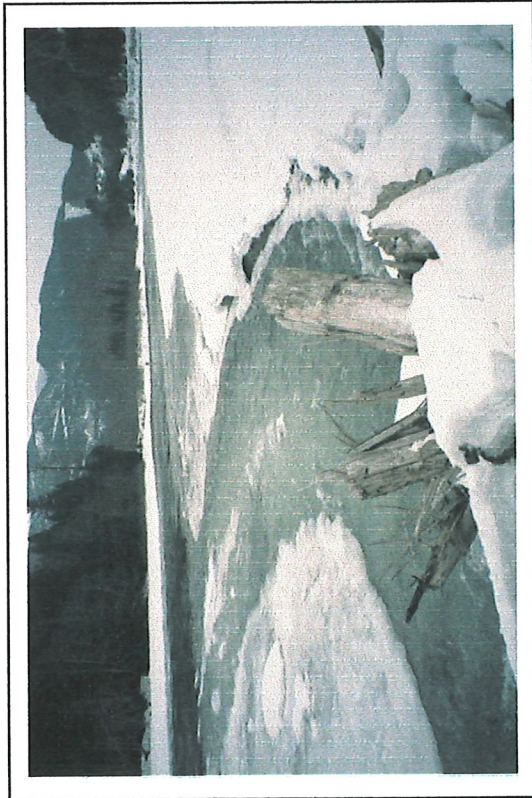
A minor change in the stream thalweg and the riffle upstream of DC1 was noted. Prior to construction the riffle upstream of DC1 flowed straight from the mid-channel bar onto the catcher. Since then the riffle has progressed upstream, almost parallel to the bank, and the stream thalweg now curves from the riffle, along the bank and onto the debris catcher causing erosion to the banks immediately upstream of the catcher. This change was not anticipated and the rate of erosion should be monitored, especially following a high flow event to ensure erosion does not compromise DC 1. The erosion rate of the banks was estimated at 2 to 4m per year but appears to have slowed since construction 1 year ago. We anticipate that the angle of repose of the bank will change from near vertical presently (see photos) to a 30 to 50 degree angle seen in other similar banks along the river. Small woody debris collected on DC1 (upstream most catcher) and the structures appear functional in intercepting instream debris. Additional woody debris was added in May 2001 to each catcher to increase the obstruction of water flowing through each structure. The woody debris persisted over the past 10 months on each structure.

Photo 9. Looking upstream at the Copper River mainstem from Debris Catcher 1 at the thalweg eroding the gravel bar.

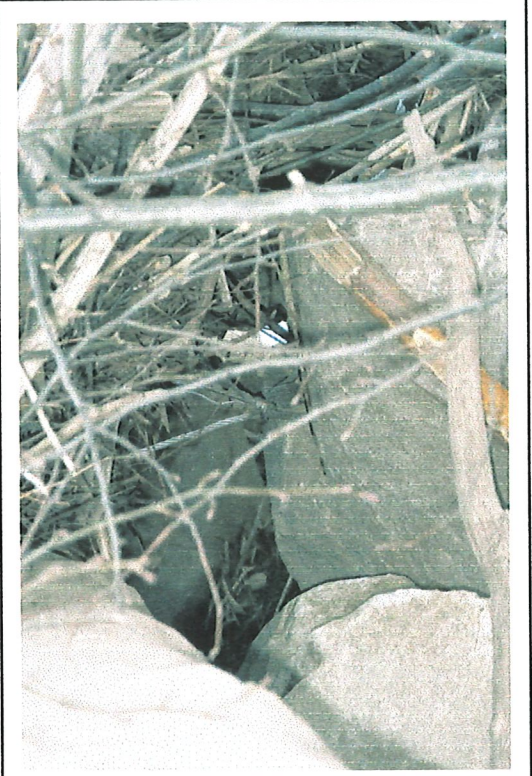
The use of knots in the steel cable instead of cable clamps is one concern. One cable underneath of DC1 tied to a boulder has frayed to the knot and may potentially fail. This boulder should be re-attached to the cable with a clamp.

Photo 11. Looking underneath Debris Catcher 1 at a frayed cable attached to a boulder that required re-attachment.

Routine maintenance is required on all three catchers. Several cables on each catcher had slackened off due to settling of the structures and require tightening. It is recommended that some of the knots used to tie the cables be reinforced with cable clamps to ensure structural stability during peak flows.

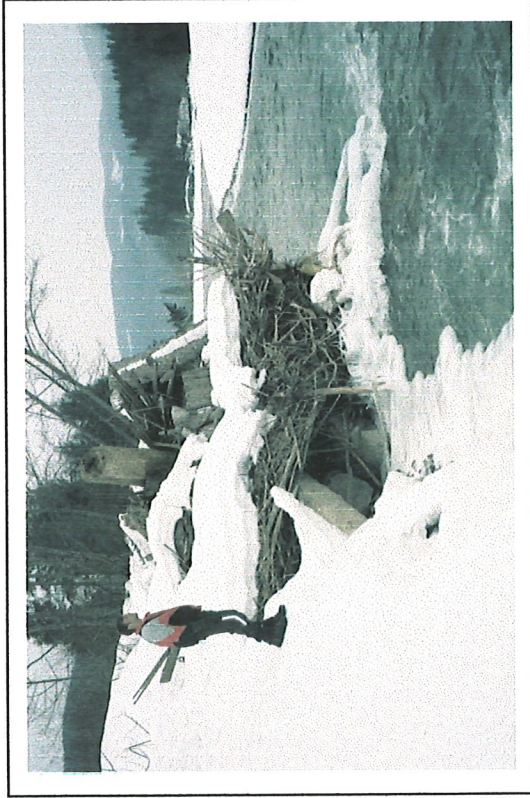
| Stream | Distance | Site ID # | Structure Type | Site Objective | Physical | | | | | | | Biological | | | | | | | Overall | | | | | Comments | |
|---|---|---|---|--|---|---|---|---|---|---|---|---|---|---|---|---|---|---|---|---|---|---|---|---|--|
| Copper R. | 3 km | DC1 | LWD -DC | Primary - deflect flow from eroding bank and collect debris. | 3 | na | na | 2.5 | 3 | na | 3 | SA | JUV | 2.5 | 3 | 2.5 | na | na | 2.5 | 3 | 3 | 2.5 | 2 | 10, 11 | SWD has accumulated on this structure. |

Photo 10. Looking downstream at Debris Catcher 1. Small woody debris is accumulating at the base of the structure.

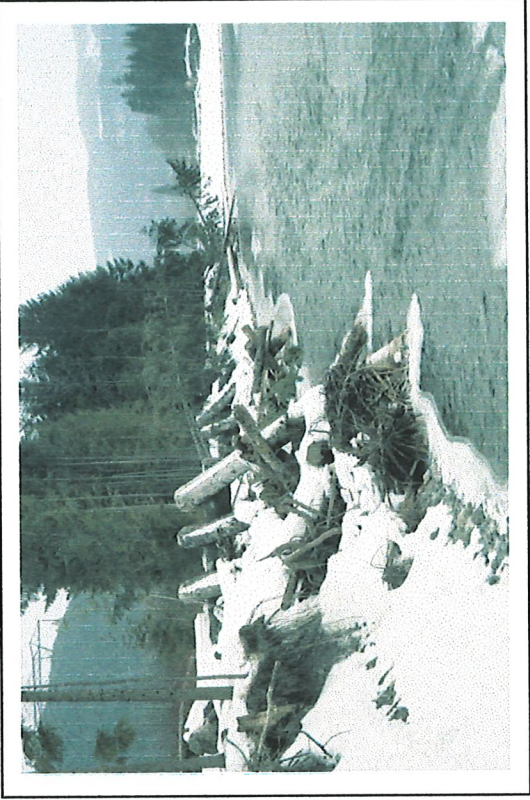
Since construction the thalweg has progressed to the center of the channel at low flows (3 m approximately) and scoured a deep run off the point of DC1. This deep run provides some holding habitat for adult salmon but limited rearing and overwintering habitat for juvenile fish. Sediment from the scouring action at DC1 was deposited downstream of DC1 creating a small riffle and the bed between these 2 catchers is beginning to form a pool/riffle/pool sequence.

Photo 12. Looking downstream at Debris Catcher 2 and 3. Note how the thalweg has been pushed into the center of the channel and away from the eroding bank.

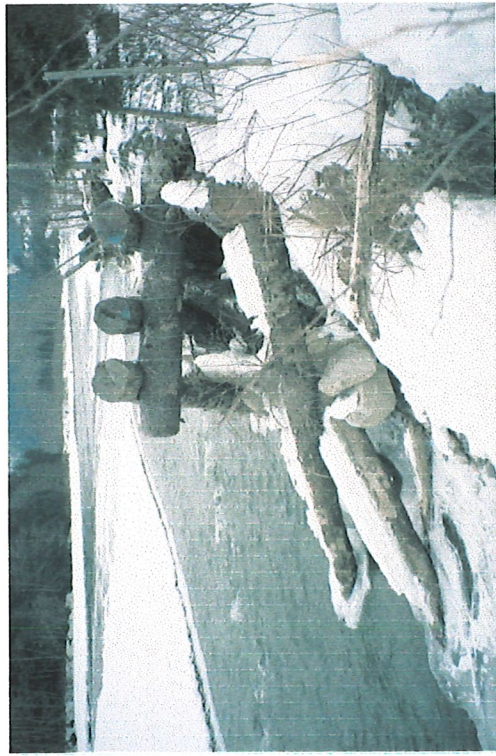
Photo 13. Looking upstream at the backside of Debris Catcher 2. The structure has remained stable with minor shifting.

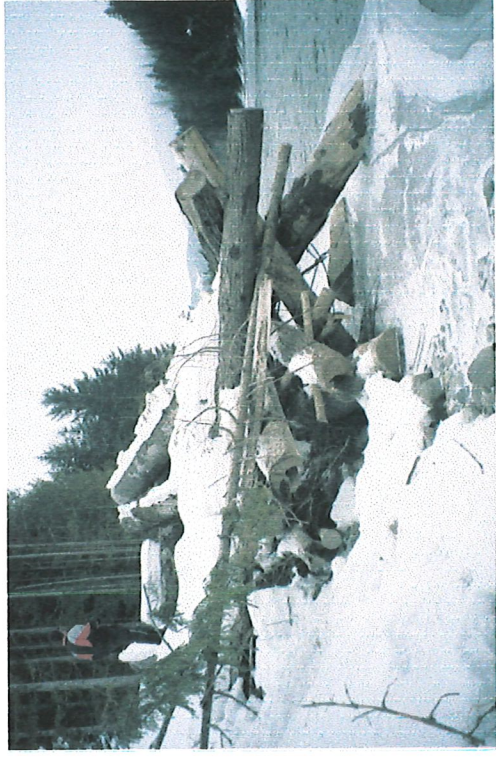
Photo 14. Looking downstream at Debris Catcher 3. Additional woody debris was loaded onto the structure in May 2001.
