Spring Creek Project: Dairy Street Landslide Rehabilitation

November, 1998

TRITON

Environmental Consultants Ltd.

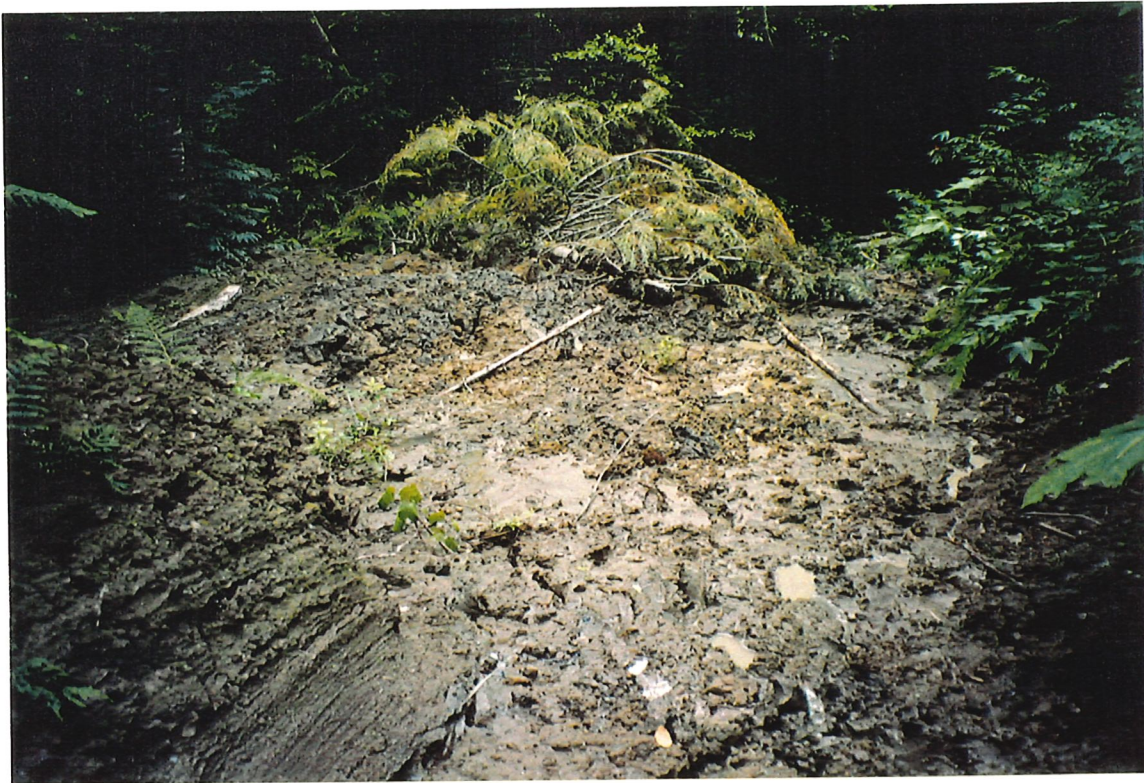
The base or toe of the slide has three aspects. One side faces upstream, one side faces directly across the stream (depositing debris in the creek) and one side faces downstream. The downstream side of the toe was of primary concern for stabilization because of its near vertical angle. This side was originally about 2m in height and was subject to undercutting by the creek. A large volume of slide material was being held back by this side of the toe. Destabilization by undercutting on this side could cause another failure, with the material landing directly in the creek.

The front face of the toe was also of major concern because debris deposited in the channel was a potential barrier to adult coho migration. Also, the debris jam acted to increase water velocities along the front of the slide causing undercutting and toe destabilization. The upstream side of the toe was of less risk of undercutting because a backwatered area had formed upstream and water velocities in this area were low, with minimal erosive power.

Photo 1: Depositional zone (toe), view towards creek, prior to rehabilitation work.

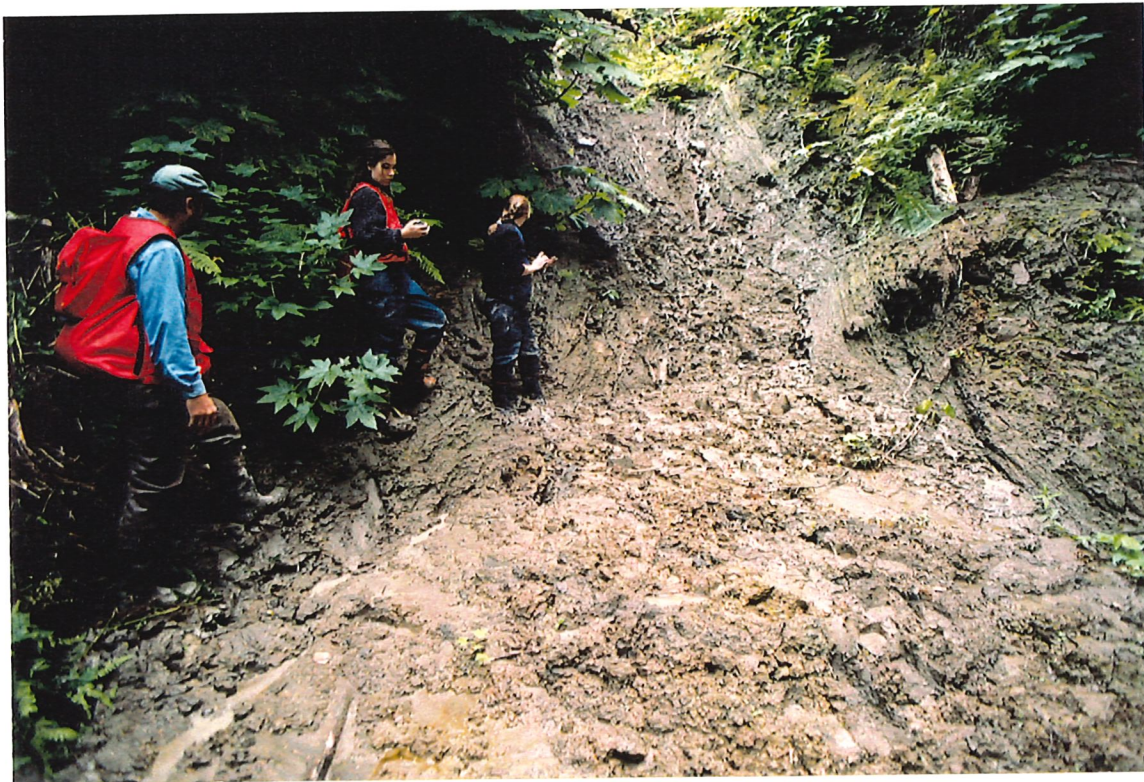
An unstable headscarp was at the initiation zone of the slide during the initial assessment. The narrow transport zone appeared to be relatively stable, however the side walls were oversteepened and failing. Some vegetation was established on the slide, primarily horsetail (*equisetum sp.*) and seedling alder (*alnus sp.*)

Photo 2: Lower end of transport zone, upper end of depositional zone prior to rehabilitation work.

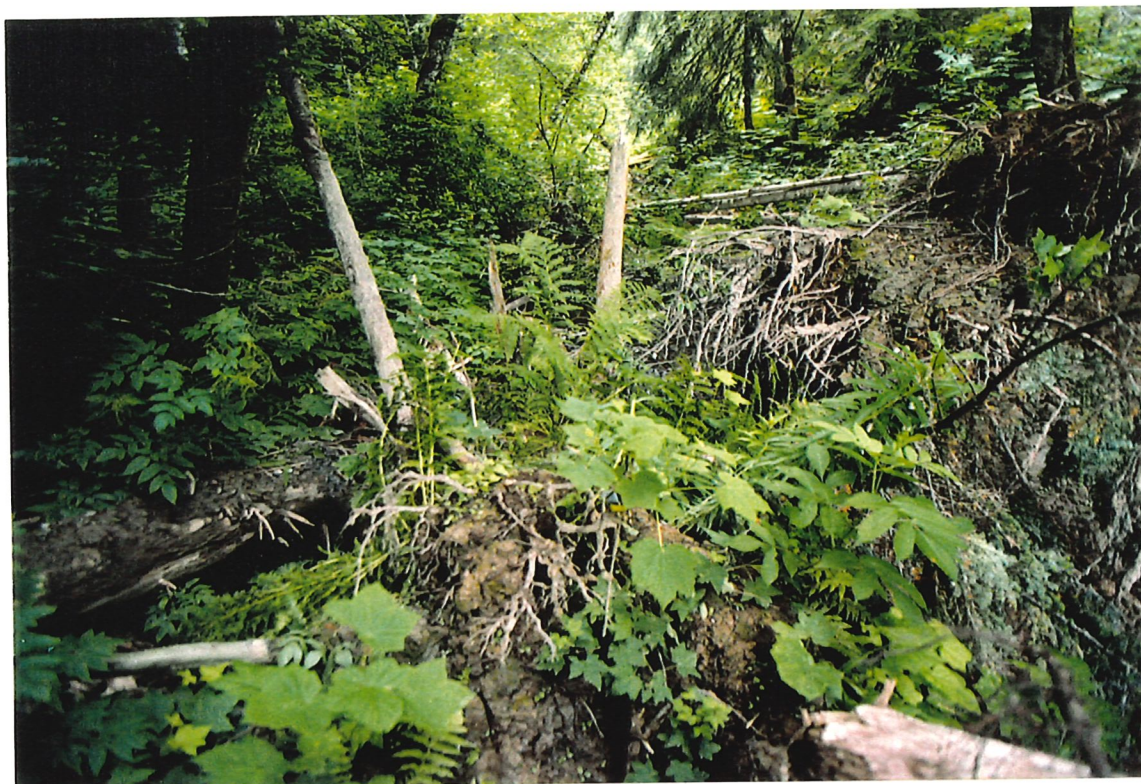
The primary concern with the slide was passage of adult coho into spawning habitats upstream. At the time of the discovery of the slide, water was flowing beneath the debris pile which had come to rest in the creek. Juvenile fish could migrate upstream and downstream of the slide but adult passage was suspect.

Photo 3: Debris in stream channel prior to instream work.

Slide debris was removed and brush was cleared on the right bank of the creek in order to create a route for the channel diversion. A small trench was dug in order to get water flowing into the new channel. A large log was angled under an existing log across the stream in the new channel. This placement caused intensive scouring beneath the placed log and deepened the new channel. After a significant rain event the pool underneath the log had scoured to over 1m deep, providing excellent fish holding and rearing habitat. The banks downstream of the log placement were undercut by the flow, creating additional fish cover. Flow was also directed away from the downstream toe by the channel diversion. Juvenile fish were observed using habitat in the new channel immediately. An adult coho was observed in the undercut downstream of the log placement. The new channel not only provides passage for adult coho migrating upstream to spawn, but also provides holding and rearing habitats.

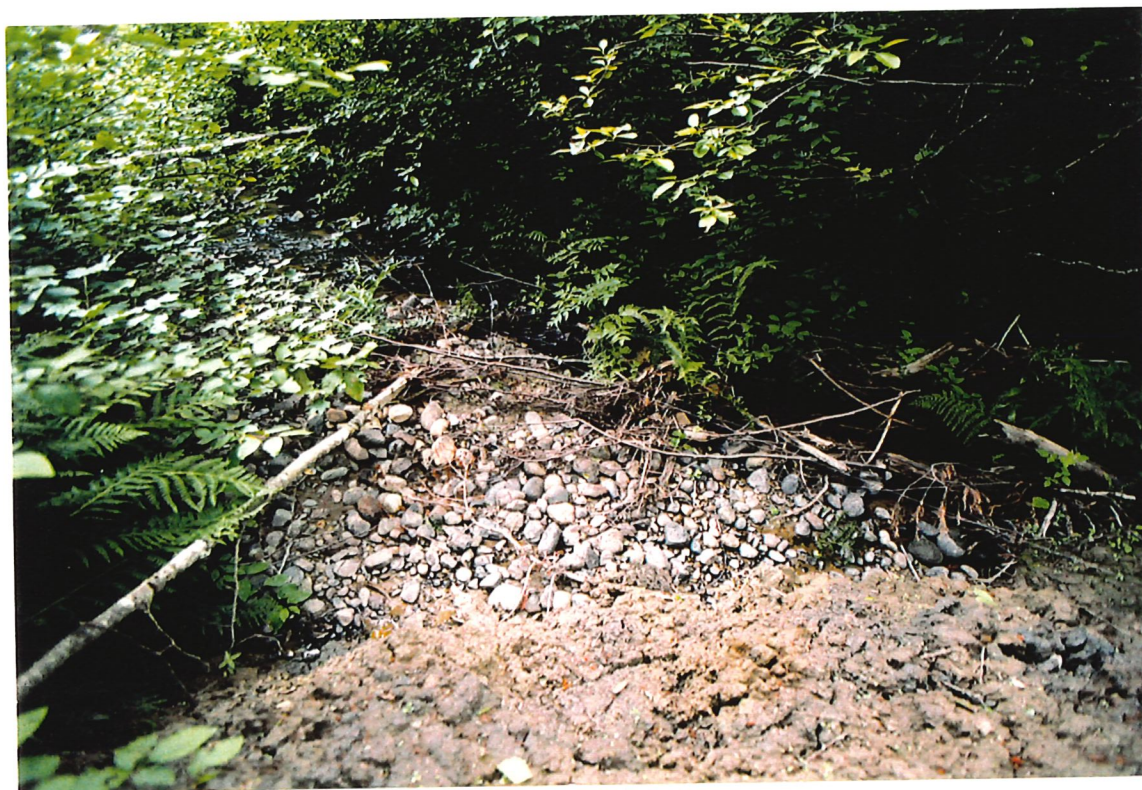
Photo 4: Slide material blocking stream channel prior to instream work.

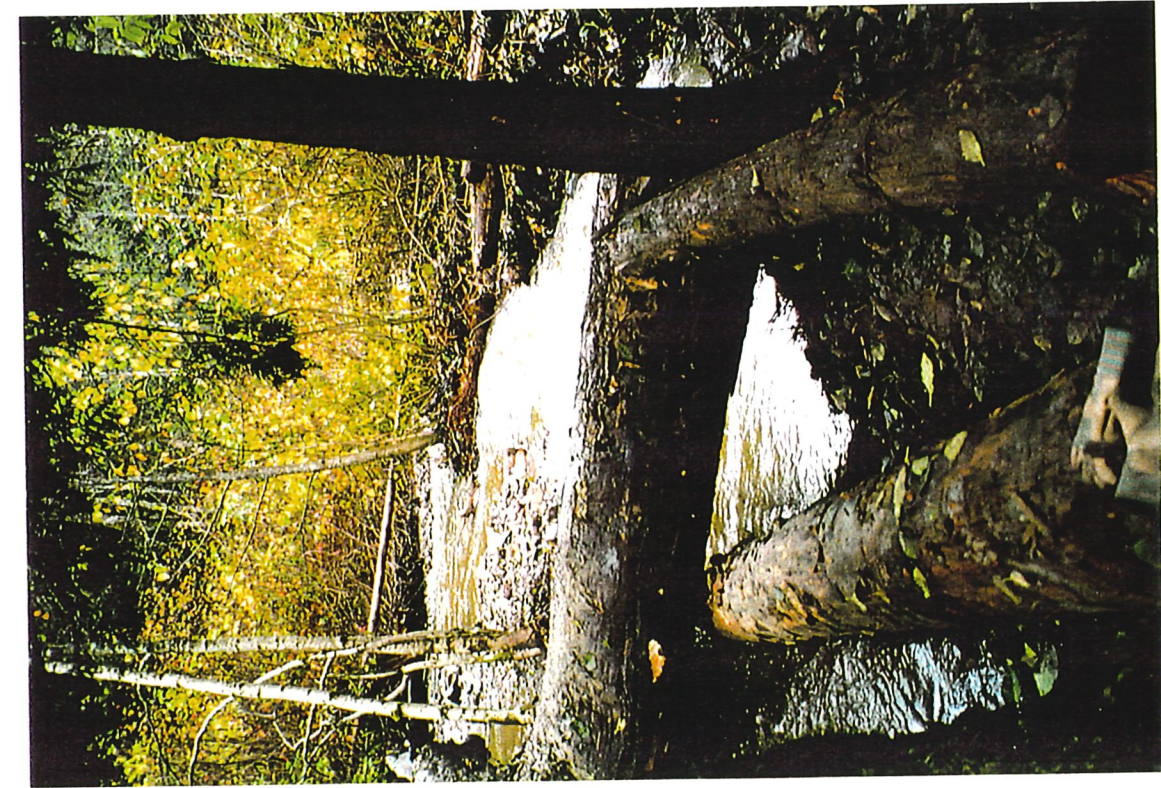
Photo 5: New channel showing LWD placement beneath log to encourage scour.

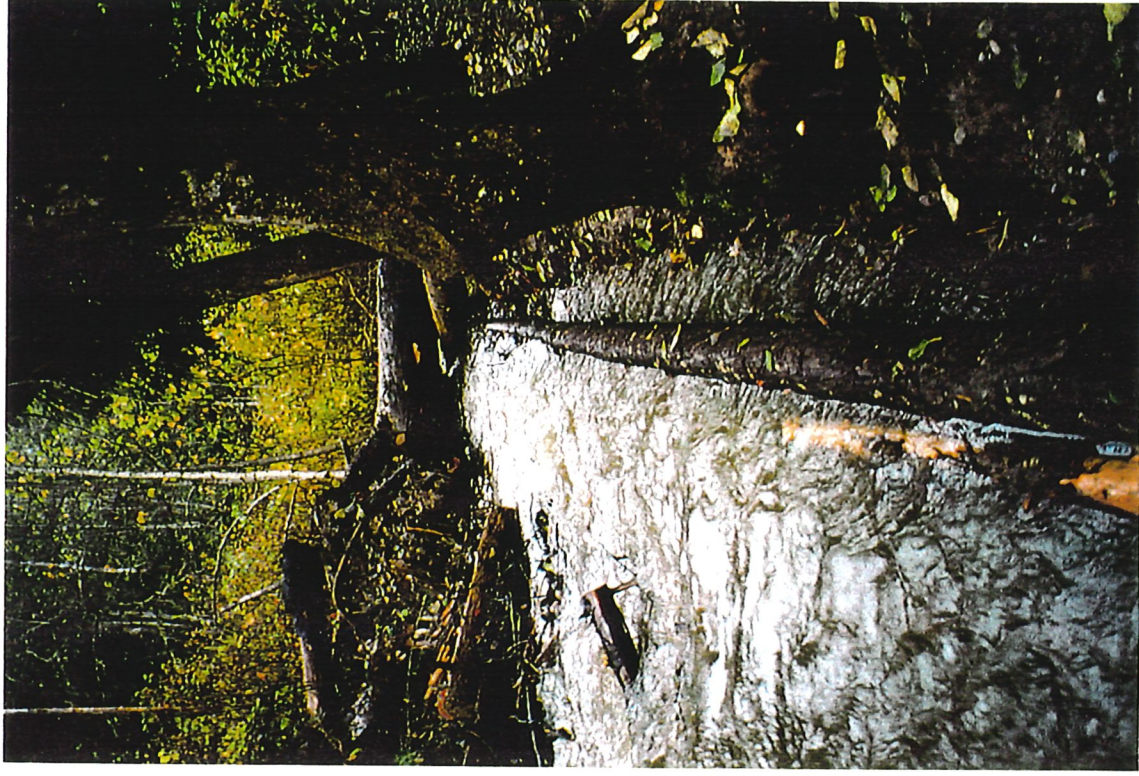
Photo 6: New channel showing LWD placements on right bank.

LWD were placed upstream of the new channel to encourage scouring on the right bank (opposite the slide) and direct water flow towards the new channel. These placements were attached to large trees on the banks with cable.

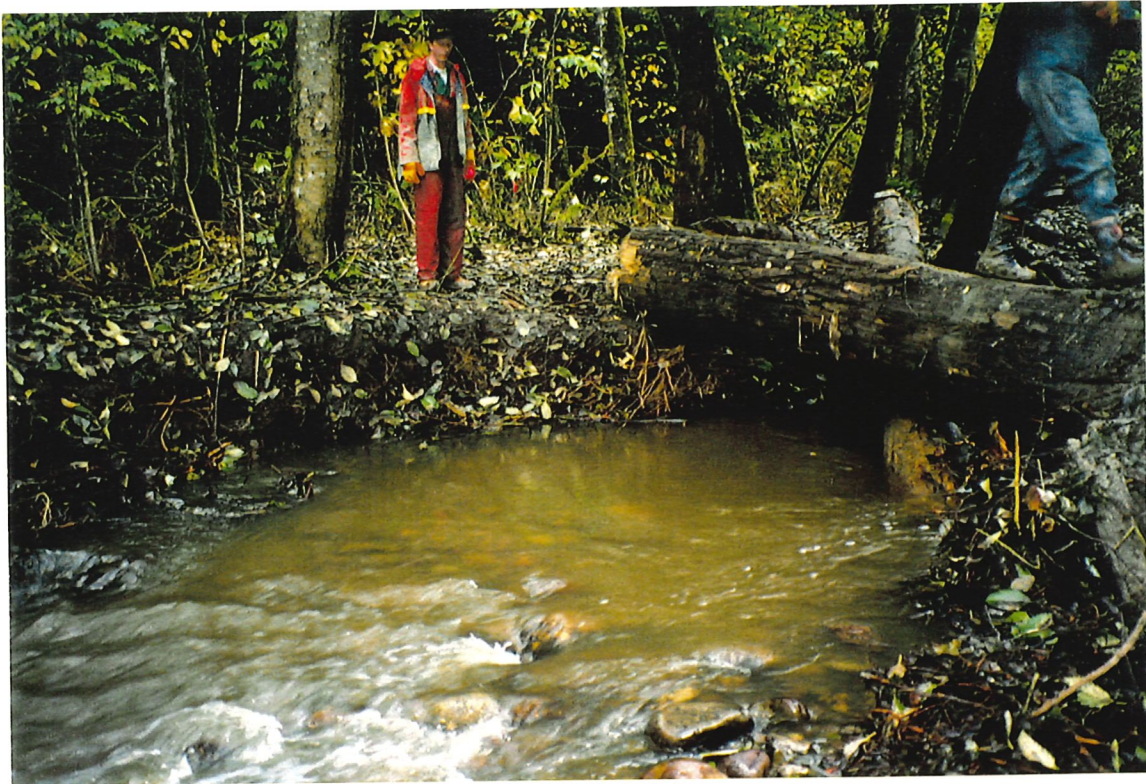
Photo 7: Instream work showing LWD placement beneath log, undercut banks and pool formed immediately downstream.

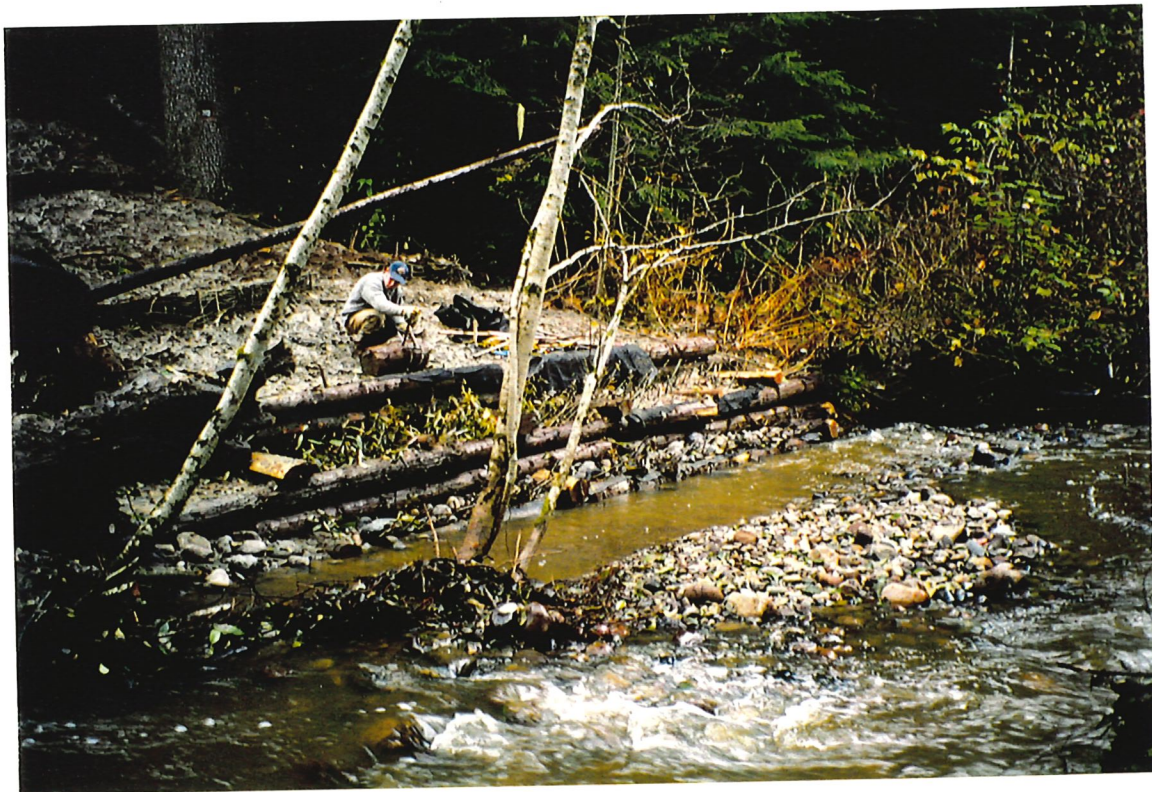
Photo 8: Crib wall structure constructed to stabilize toe of slope.

A log crib-wall structure was built to stabilize the downstream toe of the slide (Photos 8 and 11). Cedar logs donated by Bell Pole Co. were transported to the base of the slide using a cable suspension system. The crib wall was constructed at a 1/1 slope, two log-tiers in height and was stabilized by rebar pounded into the substrate through holes drilled into the logs. Deadman logs were placed and attached to the structure with rebar to provide additional strength in each level. The structure was backfilled and willow whips were planted throughout. The base of the structure was armoured with cobbles.

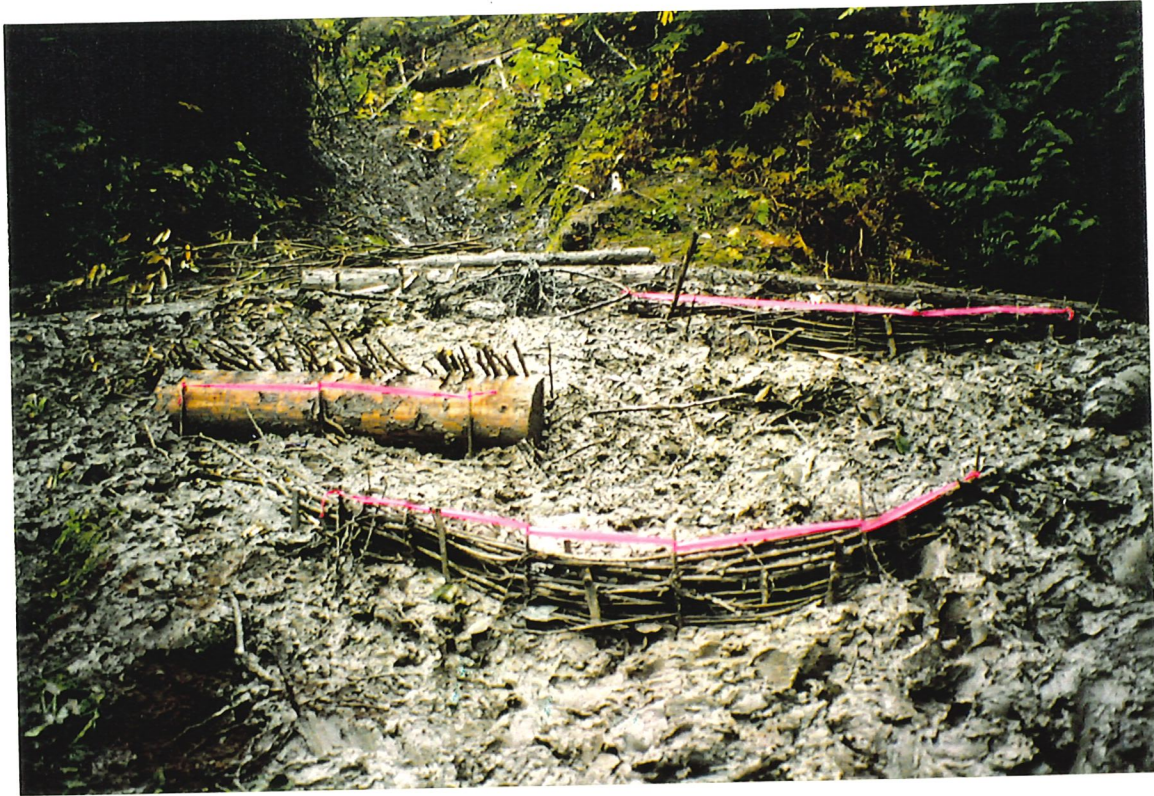
Photo 9: Bioengineering structures: live smiles (bottom and right) and modified brush layer(left).

A combination of live 'smiles' and modified brush layers were used to stabilize and revegetate the depositional zone and to prevent mud from flowing into the creek (Photo 9). Live silt fencing was placed at the outlet of one of the live pole drains to intercept sediment headed towards the creek (Photo 12).

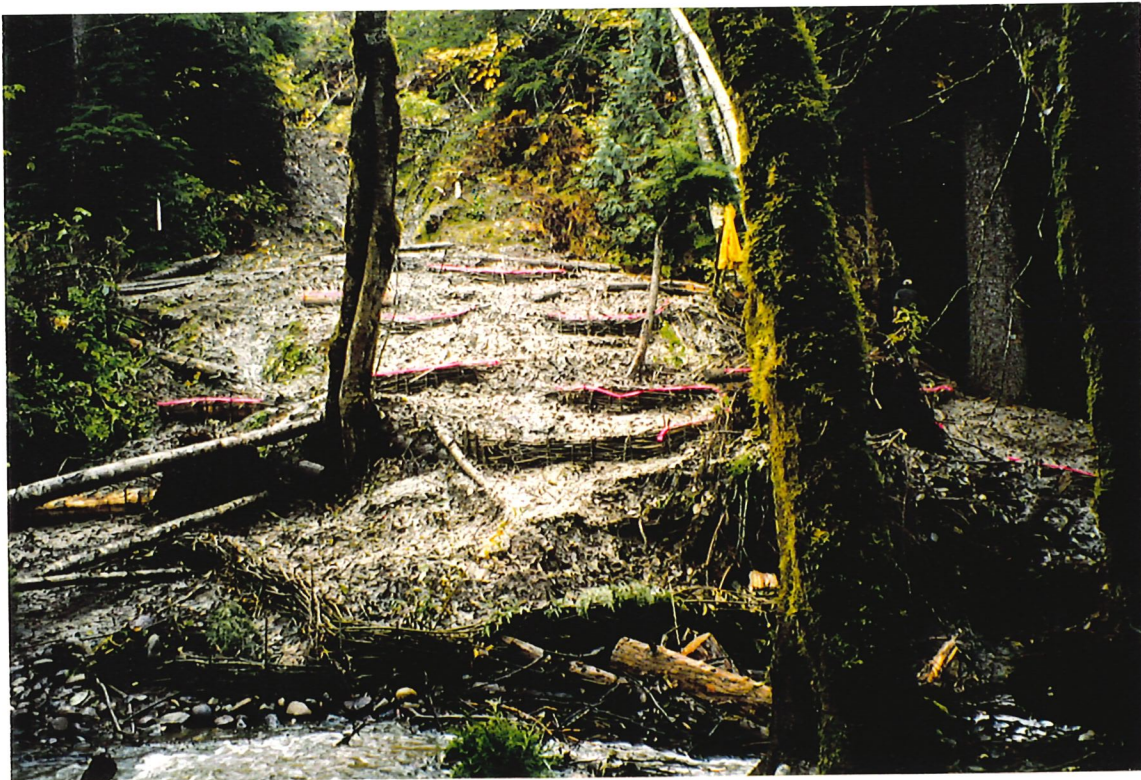
Photo 10: View of depositional zone, showing bioengineering structures.

Bioengineering structures were built from the bottom of the transport zone over the entire depositional zone to the creek (Photos 9-14).

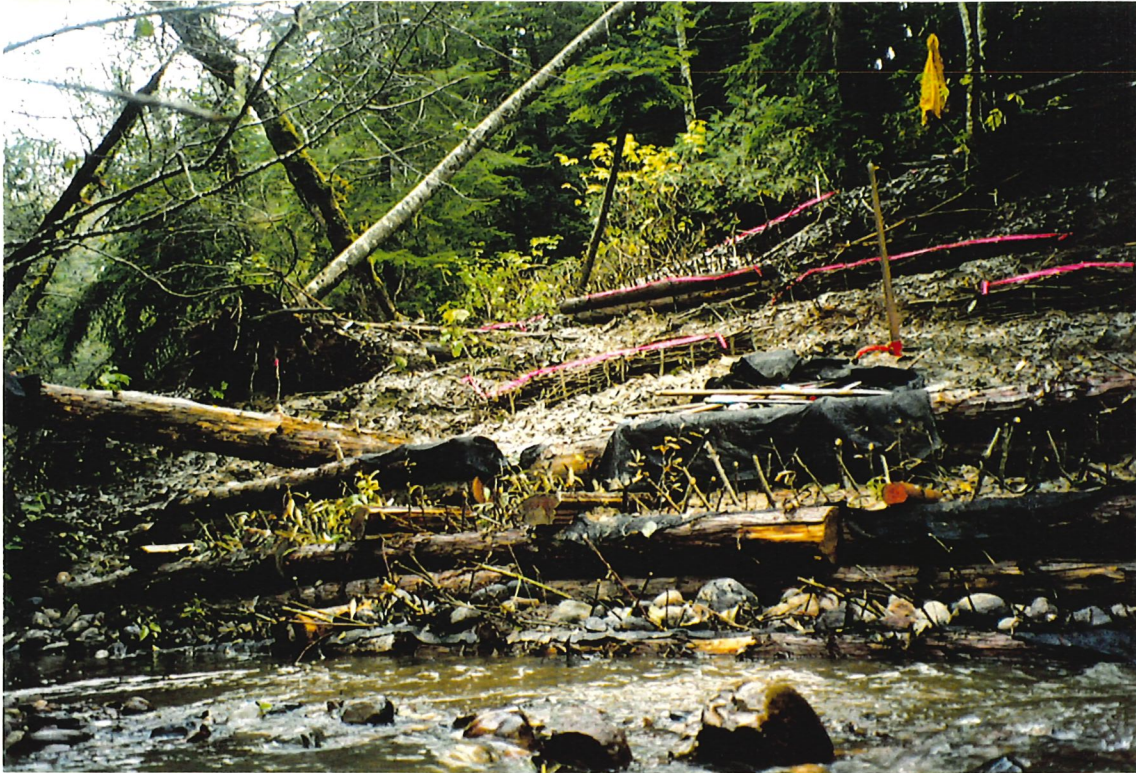
Photo 11: View from downstream of crib wall with live staking and bioengineering structures.

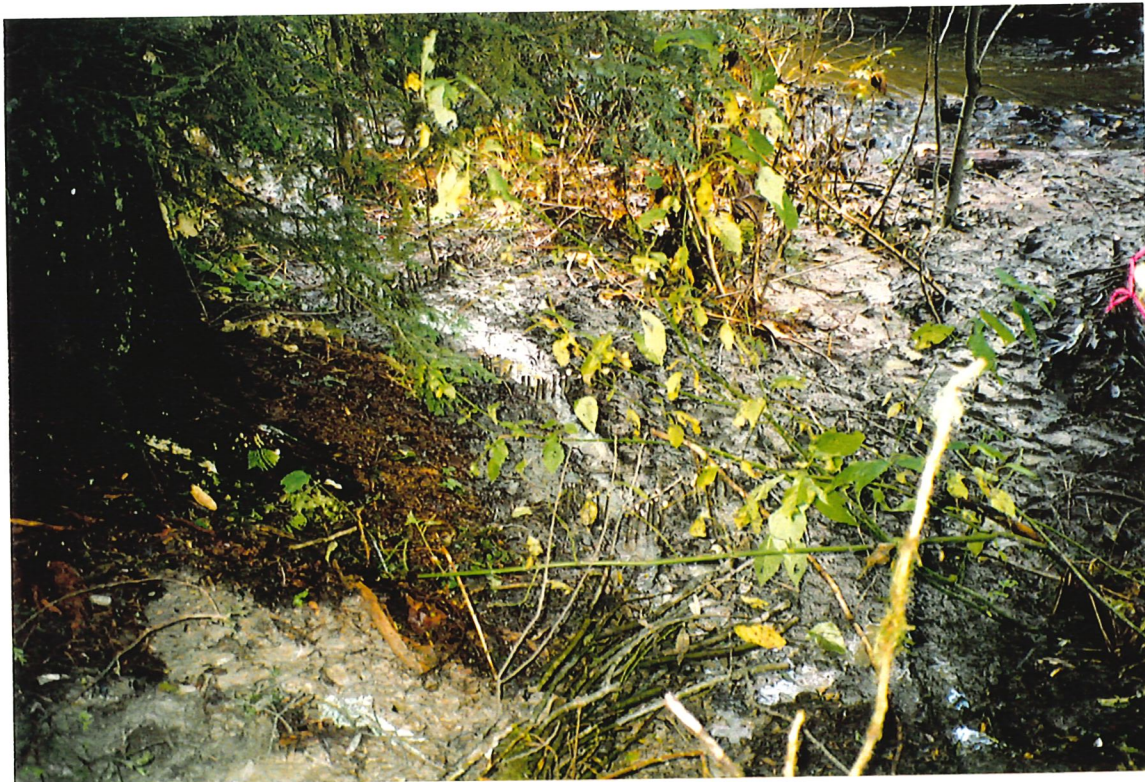
Photo 12: Live pole drain exit with live silt fencing downstream.

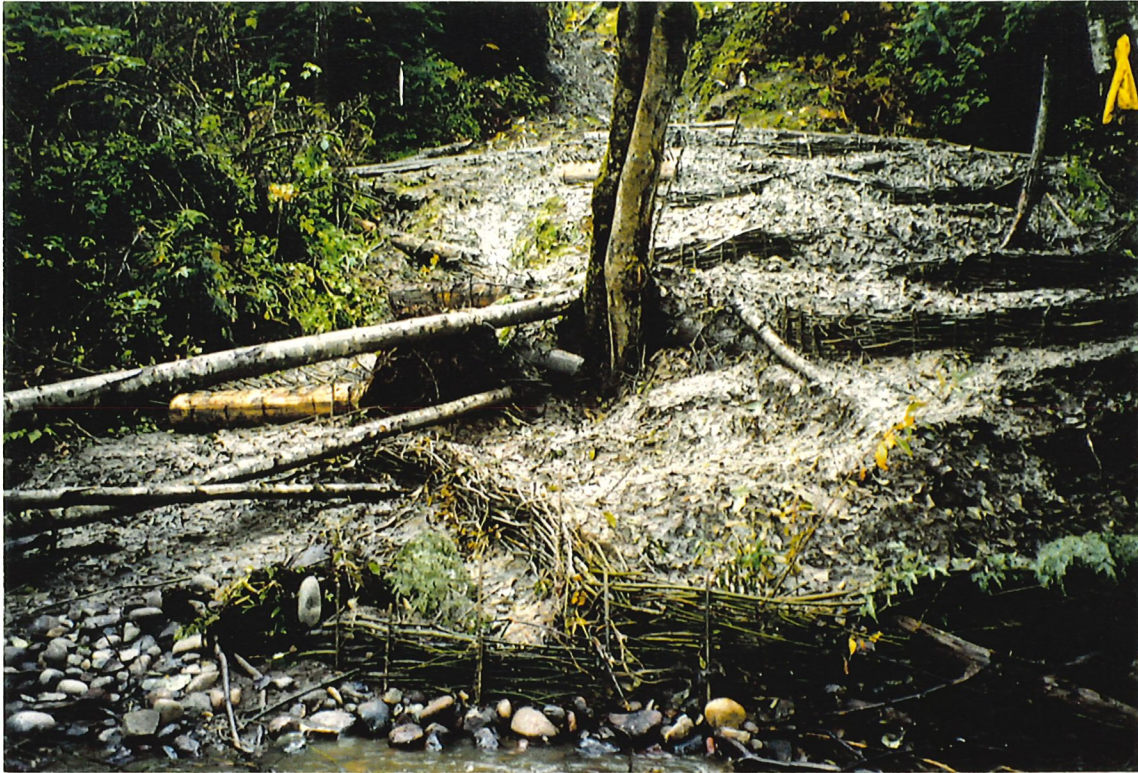
Photo 13: View of slide from right bank showing wattle fencing and bioengineering.

The debris pile at the front of the slide was partially removed. A live wattle fence was built from willow and cottonwood whips along the front of the toe, curving to cover a portion of the upstream toe. The wattle fence was built to provide some initial toe stabilization and to minimize erosion of the toe by flowing water. If the whips take, the fence will provide additional toe support and erosion control in the form of live willows with a root system.

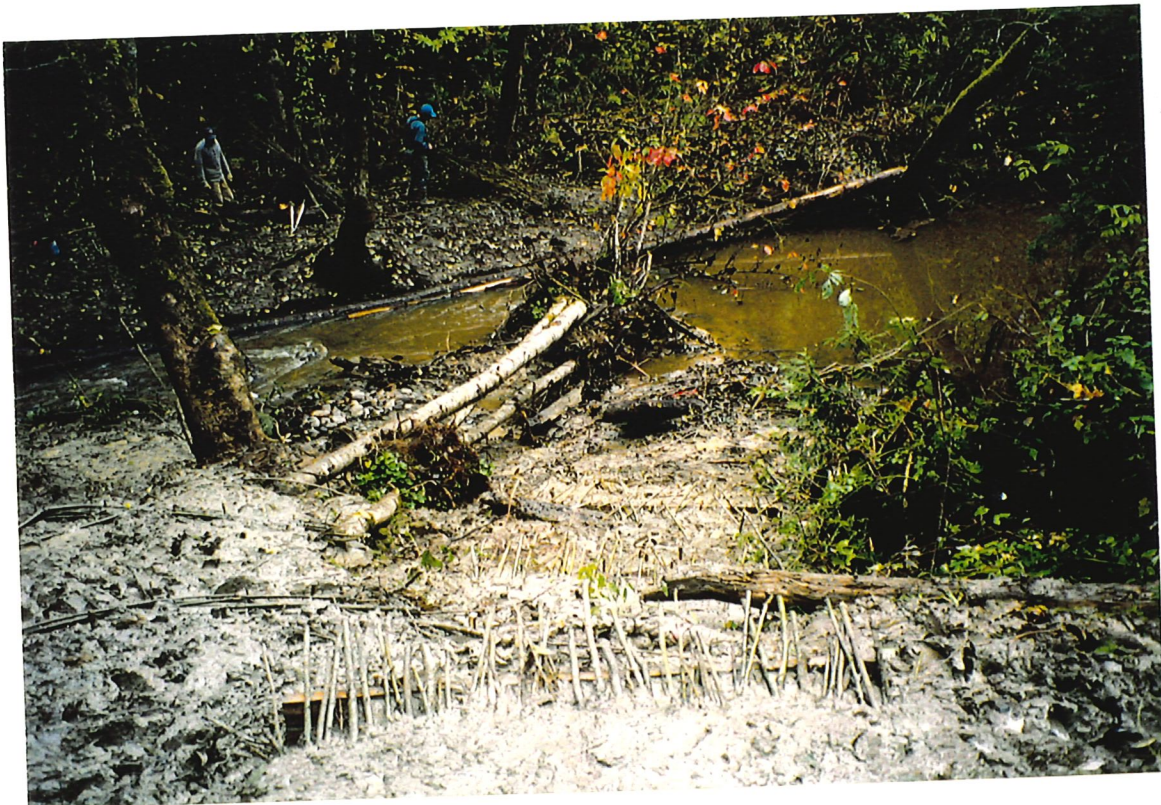
Photo 14: View of new channel showing LWD placements on right bank, modified brush layer (foreground).

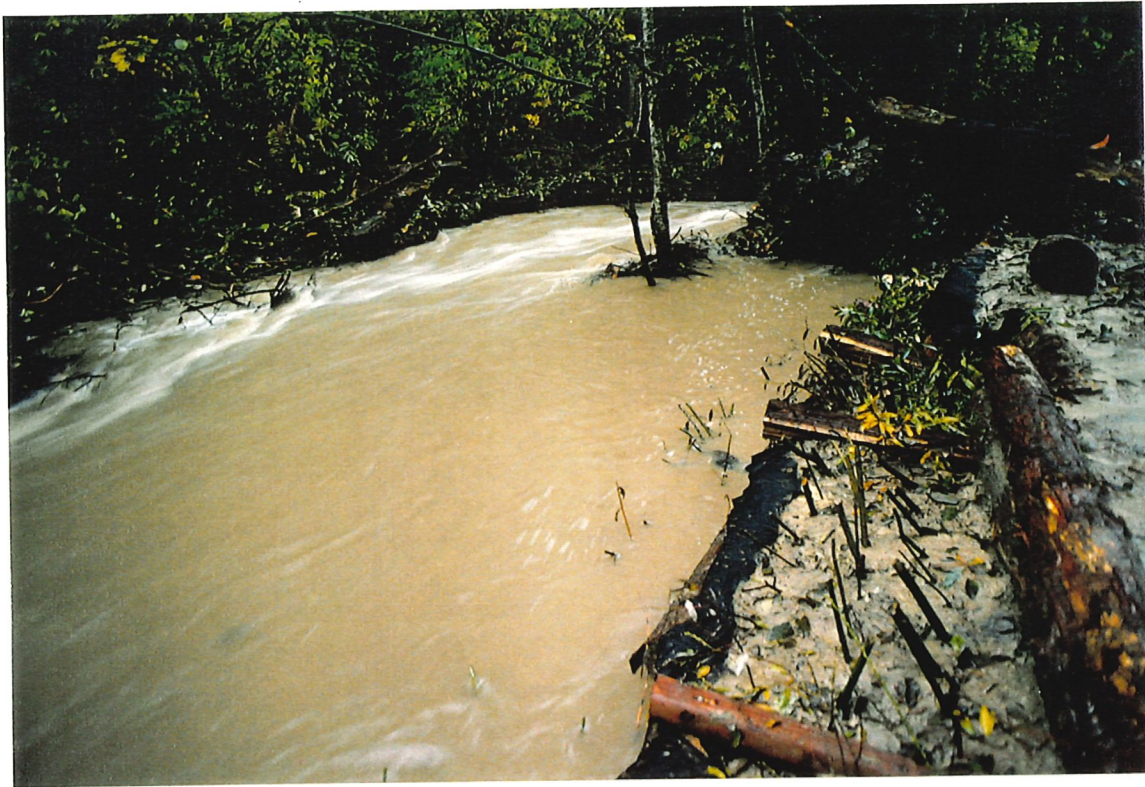
Photo 15: High water event in October showing crib wall structure protecting toe of slide.

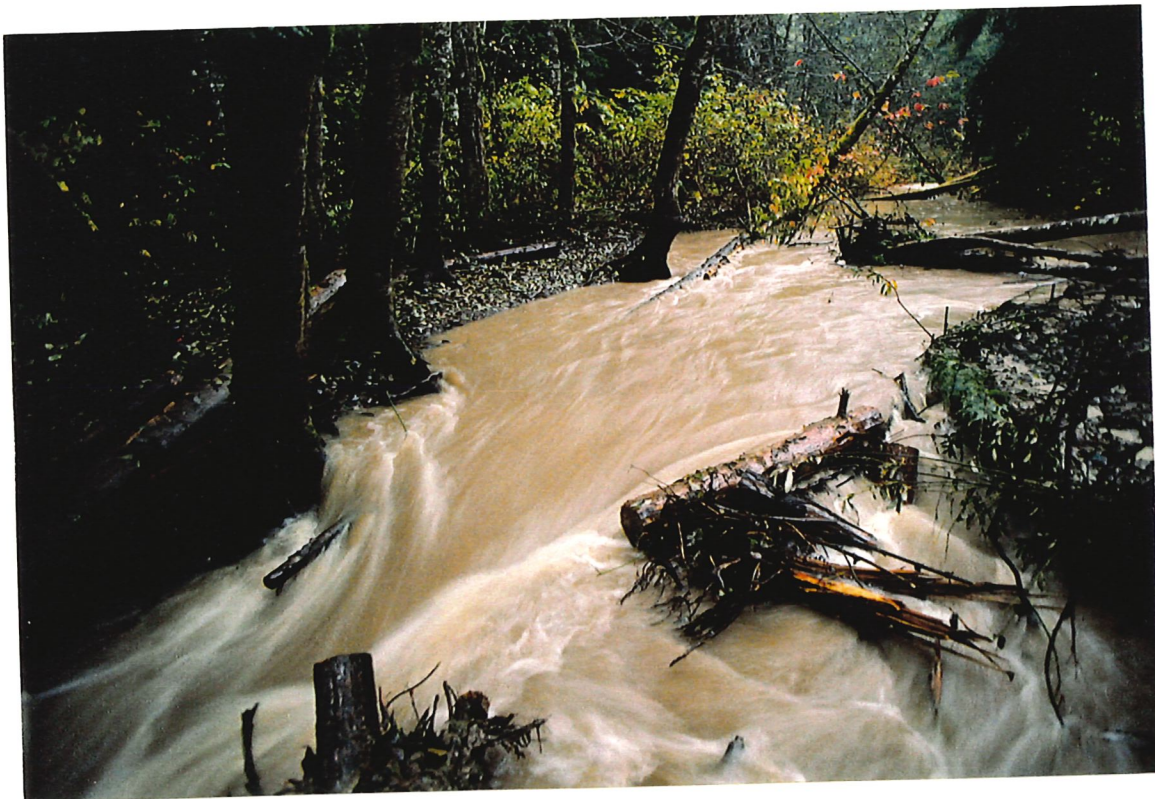
Photo 16: High water event showing new channel and LWD placement on right bank.

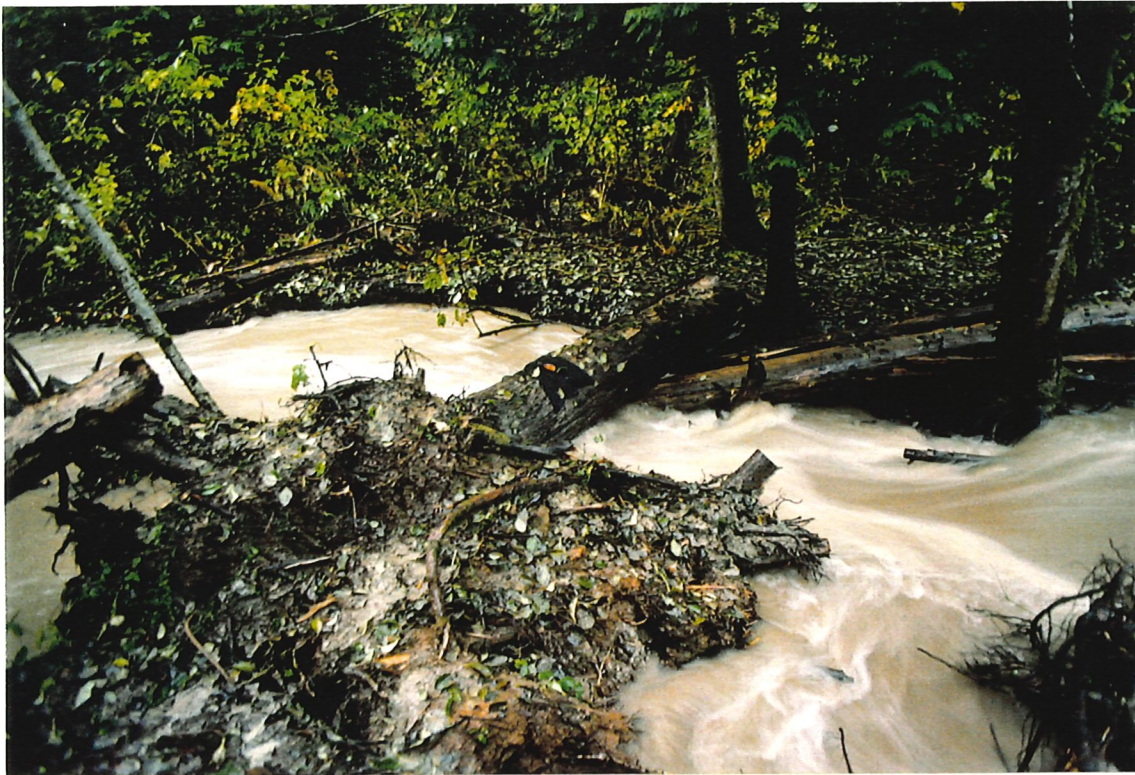
Photo 17: High water event showing water energy concentrated under LWD placement, scouring substrate.
