## Lower Skeena Fish Passage Assessment Highway #16, #37S, & CN Rail

Ken Rabnett Skeena Fisheries Commission January 2006

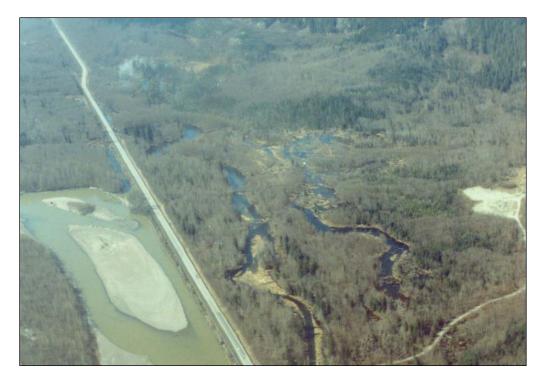
Figure 23: Aerial view to the west showing Backchannel #1, Highway #16, CN Rail, the Skeena River, and the borrow pit to the far right

Sealing the upstream side of the riprap berm that the highway and CN Rail are situated on, in the places where the backchannels come against it, would help to stabilize the backchannels water levels. Sealing the riprap could include using an impermeable layer, or possibly using material excavated when creating deep-water pockets, or material available in the nearby gravel pit. It is probable that all sites would benefit from increased backwater water levels either by excavation or by preventing leakage through the riprap by an impermeable berm, or sealing, or a combination of the two methods.

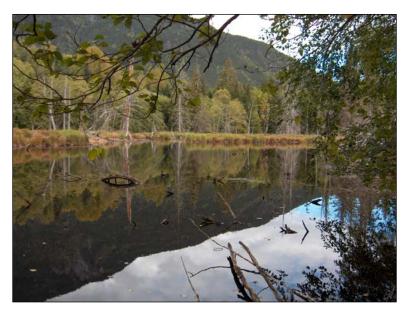
**Map Culvert No. 50** represents a small backwater pond (0.5 ha) that is cut off by Highway #16 and CN Rail. There are no culverts evident under Highway #16 or CN Rail. There are no inflow streams, and groundwater likely maintains water levels. The pond is situated approximately 800 m west of Shames River, and the location correlates to CN Rail Mile Post 16.2 and Ministry of Highways RIMS 224.1. The Skeena River is 85 m downstream from the rail line.

Fish species and presence is unknown, but from all appearances productive overwintering habitat is indicated. This type of floodplain habitat is preferred by juvenile coho and cutthroat trout for overwintering. Map Culvert No.50 is rated as medium priority; however, species and habitat use assessments and topographical elevation surveys should be completed before the type and amount of restoration efforts are prescribed.

Figure 27: Map Culvert No. 50 Upstream view of isolated pond

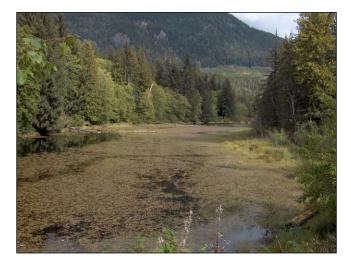
**Map Culvert No. 47** is an approximately 2 ha (500 m X 40 m wide) backchannel that has no culvert or drainage structure under Highway #16 or CN Rail. The backchannel is located 650 m east of Exstew River and is locally known as 'Exstew Backchannel'. This location correlates to CN Rail Mile Post 22.3 and Ministry of Highways RIMS 214.580.

Inflow streams are not present and the water is brackish with the surface covered with algae and aquatic vegetation growth. The backchannel likely has poor water quality and fish rearing characteristics. Trapping efforts captured no salmonids, and given that the rail and road berms have similar porosity to other sites, poor water quality is suggested as a limiting factor. The site is rated as low for restoration effort. If restoration is desired by DFO, B.C. Ministry of Environment, CN Rail, or the B.C. Ministry of Transportation, it is recommended that fish access for this backchannel be connected to the backchannel complex located approximately 80 m to the north.

Figure 34: Map Culvert No. 47 View upstream from highway

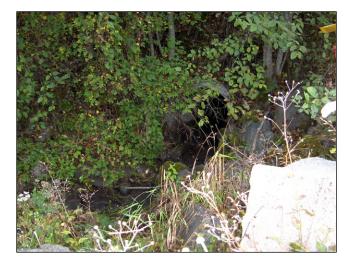
The outfall drop onto the coarse riprap is 4.75 m to the Skeena, and the final 5.0 m of the culvert is a steep 13.5% grade. Current conditions in the Skeena River at the culvert outlet are fast in most flows as it is on an inside bend. Restoration options include establishing a concrete fish ladder, but the position within the river channel and high flow conditions likely pose significant maintenance problems or failure. Re-positioning the creek outlet eastward to a more suitable site in regard to discharge and gradient is complicated due to private property concerns. This culvert restoration priority is rated low.

Figure 41: Map Culvert No. 83 View of inlet downstream

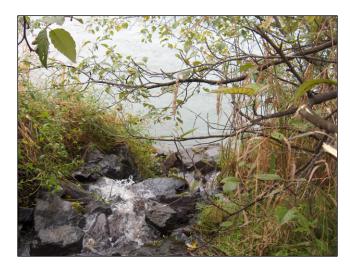
Figure 42: Map Culvert No. 83 View of outlet downstream to Skeena River

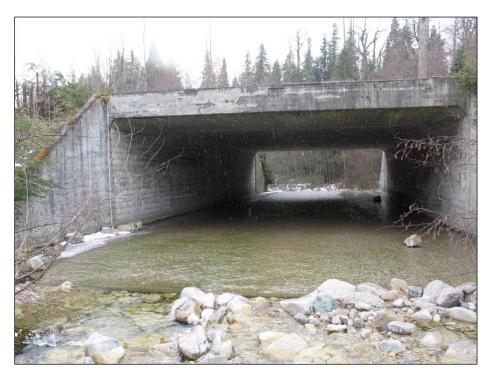
Figure 48: Furlong Creek box culvert, view shows inlet downstream.

The Furlong Creek concrete box culvert is rated as a high priority for restoration due to the fish species involved, habitat values upstream and downstream, the type of barrier, and the amount of habitat gained. Initial discussions with DFO habitat restoration biologists have identified several restoration options. The most cost effective option that will fulfil restoration objectives is to create a concrete apron at the inlet that will force all but the high flows down one side of the culvert. Establishing a concrete sill down the length of the culvert will ensure flows stay entrained to the side. It is anticipated that concrete baffles will be needed to slow the water velocity and facilitate upstream fish passage.

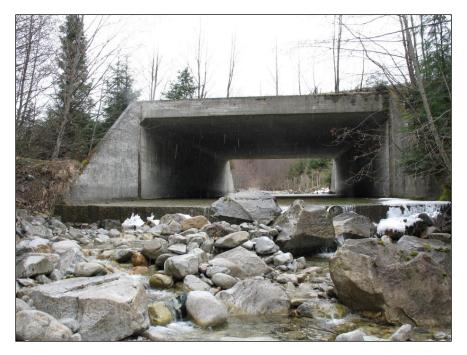
Figure 49: Furlong Creek showing outlet upstream

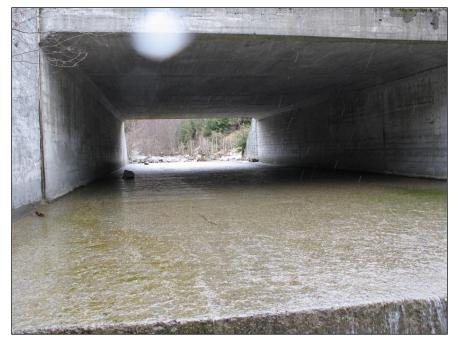
Figure 50: Furlong Creek showing outlet upstream
