Highway #16 Fish Passage Assessment in Middle Skeena Watershed

Prepared for:
Department of Fisheries and Oceans
&
Pacific Salmon Commission

By:
Ken Rabnett & Lance Williams
Gitksan Watershed Authorities
December 2004

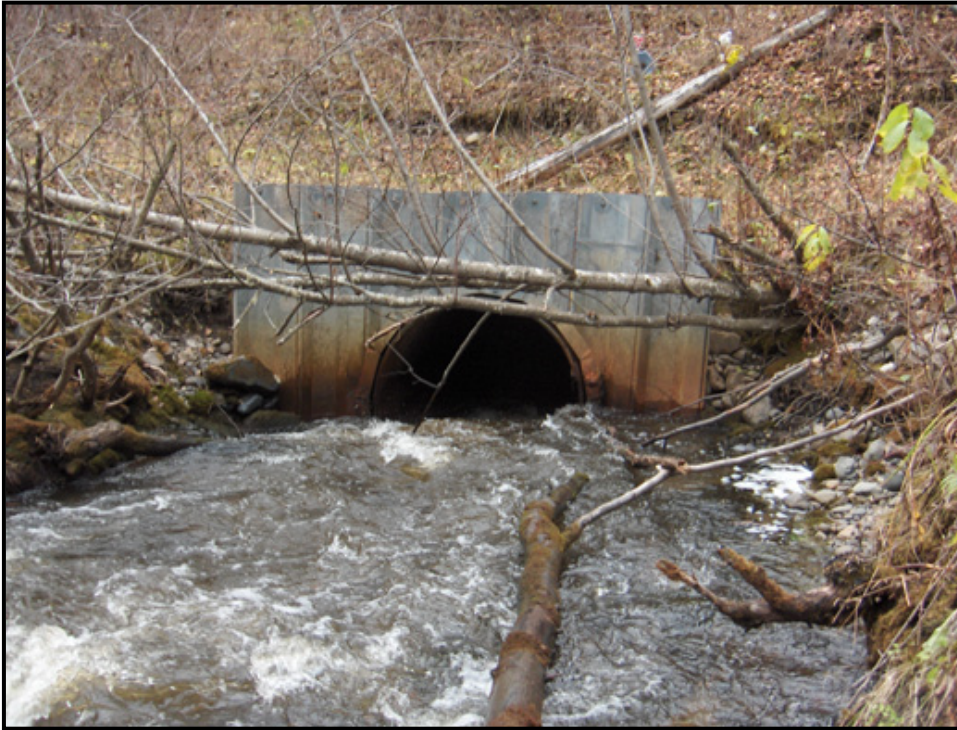
**Station
Creek: inlet
downstream**

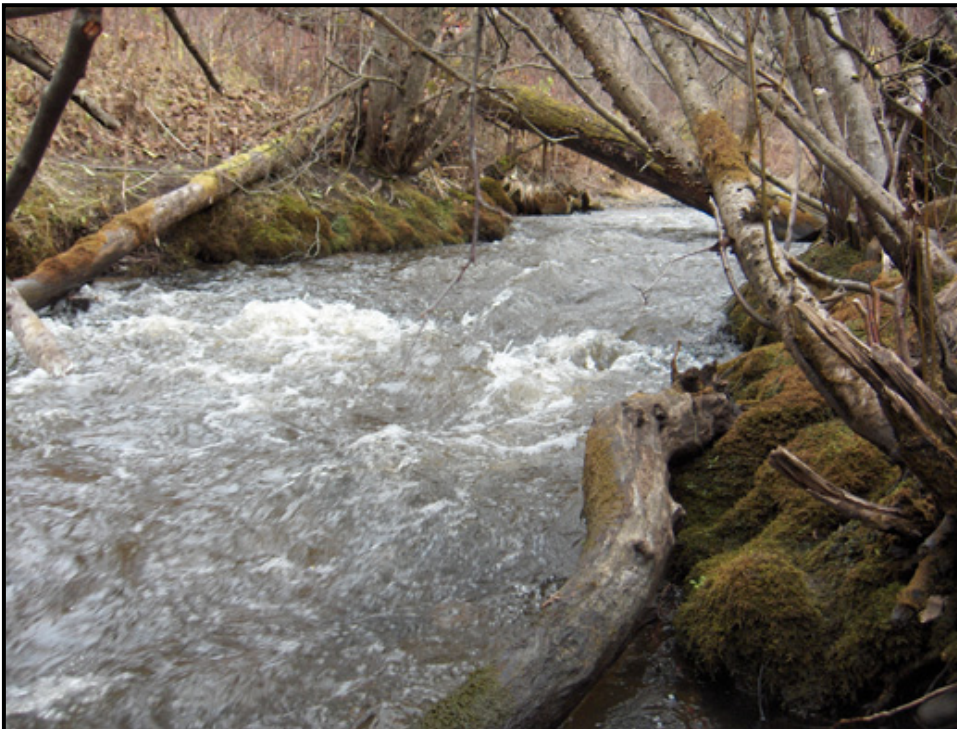
**Station
Creek: inlet
upstream**

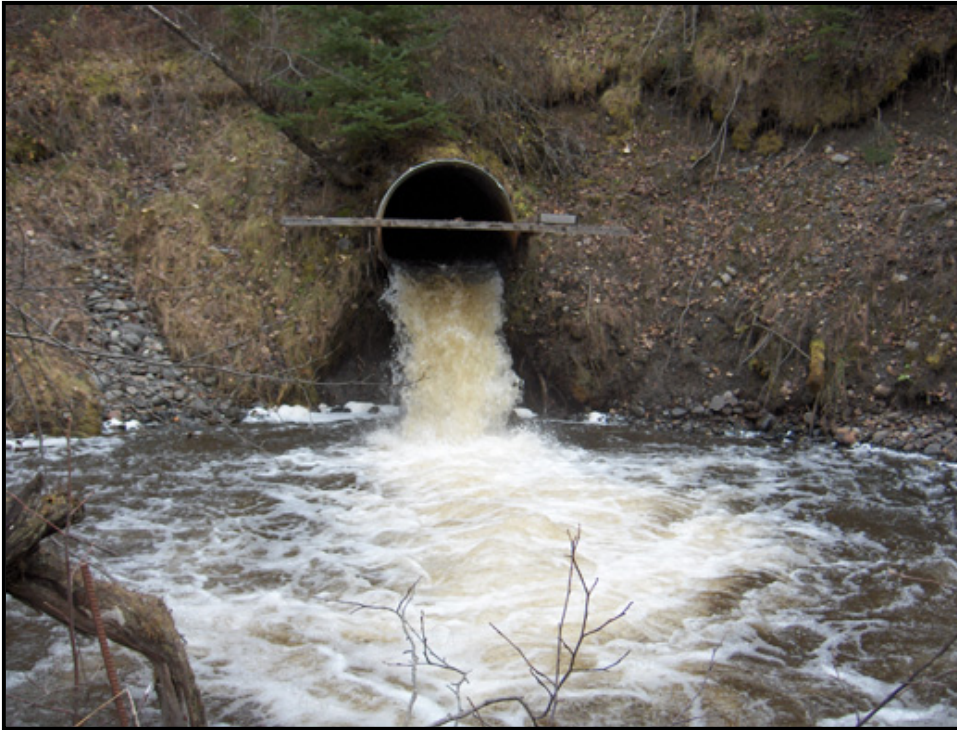
**Station
Creek: outlet
upstream**

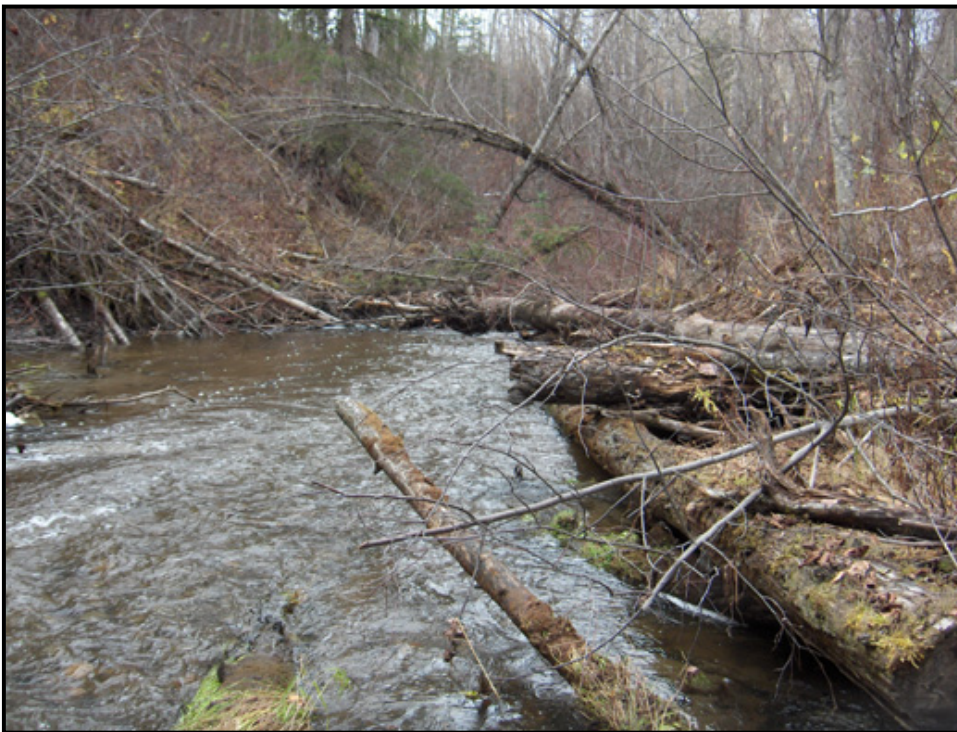
**Station
Creek: outlet
downstream**

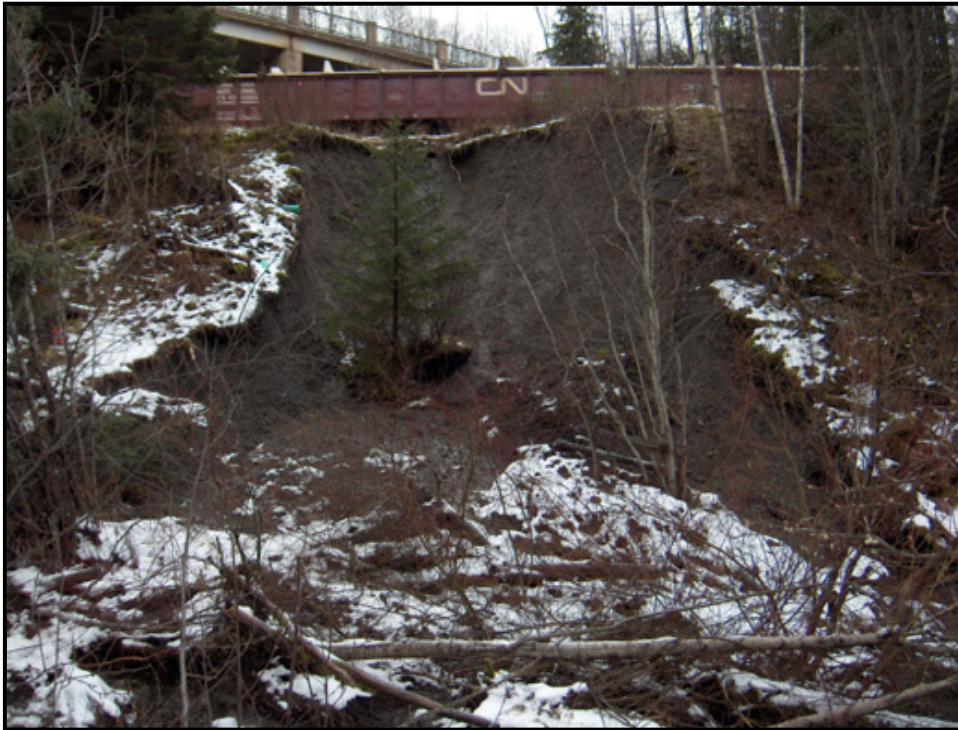
**Station
Creek:
November
22, 2004,
view across
creek 7 m
downstream
of outlet.**

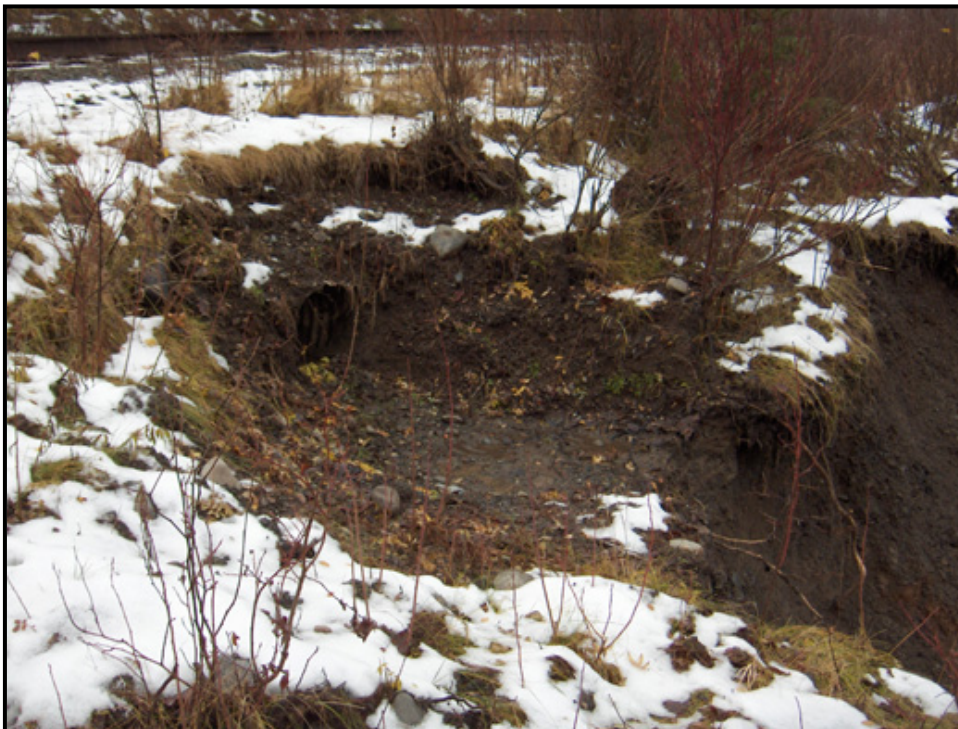
**Station
Creek slide
initiated by
ditchline
drainage
from
Highway
#16.**

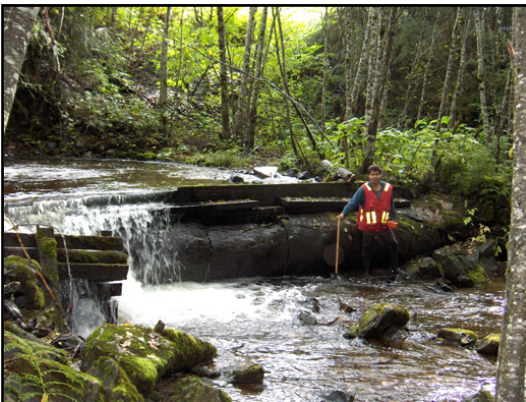
Fish Habitat Quality	High
Beaver Activity/Type	None Observed
Barrier Evaluation:	Full if previous rehab works fail
Barrier Type	Outfall drop
Prescription	Log stream works need renewal; install rock to backup and strengthen logworks.
Comment

**Singlehurst Creek: Log stream works
backwatering culvert.**

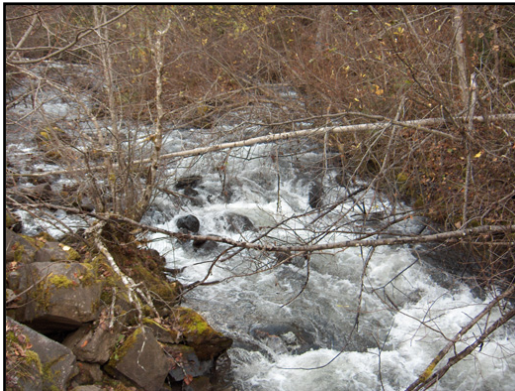
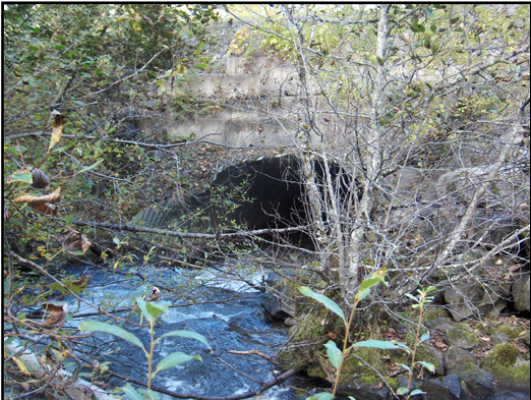
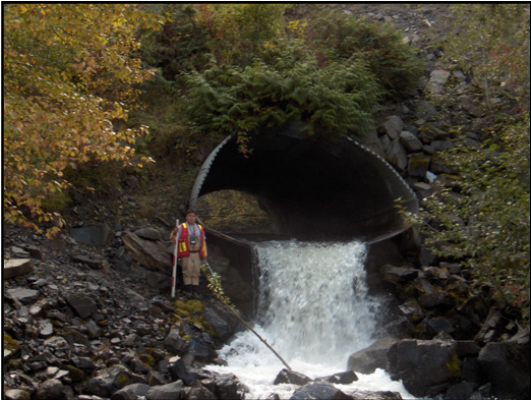
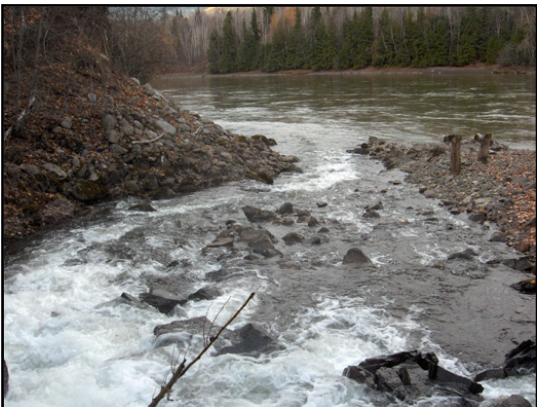
Shandilla Creek: Inlet upstream

Shandilla Creek: Inlet downstream

Shandilla Creek: Outlet upstream

Shandilla Creek: Outlet downstream

Replacement of the Shandilla Creek culvert with an open bottom structure is recommended in the near term to ensure fish passage. DFO, Ministry of Transportation, and Gitwangak Watershed managers are encouraged to meet and discuss solutions to this outstanding problem.

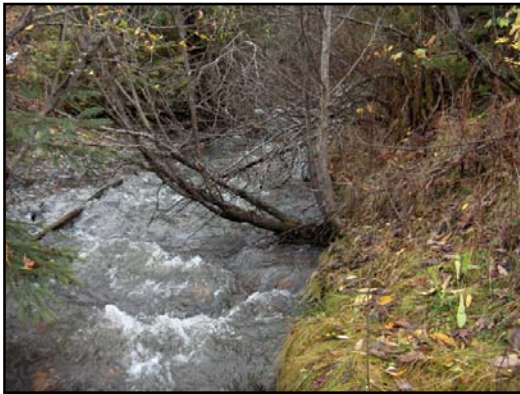
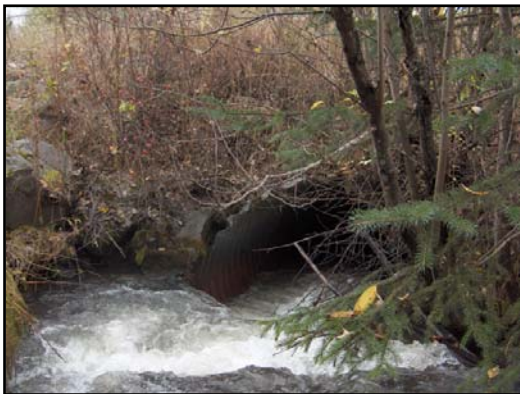
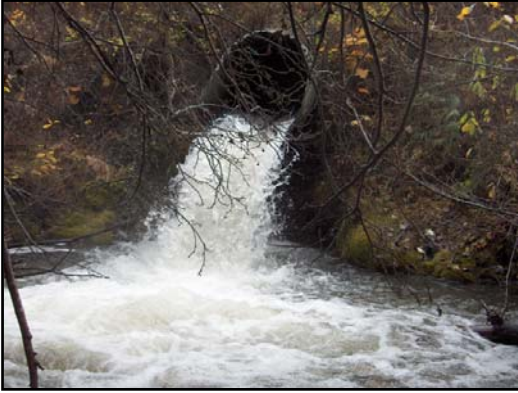
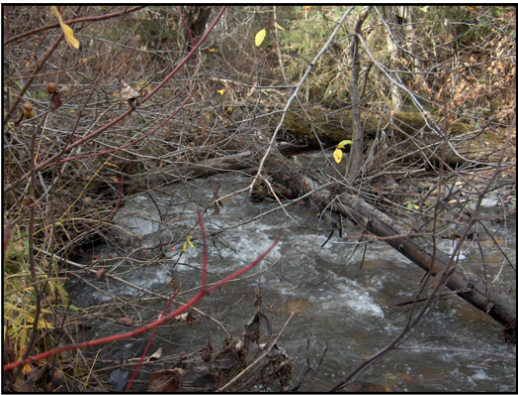
Andimaul Creek: Inlet upstream

Andimaul Creek: Inlet downstream

Andimaul Creek: Outlet upstream

Andimaul Creek: Outlet downstream

The Highway #16 crossing of Andimaul Creek received a prioritization score of 46, which falls within the highest ranking score category (SKR 2003). Replacement of the Andimaul Creek culvert with an open bottom structure is recommended in the near term to ensure fish passage.

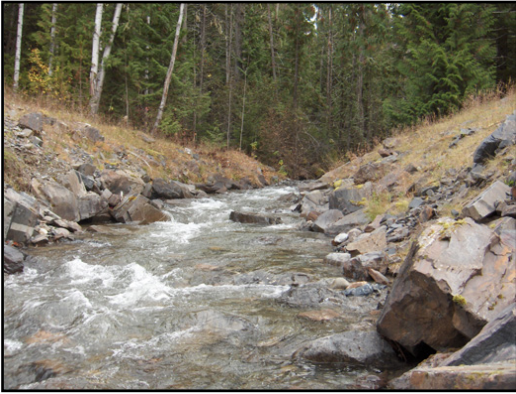
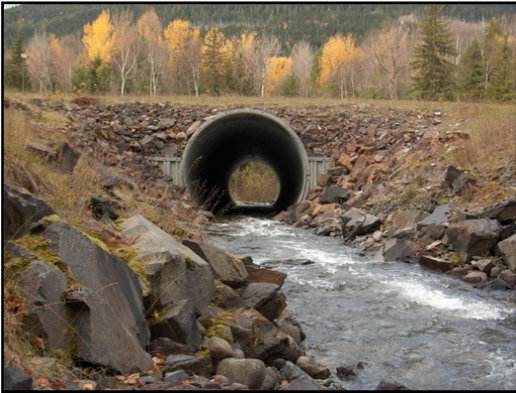
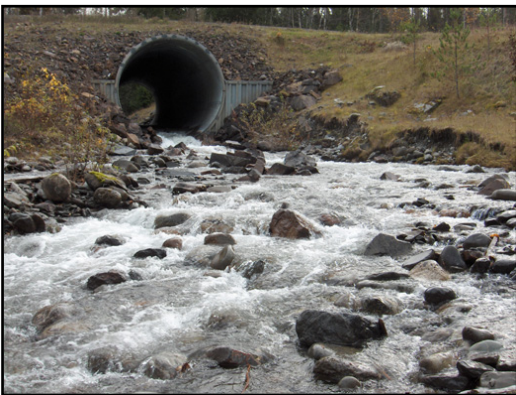
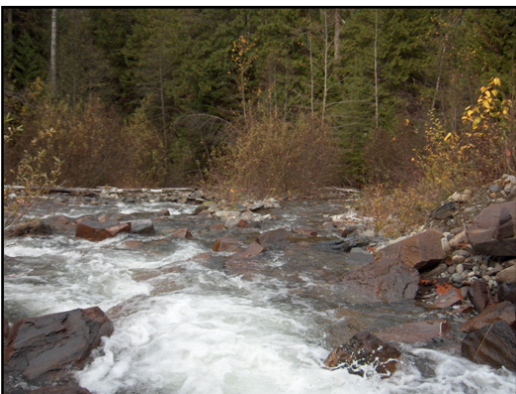
Flint Creek: Inlet upstream

Flint Creek: Inlet downstream

Flint Creek: Outlet upstream

Flint Creek: Outlet downstream

The Highway #16 crossing of Flint Creek received a prioritization score of 46, which falls within the highest ranking score category. Replacement of the Flint Creek culvert with an open bottom structure or backwatering the outlet with weirs is recommended in the near term to ensure fish passage.

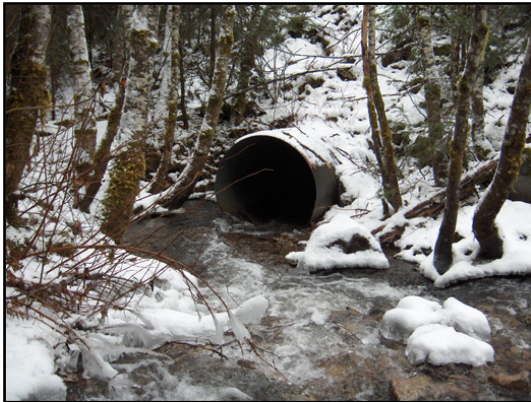
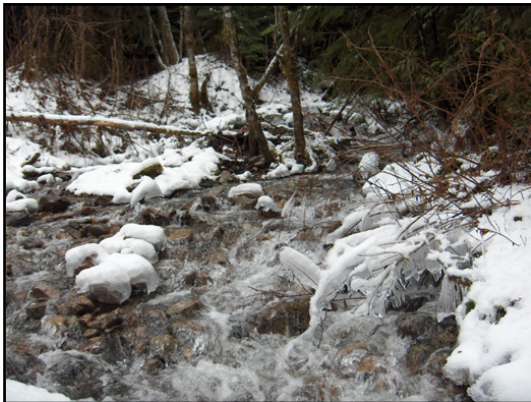
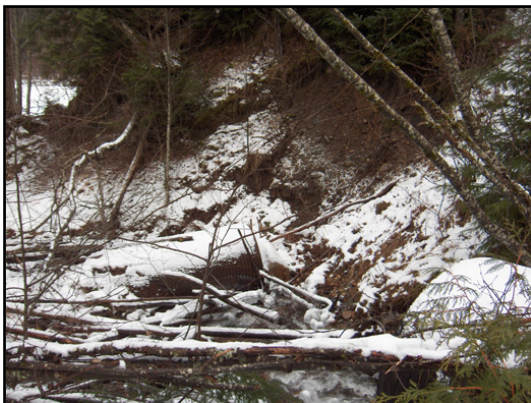
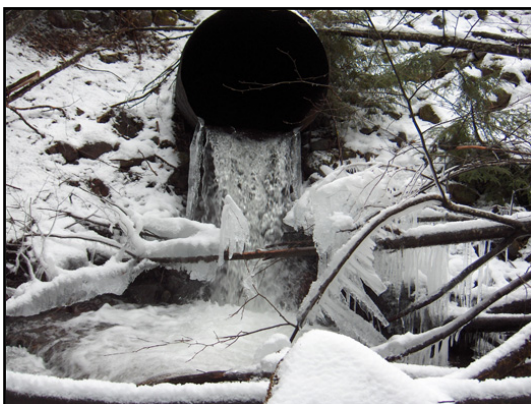
There is an outfall barrier at all flows with a 1.7 m drop. An old culvert lying perpendicular to the channel approximately 9 m downstream of the outlet has caused moderate erosion to the right bank; this situation needs to be remedied. A fish and fish habitat assessment is recommended for this unnamed creek to enable fish use, seasonal flows, and habitat values to be clearly stated.

Unnamed Stream # 76: Inlet downstream

Unnamed Stream # 76: Inlet upstream

Unnamed Stream # 76: Outlet downstream

Unnamed Stream # 76: upstream
