Fish Passage Assessment of Kispiox Forestry Road Stream Crossings

Ken Rabnett & Tim Wilson
Gitksan Watershed Authorities
January 2007

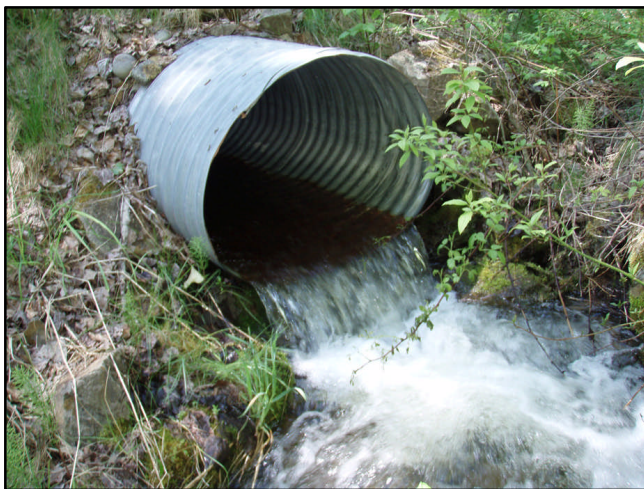
Figure 2. View upstream of Site No. 145 culvert outlet. This outfall drop is a barrier to most fish.

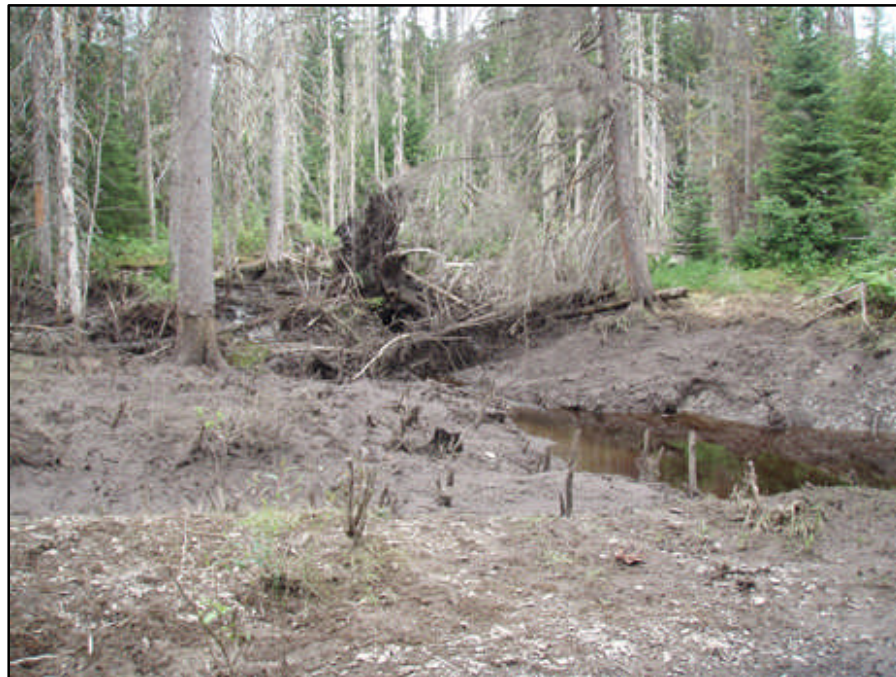
Figure 3. Typical ponded area following beaver dam failure. Site 132 located on a tributary to Ironside Creek.

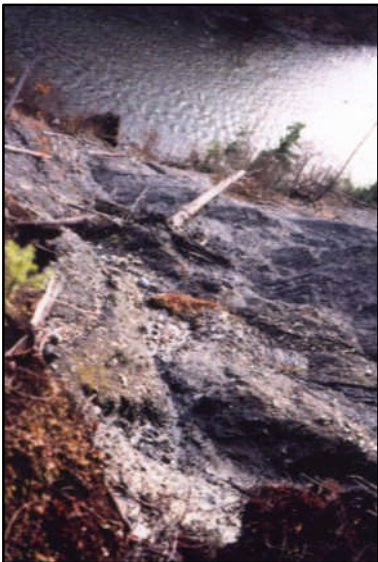
Figure 7. Cutblock slumping into Sweetin River

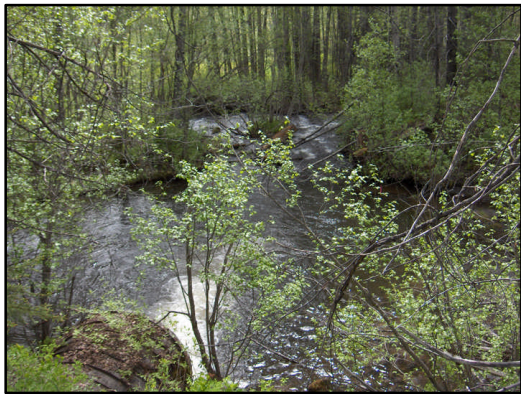
Figure 14. Clifford Creek culvert outlet.
View downstream from outlet.
Original channel is to the right of photo.

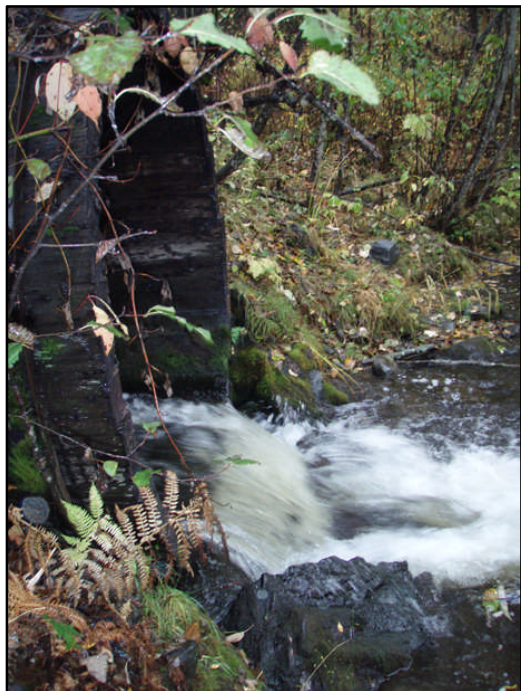
Figure 15. Clifford Creek outlet.
Side view shows culvert discharge onto boulders

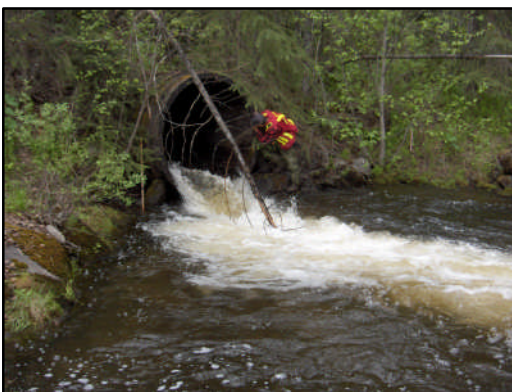
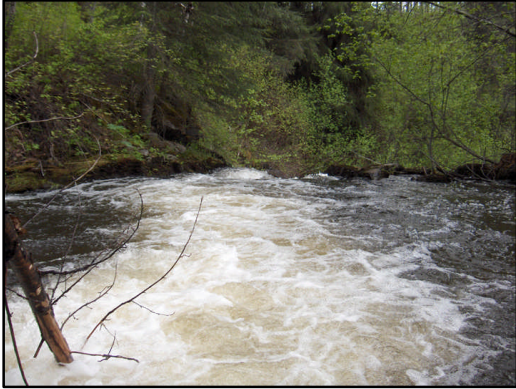
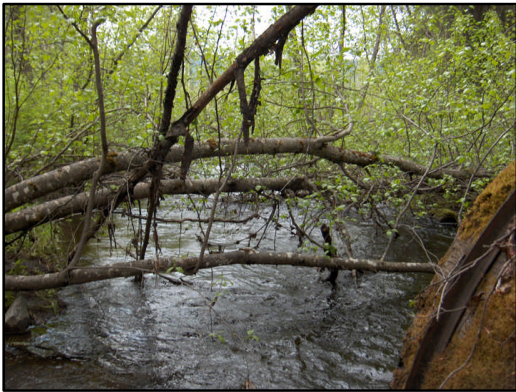
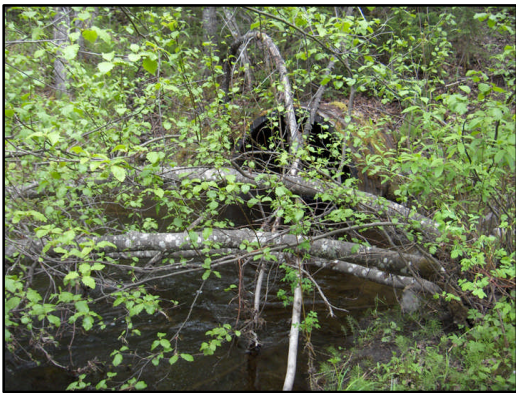
Skunsnat Creek Site 12

The Kispiox Trail crosses Skunsnat Creek at approximately 70.3 km. Since the early 1960s when the culvert was installed there have been recurring fish passage problems and implementation of short-term solutions. Baffles were first installed in 1965 to assist fish in low and high flows; as well, it was recommended that the culvert be replaced by a bridge (DFO 1966, Hancock *et al.* 1983). The fish ladder below the road crossing washed out in the October 1978 flood; a jump pool was constructed in 1979 by Department of Highways; and baffles needed to be replaced in 1981 (Hancock *et al.* 1983). The drainage has been heavily harvested except for the mid-portion which is a burn area. Overall logging related impacts are rated moderate to high and primarily consist of road, channel, and riparian disturbance.

**Figure 17. Skunsnat Creek culvert outlet.
View of outlet from downstream.**

Skunsnat Creek culvert restoration is rated High Priority with a matrix score of 46. A concrete bridge is recommended to restore suitable flows, ease fish passage, and provide low maintenance efforts.

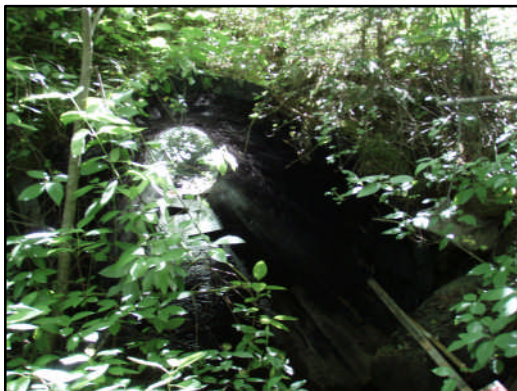
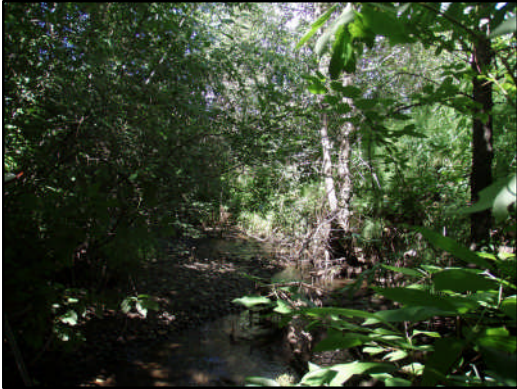
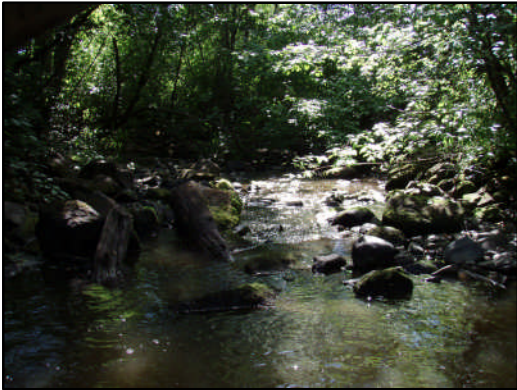
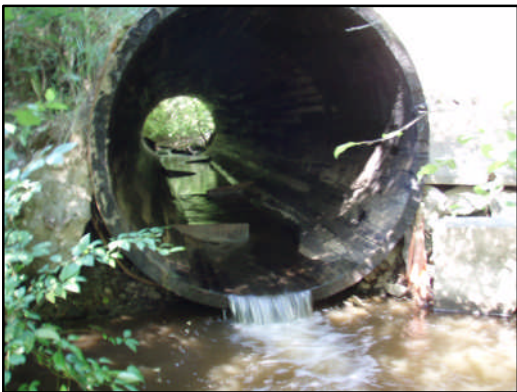
**Figure 24. Murder Creek outlet.
View upstream to outlet.
Note the few remaining baffles.**

Murder Creek culvert restoration is rated High Priority with a matrix score of 46. A concrete bridge is recommended to restore suitable flows, allow the channel to re-grade, ease fish passage concerns, and ensure low maintenance efforts. Until a bridge is in position, further rehabilitative plans and activities downstream should cease.

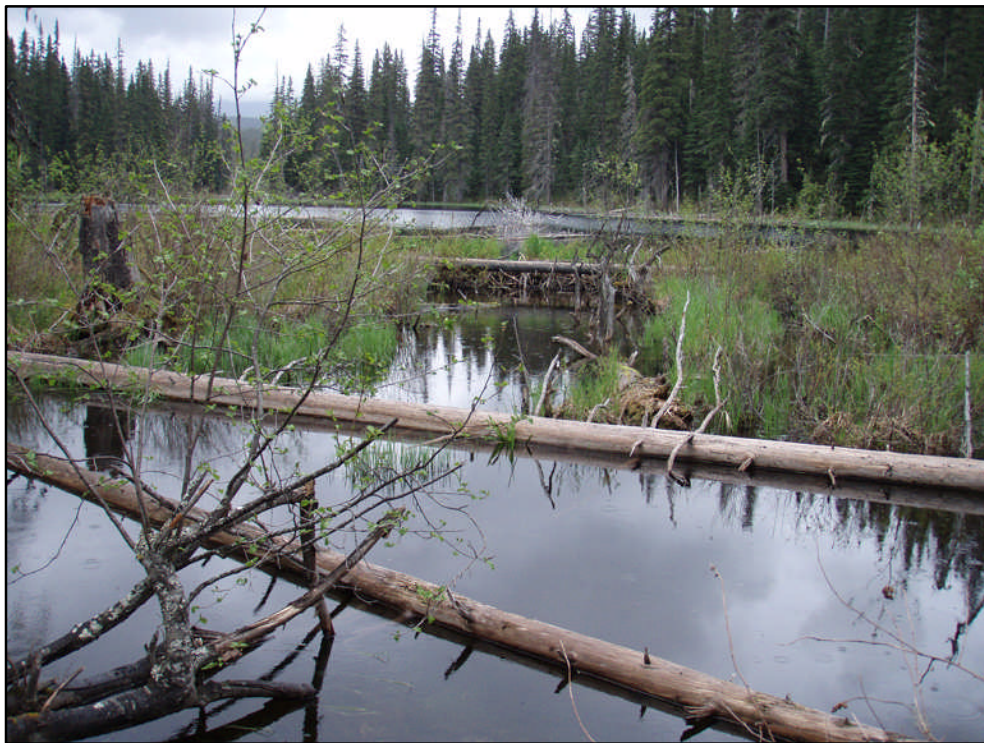
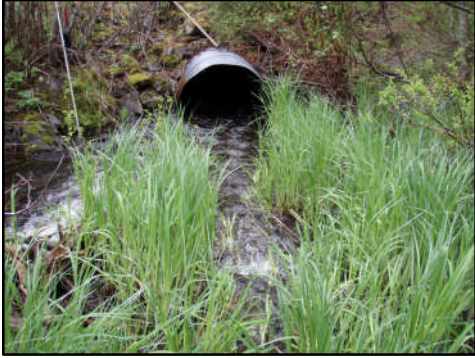
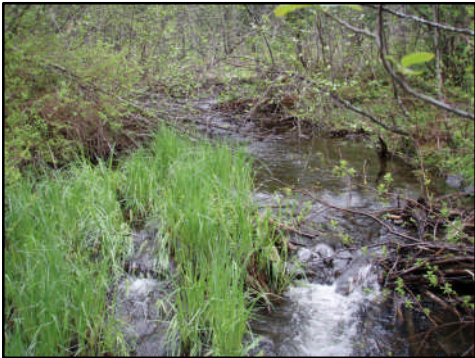
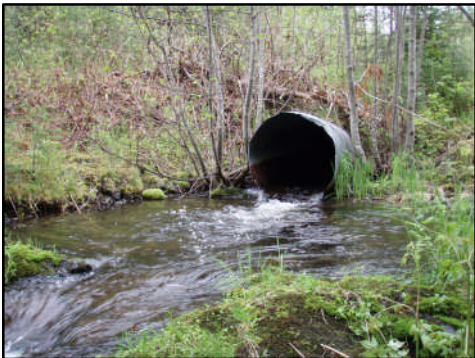
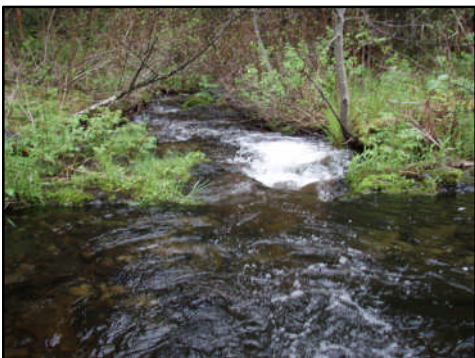
The Hodder Creek culvert supports the Kispiox Trail at approximately 88 km. The culvert controls access to high value spawning and rearing fish habitat in the lake and about 8.3 km of tributaries upstream of Hodder Lake. Bedrock limits the culvert outlet pool depth and the downstream gradient is 6%, which together do not allow a backwater solution. The culvert is undersized to adequately pass a 100 year high flow event and is 23 m downstream of a beaver dam that could potentially fail or be breached. Excess culvert velocity (0.95 m/s average on moderate flows), an outfall drop barrier at some flows, and low in-culvert water depth along with insufficient outlet pool depth limit fish passage. Hodder Creek culvert restoration is rated a High Priority Restoration site with a matrix score of 46. An open bottom arch or open bottom structure is recommended.

**Figure 25. Hodder Creek upstream of culvert.
View shows beaver dam and lake in background**

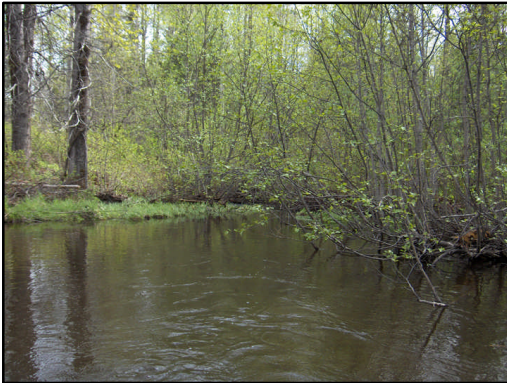
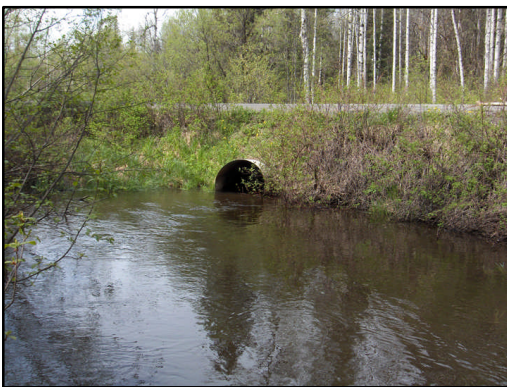
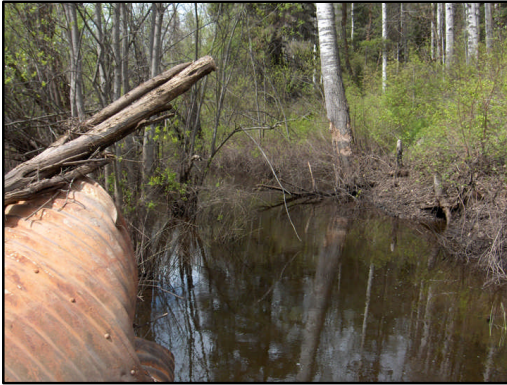
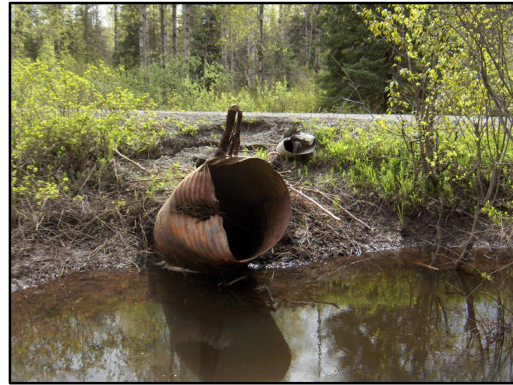
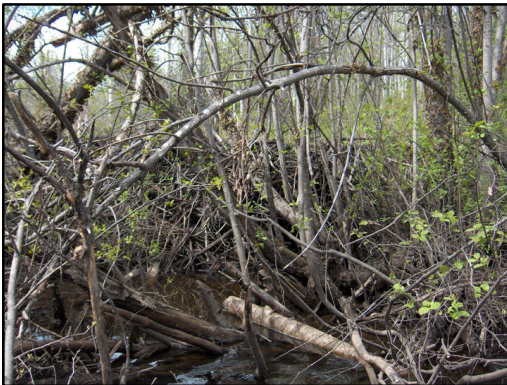
Kispiox Trail crosses Kline Creek culvert at 51 km. The culvert has historically been a fish passage problem primarily due to beaver activity with debris accumulations, dam failures, and screens on the inlet. The 500 CMP overflow culvert is crushed and dysfunctional. The 1100 main culvert is undersized for 100 year flood events, and more particularly, for beaver impoundments outbursts. The culvert is a velocity barrier for juvenile fish. Kline Creek culvert is rated medium priority with a matrix score of 42. An open bottom arch or open bottom structure is recommended.

**Figure 34. Kline Creek culvert inlet.
View to beaver dam 29 m upstream.**

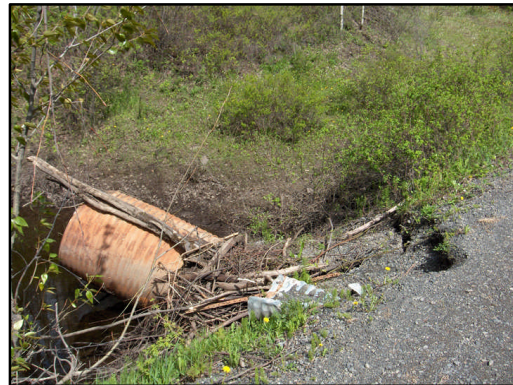
**Figure 35. Kline Creek culvert inlet.
View shows failure in road shoulder**

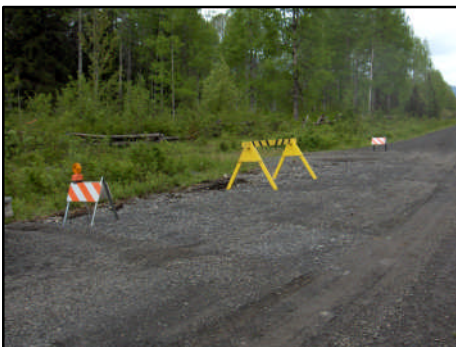
**Figure 36. Kline Creek
View shows erosion where Kline flowed over Kispiox Trail**

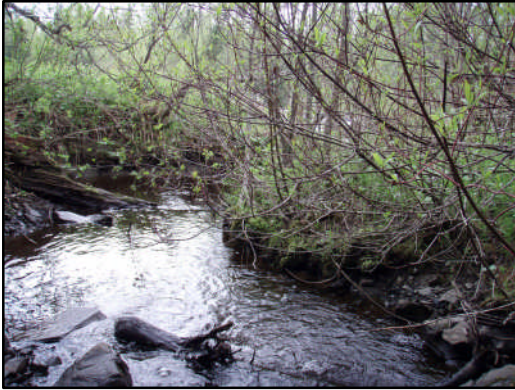
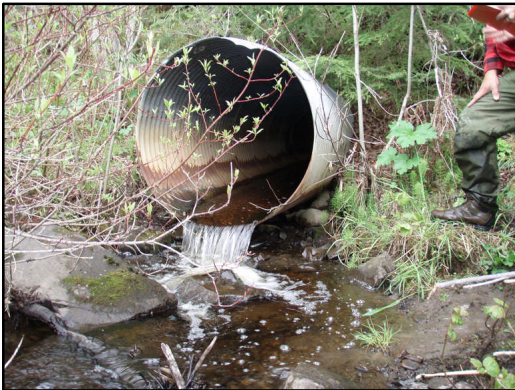
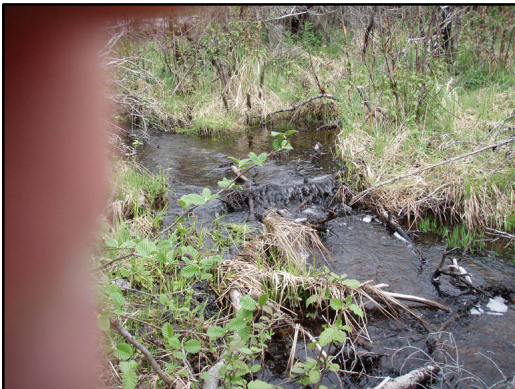
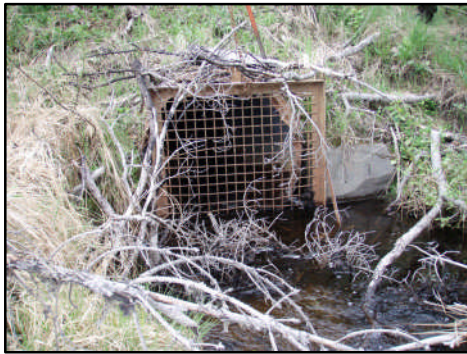
**Unnamed Stream
Site 74**

Site 74 culvert drains a small second order low gradient stream about 1.95 km in length that flows into the lower reach of Sweetin River, approximately 400 m downstream of the Sweetin Bridge. The stream is backwatered by Sweetin River 18.4 m downstream of the culvert. The stream provides excellent coho, chinook, and steelhead juvenile habitat upstream and downstream of the culvert. The culvert has a small outfall drop (11 cm) that could be easily backwatered 2.5 to 3 m downstream to enable easy juvenile passage into the culvert. Site 74 is rated moderate priority due to the fish values and ease of modifications enabling fish passage. Maintenance issues involve cleaning debris at the inlet.

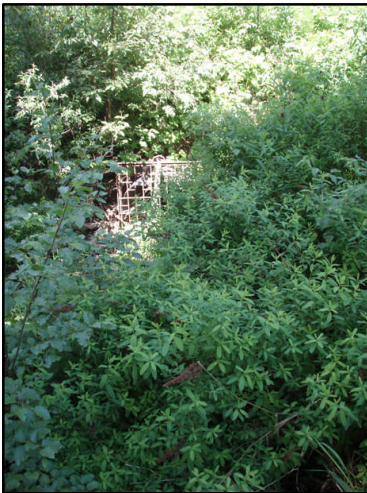
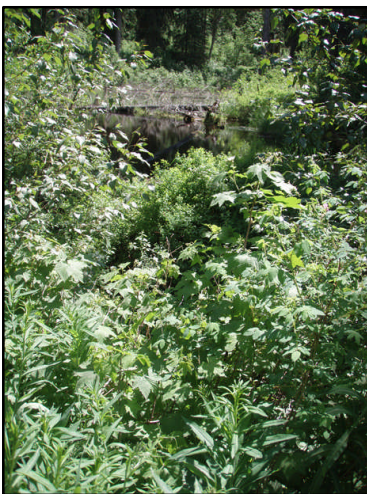
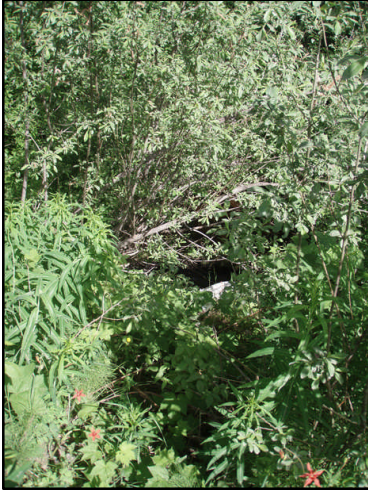
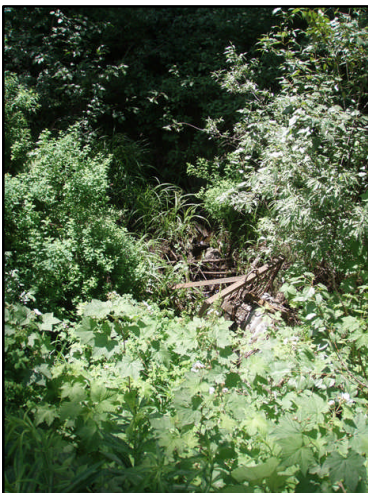
Site 240 culvert drains a small second order low gradient stream about 5.6 km in length that flows into Kispiox River. The stream provides excellent coho, chinook, and steelhead juvenile habitat upstream and downstream of the culvert. An unknown species of fry were observed trying to jump the 20 cm outfall drop into the culvert with no success. Traps set below the culvert with a 4 hour soak time yielded 2 cutthroat, 14 coho fry, and 1 rainbow; the same effort upstream of the culvert yielded no fish. Site 240 is rated moderate priority due to the fish values and ease of modifications enabling fish passage. An open bottom structure or a larger diameter culvert such as a 2000 CMP embedded 20% is recommended. Maintenance issues involve cleaning debris at the inlet.

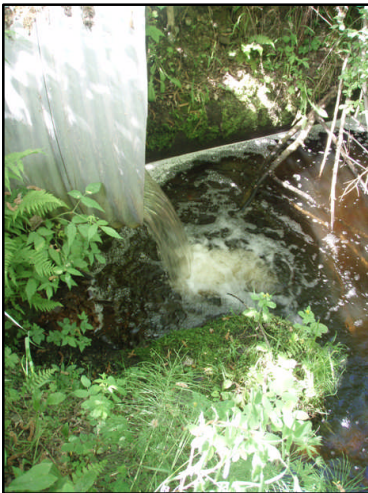
Figure 44. Site 240 outfall drop

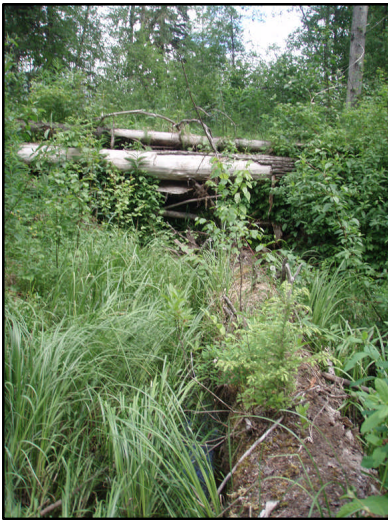
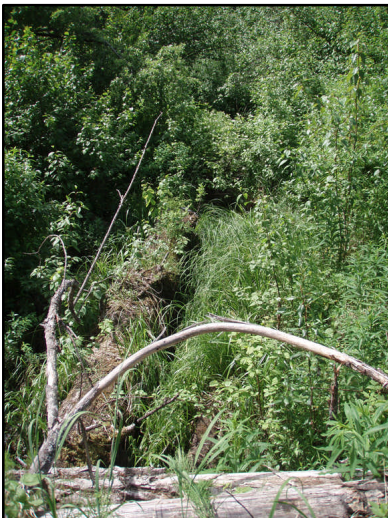
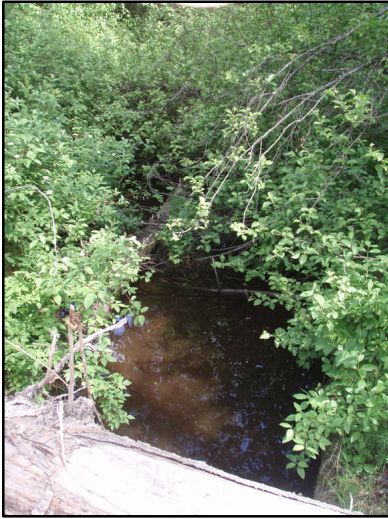
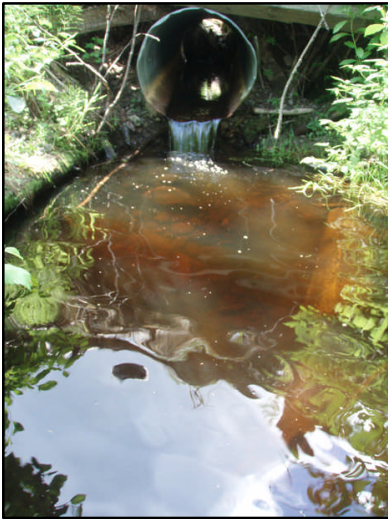
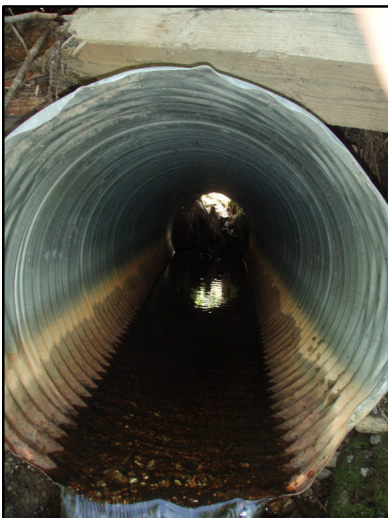
Site 239 culvert drains a small second order low gradient stream about 5.6 km in length that flows into Kispiox River. Site 239 is located on a spur road off Poplar Park Road on the same stream as Site 240 and approximately 1.1 km upstream. The stream provides excellent coho, chinook, and steelhead juvenile habitat upstream and downstream of the culvert. Unknown species of fry — ~ 25 mm in length — were observed downstream of the culvert. Upstream of the crossing, high quality rearing habitat is available; however, no fry were observed. The culvert is undersized, is a outfall barrier, and has an odd combination of fill material over it that consists of logs, small wood debris, and gravel. The crossing needs to be replaced with a larger culvert placed with proper installation practices, keeping in mind the high fish values. Site 240 is rated moderate priority due to the fish values and ease of modifications enabling fish passage. Maintenance issues involve cleaning debris at the inlet.

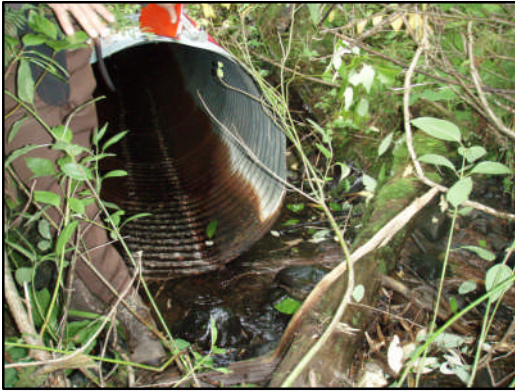
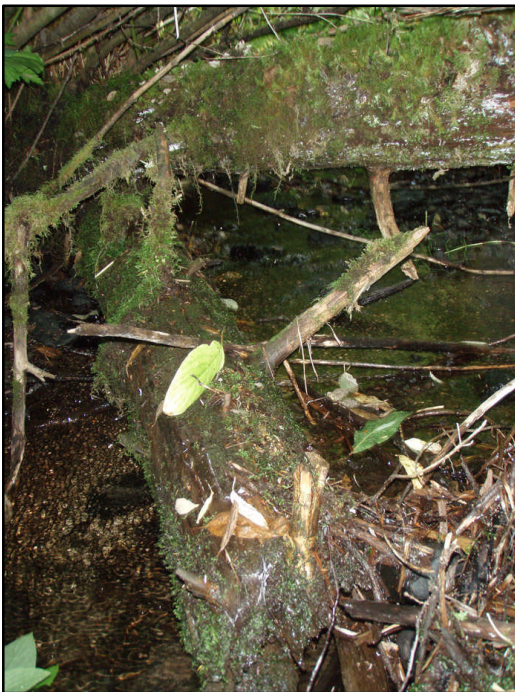
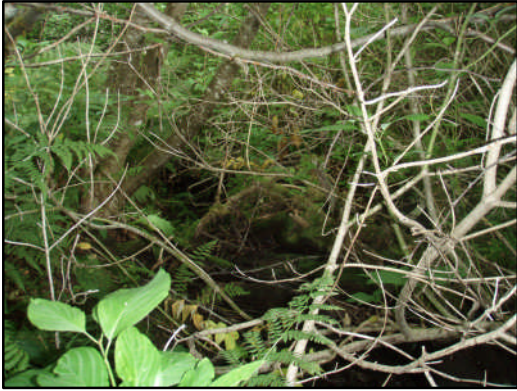
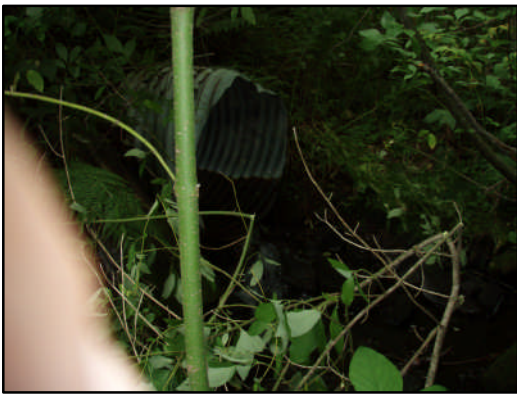
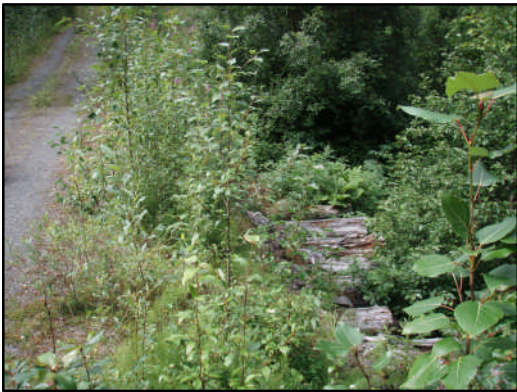
Flatfish Creek culvert is located approximately 180 m upstream from Kispiox River and drains a small second order low gradient stream. The system is centered on Flatfish Lake, which is known to have cutthroat present. The extent of fish species and presence in the Flatfish system is unknown; however, unidentified fry were observed both upstream and downstream of the culvert. The stream potentially provides habitat for coho, chinook, and steelhead juvenile. The culvert has log corduroy above the culvert supporting the road bed. Flatfish Creek culvert poses a velocity and outfall drop barrier to juvenile fish. Deactivation is recommended for this site. Site 390 is rated moderate priority due to the fish values and ease of modifications enabling fish passage.
