# Final Inspection Report

| Date and Time:<br>November 4, 2021 16:00 | Project:<br><b>Km 7.5 Morice FSR Peacock Creek</b> |
| Wildwood Employee(s):<br>J. White | Client:<br><b>MFLNRORD</b> |

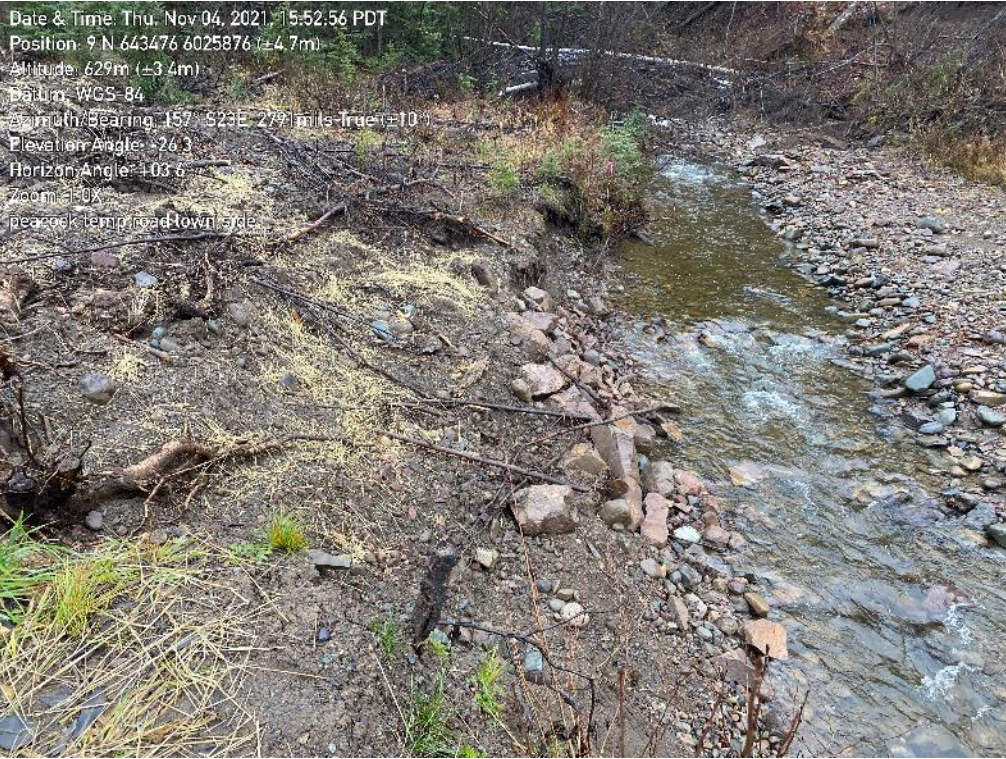
| <p>Date &amp; Time: Thu, Nov 04, 2021, 15:52:56 PDT<br/>Position: 9 N 643476 6025876 (<math>\pm 4.7m</math>)<br/>Altitude: 629m (<math>\pm 3.4m</math>)<br/>Datum: WGS-84<br/>Azimuth/Bearing: 157° S23E 279°mils True (<math>\pm 10^\circ</math>)<br/>Elevation Angle: +26.3°<br/>Horizon Angle: +03.6°<br/>Zoom: 1.0X<br/>peacock temp road town side</p> A photograph showing a rocky stream bed with a small, shallow pool of water. The surrounding area is covered with a light layer of straw mulch and some sparse vegetation. The background shows a forested hillside. | <p>Photo 1:<br/>Light application of straw mulch on the town side deactivated temp road.</p> |

- There is a lot of bare soil exposed as the mulch was lightly spread; recommend applying additional mulch, particularly within 15 m of the stream banks to provide additional erosion protection.
- Turbid ditch water is pooling on the upstream bush side on the deactivated temp road; higher flows and/or snow melt will likely result in turbid water entering the stream. Recommend extending a ditch across the deactivated temp road and lining it (options include larger gravel, small rip rap, rip rap check dams or erosion control blanket over seed).
- Turbid water and sediment on ice was observed in the stream from the bridge deck; this will be an ongoing concern based on the amount of fines in the road surfacing material. Recommend installing a splash guard to reduce the amount of sediment entering the stream.

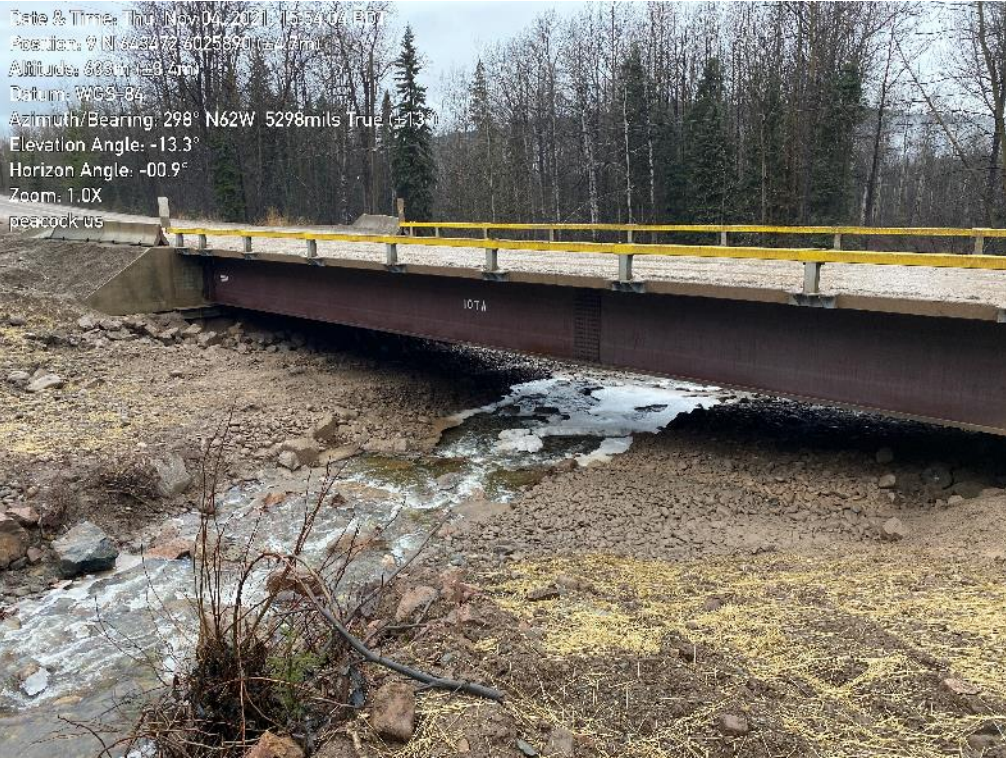
| <p>Date &amp; Time: Thu, Nov 04, 2021, 15:54:30<br/>Position: 9 N 643472 6025890mils True (<math>\pm 4.7m</math>)<br/>Altitude: 633m (<math>\pm 3.4m</math>)<br/>Datum: WGS-84<br/>Azimuth/Bearing: 298° N62W 5298mils True (<math>\pm 13^\circ</math>)<br/>Elevation Angle: -13.3°<br/>Horizon Angle: -00.9°<br/>Zoom: 1.0X<br/>peacock us</p> A photograph of a concrete bridge with yellow safety railings crossing a stream. The stream bed is rocky and covered with a light layer of straw mulch. The background shows a forested hillside. | <p>Photo 2:<br/>Light application of straw mulch on the upstream side of the bridge.</p> |

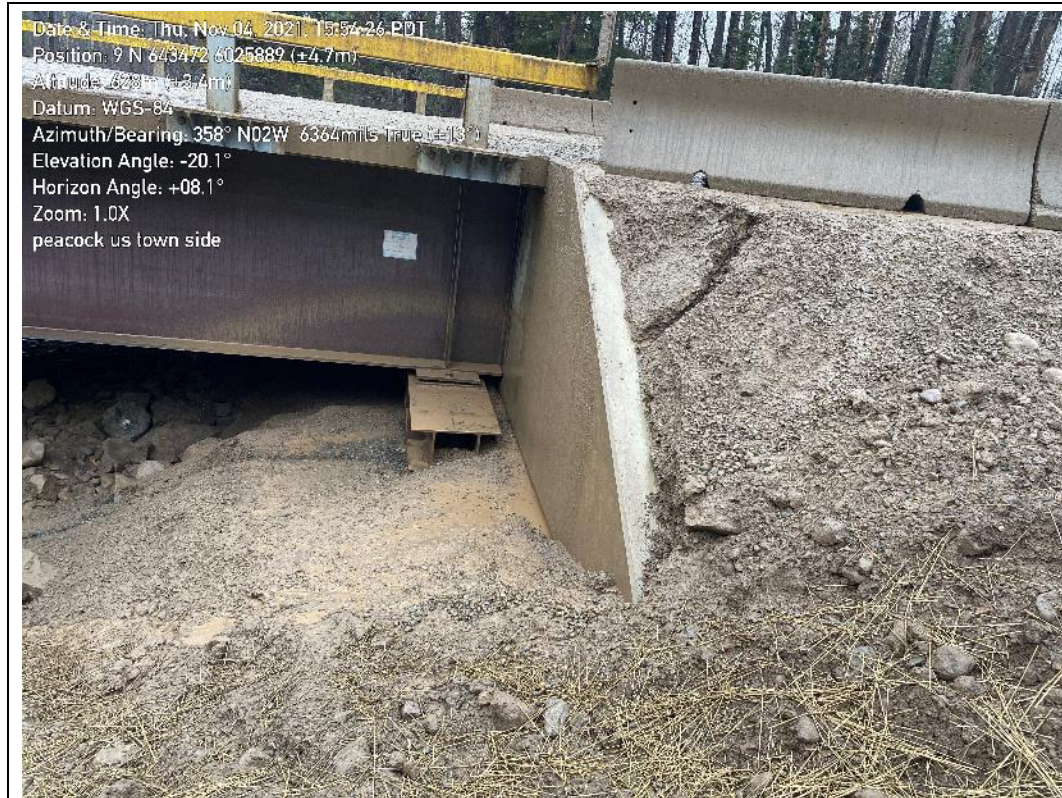
Photo 3:  
Eroding fill  
slope and  
turbid water  
dripping off the  
bridge deck on  
the upstream  
town side.

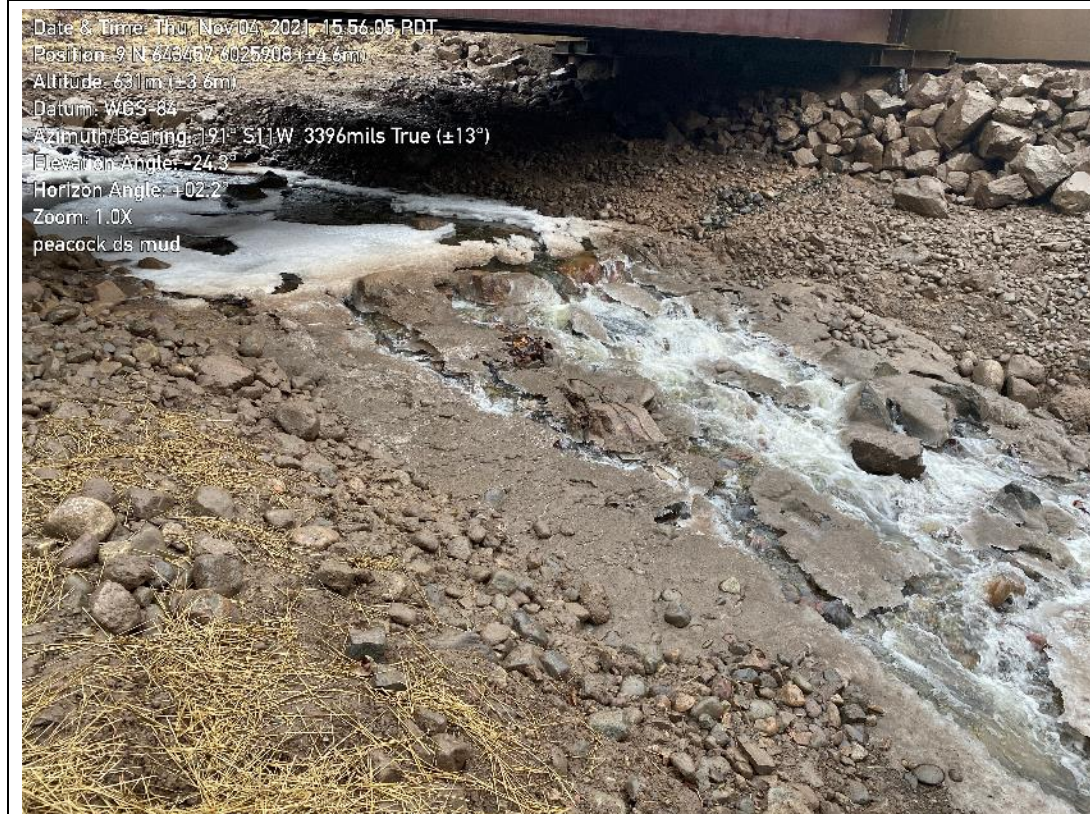
Photo 4:  
Sediment  
deposit on the  
ice and stream  
banks from the  
bridge deck.

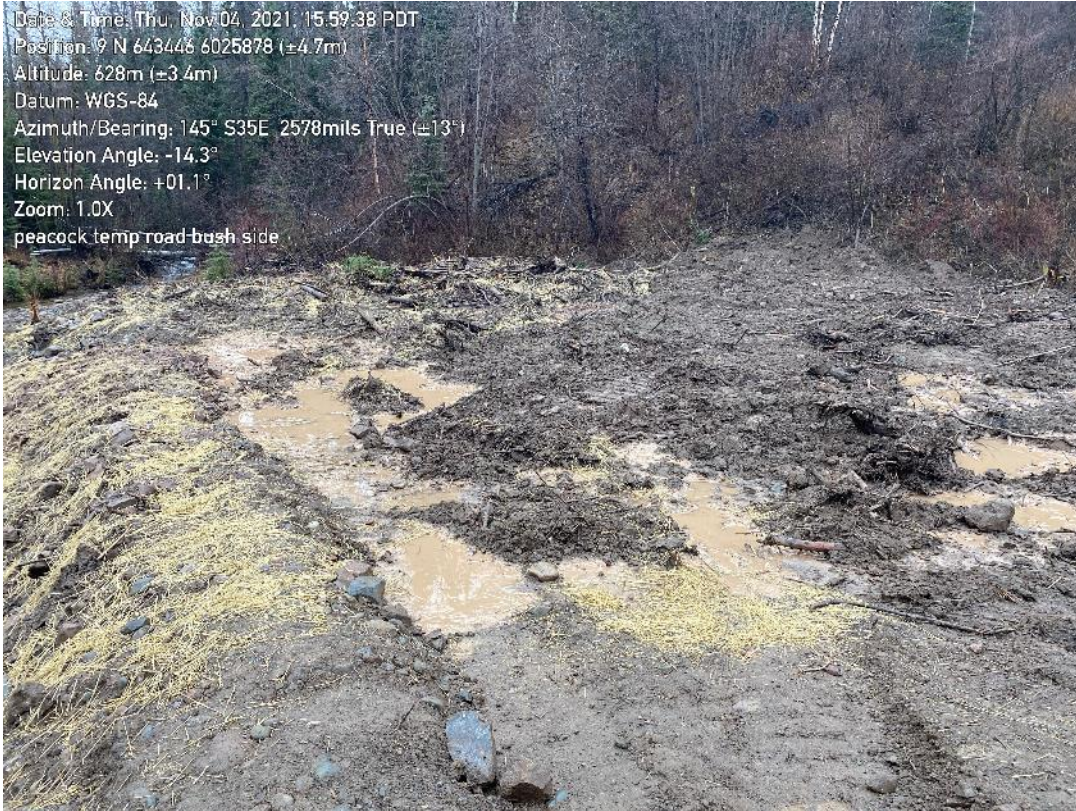
Photo 5:  
Turbid water pooling on the bush side of the deactivated road from the upslope ditch. Recommend extending the ditch and lining it

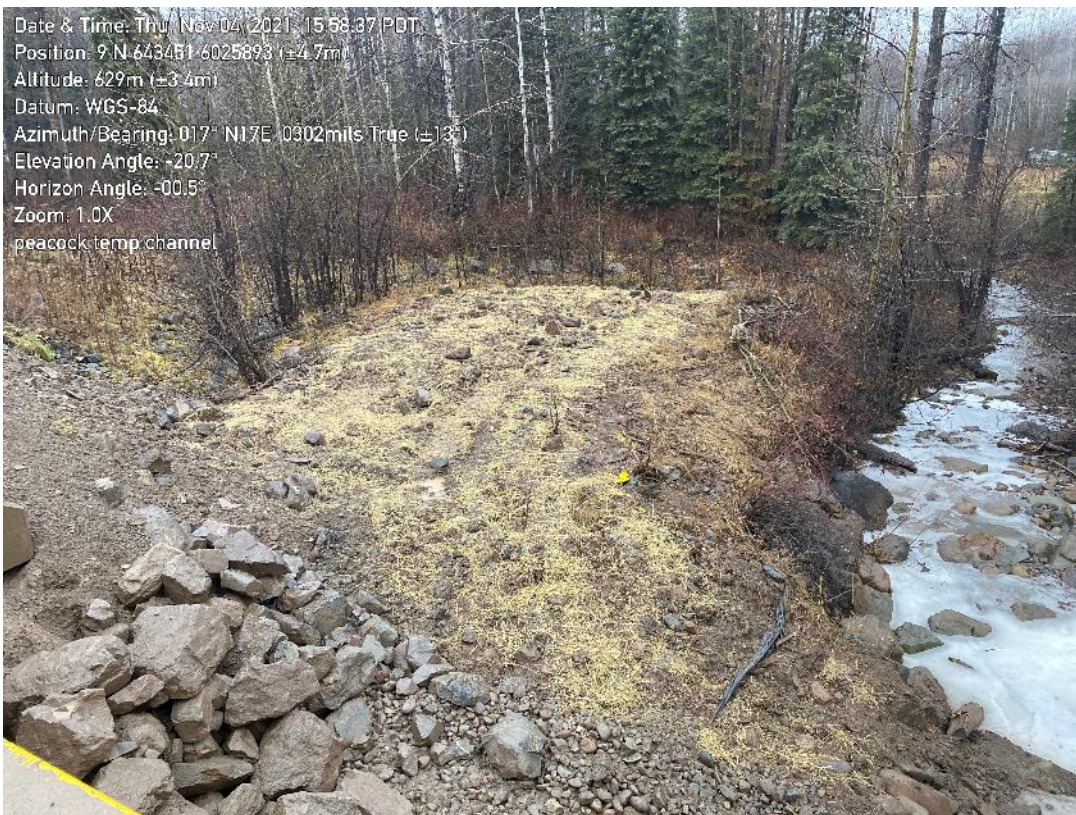
Photo 6:  
Deactivated temporary diversion channel has been mulched.
