# Khyex-Tyee: Foreshore Habitat Re-construction Works

Province of British Columbia Ministry of Transportation and Highways Highway Engineering Branch

Eric R. White 872 Coles Street Victoria, B.C. V9A 4N6

April, 1990

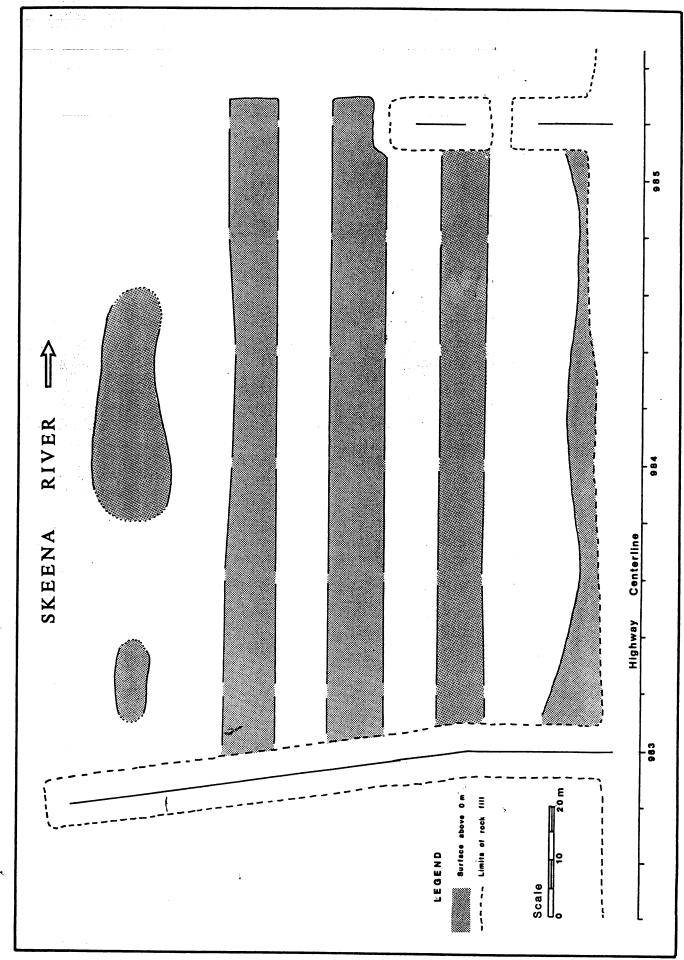
Figure 1: Foreshore habitat compensation site - revised design.

Within the compensation site three habitat pads would form a series of ridges running parallel to the highway. These habitat pads would be constructed of quarried rock capped by at least 0.30 m of fine material from the channelization works on Inver, Antigonish and Ekumsekum creeks. They would be located 62, 100 and 138 metres off centerline. Surface elevations would vary from -0.5 m to +0.25 m geodetic. Substrate slopes would be in all cases less than 10:1 and generally 20:1. This compensation site design is summarized in Figure 1.

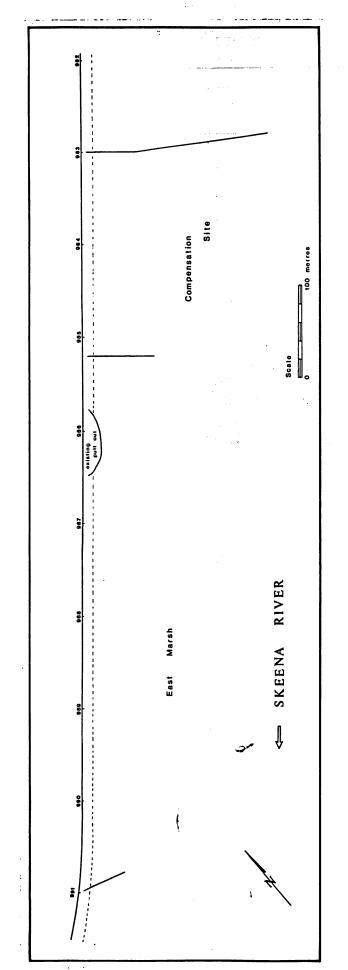
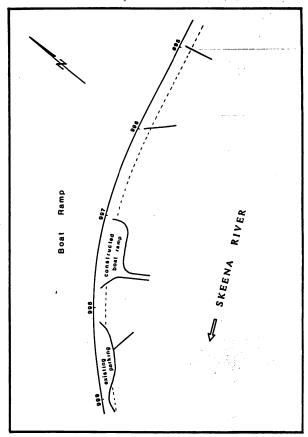
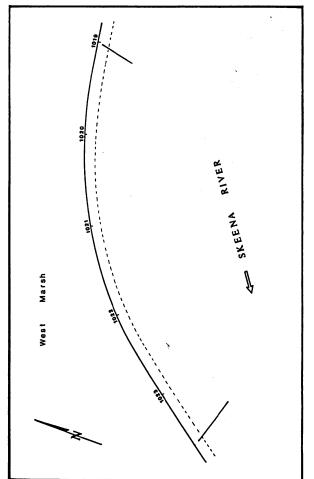
Figure 2: Foreshore habitat compensation works showing new highway centerline, rock spurs and limits of highway fill.

The 995+00 and 996+00 rock spurs were built at non-design angles from shore. The 995+00 spur was built at right angles to shore, instead of being angled downstream, and the 996+00 spur was built at with an upstream orientation, rather than at right angles to shore. These changes were allowed to stand as they would not change the protective capabilities of the spurs (Kellerhals, 1989, personal communication).

The rock spurs, as constructed, are shown in Figure 2.

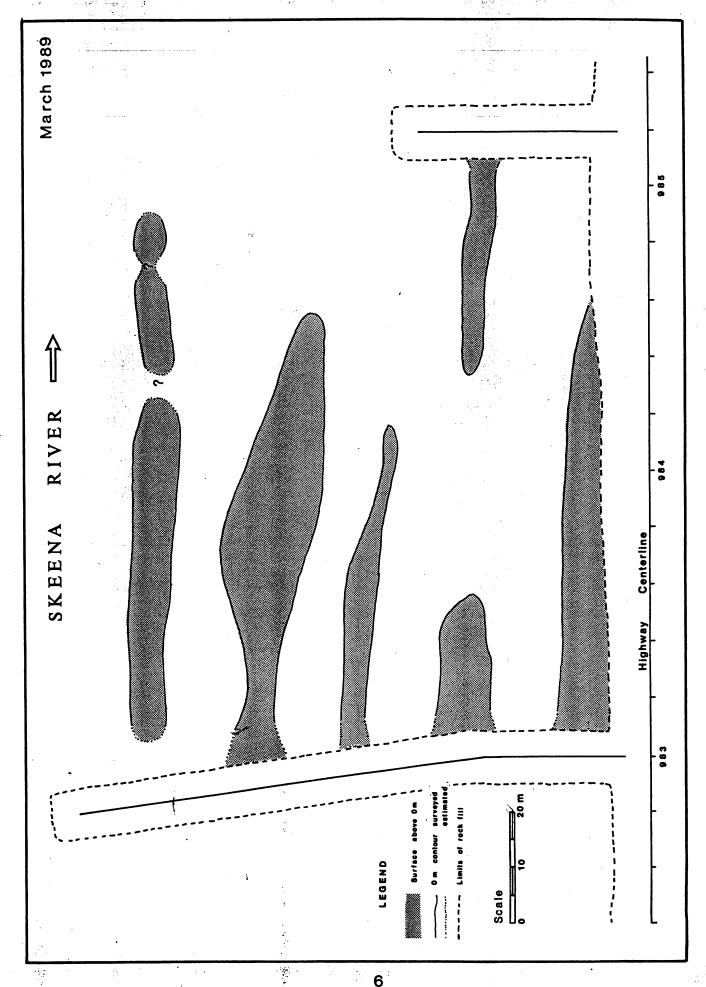
Figure 3: Changes in the area above 0.0 m geodetic elevation within the compensation site between March and July, 1989.

These survey results show major changes in surface elevations throughout the compensation site. By July 1989 there was an obvious increase in the amount of area above 0.0 m geodetic. In general, the low points had been filled in and there was a decrease in the surface roughness of the site. Importantly, there was no observed decrease in the elevation of the high areas. This would indicate that the filling in of the low points was not due to the simple re-distribution of the placed material, but was from sedimentation within the site.

Increased substrate elevations have also been observed downstream of the site. The area involved extends approximately 300 m downstream of the compensation site and 80 - 100 m offshore.

The average elevation change appears to be in the order of 0.75 m both within and downstream of the compensation site. This indicates that a substantial amount of new material - in the order of 20 - 40 000 m<sup>3</sup> - has been deposited by the river.

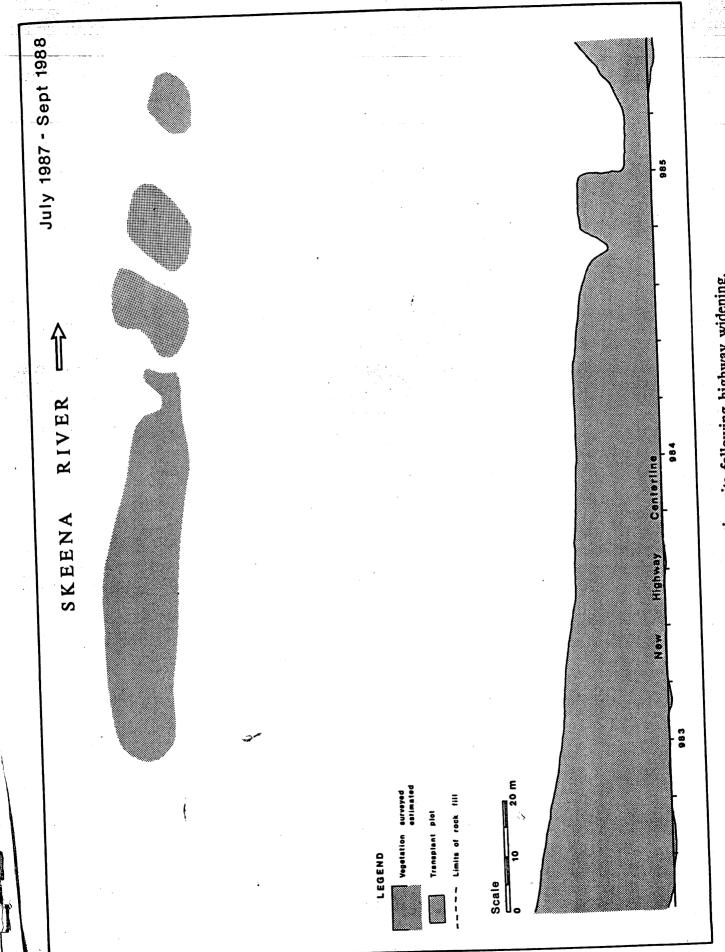
The amount of permanently lost habitat appears to be consistent with the design loss figure presented in White, 1988. However, the amount of lost habitat as of July, 1989 is greater than the anticipated.

This increase appears to be due to increased sedimentation (up to 50 - 80 cm), apparently resulting from the effect of the rock spurs. Although this is an immediate negative impact, it does have positive long-term ramifications. Foreshore marsh area should increase as vegetation colonizes the new habitat. This new habitat will be created as the substrate surface rises to elevations compatible with plant growth.

Figure 4: Changes in the vegetated area with the compensation site following highway widening.

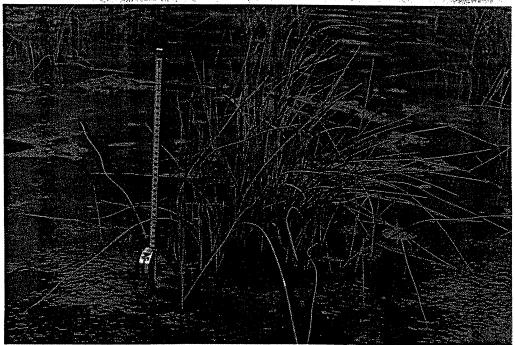
Spike-rush, on the other hand, grows in the classic manner, i.e., new growth is a result of the conversion of soil and light into plant material. Spike-rush in virgin substrate, with little competition for either space or light, will burst into vigorous growth producing both new stems and rhizomes as it goes. (Photographs 3 & 4).

Photograph 3: A 10 cm plug showing robust spike-rush growth. Note stems up to 30 - 50 cm away from the plug.

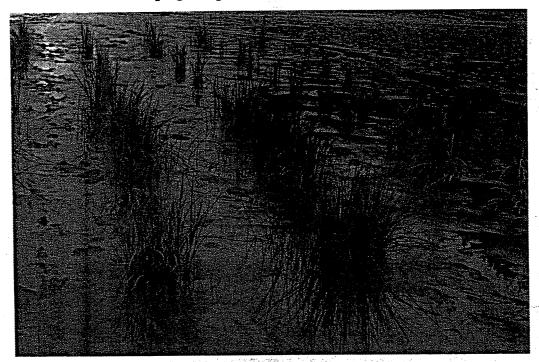
Photograph 4: Test plot #1: shovel plugs in the near rows, 16 cm plugs in center and 10 cm plugs in rear.
