**AS-BUILT REPORT OF AQUATIC RESTORATION AND ON-FARM  
CATTLE MANAGEMENT IMPROVEMENTS WITHIN THE  
WET'SUWET'EN FIRST NATION TERRITORY, 2017**

**November 2017**

**Wet'suwet'en First Nation  
Yinka Dene Economic Development Limited Partnership Inc.  
P.O. Box 245, 37 Sampson Crescent  
Burns Lake, BC V0J 1E0**

**J.J. Smith  
LGL Limited environmental research associates  
9768 Second Street  
Sidney, BC V8L 3Y8**

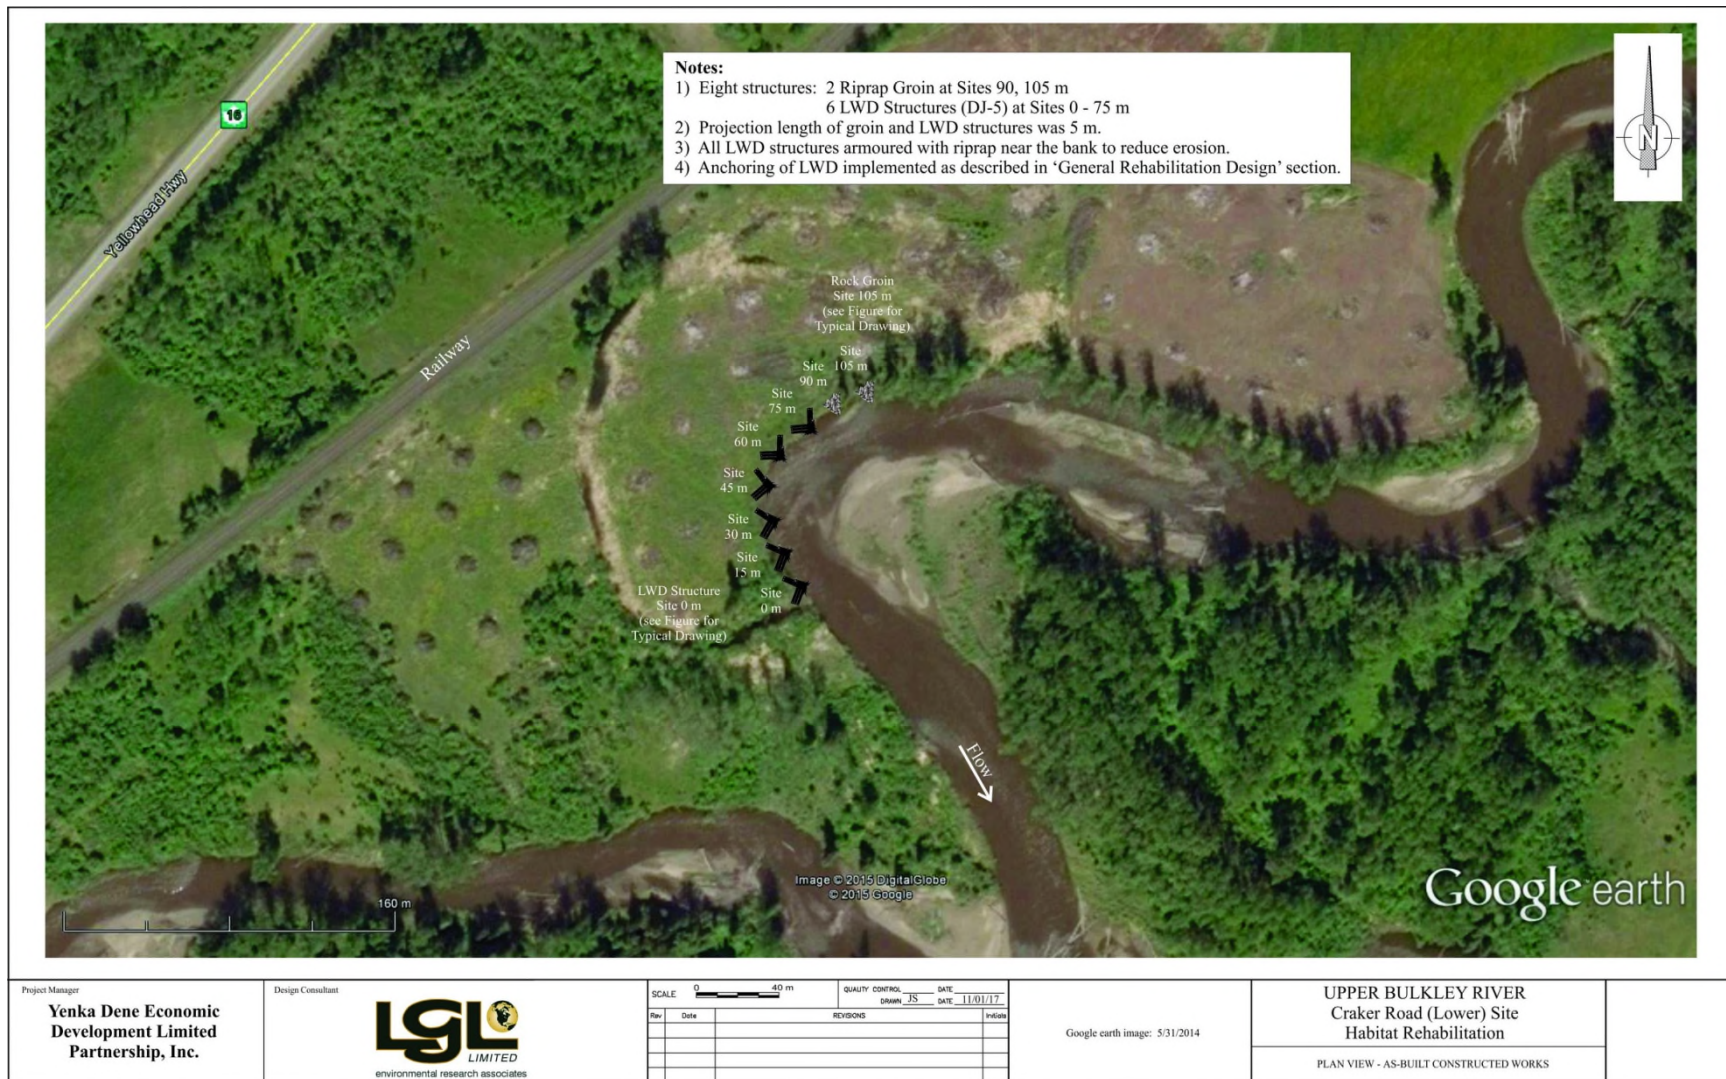
Figure 5. As-built plan view of restoration works at the Craker Road (Lower) site on the upper Bulkley River, 2017.

Constructed works at the Craker Road (Lower) site involved six LWD structures and two rock groins installed along a 105-m reach (Figure 5). Acquisition and transporting of construction materials to the site was initiated on 22 September 2017, and construction of the instream structures occurred from 25 September to 1 October 2017 (Photo 1 to Photo 8). A Caterpillar 320B hydraulic excavator was used for the work. The quantity of materials used in construction of the LWD structures was compared to the design requirements for ballast in Table 2.

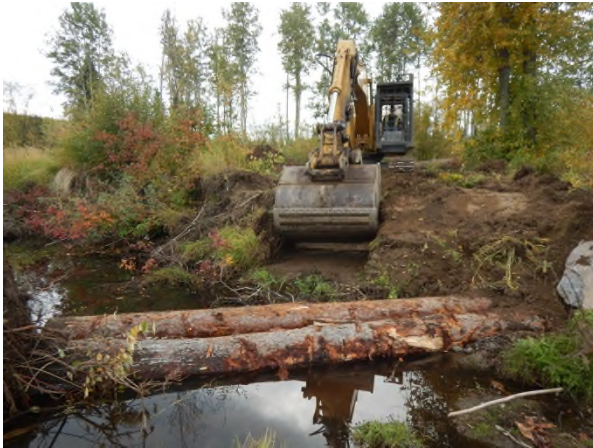
Photo 1. Bulkley River at Craker Rd (Lower) – Excavating the 3-log trench of the LWD structure at 0+000 m (26 September 2017).

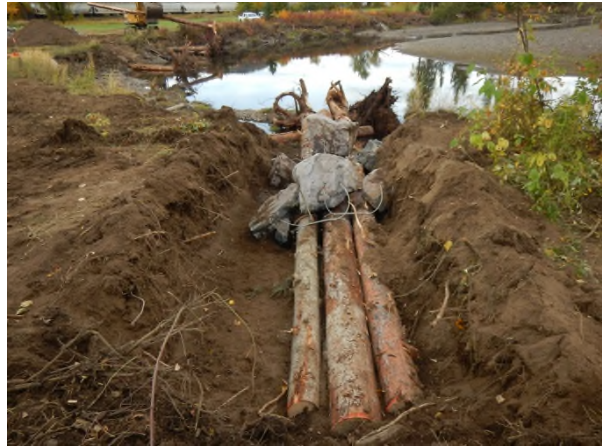
Photo 2. Bulkley River at Craker Rd (Lower) – Ballasted logs in the upstream-facing trench of the LWD structure at 0+030 m (26 September 2017).

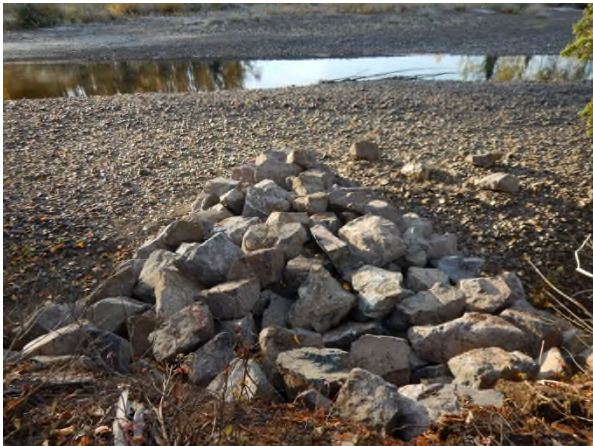
Photo 3. Bulkley River at Craker Rd (Lower) – View from the right bank of the rock groin at 0+105 m (3 October 2017).

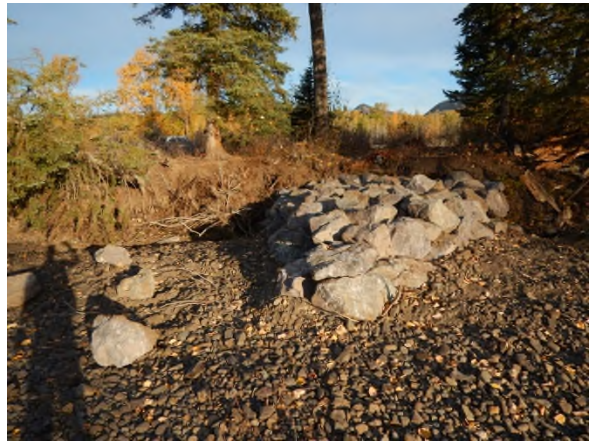
Photo 4. Bulkley River at Craker Rd (Lower) – View from the riverbed towards the right bank at the rock groin at 0+105 m (3 October 2017).

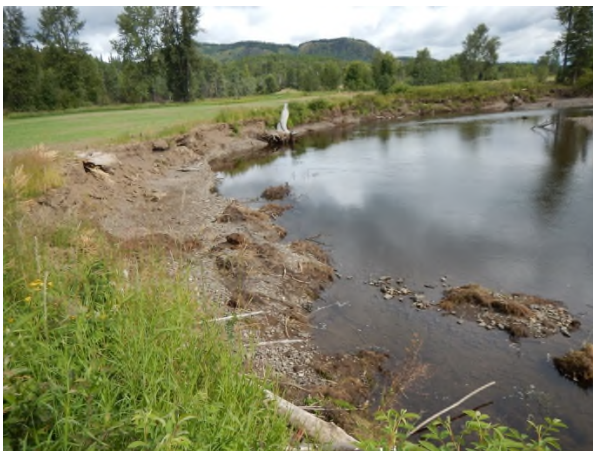
Photo 5. Bulkley River at Craker Rd (Lower) – Looking upstream from 0+015 m prior to construction (23 July 2017).

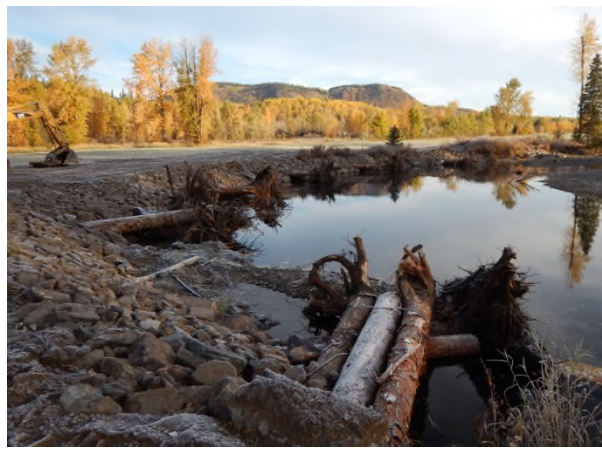
Photo 6. Bulkley River at Craker Rd (Lower) – Looking upstream from 0+015 m after construction was completed (3 October 2017).

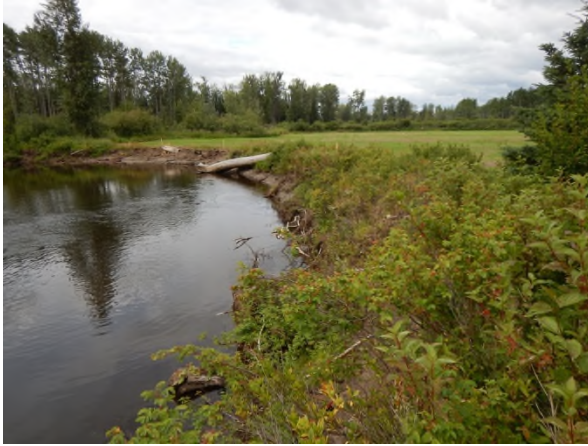
Photo 7. Bulkeley River at Craker Rd (Lower) – Looking downstream from 0+090 m prior to construction (23 July 2017).

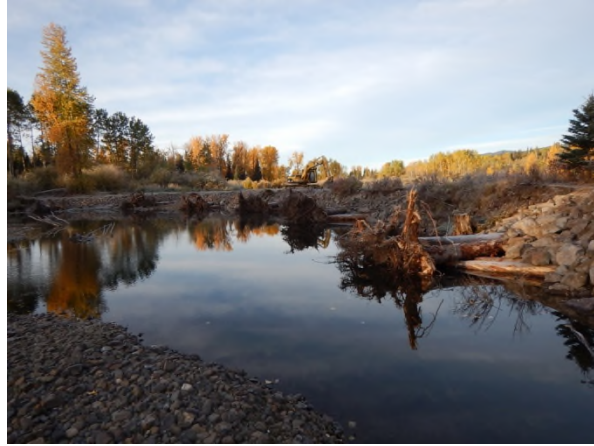
Photo 8. Bulkeley River at Craker Rd (Lower) – Looking downstream from 0+090 m after construction was completed (3 October 2017).

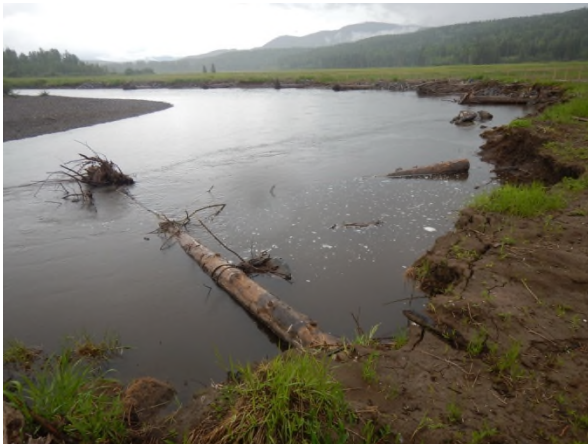
In late September 2016, 7 LWD structures and 2 rock groins were installed at the McKilligan Road (Lower) site along the left bank of the Bulkley River, approximately 8.8 km northeast of Houston (Figure 2; Smith and Gaboury 2016). During a high-water event in mid-May 2017 when Bulkley River discharges reached 201 m<sup>3</sup>/s near Houston (Figure 6), one LWD structure (0+000 m) and one rock groin (0+018 m) were significantly damaged (Photo 9). On 2 October 2017, both the LWD structure and rock groin were repaired, and some additional riprap material was added between the two structures (Photo 10).

Photo 9. Bulkeley River at McKilligan Rd (Lower) – Upstream view of the damaged LWD structure (0+000 m) and groin (0+018 m; 19 July 2017).

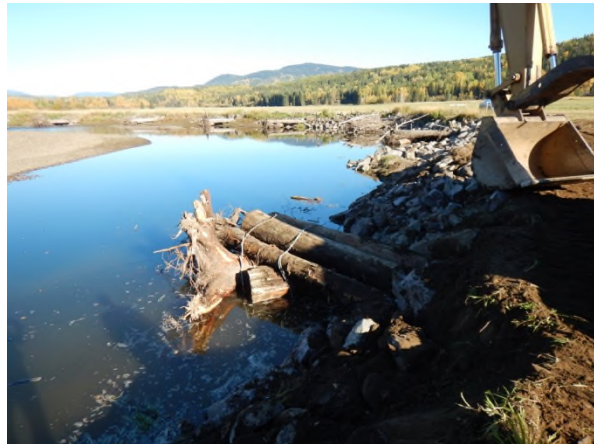
Photo 10. Bulkeley River at McKilligan Rd (Lower) – Upstream view of the repaired LWD structure (0+000 m) and groin (0+018 m; 2 October 2017).

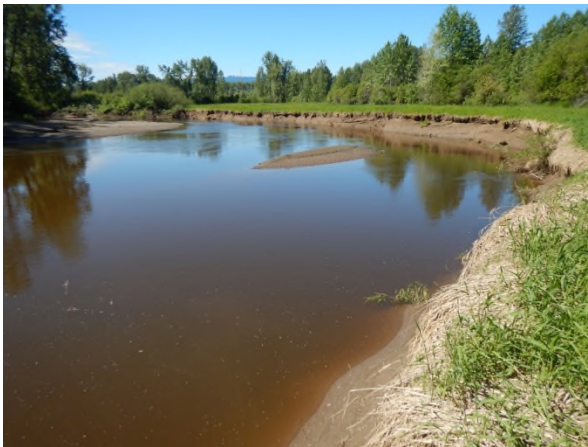
Three potential restoration sites on the Bulkley River that were assessed by Gaboury and Smith (2016) in the fall of 2015 were re-assessed in 2017 and deemed unsuitable for restoration using LWD structures and rock groins due to their excessive bank heights (> 3 m). These included the Craker Road Upper, Craker Road Middle, and C.R. Matthews Road Lower sites (Figure 2; Photo 11 and Photo 12).

Photo 11. Bulkeley River at C.R. Matthews Rd (Lower) – Downstream view of the potential restoration site on the right bank (23 June 2017).

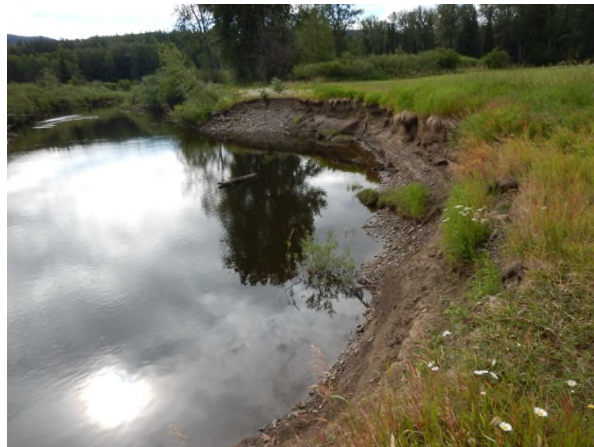
Photo 12. Bulkeley River at Craker Rd (Lower) – Downstream view of the potential restoration site on the right bank (23 July 2017).
