***EXCHAMSIKS BACKCHANNEL
REHABILITATION
2008***

June 2009

Fisheries and Oceans Canada
Sandra Devcic – Restoration Eng. Tech.
Don Hjorth – Restoration Engineer
Lana Miller – Restoration Biologist
North Coast Area

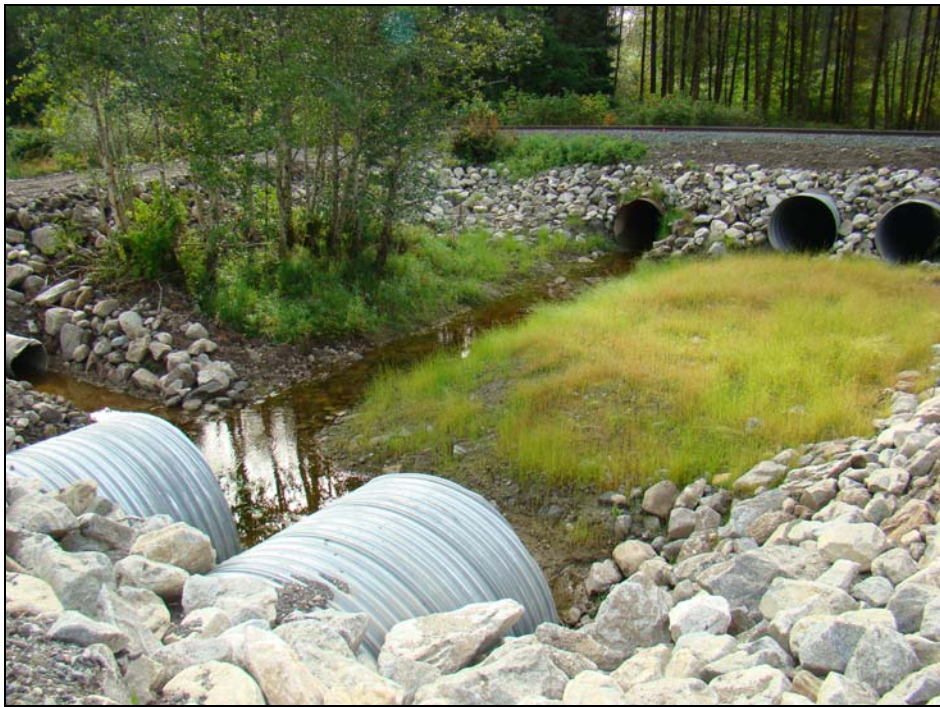
Figure 5: Site 3, looking downstream at the section between the CN and MOT right of ways at the newly constructed sidechannel outlet. Work was done with the funding acquired in 2007 from MoT and CN. Photo taken in August 2008.

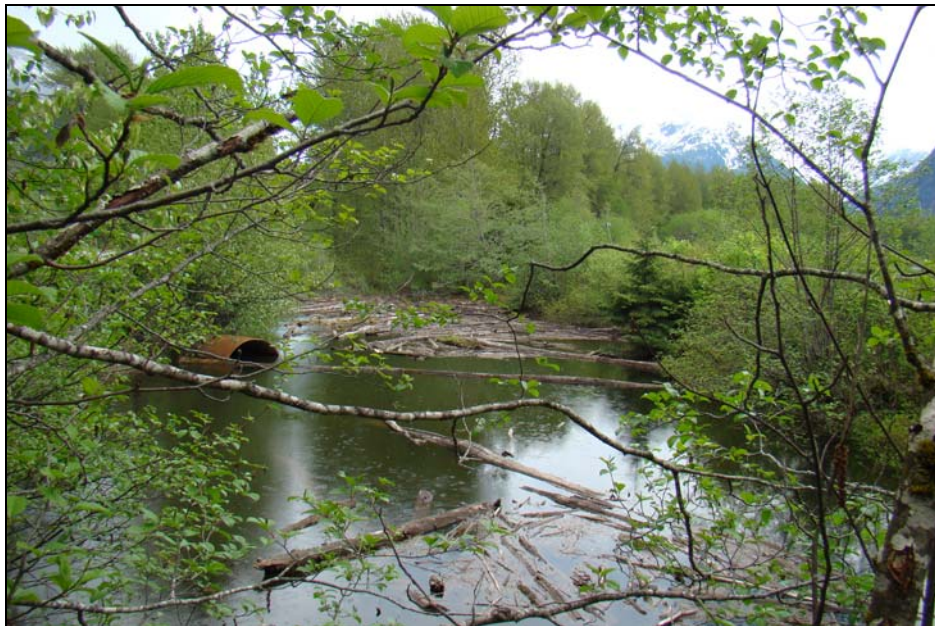
Figure 6: Site 4 (the Death Hole) on May 21, 2008. The visible (2600 mm diameter) culvert through the highway grade does not have a match through the railway grade (on the photo right). The isolated pool frequently stranded fish when the floodplain water levels dropped and the fish were unable to retreat back into the sidechannel due to the elevation of the culvert outlet.

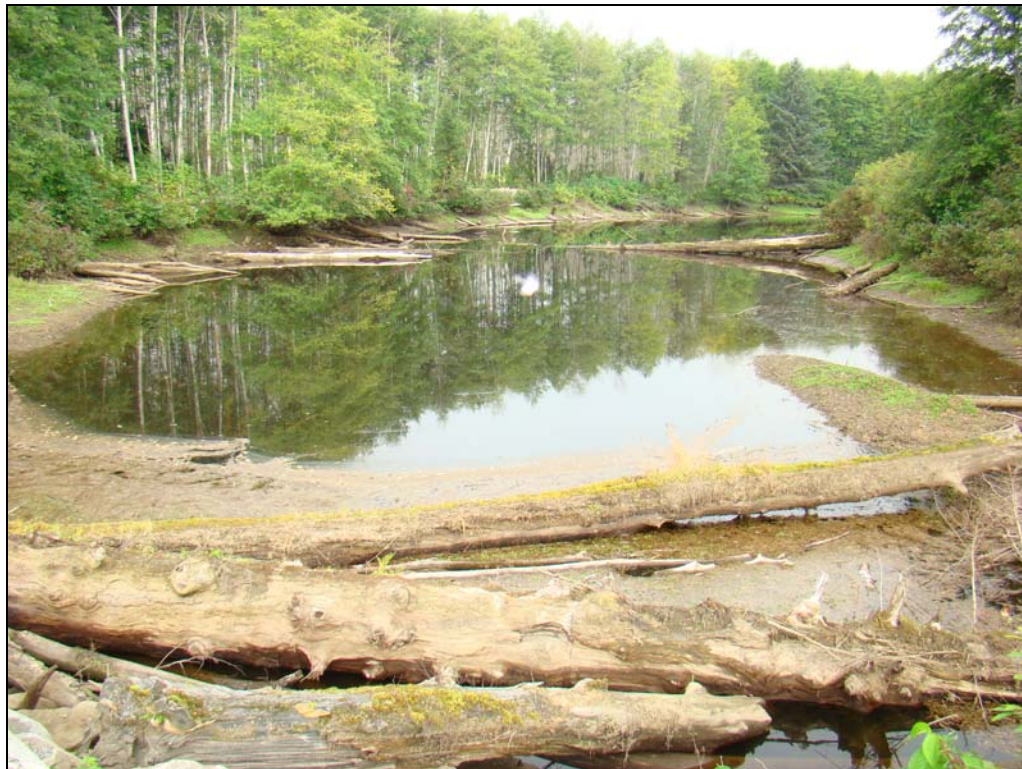
Figure 8 – The backchannel at Site 2 on September 18th, before the lower water connection to the outlet culverts at Site 3 was opened up.

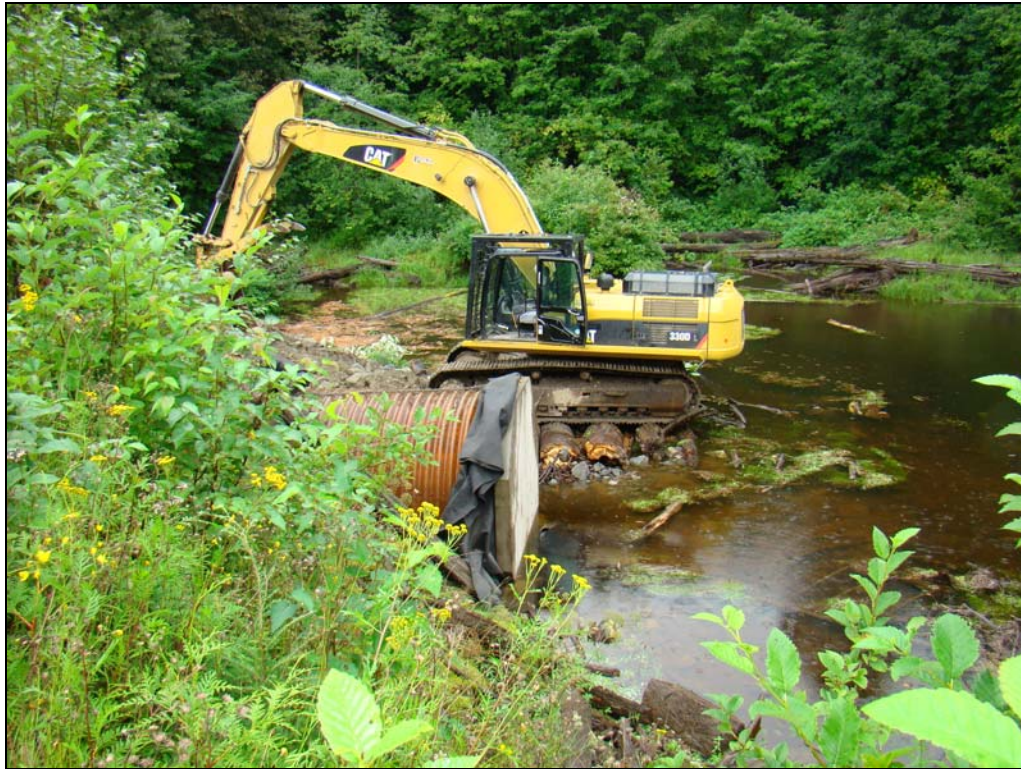
Figure 9: Sealing off the culvert at Site 4 (Death Hole) on the north side of the highway. The photo shows the concrete cap in place before the area was sealed off with backfill.

The first step to correcting the problem was to install a specially fitted concrete cap to the upstream end of the highway culvert, completely isolating the pool. Cambria Gordon Ltd. was retained to conduct a salvage at Site 4 (the Death Hole). They were able to trap out the pool in between the highway and the railway, prior to the culvert being sealed off and the depression being backfilled. There were approximately 562 Salmonids, 2539 Trout and Stickleback, and 108 fish of other species removed from the pool, over approximately 1 week. All of the aquatic life removed from the pool were relocated upstream of the Site 4 culvert.

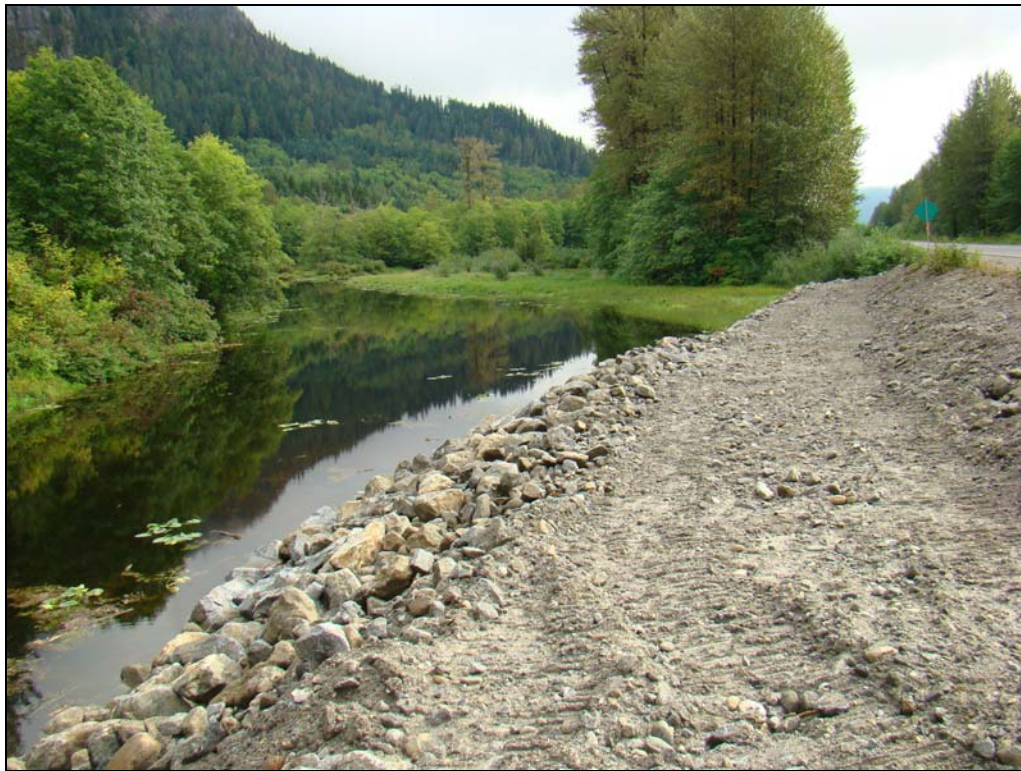
Figure 10: The completed grade seal at the north end of the highway culvert at Site 4.

Once the backfill was in place between the railroad tracks and the highway grade, a second seal on the north side of the highway was added. This seal was intended to slow down the amount of water lost by percolation through the highway fill at this location. We estimate that the fill backed up water the extent that it provided an additional 20 cm of depth to the water flowing through the culvert at Site 3.

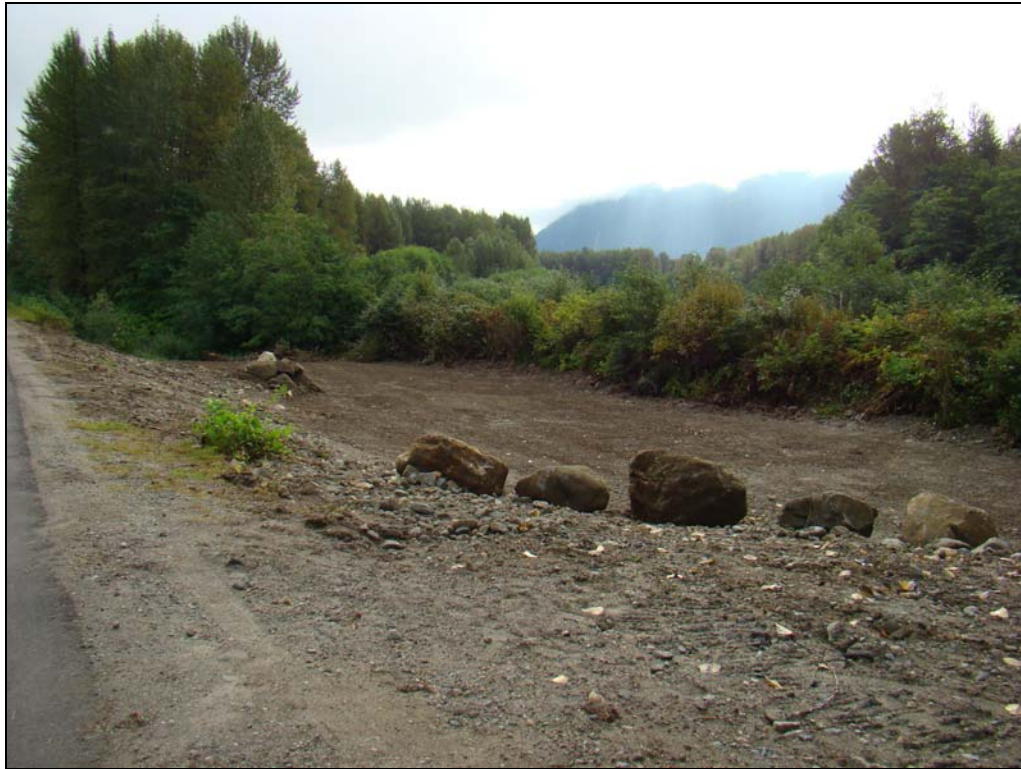
Figure 11 – Backfilling completed at the area between the highway and railway at Site 4.

After the culvert was sealed and the fish had been removed, backfilling the low area on the south side of the highway culvert began. The first step was to move the large organic debris around to accommodate a filter cloth liner which will slow down the flows through the grade and block fish from migrating through the area. Backfill, donated by the Ministry of Transportation from the nearby Polywog Pit, was then brought to site, placed, and compacted.

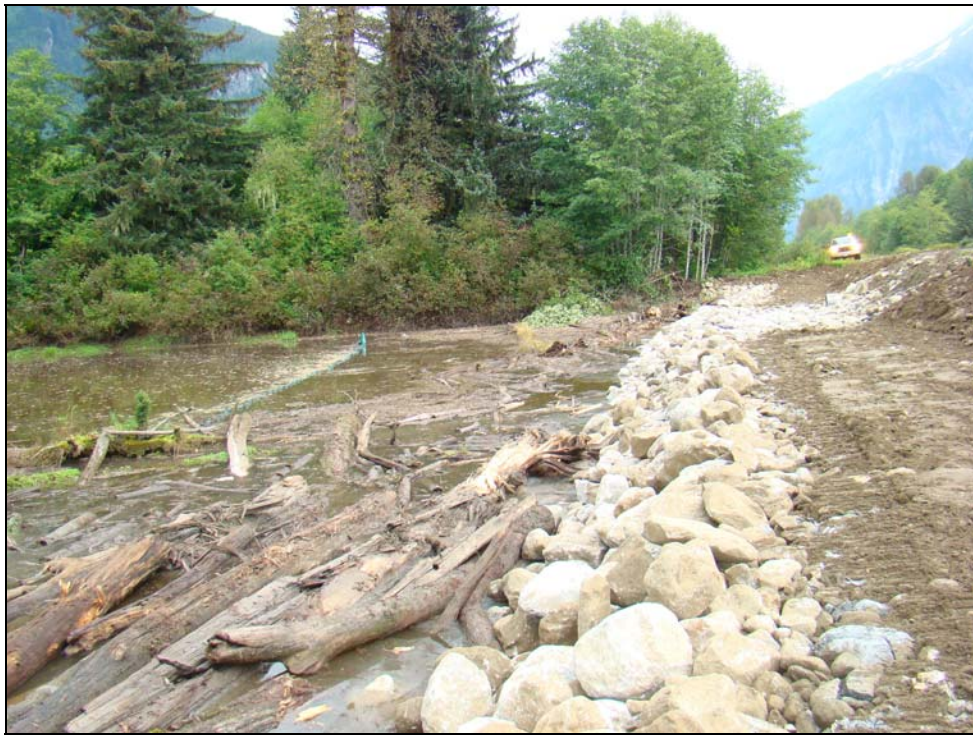
Figure 12 – The grade seal being constructed on the north side of Site 2 where there is a 600 mm culvert through the road & rail grade.

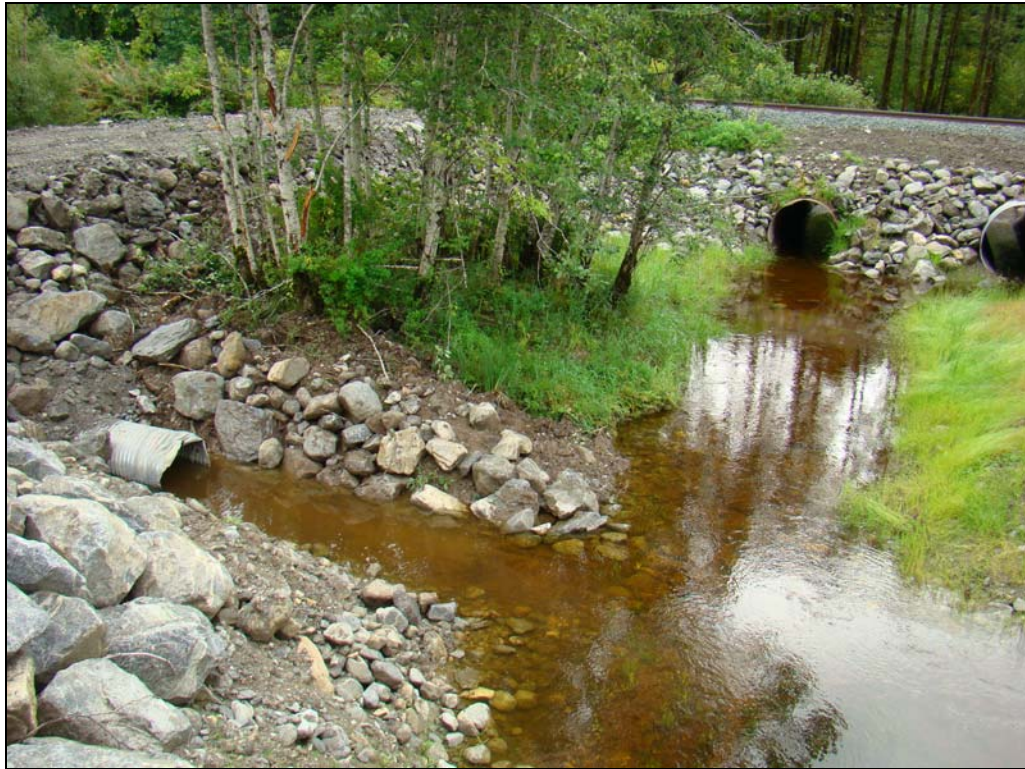
Figure 14 – An additional culvert was inserted into the east CN berm at Site 3.

A small diameter culvert was installed south of the Highway 16 grade, through the east CN berm to connect an isolated pond area to the outlet channel at Site 3. The pond is wetted for most of the year and is fed by the upstream flows percolating through the grade. The pool is typical juvenile coho habitat. This was confirmed by trapping when the berms at Site 3 were constructed in 2007 (Figure 14).

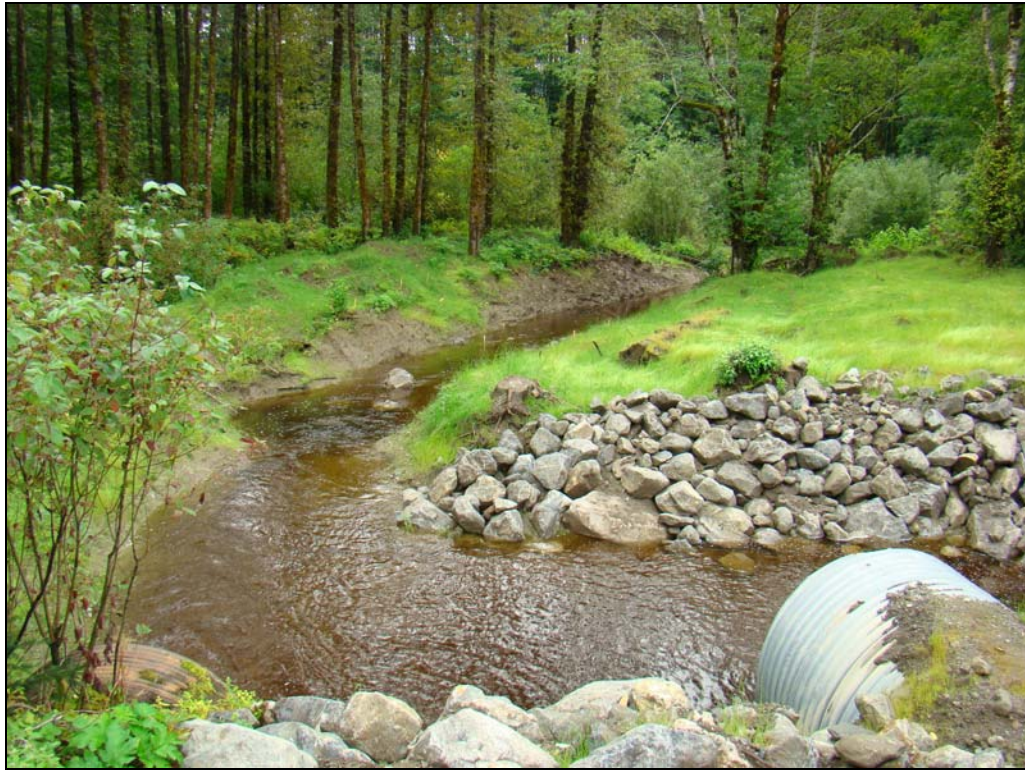
Figure 15 – A view of the outlet area downstream of the culverts put in at Site 3 by CN. A low weir has been added to the outlet channel. Note the vegetation cover has been restored by hydroseeding.

A low rock weir was added to the outlet channel from Site 3, immediately downstream of the CN culverts. The small weir is intended to give juveniles additional time to retreat into the marsh during periods of low flow, before they become stranded (Figure 15).

All areas disturbed by construction were revegetated by hydroseeding in the late fall (Figure 15).

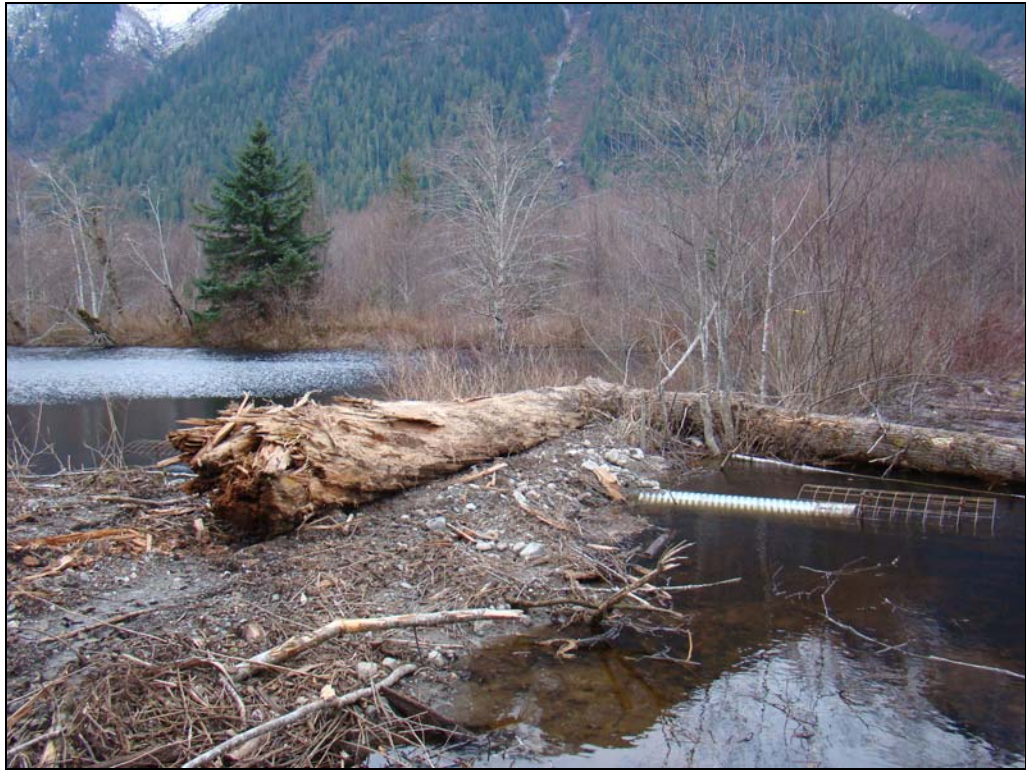
Figure 16 – Beaver stops on both ends of a culvert installed through an old corduroy bridge.
This location was identified in the original studies as a partial barrier to fish movement within the project. The beaver stops alleviate this problem.

Beavers occupied portions of the side channel prior to construction. In order to ensure that flow through the sidechannel was not affected during the first winter, the primary dam impacting the elevation of the water was manipulated until the area froze over for the winter. Beaver stops were installed at an abandoned road crossing of the back channel (Figure 16).
