**AS-BUILT REPORT OF FISH PASSAGE IMPROVEMENT PROJECTS
WITHIN THE WET'SUWET'EN FIRST NATION TERRITORY, 2017**

November 2017

**J.J. Smith and M.N. Gaboury
LGL Limited environmental research associates
9768 Second Street
Sidney, BC V8L 3Y8**

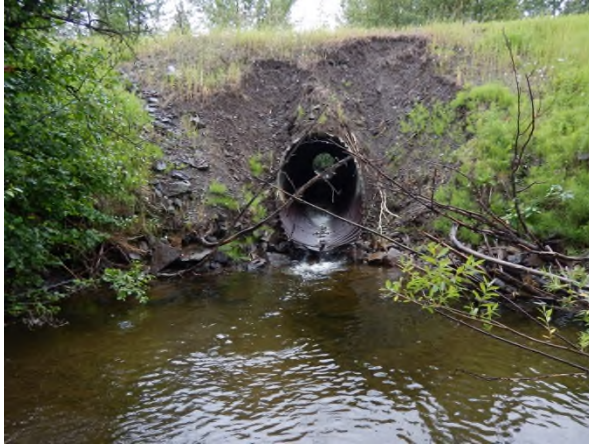
Johnny David Creek is a 2nd order stream that flows southward before draining into the upper Bulkley River along its right bank. Johnny David Creek crosses Highway 16 about 25 km northeast of Houston, and the Hwy 16 crossing is located approximately 1 rkm upstream from the Bulkley River. Fish species present in Johnny David Creek include Chinook and Coho salmon, Steelhead, Cutthroat and Rainbow trout, and Dolly Varden (FISS 2015). At the Hwy 16 crossing, Johnny David Creek passes through a round, multi-plate culvert (2 m dia x 20 m long). The slope of the culvert is 3.96% and the height of the outfall drop was 0.19 m on 10 October 2015.

Photo 1. Johnny David Creek at Highway 16 – Upstream view of the culvert outlet prior to construction (15 July 2017).

From 14-20 July 2017, rock material was delivered to the Johnny David site and three riffles were constructed approximately 16, 38, and 50 m downstream of the Highway 16 culvert outlet (Figure 4, Figure 5; Photo 1 to Photo 6). Post-construction, the culvert was backwatered 9.5 m (31% of the 30-m length) and water depth at the invert of the culvert outlet was 0.38 m on July 20. Berms were constructed on both banks, extending from the culvert outlet downstream to the first riffle. In total, approximately 224 m³ of riffle rock and gravel, 16 m³ of spawning gravel, and 120 m³ of berm material were used.

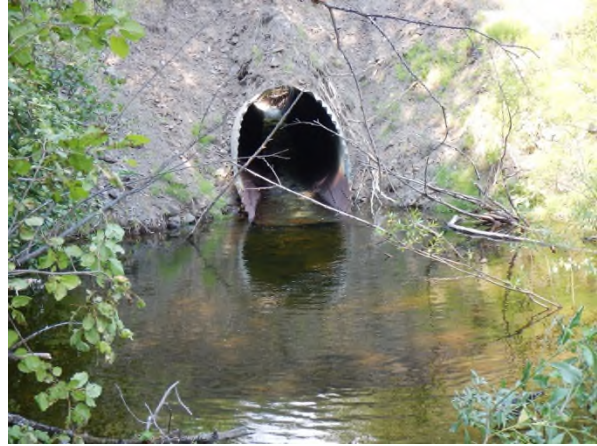
Photo 2. Johnny David Creek at Highway 16 – Upstream view of the culvert outlet after construction (20 July 2017).

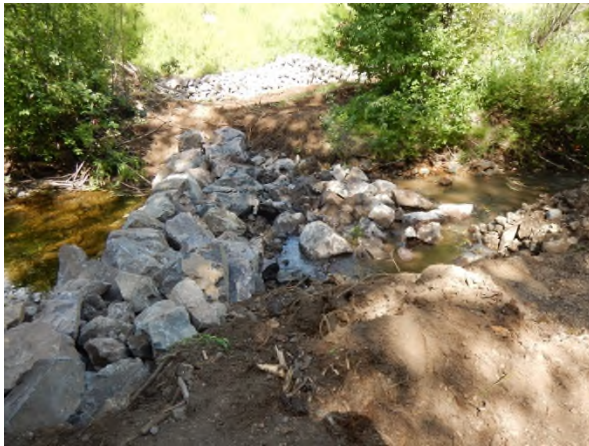
Photo 3. Johnny David Creek at Highway 16 – View from the right bank of riffle 1 (12 m d/s culvert outlet) during construction (17 July 2017).

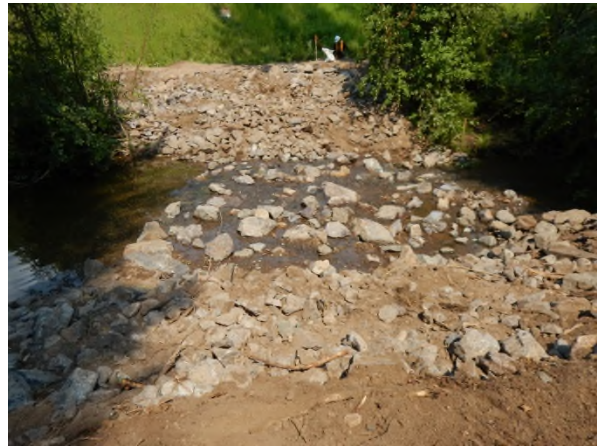
Photo 4. Johnny David Creek at Highway 16 – View from the right bank of riffle 1 (0+012 m) after construction (20 July 2017).

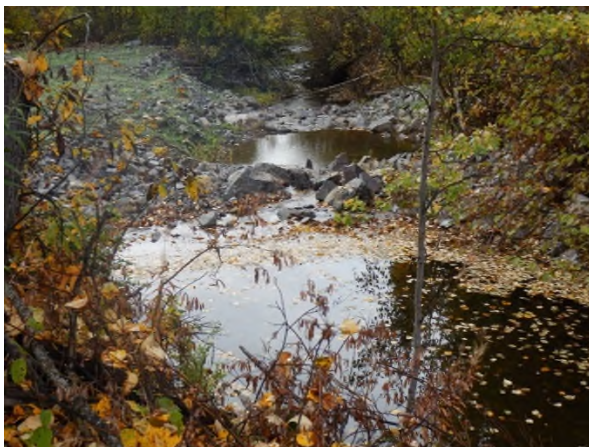
Photo 5. Johnny David Creek at Highway 16 – Downstream view of riffles 2 and 3 after construction (30 September 2017).

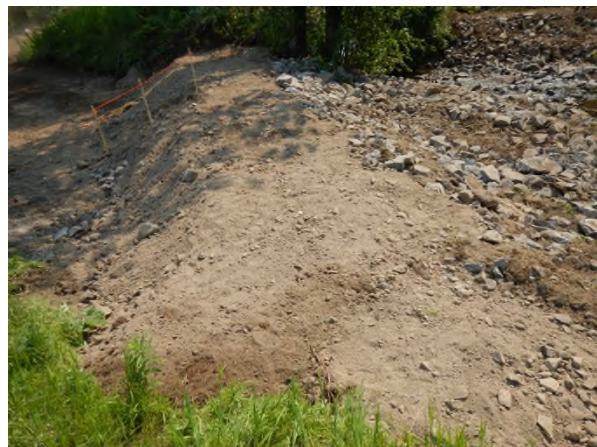
Photo 6. Johnny David Creek at Highway 16 – Downstream view of the left-bank berm after construction (20 July 2017).

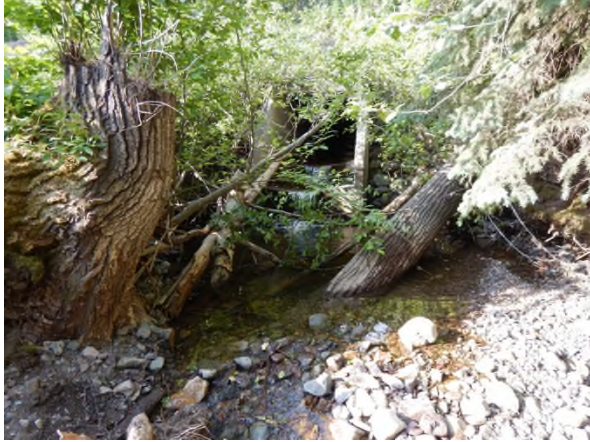
Moan Creek is a 2nd order stream that flows northwest before draining into the upper Bulkley River along its left bank, approximately 9.5 km upstream of the Telkwa River mouth. Fish species present in Moan Creek include Cutthroat, Rainbow and Bull trout, as well as Dolly Varden (FISS 2015). Wilson and Rabnett (2007) indicated that Chinook and Coho salmon have been observed in the lower 500 m reach of the creek. At the Lawson Road crossing located approximately 500 m from its mouth, Moan Creek passes through a concrete, baffled culvert. The culvert is 1.5 m wide, 1.5 m high and approximately 22 m long. Fifteen v-shaped baffles (0.33 m in height at the center notch) create a series of step pools through the entire length of the culvert. The culvert is steeply sloped at 10% and there was an outfall drop of 0.27 m on 10 October 2015.

Photo 7. Moan Creek at Lawson Road – Upstream view of the culvert outlet prior to construction (21 July 2017).

Rock material for the Moan Creek site was delivered from 13-14 July and 21-24 July 2017. From 21-24 July, three riffles were constructed approximately 6, 17, and 27 m downstream of

the Lawson Road culvert outlet (Figure 6, Figure 7; Photo 7 to Photo 12). Post-construction, the first step pool was backwatered with a water depth of 0.08 m flowing over the notch in the lowermost v-shaped baffle on 24 July. A berm was constructed along the right bank, extending from the culvert outlet downstream to the crest of the third riffle. Approximately 102 m³ of riffle rock and gravel and 61 m³ of berm material were used.

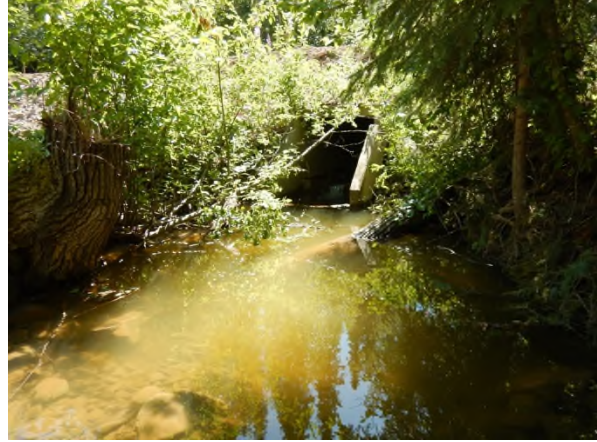
Photo 8. Moan Creek at Lawson Road – Upstream view of the culvert outlet after construction (24 July 2017).

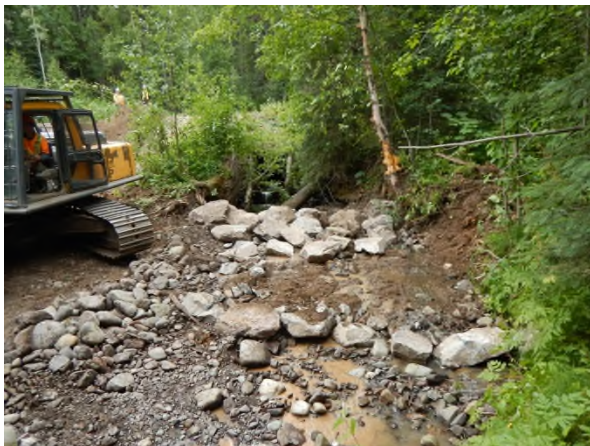
Photo 9. Moan Creek at Lawson Road – Upstream view of riffle 1 (6 m d/s culvert outlet) during construction (24 July 2017).

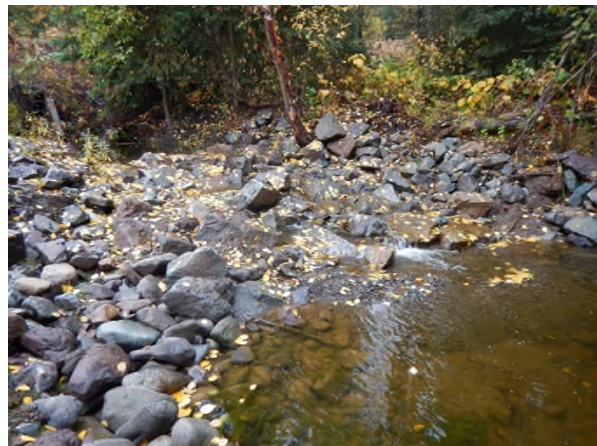
Photo 10. Moan Creek at Lawson Road – Upstream view of riffle 1 (6 m d/s culvert outlet) after construction (29 September 2017).

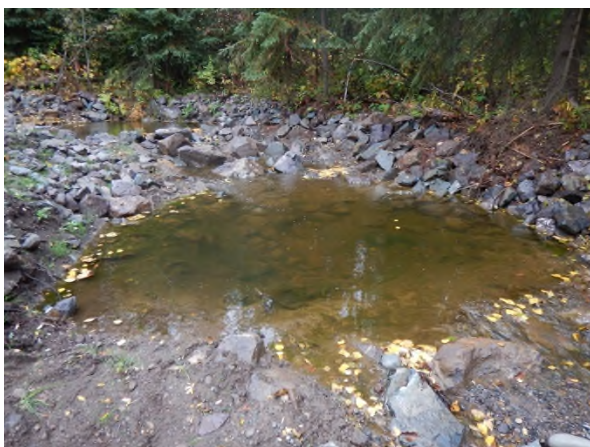
Photo 11. Moan Creek at Lawson Road – Upstream view of the pool between riffles 2 and 3 after construction (29 September 2017).

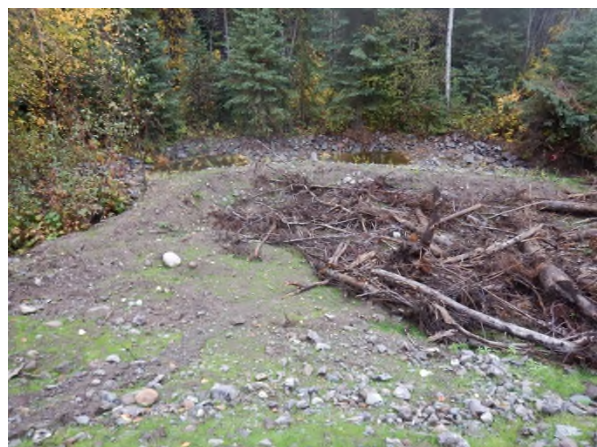
Photo 12. Moan Creek at Lawson Road – View of the right-bank berm and creek from Lawson Rd. The creek flows from left to right (29 September 2017).

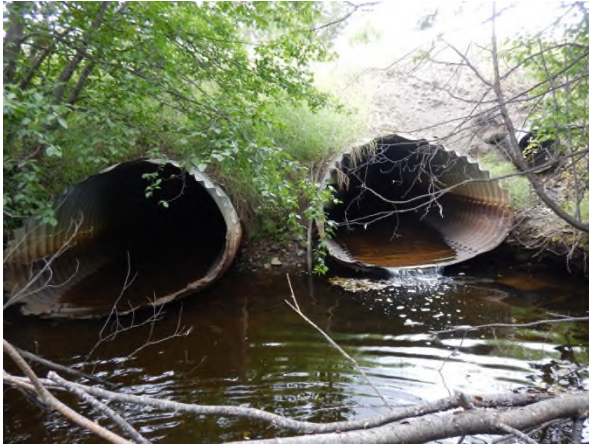
The upper portion of Tchesinkut Creek flows eastward and empties into the west side of Tchesinkut Lake. The lower portion of Tchesinkut Creek flows northeast from the outlet of Tchesinkut Lake (at the east end) and empties into the Endako River. The Endako River feeds into the Nechako River, and the Nechako River drains into the Fraser River at Prince George. Rainbow Trout are present in Tchesinkut Creek, while Kokanee, Rainbow Trout, Lake Trout, Lake Whitefish, and Burbot are among the fish species observed in Tchesinkut Lake (FISS 2015). At the Highway 35 crossing located approximately 75 m upstream from Tchesinkut Lake, Tchesinkut Creek passes through two, elliptical, multi-plate culverts. Each culvert is 2.2 m wide, 1.65 m high and 21 m in length. The culvert closer to the north (left) side of the creek had a slope of 1.49% with an outfall drop of 0.19 m on 12 October 2015.

Photo 13. Tchesinkut Creek at Highway 35 – Upstream view of the culvert outlets and outlet pool prior to construction (23 July 2017).

From 28-29 August 2017, rock material was delivered to the Tchesinkut Creek site and one riffle was constructed approximately 35 m downstream of the Highway 35 culvert outlets (Figure 8, Figure 9; Photo 13 to Photo 16). Post-construction, the culvert was backwatered 16.8 m (81% of the 20.8 m length) and water depth at the invert of the culvert outlet was 0.29 m on 29 August 2017. Approximately 24 m³ of riffle rock was used.

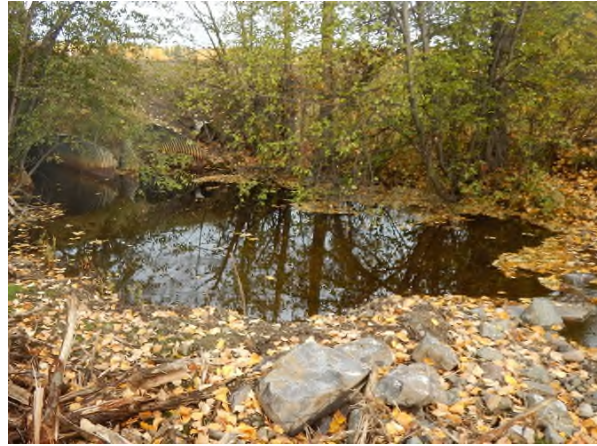
Photo 14. Tchesinkut Creek at Highway 35 – Upstream view of the culvert outlets and outlet pool after construction (30 September 2017).

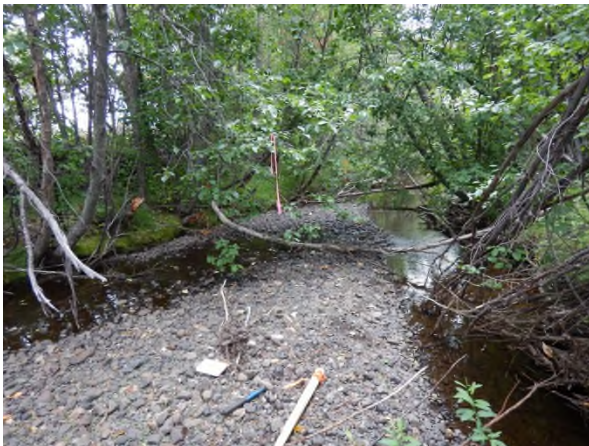
Photo 15. Tchesinkut Creek at Highway 35 – Downstream view of the proposed riffle 1 site prior to construction (23 July 2017).

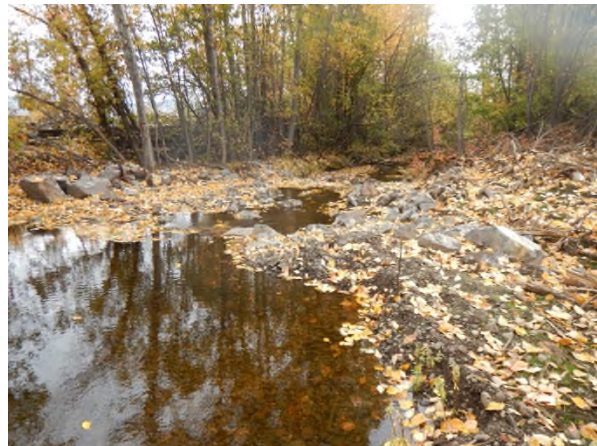
Photo 16. Tchesinkut Creek at Highway 35 – Downstream view of riffle 1 after construction (30 September 2017).
