Copper River WRP

2000-2001 Instream Works Summary Report

TRITON
ENVIRONMENTAL CONSULTANTS LTD.

January 2001

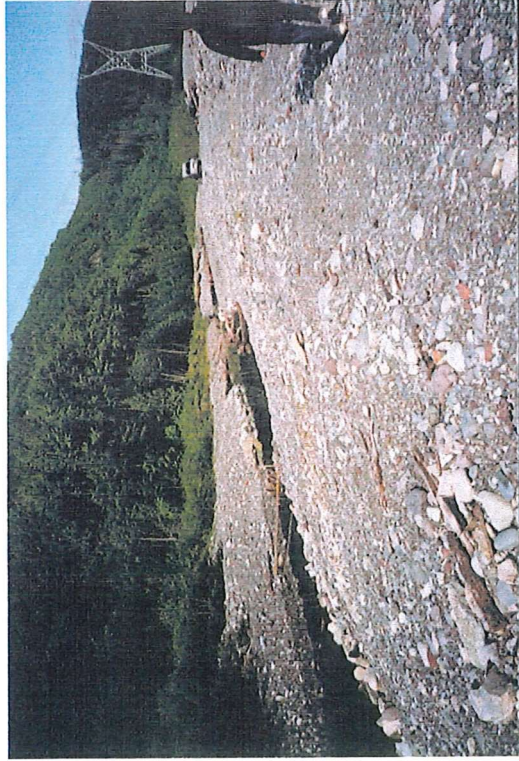
Photo 1: Copper River Site 9 Channel Downstream view of the channel to be infilled.

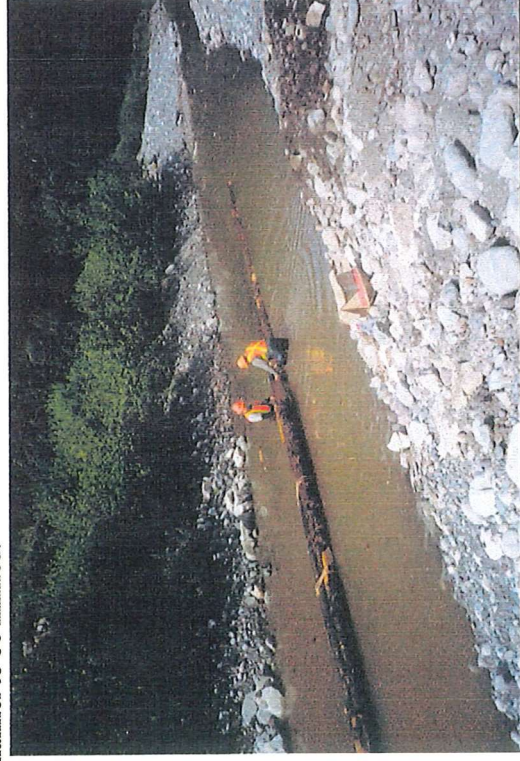
Photo 2: Copper River Site 9 Channel. After fish salvage and relocation of woody debris to lower section of channel, logs placed in the channel will enable groundwater to flow to the lower channel.

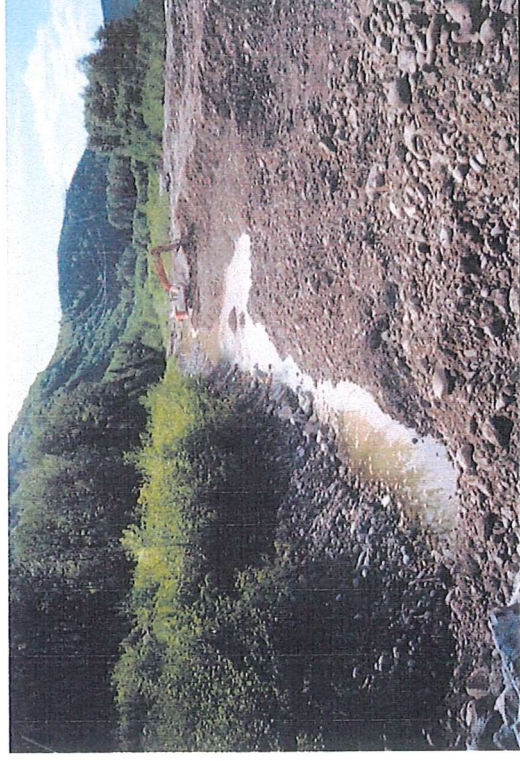
Photo 3: Copper River Site 9 Channel. Excavator backfilling the upper section of the channel.

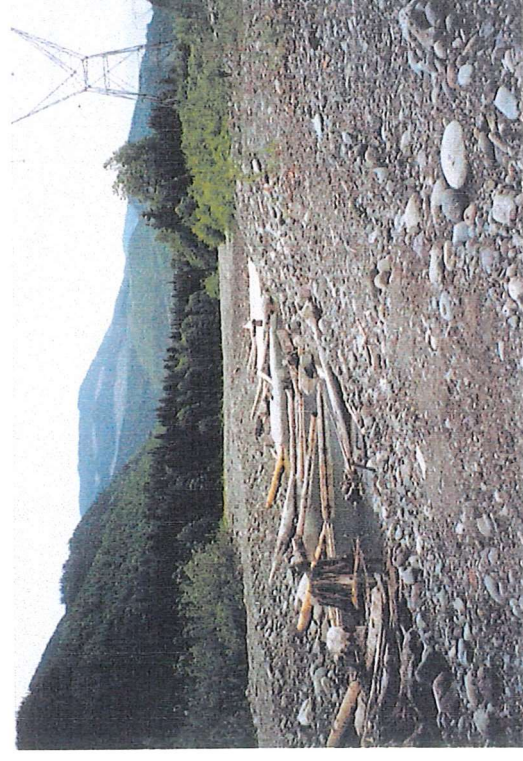
Photo 4: Copper River Site 9 Channel. Upstream view after modifications. Channel inlet is returned to the natural contour.

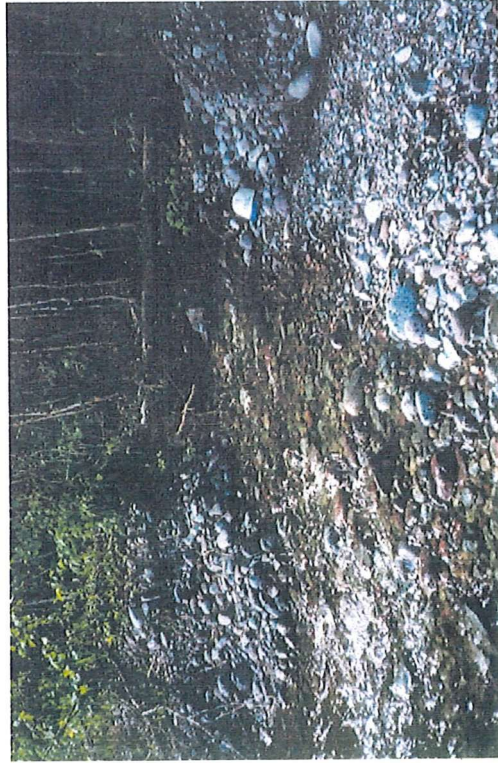
Photo 5: Copper River Off-channel May 2000. Flow diverted down old spur road to Site 9 Channel due to blocked culvert. The outlet to Site 9 shown here.

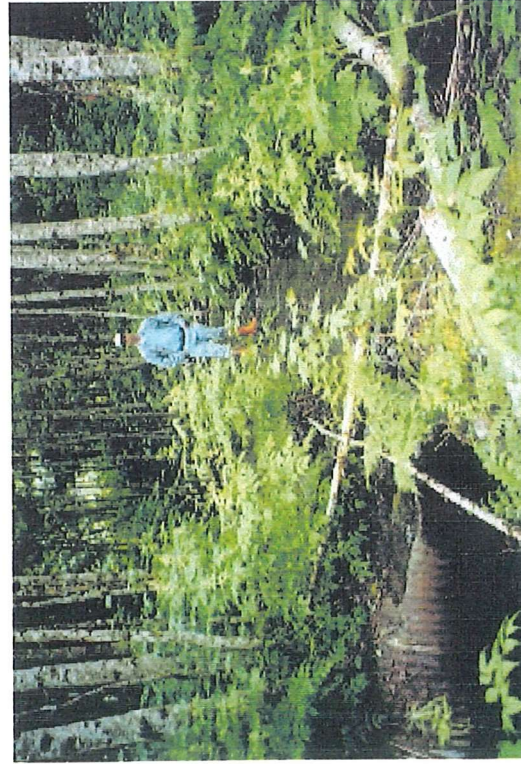
Photo 6: Copper River Off-channel. Middle section of proposed channel with blocked culvert (foreground) which diverted flow down spur road.

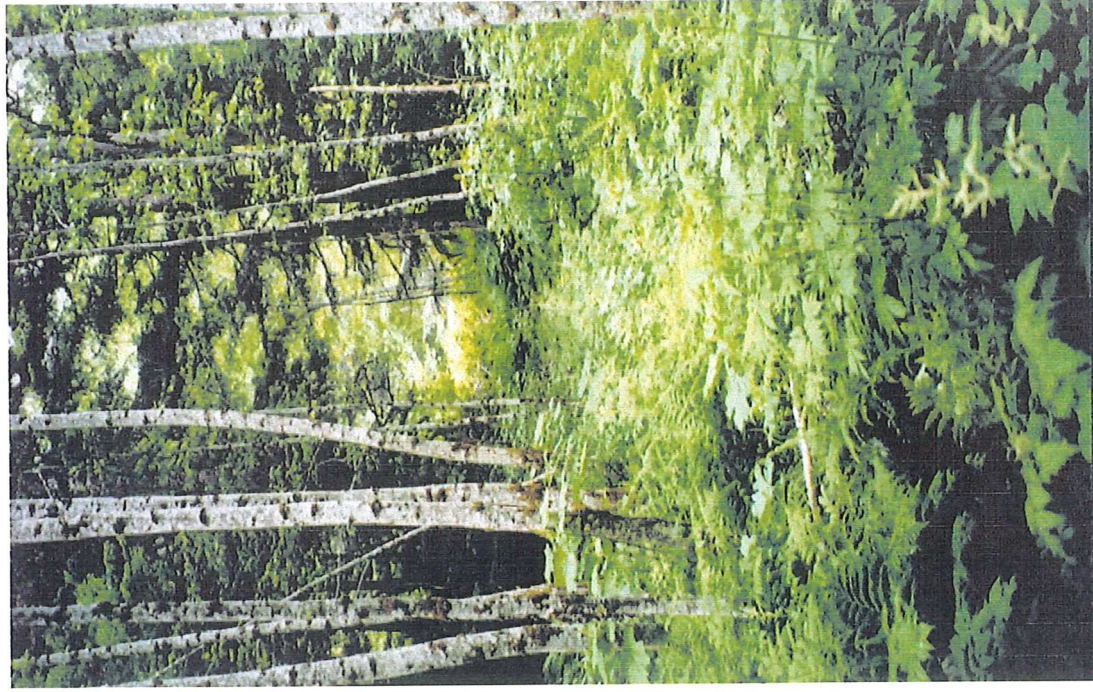
Photo 7: Copper River Off-channel. Middle section of proposed channel was old spur road which flooded when culvert blocked. Looking towards Site 9 Channel.

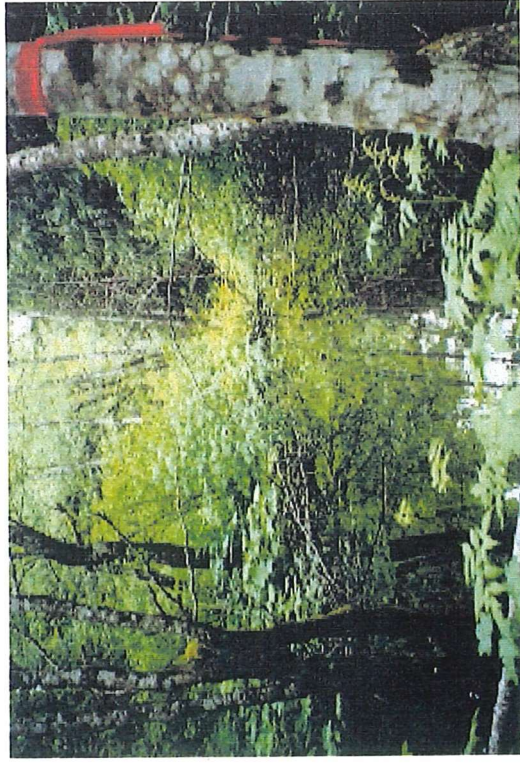
Photo 8: Copper River Off-channel. Upper 100 m of ephemeral channel. Pounded water was due to blocked culvert was diverted down old spur road. Upstream view at culvert.

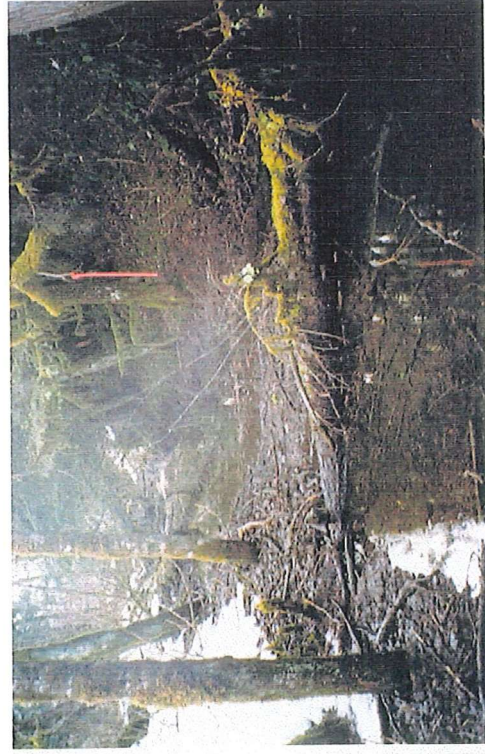
Photo 9: Copper River Off-channel. Upper section of proposed site, upstream view. New channel excavated 1.5 m lower than the water level shown.

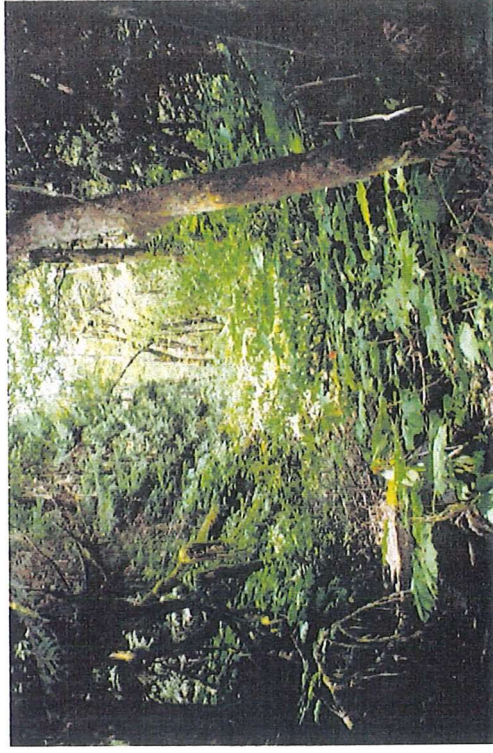
Photo 10: Copper River Off-channel. Uppermost section of the proposed channel. Excavator dug new channel 1 m lower than existing.

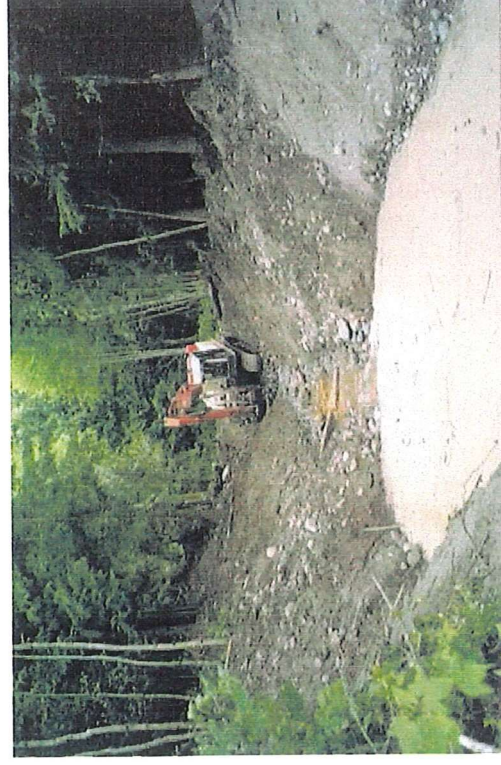
Photo 11: Copper River Off-channel Project. Lower section between pools 1 and 2 during excavation, looking upstream.

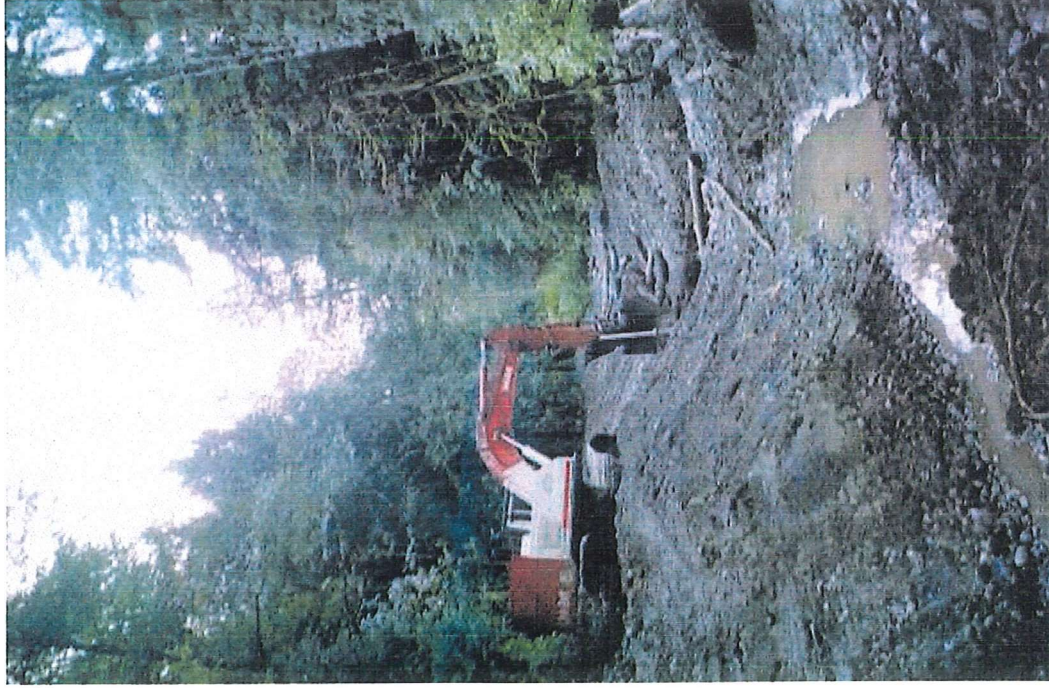
Photo 12: Copper River Off-channel. Upper section during construction, looking upstream from old culvert location..

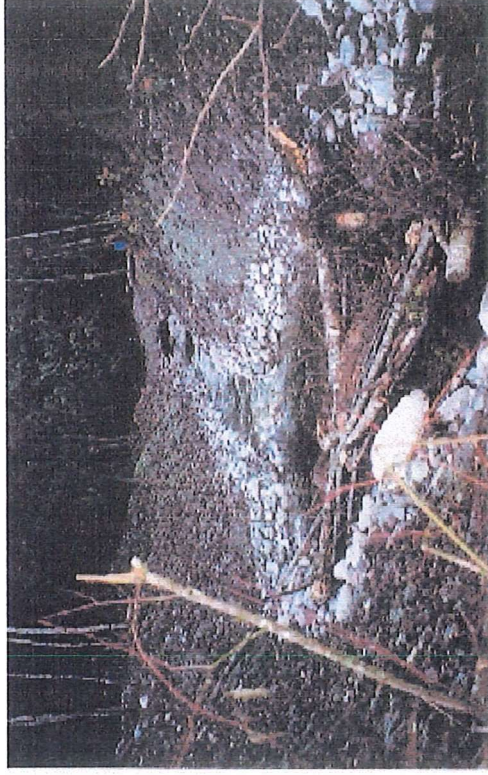
Photo 13: Copper River Off-channel. Lower section of off-channel after excavation and complexing, looking upstream. Coho spawned immediately upstream of the pool in foreground.

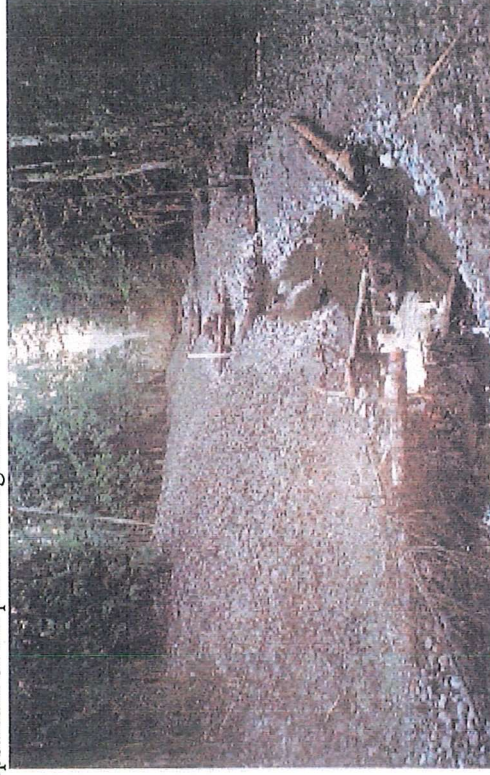
Photo 14: Copper River Off-channel. Upper section of off-channel after excavation and complexing. Note cobble armoring along edges of channel which prevented flood damage in October.

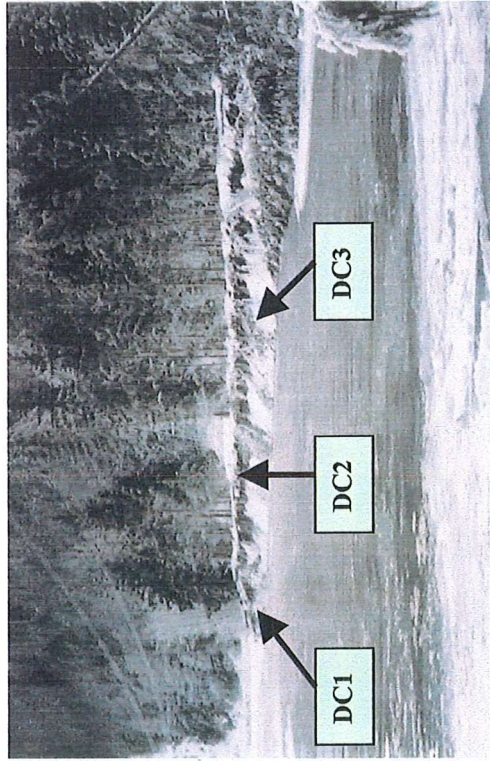
Photo 15: Copper River Debris Catchers. Looking upstream at eroding bank where the three debris catchers were constructed.

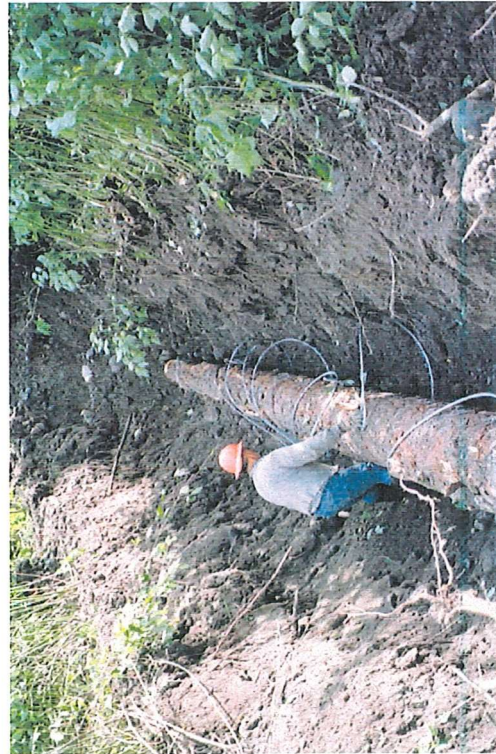
Photo 16: Buried deadman log cabled to upstream logs for stability.

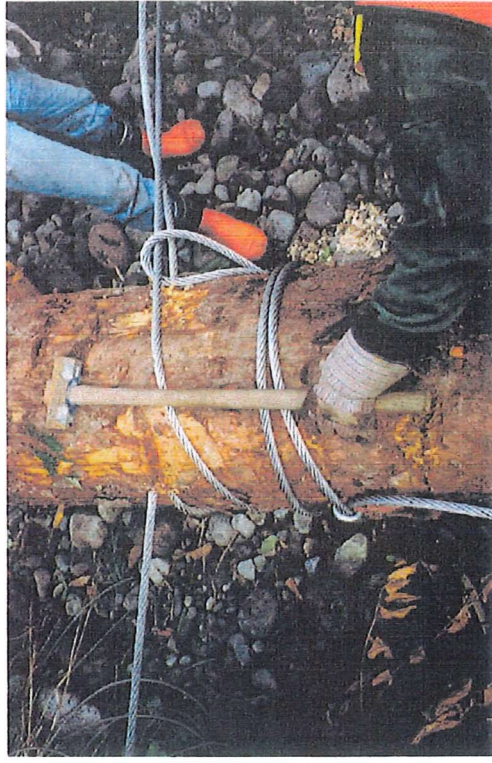
Photo 17: Copper River Debris Catcher 1. Secured cable hitched to log and joined to deadman.

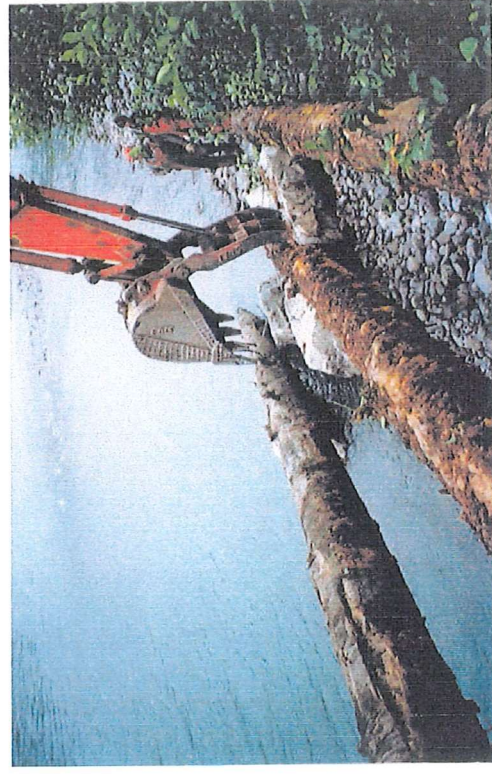
Photo 18: Copper River Debris Catcher 1. Upstream end of structure anchored to rock ballast.

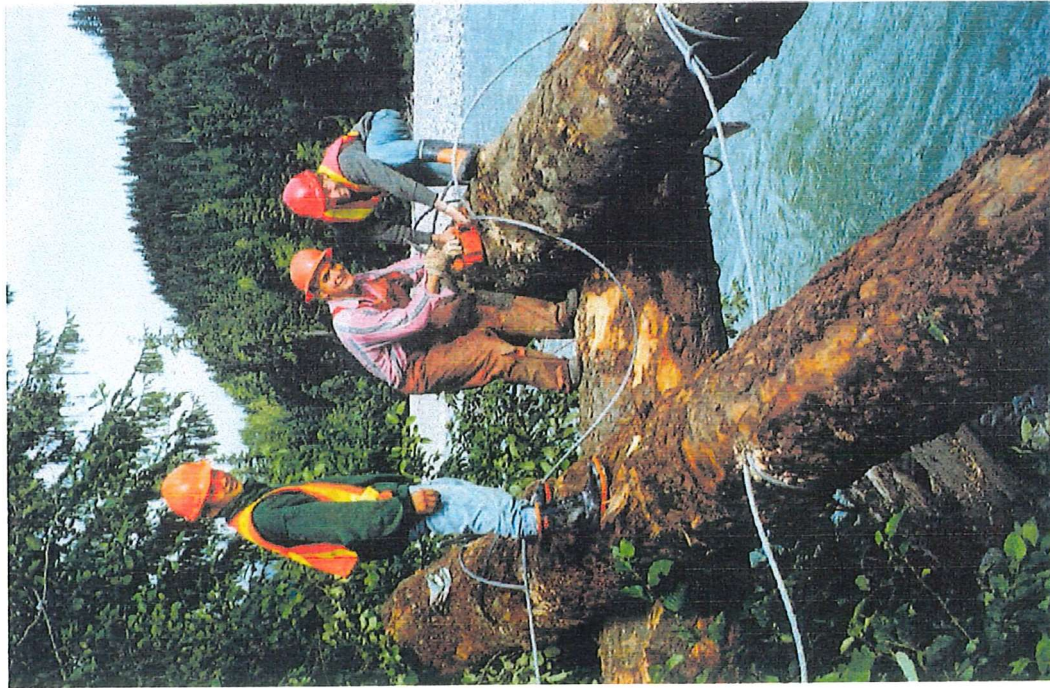
Photo 19: Copper River Debris Catcher 1. Cabling trash logs to support log. From left to right, Steve Bolton, Jack Mussel and Brian Schafhauser.

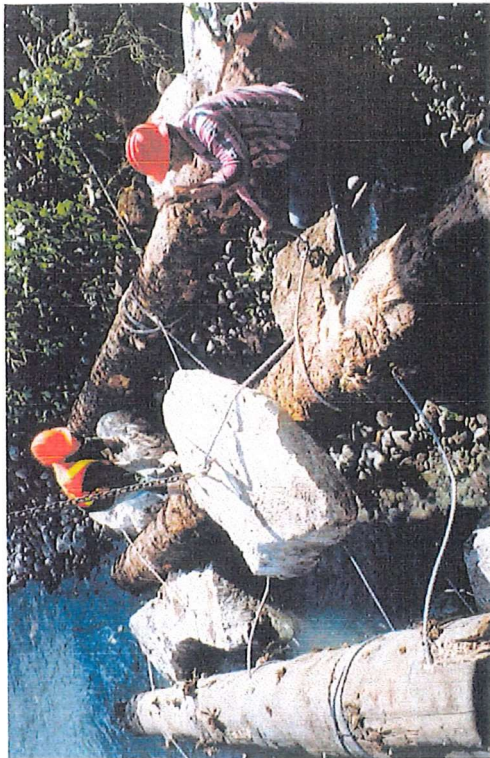
Photo 20: Copper River Debris Catcher 1. Rock ballast being anchored to trash logs to support the upstream end of the structure.

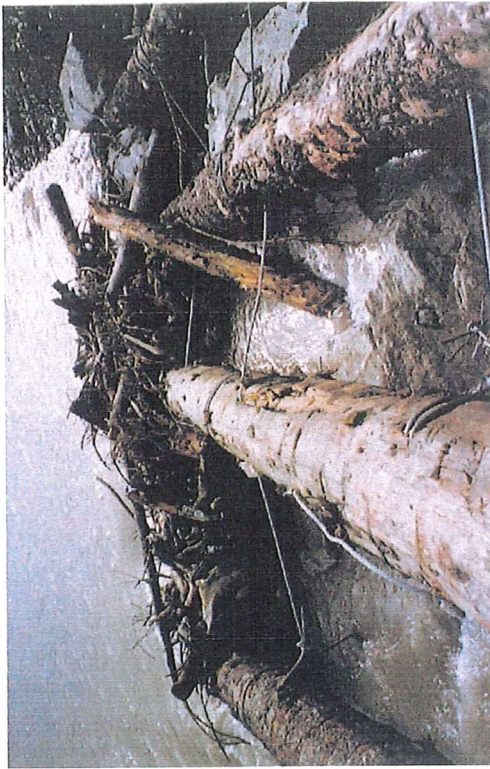
Photo 21: Copper River Debris Catcher 1. Debris piled on the upstream end of the catcher by a machine.

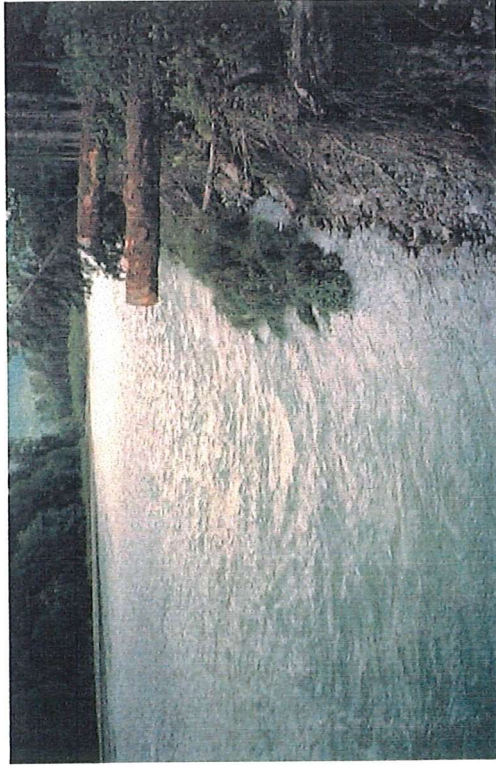
Photo 22: Copper River Debris Catcher 2. Upstream view prior to construction. Note the 3 m high eroding bank and thalweg approx. 2 m from the water edge.

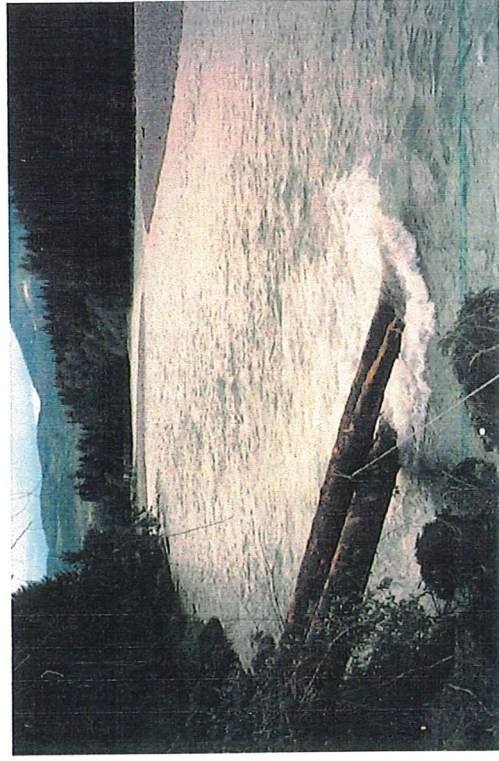
Photo 23: Copper River Debris Catcher 2. X-frame logs are installed into channel to support horizontal-cross logs and debris catching (trash) logs.

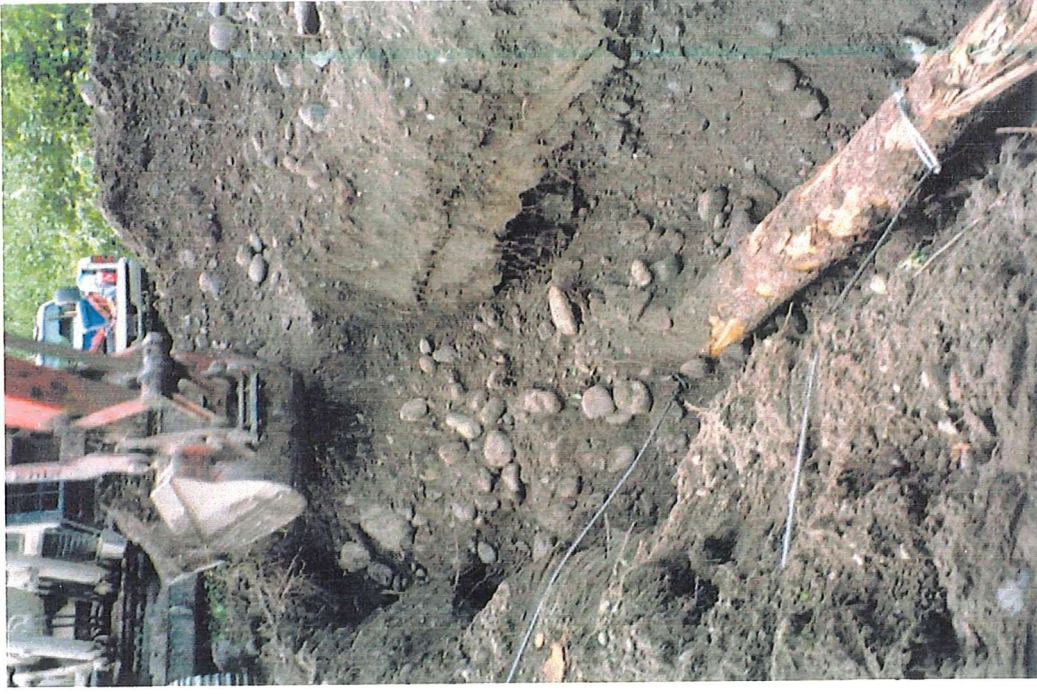
Photo 24: Copper River Debris Catcher 2. Deadman log buried 6' below ground and cabled to debris logs to provide lateral stability and anchoring.

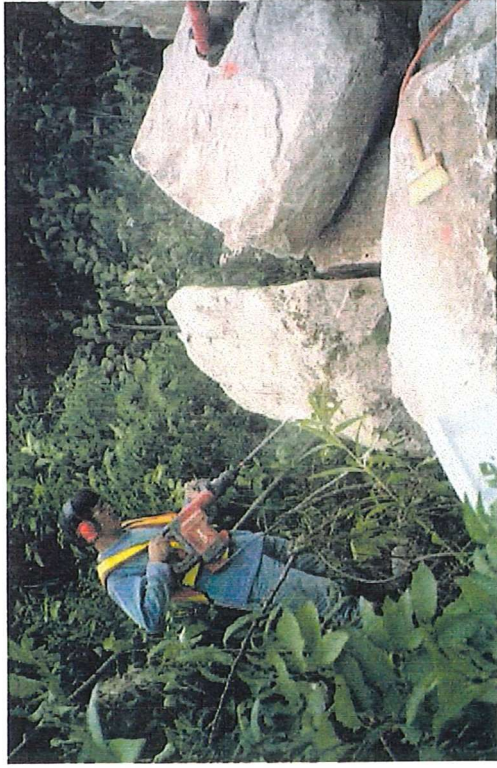
Photo 25: Copper River Debris Catcher 2. Rock is drilled then Hilti epoxy is used to secure 5/8" galvanized cable.

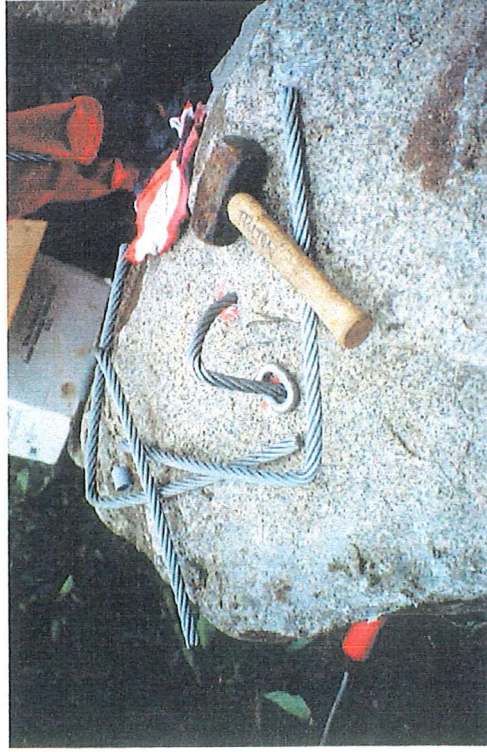
Photo 26: Copper River Debris Catcher 2. 5/8" cable is epoxied into rock 20 to 25 cm with a chain link added to connect the cable to the log.

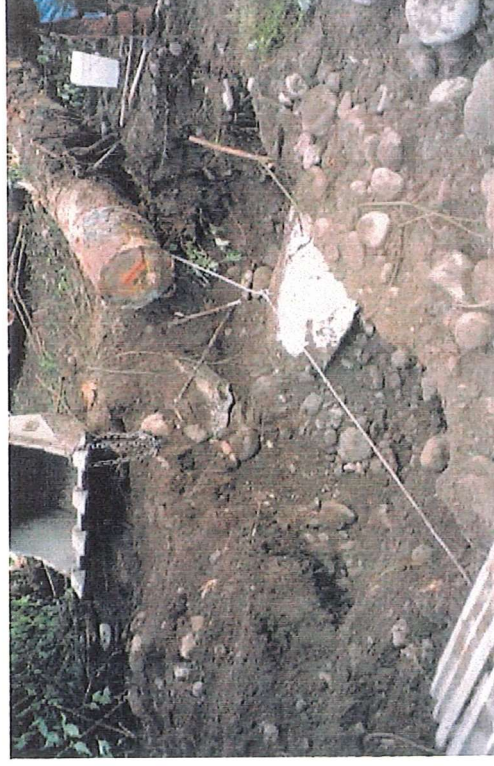
Photo 27: Copper River Debris Catcher 2. Three rocks buried adjacent to cross log. The main cable to the buried deadman (bottom left) is joined to rock as well.

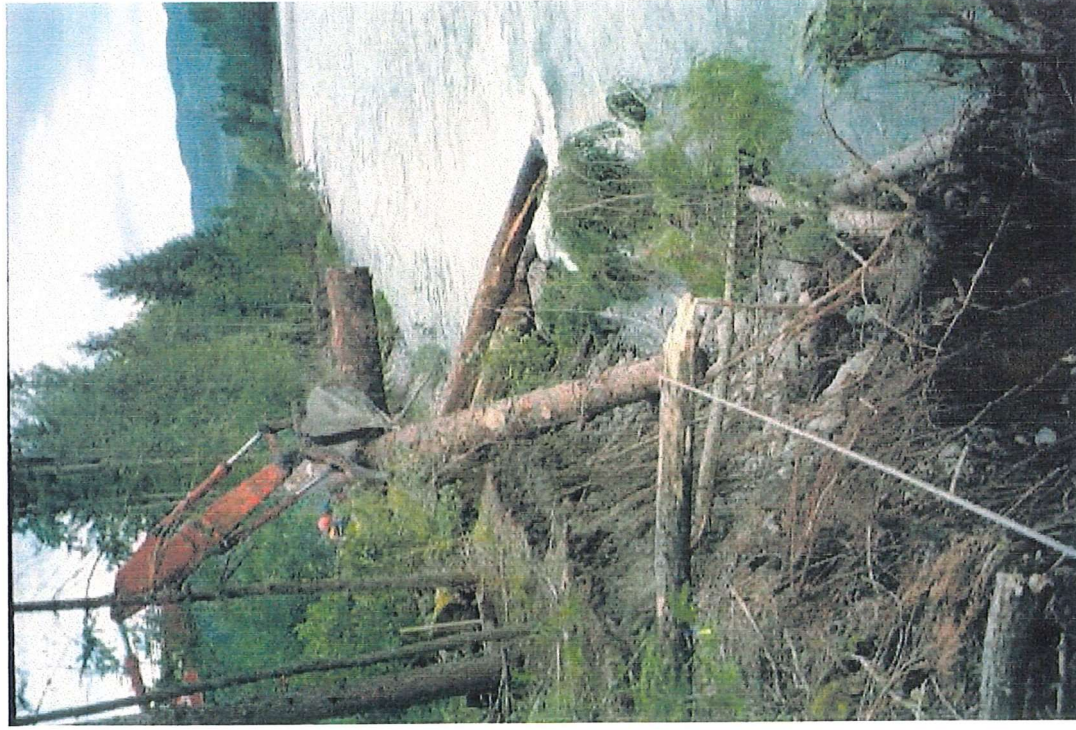
Photo 28: Copper River Debris Catcher 2. First trash log is placed on X-frame logs.

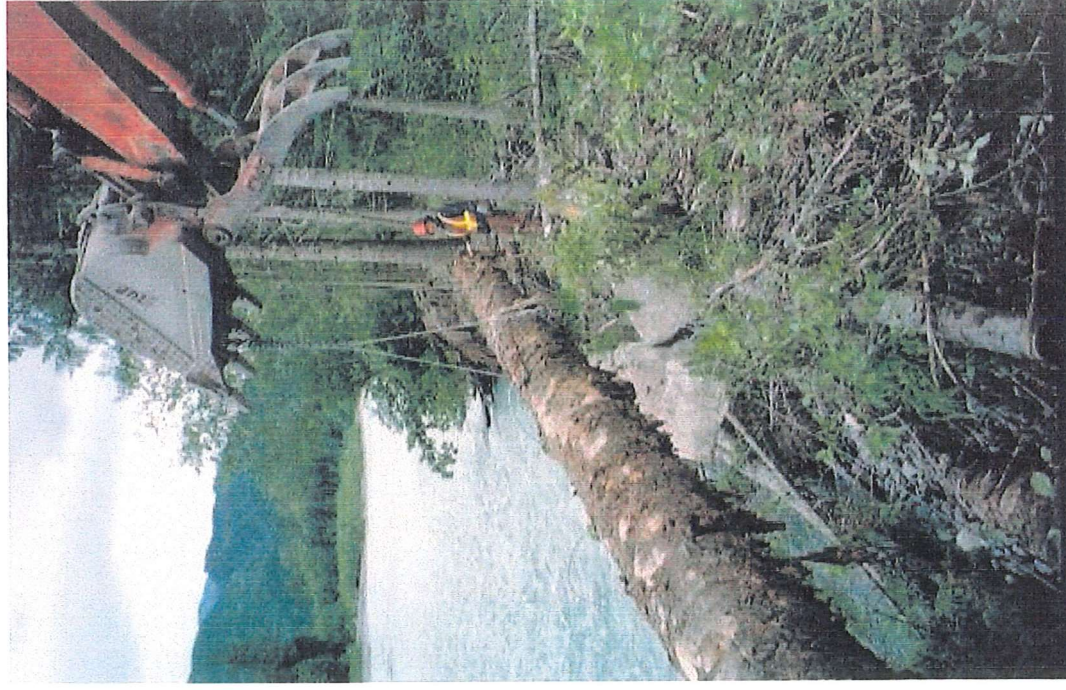
Photo 29: Copper River Debris Catcher 2. Rock ballast (approx. 3000 lbs pre rock) is hung on the second log then placed into stream channel.

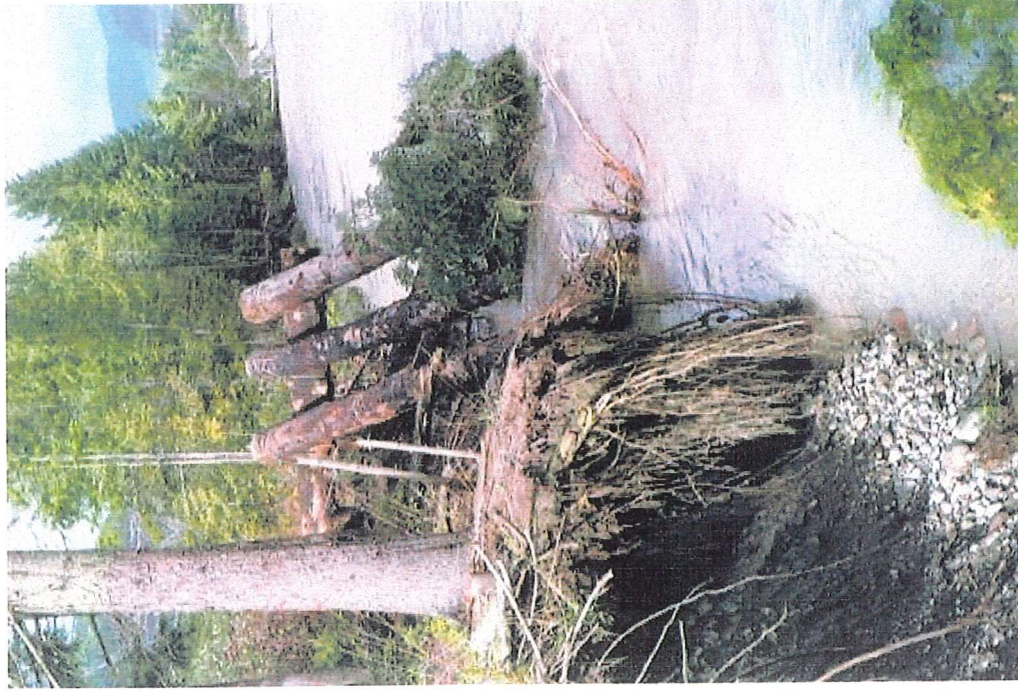
Photo 32: Copper River Debris Catcher 2. Downstream view during fall runoff (1m higher than summer). Floodwaters inundated the lower portion of the catcher. Fallen trees from eroding bank were loaded onto debris catcher in October.

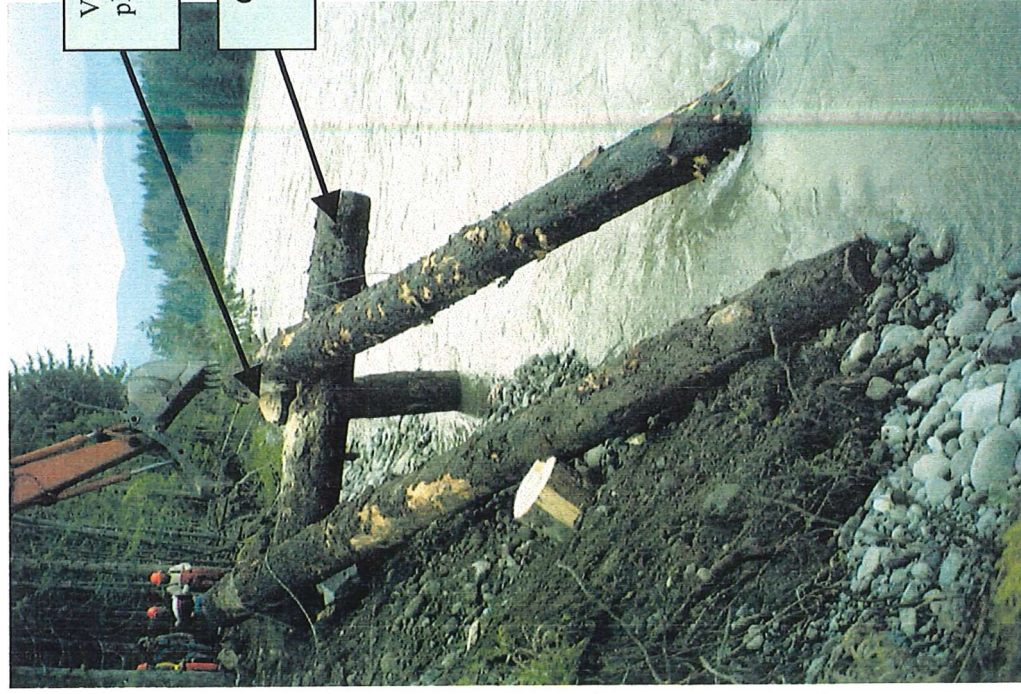
Photo 33: Copper River Debris Catcher 3. Downstream view of construction. Post is being placed under cross log.

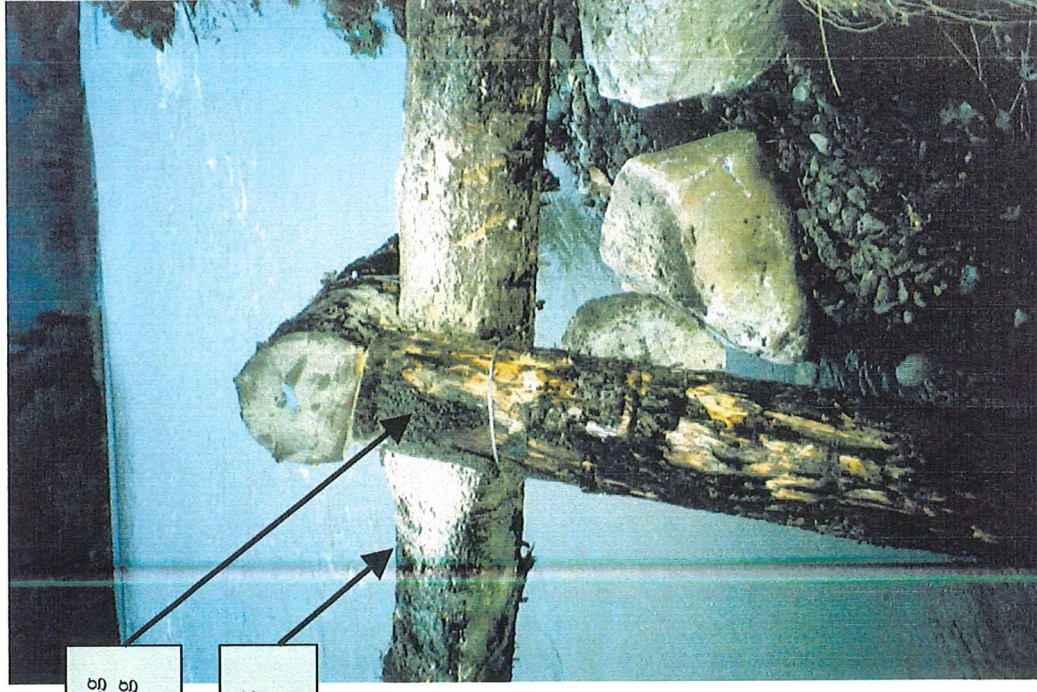
Photo 34: Copper River Debris Catcher 3. Upstream view of post support log underneath trash log which is angled upstream into flow. Note that the boulders hang from cables and keep logs together.
