**1996 MAXAN WATERSHED STREAM
HABITAT RESTORATION AND
ENHANCEMENT DESIGN REPORT**

Dz'ilh K'Az Kwa Development Corporation
Burns Lake, British Columbia

AGRA Earth & Environmental Limited
Prince George, British Columbia
Calgary, Alberta

March 1997

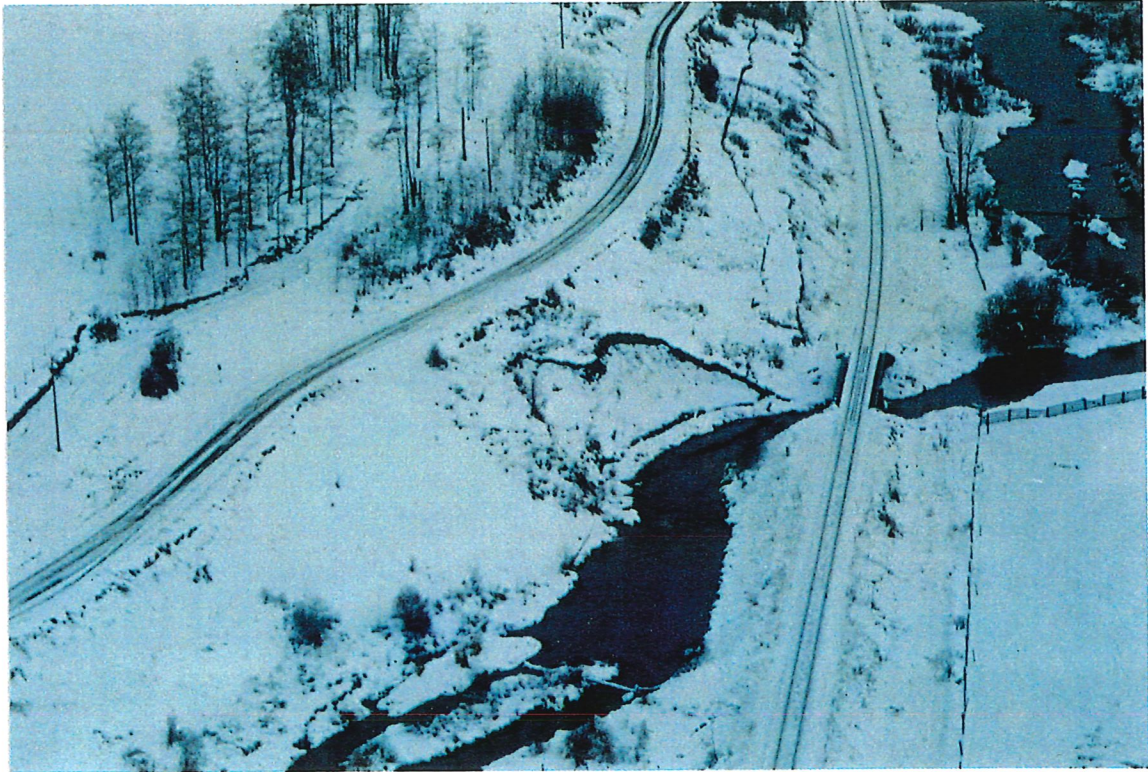
Photo 10
Mass Wasting Along the Right Cutbank of BR-51

Initial bank stabilization activities of the slump will involve flattening of the slope to 2H:1V. Excess material (2 loads) will be transported and stockpiled at Site 2. Filter cloth (Petromat 4553) will then be laid across the bottom of the bank (up to the high water mark) to allow water passage and containment of fines. Filtercloth loose staples (6") will pin the fabric in place. Haul trucks (with rock boxes) will dump riprap at the top of the bank to facilitate hoe installation of the material. Wattle bundles, brush layers and shrub stakes will be installed on the recontoured surface above the riprap. Canada #1 forestry seed mix will be broadcast on all disturbed areas.

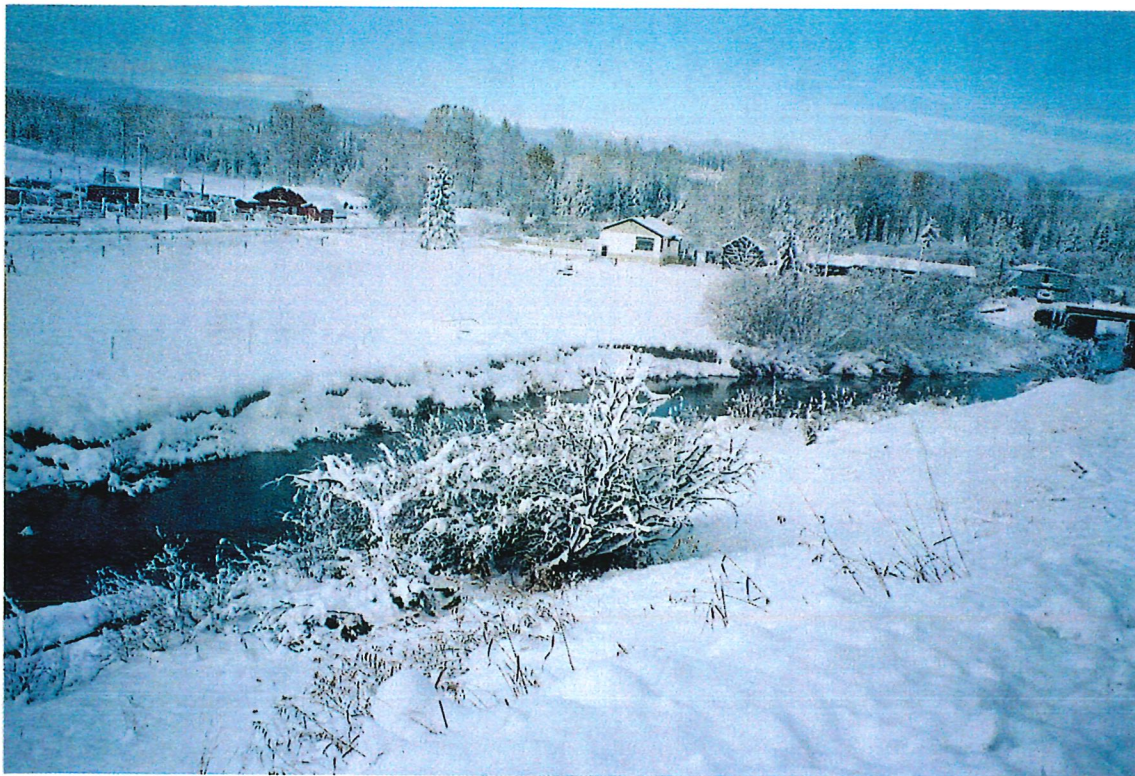
Photo 11
Unstable Banks with Limited Overhead Cover at BR-S1

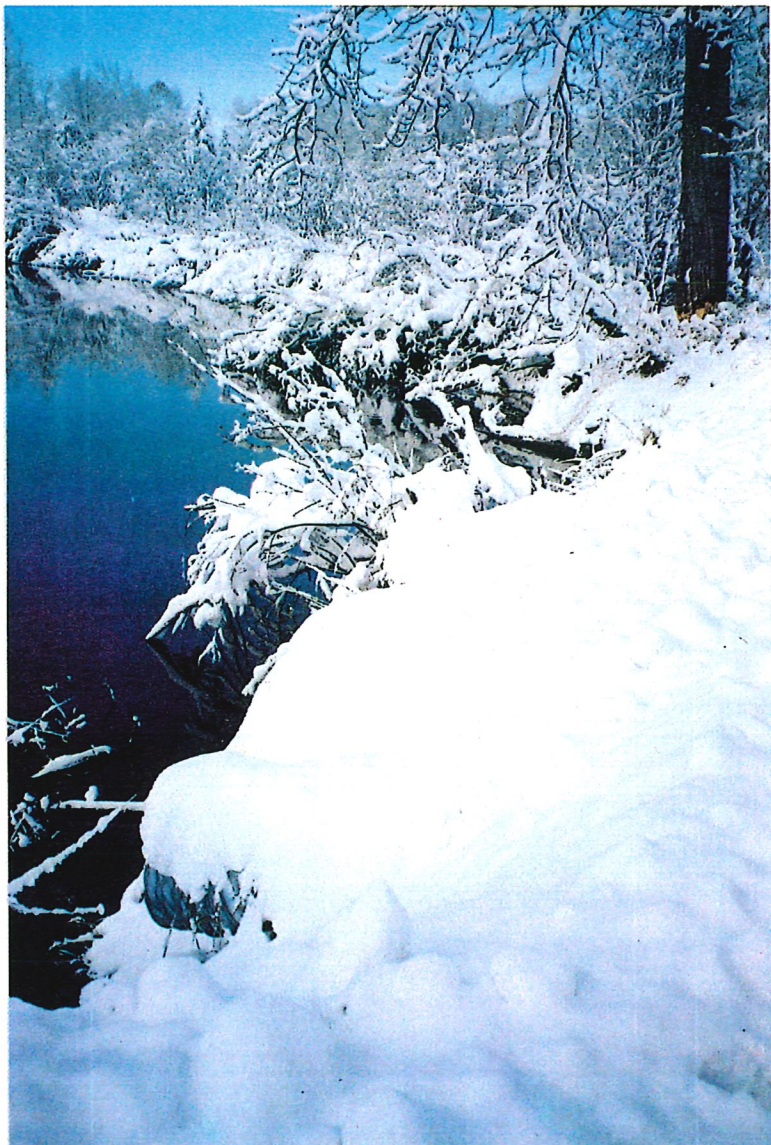
Photo 12
Bank Erosion and Limited Streamside Cover at BR-S2

AEE recommends that blowouts around the culvert and at the downstream end of the site be infilled with 2 loads (1 load each) of spoil material acquired from Site 1. A tree revetment constructed from five 10 m long, well-branched spruce trees will then be installed along the bank. Trees will be transported to the site and positioned using a hoe and 9' x 9/16" choker. Rebuilt bank sections will be staked and seeded. It is expected that bank building will occur as a result of sediment and debris deposition within and behind the structure.

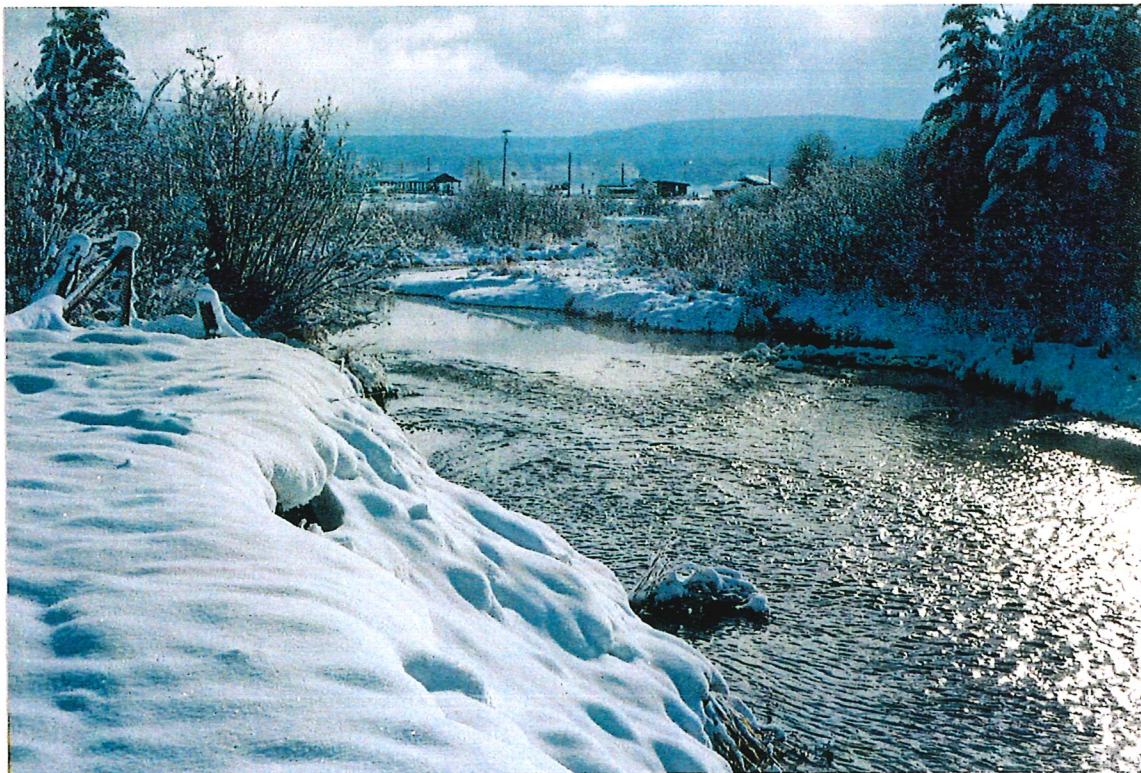
Photo 13
Shallow Riffle Complex and Partially Unstable Bank at BR-S3

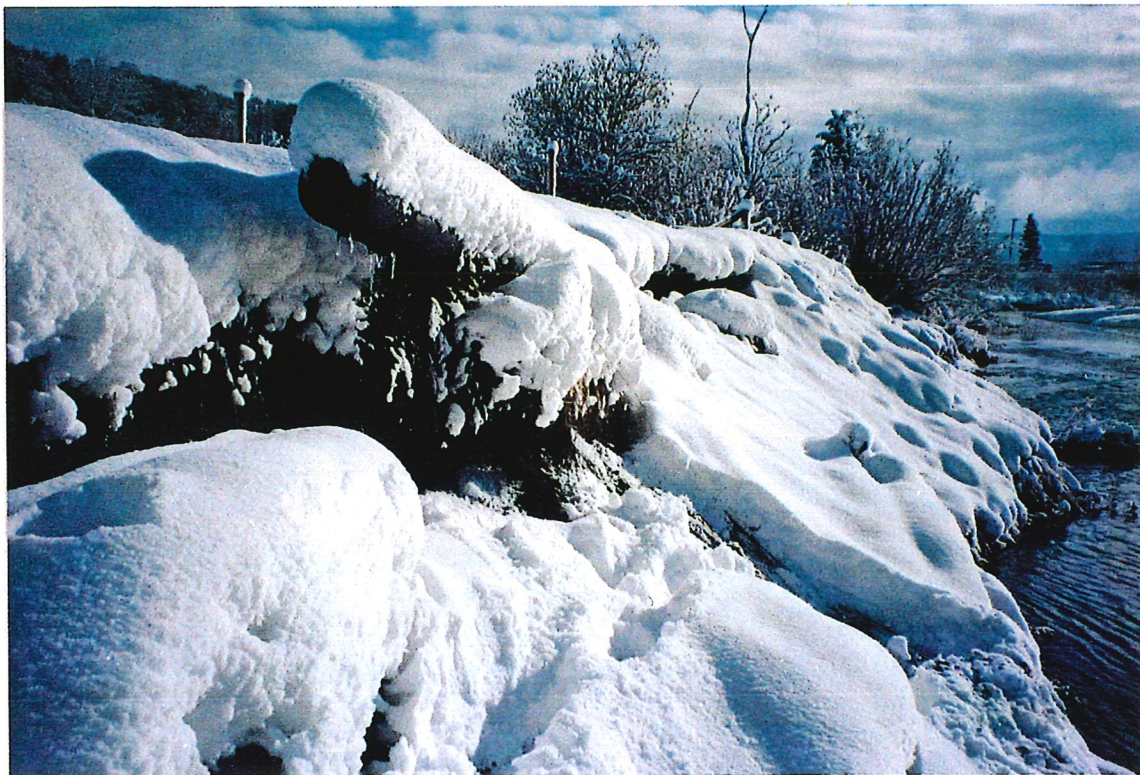
Photo 14
Stockpiled Pipe Slumping Down the Streambank at BR-S3

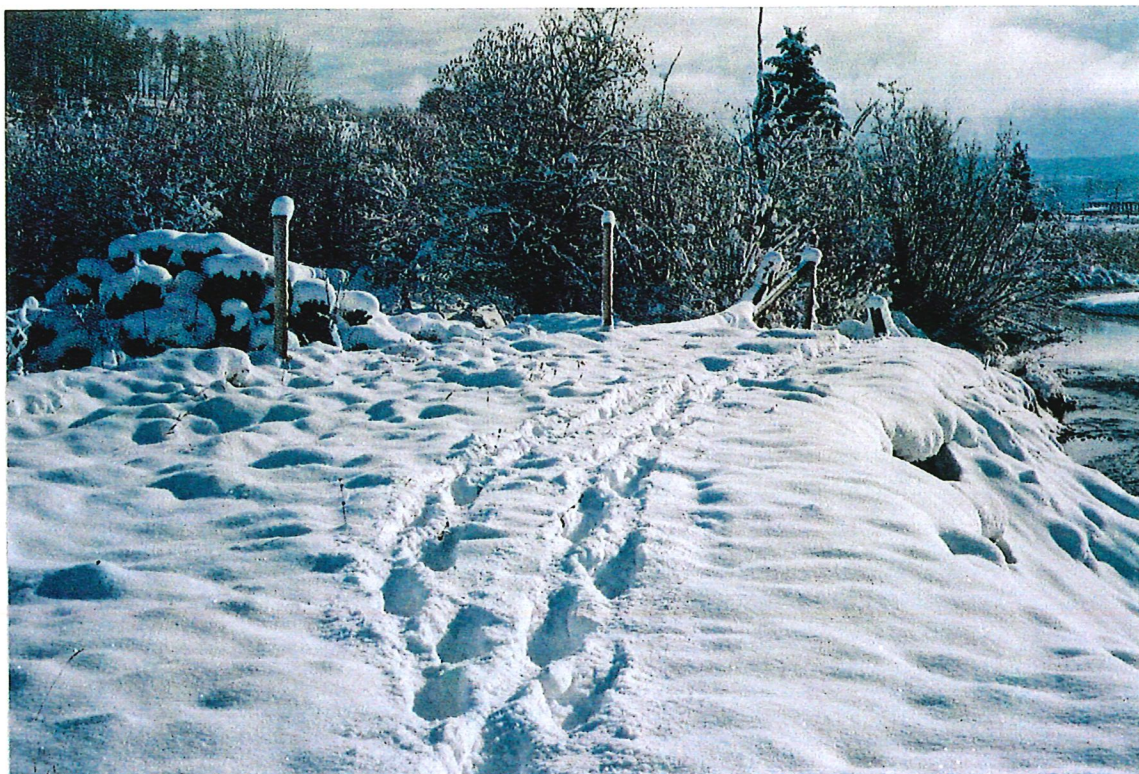
Photo 15
Limited Streamside Cover Along the Right Bank at BR-S3

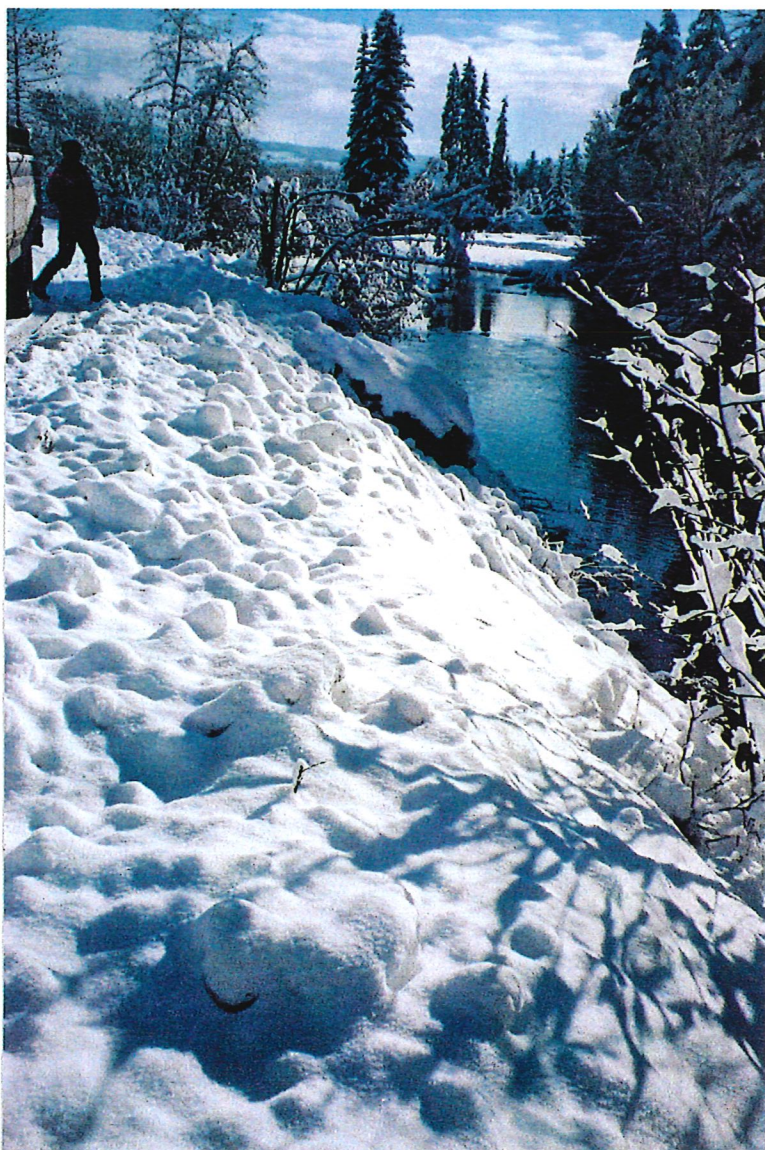
Site 4 (BR-S4) is located 300 m downstream of Site 3 and lies parallel to the Rose Lake Cutoff Road (Photo 16). It is 60 m long and is characterized by a long run. Although generally stable, minor slumping is occurring at this site. Herbaceous vegetation dominates and a few willow bushes have colonized the bank.

Photo 16
Stream Channel and Bank
Characteristics at BR-S4

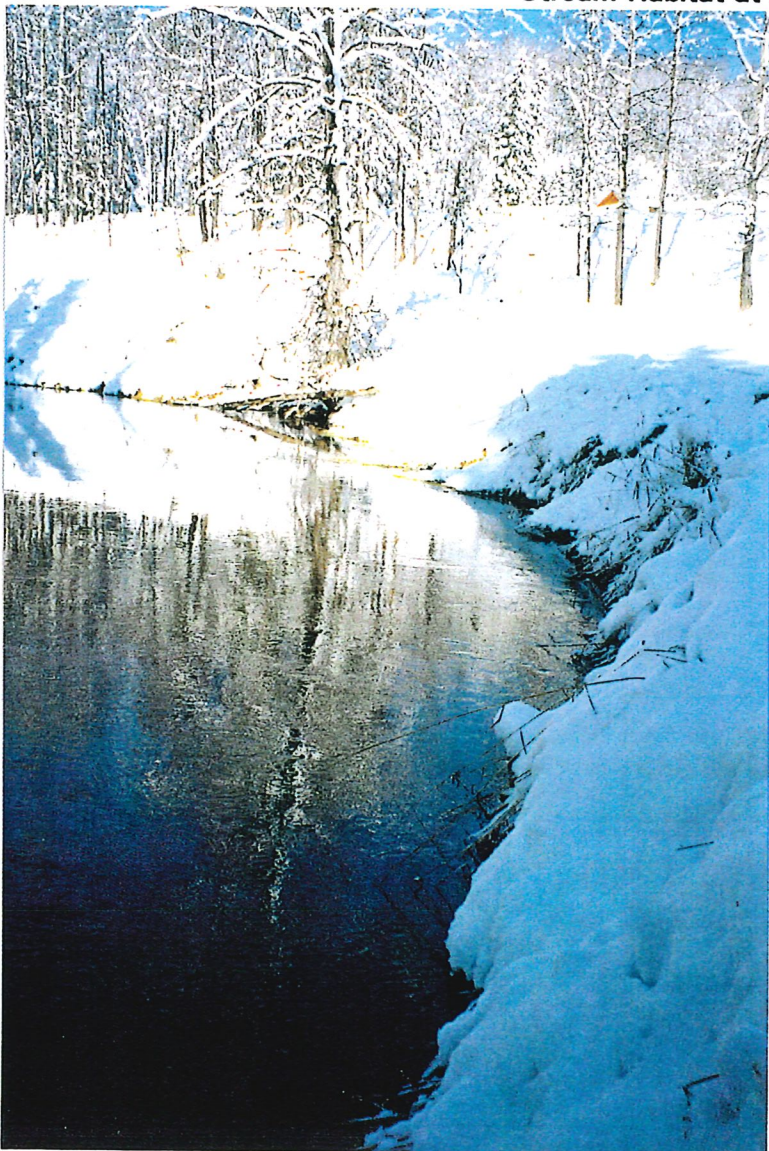
Photo 18
Oversteepened, Unstable Bank
At the Upstream and of BR-S5

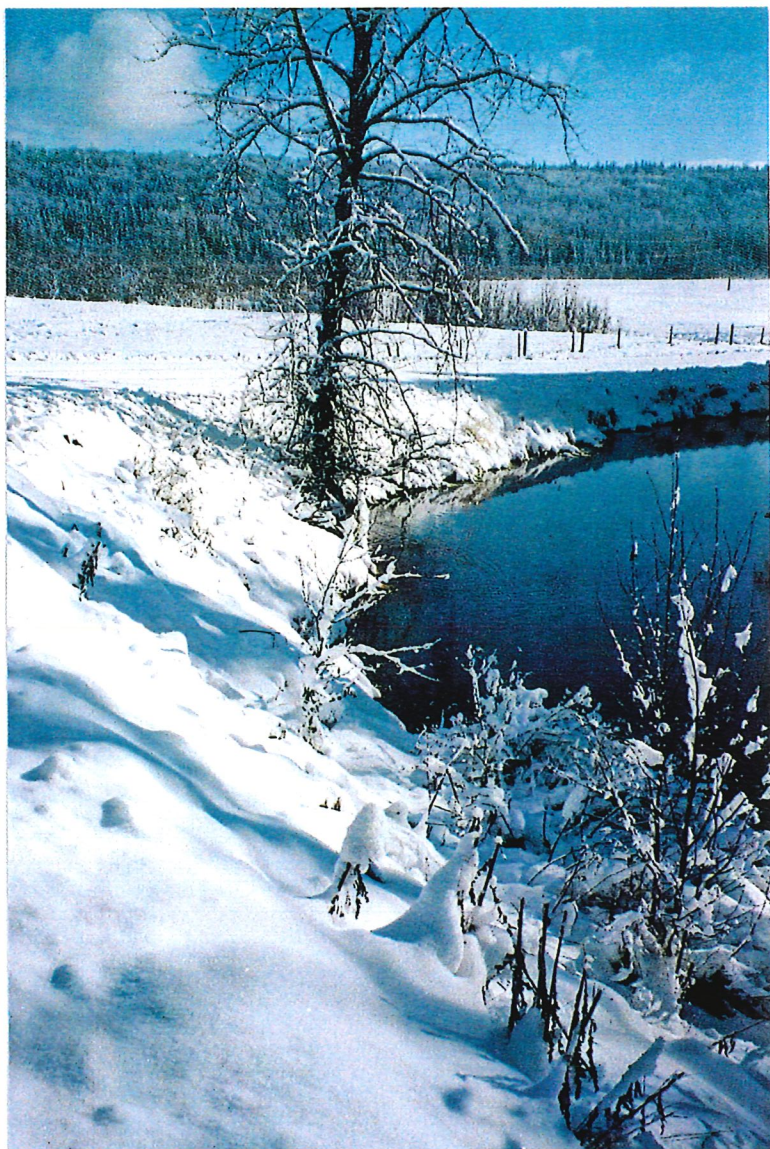
Photo 19
Limited Woody Vegetation at
the Downstream End of BR-S5

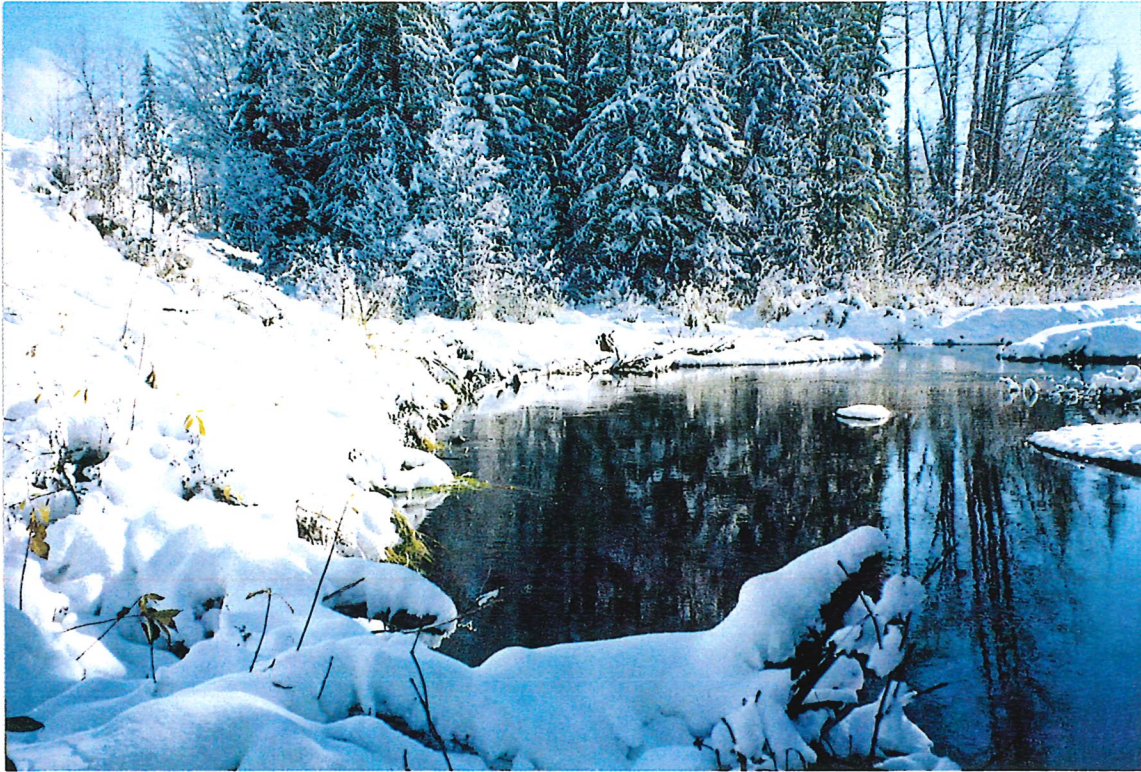
Photo 21
Trees and Shrubs Provide No Overhead Cover at BR-S6

AEE recommends that shrub stakes be planted over the entire bank to maintain bank stability at this site. Shrubs will also increase streamside cover characteristics. No heavy equipment will be required.

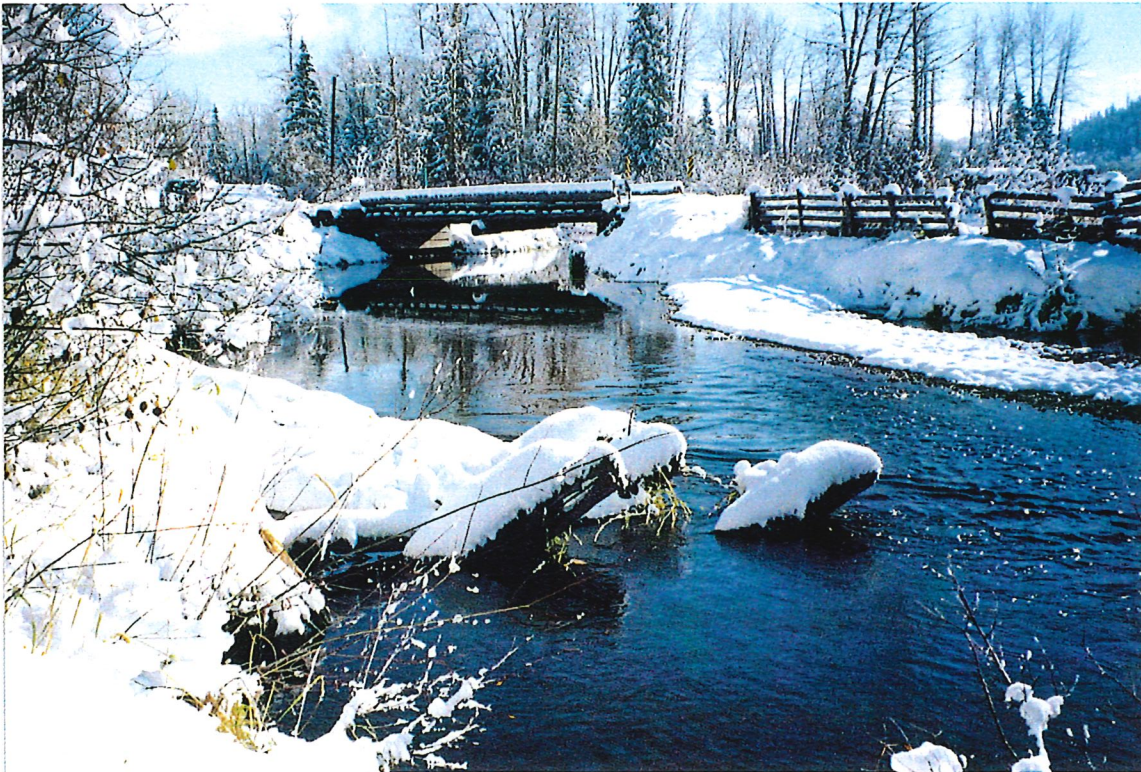
Site 7 (BR-S7) is 70 m long and lies immediately downstream of a permanent timber bridge located 200 m from Site 6 (Photo 22). Back-eddies have removed vegetation and undercut the right bank downstream of the bridge crib. A pool-riffle-run sequence is found in this reach.

Photo 22
Site Overview of BR-S7

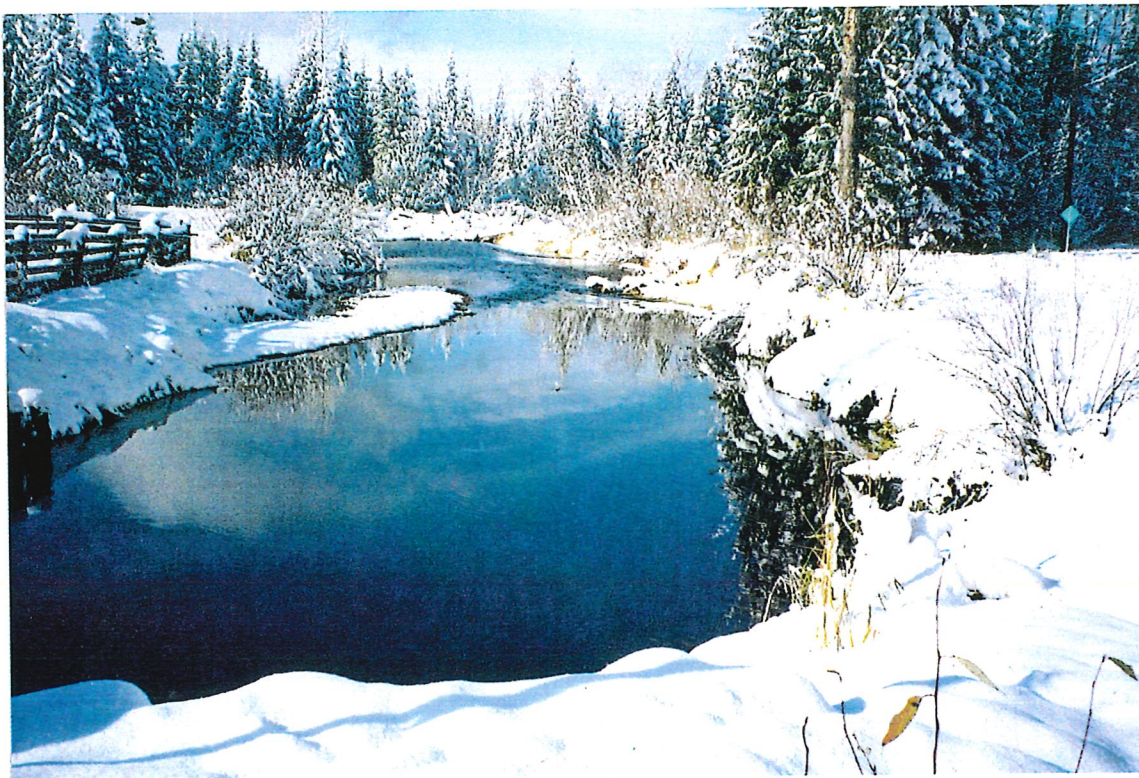
Photo 23
Patchy Shrub Growth Along the Banks at BR-S7

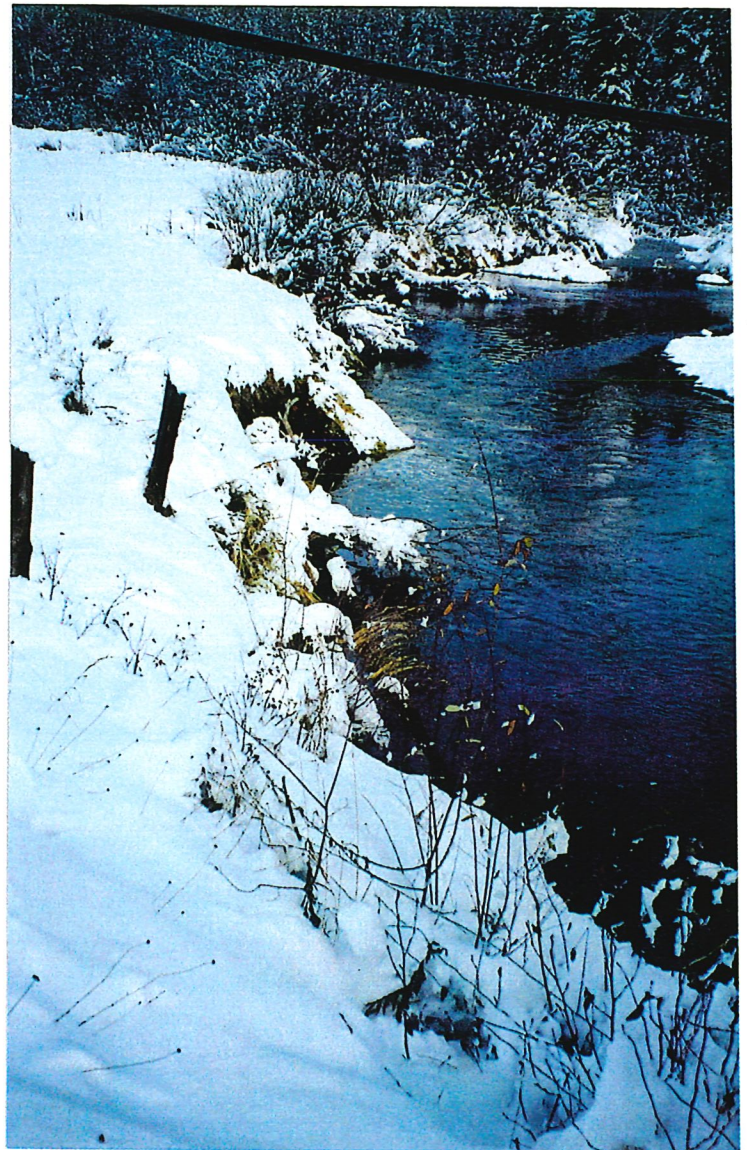
Photo 26
Vertical Eroding Banks
at BR-S9

A shrub/tree revetment will be positioned along the right bank to control erosion and provide overhead fish cover. Shrub revetments will be constructed from individual shrub clumps (bushes) which will be cut near the base and bound with heavy biodegradable twine and #9 galvanized wire. Trees and shrub bundles will be transported to the site by quad. If possible, revetment tips will be anchored near the base of the bank using T-posts. Tips will not be anchored if the posts cannot be pounded flush into the base of the bank. A floating revetment has the ability to move laterally, as well as up and down as streamflow rates increase and decrease. It is expected that continued build-up of material behind the structure will create a relatively stable overhanging bank while also enhancing fish habitat.

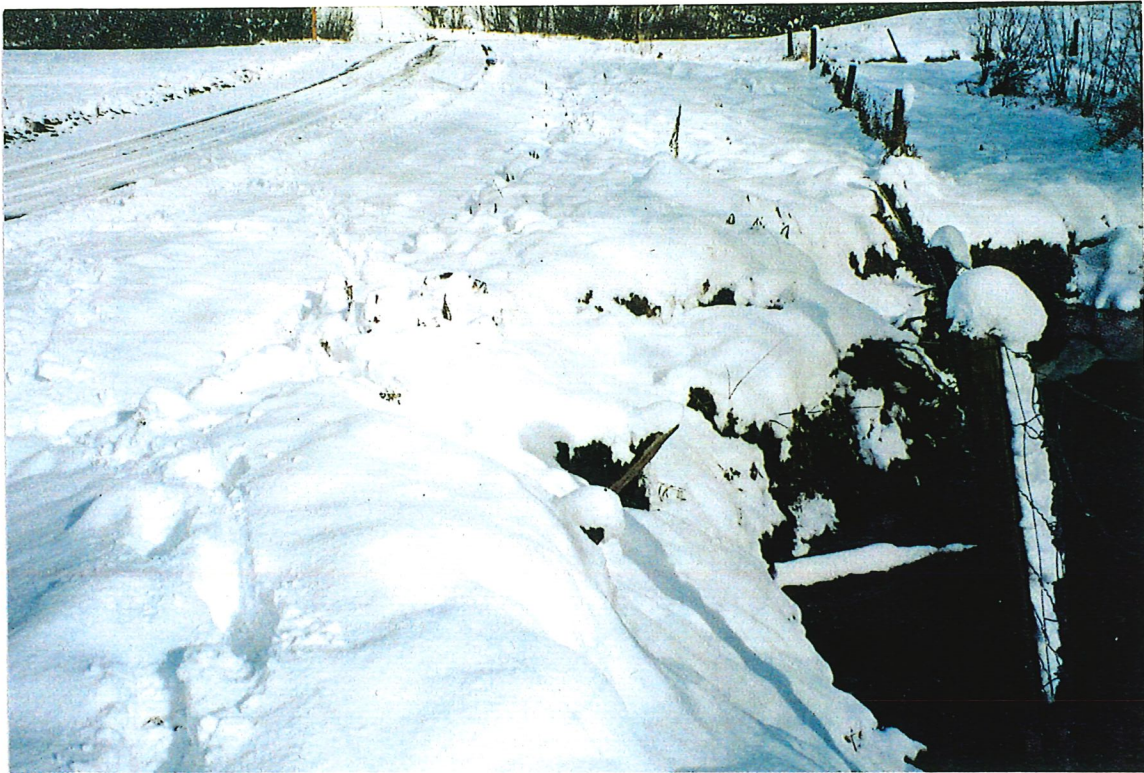
Photo 27
Bank Erosion is Gradually Undermining the Rose Lake
Cutoff Roadbank at BR-S10

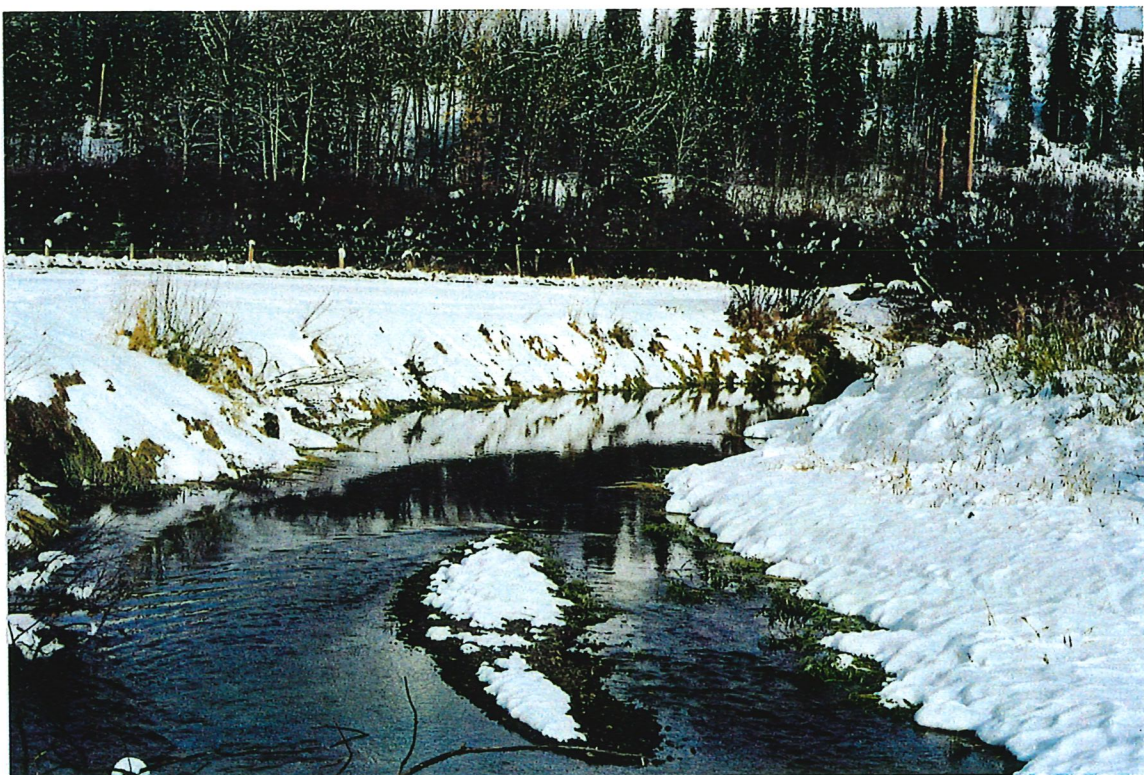
Photo 28
Marginal Overhead Fish Cover Near the Downstream End of BR-S10

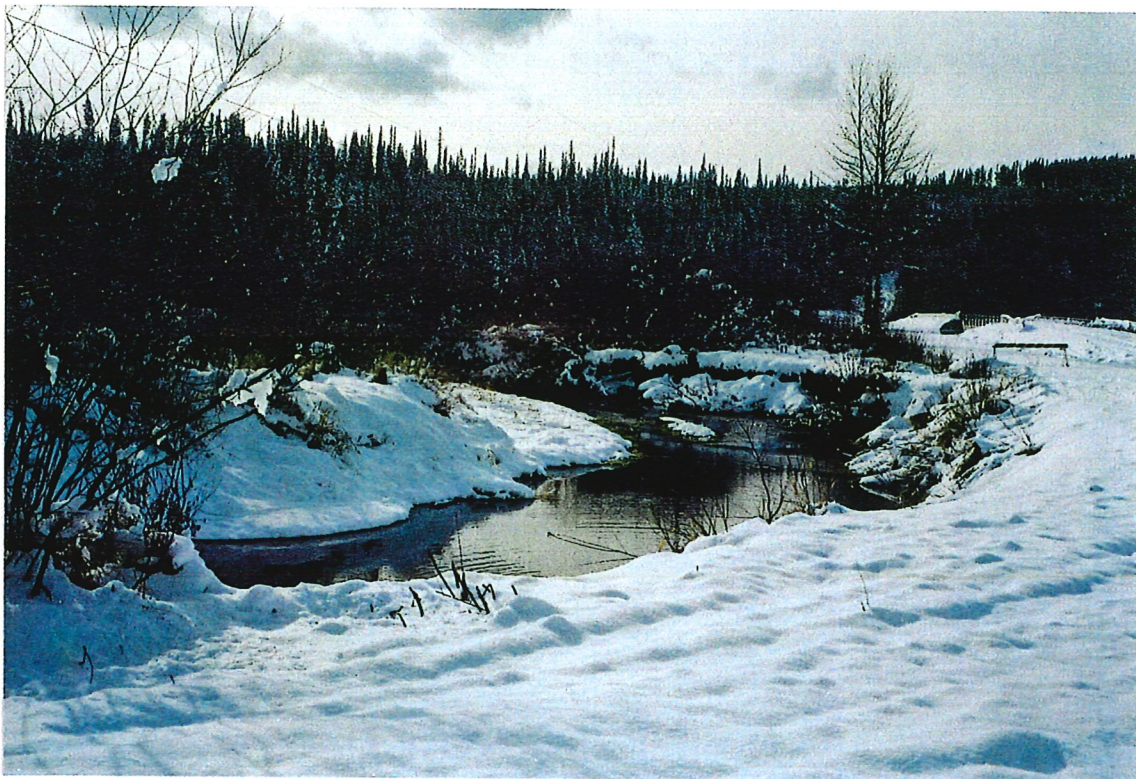
Photo 29
Steep, Eroding Banks at the Downstream Extent of BR-S10

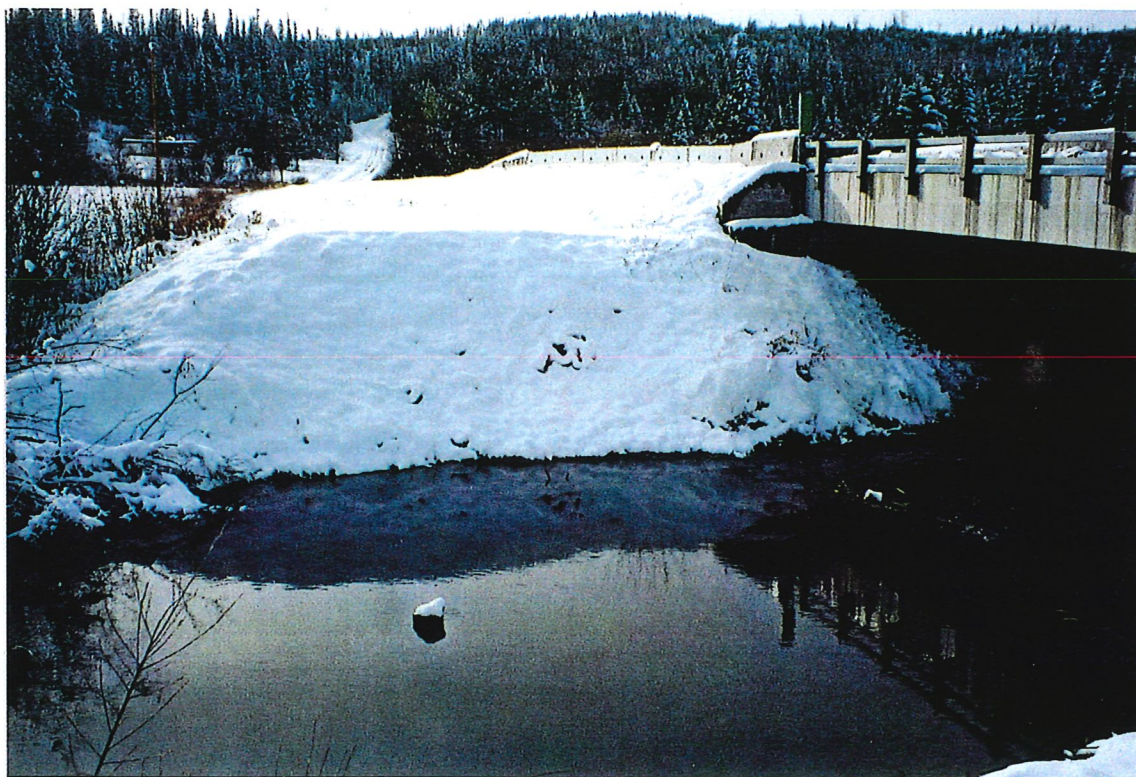
Photo 30
**Unvegetated Former Bridge Approaches Immediately Upstream
 of the New Bridge at BR-S11**

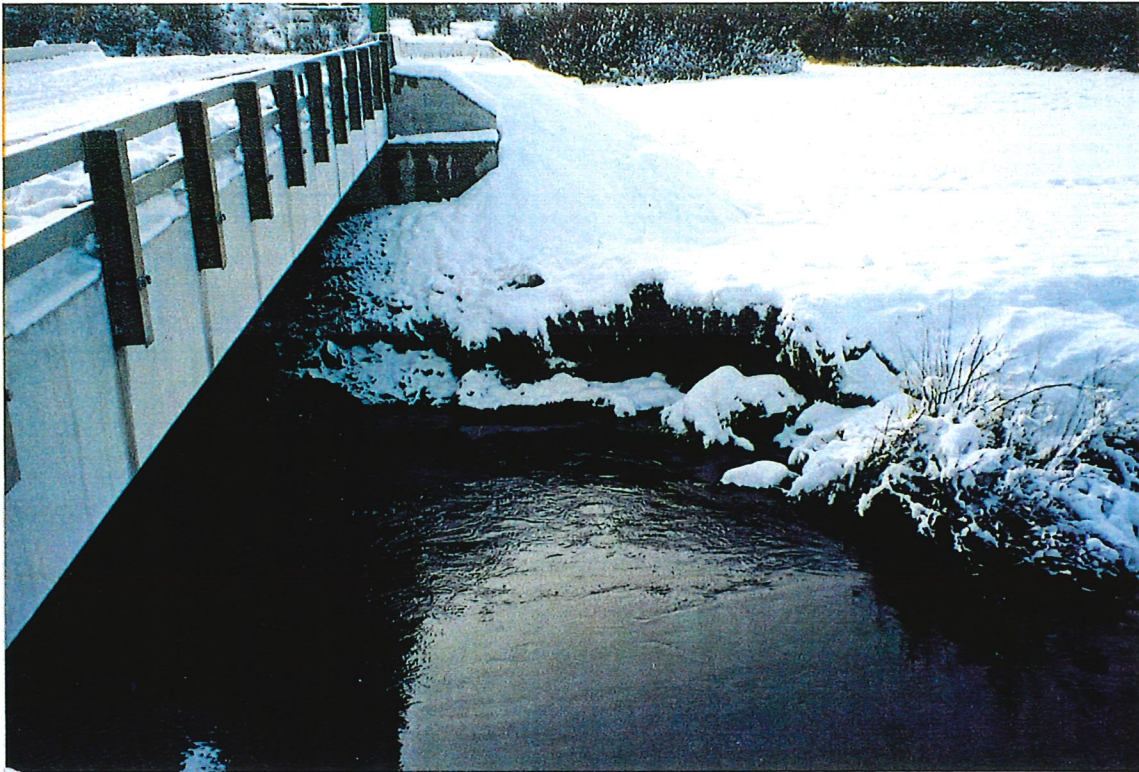
Photo 31
Direct Flow Attack and a Deep Upwelling Pool are Increasing Left Bank Erosion Immediately Downstream of the Bridge Crossing at BR-S11

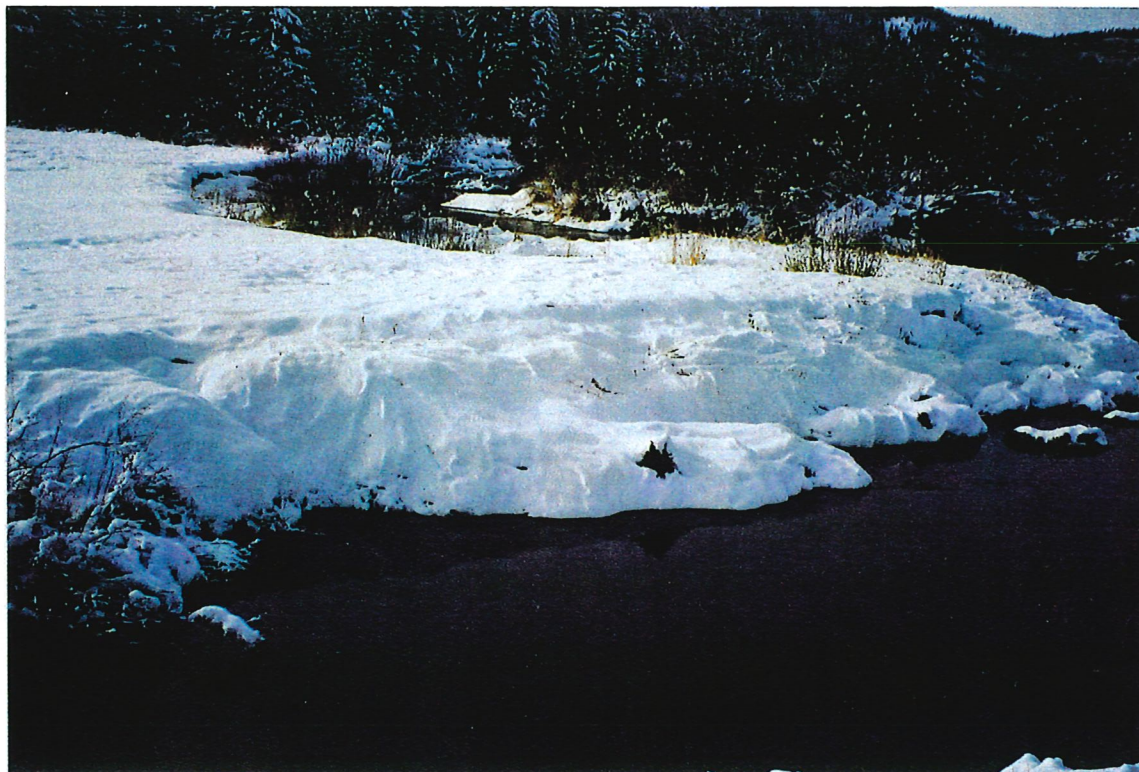
Photo 32
Slumping, Sparsely Vegetated Banks at BR-S11

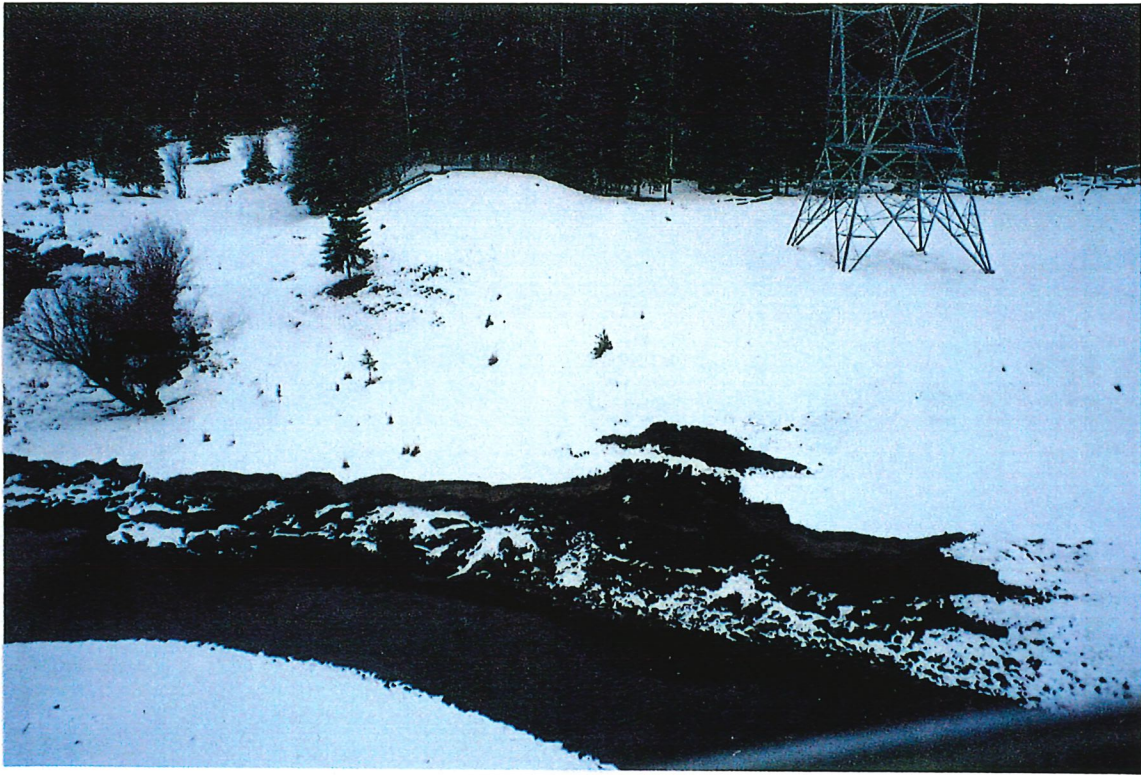
Photo 35
Example of an Unvegetated, Eroding Streambank at BR-S13

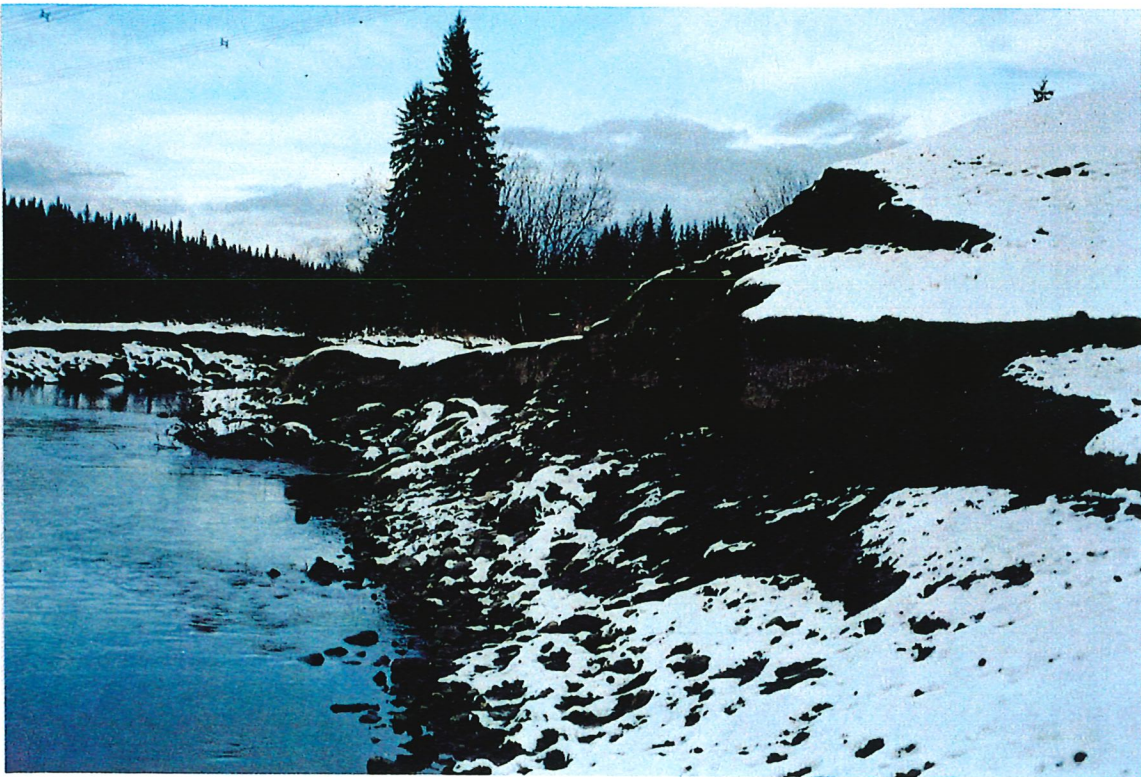
Photo 36
Livestock Damage to Banks at BR-S13

Livestock access to this site (and along all watercourses and waterbodies in the watershed) should be restricted to protect downstream water quality and aquatic resources. This will involve large scale participation of landowners in the area. Ranchers, for example, should be educated about livestock impacts and learn the different methods available to mitigate these impacts.

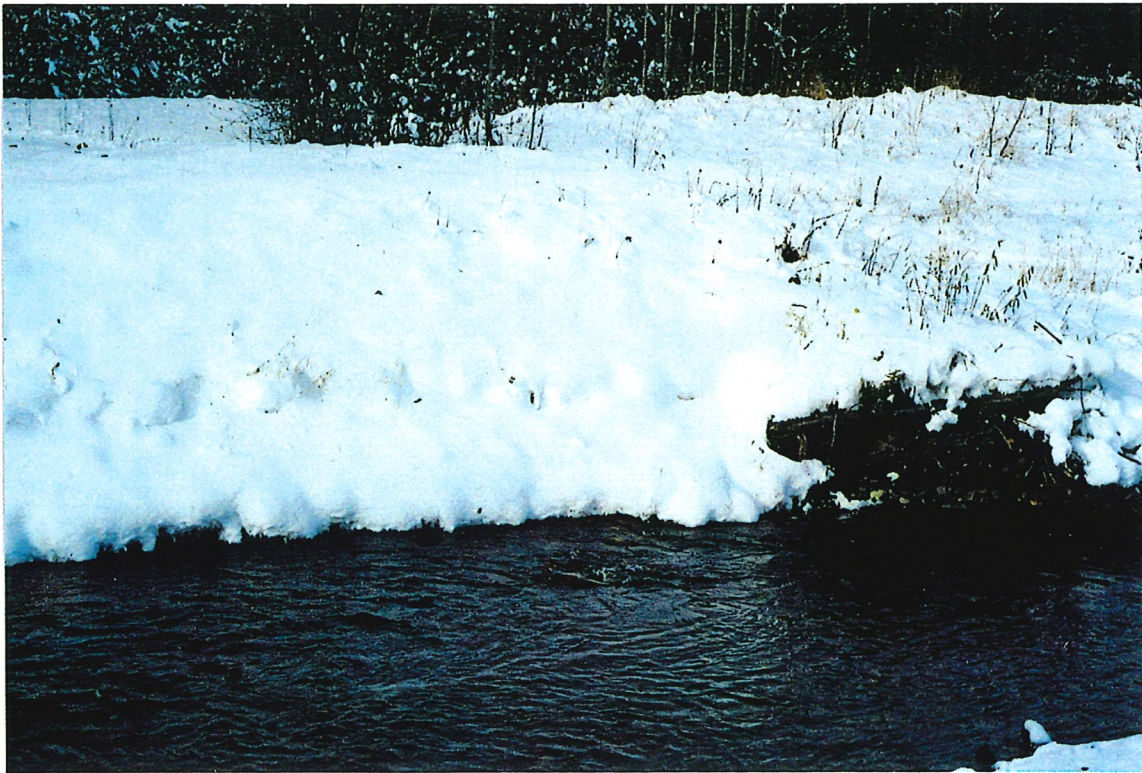
Photo 38
Unvegetated Left Bridge Approach with Minor Bank at Erosion FC-S1

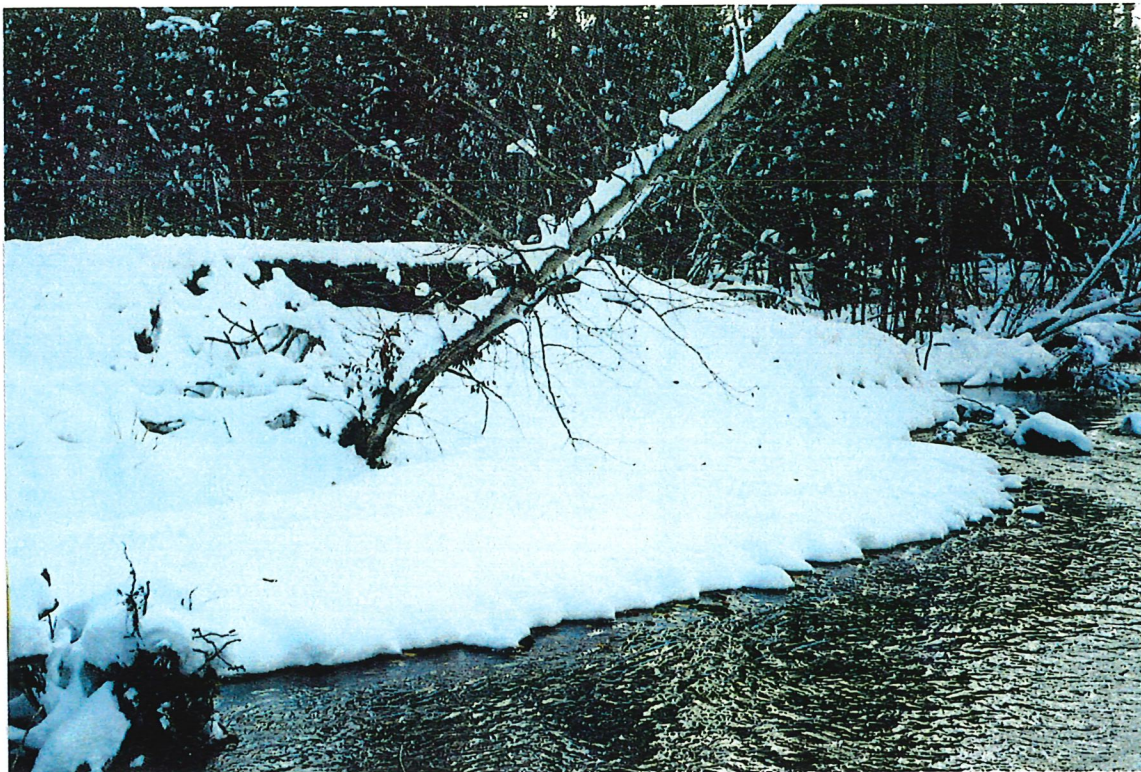
Photo 39
Extensive Erosion of the Right Bridge Approach at FC-S1

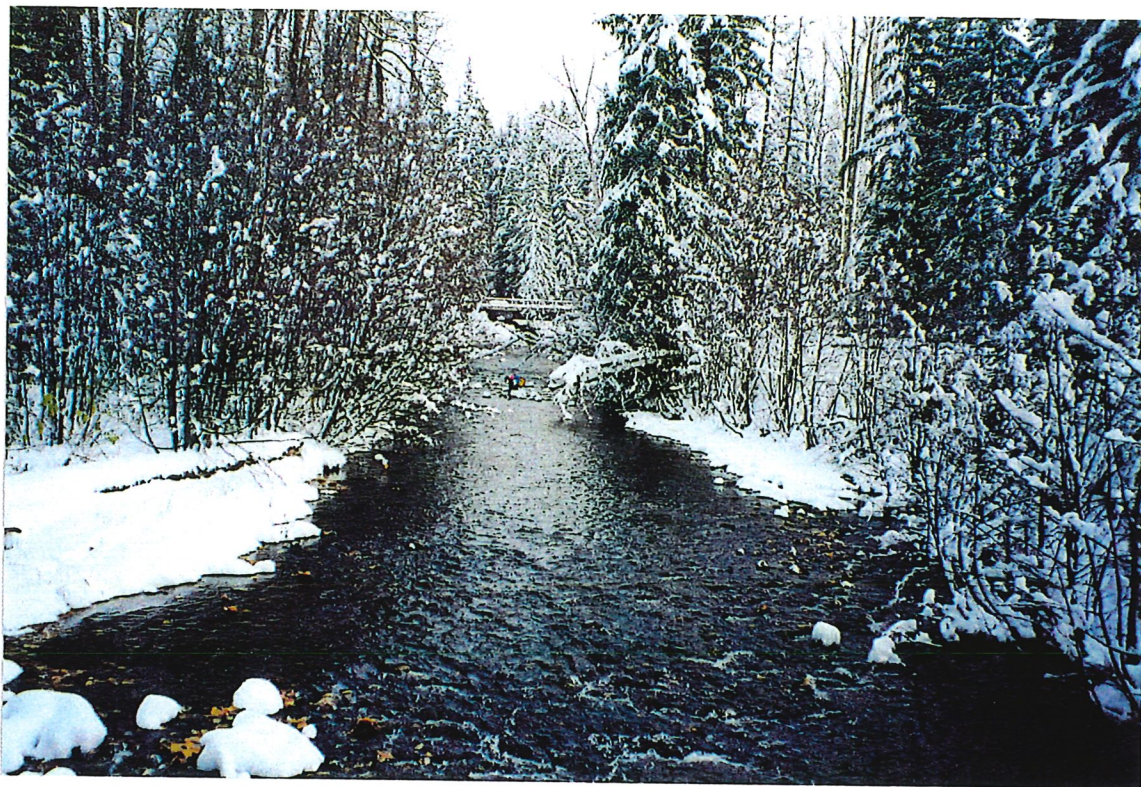
Photo 41
Straight, Featureless Stream Habitat at FC-S2
