**1996 MAXAN WATERSHED STREAM
HABITAT RESTORATION AND
ENHANCEMENT DESIGN REPORT**

Dz'ilh K'Az Kwa Development Corporation
Burns Lake, British Columbia

AGRA Earth & Environmental Limited
Prince George, British Columbia
Calgary, Alberta

March 1997

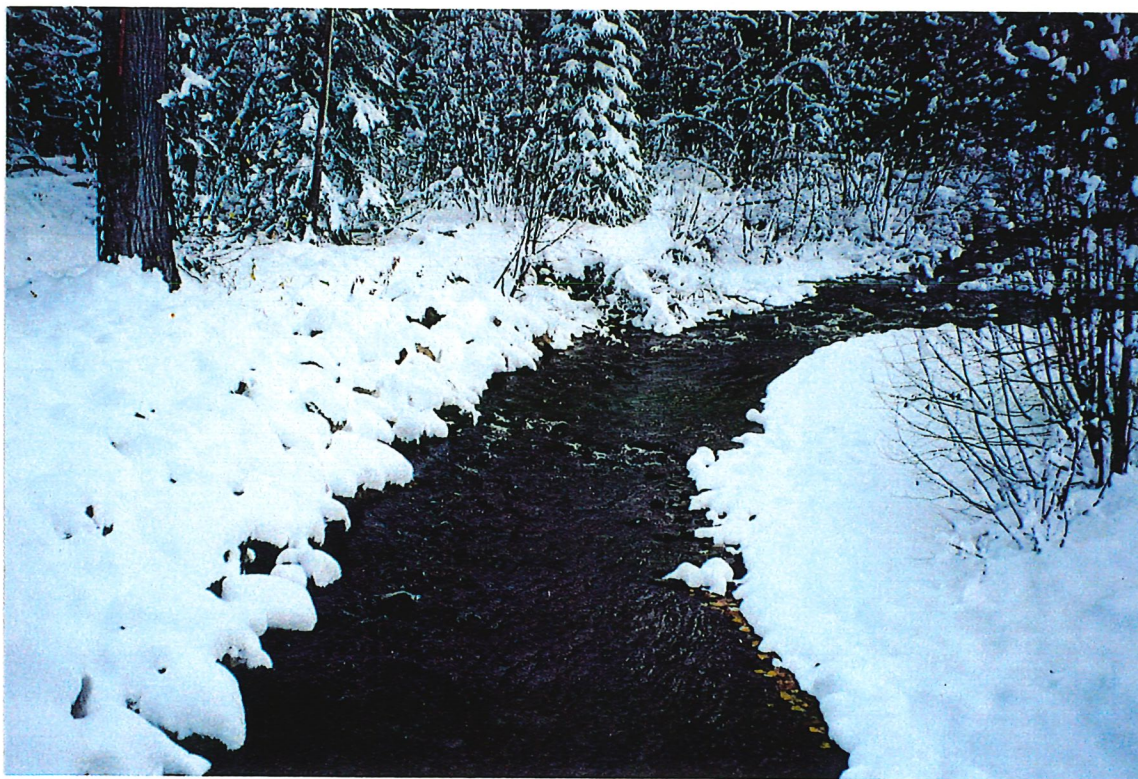
Photo 42
Right Bank Erosion Immediately Upstream of Existing Riprap at FC-S2

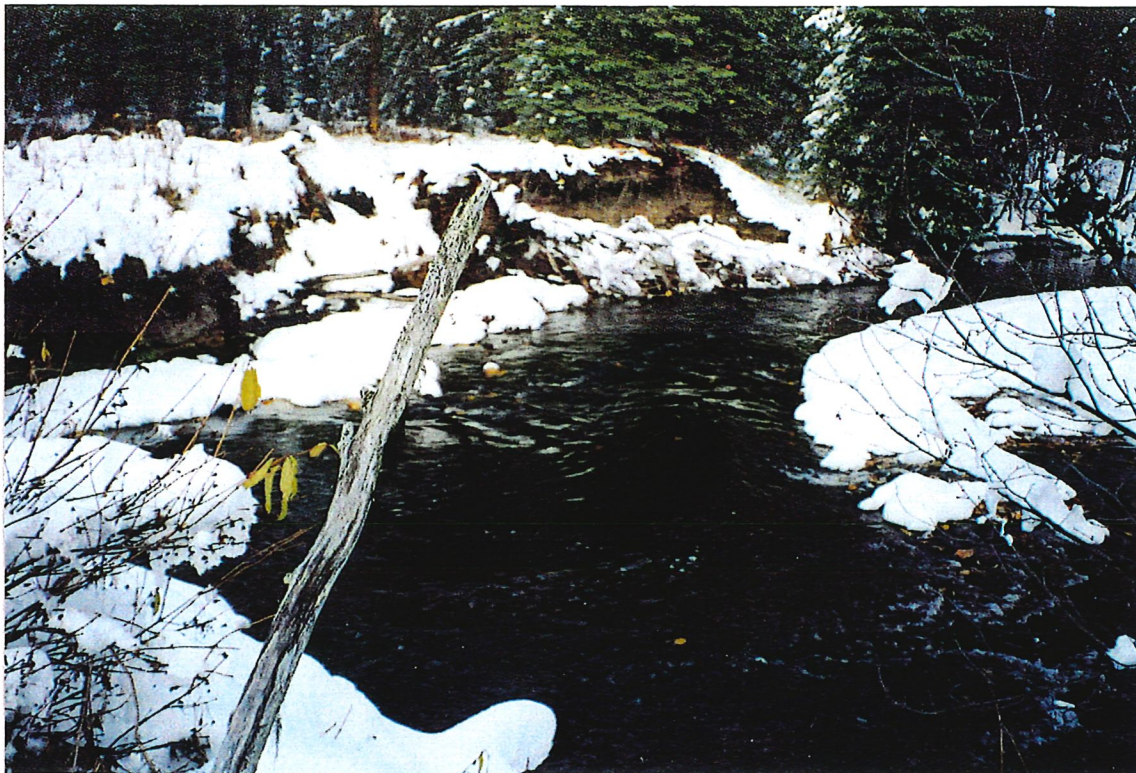
Photo 43
Bank Erosion at the Downstream End of FC-S2

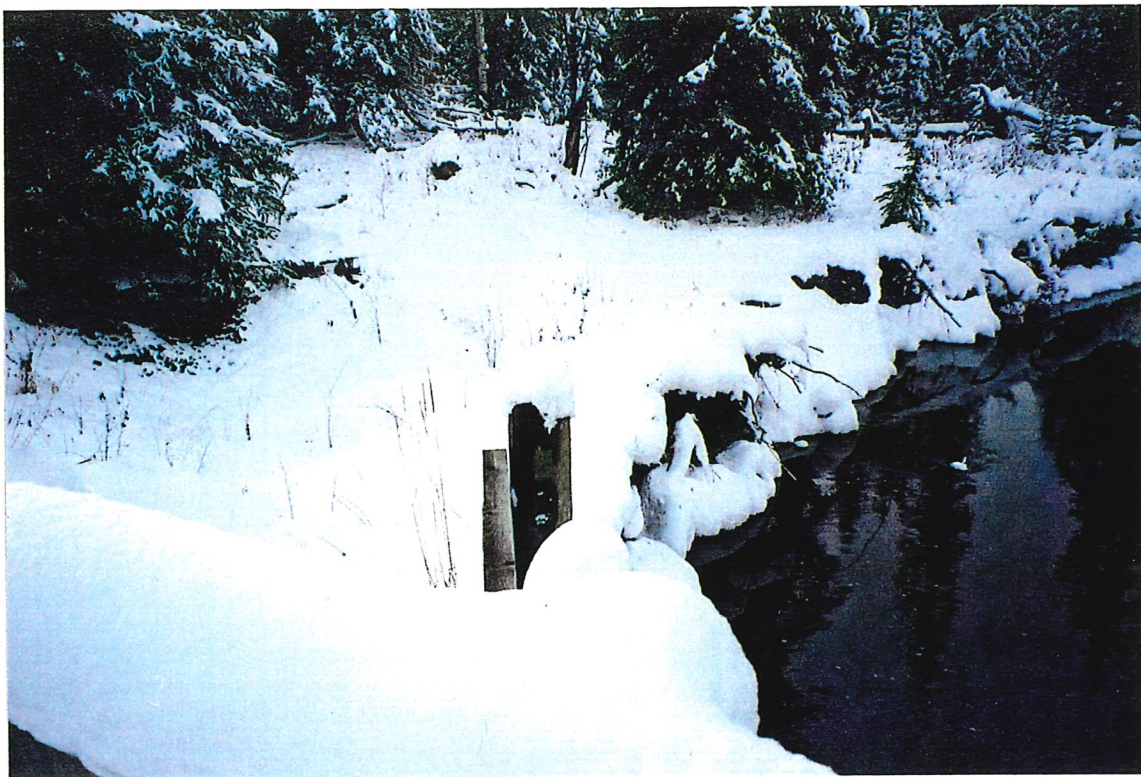
Photo 45
Right Bank Erosion Upstream of the Bridge Crossing at LMC-S1

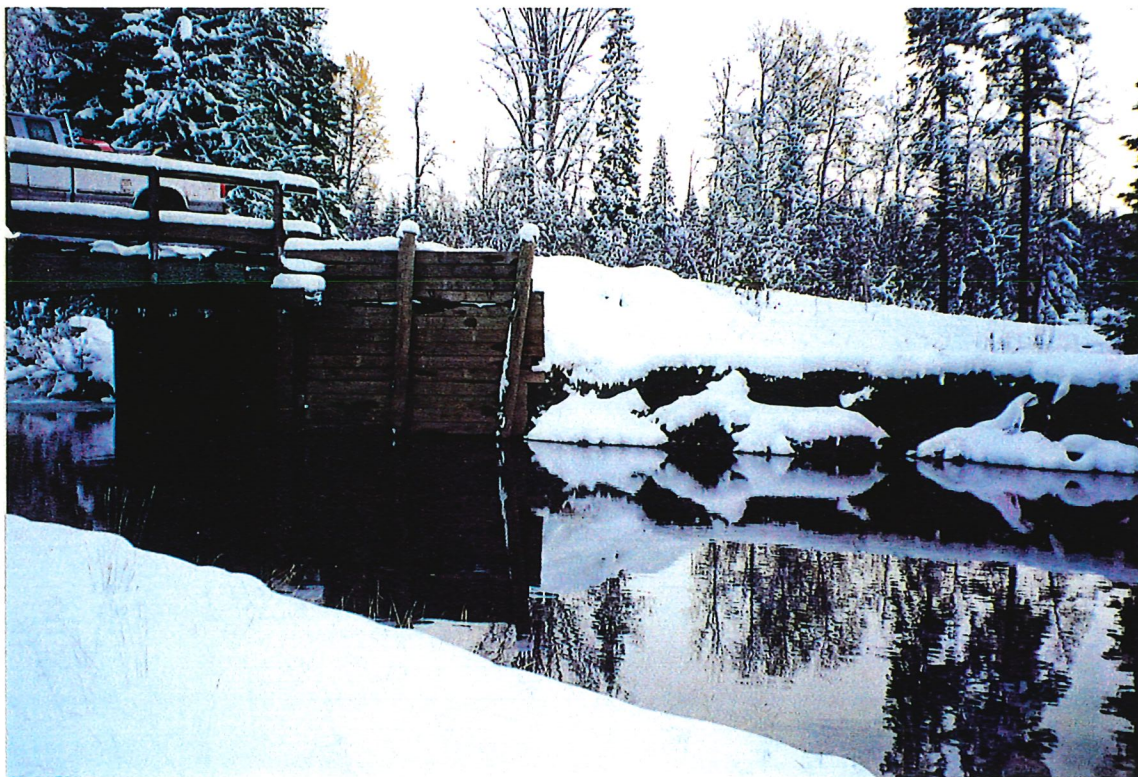
Photo 46
Left Bank Erosion Downstream from the Bridge Crossing at LMC-S1

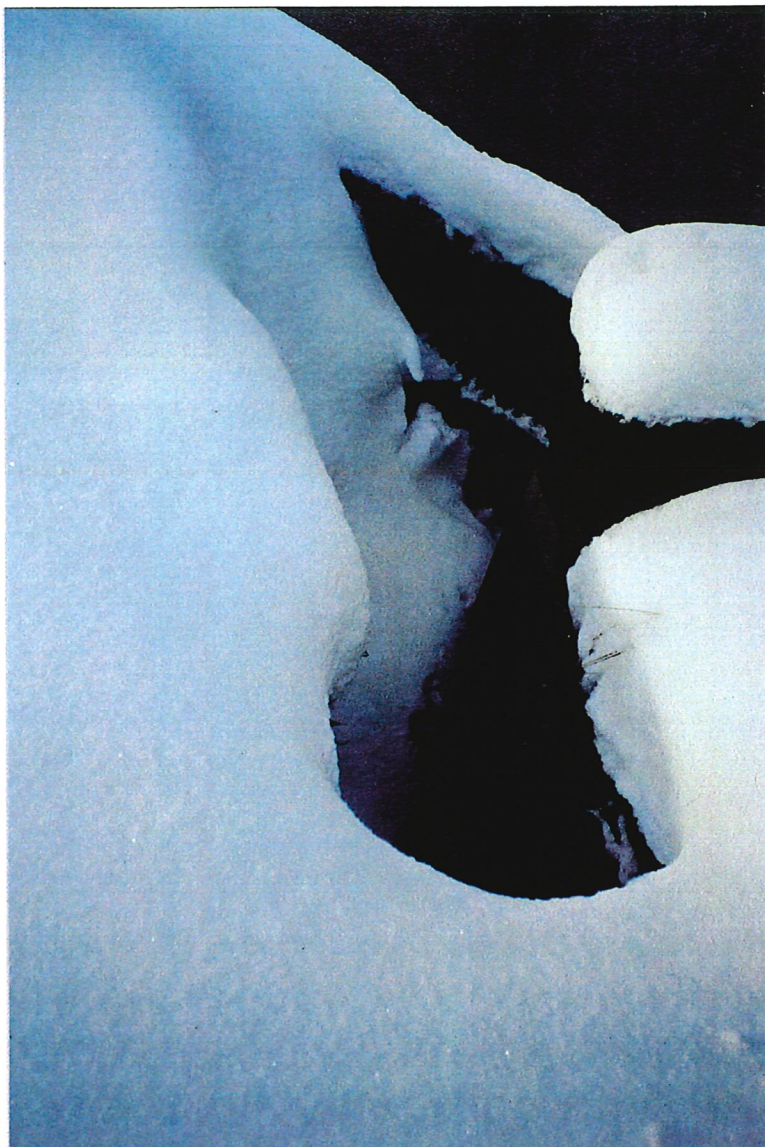
Photo 47
Erosional Piping Behind the Left Bridge Crib
(looking downstream) at LMC-S1
