2009/10 Water Quality Effectiveness Evaluations

2009/10 Fish Passage Culvert Inspections

Prepared by:

BC Timber Sales Skeena Business Area

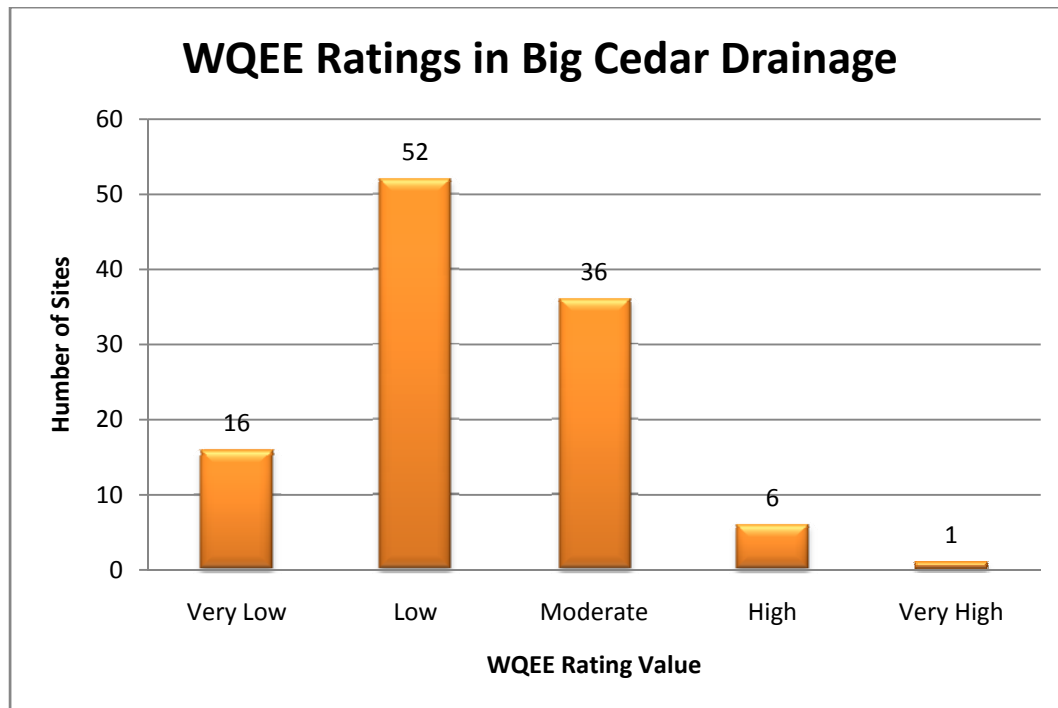
Figure 3 – WQEE rating for 111 sampled streams in Big Cedar Drainage

Figure 3 show that there is a high proportion of Very Low, Low and Moderate risk sites. Much of the forest development in the Big Cedar drainage occurred over fifty years ago. Since that time many of the roads and areas have over grown and self-stabilized. While the heavily over-grown roads created access problems for much of the project, they have effectively stabilized the cut and fill slopes along the roads. As well, many of the streams have stabilized into their new channels and any fine sediment has long since eroded away.

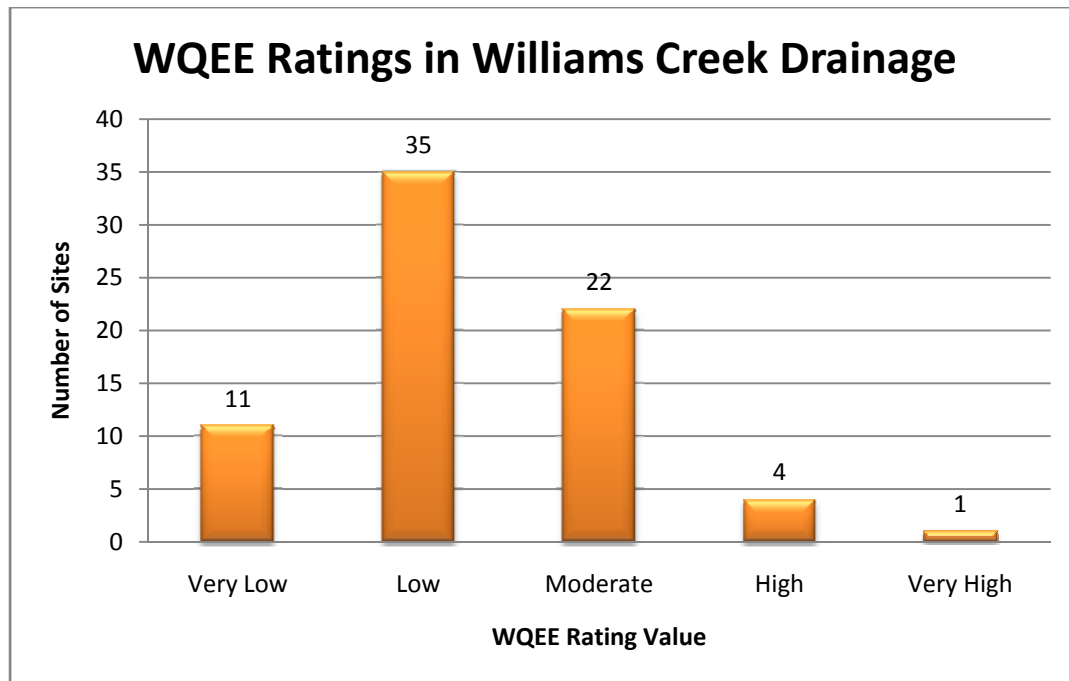
Figure 4 – WQEE rating for 73 sampled streams in Williams Creek Drainage

The same can be said for the Lakelse, Williams Creek and Hazelton drainages. The higher proportion of Moderates in the Lakelse areas is attributed to the high level of recreational and private development occurring in and around the lake and river. Many of the FSR's are well maintained to provide access for recreational and private users.
