FINAL REPORT

Nelson River Level 1 Riparian Assessment

March 2002

Prepared by: Jodi Friesen RPBio

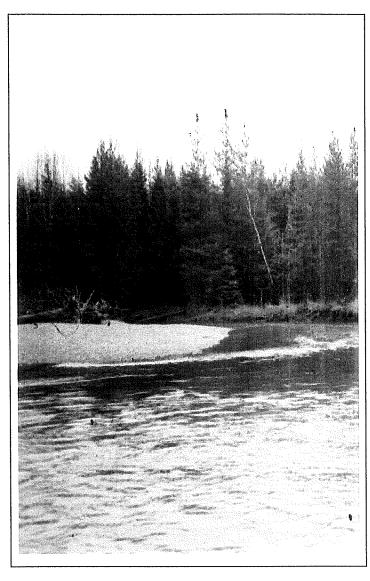
RVT 1 describes gravel bars in the initial stages of succession that have been recently scoured or deposited by continuous flooding. Vegetative cover is less than 5% and the ground surface consists of gravels, cobbles, and coarse sands. Many of the naturally occurring low fluvial benches are highly unstable and maintain annual flooding. Although riparian function has been completely lost, sites continue to experience scouring or deposition by high velocity flows, therefore there is no opportunity for restoration.

Figure 1: RVT 1 (INIT) – gravel bar 17/11/01; Reach 1

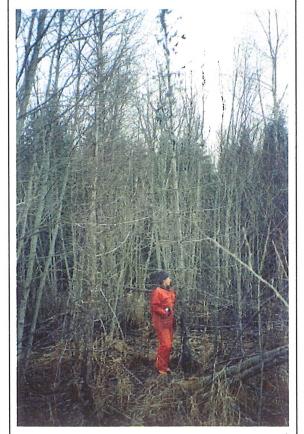
RVT 5 is a disclimax Shrub/herb community of red alder and ladyfern. It is found on inundated sites, and avalanche or seepage tracks that intercept the riparian area. These generally are natural occurring sites due to the high water table and constant seepage, and are not considered for restoration. In the upper reaches of the river however, the frequency and/or size of these sites have been increased due to road failures associated with harvesting on the upper slopes of the watershed. Restoration of these communities could not be considered unless the road failures are repaired and hydrological function of the slope is restored.

Figure 2: RVT 5 (SHd3) - Dr/ladyfern 17/11/01; Plot 6b

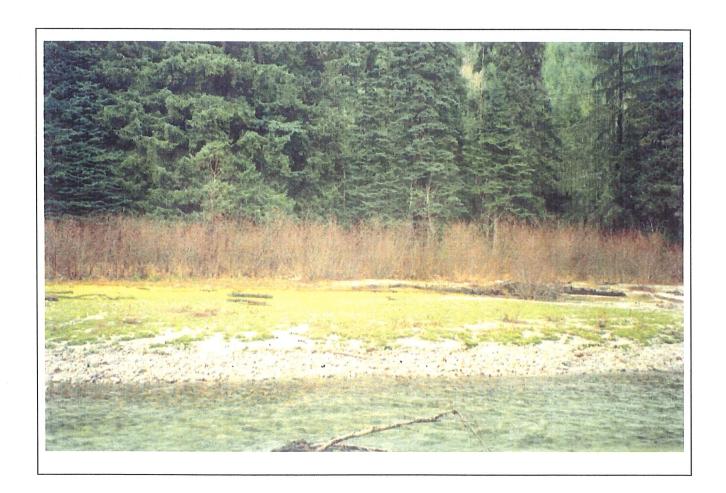
RVT 6 is a Shrub/herb community dominated by black cottonwood, Sitka alder, and willows. Soils are of the Regosolic order and consist of sand, gravels, and cobbles. As a natural low fluvial bench, these sites will experience frequent over bank flooding and erosion. Riparian function is naturally low; however, there is no opportunity for restoration due to the unstable nature of the site.

Figure 3: RVT 6 (SHd3) – Natural low fluvial bench 17/11/01; opposite bank of Plot 5

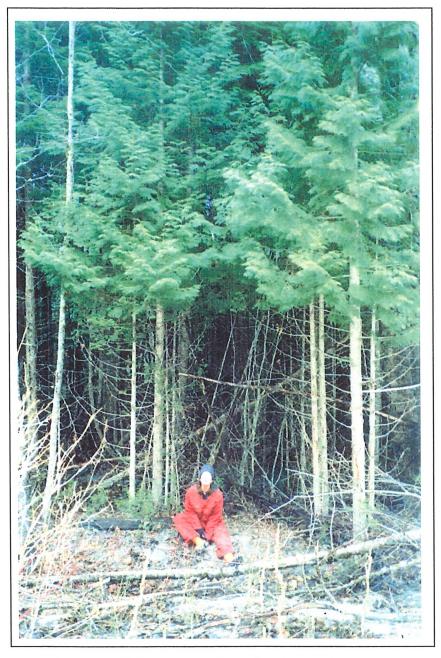
RVT 7 describes a densely stocked post harvest Pole Sapling stand of conifer trees. They are found on upper fluvial benches with sandy soil textures of the Regosolic or Brunisolic soil order. Thinning these stands would shorten the period of LWD development; therefore the opportunity for restoration is high.

Figure 4: RVT 7 (PSc) – Pole Sapling conifer stand 17/11/01; Plot 7

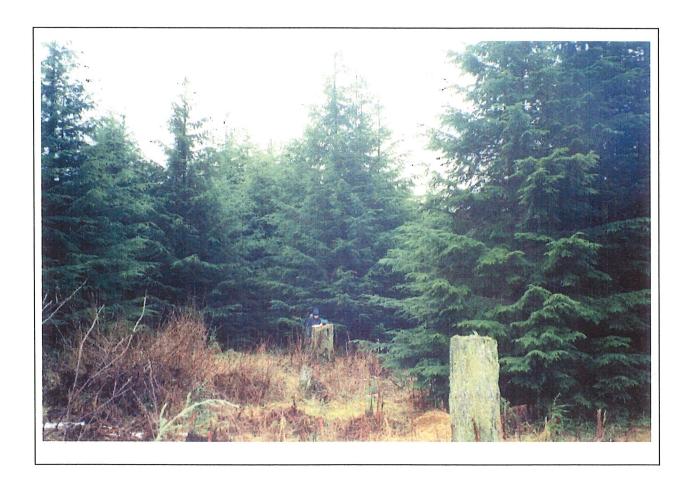
RVT 8 is a post harvest Pole Sapling stand with patches of dense 20–40 year old conifer trees and open areas that have been recently fill planted with conifer seedlings. At the present time there is a low to moderate level of riparian function, however the fill plant that was carried out in the year 2000 has been successful with little seedling mortality, and is of adequate stocking density. The patches of older conifer trees are of a very high density and thinning these patches would increase the development of LWD sooner, although the benefits of thinning versus the cost and difficult access make these stands a moderate priority for restoration.

Figure 5: RVT 8 (PS(t)c) – Two storied Pole Sapling conifer stand 17/11/01: Plot 5

RVT	Scenario	Function	Rehabilitation	Treatment	Desired Future Condition
		impaired	action/objective		
RVT 8: PS(t)c/Hw(SsBa)/HwSs	dense clusters of 25 yr. old conifers intermixed with fill planted conifer seedlings	large wood, shade, bank stability	juvenile space dense clusters to promote tree growth, the production of large woody debris and larger root mass for bank stability		D . 2 . D . C .
RVT 9:PSm/ActHwSsDr(CwBa)	a post harvest conifer plantation often with high deciduous stocking densities	large wood, shade	juvenile space to focus growth on fewer trees, greater conifer density, production of large woody debris, and increase stand biodiversity		
RVT 11: PSd2/ActDr	a post harvest plantation overgrown by deciduous species	large wood, shade	juvenile space in groups, cluster plant with conifers and maintain a brushing program to produce large woody debris, and increase stand biodiversity

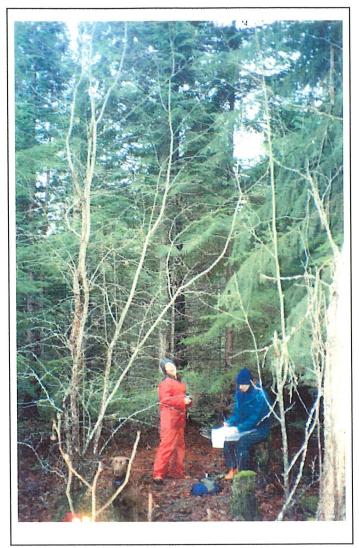
RVT 12 represents Young Forest coniferous stands on high fluvial benches. These stands are typically well stocked, and may have areas of higher densities. Stands generally have well expressed dominance of the overstory conifer species. There is an option to juvenile space in areas of higher densities, however the cost of implementing the treatment must be weighed against the benefits The restoration opportunity for these stands is generally moderate.

Figure 6: RVT 12 (YFc) – Young Forest coniferous stand 17/11/01; Plot 6a

RVT	Scenario	Function	Rehabilitation	Treatment	Desired Future Condition
		impaired	action/objective		
RVT 12: YFc/HwSsPl(CwBaAct)	a well stocked young conifer stand with few areas having higher densities	large wood, shade	higher density areas could be juvenile spaced to promote the production of large woody debris		
RVT 13: YFm/ActSsDr(CwBa)	an evenly spaced mixed stand with dense stocking of red alder	large wood, shade	thin red alder around conifer trees to promote tree growth and development of large woody debris, may fill plant with conifer seedlings		
RVT 15: YFd2/ActDr/SsCw	a young, post- harvest deciduous stand with few or no conifers in the understory	large wood, shade	thin deciduous around conifer trees, and/or juvenile space in groups, cluster plant with conifers and maintain a brushing program to promote large woody debris

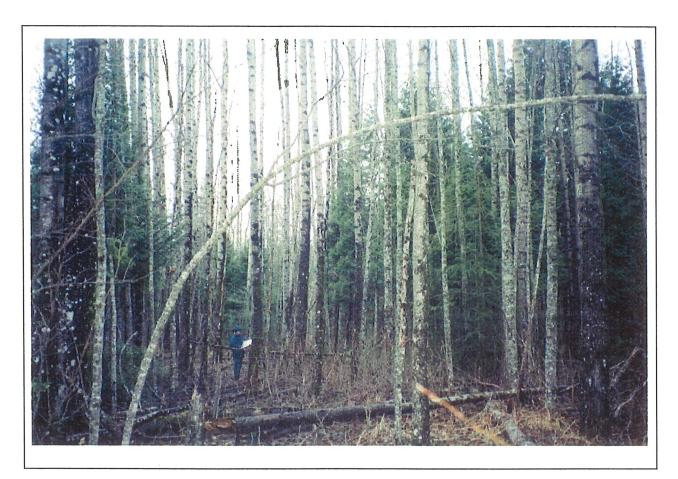
RVT 18 describes a mature deciduous forest of cottonwood and red alder with variable densities of conifer trees in the understory. The riparian function of the stand is recovering, but the rate at which LWD is produced could be increase by thinning to release the conifers in the understory or by group thinning and planting conifers in clusters. There is generally a high opportunity for restoration in these stands.

Figure 7: RVT 18 (MFd) – Mature Forest deciduous stand. 17/11/01; Plot 6a

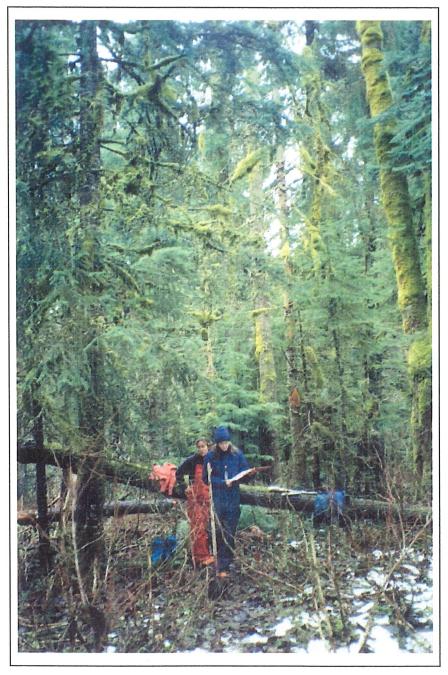
RVT 20 represents mixed deciduous and coniferous old forest stands that have not been harvested and riparian function is unaffected, and restoration opportunity does not apply.

Figure 8: RVT 20 (OFm) – Old Forest mixed stand 17/11/01; Plot 6a
