## Project Completion Abstract

### Km. 39.2 Morice River FSR Fish Passage Project

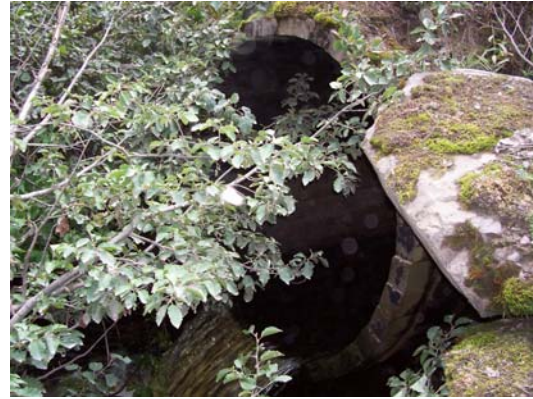
The original culvert was considered a full barrier to fish migration based on the vertical drop at the outlet of the culvert. (See photo # 1)

The original wooden culvert installation scored 46 based on the results of the FPCI Scoring Matrix. Based on the results the culvert was given a high priority score for replacement.

Photo 1. Original stream culvert.

Replace closed bottom culvert with a clear span bridge and restore the stream channel. (Photo 2.)

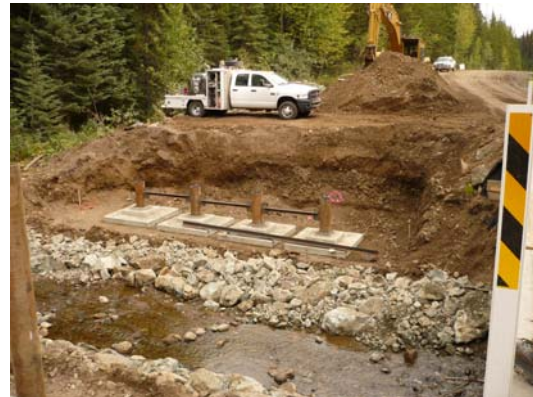
Photo 2. View of bridge footing beyond newly restored stream channel

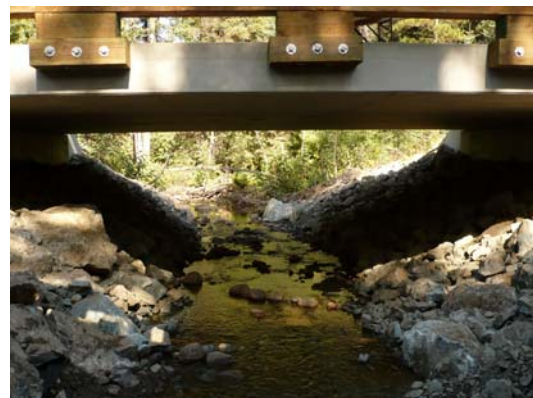
Photo 3. View of new bridge across restored stream channel.
