## **Appendix - 197360 - Riddeck Creek**

Table 5.36: Summary of fish passage assessment for PSCIS crossing 197360.

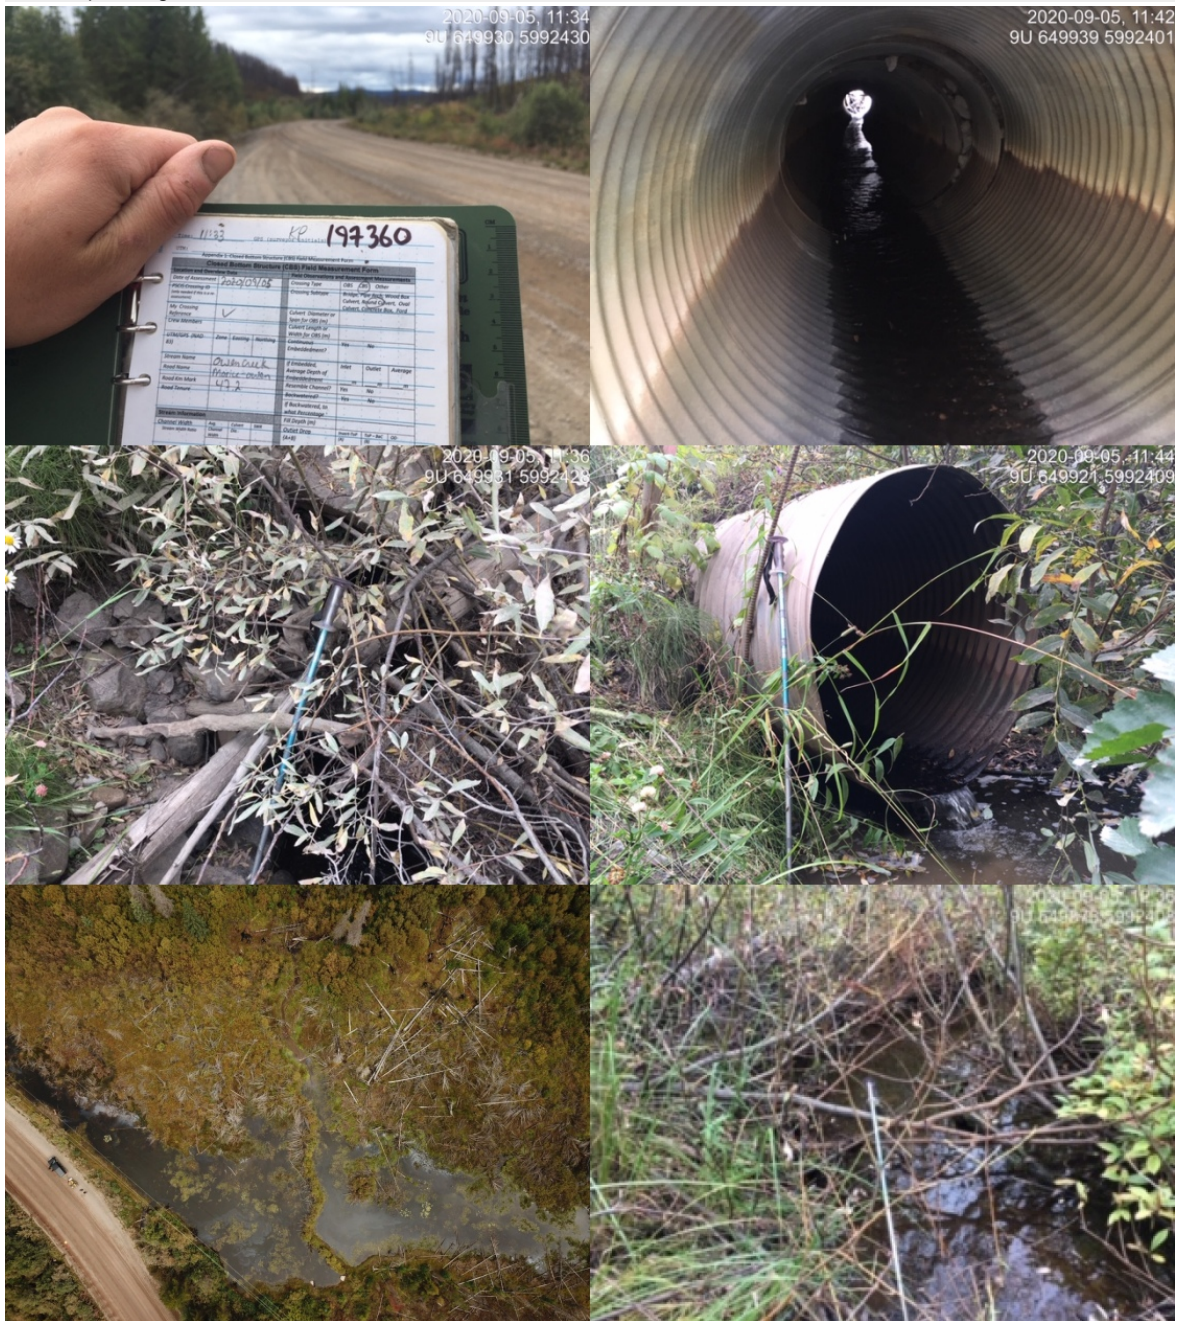
At the time of the survey, the culvert was un-embedded, non-backwatered and considered a barrier to upstream fish passage. The pipe was 1.2m in diameter with a pipe length of 27m, a culvert slope of 1%, a stream width ratio of 1.8 and an outlet drop of 0.24m (Table [5.36](#)). Water temperature was 15°C, pH was 6.8 and conductivity was 140uS/cm.

Location and Stream Data	•	Crossing Characteristics	–
Date	2020-09-05	Crossing Sub Type	Round Culvert
PSCIS ID	197360	Diameter (m)	1.2
External ID	–	Length (m)	27
Crew	AI, KP	Embedded	No
UTM Zone	9	Depth Embedded (m)	–
Easting	649936	Resemble Channel	No
Northing	5992406	Backwatered	No
Stream	Riddeck Creek	Percent Backwatered	–
Road	Morice-Owen FSR	Fill Depth (m)	2.5
Road Tenure	FLNR Nadina 9947	Outlet Drop (m)	0.24
Channel Width (m)	2.2	Outlet Pool Depth (m)	1.6
Stream Slope (%)	1.5	Inlet Drop	No
Beaver Activity	Yes	Slope (%)	1
Habitat Value	High	Valley Fill	Deep Fill
Final score	29	Barrier Result	Barrier
Fix type	Replace with New Open Bottom Structure	Fix Span / Diameter	10
Photos: From top left clockwise: Road/Site Card, Barrel, Outlet, Downstream, Upstream, Inlet.

Comments: Wetland type habitat for first 300m upstream then 3m wide channel with cover available in all forms with pools suitable for juvenile RB and CO overwintering. Abundant gravels and small cobbles through suitable for CO or RB/ST spawning.

Structure replacement with a bridge (10m span) is recommended to provide access to the habitat located upstream of PSCIS crossing 197360. In addition to not facilitating high velocities and erosion due resulting from flow constriction, structures with large openings in relation to stream channel size have been demonstrated to reduce the likelihood of structure blockage due to beaver (Jensen et al. 2001). The cost of the work is estimated at \$125,000 for a cost benefit of 9.6 linear m/\$1000 and 31.7m<sup>2</sup>/\$1000.

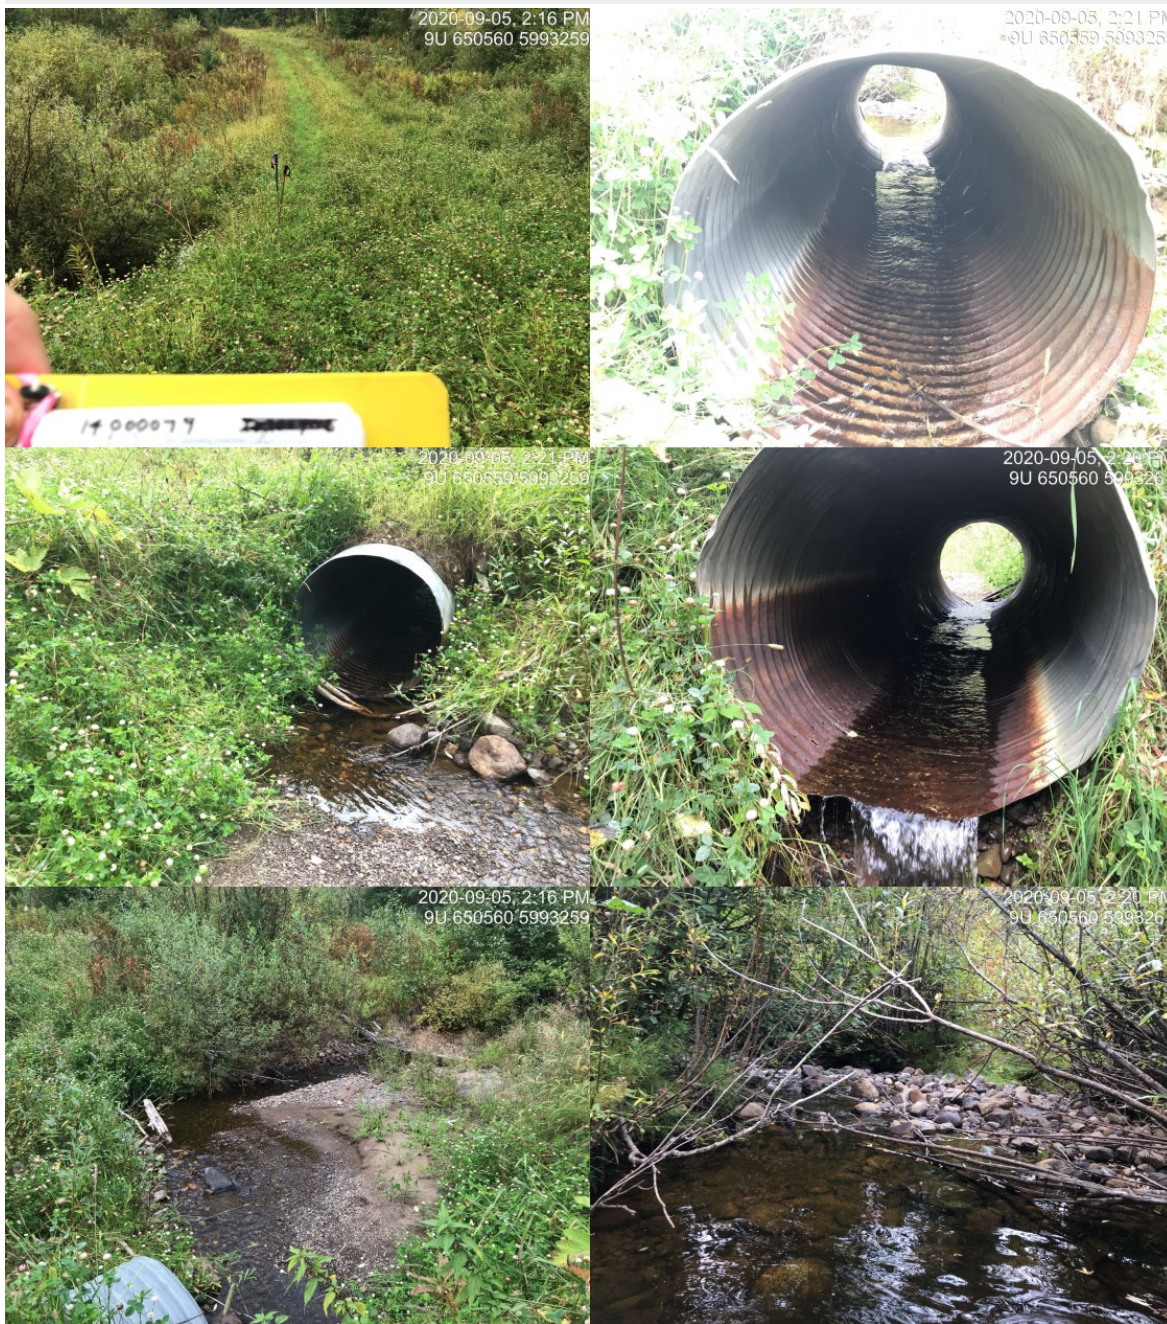
Table 5.37: Summary of fish passage assessment for PSCIS crossing 197669.

PSCIS culvert 197669 was documented on Riddeck Creek, 1.2km upstream of the FSR and PSCIS crossing 197360. The culvert was un-embedded, non-backwatered and considered a barrier to upstream fish passage. The pipe was 1.25m in diameter with a pipe length of 6m, a culvert slope of 2%, a stream width ratio of 2.1 and an outlet drop of 0.45m (Table [5.37](#)).

Crew	AI, KP	Embedded	No
UTM Zone	9	Depth Embedded (m)	–
Easting	650567	Resemble Channel	No
Northing	5993274	Backwatered	No
Stream	Riddeck Creek	Percent Backwatered	–
Road	Private	Fill Depth (m)	0.3
Road Tenure	unclassified	Outlet Drop (m)	0.45
Channel Width (m)	2.6	Outlet Pool Depth (m)	0.7
Stream Slope (%)	4	Inlet Drop	No
Beaver Activity	No	Slope (%)	2
Habitat Value	High	Valley Fill	Deep Fill
Final score	31	Barrier Result	Barrier
Fix type	Replace with New Open Bottom Structure	Fix Span / Diameter	10
Photos: From top left clockwise: Road/Site Card, Barrel, Outlet, Downstream, Upstream, Inlet.

Comments: Extensive rearing habitat and gravels suitable for spawning. Stream eventually flows into top end of Owen Lake.

There is 1.2km of habitat upstream of crossing 197360 and downstream of PSCIS barrier culvert 197669. Habitat in this area was rated as high value for salmonid rearing/spawning. Remediation of PSCIS culvert 197669 would facilitate fish passage to an additional 1.5km of habitat upstream of the area surveyed and can also be considered in the future. Densities of rainbow trout fry captured at upstream sites were higher than the density of fish captured downstream however this may have been a result of habitat differences and difficult electrofishing conditions downstream including thick shrub overhead cover and areas deep water. Although only rainbow trout were captured both upstream and downstream the stream contains habitat likely suitable for spawning and rearing for other species including lamprey, burbot, coho salmon and others. In order to delineate pre-road channel locations/conditions and to inform the positioning of a replacement bridge, a pre-road hydrology assessment could be undertaken. Morice-Owen FSR is the responsibility of the Ministry

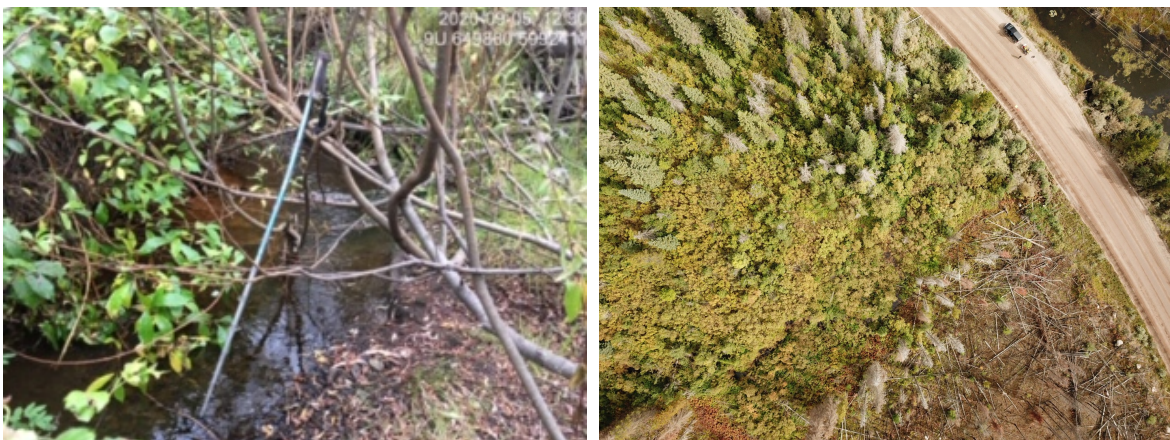
The stream was surveyed downstream from the culvert for 300m (Figure [5.22](#)). Overall, total cover amount was rated as moderate with overhanging vegetation dominant. Cover was also present as small woody debris, large woody debris, undercut banks, deep pools, and instream vegetation (Table [5.38](#)). The average channel width was 3.7m, the average wetted width was 3.2m and the average gradient was 1.1%. The dominant substrate was fines with gravels subdominant. A somewhat recent burn was noted within a forested area on left bank of stream. Habitat was rated as moderate as it was considered an important migration corridor with moderate value habitat for fry/juvenile salmonid rearing.

Figure 5.22: Left: Typical habitat downstream of PSCIS crossing 197360. Right: Aerial view of typical habitat downstream of PSCIS crossing 197360.

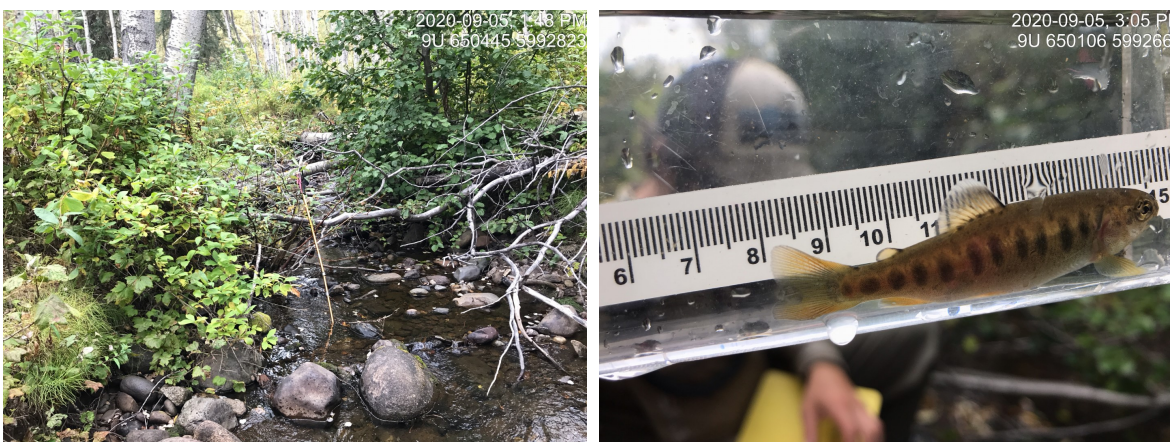
The stream was surveyed upstream from 197360 for 1200m (Figure [5.23](#)). Immediately upstream of the crossing for a distance of approximately 150m is a beaver influenced wetland with a beaver dam structure located approximately 40m upstream of the road. Within the area surveyed, total cover amount was rated as moderate with deep pools dominant. Cover was also present as small woody debris, large woody debris, boulders, undercut banks, and overhanging vegetation (Table [5.38](#)). The average channel width was 3.3m, the average wetted width was 1.8m and the average gradient was 2.7%. Abundant gravels and small cobbles suitable for resident, fluvial, adfluvial and anadromous salmonid spawning were present throughout the area surveyed. Habitat value was rated as high for salmonid rearing and spawning.

Figure 5.23: Left: Typical habitat upstream of PSCIS crossing 197360. Right: Rainbow trout captured upstream of PSCIS crossing 197360.
