**Waterfall Creek Restoration Project  
FsRBC Project #S-006-Y02-13**

**Submitted to: the District of New Hazelton**

**Submitted by: Nortec Consulting**

**March 31, 2002**

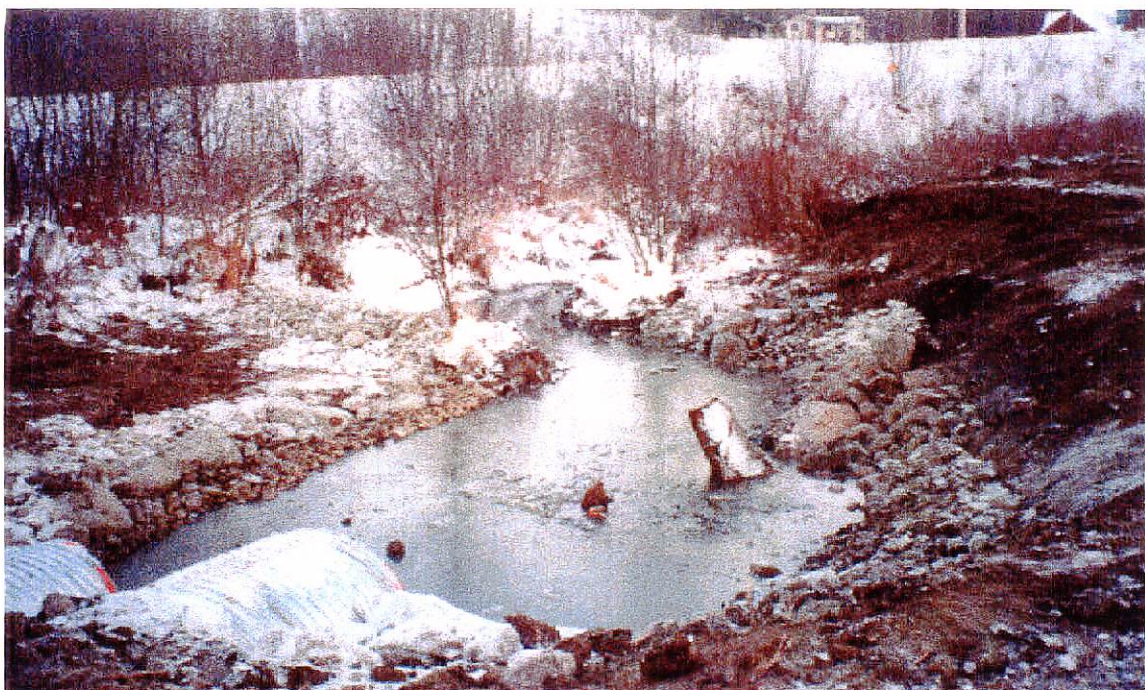
5. A sandbag and poly berm, as well as hay bales, were used to isolate the excavation area downstream of the culverts and monitored and maintained during works (*Figure #2*). Pumping of silted water seeping into the site was carried out as required.

Figure #2 – Upstream view of Site 2 – Installation of culverts & pool development

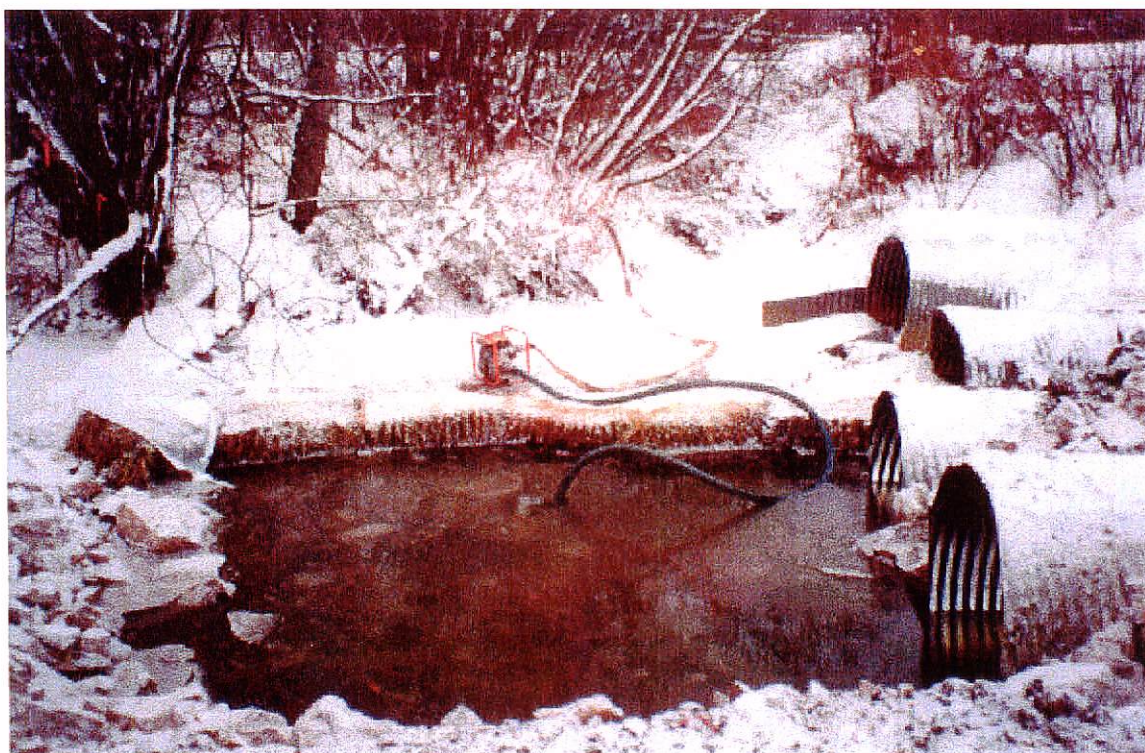
Figure #3 – Site 2- Downstream view

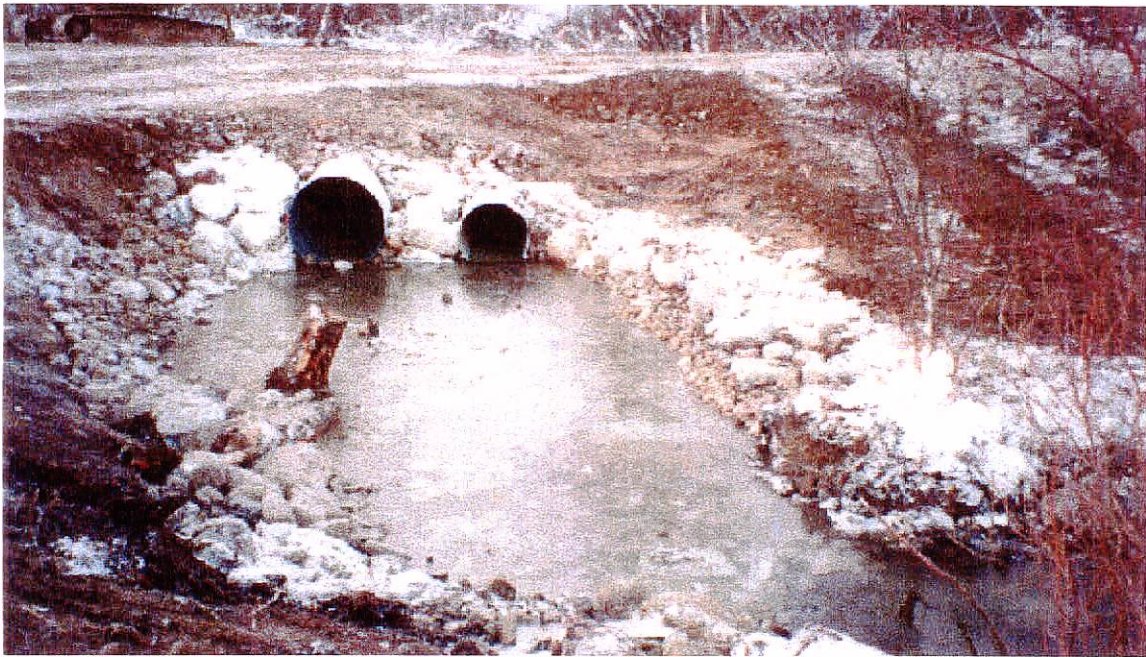
Figure #4 – Site 2 – Upstream view – Pool development

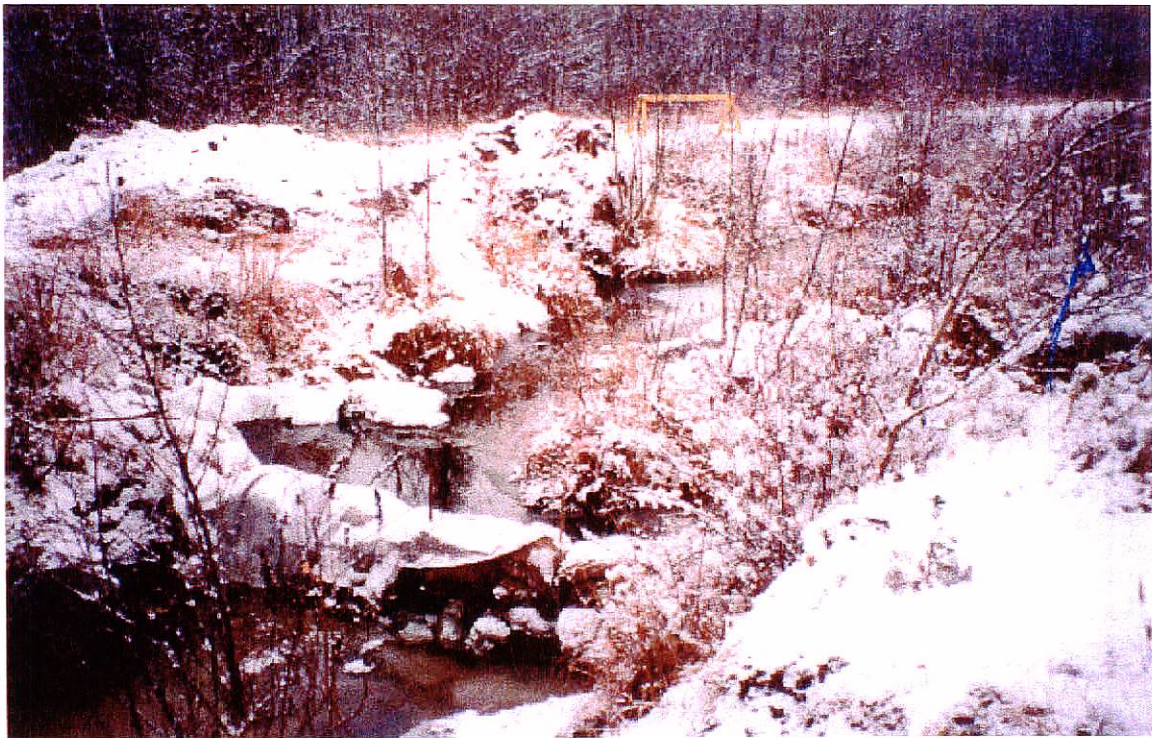
3. On Dec. 7/01 a culvert was replaced from the wetland complex to the main channel below Site 2B on Pugsley Ave. A culvert was installed upstream of the proposed berm site to divert flows into the wetland and around the works location of Site 3B.. A sandbag/poly berm was constructed at the upstream end of the site to divert flows through the culvert to the adjacent wetland complex and around the proposed work site (*See Figure #5*).

Figure #5 – Site 3B – Upstream diversion site and berm

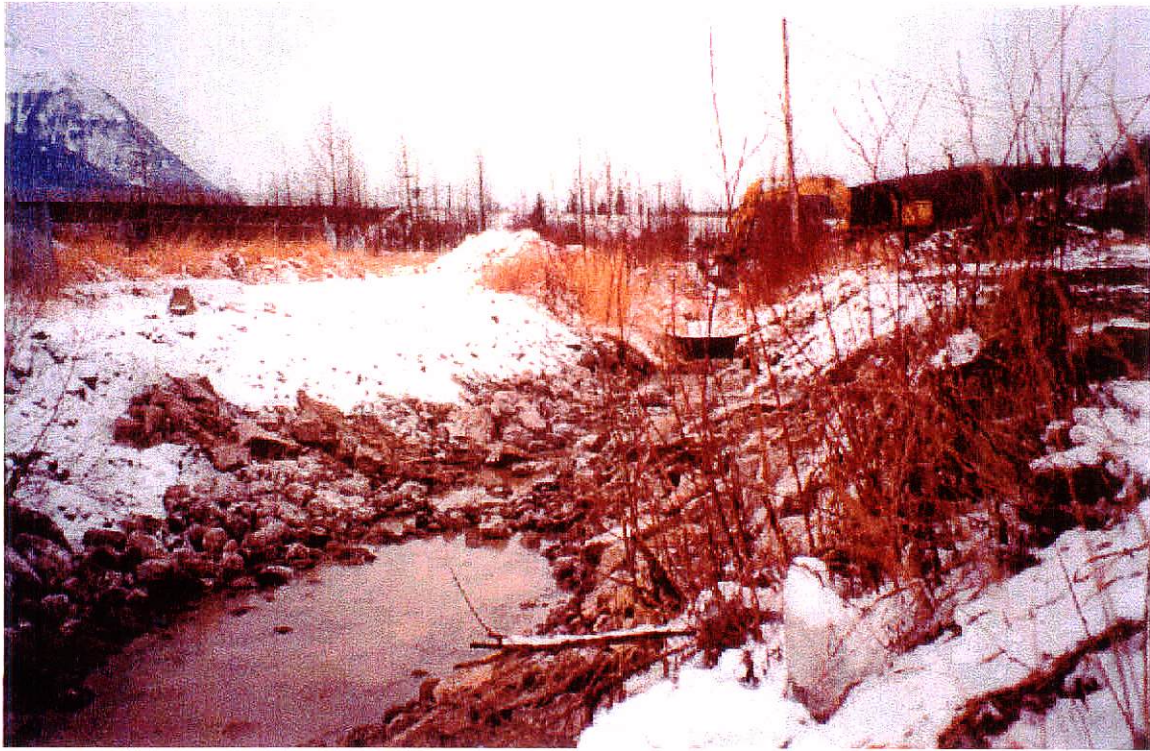
5. Culvert removal and pool development in upper Site 3B was carried out in the dry channel from Dec. 10 – 11/01 (*See Figure #6*). Substrate sediments were removed and replaced with cobble and gravel and the banks armored where culverts were removed. Silt fencing was utilized below pool development sites and pumped out to the adjacent wetlands as silty waters accumulated.

Figure #6 – Upper Site 3B – Channel reconstruction

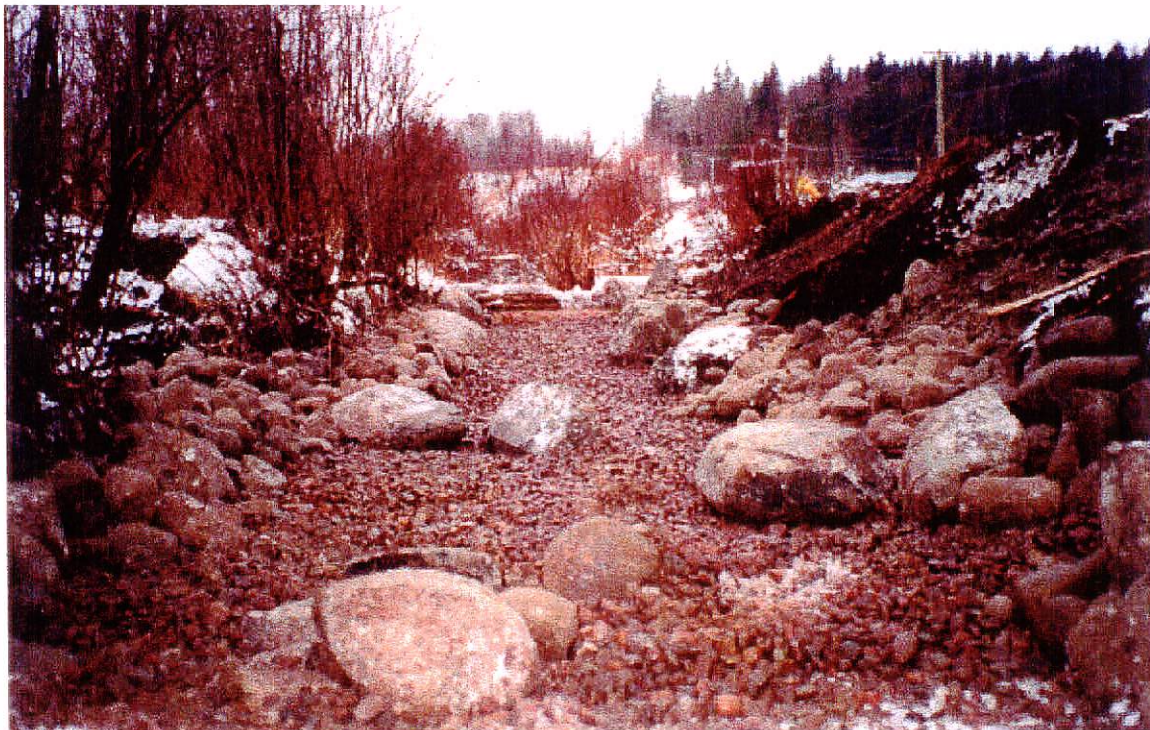
6. Construction of the spawning pads and placement of abutments and gravels in lower 3B began on Dec. 12/01 (*See Figure #7*). Excavation and works were carried out from the road to minimize impact to stream banks and riparian areas as much as possible. Abutments were constructed using marine grade plywood versus treated materials and a cedar log was placed on top spanning the channel (*See Figure #8*). During excavation a pipeline was broken during excavation and repaired by district crew immediately.

Figure #7 – Site 3B – Spawning riffles with substrates restored

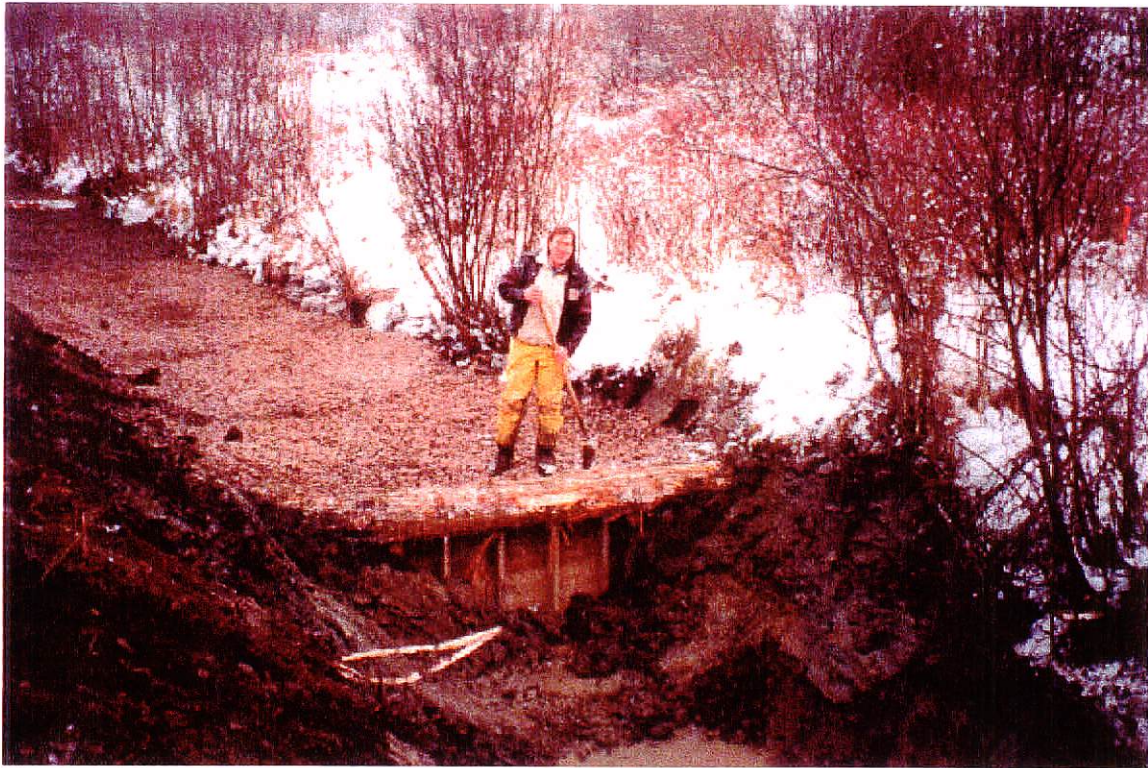
Figure #8 – Site 3B – Abutment placement in spawning channel
