**Summary of Stream Restoration Activities at Site 3 in the Kitseguekla
River South Sub-Basin to March, 1999**

Prepared for the
Gitsegukla Band Council

by
Glenn Grieve, R.P. Bio.
BioLith Scientific Consultants Inc.
Terrace, B.C.

March 31, 1999

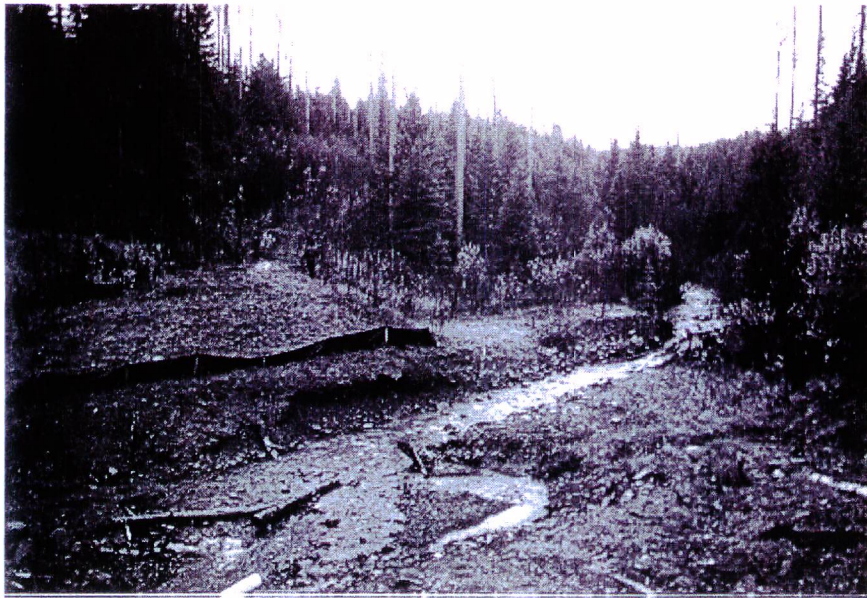
- significant bank erosion,
- channel instability,
- a general lack of LWD, habitat variety and cover, and
- there was evidence of more erosion associated with the previously pulled back bridge approach on the northeastern side (see Photos 1 and 2).

Photo 1. Looking upstream from the former road crossing on Site 3. Note that the road material on the far side was eroding despite earlier pull back of the slope.

It is recommended that the left (southeast) bank at the old road crossing, be made more resistant to erosion at high water by placement of larger shot rock than is currently there.

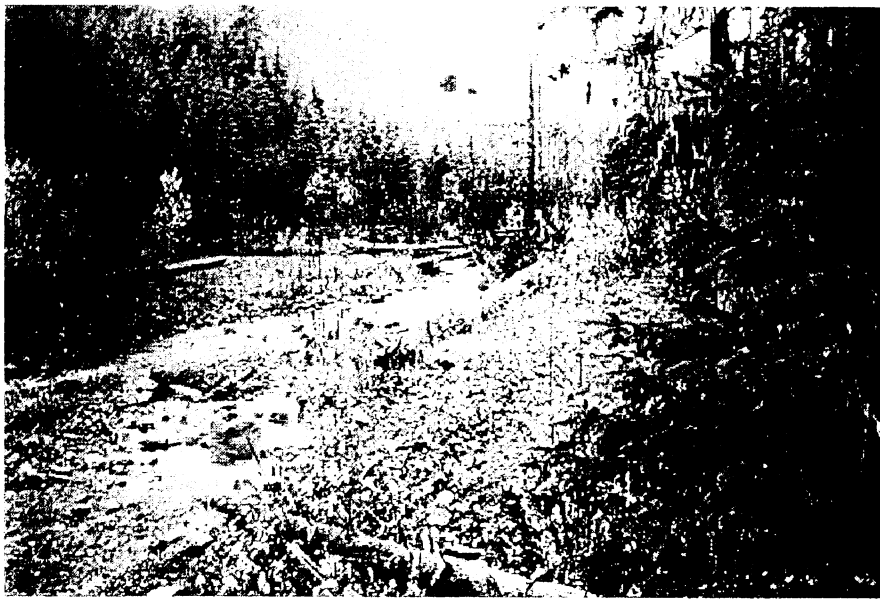
Photo 2. Looking downstream from Photo Point 1.

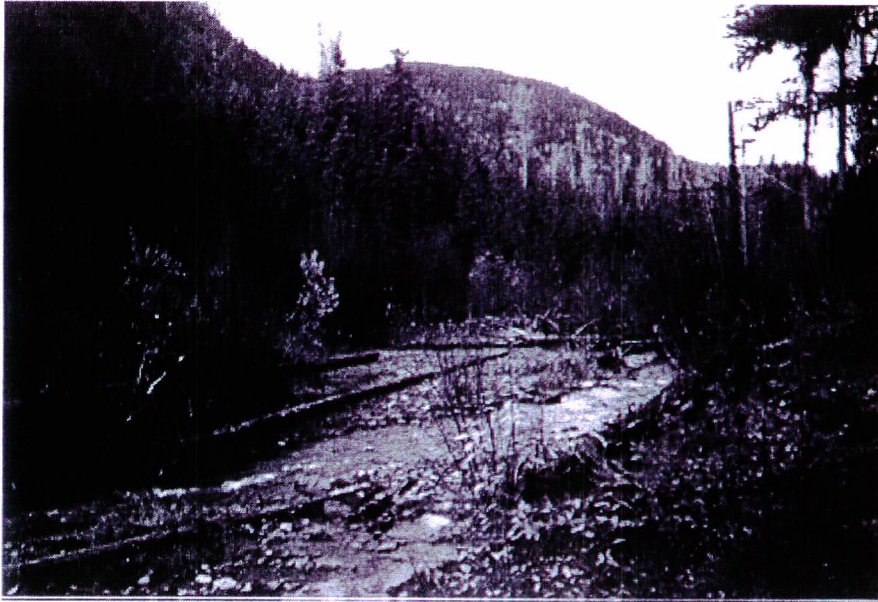
Photo 3. View looking downstream from Photo Point 1 after placement of LWD.

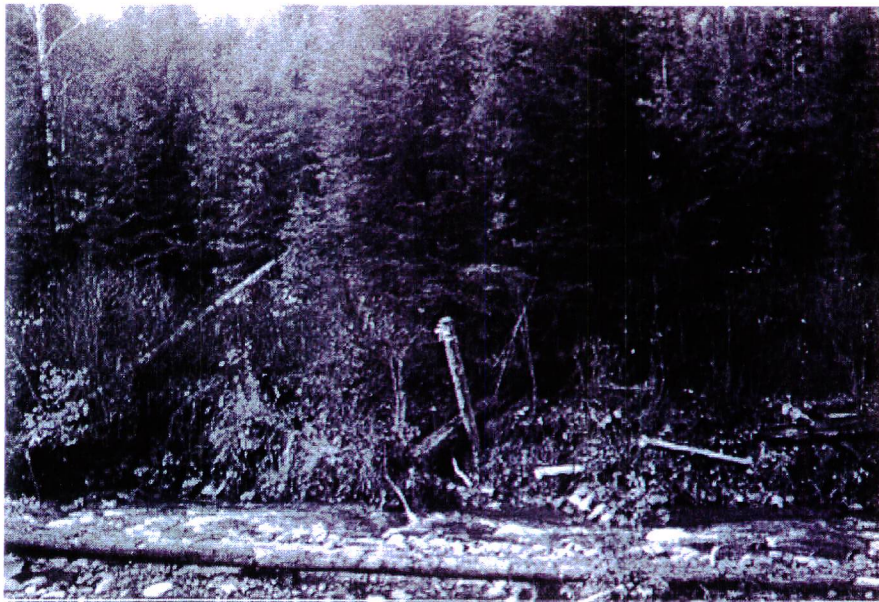
Photo 4. Looking southeast from Photo Point 1. Note the post placed in the bank to stabilize the LWD with root wad.

- A wood post was driven vertically into the western stream bank near the water's edge and downstream from the root wad of LWD Structure F on the construction plan. The purpose of this post was to stabilize the end of Structure F to prevent it from moving downstream.

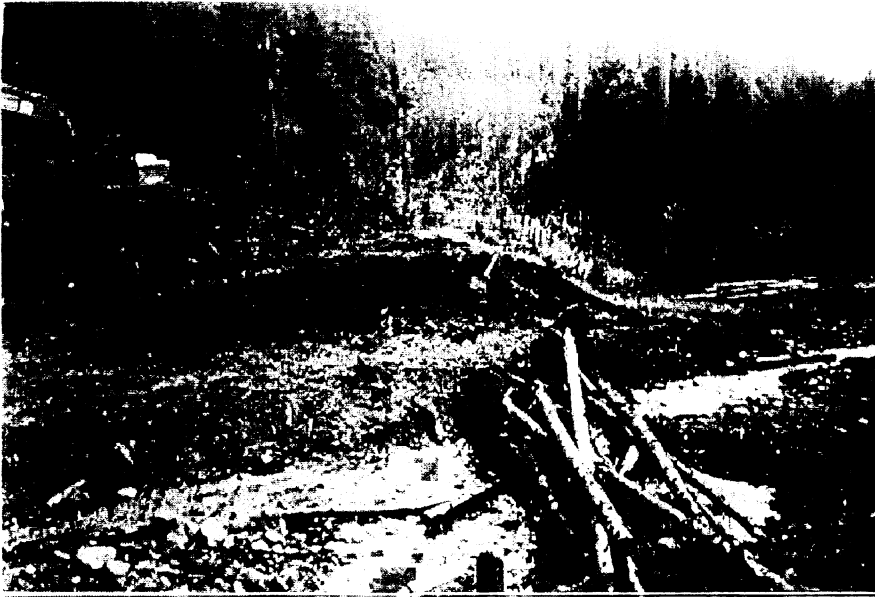
Photo 5. Looking upstream and southeast during transport of the logs and pullback of the bank.
