Gitsegukla Band Council 1998 Submission to

**Annual Compendium of WRP
Aquatic Rehabilitation Projects**

Site 3, Tributary 1, Kitsequecla River

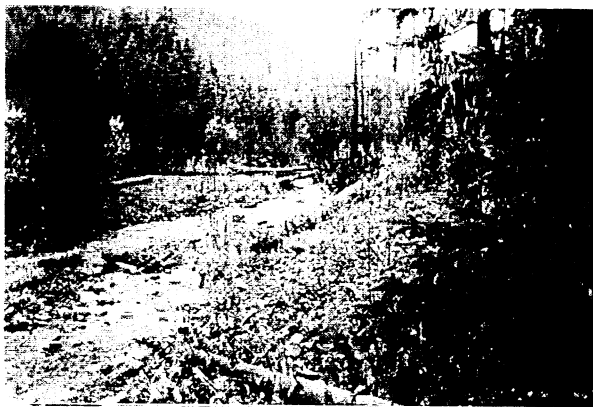
Photo 2. Looking d/s from Photo Point 1 before construction.

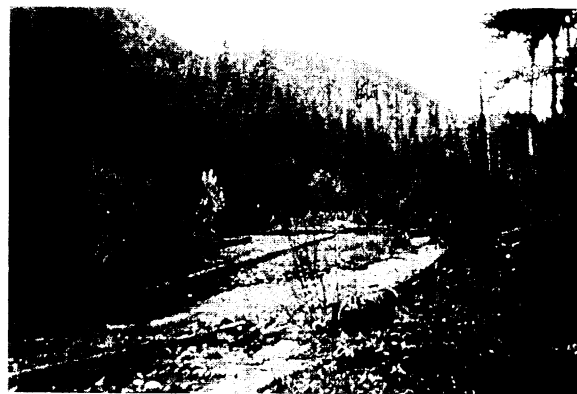
escapement estimates for the mainstem river. Site 3 exhibited the most prominent damage. It was associated with a collapsed bridge crossing (see Photo 1).

Photo 1. Looking d/s from Photo Point 1 after construction.

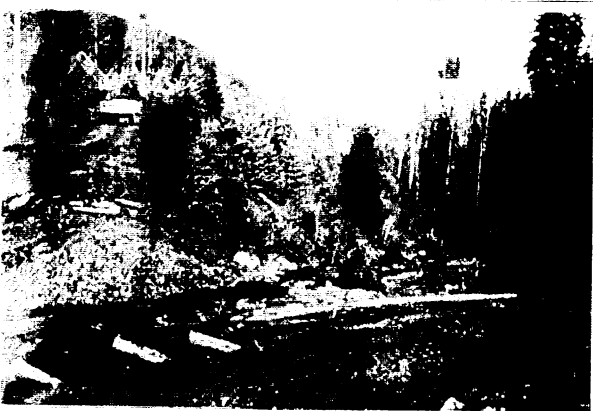
Photo 4. Looking toward the west and across the old road site. Note the debris catchers.

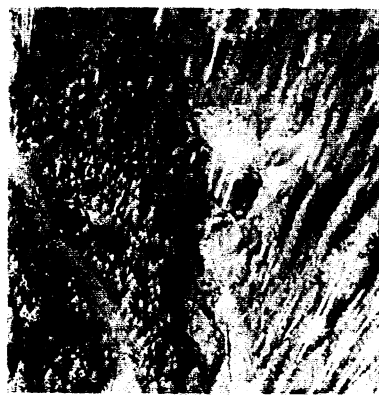
Photo 3. An aerial view of Site 3 after construction. North and downstream are toward the top of the picture.

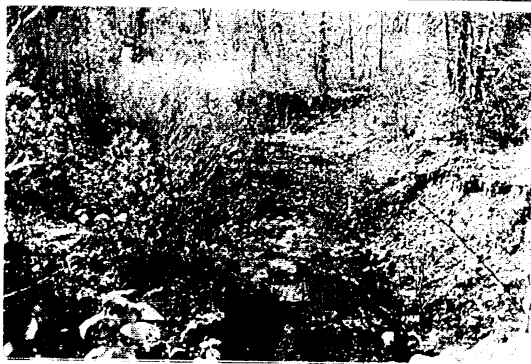
Photo 6. Looking d/s from atop the barrier culvert before construction. The red ribbon marked the upstream limit of restoration.

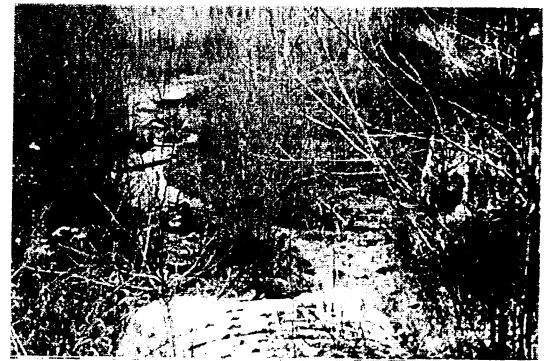
Photo 7. Looking d/s after construction. The technician is standing on the uppermost LWD cluster.

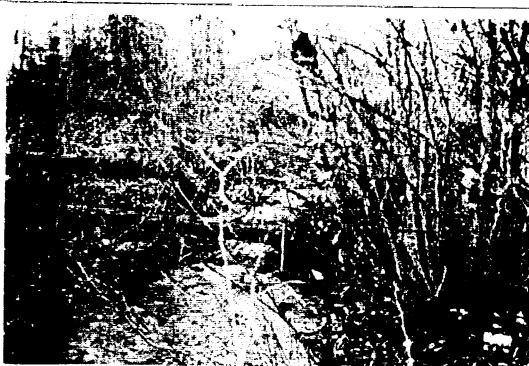
The channel spanning log furthest downstream was installed as prescribed, but because there was an extra complete tree with root wad, which are hard to get and more desirable as functional LWD than logs, it was installed at the prescribed site further upstream instead of a log.

Photo 9. Looking u/s from Photo Point 2. An extra tree complete with root wad was substituted for the originally prescribed channel spanning log weir.
