Gitsegukla Band Council 1998 Submission to

**Annual compendium of WRP
Aquatic Rehabilitation Projects**

Kitsequecla River WRP 1998 Site Works

Kitwanga River WRP 1998 Site Works

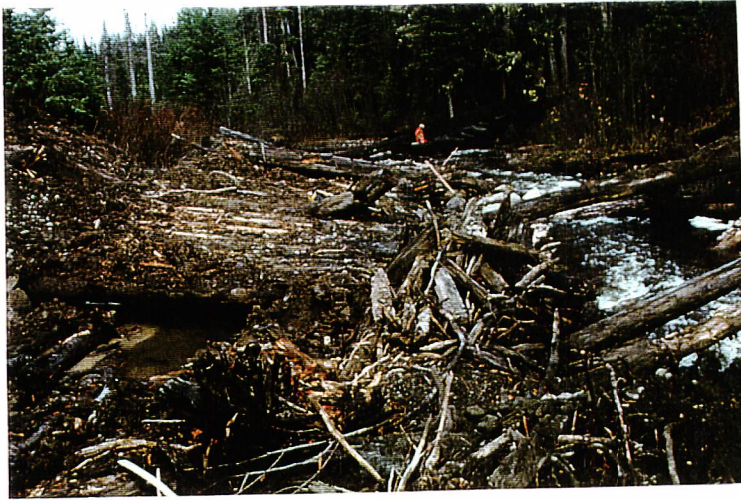
Photo 1. Kitsequecla trib 1 looking downstream before pullback.

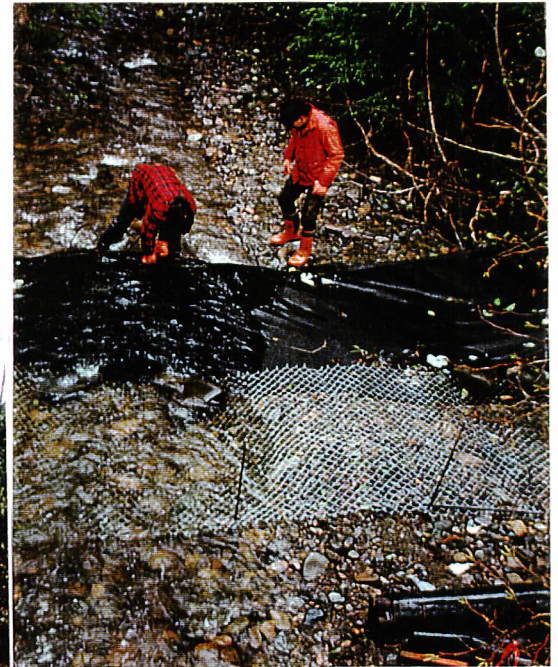
Photo 2 installing silt fence.

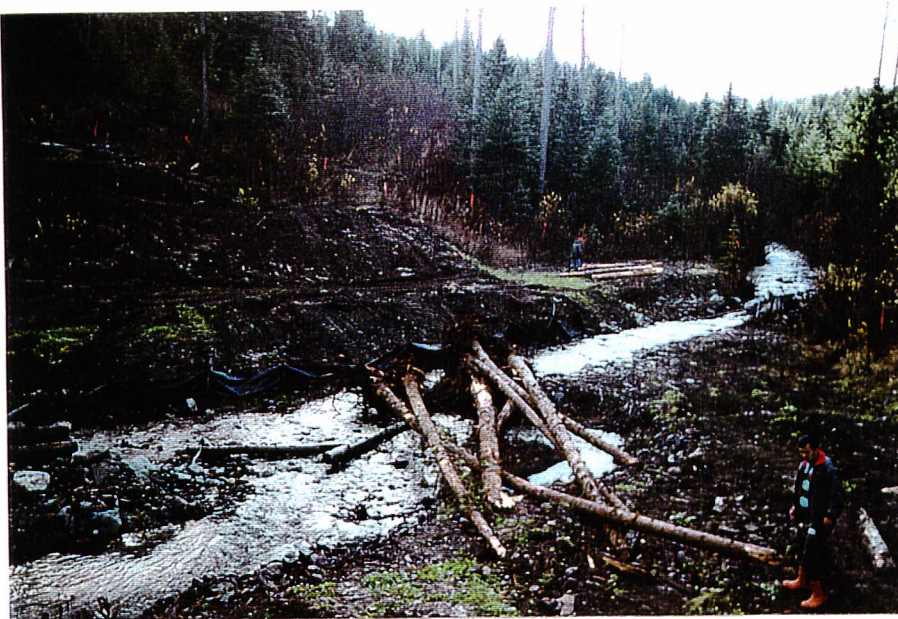
Photo 3 looking upstream after pullback of the collapsed bridge. The foreground shows a thalweg formed around a collapsed bridge structure removed during 1997. The sediment wedge in the upper right of the photo was deposited above the bridge in a 1 in 100 year event and is considered stable.

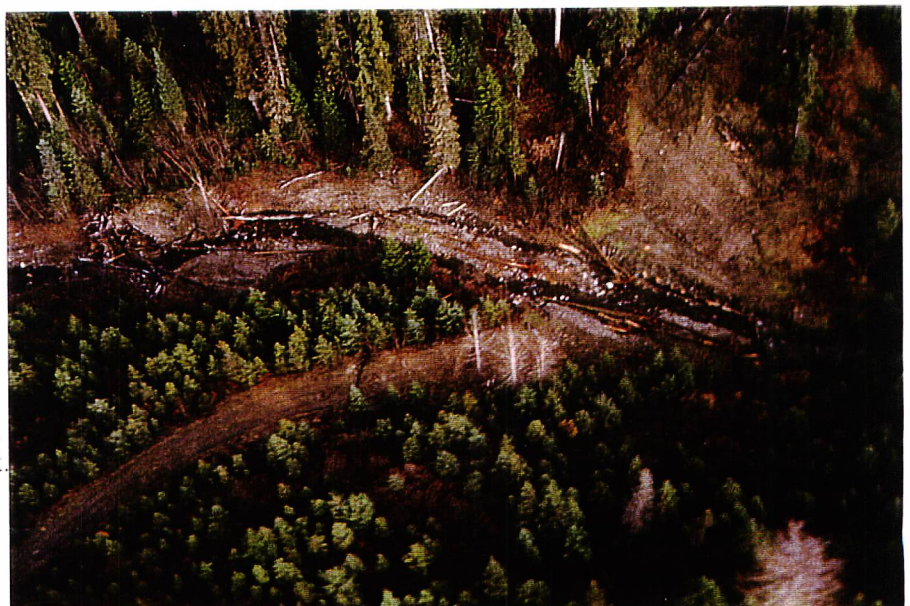
Photo 4 Aerial view of installed stems. Upstream is to right side of photo right.

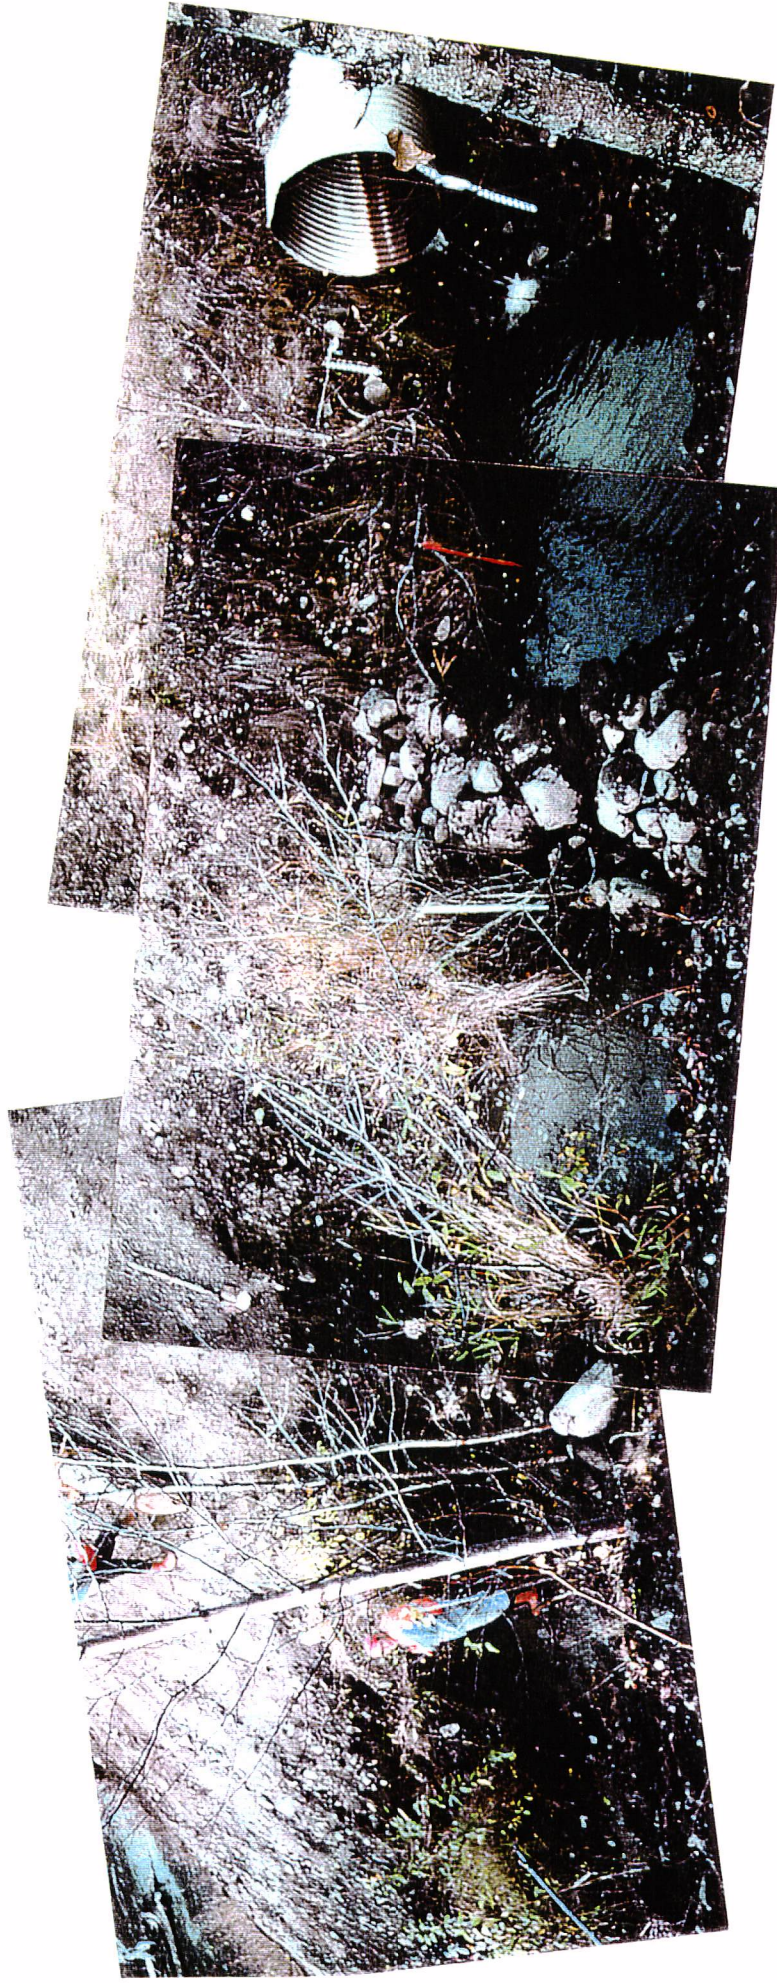
Photo caption of Site 14 shows the two jump pools constructed and the LWD being installed by hand below the pools. The pullback above the site was completed to open the area to light without removing the riparian vegetation or the stream bed. The area was seeded and a silt fence installed.

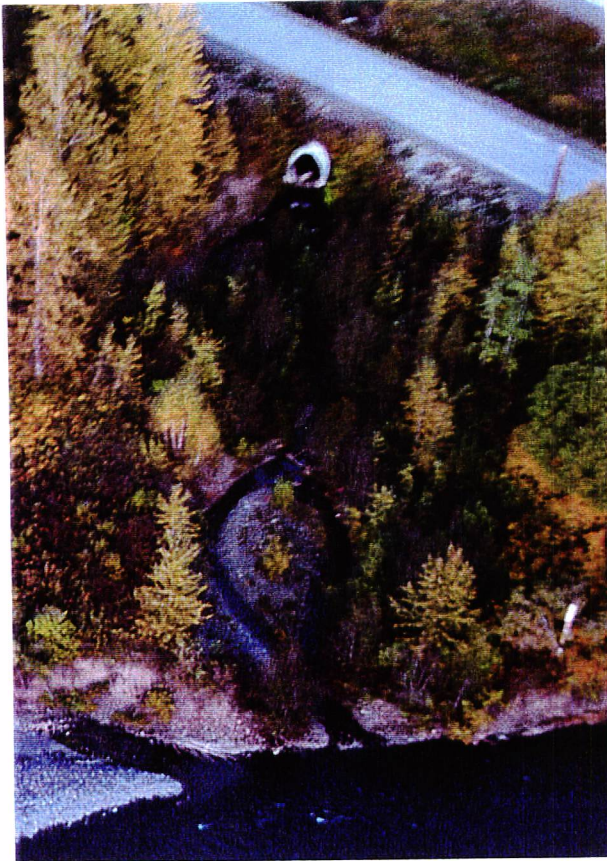
Aerial view of Tributary 18, Reach 1 where it enters the Kitwanga River. The Works were installed between the mouth and the culvert. Above

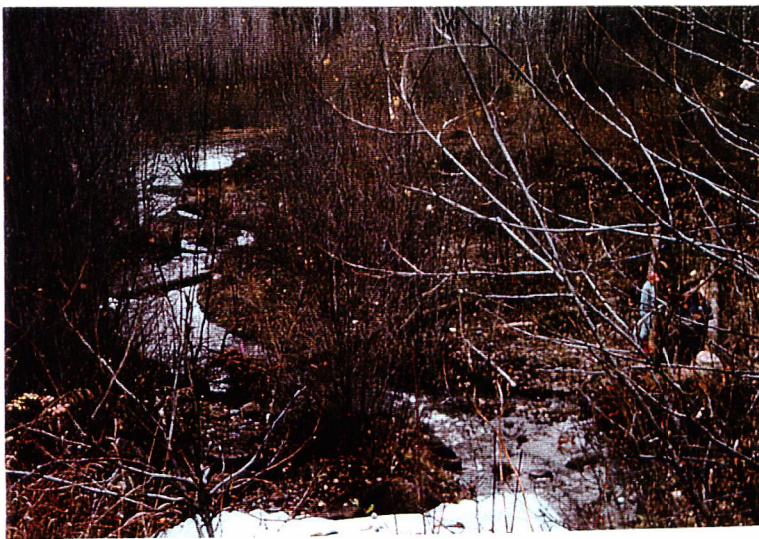
Site 15/Photo 2. Installed works from photo station 1. Workers are tying down the stems placed to control high water erosive forces. The log in the center of the photo is the log in Photo 3. Above

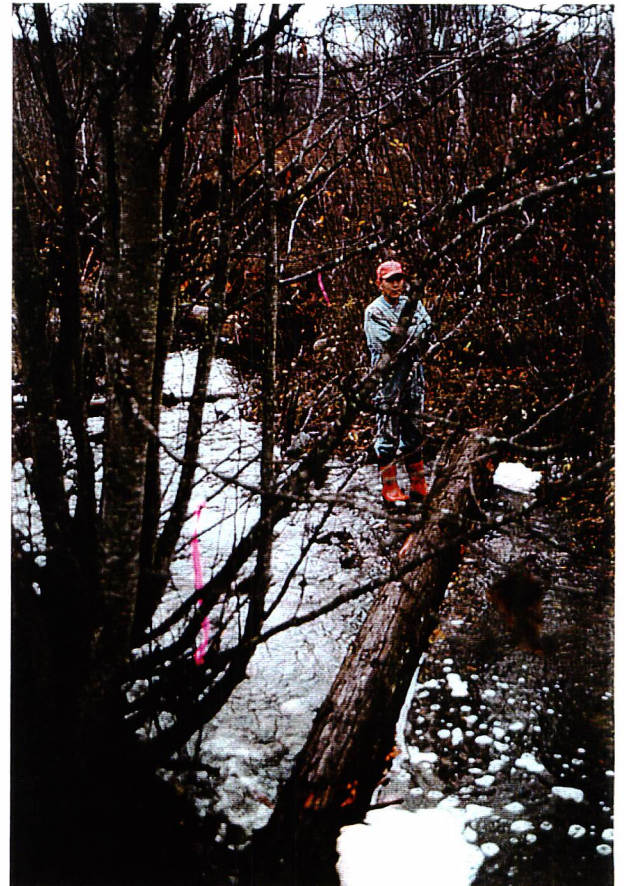
Below
Site 15/Photo 3. Installed channel span LWD provides cover, and backwater for sediment trap and step pool development. The log was placed with a winch and roller logs, and anchored with rock.
