# **ROUTINE EFFECTIVENESS EVALUATIONS**

### **SELECTED SITES IN THE BULKLEY TSA**

Prepared for: **WEST FRASER MILLS LTD**  
**PACIFIC INLAND RESOURCES DIVISION**  
**P.O. BOX 3130**  
**SMITHERS, B.C. V0J 2N0**  
Telephone: (250) 847-2656  
Fax: (250) 847-5520  
Email: [Kent.coish@westfraser.com](mailto:Kent.coish@westfraser.com)

Prepared by: **Silvicon Services Inc.**  
3560 Victoria Drive  
Smithers, B.C. V0J 2N0

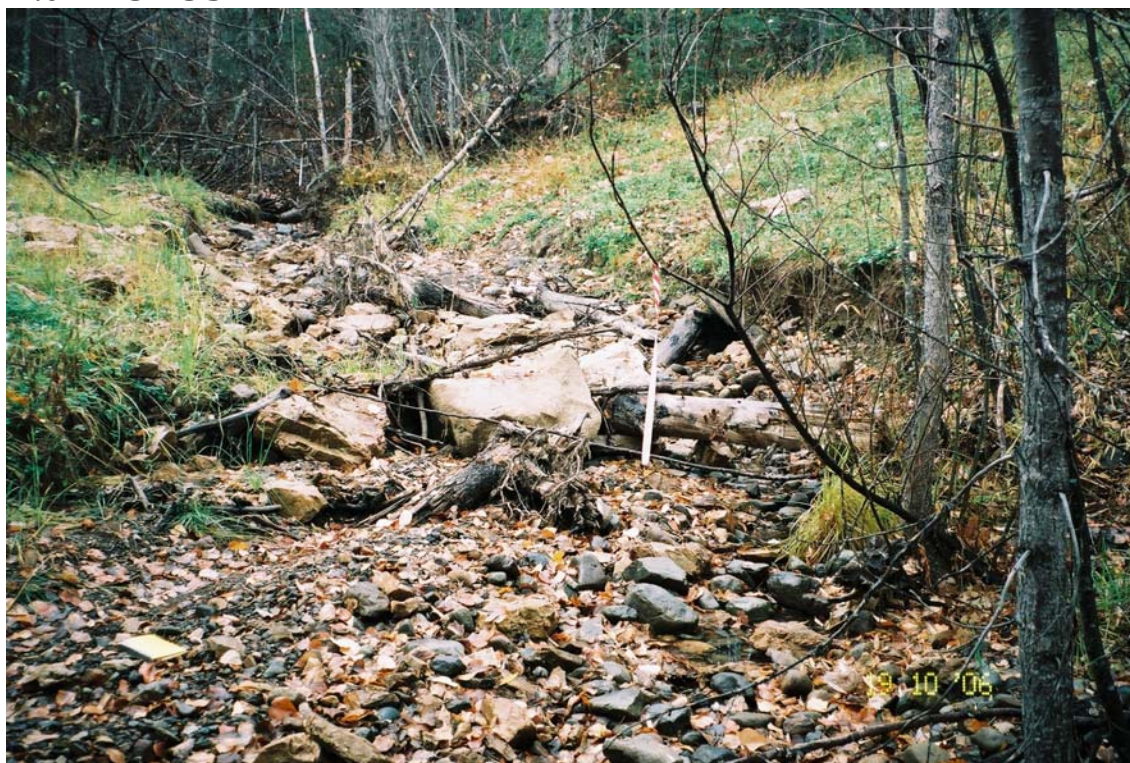
| SITE DESCRIPTION | | | | | PERFORMANCE OBJECTIVES | | | | | | | | | | | | | | OVERALL | | | | | | |
|---|---|---|---|---|---|---|---|---|---|---|---|---|---|---|---|---|---|---|---|---|---|---|---|---|---|
| <b>Comments:</b><br>3006-1 | The site has seen some scour (and erosion) at the stream crossing. Lots of gravel has been transported and deposited in the reconstructed channel (REK-12 #21). Some boulders and cobbles from rip-rap in re-constructed channel have been carried up to 10m downstream from old outlet pool. This is possibly from very high flows during an extreme rain event last spring. Erosion has only occurred on downstream half of loaded side bank. Grass very well established on approach slopes, possibly due to straw mulch laid down over seeded areas. Suspect that channel will stabilize now that channel is widened and has down-cut. Revisit in 1-2 years to see if channel stabilizes and scour stops on downstream loaded side bank. | | | | | | | | | | | | | | | | | | | | | | | | |

Site 3006-1. Upstream view of reconstructed channel. Note bank scour at toe of loaded approach to right of ribbon.

Overall the works evaluated at the eleven sites visited are functioning well and appear to be structurally stable and in good structural condition. The reconstructed stream channel at Site 3006-1 in the Fulton sub-basin should be re-visited for a REE again next year after the spring freshet is complete. As well the fords at Site 473-1 on the 473 Road in the Lower Nilkitkwa sub-basin and the ford at Toboggan Creek on the Silvern Lakes Road should be visited annually to monitor their performance and structural stability and condition. Due to the high energy flows in Toboggan Creek, the site should be a priority for routine monitoring. The backwater weirs on Williams Creek and Heal Creek appear to be holding up well and are functioning as intended in the site prescriptions. The site at Williams Creek should also be monitored on a routine basis, either every year or at least every other year as it is also a high energy system. Heal Creek seems to have much more benign flows than Williams Creek therefore it should be monitored on a longer interval basis, either 3 or 5 years. The reconstructed channels under the bridges at Site 487-34 and at the 19.3km Telkwa Site should not require any further monitoring as they are stable and should not require any routine maintenance.

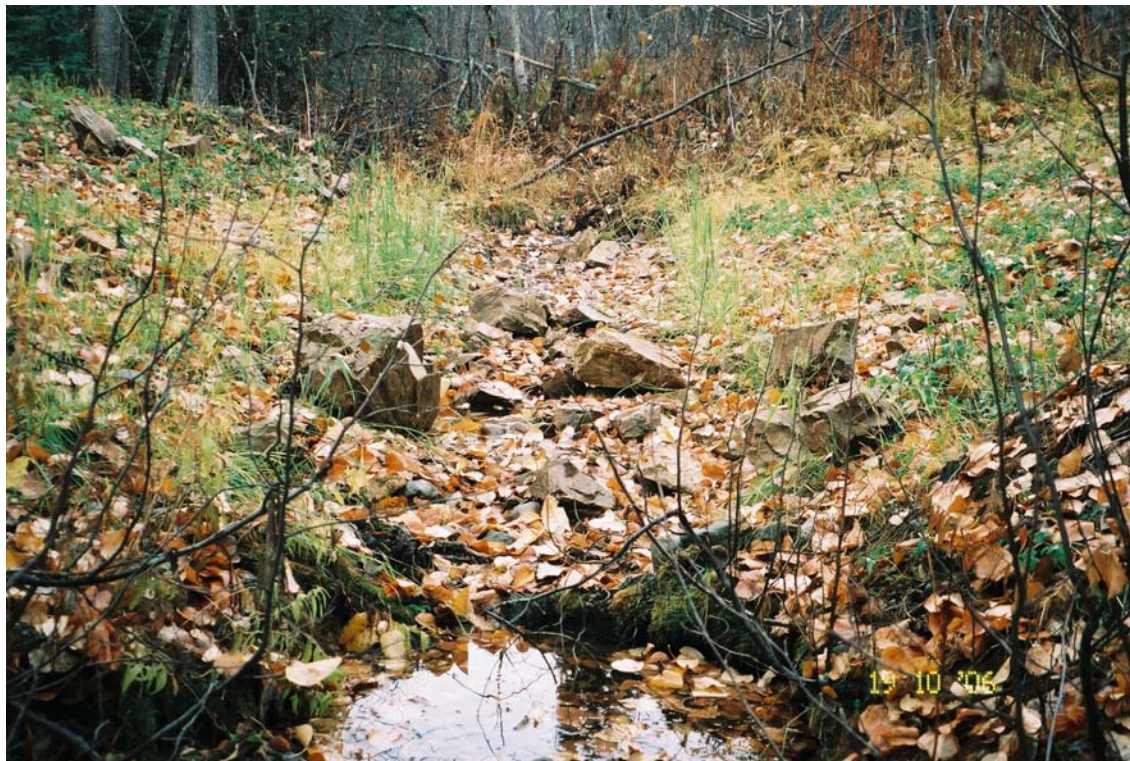
| SITE DESCRIPTION | | | | | PERFORMANCE OBJECTIVES | | | | | | | | | | | | | | OVERALL | | | | | | |
|---|---|---|---|---|---|---|---|---|---|---|---|---|---|---|---|---|---|---|---|---|---|---|---|---|---|
| <b>Comments:</b><br>3006-2 | There is no evidence of erosion or scour at this site. The reconstructed channel is holding up well and the site appears to be stable. There is no sign of large amounts of sediment transport and/or deposition. The gradient of the reconstructed stream channel is 7-8% with no apparent obstacles to upstream fish passage for any life stage of fish. Grass seeding of the site was successful as grass is very well established at the site helping to stabilize the approaches, thereby minimizing the risk of erosion at the site. | | | | | | | | | | | | | | | | | | | | | | | | |

Site 3006-2. Upstream view of completed channel.

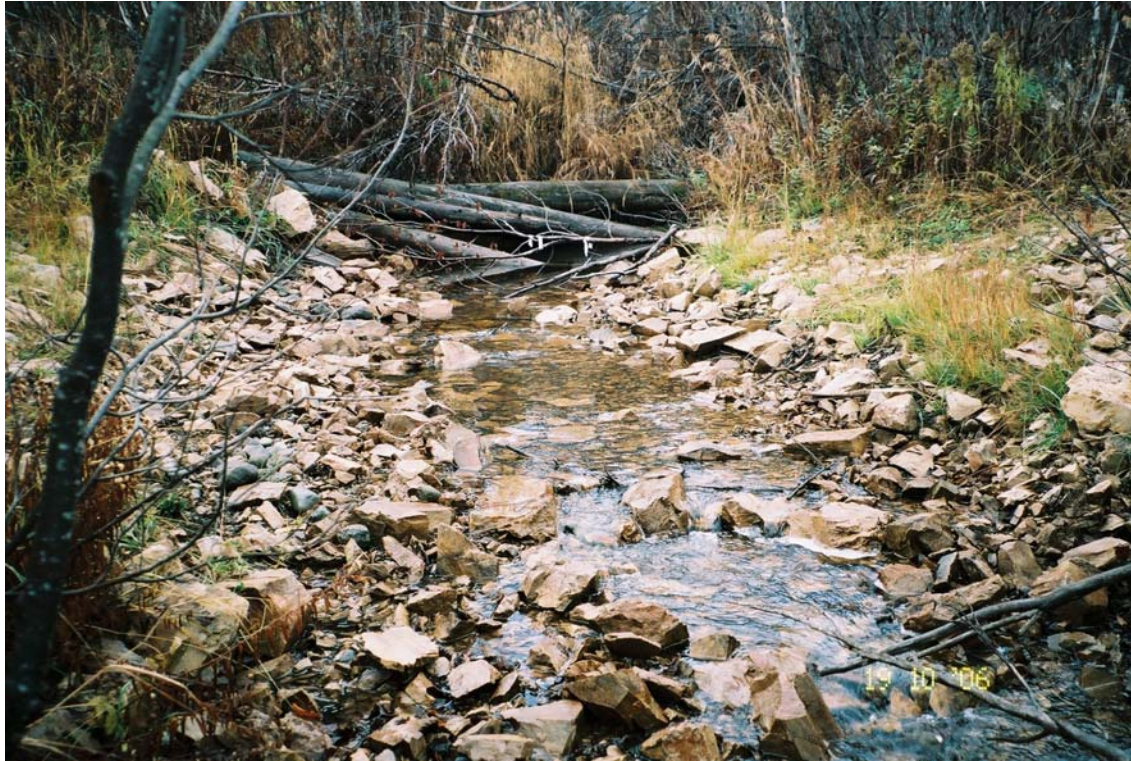
| SITE DESCRIPTION | | | | | PERFORMANCE OBJECTIVES | | | | | | | | | | | | | | OVERALL | | | | | | |
|---|---|---|---|---|---|---|---|---|---|---|---|---|---|---|---|---|---|---|---|---|---|---|---|---|---|
| <b>Comments:</b><br>3006-3 | Reconstructed channel is holding up well, no erosion or scour of reconstructed channel evident. There is no evidence of significant amounts of sediment transport or deposition at the site. Overall the site appears to be quite stable. The stream flow is predominantly through the empty side channel but still flows through the secondary channel on the loaded side of the stream crossing at higher flows. Fish passage is greatly improved at the site, it is passable now even at relatively low flows. The crossing does not present an obstacle to upstream fish passage for any life stage of fish. | | | | | | | | | | | | | | | | | | | | | | | | |

Site 3006-3. View of reconstructed stream channel.

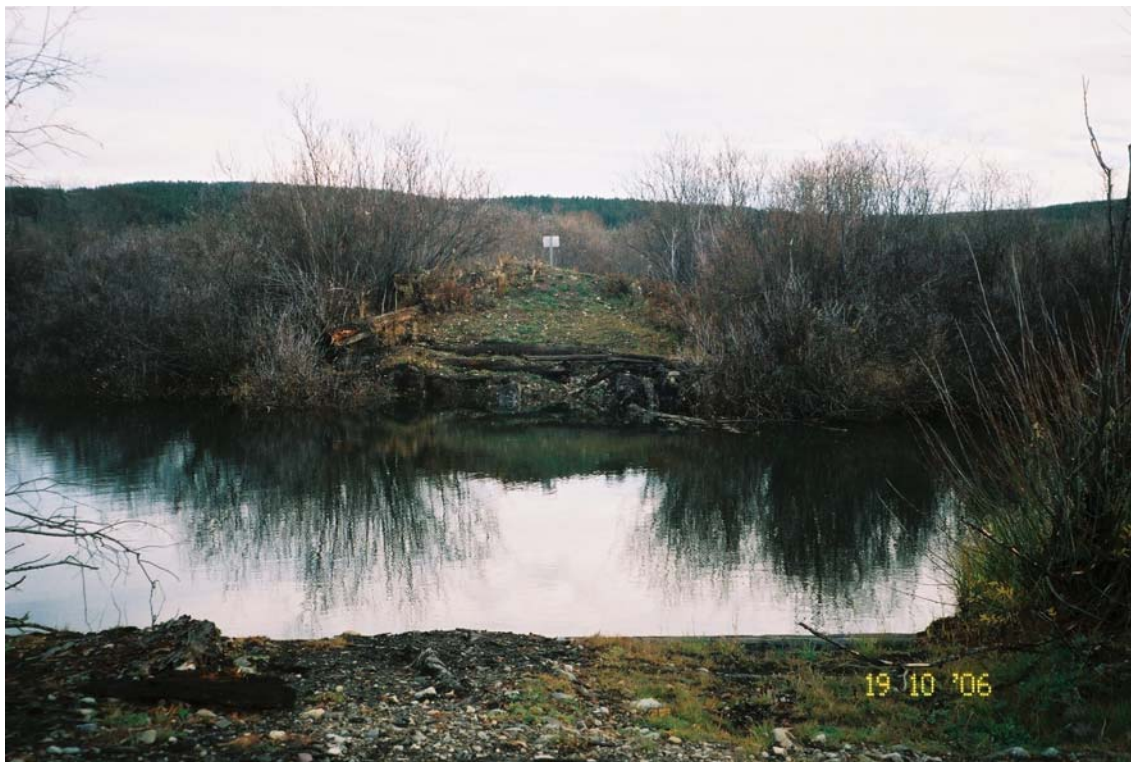
| SITE DESCRIPTION | | | | | PERFORMANCE OBJECTIVES | | | | | | | | | | | | | | OVERALL | | | | | | |
|---|---|---|---|---|---|---|---|---|---|---|---|---|---|---|---|---|---|---|---|---|---|---|---|---|---|
| <b>Comments:</b><br>306A | There is no evidence of scour or erosion of the banks at the site of the bridge deactivation. The deactivated bridge crossing is holding up very well and there are no concerns with the deactivation prescription or deactivation works at this time. Due to the slow meanders of the Fulton River in this reach, erosion and scour are not a high risk. This site is on an active floodplain and wetland so the river channel could move at any time or location in this reach under flood or peak flow conditions. There also appears to be ongoing beaver activity throughout this reach which could cause flooding or the movement of the main channel at any time. Possibly revisit in 2 years for a very quick overview assessment. | | | | | | | | | | | | | | | | | | | | | | | | |

Site 306A. View across Fulton River with bridge removed.

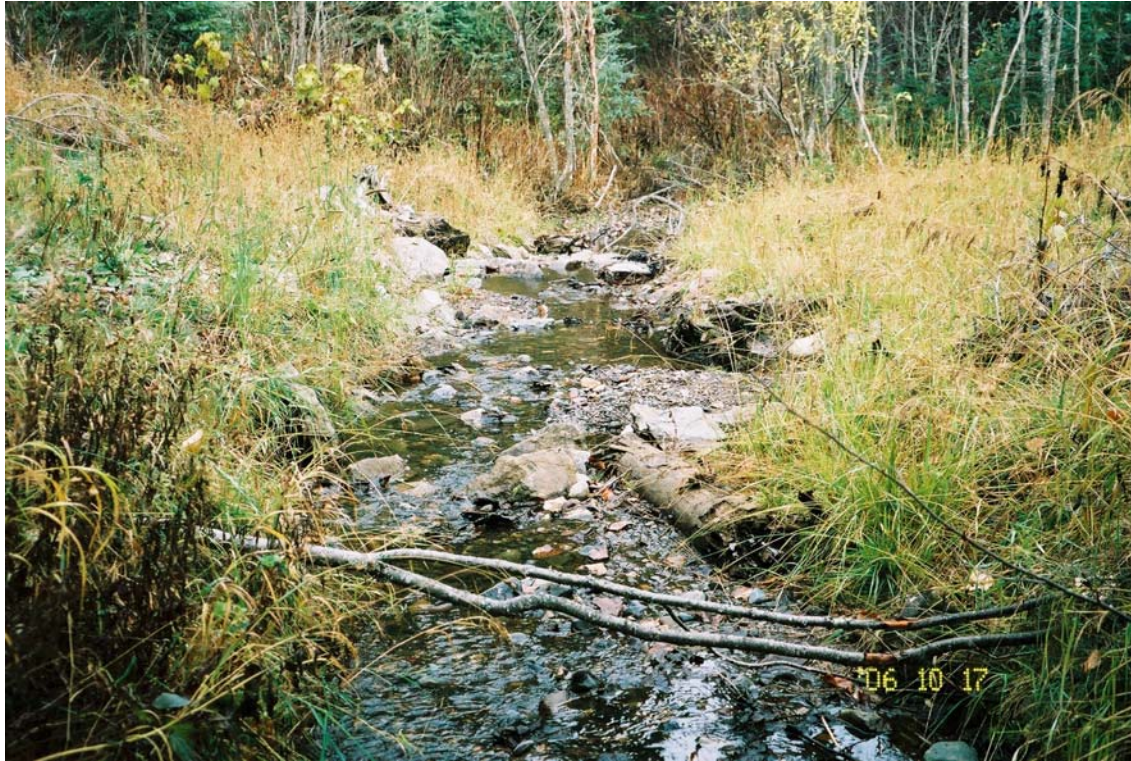
| SITE DESCRIPTION | | | | | PERFORMANCE OBJECTIVES | | | | | | | | | | | | | OVERALL | | | | | | | |
|---|---|---|---|---|---|---|---|---|---|---|---|---|---|---|---|---|---|---|---|---|---|---|---|---|---|
| Comments: | No evidence of erosion at banks or on approaches. Grass seeding well established. Upstream fish migration much better than old culverts, no drop as with old culverts. A series of small steps was created through the use of rock lines in the reconstructed channel. Bed material predominantly gravel in reconstructed channel, possible spawning habitat but no cover yet, some deciduous stems appearing on approaches to channel. Appears to be good rearing habitat but more cover especially from O.V. is needed to really improve habitat quality. Channel appears to be stable, no erosion or scour of banks evident. Some coarse woody debris and boulders in reconstructed channel for cover but still very open. Site basically just needs more cover on the reconstructed channel to be really good habitat. Should fill in naturally in next few years, some deciduous trees and shrubs becoming established on approach slopes. | | | | | | | | | | | | | | | | | | | | | | | | |

Site 413-123. Downstream view of reconstructed channel.

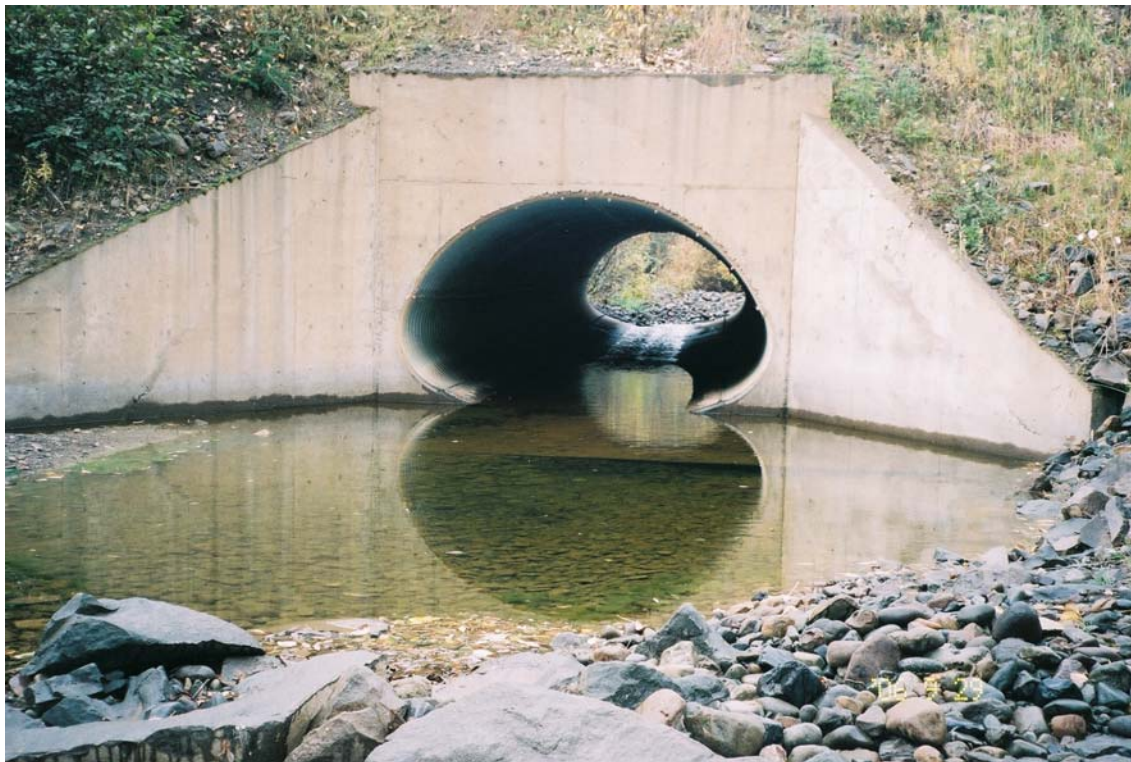
| SITE DESCRIPTION | | | | | PERFORMANCE OBJECTIVES | | | | | | | | | | | | OVERALL | | | | | | | | |
|---|---|---|---|---|---|---|---|---|---|---|---|---|---|---|---|---|---|---|---|---|---|---|---|---|---|
| Comments: | Structure (backwater weir) is functioning well, culvert is still backwatered through 50% of downstream length despite very low flow conditions this year. Sampled same length as upstream baseline sample we did just prior to weir construction in 2003. No CO or CH captured upstream in baseline sample area during September 29, 2006 sampling. Only captured RB and DV/BT. The 2003 fish salvage captured RB, CO and DV/BT and the 2003 baseline sample captured 2 RB, 4 CO and 4 DV/BT. The 2006 baseline sample captured 11 RB, 5 DV/BT and no CO. Backwater weir has resulted in outlet pool infilling and raising the water level so the outlet fall from the culvert apron has been completely eliminated. Apron is now submersed approximately 30 cm. Water velocity in the culvert has also definitely reduced in the backwatered section of the culvert. This is evidenced by the lack of scour at outflow pool and the infilling of the outlet pool with sediments since the backwater outlet control weir constructed at outlet. The excessive scour that was undermining the outlet apron prior to the construction of the backwater weir has been stopped and much of the scour pool has filled in with sediments. | | | | | | | | | | | | | | | | | | | | | | | | |

Site 4000-Feature 17/678. Williams Creek. Upstream view of backwatered culvert outlet, in-filled outlet pool.

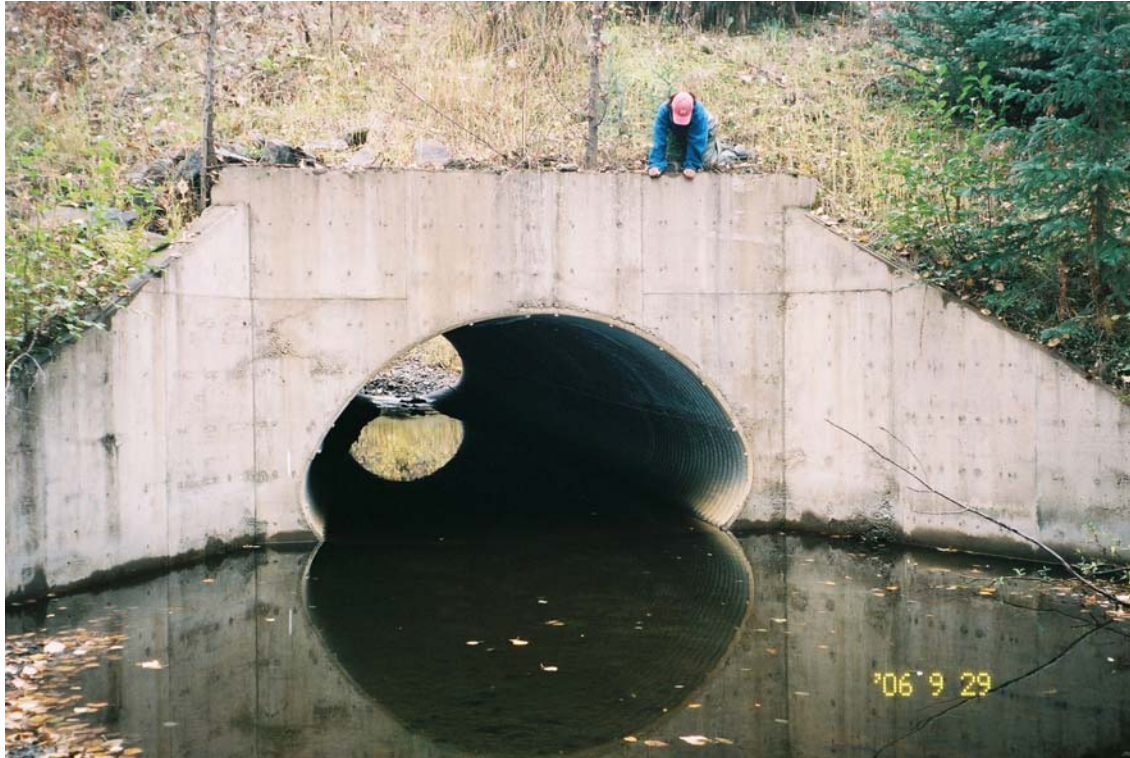
| SITE DESCRIPTION | | | | | PERFORMANCE OBJECTIVES | | | | | | | | | | | | OVERALL | | | | | | | | |
|---|---|---|---|---|---|---|---|---|---|---|---|---|---|---|---|---|---|---|---|---|---|---|---|---|---|
| Comments: | Structure (backwater weir) is functioning well, culvert is backwatered almost entire length except for approx. 5m at upstream end despite extremely low flows this fall. Outlet pool has in-filled level with concrete apron 3 years after construction of backwater (outlet control) weir. Weir has nice steep pools for upstream passage, only 10-15cm between steps. Weir appears to be holding up very well. Should have no problems remaining as a permanent structure especially after unusually high flows during rain events last spring (spring 2006). 2003 upstream baseline sampling captured 21 fish, 19 CO and 2 DV/BT. Baseline sampling 3 years later in 2006 saw the capture of 1 CH, 9 RB, 3 DV/BT and 1 unidentified salmonid 70mm in length. No sediment transfer or transfer of rip-rap used to construct the weir was evident. Backwater weir has resulted in the outlet pool in-filling and raising the water level so the outlet fall has been completely eliminated. Apron is now submersed by approximately 40 cm of water. Culvert water velocity has definitely been reduced in the backwatered section. This is evidenced by the lack of scour at outflow pool and the infilling of the outlet pool with sediments since the backwater outlet control weir was constructed at the outlet. | | | | | | | | | | | | | | | | | | | | | | | | |

Site 4000-Feature 23/696. Heal Creek. Culvert outlet; apron and culvert backwatered.

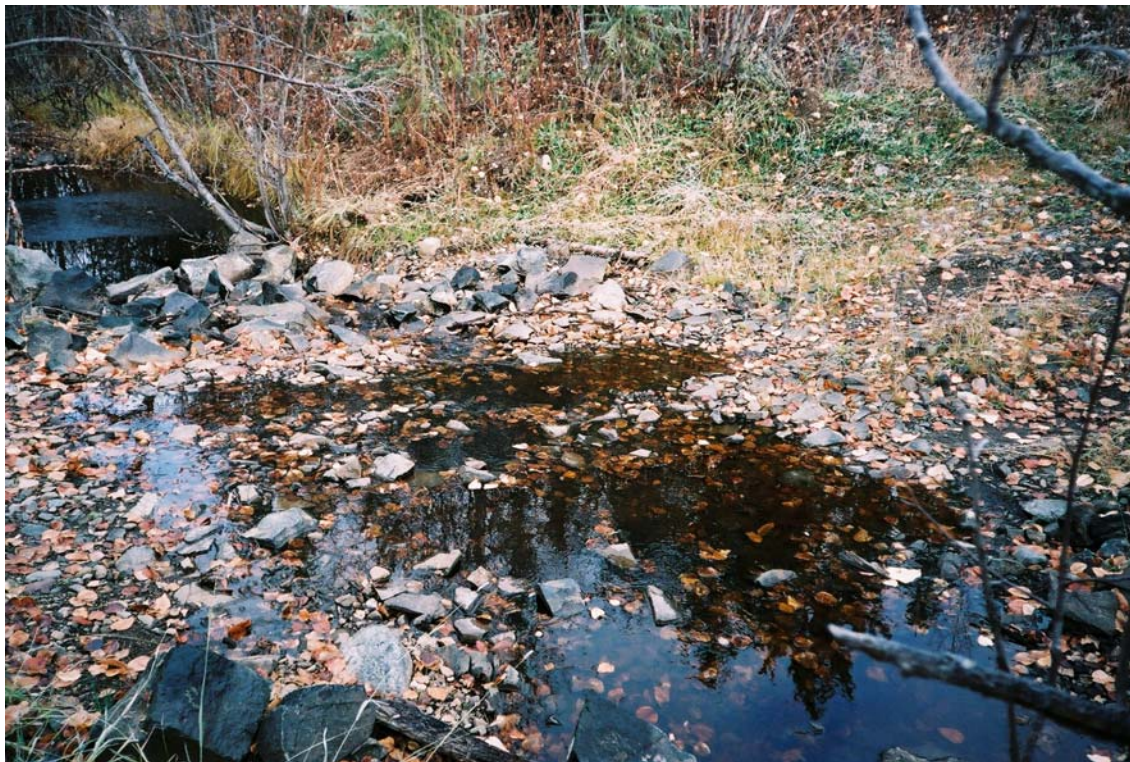
| SITE DESCRIPTION | | | | | PERFORMANCE OBJECTIVES | | | | | | | | | | | | | OVERALL | | | | | | | |
|---|---|---|---|---|---|---|---|---|---|---|---|---|---|---|---|---|---|---|---|---|---|---|---|---|---|
| Comments: | This stream crossing culvert location was deactivated in the fall of 2004; however, since the gravel pit at the end of the 473 Road was commonly used as a camping area by hunters, fording the site was recommended rather than complete deactivation. No erosion was visible at the ford during our field visit. Both approaches are holding up very well. The gravel that was spread on the empty and loaded approaches during the ford construction remains clean and is working well in preventing the approaches from becoming muddied by 4WD vehicles spinning on the approach slopes. The grass seed that was spread on all the mineral soil exposed during the ford construction has taken very well and is assisting in stabilizing and minimizing erosion of exposed soil surfaces. Upstream fish migration conditions are much more favourable than the culvert conditions, especially for juvenile fish. The stream velocity is much slower in the ford than it was through the culvert. Based on the appearance and condition of the ford during the REE, no maintenance of the ford is required at this time. This site should possibly be re-evaluated on a bi-annual basis (every 2 <sup>nd</sup> year) to briefly ensure the function of the ford is maintained and no deterioration or erosion of the ford is occurring. | | | | | | | | | | | | | | | | | | | | | | | | |

Site 473-1. View across ford from loaded side. No erosion or scour evident.

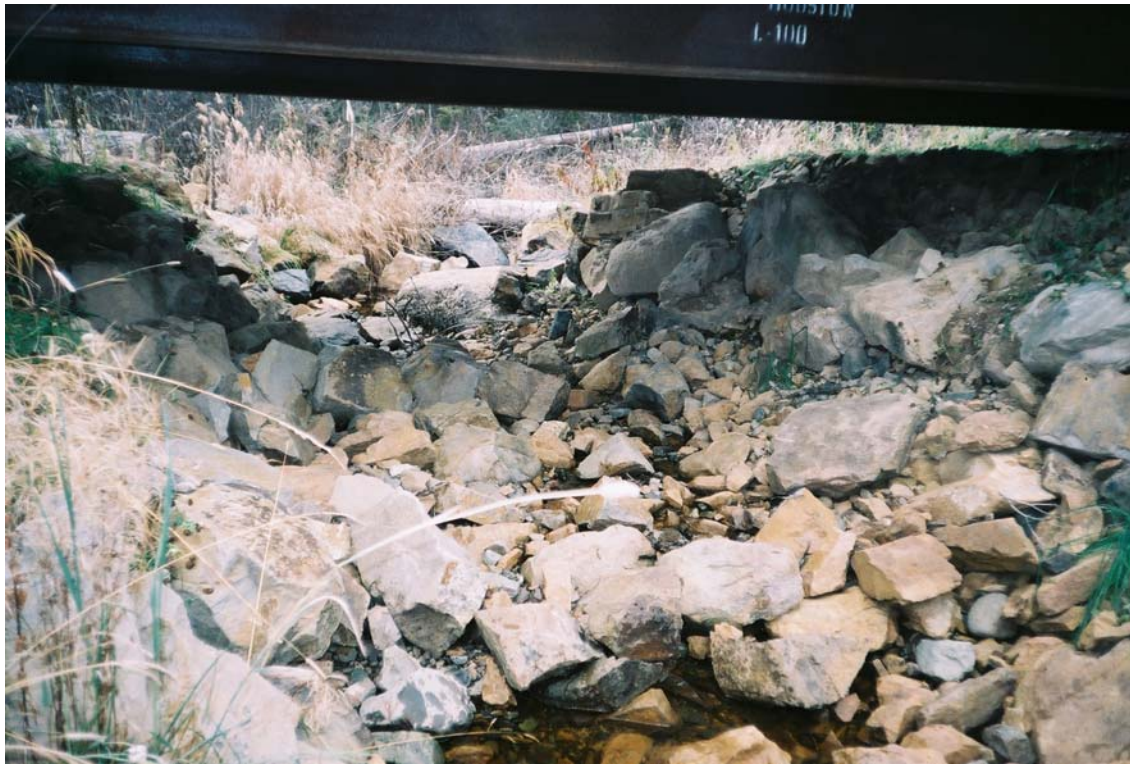
| SITE DESCRIPTION | | | | | PERFORMANCE OBJECTIVES | | | | | | | | | | | | | OVERALL | | | | | | | |
|---|---|---|---|---|---|---|---|---|---|---|---|---|---|---|---|---|---|---|---|---|---|---|---|---|---|
| Comments: | The grass seeded at this site is well established and is assisting in stabilizing the fill. Water flow at the time of the Routine Effectiveness Evaluation was very low. A small amount of rip-rap on the loaded side of the restored stream channel directly underneath the bridge has dislodged and rolled into the thalweg of the stream channel. This appears to be a relatively recent event, probably within the last few months prior to the REE. The restored channel is definitely an improvement in fish passage although the extremely low water levels at the time of the evaluation would pose difficulties for adult fish migration upstream. There were no apparent run-off or sediment issues; no visible sediments have been introduced into the stream as a result of the post construction layout of the site. A follow up visit in 2007 may be in order to ensure that no further rip-rap has fallen into the stream channel and that the rip-rap has stabilized. | | | | | | | | | | | | | | | | | | | | | | | | |

Site 487-34. Upstream view of reconstructed stream channel under new bridge.

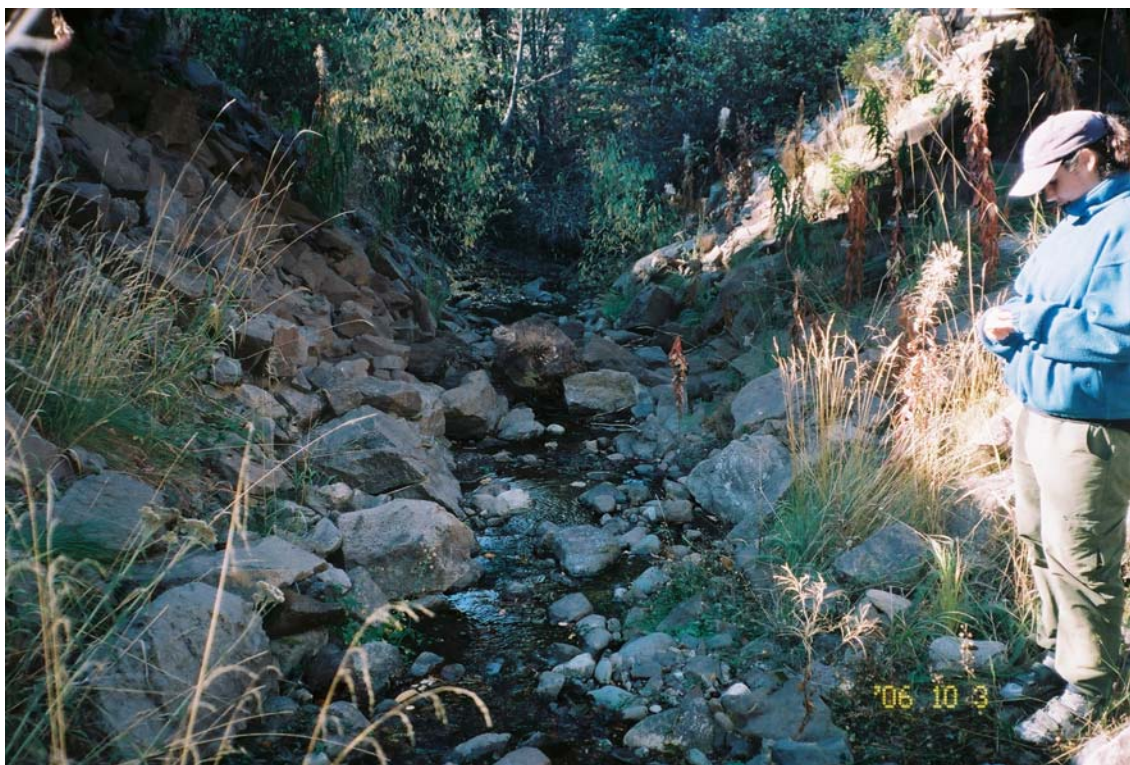
| SITE DESCRIPTION | | | | | PERFORMANCE OBJECTIVES | | | | | | | | | | | | | OVERALL | | | | | | | |
|---|---|---|---|---|---|---|---|---|---|---|---|---|---|---|---|---|---|---|---|---|---|---|---|---|---|
| Comments: | <p>Good stream channel restoration where the old culvert rested. No evidence of stream bank scour or erosion. The gradient of the reconstructed channel is 5%, no difficulties for upstream fish passage through the area of reconstructed stream channel under the bridge where the culvert used to lay. Access to this stream from the Telkwa River can be difficult or impossible during periods of low flow in the Telkwa. Fish access into the unnamed stream at kilometer 19.3 is much more likely during higher flow conditions. A single DV/BT approximately 170mm long was observed in a stream pool located approximately where the old culvert outlet used to be. Other sampling conducted on this stream reach for Fish Passage Culvert Inspection purposes about 250m upstream captured only DV/BT. Although we wished to sample further in this reach to get a better indication of fish species present and overall fish densities, the unusually low water levels prevalent in the summer and fall of 2006 made this objective impossible. Determining coho presence/absence and fish densities overall in the reach between the Telkwa River confluence and the 119 Road crossing approximately 250m upstream would still be a worthwhile objective. If funding is available in 2007/2008, the previously discussed objective should be pursued for this site with a follow-up effectiveness evaluation in 2007.</p> | | | | | | | | | | | | | | | | | | | | | | | | |

Site 19.3km Telkwa. Downstream view of reconstructed channel under bridge installed in 1999.

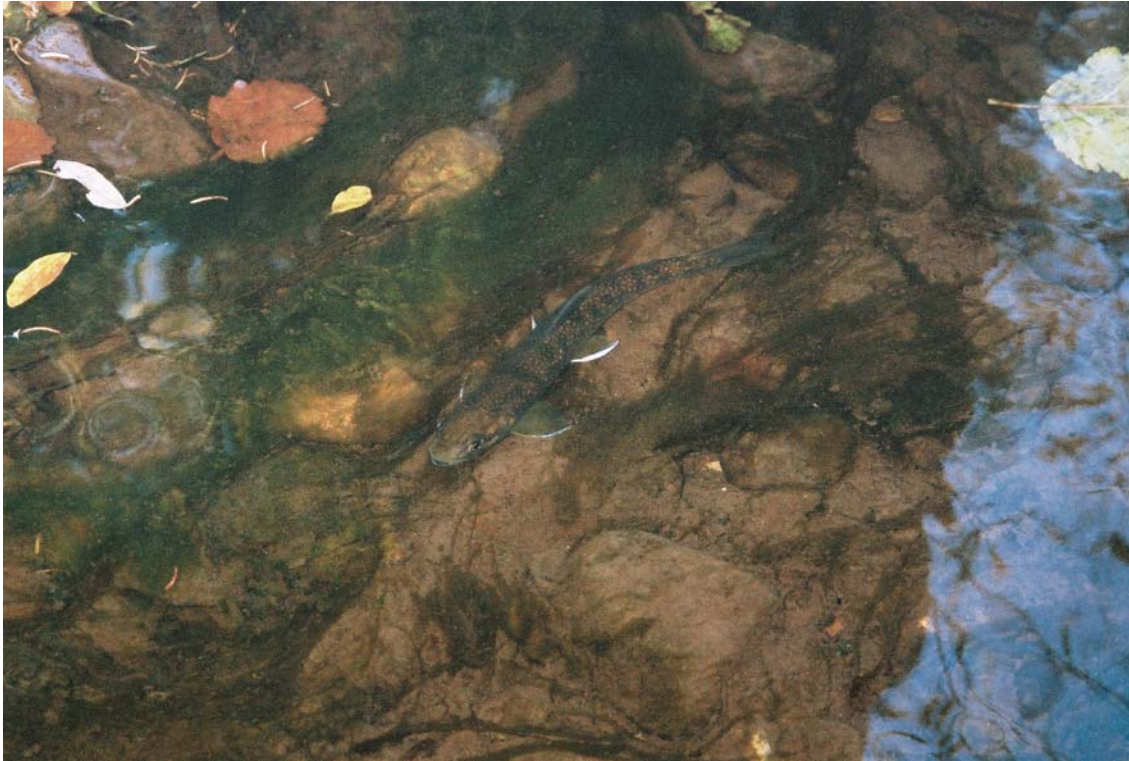
Site 19.3km Telkwa. 170mm BT/DV in pool under bridge.

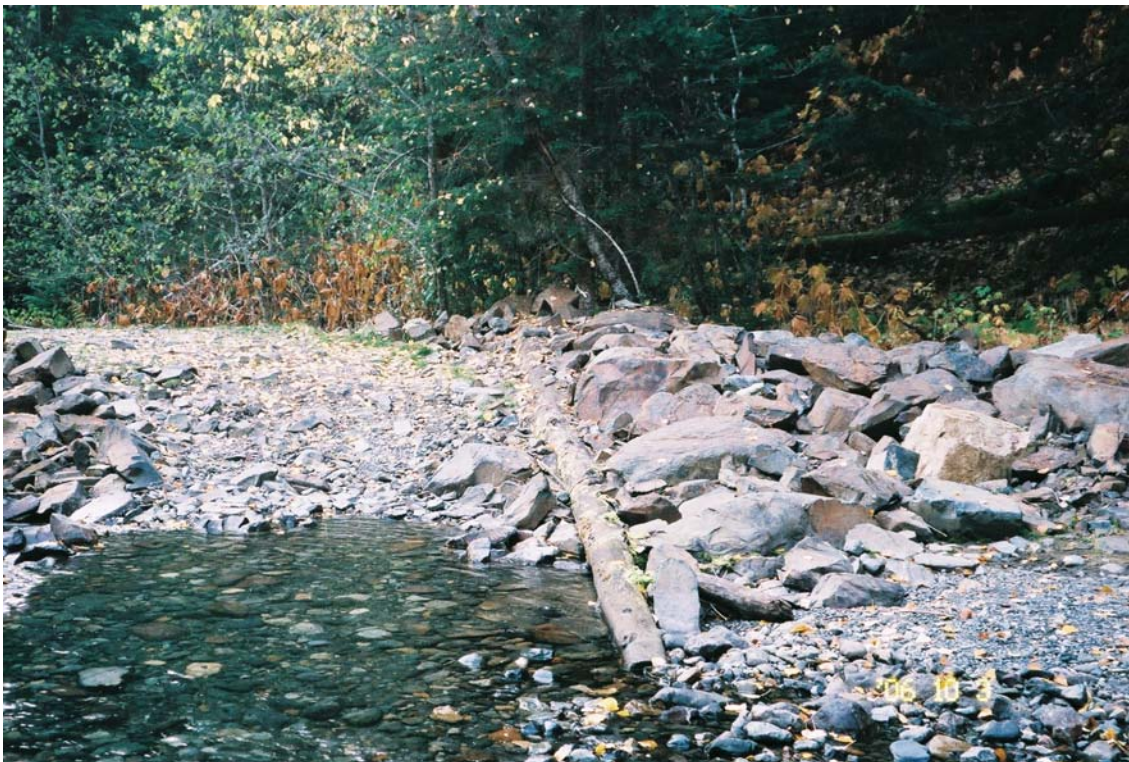
| SITE DESCRIPTION | | | | | PERFORMANCE OBJECTIVES | | | | | | | | | | | | OVERALL | | | | | | | | |
|---|---|---|---|---|---|---|---|---|---|---|---|---|---|---|---|---|---|---|---|---|---|---|---|---|---|
| Comments: | The ford across Toboggan Creek was constructed in 2000, only on the empty side approach, under the Watershed Restoration Program (WRP) of Forest Renewal BC (FRBC). Concerns by DFO over downstream impacts to fish habitat prevented the completion of any in-stream works or works on the loaded side approach to the stream crossing. The ford works on the empty side approach are holding up well. Rip-rap used to construct the empty side berms and ford approach has not been displaced. The log deflector on the upstream side of the empty approach is still in place and functioning as intended. There is no evidence of rip-rap being washed downstream. The empty side works (berms and ford approach) have so far been completely effective at keeping Toboggan Creek flowing in the primary channel and preventing it from jumping onto the road on the empty side approach. There is some indication that during peak flows minor amounts of water may overtop the berm at the ford approach and run down the road on the empty side for approximately 200m before running downhill off the road. There appears to be some scour of the road surface due to this seasonal overflow. It would be prudent to re-evaluate this site on an annual basis and establish permanent photo points to record changes overtime due to the high energy characteristics of Toboggan Creek. | | | | | | | | | | | | | | | | | | | | | | | | |

Toboggan Creek Site. Empty side ford approach at Toboggan Creek crossing with log deflector in place.
