# Lower Skeena Fish Passage

Closed Bottom Structure Assessments 2009

Prepared by Shauna Bennett, RP Bio

Coast Tsimshian Resources Ltd., Terrace, BC

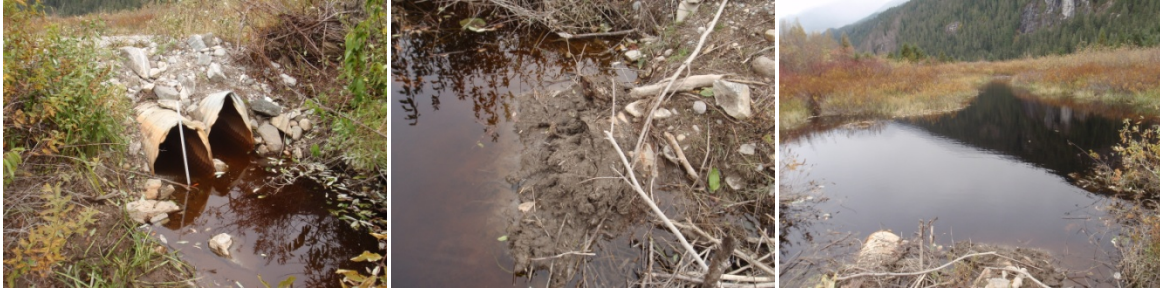
In several cases, an OBS has been recommended for replacement of the existing CBS below an active beaver pond (e.g. EX004). Replacing the existing structure with an OBS will likely cause a loss of pond habitat upstream. The trade-off between gaining fish passage and loss of pond habitat must be considered carefully in each case.

Crossing ID	Location	Notes	FPCA Result	Habitat Value	Fish Sighted?	Fish Habitat Gain (m)	Dnstrm Crossings & ID	Beaver Activity	Channel Width (m)	Valley Fill	Proposed Solution
EX004	9U 494953 6031090	2 culverts plugged solid with beaver dam debris. Active beaver pond upstream. Culvert slope measured from top of culvert (intakes buried in mud). Coho fry inside culvert.	21,Barrier	High	Yes	500*	0	Yes	5	DF	OBS, 7m span
EX005	9U 495007 6031097	Intake completely plugged with beaver debris. Minimal flow. Drains same pond complex as Exstew004. Recommend clearing culvert, install beaver cage. Culvert sloping upward.	21,Barrier	High	No	500*	0	Yes	2	DF	OBS, 4m span
EX007	9U 496207 6030378	2 culverts. Left is set lower at outlet but inlet is bent upwards causing more water to flow into right culvert. Both inlets partially plugged with small woody debris. Large outlet pool, good habitat. Gradient increases upstream to 10%+	31,Barrier	Mod.	No	100*	0	No	5	SF	OBS, 9m span

Figure 2. Crossing structure EX004, the culvert outlets (left) and inlets (middle) and upstream (right).

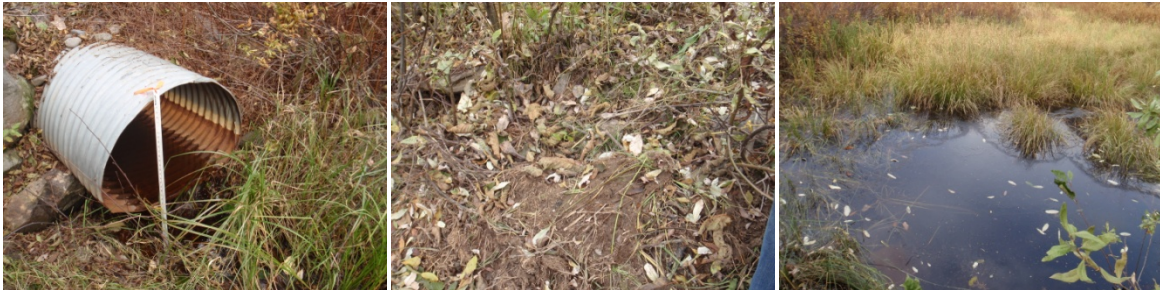
Figure 3 Crossing structure EX005, the culvert outlet (left) and inlet (middle) and upstream (right).

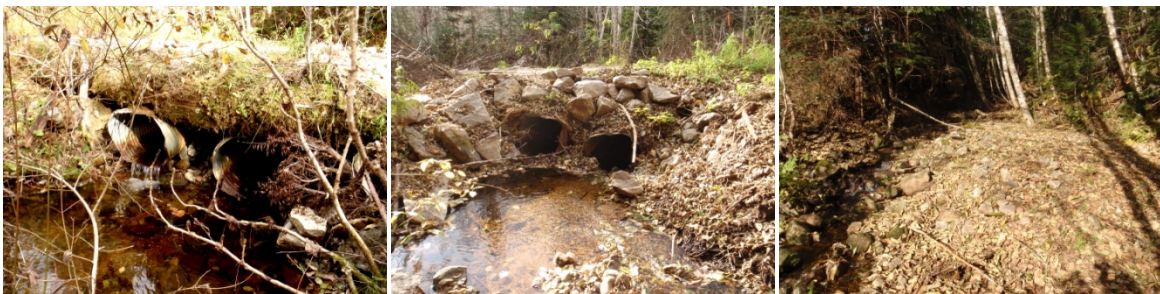
Figure 4. Crossing structure EX007, the culvert outlets (left) and inlets (middle) and upstream (right).

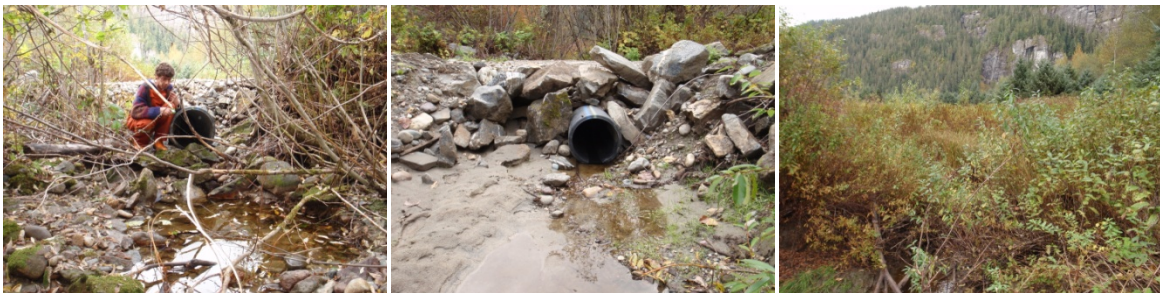
Figure 5. Crossing structure 377319, the culvert outlet (left) and inlet (middle) and upstream (right).

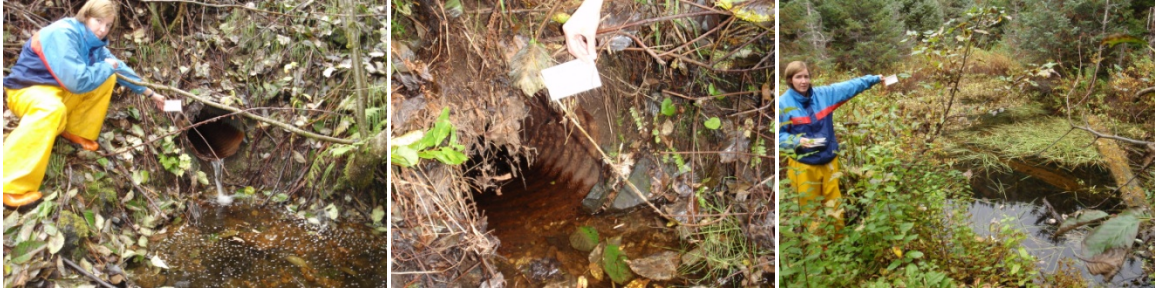
Figure 6. Crossing structure 377276, the culvert outlet (left) and inlet (middle) and upstream (right).

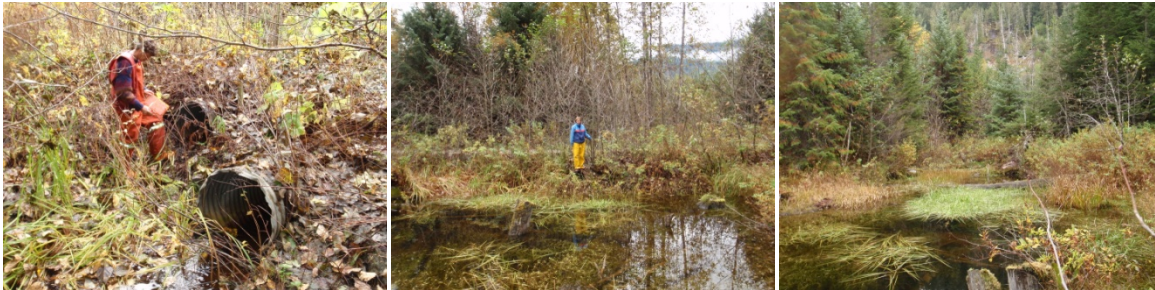
Figure 7 Crossing structure 377279, the culvert outlets (left) and inlets (middle) and upstream (right).

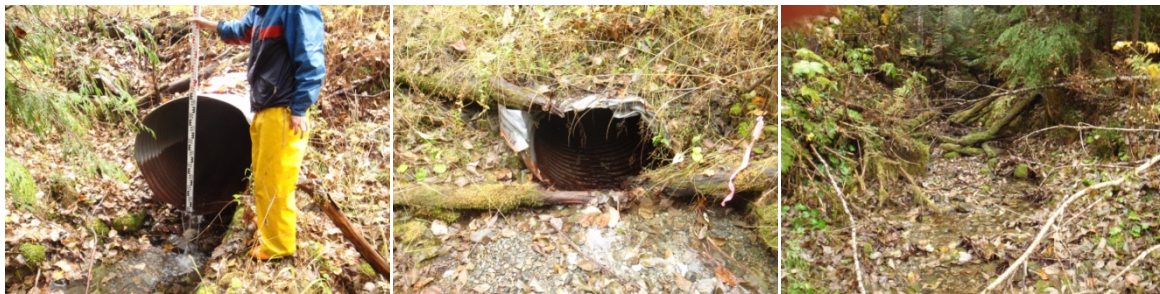
Figure 8 Crossing structure 377334, the culvert outlet (left) and inlet (middle) and upstream (right).

Crossing ID	Location	Notes	FPCA Result	Habitat Value	Fish Sighted?	Fish Habitat Gain (m)	Dnstrm Crossings & ID	Beaver Activity	Channel Width (m)	Valley Fill	Proposed Solution
377334	9U 511506 6029684	Culvert inlet crushed in, very low flow. Inlet drop caused by debris jam.	36, Barrier	Mod.	No	417	377336, NCS	No	4.6	DF	OBS, 7m span
378013	9U 518490 6034757	Intake is plugged with beaver dam debris, non-functional beaver cage at inlet. Dense over stream vegetation downstream (alder, willow). Stream flows through private land d/s, may be crossing structure present.	21, Barrier	Mod.	No	3129	unknown - private land	Yes	2	DF	OBS, 4m span
378137	9U 498353 6025948	Dry channel, only a bit of rust in culvert. Stream runs down ditch for 60m and then through culvert. Stream 7% upstream. Bystander (and previous MOE employee) said Coho used to use stream 10 years ago.	36, Barrier	Mod.	No	163	377377 - NCS, hydro line	No	3	SF	OBS, 5m span

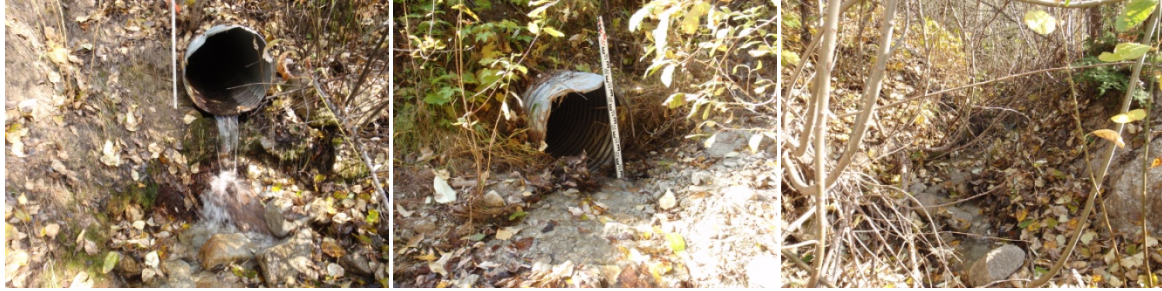
Figure 9 Crossing structure 377970, the culvert outlet (left) and inlet (middle) and upstream (right).

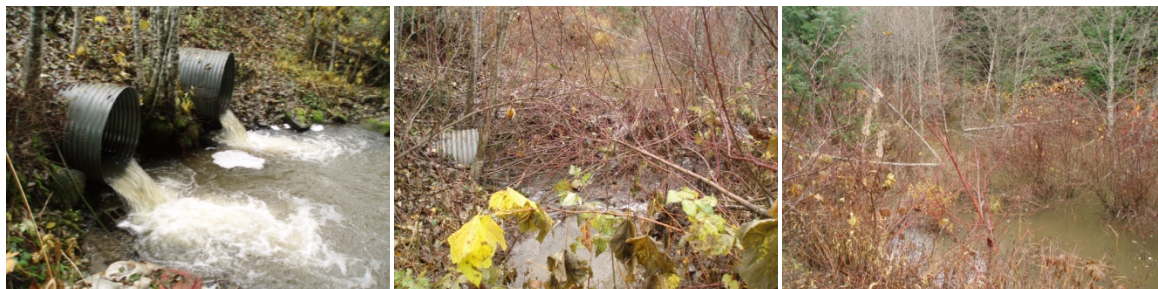
Figure 10 Crossing structure 378014 on Matson Rd., the culvert outlets (left), inlets and beaver dam (middle), and upstream (right).

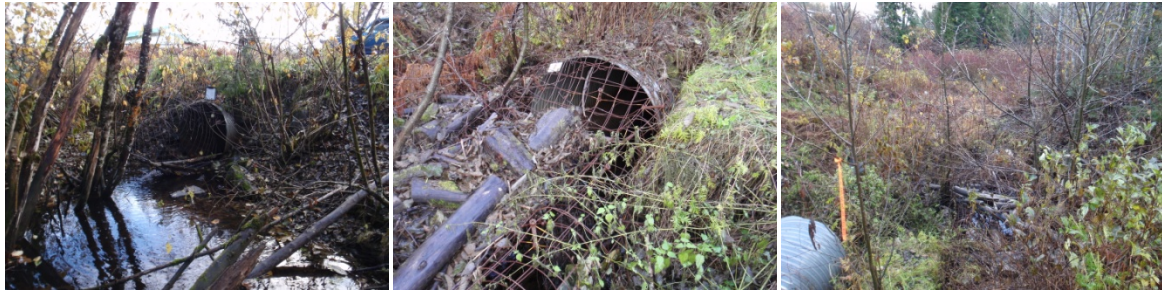
Figure 11 Crossing structure 377977 on Kozier Rd., the culvert outlet (left), inlet (middle), and upstream (right).

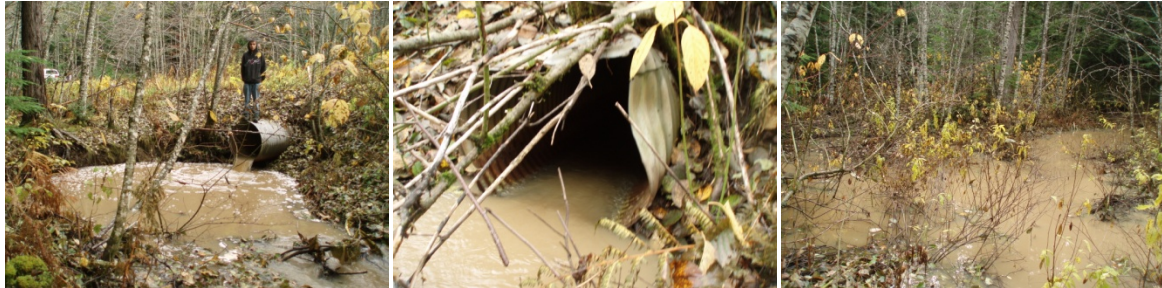
Figure 12 Crossing structure 378039 on Matson Rd., the culvert outlet (left), inlet (middle), and upstream (right).

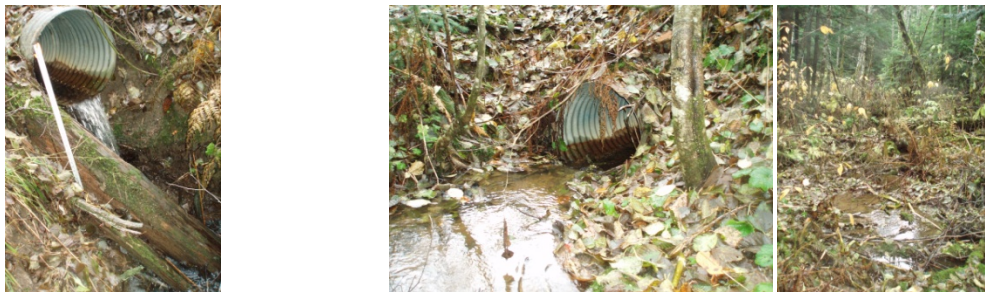
Figure 13 Crossing structure AL002 on Matson Rd., the culvert outlet (left), inlet (middle), and upstream (right).

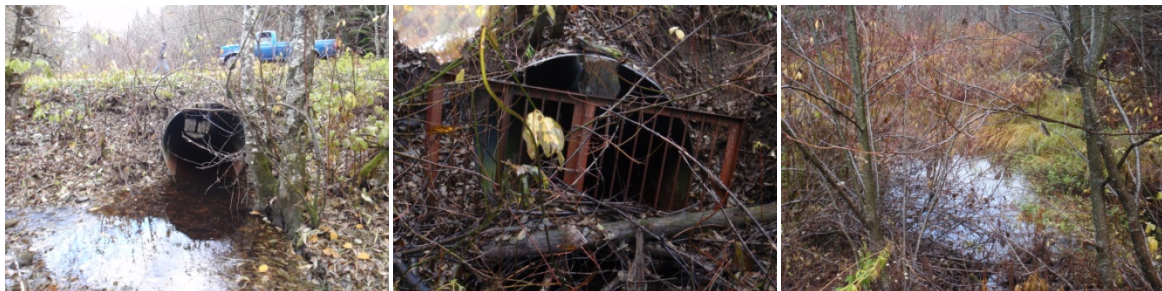
Figure 14 Crossing structure 377968 on Old Remo Rd., the culvert outlet (left), inlet (middle), and upstream (right).

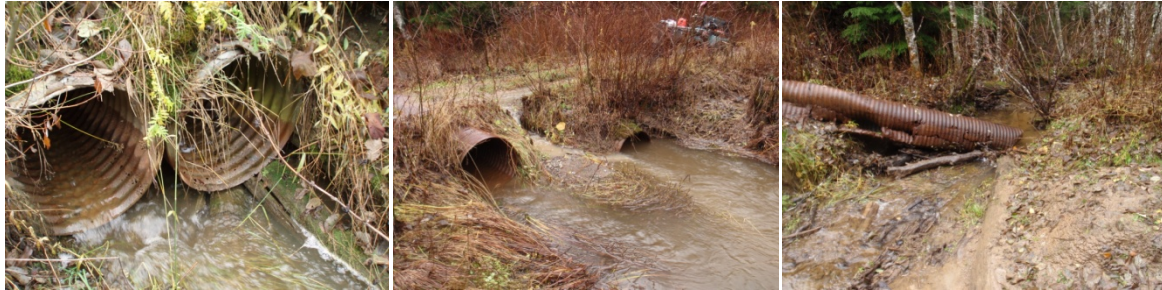
found sitting in the stream, likely the result of a wash-out from an unmaintained crossing. This structure should be removed. The three structures proposed for removal are shown in Figure 15. The highest priorities of the three are 378019 and 378034.

**Figure 15. Crossing structures along the hydro line which should be removed or replaced with OBS. (378044 is shown on the left, 378019 is in middle and 378034 is shown on the right).**

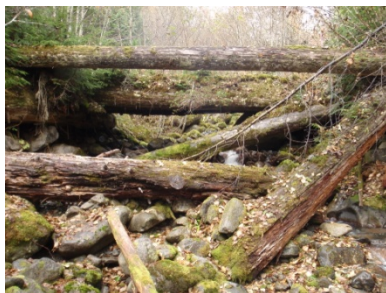
**Figure 16** Old collapsing bridge across Delta Creek (crossing structure 378065)

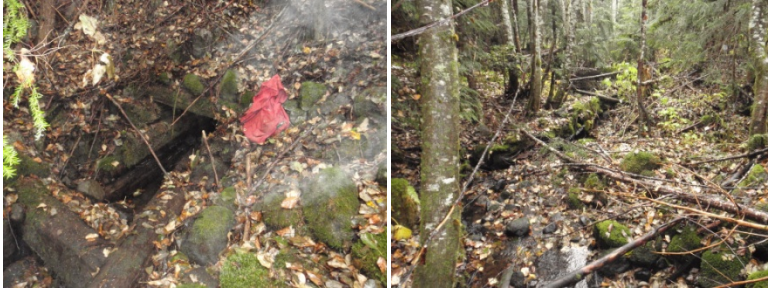
Figure 17. Collapsing WBC creating a 1 meter fish barrier (left) and upstream habitat (right). Crossing structure 377976 on unnamed creek east of Amsbury Creek.

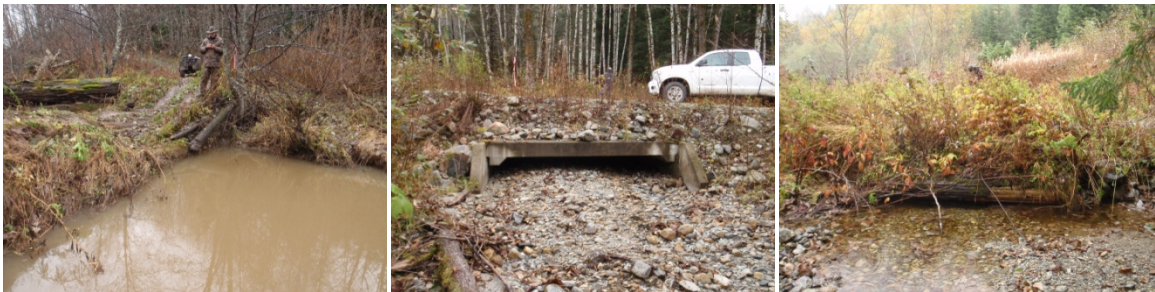
Figure 18 WBC in poor condition. Crossing 378021 (left), DAS010 (middle) and WB006 (right). DAS010 and WB006 are nearly blocked with alluvial deposits resulting in poor fish passage conditions.
