Upper Bulkley Riparian Restoration

November 2022

Prepared For: Morice Watershed Monitoring Trust

Prepared By: Adam Wrench, Northwest Research and Monitoring Ltd.

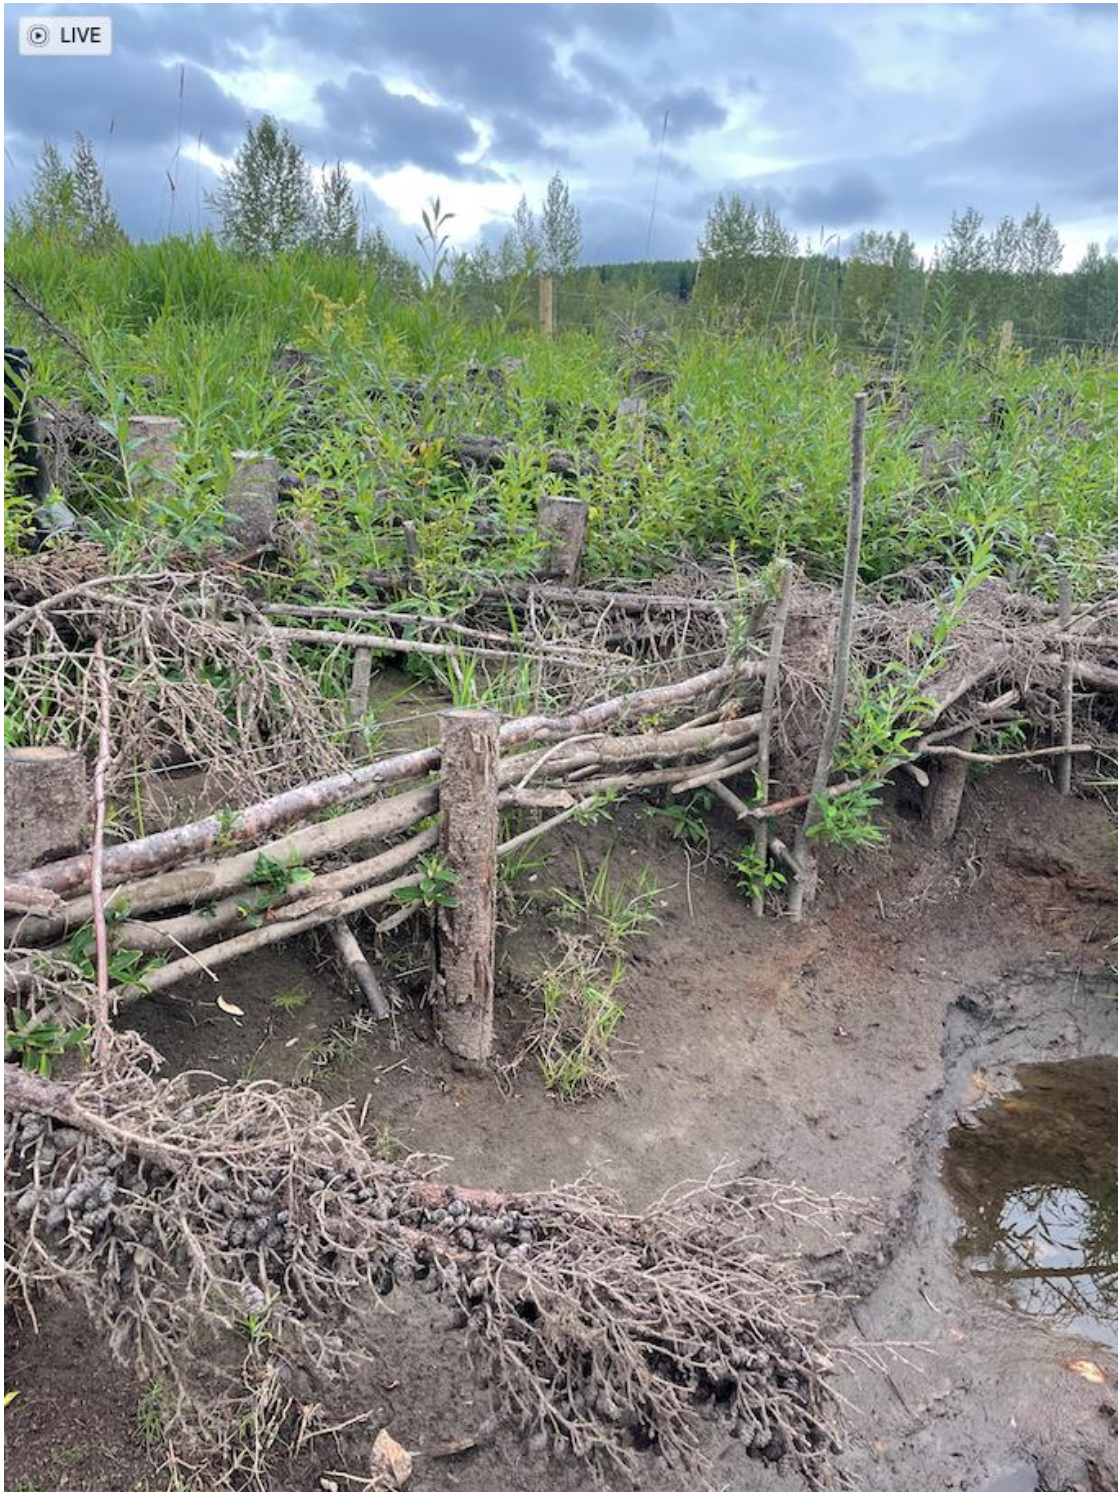
Some amount of re-grade by river erosion occurred, causing some undercutting of the 2021 installation (Figure 2). The result was the creation of unprotected void space with little interaction with the river. As a result, the 2021 project supervisor prepared a restoration prescription for the site that was followed during site repairs in October 2022 (see Section 4).

Figure 2: Photo showing undercutting at Dickson site.

Some low-tech touch up work was required to address the erosional issues noted at the two sites on the Dickson property. Low-tech methods using live willow and woody debris were employed to armour the eroding areas. Figure (3), illustrates the general approach taken to address the erosional sites.

Vertical fascines, consisting of approximately 4-6 individual dormant willow cuttings were partially buried along the face of the erosional zone. The fascines were staked into place with angled live stakes pounded in using a gas-powered hand-held post pounder. Individual willow stems were then woven horizontally across the face with lateral branches attached to maximize roughness. Along the toe at the lower site, a horizontal fascine was partially buried to take the brunt of the erosional force. The upper site did not allow for placement of a horizontal fascine at the toe due to the undercutting clay shelf and water depth. Void spaces underneath the 2021 spruce tops were filled with large woody debris and pressured in with live willow stems. Overall, the goal was to armour the bare soils with rough woody debris and establish live material at very high density in the problem zone.

All works were completed using hand tools and labour over a period of three days. Bare soils at each site are now protected by woody debris, pressured into the existing vertical structure at the site. We felt we did about all that could be practically achieved using willow and hand tools.

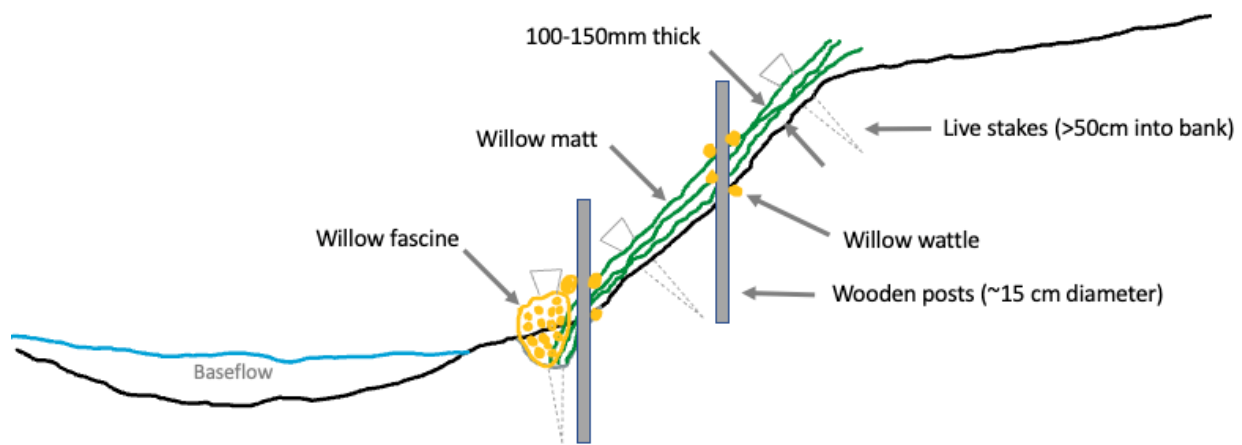
Figure 3: Restoration prescription to address erosional issues at Dickson property sites.
