FISH PASSAGE CULVERT INVESTIGATIONS 2014

Babine TSA

Prepared By: MarLim Ecological Consulting Ltd.

February 2015

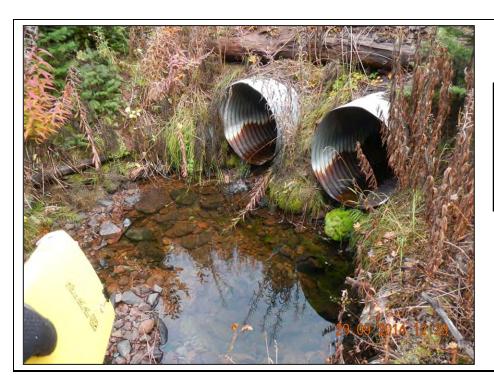
Photo 10: M14-050

Description: Outlet

The stream had an average channel width of 2.80m and a gradient of 9.0%. The outlet pool depth was 0.31m. There was no presence of beaver activity at this site and no fish were observed. The valley fill at the site was deep and it was determined that this stream had high habitat value.

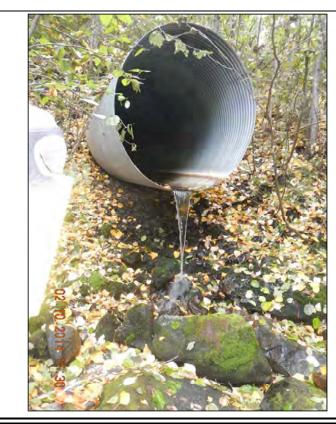
Photo 22: M14-064

The stream had an average channel width of 1.72m and a gradient of 11.0%. The outlet pool depth was 0.16m. There was no presence of beaver activity at this site and no fish were observed. The valley fill at the site was shallow and it was determined that this stream had medium habitat value.

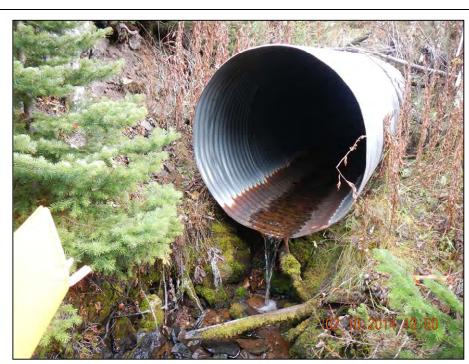
MAP No.: 284724 MARLIM No.: M14-099

Description: Outlet

The stream had an average channel width of 2.26m and a gradient of 6.0%. The outlet pool depth was 0.12m. There was no presence of beaver activity at this site and no fish were observed. The valley fill at the site was deep and it was determined that this stream had high habitat value.

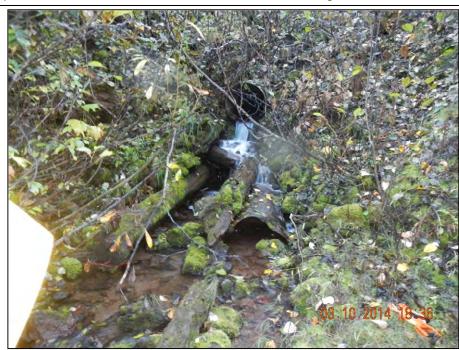
<u>MAP No.</u>: 284699 <u>MARLIM No.</u>: M14-206

Description: Outlet - both.

The stream had an average channel width of 2.13m and a gradient of 7.0%. The outlet pool depth was 0.38m. There was no presence of beaver activity at this site and no fish were observed. The valley fill at the site was deep and it was determined that this stream had medium habitat value.

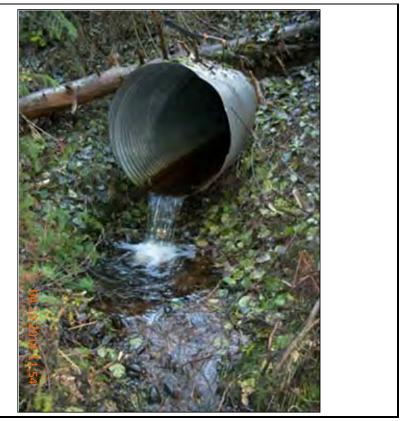
Photo 46: M14-249

The stream had an average channel width of 1.50m and a gradient of 13.0%. The outlet pool depth was 0.33m. There was no presence of beaver activity at this site and no fish were observed. The valley fill at the site was deep and it was determined that this stream had high habitat value.

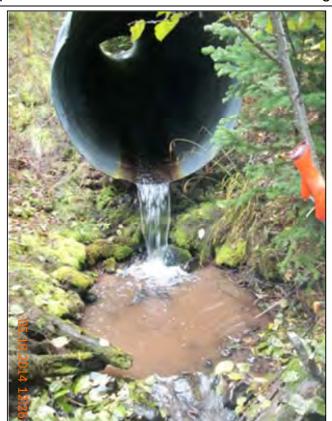
Photo 51: M14-254

The stream had an average channel width of 1.63m and a gradient of 13.0%. The outlet pool depth was 0.52m. There was no presence of beaver activity at this site and no fish were observed. The valley fill at the site was deep and it was determined that this stream had medium habitat value.

It is recommended that the current culvert be replaced with an open bottom structure with a minimum span of 1.50m, and the channel at the crossing site be restored.
