The purpose of this report is to present background information and results from effectiveness evaluations conducted on instream structures, riparian, road deactivation, and stream crossing works that were installed between four and eight years ago by watershed restoration programs. In 2006, Gitksan Watershed Authorities was retained by the Pacific Salmon Commission to conduct a effectiveness monitoring in three Mid Skeena sub-basins: the Kispiox, Kitseguecla, and the Suskwa.

This watershed restoration effectiveness monitoring assessment is part of a larger regional effort to ensure treatment designs and their applications are effective, and if not, provide technical feedback to refine designs. As well, the evaluations will rate the extent of watershed recovery achieved and help to ensure funds are spent on the most cost-effective treatments.

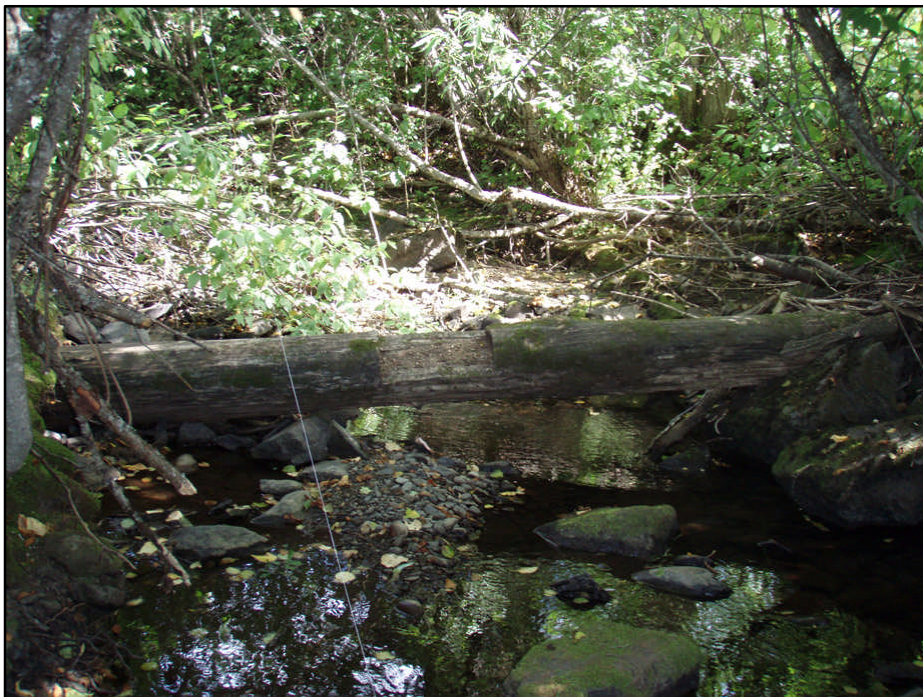
In 1997, baffles were re-installed in the culvert to lessen the culvert discharge velocities, a log weir was installed 30 m downstream of the culvert to decrease the culvert outfall drop, and a log deflector was installed 45 m downstream of the culvert to deflect the stream away from the eroding left bank. These completed site works are reported in Wadley and Wiley (1997). These installations were largely ineffective in dealing with the problem, which as noted above, is the undersized culvert.

**Figure 5. Notched weir log 15 m downstream of culvert.  
40 cm log was installed in 1997 to increase height of outfall drop pool.**

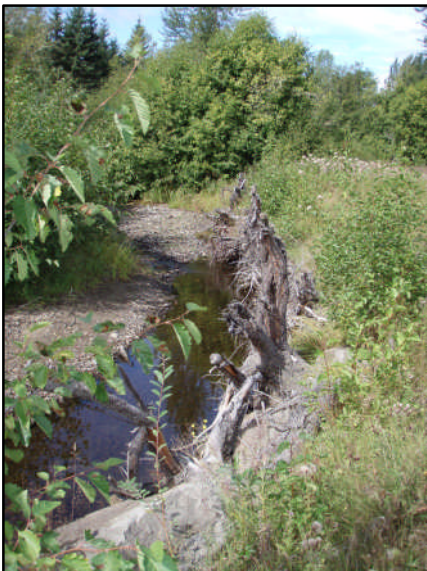
Figure 6. View upstream at P8-1.

All structures site and conditions at site P8 remain integral and are achieving the restoration objectives of channel and bank stabilization. A functional riparian zone is slowly growing in and beginning to function.

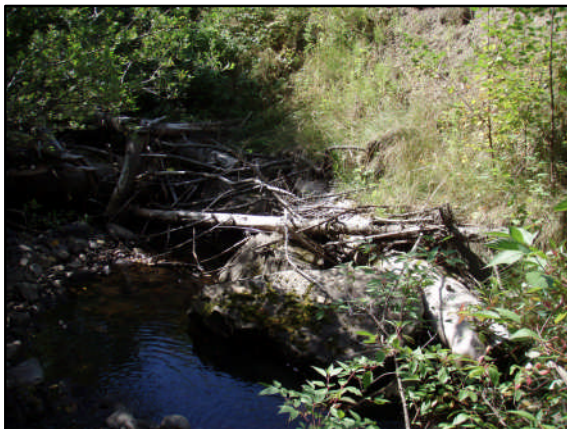
Figure 16. Site P-6 view downstream.

The log cluster has worked out exceptionally well in achieving the objective of stabilizing the stream channel, and as well, providing cover and promoting riparian growth. The structure is integral and in excellent condition. Material recruited to the site is also performing well. When the Kispiox Trail culvert is replaced with a bridge or open bottom structure, this installation will require monitoring.

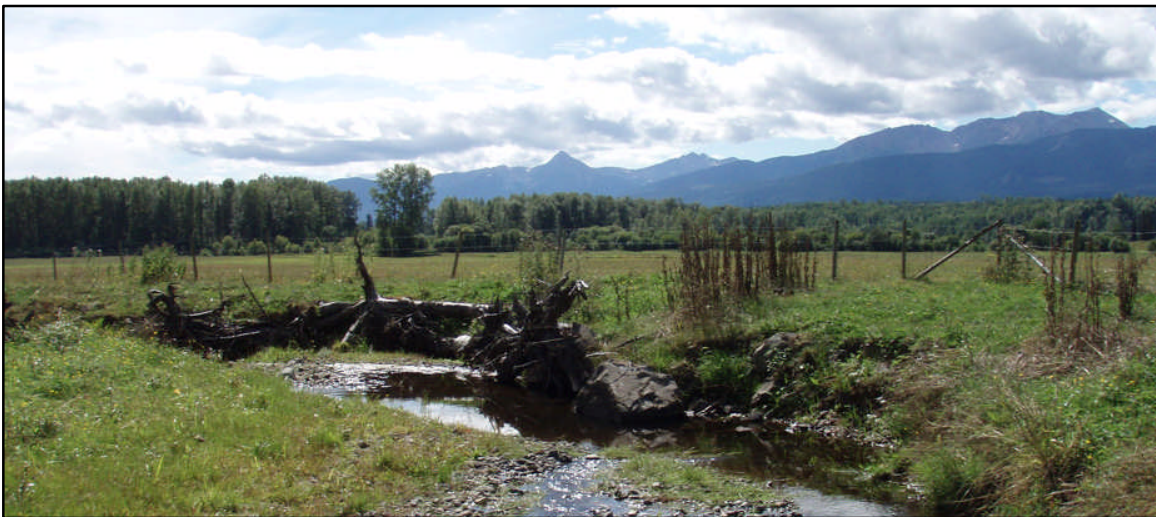
Figure 20. View downstream to Site P-2.

The Site P-2 restoration installation is achieving its objectives of reducing bank erosion, creating instream habitat, and reducing water velocity. All structural components are integral with no sign of instability. There is minor bank erosion upstream of the installation as seen in Figure 31. It is recommended that angular rock could be hand-placed at this point for 4-5 m upstream to reduce any erosion in high flow events.

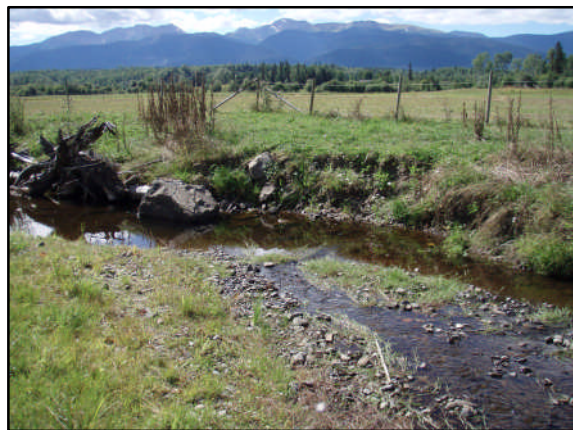
**Figure 26. View of bank erosion at upper end.**

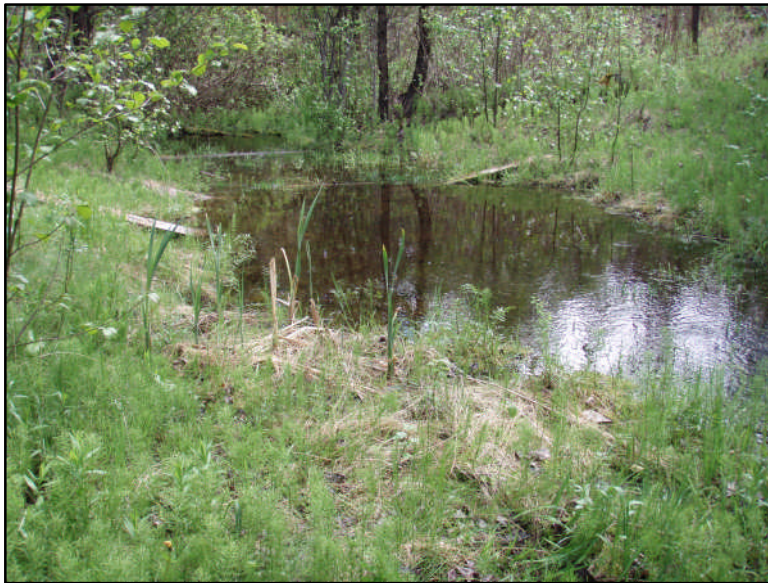
Significant road deactivation has been conducted throughout the drainage and monitoring revealed a few excellent examples of wooden box culverts removal where material was placed instream to provide cover and general stream complexing as shown below.

Figure 35. Deactivated wooden box culvert on Corral Creek tributary.

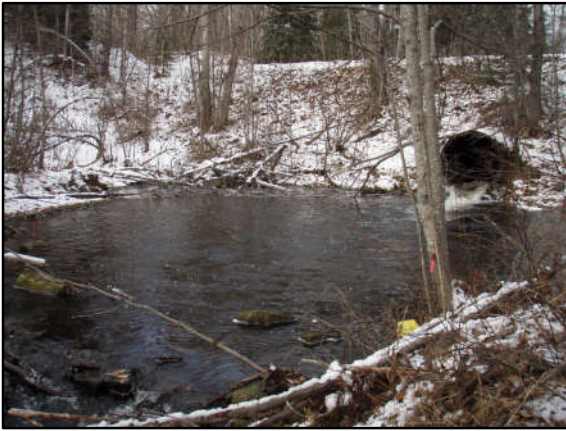
Figure 36. Clifford Creek outlet pool.

Observations in 2006 indicate that the weir is not beneficial to raising the outlet pool depth, nor is it acting as an effective component in establishing a downstream scour pool. It is likely that the weir has degraded since installation in 1996 due to the excessive culvert velocities and the relatively small size of boulders utilized. Typical weirs or berms to backwater culverts built in this area degrade relatively quickly and do not provide moderate to long-term fish passage solutions.

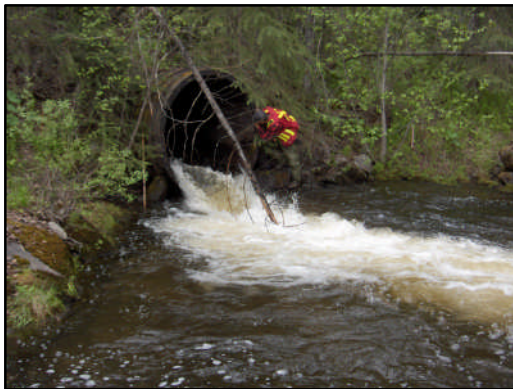
The Kispiox Trail crosses Skunsnat Creek at approximately 70.3 km. Since the early 1960s when the culvert was installed there have been recurring fish passage problems and implementation of short-term solutions. Baffles were first installed in 1965 to assist fish in low and high flows; as well, it was recommended that the culvert be replaced by a bridge (DFO 1966, Hancock *et al.* 1983). The fish ladder below the road crossing washed out in the October 1978 flood; a jump pool was constructed in 1979 by Department of Highways; and baffles needed to be replaced in 1981 (Hancock *et al.* 1983). Metal baffles were installed in 1998, but proved largely ineffective in slowing culvert water velocities.

**Figure 53. Skunsnat Creek culvert outlet.**  
View of outlet from downstream with velocities over 3.1 m/s.

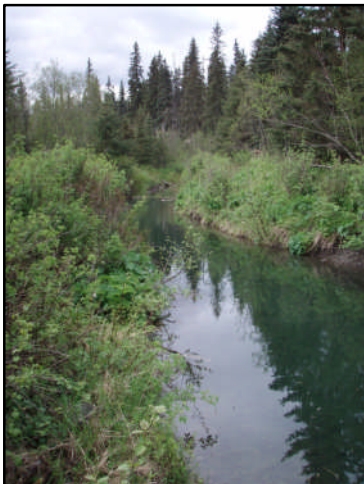
**Figure 58. View southward on east channel.**

This restoration effort suffers from a lack of site suitability, conceptual planning, and adult recruitment. The site should have been initially monitored with test pits that would indicate ground water DO levels, temperature regime, and seasonal water quantities. It is recommended that the site be abandoned.

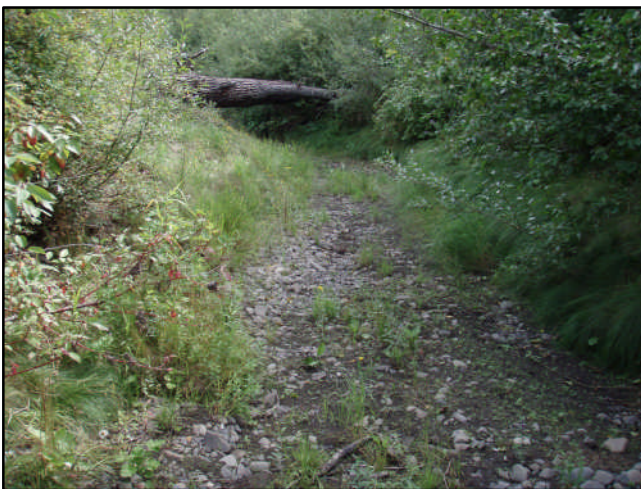
**Figure 62. View shows Cullon ground channel at the upper end.**

Overall, the conceptual design and site suitability for this project are rated poor. Critical physical characteristics needed such as appropriate DO levels and in-flowing water reflect poor planning. It is recommended that the site be abandoned.

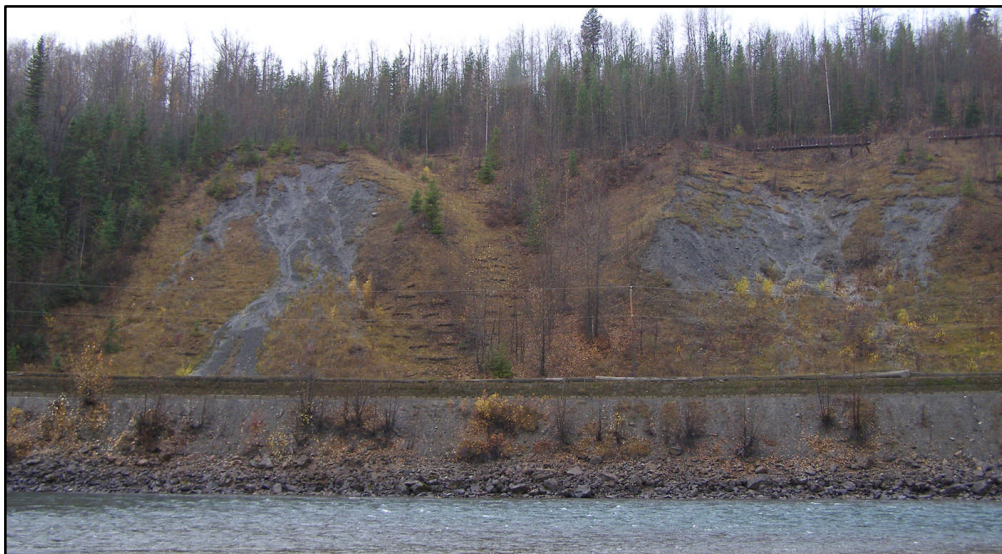
Evaluation results indicate that the seepage zones located high on the hillslope need to be drained by mechanical or bioengineering methods if full restoration is to occur. It is recommended that a rock filled drainage ditch that directs water to the side of the slide and into the gullies with rock blankets installed over the seepage zones and applied from the CN Rail grade would likely be successful in stabilizing the slope. Future bioengineering projects could benefit from the addition of fertilizers or manure.

**Figure 71. Photo shows the two areas of chronic wasting that need to be drained and rock blanketed.**

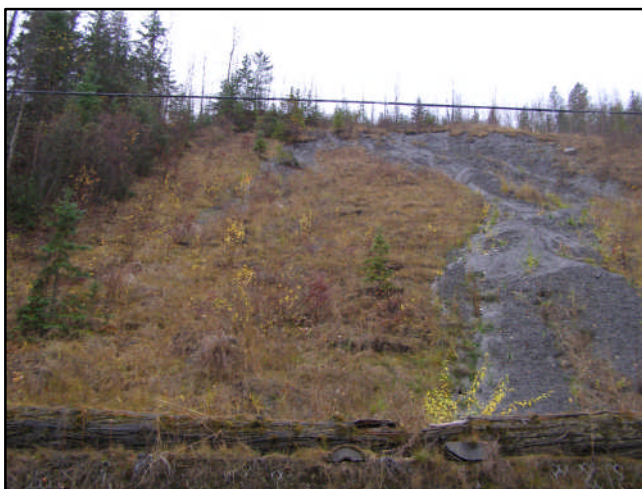
**Figure72. Photo shows drainage berm at the bottom and stabilized and failed brush layer areas.**

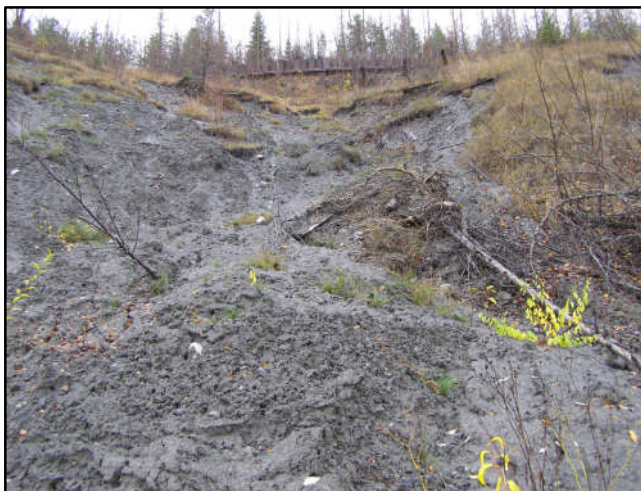
**Figure 77 . Wasting in Area #4.**

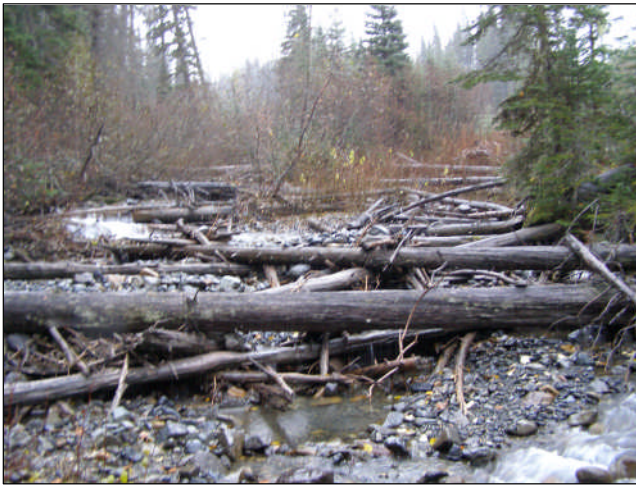
**Figure 91. View upstream on Thirty Mile Creek 330 m from road.**

Investigations for this evaluation could find no trace of any deflector logs. This high energy creek has a relatively large amount of windblown trees strewn across it for approximately 700 m upstream of the Grizzly Main FSR, and as a result, multiple channels have formed. The following photos show the amount and frequency of the LWD. Further restoration efforts at this site should be abandoned.

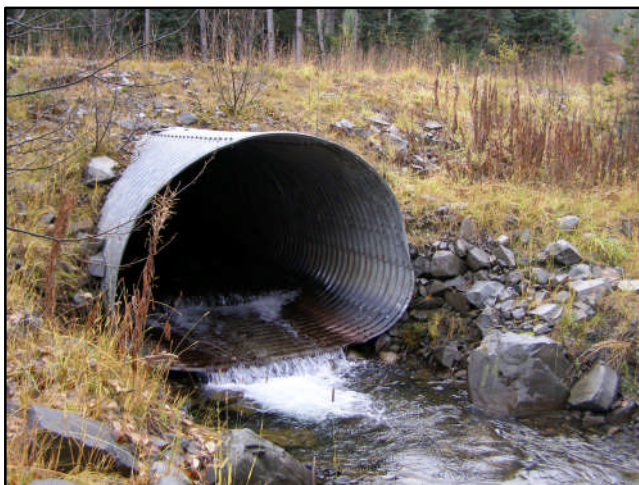
This effectiveness evaluation found high elevation, low quality habitat with 1.3 m falls and shallow, swift flows upstream and downstream of the culvert. The stream gradient upstream for approximately two km averages 14%. Currently Dolly Varden and bull trout are negotiating the 1.3 m falls framing the crossing site. Currently the culvert outfall drop is 15 to 20 cm depending on water levels. Velocities range from 0.85 to 2.13, again depending on flow levels. The outlet pools have been scoured out by high flows and don't function as step pools presently. Our recommendation is to install an open bottom structure, be it a culvert or bridge.

Figure 94. Side view shows 17 cm culvert outfall drop.

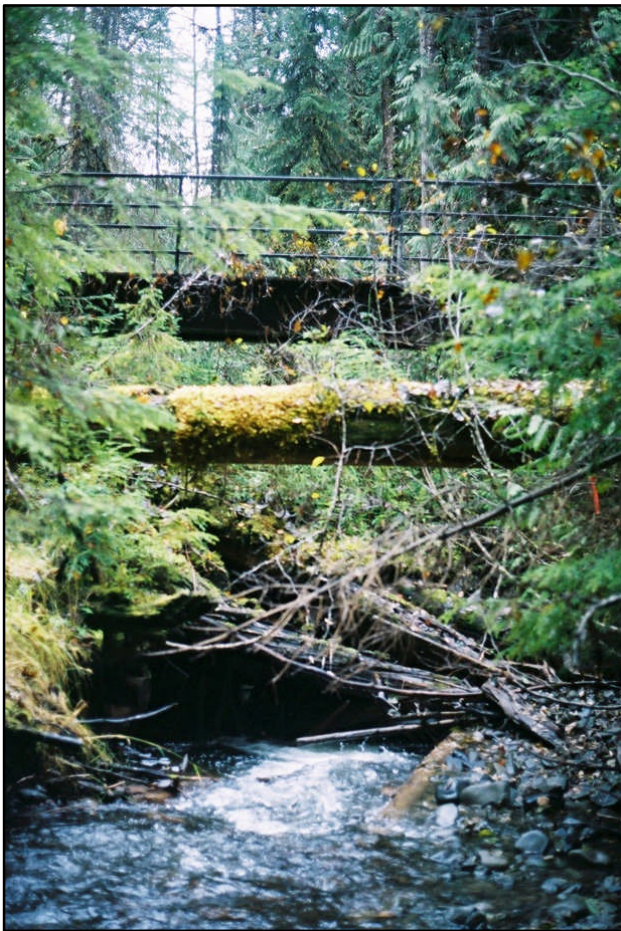
At some point in the near future, the old crossings will sink into the channel and exacerbate the bank failures that have occurred in the past. The ATV bridge instalment indicates poor planning and conceptual development. It is recommended that the ATV bridge be pulled, the old crossing structures be pulled out of the channel and the ATV bridge be repositioned. The streambank failures need to be assessed by a geomorphologist in regard to drainage and stabilization.

Figure 95. View downstream of collapsed structures.

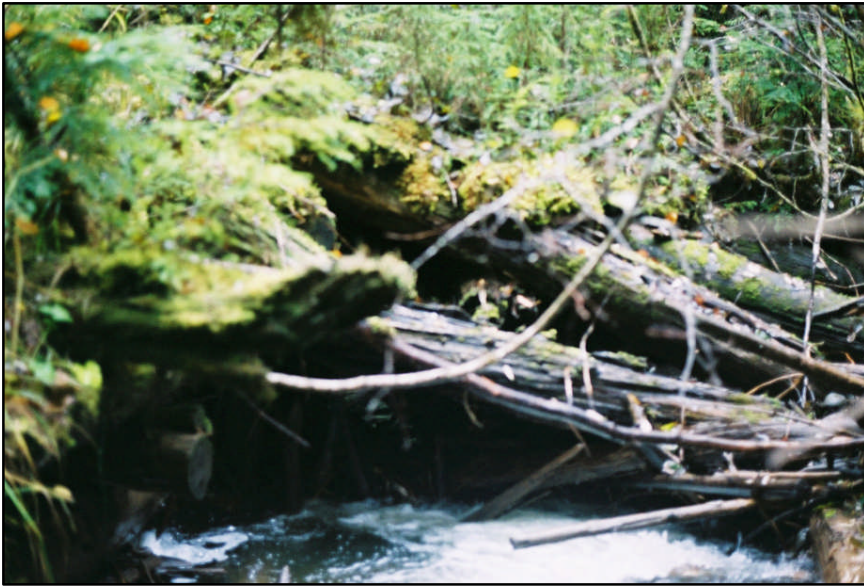
Figure 96. Close view downstream of collapsed structures Fifteen Mile Creek.

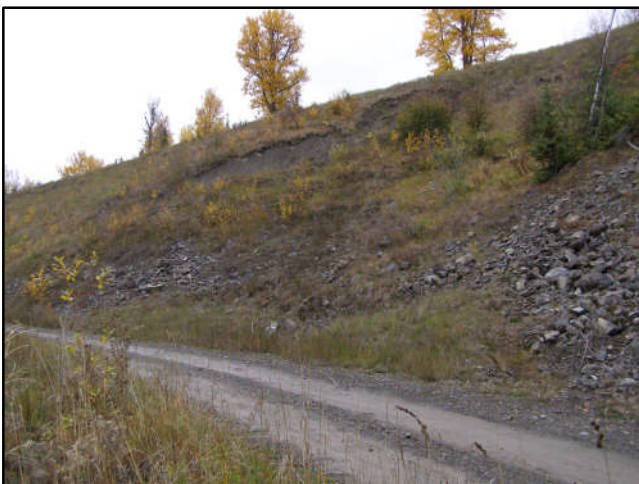
being ravelling. On Slide 3, the upper, northern portion has experienced light slumping. The southern portion of Slide 4 and Slide 5 are experiencing active wasting and the live pole drains are no longer functional. These sections need to be reconstructed and then maintained. We recommend a hydrologist visit the site and make recommendations on potential drainage solutions that may be an opportunity upslope of Slides 4 and 5. If drainage solutions aren't apparent, we recommend installing a rock blanket the lower portion of Slide 5 and the southern lower section of Slide 4. Overall, this effectiveness evaluation rates the site as fair to good.

**Figure 108. View up Kitseguecla FSR and the upper, northern portion of Slide 3. Note minor slumping above rock blanket.**

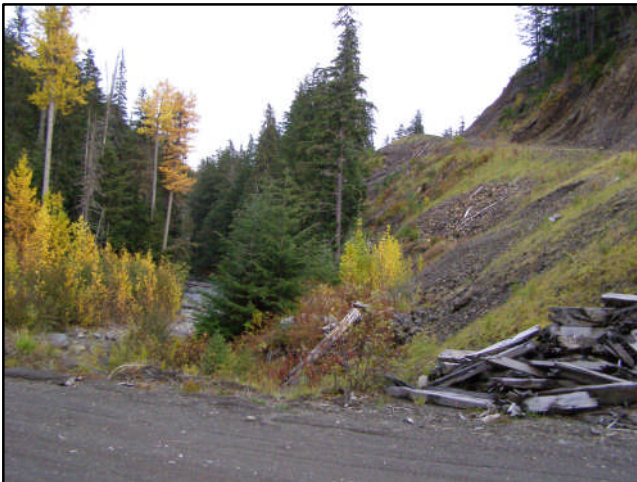
This effectiveness evaluation noted that while some areas appeared to be stable and sediment production was quiescent, instability is an ongoing problem. An overall sediment source and production investigation that includes surface erosion potential and sediment transfer capability should be commissioned with sufficient resources to plan and implement appropriate restoration activities as needed.

**Figure 111.** View downstream from bridge on West Kitsuns Creek. Slim Jim Road (aka: W7 Branch, Kitsuns 701) ascends the hill on the right. Much of the right streambank has slid into the creek and was subsequently covered with rock blankets.
