Richfield Creek Riparian Fencing Installation Report 2021

Prepared For:
Department of Fisheries and Oceans Canada
&
Society for Ecosystem Restoration in Northern British Columbia

Prepared By:
Adam Wrench B.NRSc. on behalf of
Northwest Research and Monitoring Ltd.

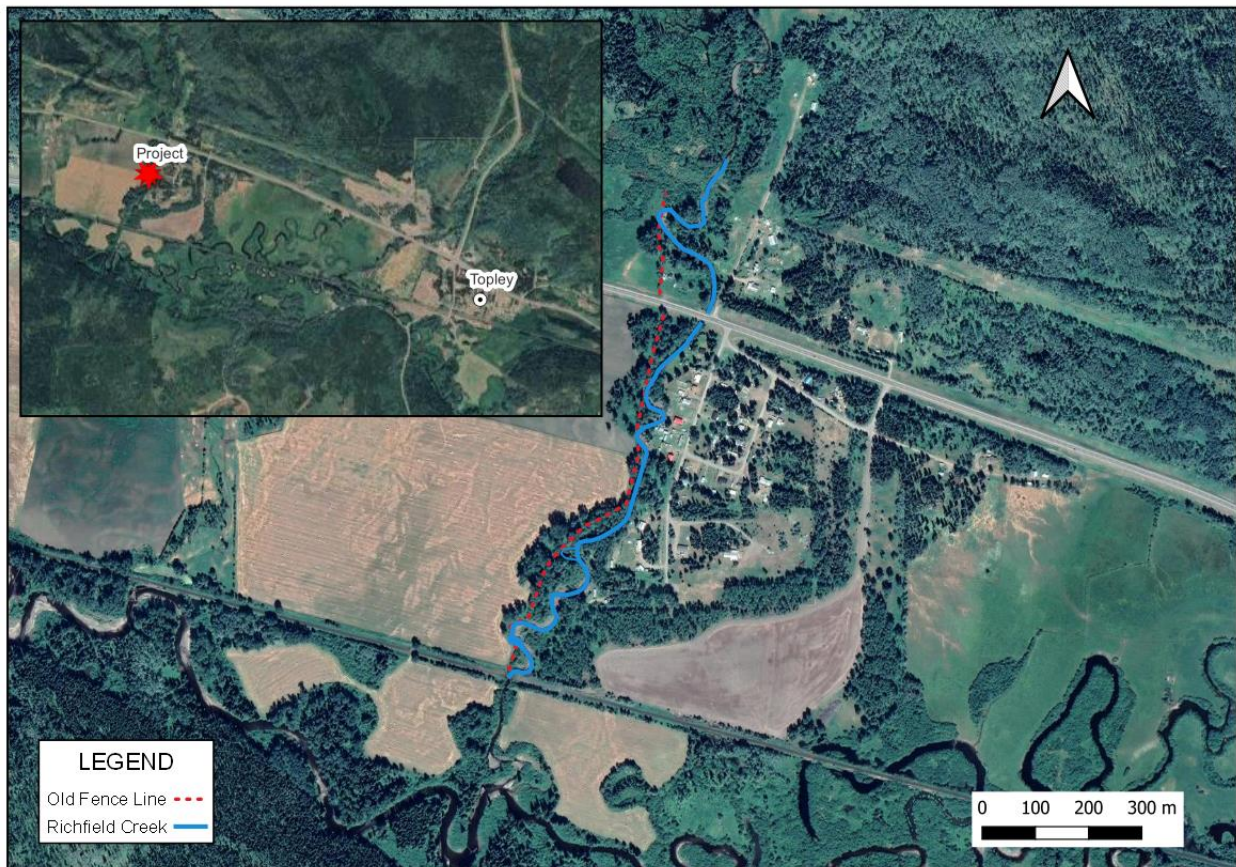
Much of the riparian zone along the eastern boundary of Richfield Creek is heavily degraded or absent and the stream has nowhere to move in that direction due to the homes and private land there. Along the western bank is mostly a well forested riparian zone bordering hay fields owned by Hatch Creek Ranch Ltd. Mature black cottonwood (*Populus trichocarpa*) tower over the western zone and exist in a corridor ranging in width, but regularly exceeding 30 m from the water's edge. Due to poor placement of historic fencing very close to Richfield Creek (Table 1), much of the understory vegetation and spruce have been eliminated from this zone due to the presence of cattle. In addition, in several places the historic fence line was lost to erosion from Richfield Creek into the adjacent hay fields. An inadequate riparian zone existed as a result of poor fence line placement historically (Figure 2 & Appendix A).

Figure 2: Project overview showing Richfield Creek with existing riparian zone and historic fence line.

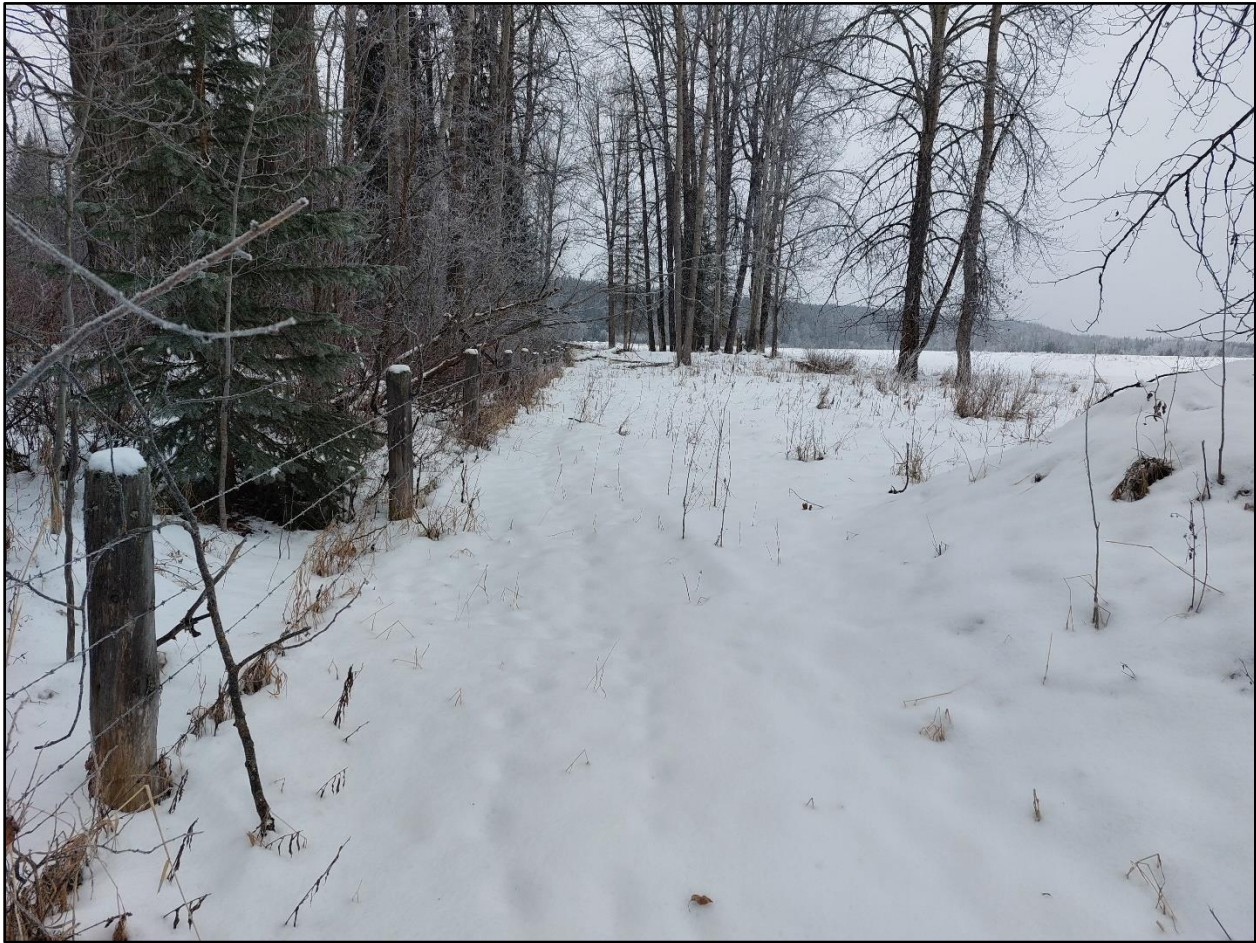
Figure (3) below is a photo from one section of the riparian zone documenting the lack of understory vegetation due to livestock damage. Note the presence of a thick understory and numerous spruce adjacent to the old fence line in the excluded area compared to the foreground where cattle are present. What we noticed most was the impact to the shrub layer and lack of replacement trees for the sustainability of the riparian zone. Conifers are conspicuously absent along the western edge of the historic fence line as a result of damage from cattle.

Figure 3: Photo along historic fence line showing healthy riparian zone on left and results of cattle pressure on right.

Areas of active erosion into the adjacent fields was addressed during the fall of 2021 using a series of low-tech restoration techniques to both stabilize and revegetate the various problem sites. Additionally, as a result of this fencing project, we decided to plant approximately 2500 rooted willow seedlings along a large section of riparian zone now protected from cattle by the new fencing. This planting occurred under the mature black cottonwood trees and is detailed in Figure (10) in Appendix B. Fencing this area protected the significant restoration work already completed in by the MWMT-HWI project, while at the same time drastically expanding and improving the area of the riparian zone along Richfield Creek.

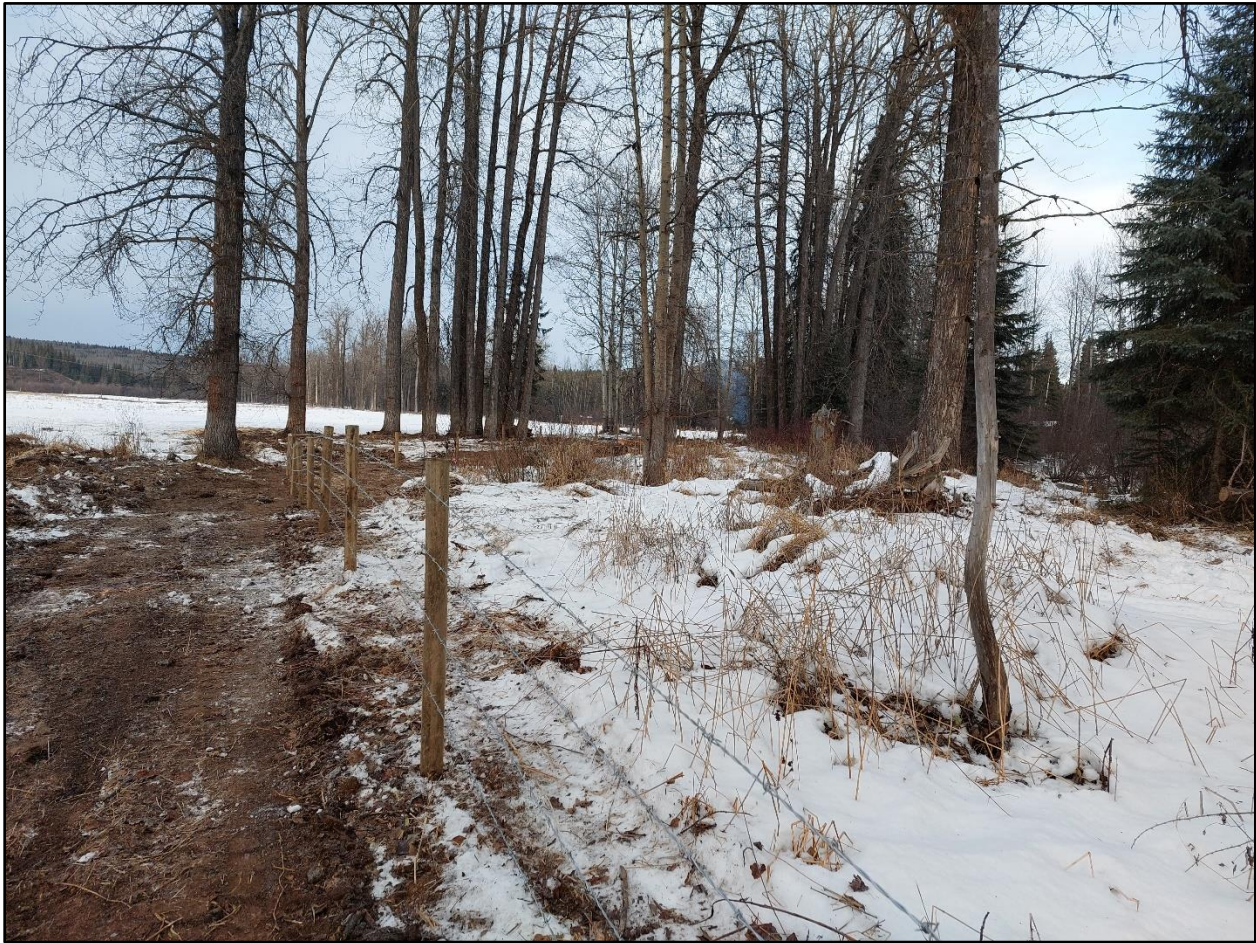
Approximately 1100 m of new four strand barbed wire fencing was installed to the west of Richfield Creek between November 26 and December 14, 2021. Figure (4) shows a representation of the new fencing installed on site.

Figure 4: Representative photo of new fence line.

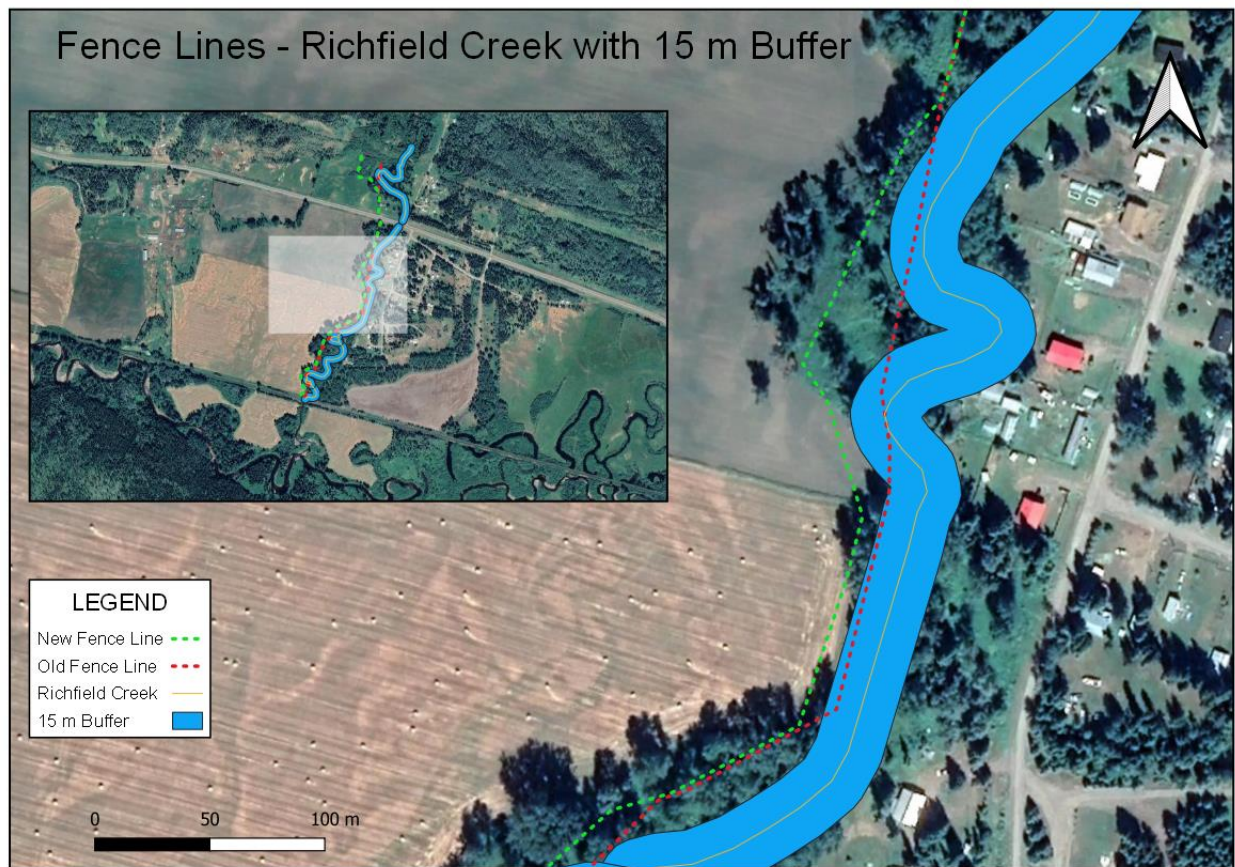
Figure (5) illustrates the improvement of the riparian corridor along one section of Richfield Creek; a 15 m buffer was added to Richfield creek to illustrate how much of the old fence line was within the 15 m riparian corridor. Appendix (A), includes a series of maps illustrating the riparian improvement as a result of new fencing for the entire project site.

Figure 5: Map showing Richfield Creek with 15 m buffer and old and new fence lines overlayed in central part of project area.

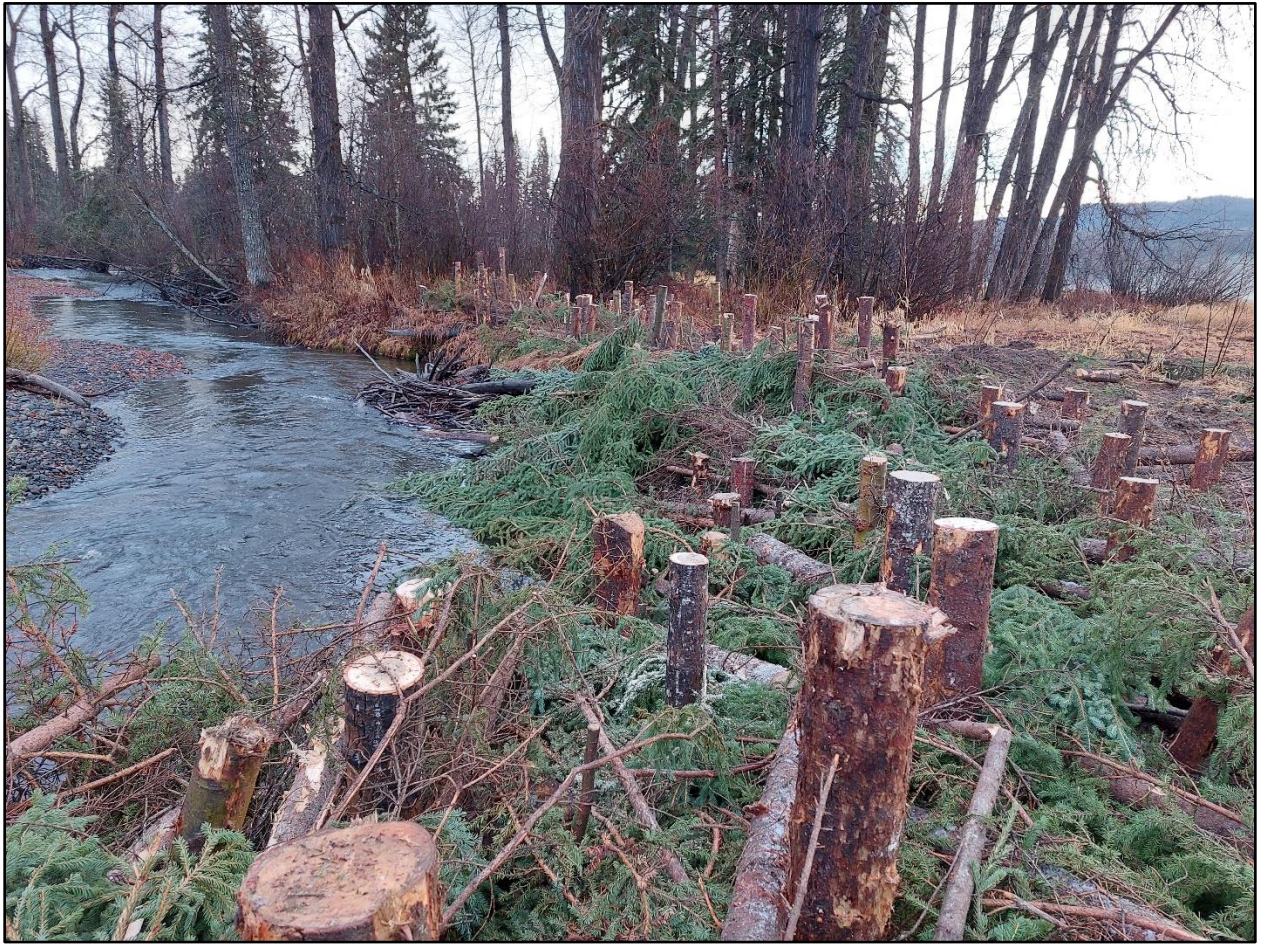
Figure 12: Photo of MWMT-HWI restoration works completed on Richfield Creek in the northern portion of the project area.
