**AS-BUILT REPORT OF AQUATIC RESTORATION AND ON-FARM
CATTLE MANAGEMENT IMPROVEMENTS WITHIN THE
WET'SUWET'EN FIRST NATION TERRITORY, 2016**

November 2016

**Wet'suwet'en First Nation
Yinka Dene Economic Development Limited Partnership Inc.
P.O. Box 245, 37 Sampson Crescent
Burns Lake, BC V0J 1E0**

**J.J. Smith and M.N. Gaboury
LGL Limited environmental research associates
9768 Second Street
Sidney, BC V8L 3Y8**

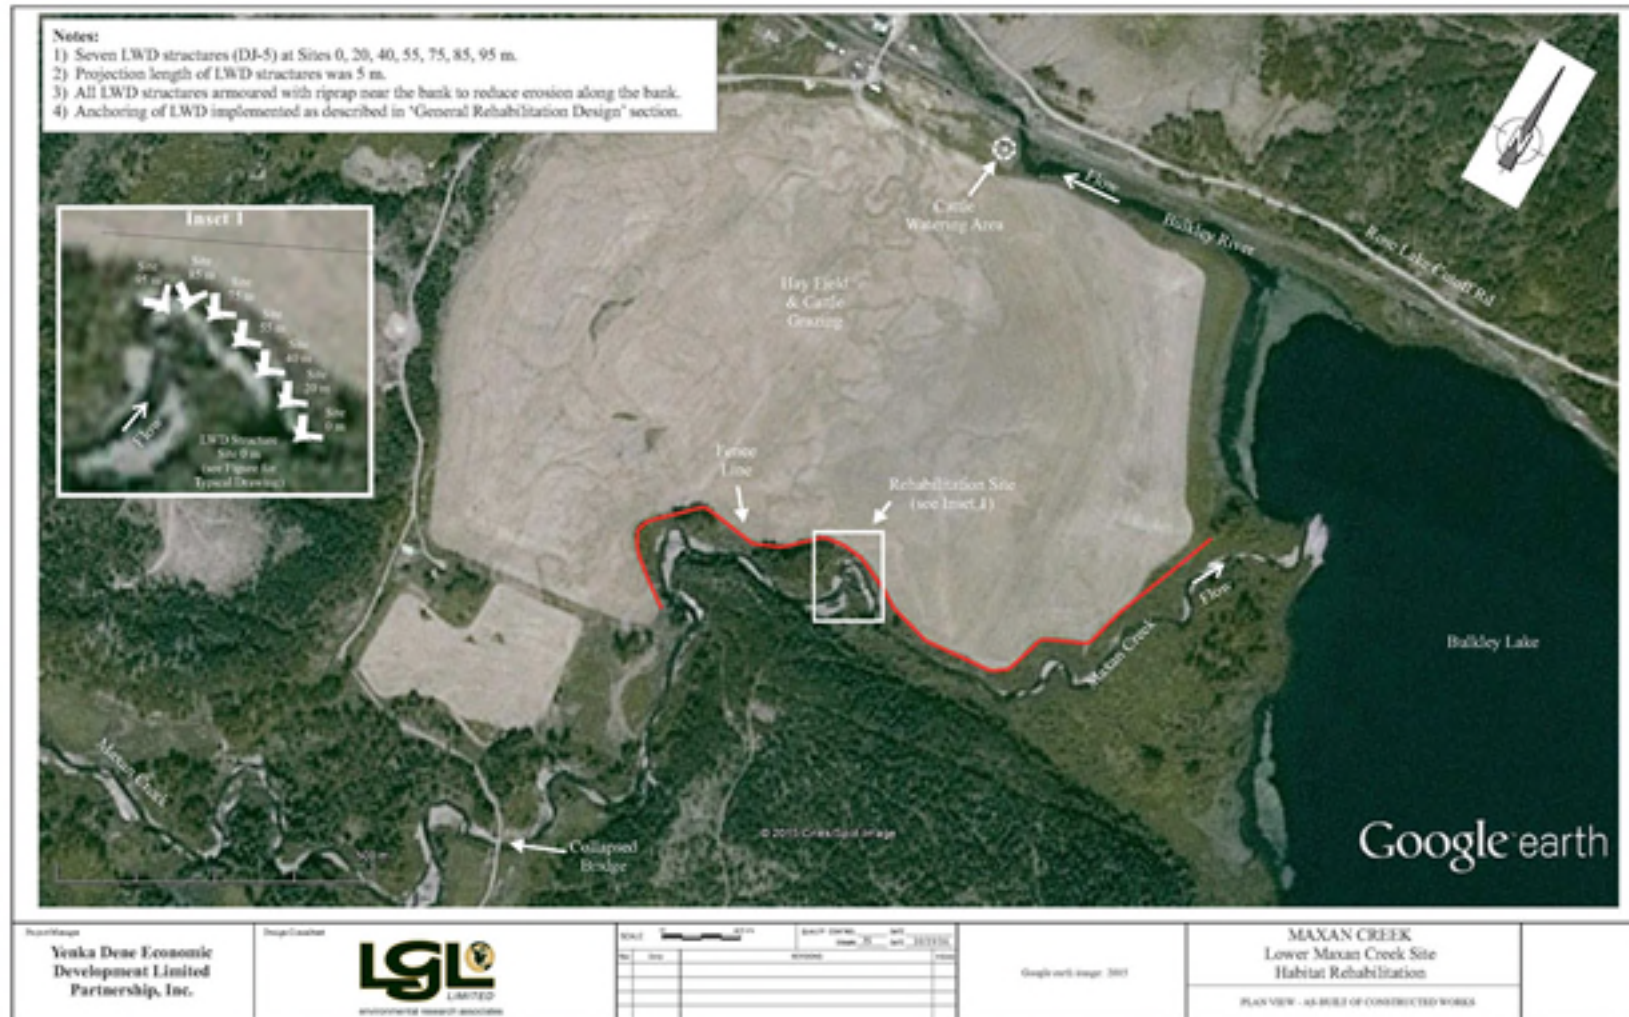
Figure 5. As-built plan view of rehabilitation works at the lower Maxan Creek site.

The Lower Maxan Creek project site was located approximately 1 km upstream from the mouth of Maxan Creek approximately 35 km northwest of Burns Lake, BC (Table 1; Figure 2). Constructed works involved seven LWD structures installed along a 95-m reach (Figure 5) and 1.5 km of barbed-wire fence installed along the left bank of the creek. Acquisition and transporting of construction materials to the site was initiated on 9 August 2016 (Photo 1 to Photo 3). Construction of the instream structures began on 11 August and was completed by 16 August 2016 (Photo 4 to Photo 10). Two types of excavators were used at this site (Volvo EC330CL and Komatsu PC200LC). Ballast requirements for the LWD structures as determined during the design phase are shown in Table 2. The quantity of materials used in construction was compared to the design requirements for ballast in Table 3. The fence was constructed from 16–19 August and 14–16 September 2016.

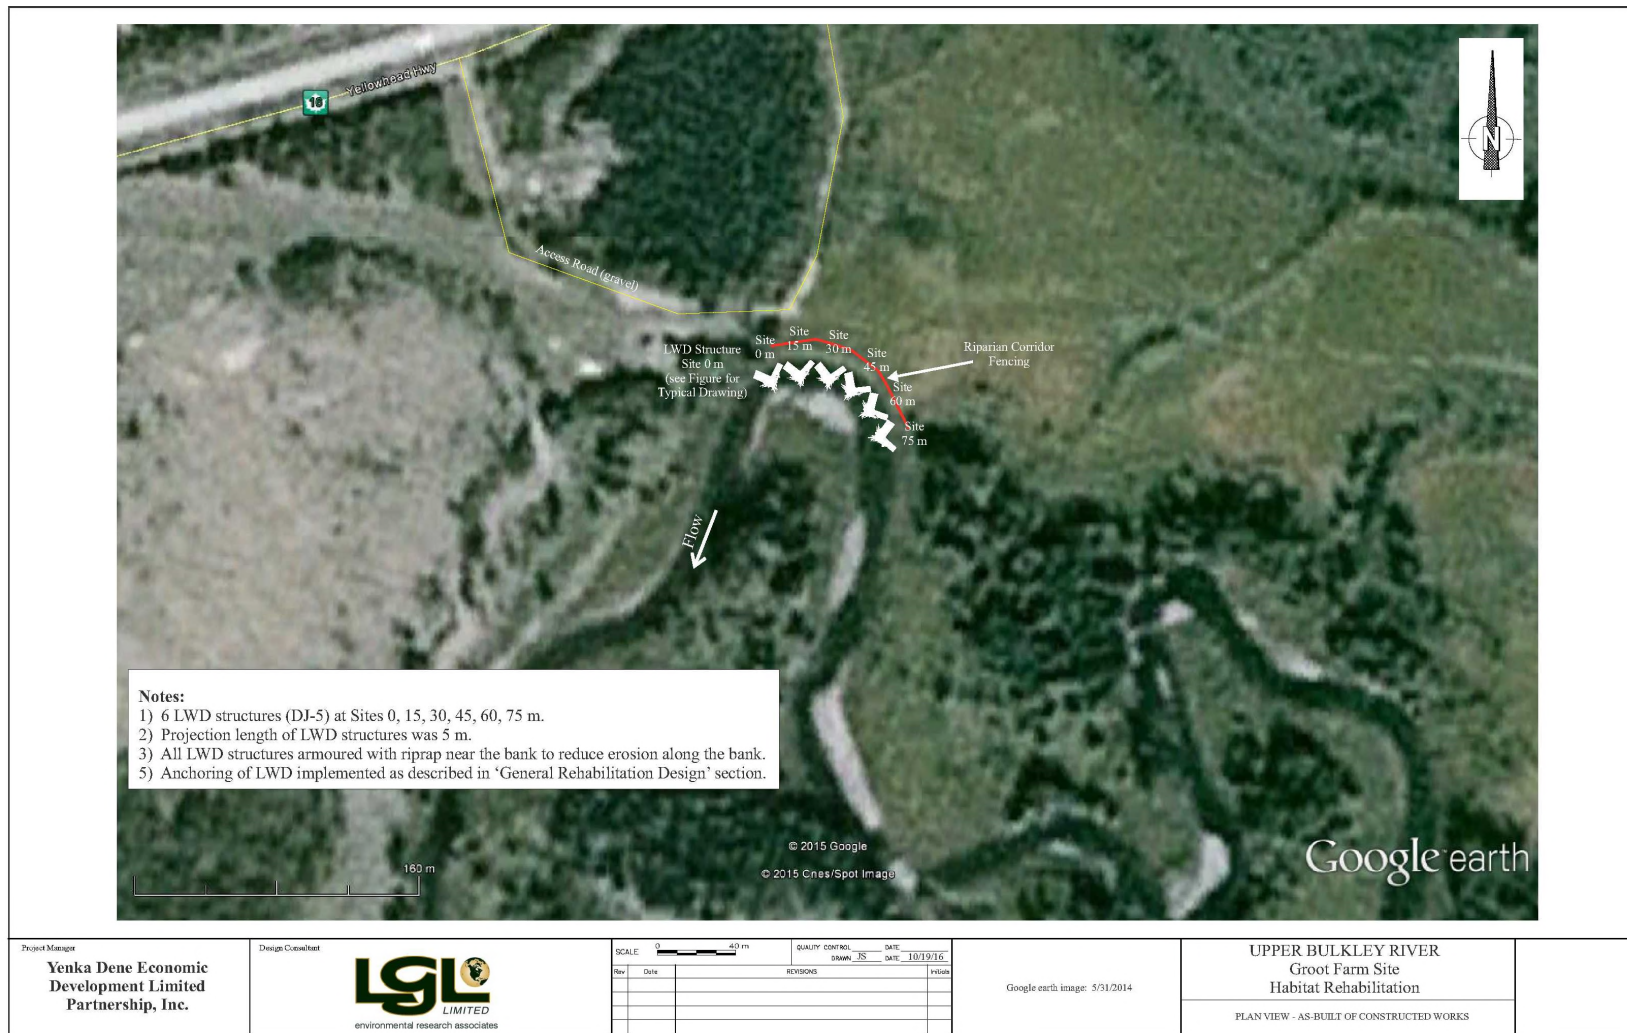
Figure 6. As-built plan view of rehabilitation works at the Groot Farm site on the upper Bulkley River.

The Groot Farm project site was located on the upper Bulkley River approximately 22 km northeast of Houston, BC (Table 1; Figure 2). Constructed works involved six LWD structures installed along a 75-m reach (Figure 6) and 130 m of barbed-wire fence installed along the right bank of the river. Acquisition and transporting of construction materials to the site was initiated on 5 September 2016, and construction of the instream structures occurred from 7–13 September 2016 (Photo 11 to Photo 16). A Caterpillar 322B excavator was used at this site. Ballast requirements for the LWD structures as determined during the design phase are shown in Table 4. The quantity of materials used in construction was compared to the design requirements for ballast in Table 5.

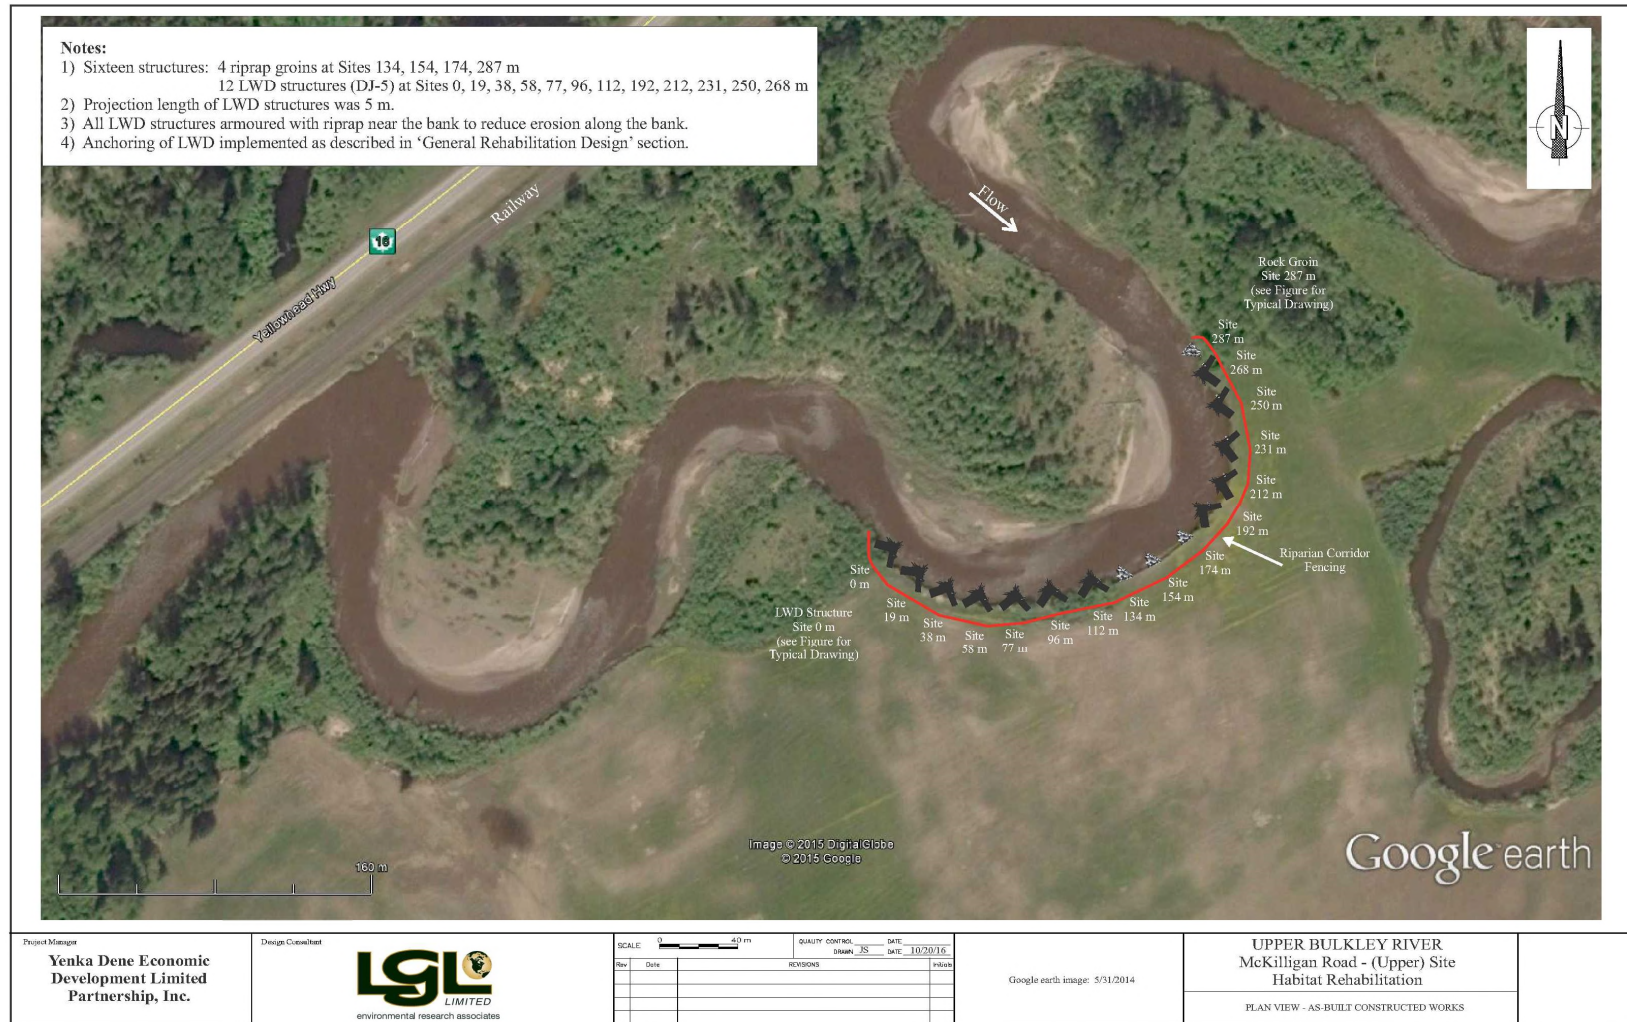
Figure 7. As-built plan view of rehabilitation works at the McKilligan Road (Upper) site on the upper Bulkley River.

The McKilligan Road (Upper) project site was located on the upper Bulkley River approximately 8.8 km northeast of Houston, BC (Table 1; Figure 2). Constructed works involved twelve LWD structures and four rock groins installed along a 290-m reach (Figure 7) and 341 m of barbed-wire fence installed along the left bank of the river. Acquisition and transporting of construction materials to the site was initiated on 26 September 2016, and construction of the instream structures occurred from 28 September to 4 October 2016 (Photo 17 to Photo 24). Two types of excavator were used at this site (Caterpillar 34 and Caterpillar 330FB). Ballast requirements for the LWD structures as determined during the design phase are shown in Table 6. The quantity of materials used in construction was compared to the design requirements for ballast in Table 7. The fence was constructed from 4–5 October 2016.

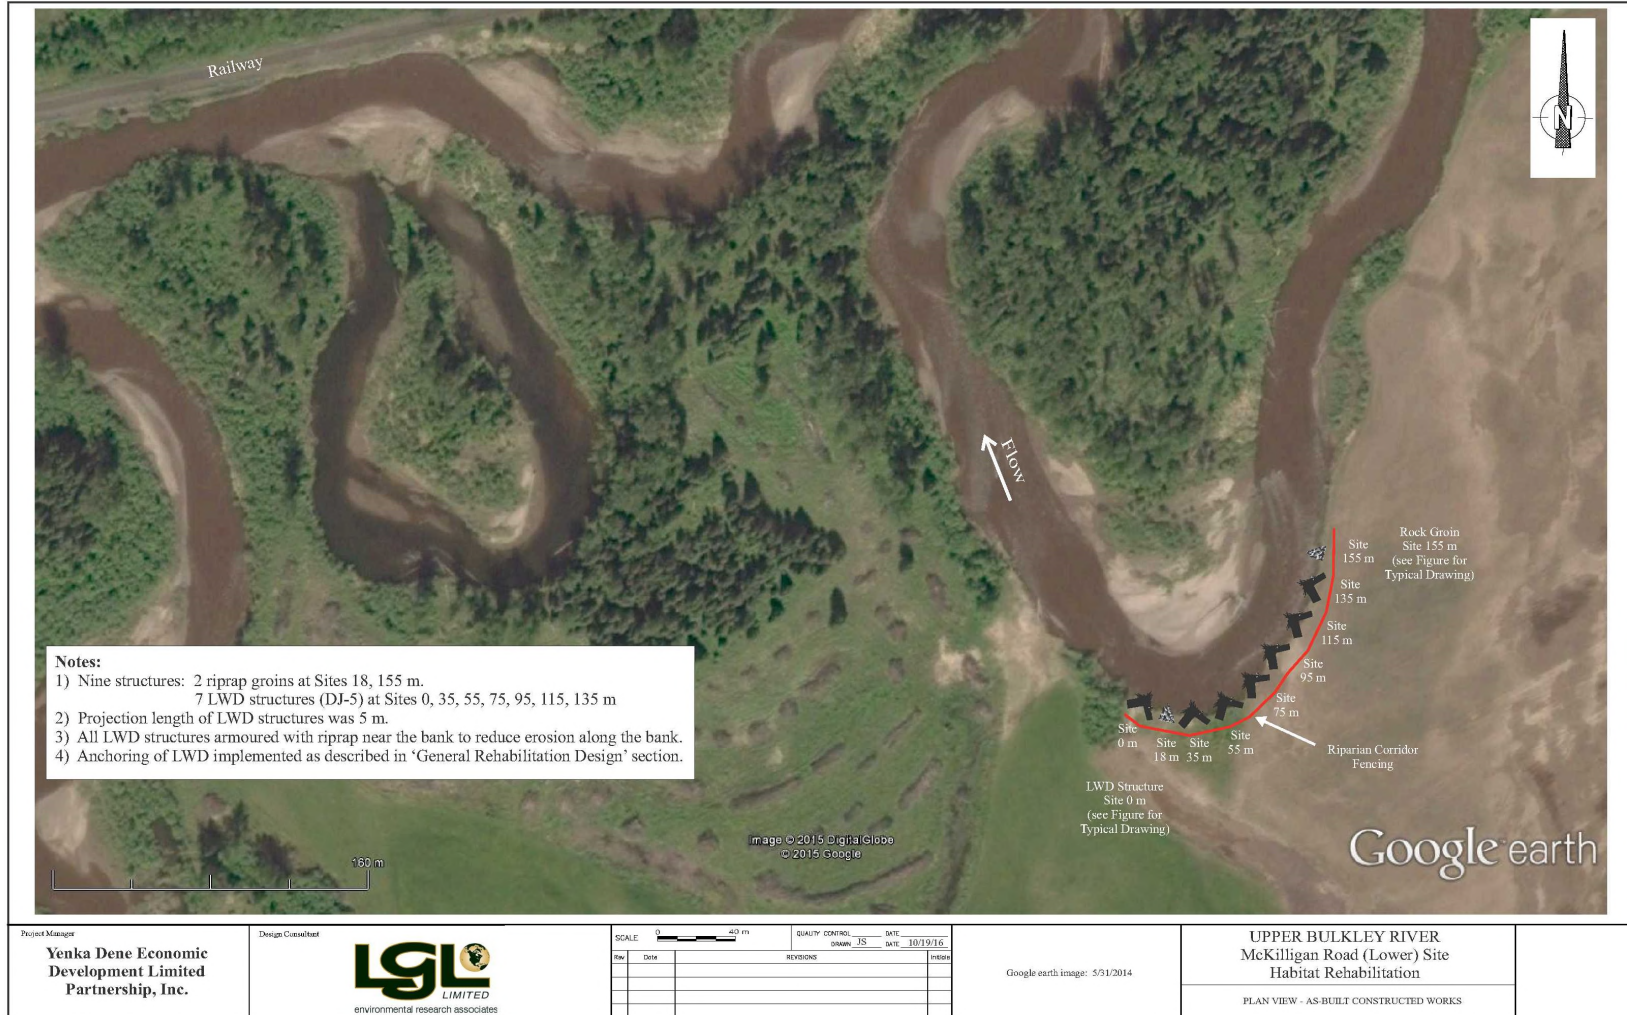
Figure 8. As-built plan view of rehabilitation works at the McKillingan Road (Lower) site on the upper Bulkley River.

The McKilligan Road (Upper) project site was located on the upper Bulkley River approximately 8.8 km northeast of Houston, BC (Table 1; Figure 2). Constructed works involved seven LWD structures and two rock groins installed along a 160-m reach (Figure 8) and 198 m of barbed-wire fence installed along the left bank of the river. Acquisition and transporting of construction materials to the site was initiated on 19 September 2016, and construction of the instream structures occurred from 20–24 September 2016 (Photo 25 to Photo 32). Two types of excavator were used at this site (Caterpillar 34 and Caterpillar 330FB). Ballast requirements for the LWD structures as determined during the design phase are shown in Table 8. The quantity of materials used in construction was compared to the design requirements for ballast in Table 9. The fence was constructed from 3–4 October 2016.

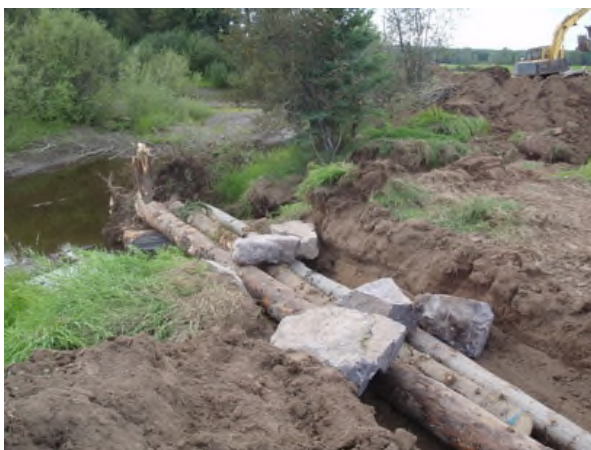
Photo 4. Lower Maxan Creek – Three upstream-facing logs and ballast rocks in a trench at 0+055 m during construction (13 August 2016).

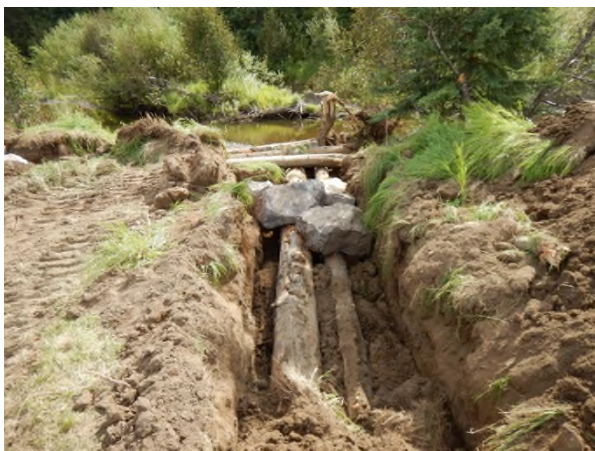
Photo 5. Lower Maxan Creek – Two downstream-facing logs and ballast rocks in a trench at 0+055 m during construction (13 August 2016).

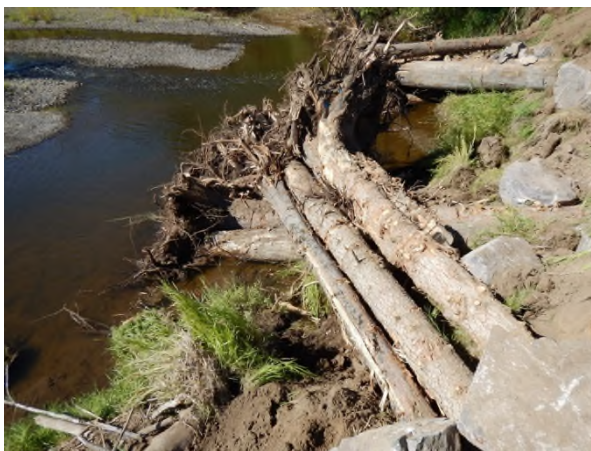
Photo 6. Lower Maxan Creek – Looking upstream at the LWD structure at 0+085 m after construction (14 August 2016).

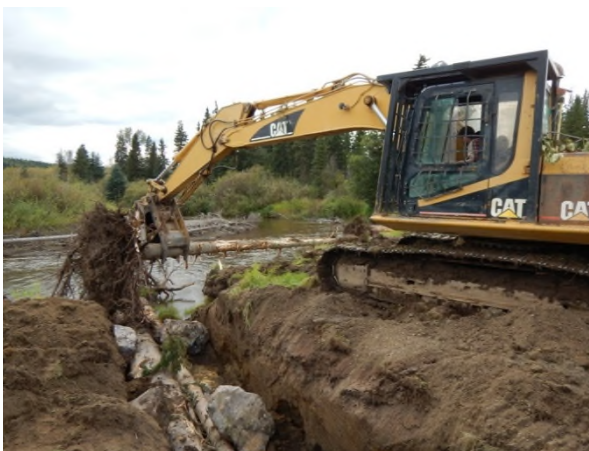
Photo 11. Bulkley River at Groot Farm – An excavator placing a log with rootwad attached in a trench at 0+030 m (8 September 2016).

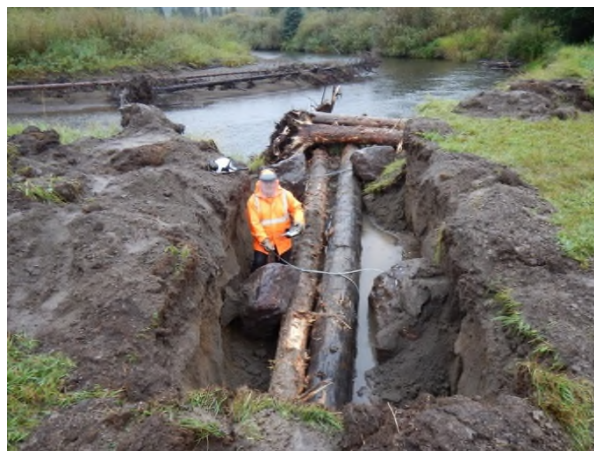
Photo 12. Bulkley River at Groot Farm – Securing ballast rocks to logs using epoxy and 12.7 mm diameter cable at 0+015 m (7 August 2016).

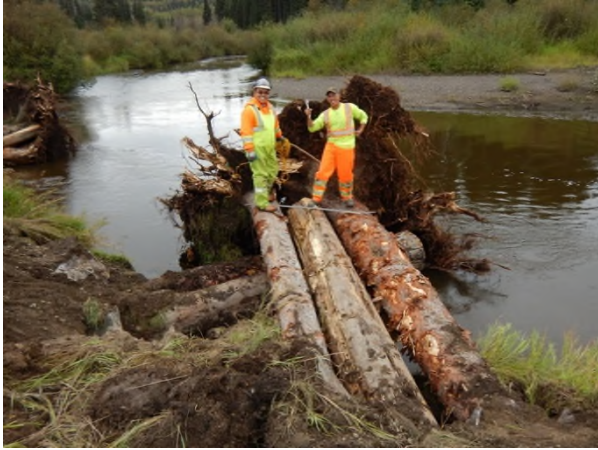
Photo 13. Bulkley River at Groot Farm – Looking upstream at a LWD structure at 0+045 m after construction (9 September 2016).

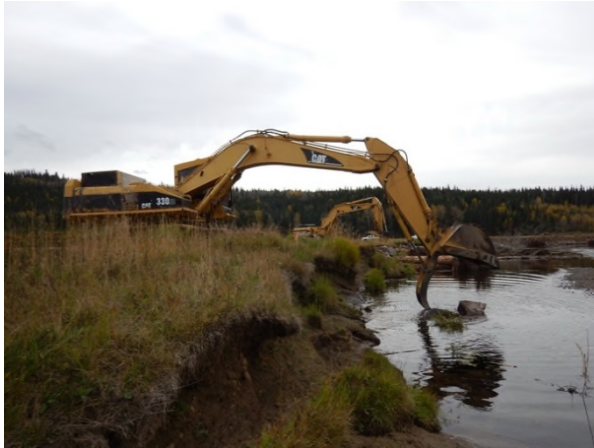
Photo 25. Bulkley River at McKilligan Rd (Lower) – Looking downstream at an excavator constructing a rock groin at 0+287 m (24 September 2016).

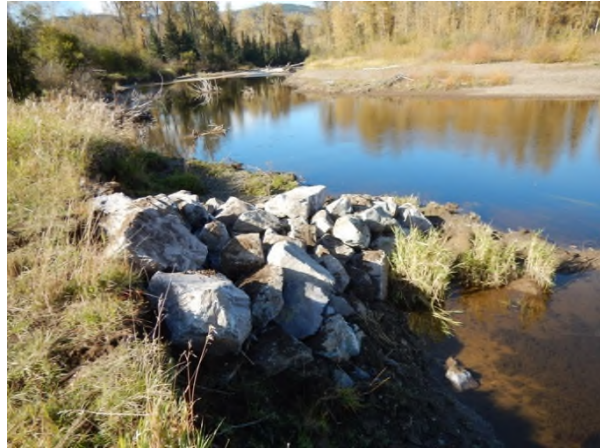
Photo 26. Bulkley River at McKilligan Rd (Lower) – Looking downstream at the rock groin at 0+018 m after construction (23 September 2016).
