Riparian and Channel Photos

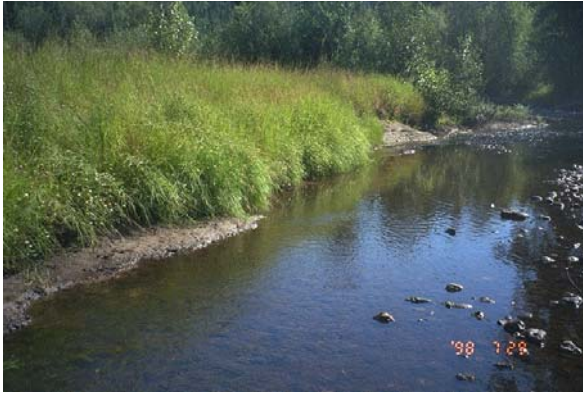
Plate # 1: Vegetated sediment wedges in aggraded section below railway crossing.

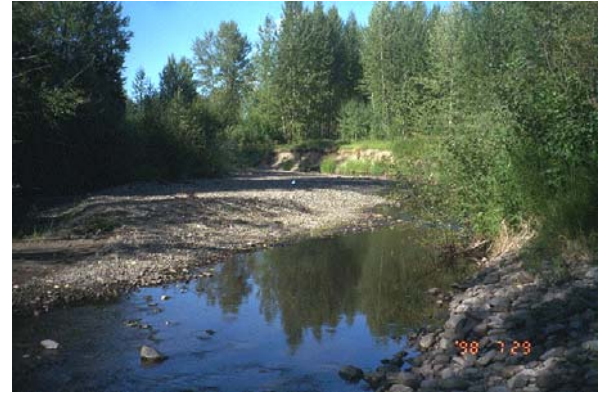
Plate # 2: Aggraded channel with eroding banks in densely habituated lower half of reach. Typical riparian forest community in predicted site series 08 (\$58) polygons.

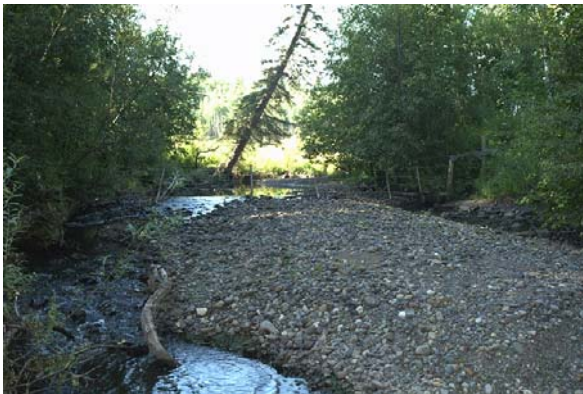
Plate # 3: Elevated mid-channel bar with cattle fence crossing creek 1400 metres upstream of the creek mouth.

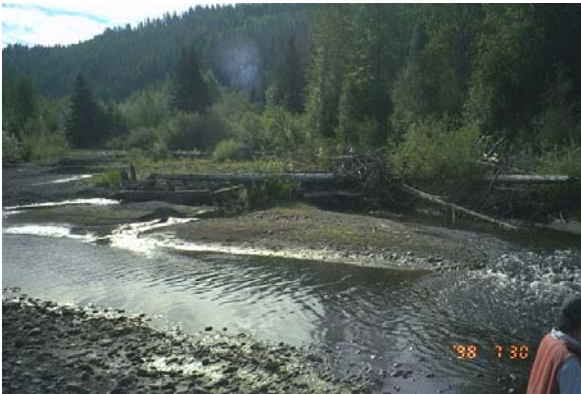
Plate # 4: Extensive aggradation and revegetating bars at the mouth of the creek.

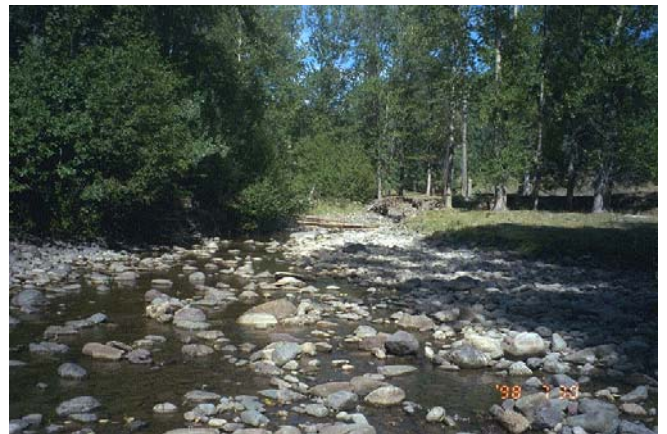
Plate # 7: Typical riparian forest community in predicted site series 07a polygons at toe of slope to left of photo.

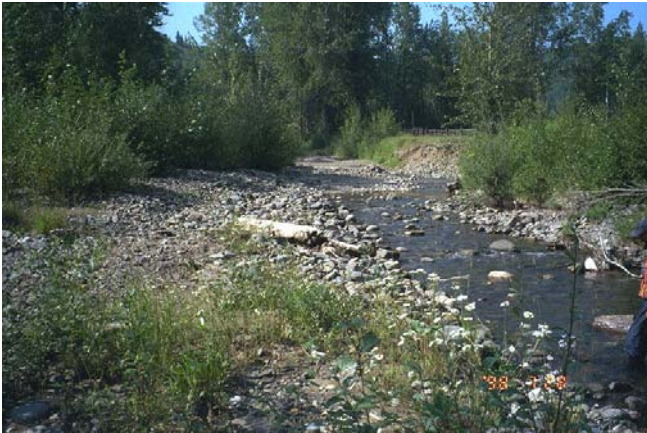
Plate # 12: Large clasts, minimal functional LWD, and extensive bars.

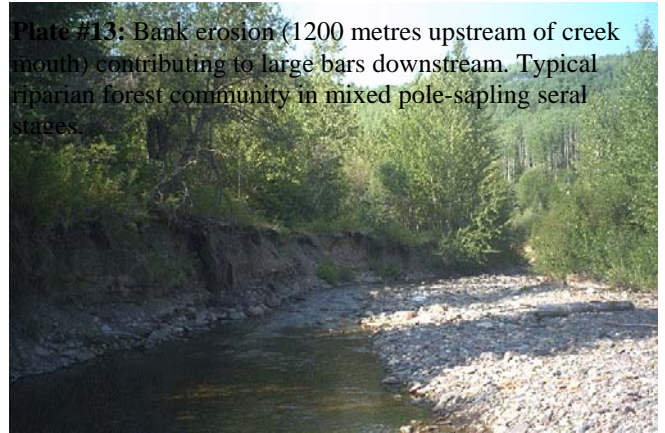
Plate #13: Bank erosion (1200 metres upstream of creek mouth) contributing to large bars downstream. Typical riparian forest community in mixed pole-sapling seral stages.

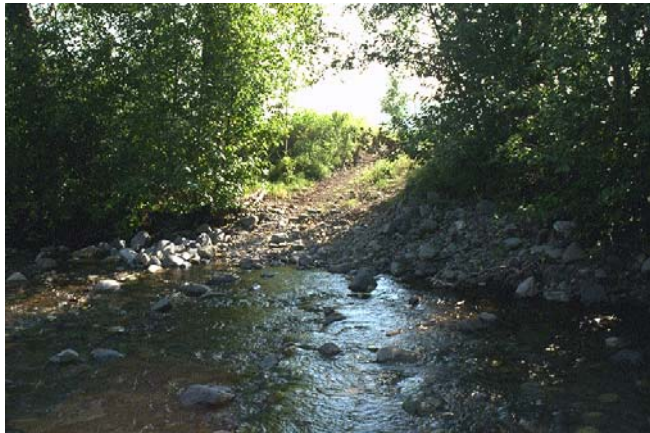
Plate # 14: Ford crossing the creek in the bottom half of the reach, resulting in the loss of riparian vegetation and a source of sediment input.

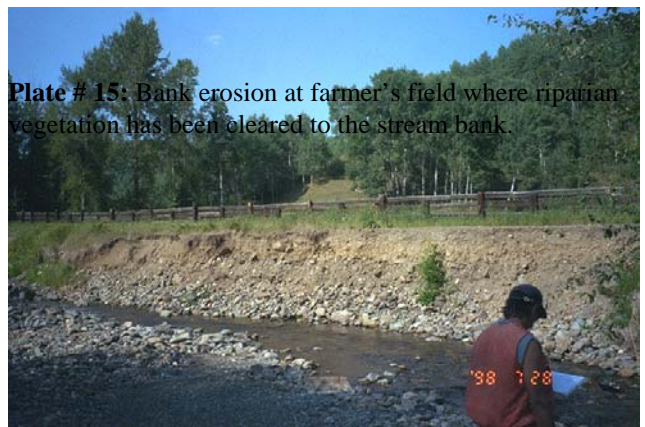
Plate # 15: Bank erosion at farmer's field where riparian vegetation has been cleared to the stream bank.

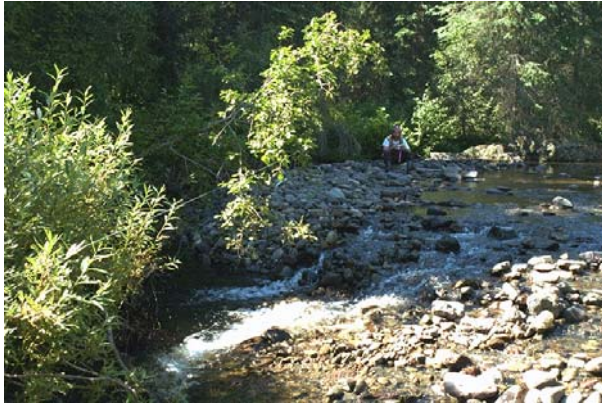
Plate #16: Elevated mid-channel bar in highly aggraded section of creek 400 metres upstream of the 2/3 reach break.

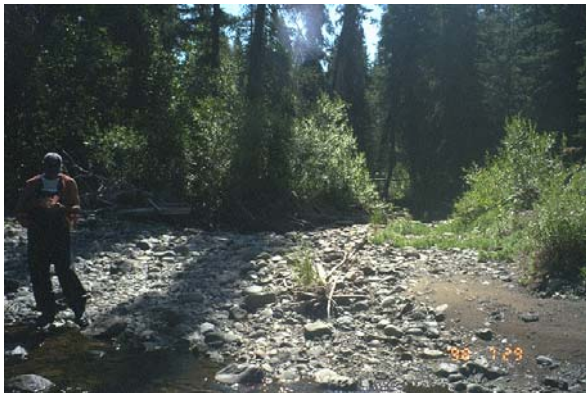
Plate #18: Large point bars in upper half of reach. Typical riparian forest community in predicted site series 10a polygons.

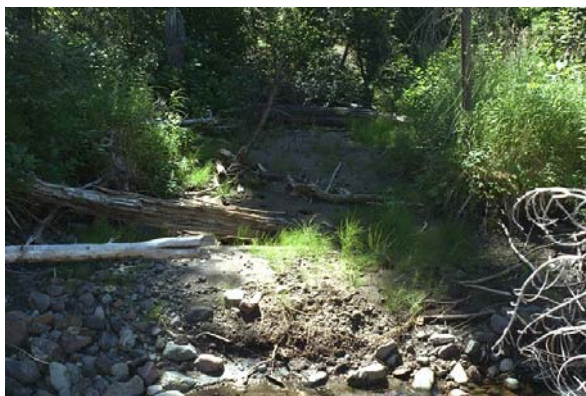
Plate #19: Point source of sediment 600 metres upstream of 2/3 reach break where North Road closely parallels the creek.

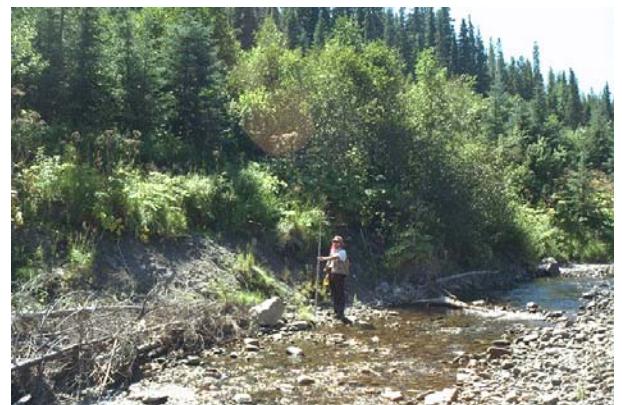
Plate #20: Bank erosion below the North Road, 1000 metres upstream of the 2/3 reach break.

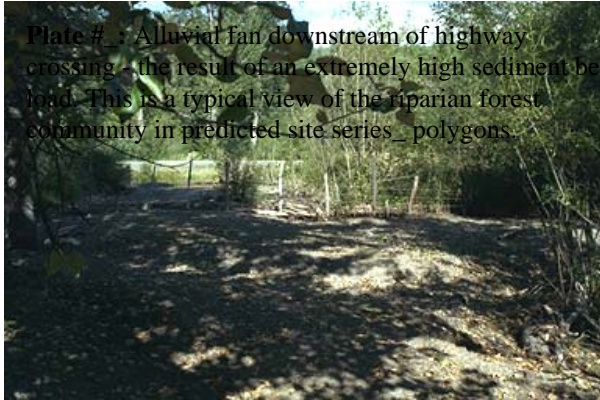
Plate #_: Alluvial fan downstream of highway crossing - the result of an extremely high sediment bed load. This is a typical view of the riparian forest community in predicted site series_ polygons.

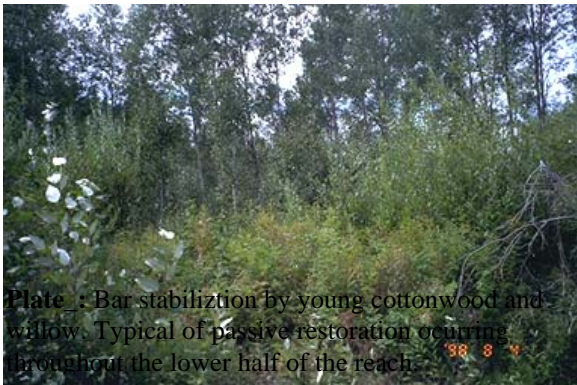
Plate #_ : Bar stabilization by young cottonwood and willow. Typical of passive restoration occurring throughout the lower half of the reach.

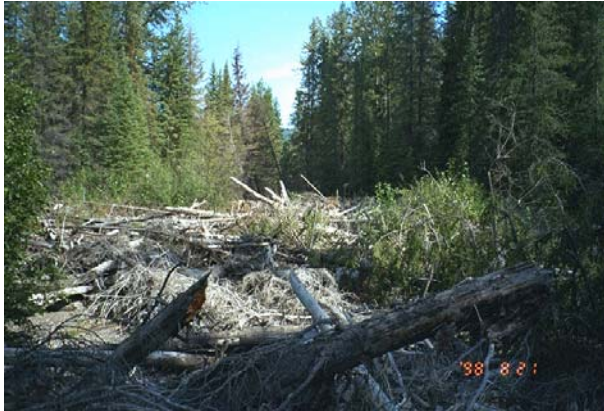
Plate # 38: Numerous log jams in aggraded channel at 1250 metres upstream of the Klo/Buck confluence. Typical riparian forest community in predicted site series 05 polygons.

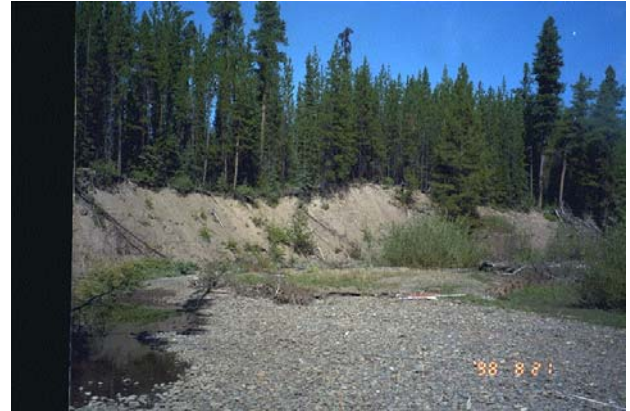
Plate # 39: Large slide (leading to log jams and diversions) in area of extensive aggradation 800m upstream of mouth. Typical riparian forest community in predicted site series 06 polygons, above slide.

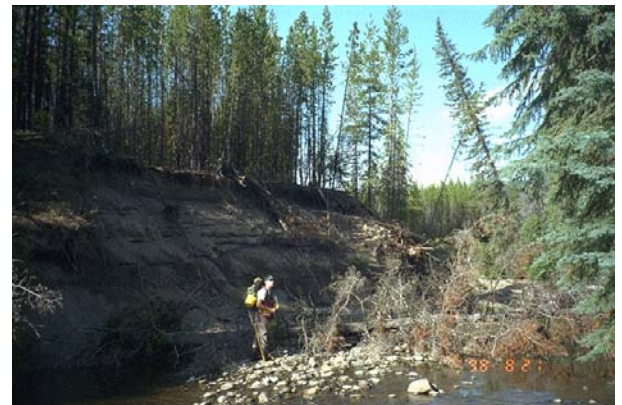
Plate # 41: Bank erosion site. Typical riparian forest community in predicted site series 06 polygons.

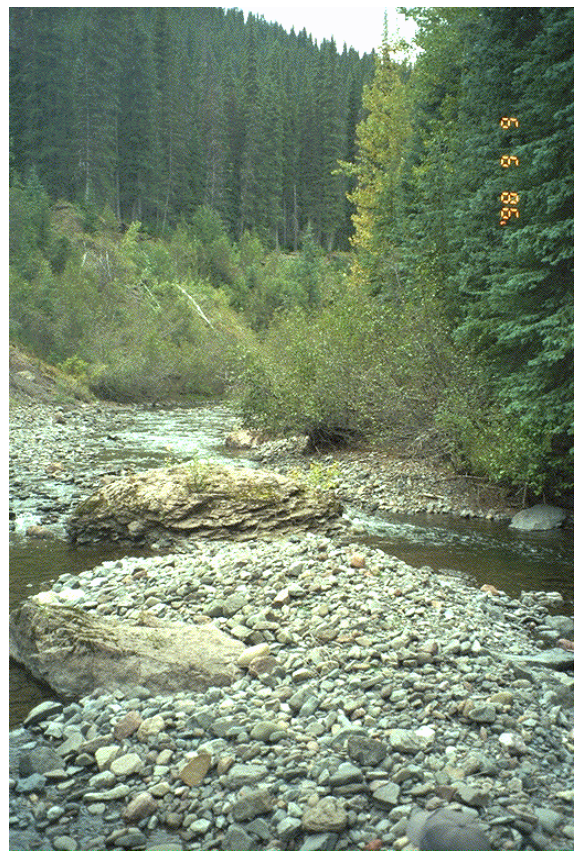
Plate # 45: Elevated mid-channel bars at 2700 metres above 1.2 reach break.

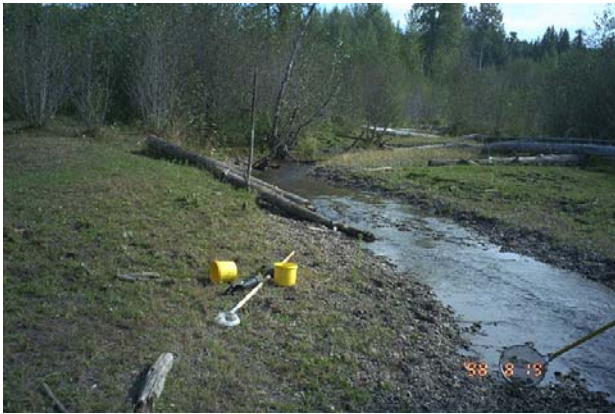
Plate #46: Main channel braid in heavily grazed area in bottom half of reach. Typical riparian forest community in predicted site series 08 polygons.

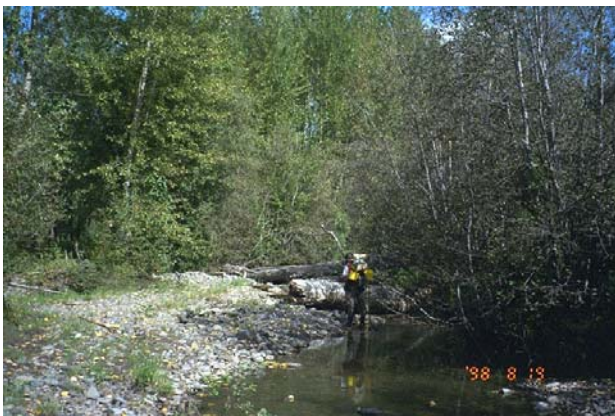
Plate #48: Major aggradation and instability where channel becomes more confined at top of the alluvial fan. Typical riparian forest community in predicted site series 08 (\$58) polygons.

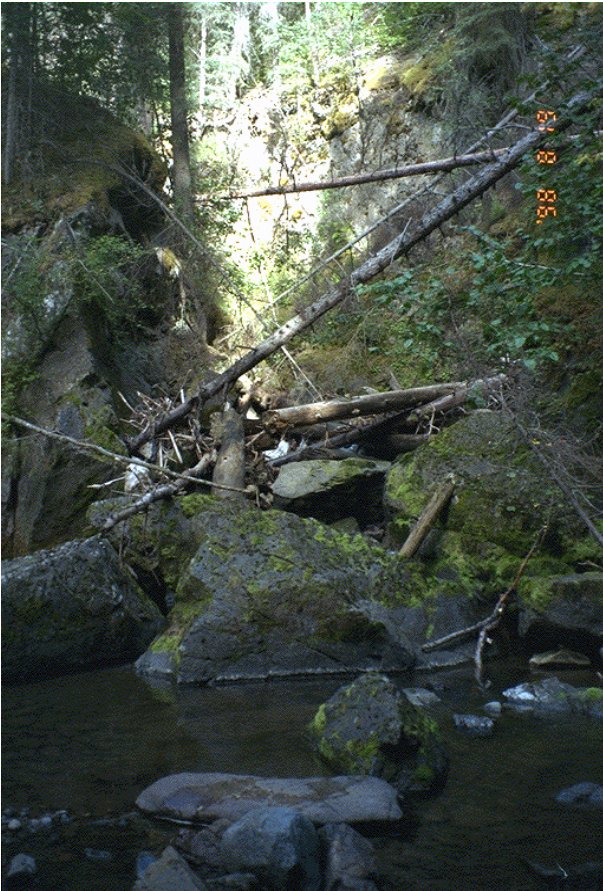
Plate #54: Upstream of the 1/2 reach break where the channel becomes a bedrock controlled canyon. Note the trapping of wood.

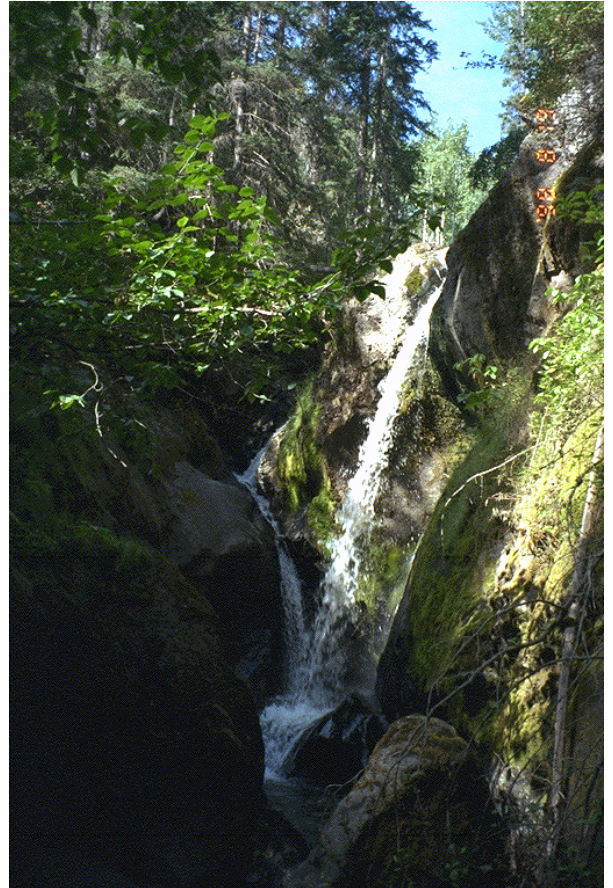
Plate #55: Impassable falls signifying the a/b section break.

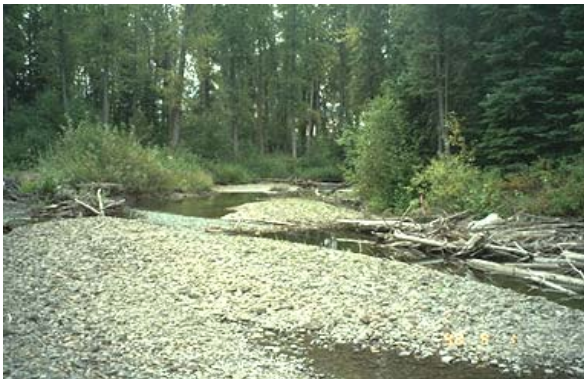
Plate #56: Aggraded section of channel found below channelized area in lower reach. Typical riparian forest community in predicted site series 08 (\$58) polygons. Most of the LWD is clumped into jams.

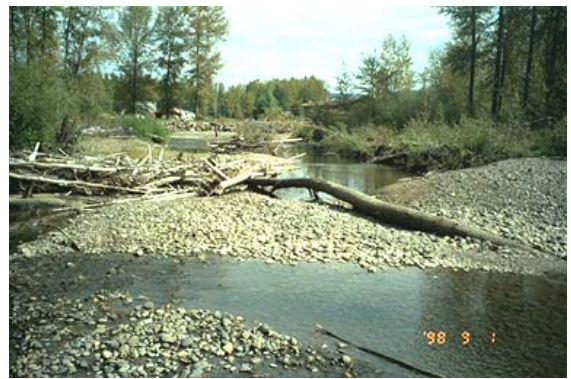
Plate #57: Aggraded channel found below channelized area in lower reach. Typical riparian forest community in predicted site series 08 (\$58) polygons. Note extensive elevated mid-channel

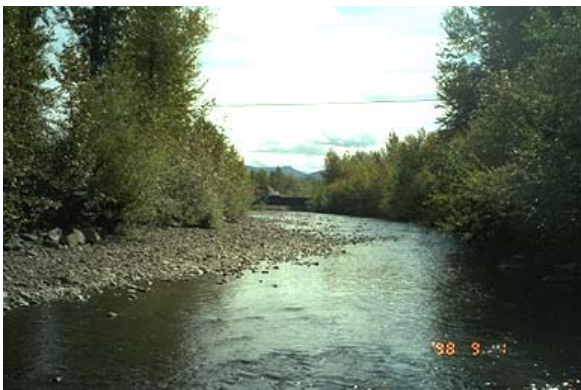
Plate #58: Channelized section of the creek, characterized by minimal complexity, long riffles and a lack of wood.

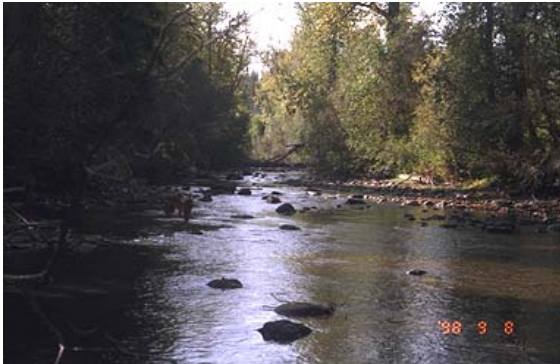
Plate #_: Typical degraded (scoured, low complexity) channel found in the bottom end of the reach, and riparian forest community in predicted 08 (\$58) site series_ polygons.

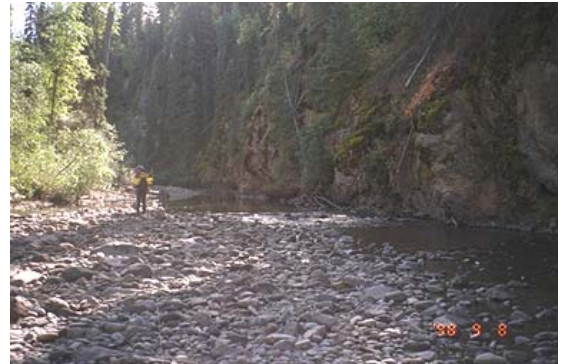
Plate #_: Typical aggraded channel found in the bottom end of the reach (with some bedrock control)

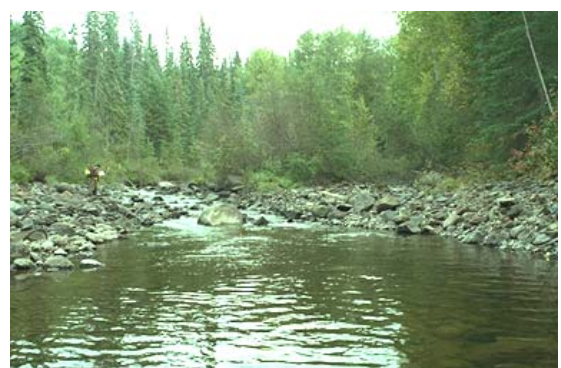
Plate #_: Avulsion located at top end of the reach (Abandoned channel to the right of photo) Representative shot of channel conditions and riparian forest community.

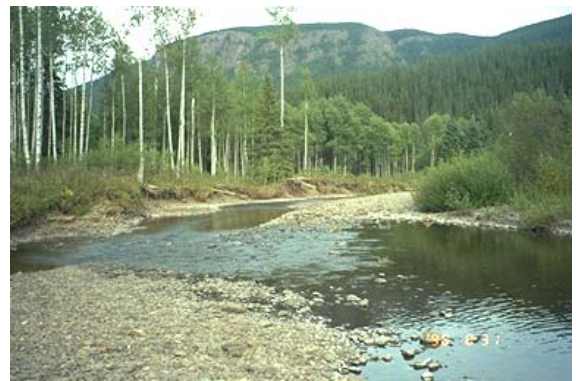
Plate #69: Typical channel characteristics found ~1400 metres upstream of the 3/4 reach break. Typical riparian forest community in predicted site series 07a (\$57) polygons.

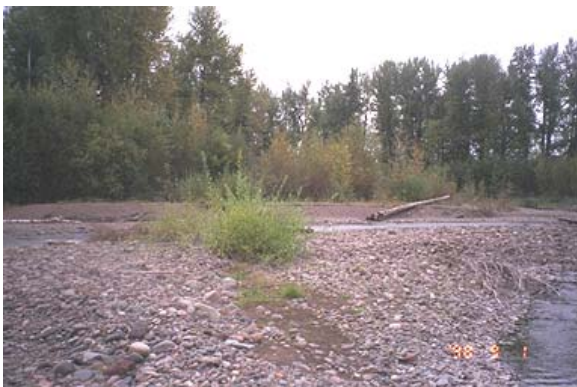
Plate #70: Large elevated gravel bars located in mid-reach highly aggraded section of creek.

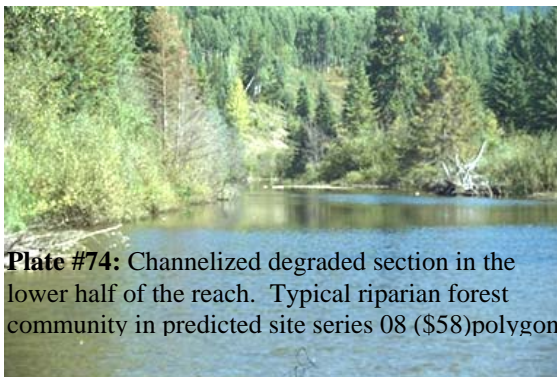
Plate #74: Channelized degraded section in the lower half of the reach. Typical riparian forest community in predicted site series 08 (\$58) polygons.

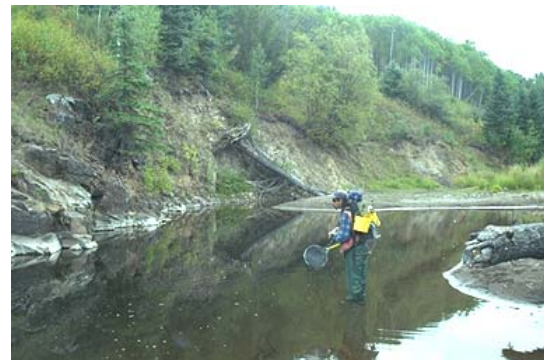
Plate #77: Section of heavy sediment wedge deposits, exposed bedrock, and eroding clay banks 2340 metres upstream of the 4/5 reach break.

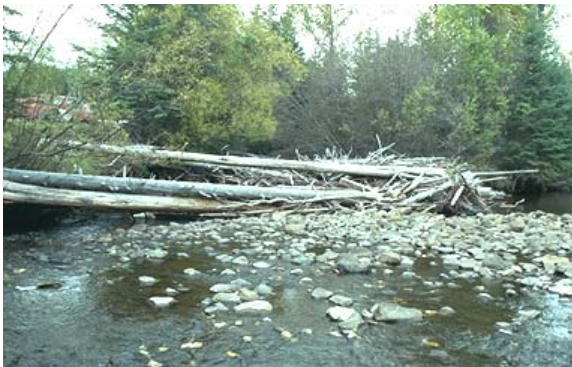
Plate #78: Clumped LWD in degraded section of channel at 4610 metres upstream of the 4/5 reach break.

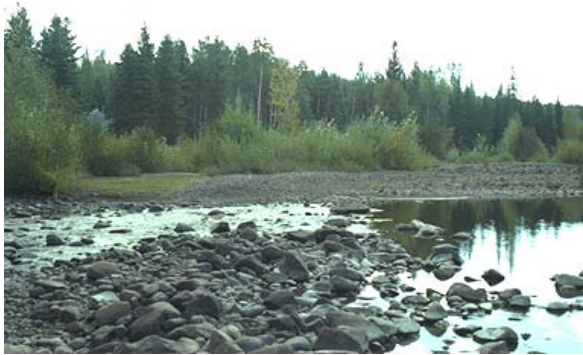
Plate #82: Aggraded section of the reach with high level of lateral channel movement. Private land cleared for lawn on downstream right at 380metres upstream of the 5/6 reach break.

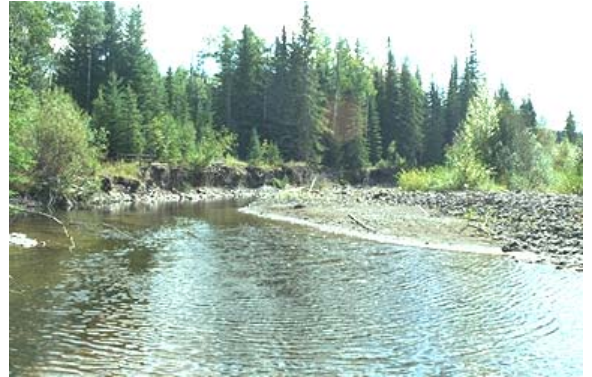
Plate #83: Typical riparian forest community in predicted site series 08 (\$58) polygons. Located 500 metres upstream of 5/6 reach break. Note eroding bank on downstream right.

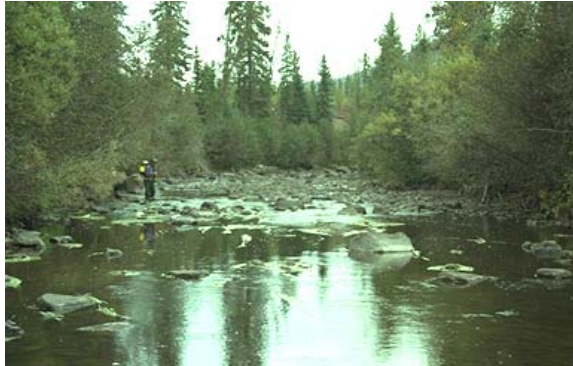
Plate #84: Degraded section of channel at 3300 metres upstream of the 5/6 reach break. Typical riparian forest community in predicted site series 08 polygons.

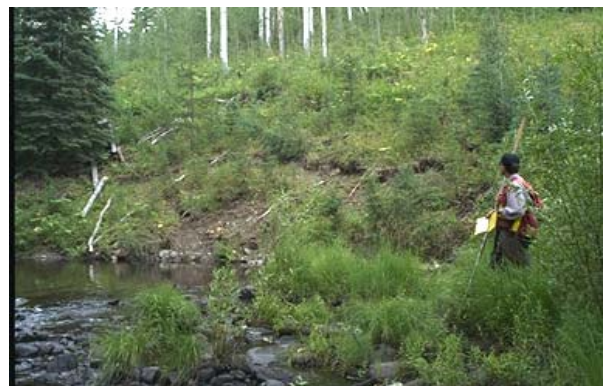
Plate #94: Road related bank slumpage occurring in the upper half of the reach.

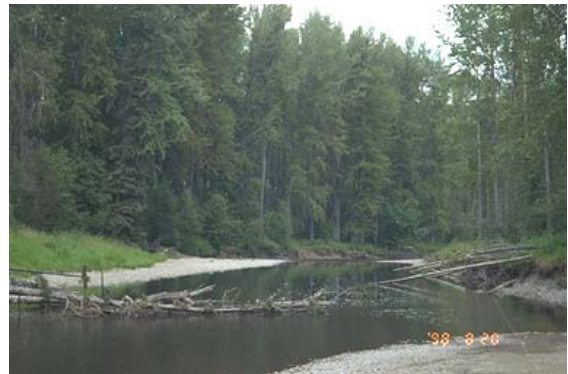
Plate #98: Ideal and typical cottonwood-spruce riparian conditions with functional LWD in foreground, located 1000 metres above Bulkley/Morice confluence.

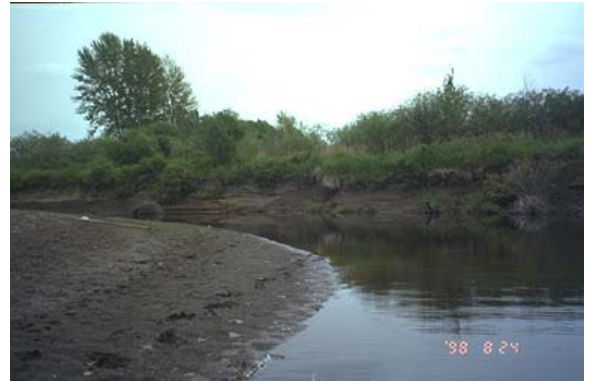
Plate #105: Bank failure below private land clearing and sediment wedge at 2500 metres above the 1/2 reach break.

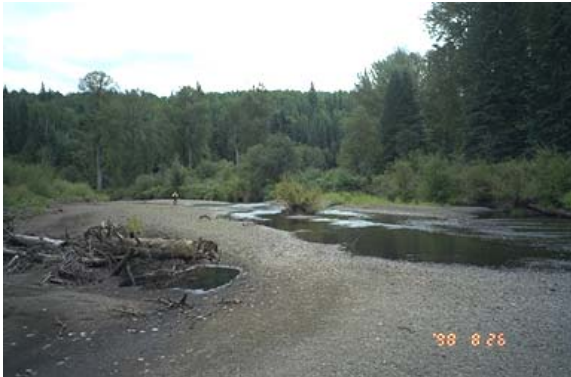
Plate #106: Severely aggraded, braided section just upstream of railway crossing at 4300 metres upstream of 1/2 reach break.

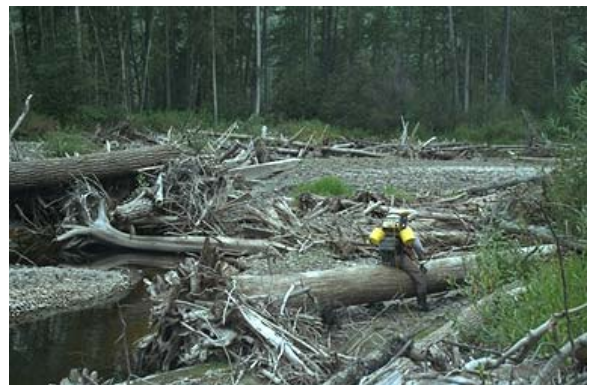
Plate #109: Extensive log jam in the upper half of the reach.

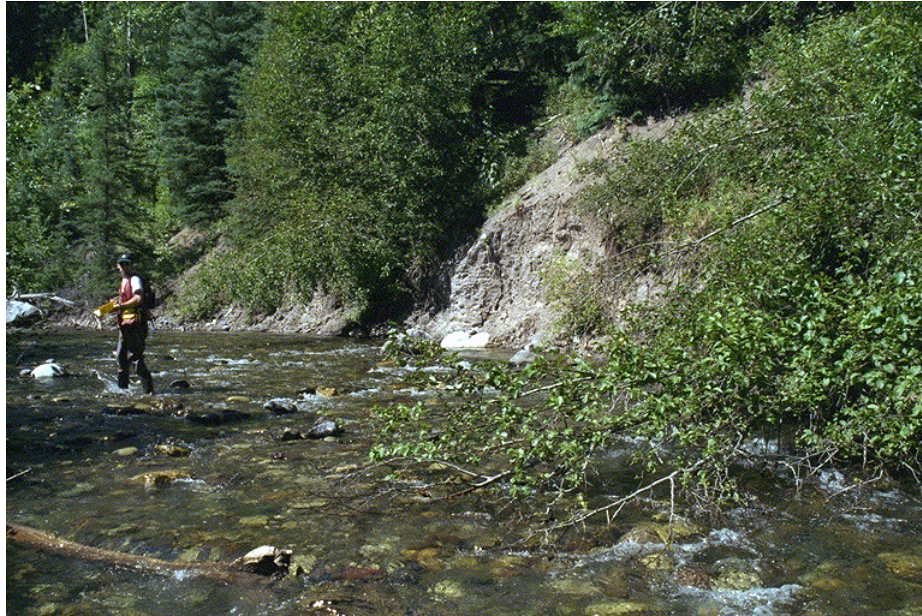
Plate #124 : Riffle section of lower half of reach, with bank failure on upstream right bank. Typical riparian forest community in predicted site series 08 (\$59) polygons.
