Land Use and Impact Photos

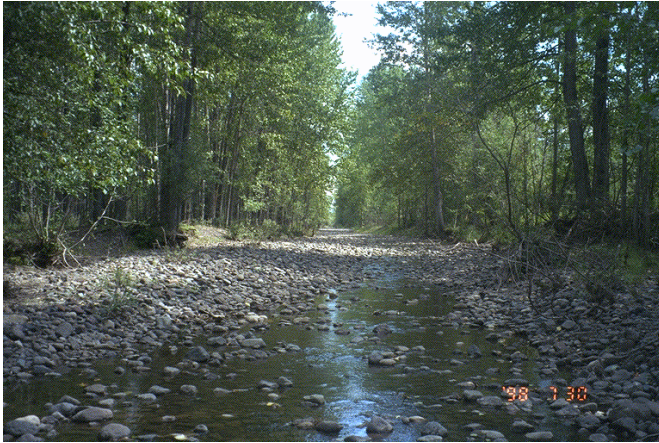
Plate # 8: Dyking within the lower half of the reach to protect grazing lands. Typical riparian forest community in grazed deciduous forest seral stages.

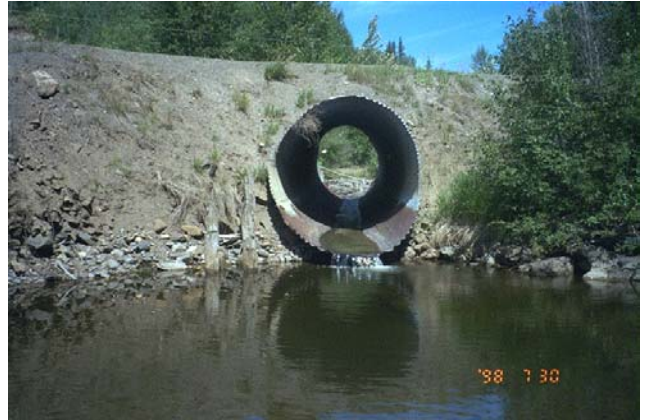
Plate # 9: Highway culvert, with gradient of upto 3%.

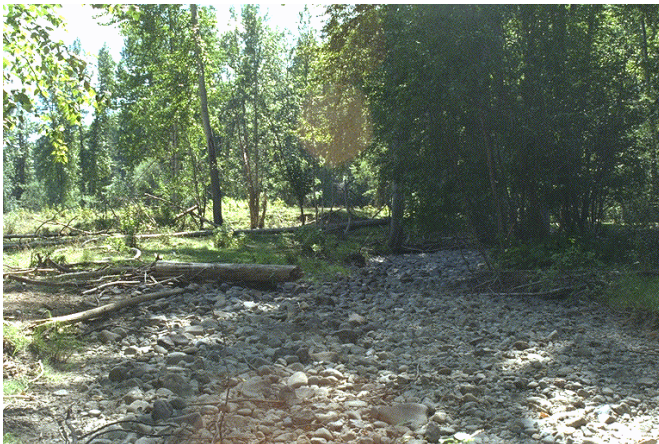
Plate # 10: One point of diversion , 3800m upstream from the creek mouth.

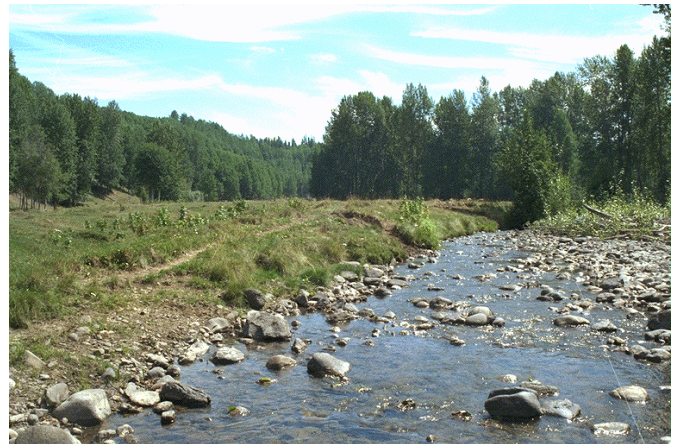
Plate # 11: Cattle trails along stream bank causing bank failure and increased erosion in the upper half of the reach.

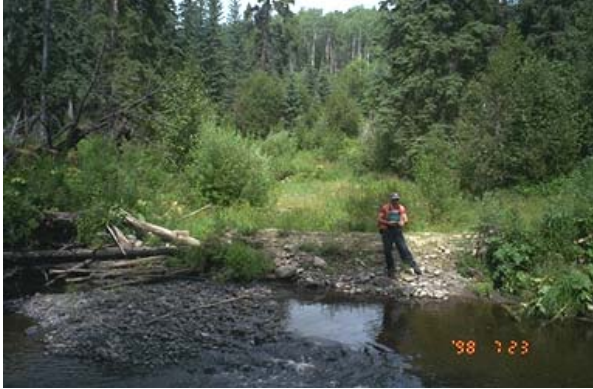
Plate #_: Man-made dyke made by landowner to protect road during spring 1997 flood. Located in bottom half of reach. '98 7 23

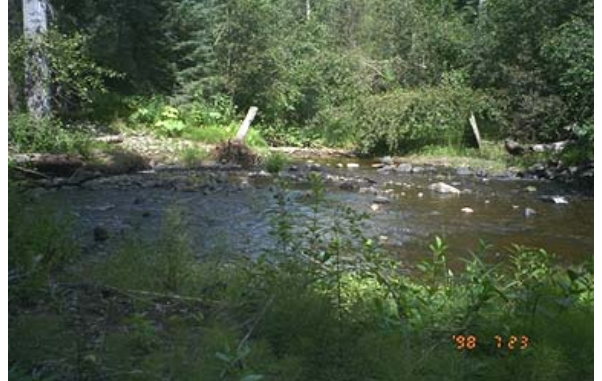
Plate #_: concrete/cobble dam used for backwatering to supply power for private landowner.

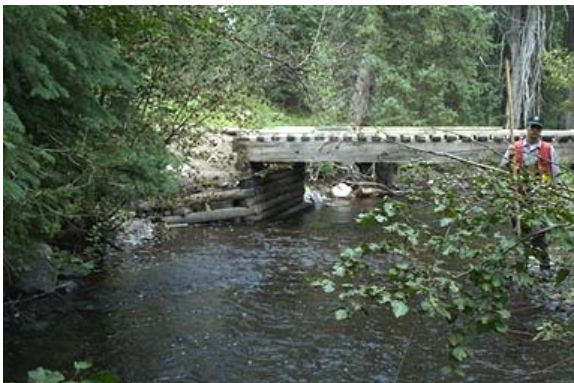
Plate #_: Second upstream bridge crossing, located in the upper reach.

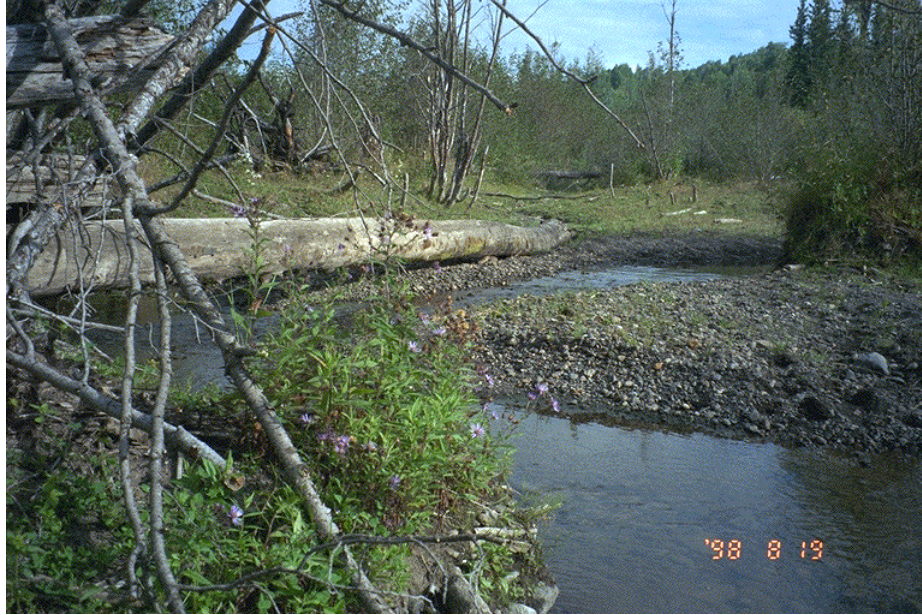
Plate #52: Heavy grazing on fan, Area of intensive lateral channel movement and siltation due to loss of riparian vegetation.

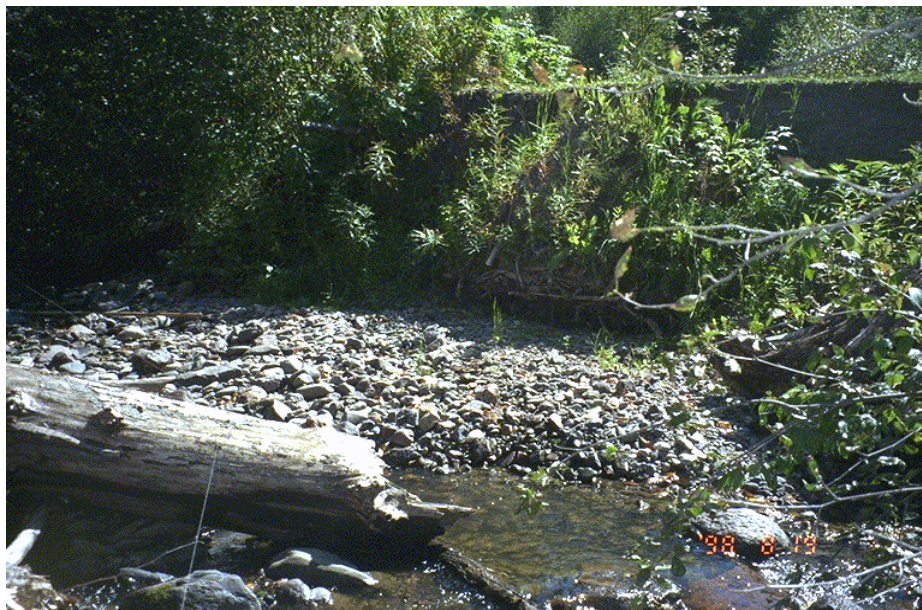
Plate #53: Bank erosion at site of old private bridge site.

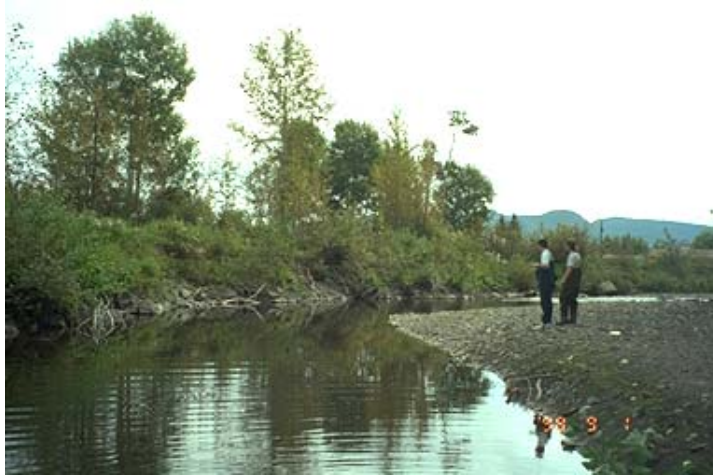
Plate_: Dyking on one side of the channel in the lower half of the reach, resulting in stream channelization.

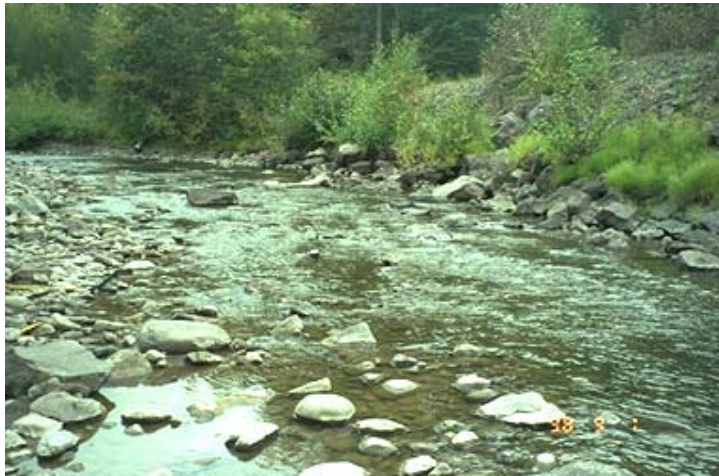
Plate_: Double sided dyking in the upper half of the reach. The channel is complexed with rip-rap and a higher gradient resulting in some diffusion of the creek's energy and productive fish habitat.

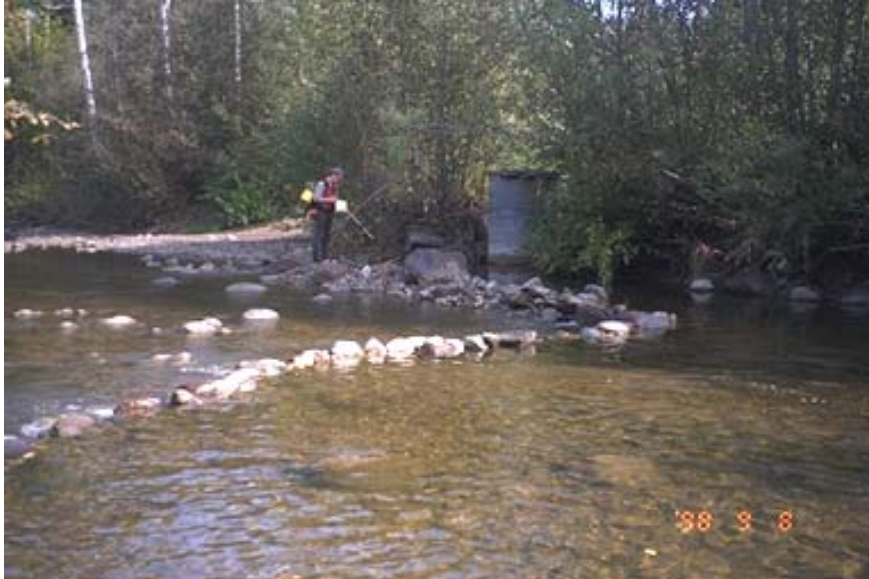
Plate 64: Intersecting powerline corridor crossing the creek between 550-600 metres upstream of the 1/2 reach break. Rocks and boulder have been placed to allow for water at the pump house.

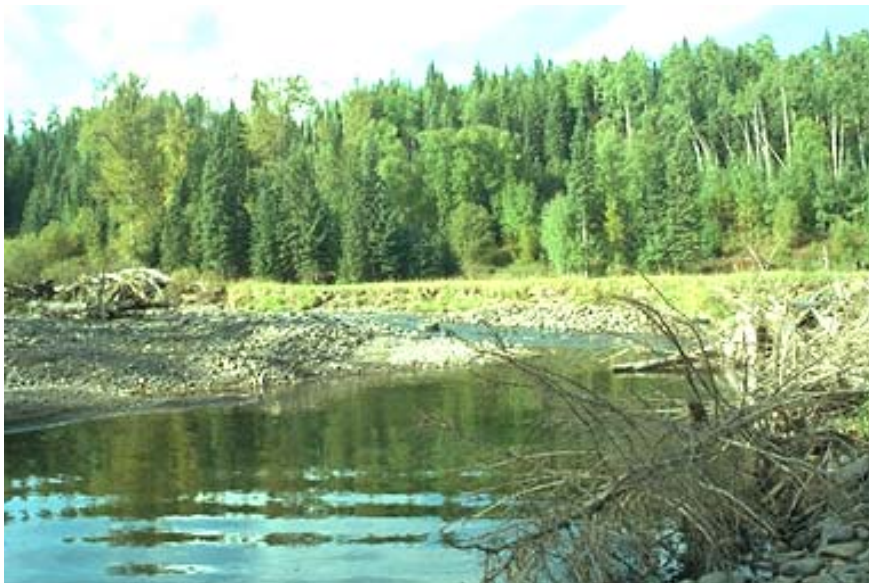
Plate 65: Hay field at approximately 4300 metres upstream of the 1/2 reach break. Note slumping bank.

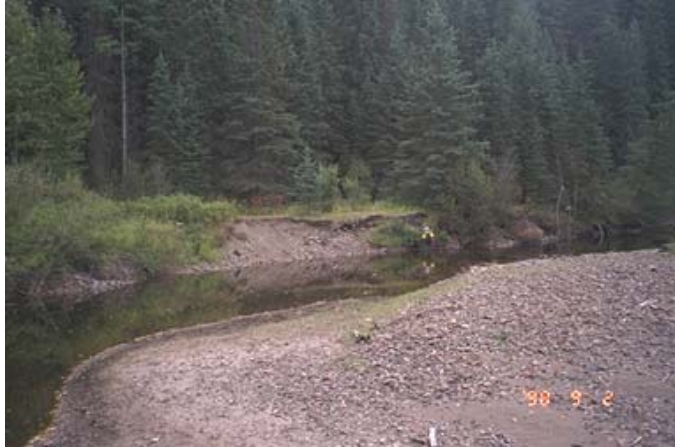
Plate 71: Access road to Bob Creek mine claim at 3925 metres upstream of the 3/4 reachbreak.

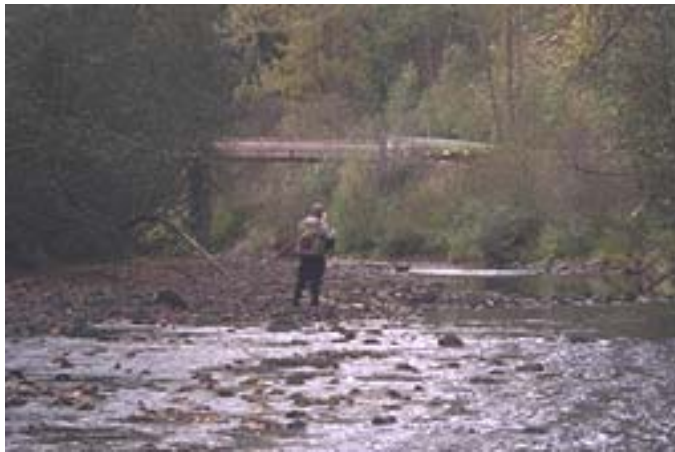
Plate 72: Buck Creek Bridge #1 located at 4100 metres upstream of the 3/4 reachbreak.

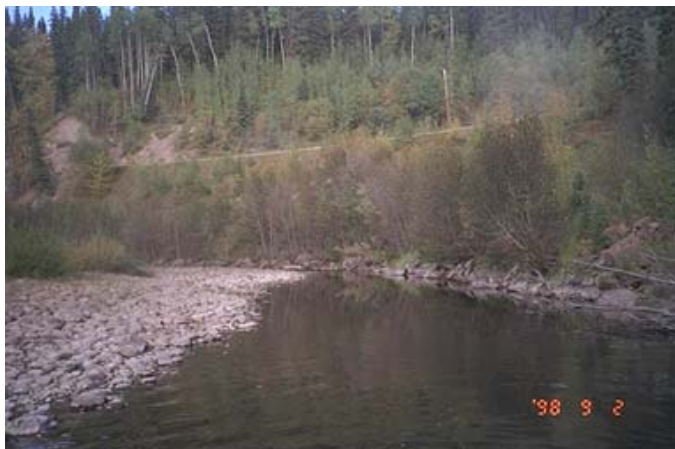
Plate 73: Rip-rap bank channelizing at 4700 metres upstream of the 3/4 reach break, where the Buck Flats Road parallels the creek.

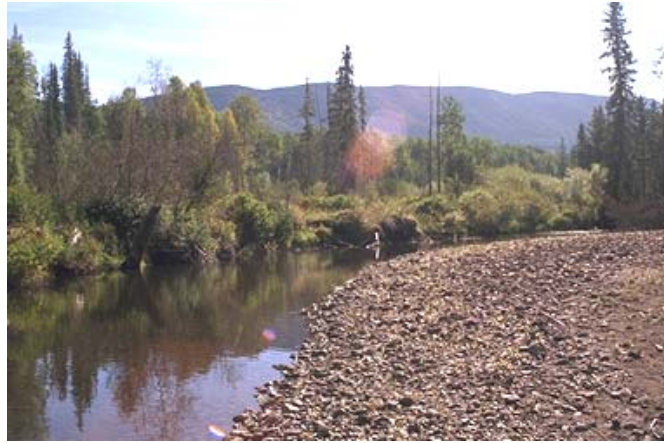
Plate #79 : Old land clearing site at the bottom of the reach.

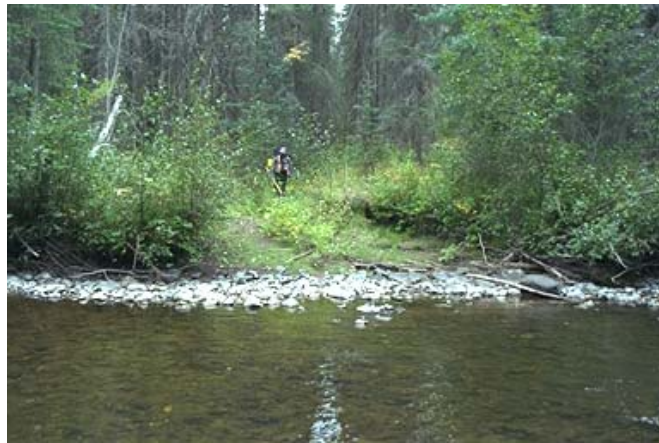
Plate #80: Old skidtrail crossing creek at 3290 metres upstream of the 4/5 reach break.

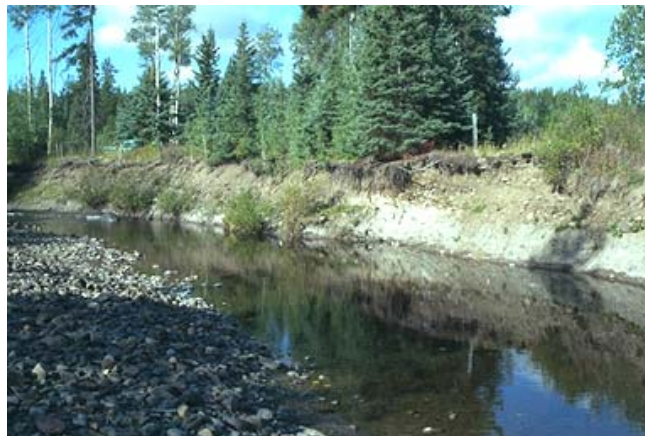
Plate #81: Cleared land and eroding bank at 4969 metres upstream of 4/5 reach break.

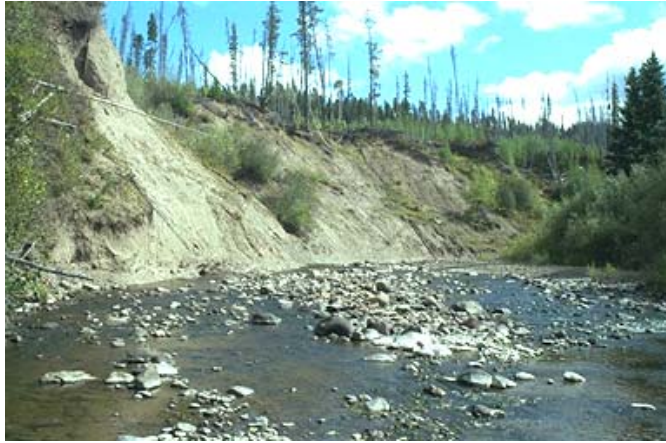
Plate # 86: Estimated 20 metre high landslide located below a selectively logged section of the Swiss Fire, on the downstream right side at 870 metres above the 5/6 reach break. A major source of clay input.

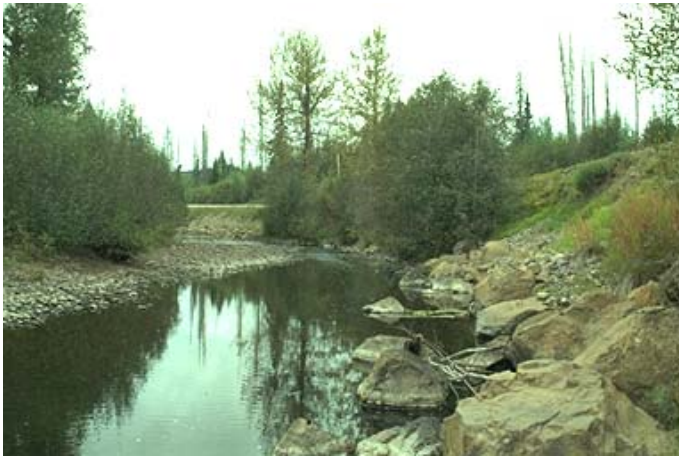
Plate #87: Rip-rapped channelized section of the reach where the Buck Flats Road parallels the creek located 2750 metres upstream of the 5/6 reach break.

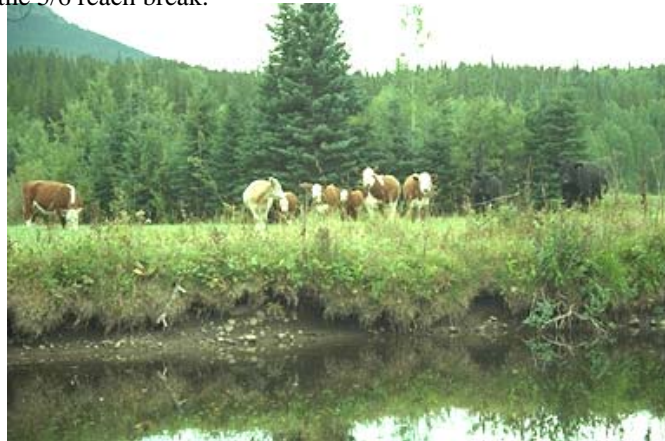
Plate #88: Land clearing to the stream bank for cattle grazing associated with loss of bank stability, sediment inputs, and soil compaction. Located 2800 metres above the 5/6 reach break.

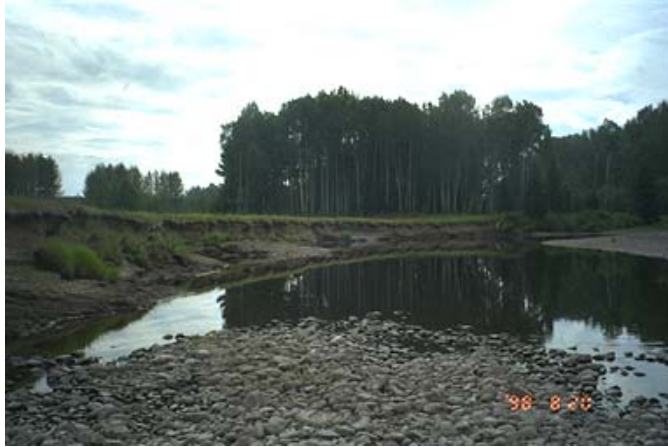
Plate #101: Cleared hayfield with eroding bank in lower half of reach resulting in complete loss of riparian vegetation, soil compaction and sediment input.

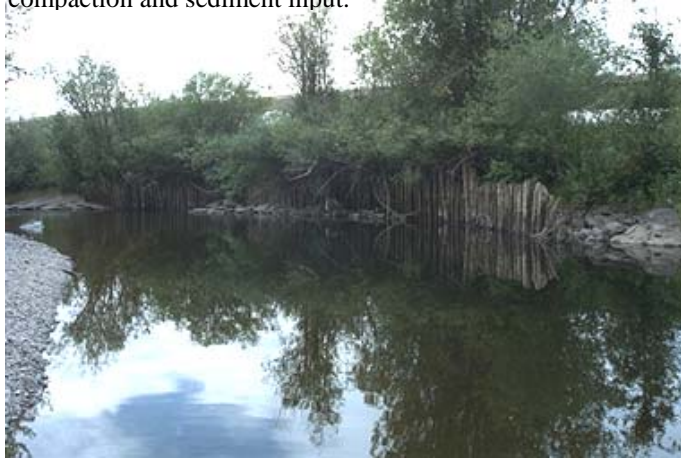
Plate #102: Flood protection dyking occurring mid reach (just upstream of the Highway 16 bridge enforcements) contributing to stream channelization.

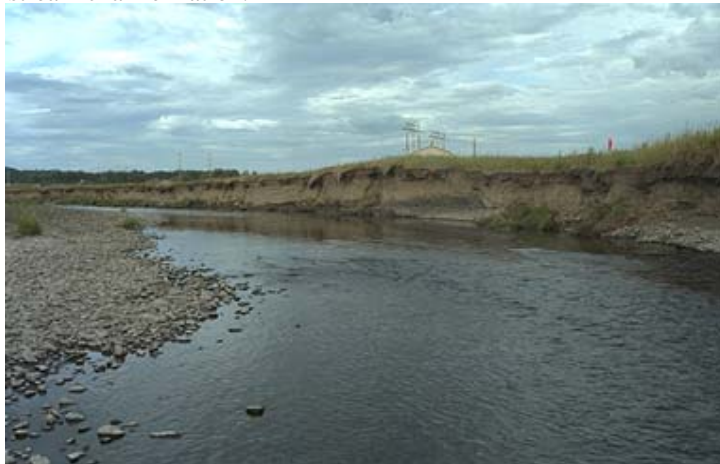
Plate #103: Powerline corridor right-of-way paralleling the system at 900 m upstream of the Bulkley/Morice River confluence.

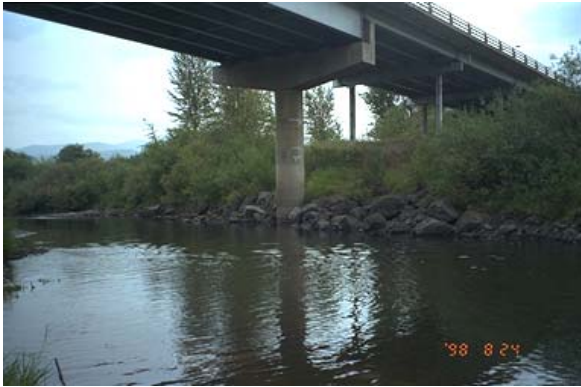
Plate #112: Downstream view of the rip-rapped Highway 16 bridge crossing (east of Houston), channelizing that section of the reach.

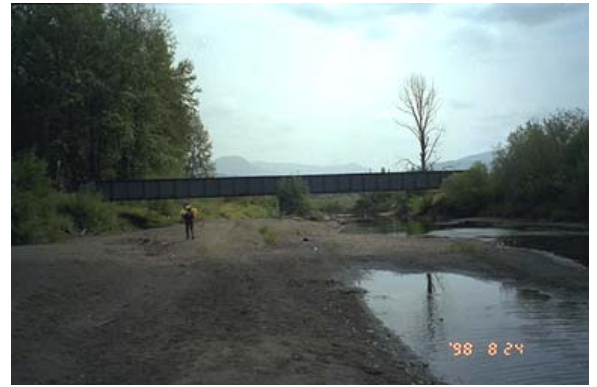
Plate #113: CN railway crossing aggraded section of reach (sediment wedges) approximately 2500 metres upstream of the 1/2 reach break.

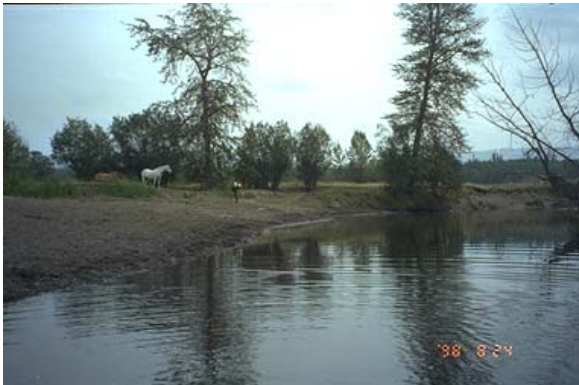
Plate #114: Livestock watering area and rip-rapped farmer's field located 3100 metres upstream of the 1/2 reach break.

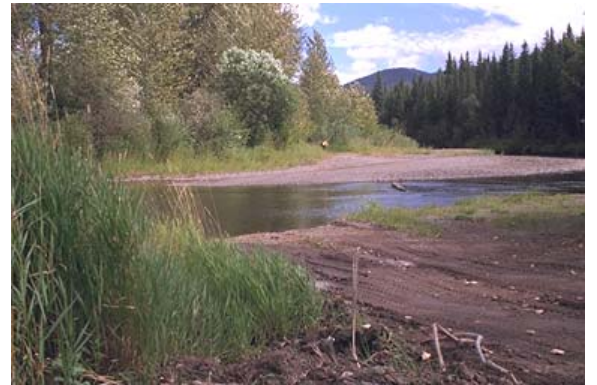
Plate #115: Ford across channel at approximately 22000 metres above the 1/2 reach break.

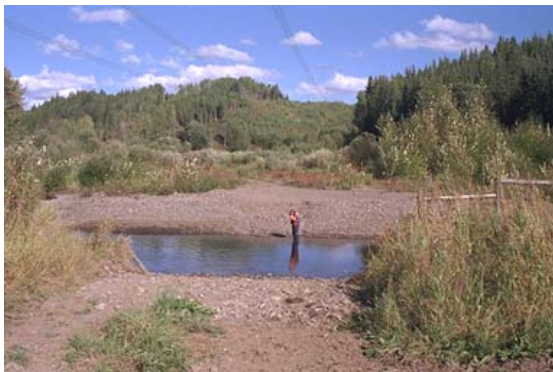
Plate #116: Cattle crossing near the powerline at the top end of the reach, resulting in increased sediment and nutrient input, loss of riparian vegetation, and compacted soils.

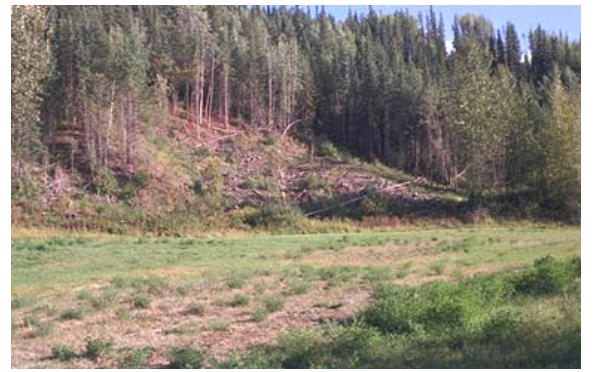
Plate #117: Small, privately logged patch at the top end of the reach.

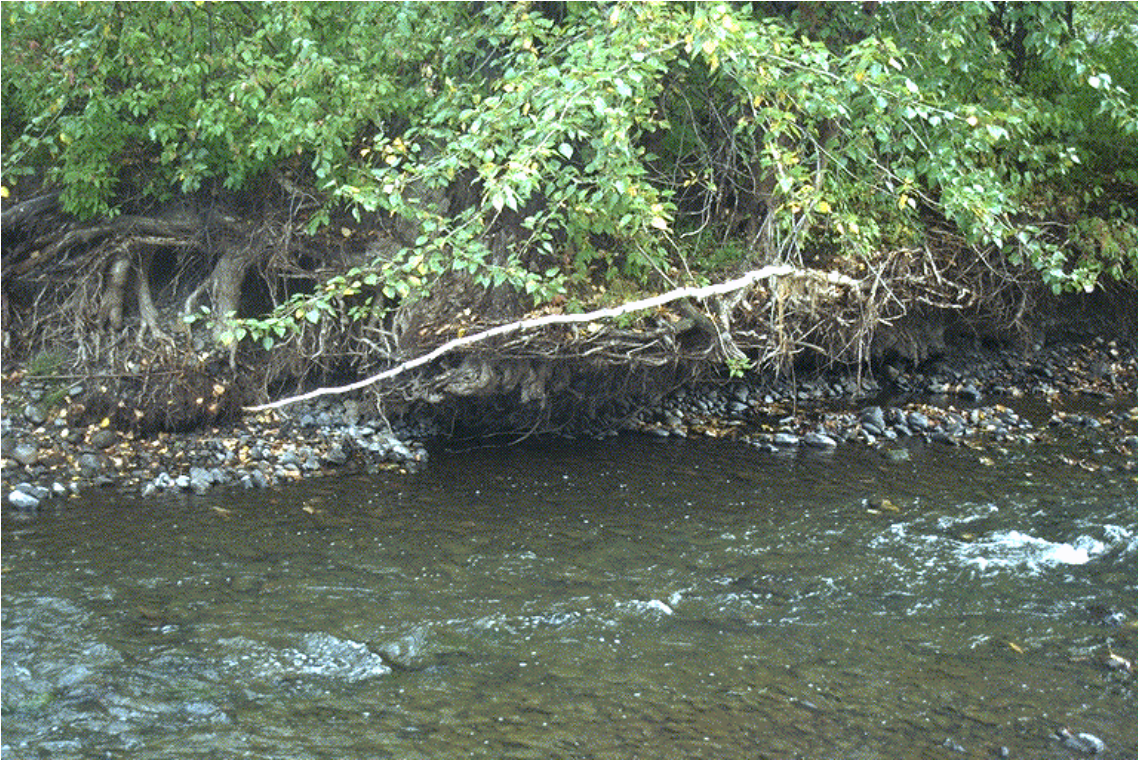
Plate #123: Bank erosion occurring at the head of CN rip-rapped section approximately 440 metres upstream of the 2/3 reach break.
