**MORICE RIVER  
WATERSHED ASSESSMENT**

**Survey of logging related impacts on Cedric, Lamprey, Fenton and Owen Creeks**

**Prepared by  
Regina K. Saimoto  
SKR Environmental Consultants**

**for  
B.C. Environment  
(Watershed Restoration)**

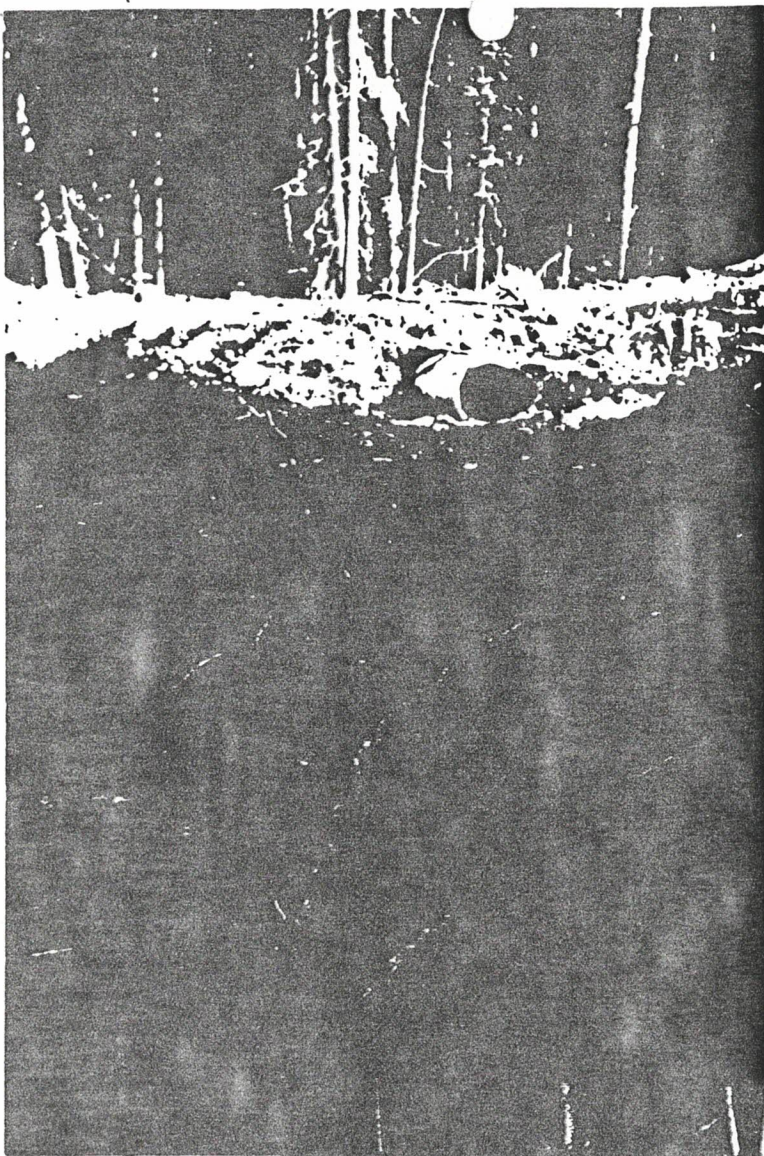
**Figure 2 (Left).** Creek 460-6006-364-192 Site D, illustrating damage due to recent road construction. Note large amount of debris in creek.

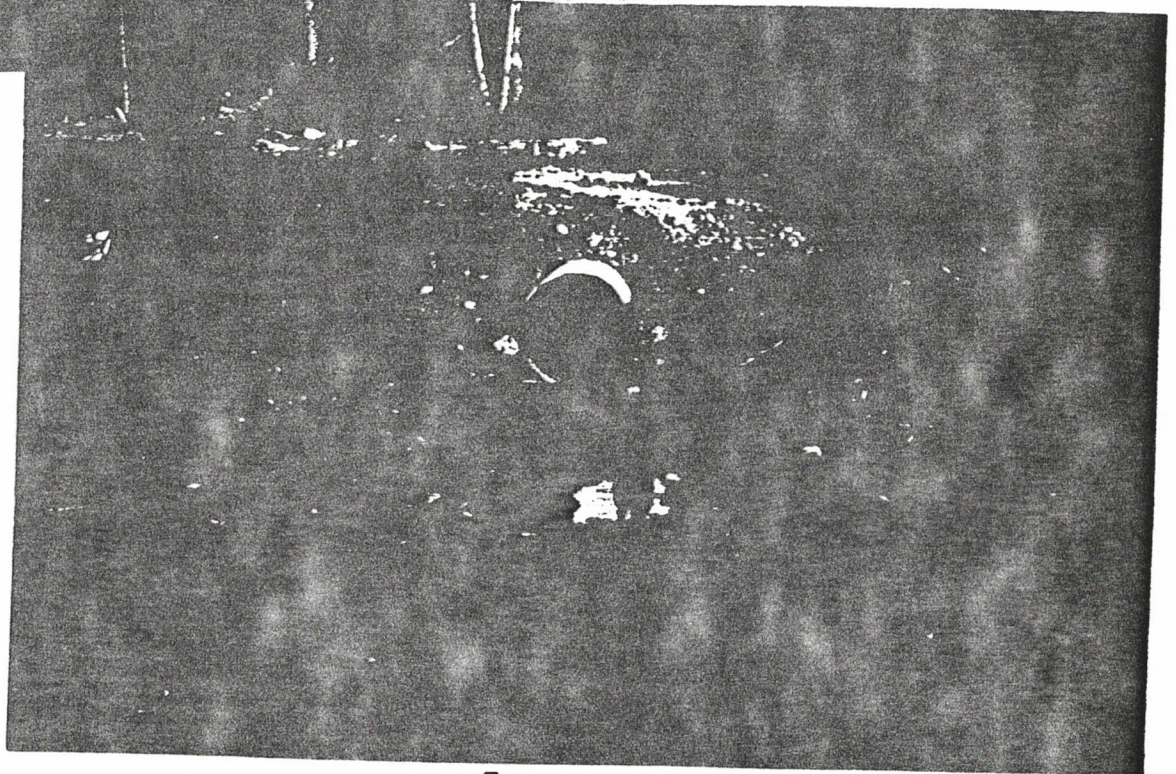
**Figure 3 (Below).** Creek 460-6006-364-263 Site C. Damage due to recent road construction. Note turbidity of water, lack of riparian vegetation and vegetation on banks of road, soft substrate immediately downstream of culvert.

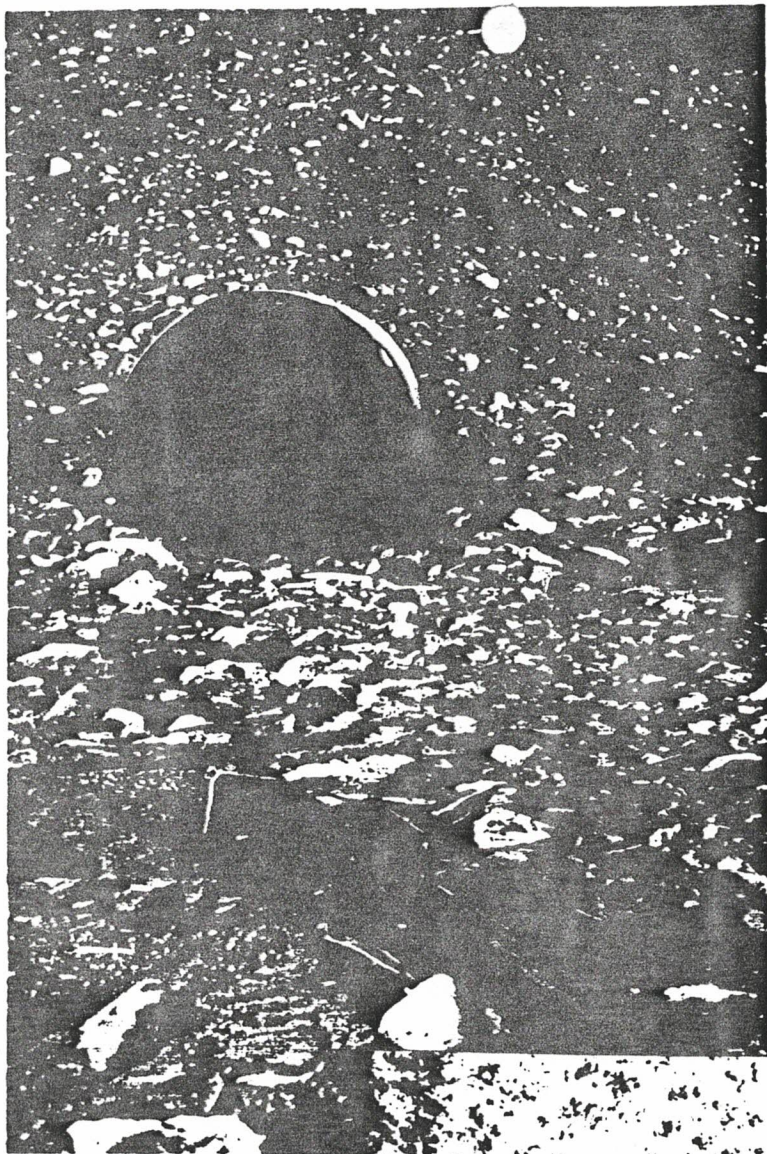
**Figure 4 (Left).** Creek 460-6006-364-397-324 Site C. Increased siltation and increased erosion potential due to recent road construction.

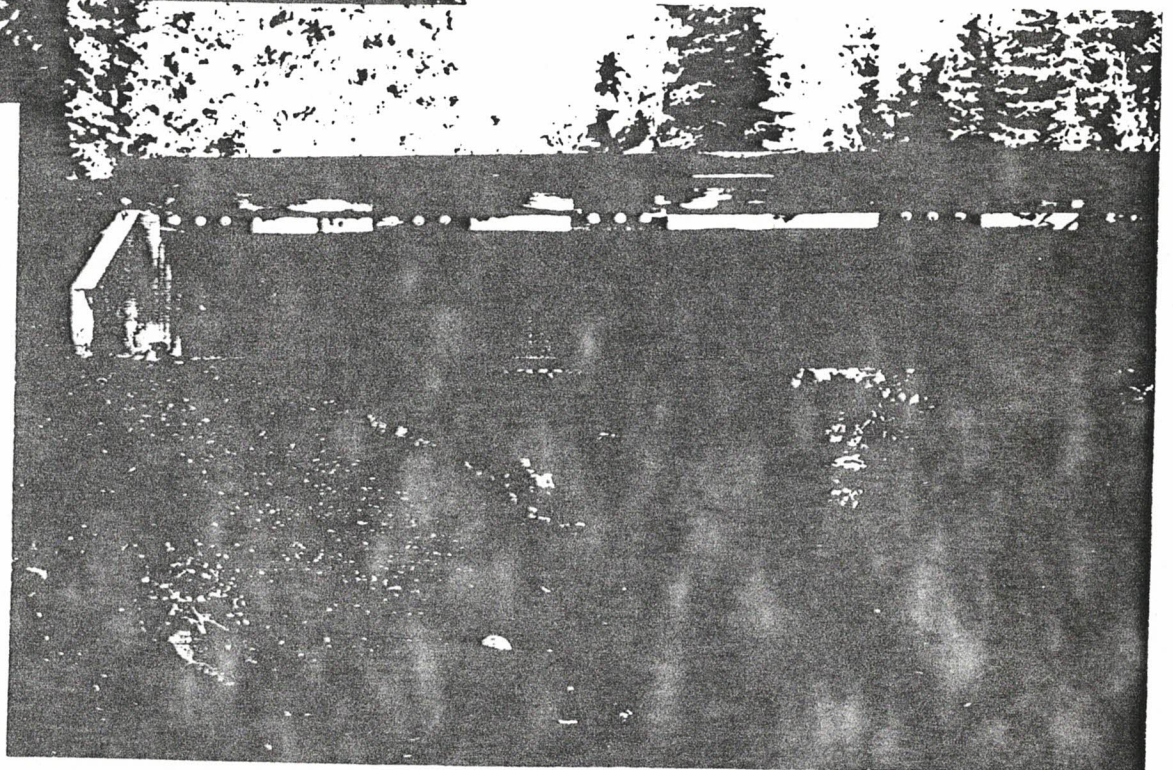
**Figure 5 (Below).** Creek 460-6006-364-397 Site B. Bridge at Pimpernel Creek. Dust from bridge traffic adds to the siltation of Pimpernel Creek at this site.

Although the bridge does provide adequate access for fish, traffic across the bridge appears to increase sedimentation in the creek immediately below and above the bridge. Dust disturbed due to logging and other traffic enters the creek, and turbidity was observed to increase rapidly due to use of the road. A time of 15 minutes or more elapsed before the turbidity cleared.

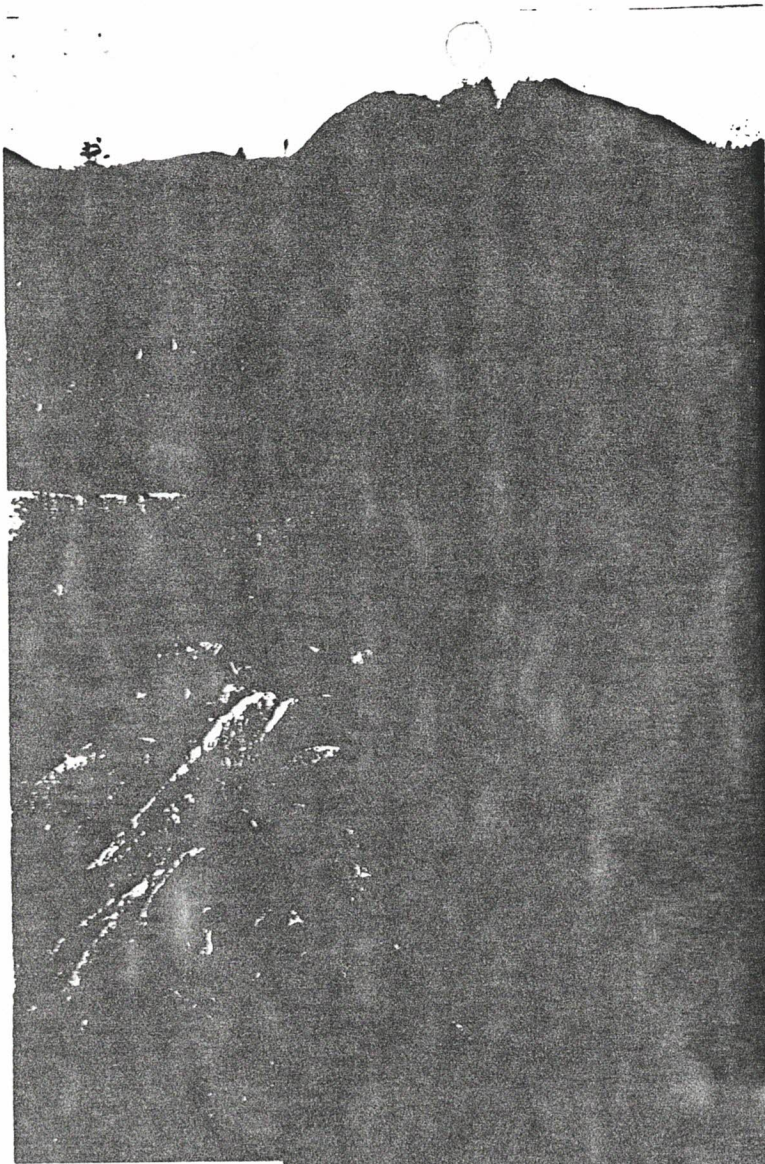
**Figure 6 (Left).** Creek 460-6006-364-397-324-447 Site C. Road deactivation site. Road crossing via a culvert has been removed, but the culvert remains adjacent to the creek bed.

Few roads were found to be at various stages of deactivation. One of these sites (Creek 460-6006-364-397-324-447 Site C [Figure 6]) was deactivated at the first creek crossing by removal of the culvert. The culvert was excavated, but was left lying beside the creek bed. A culvert was found lying in a creek situated in a ravine near a road crossing. This culvert should be removed, unless removal will cause excessive damage to the stream or riparian vegetation (Creek 460-6006-364-202 Site B [Figure 7]). It is suggested that in future deactivations where culvert or bridge removal is involved, the man-made structure be removed, and that the exposed soil be reseeded as soon as possible.

4. Culverts remaining in creek beds with no purpose (e.g. Creek 460-6006-364-397-324-447 Site C) should be removed with as little damage to the creek as possible. All culverts and bridges of deactivated roads should be removed, and exposed soil should be reseeded.

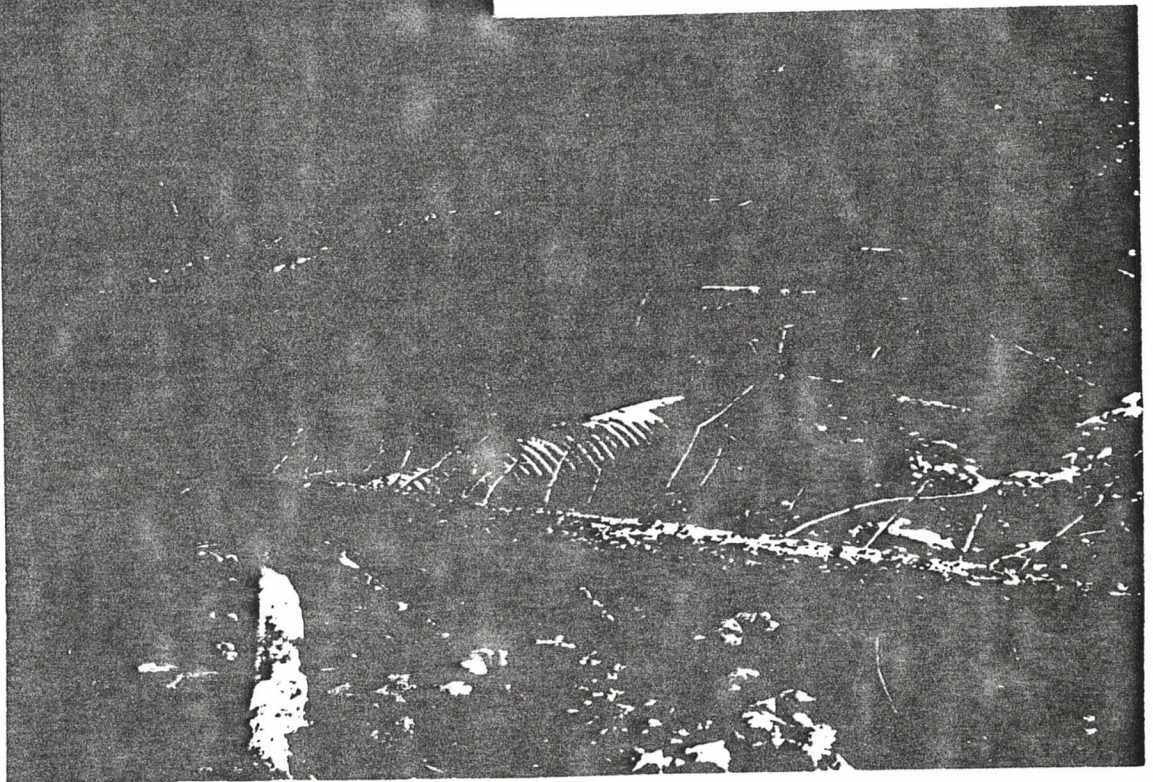
**Figure 7 (Below).** Creek 460-6006-364-202 Site B. Culvert in creek bed near road crossing. Also note the large amount of windfall.

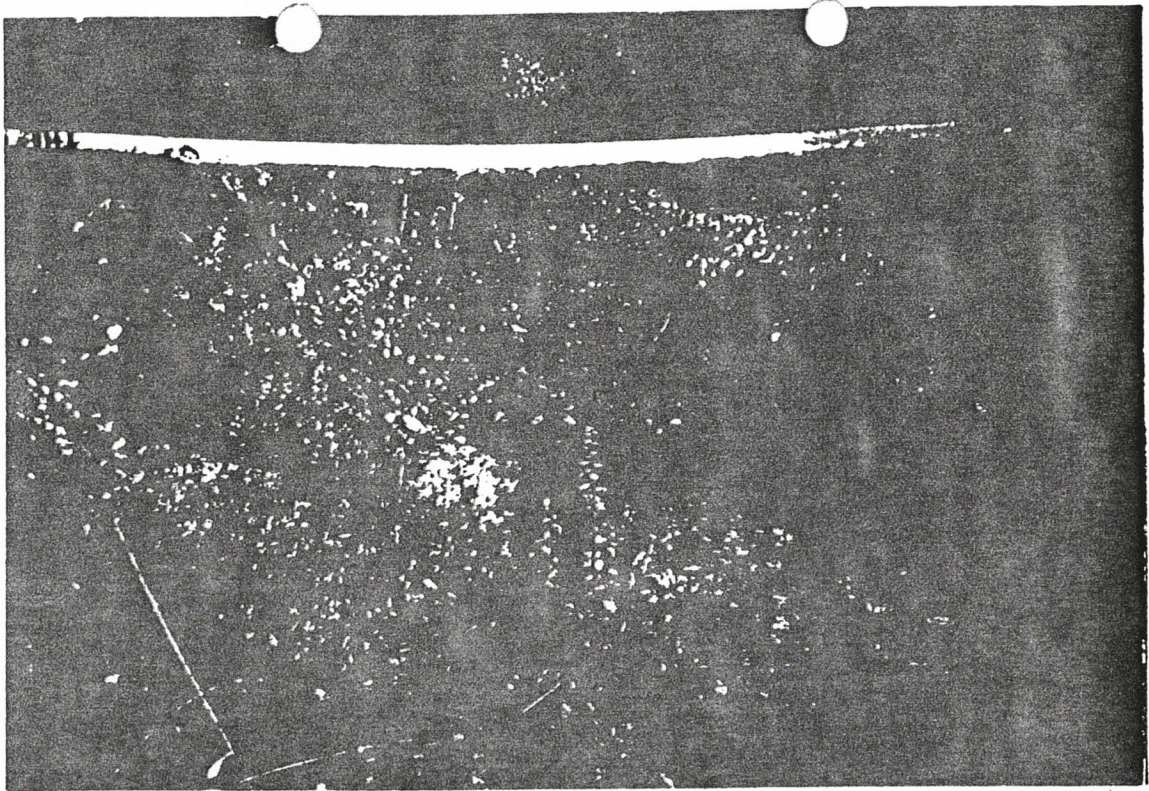
Fenton Creek is a relatively small tributary to the Morice River. One culvert is located under the Morice River road. Morris and Eccles (1975) reported that this culvert was a definite barrier to fish movement, and attributed difficulties in fish passage to steep gradient, long smooth flow and the drop from the culvert to the creek bed. Due to the location of the culvert, the surrounding terrain, and the gradient immediately below the culvert, it remains a barrier to fish, at least at some flows. In addition, the sharp turn in the Morice River Road at this location (Creek 460-6006-266 Sites A and B) contributes to siltation of Fenton Creek (Figure 8). Due to the nature of the turn, the road is sloped towards the creek. Water drains across the road, carrying silt directly into Fenton Creek. This is evident after only little precipitation. Signs of are present on the edge of the road, immediately above the culvert. A mower mowed the riparian vegetation and other vegetation around the down stream side of the creek to increase visibility at this sharp turn. This leads to further destabilization of the bank. It is also evident that reseeded of the bank from the road will not aid in reducing erosion and siltation since it will need to be cleared to increase visibility. Due to the siltation problem at

**Figure 8 (Above).** Creek 460-6006-266 Site A. Erosion problem at Morice Main Road crossing. Note large amount of siltation and signs of erosion.

this site, the difficulty in passage presented by the culvert, as well as dangers associated with a sharp turn on a logging road, it is suggested that a different method for crossing the creek be found. Reseeding the placement of rip-rap will not be sufficient.

5. The Morice River road crossing at Fenton Creek should be assessed by a hydrologist and engineer for recommendations as to the alteration of the creek crossing to reduce siltation, erosion, and to allow for the growth of vegetation to stabilize soils on the downstream side of the creek. In addition, an alternative crossing should provide passage for fish at all water levels.

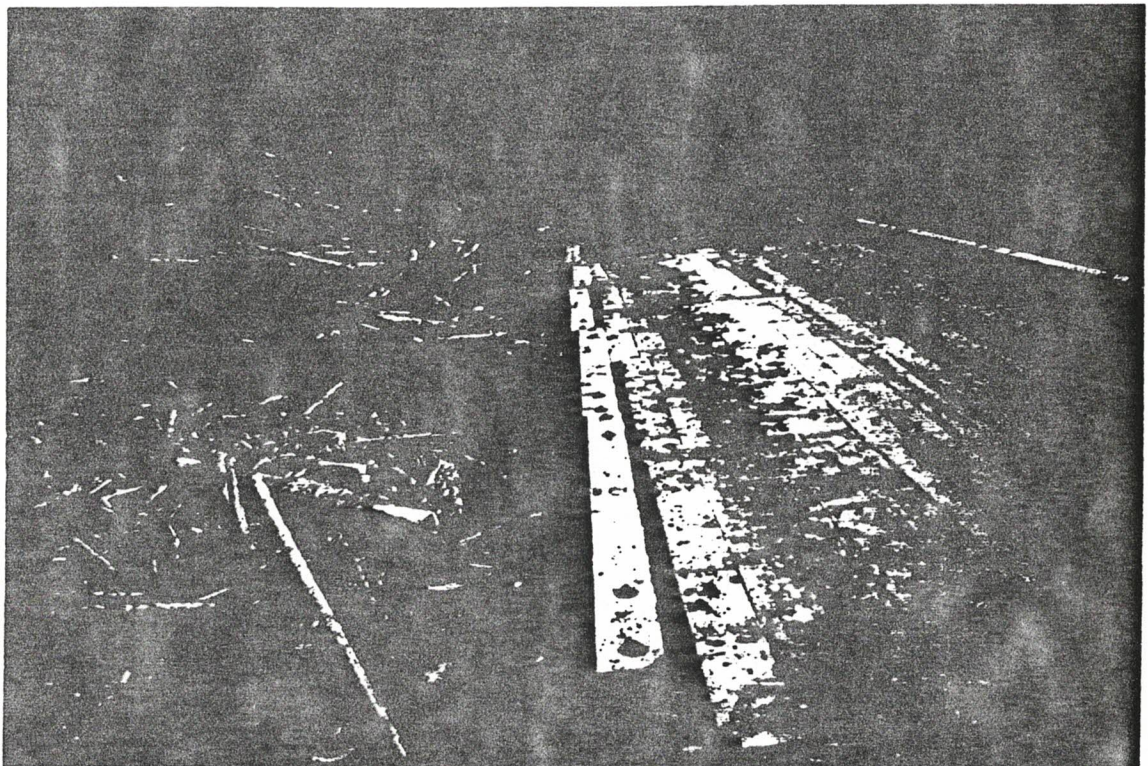
**Figure 9 (Below).** Creek 460-6006-266 Site C. New bridge crossing. Note that the bridge is twisted, and the debris in and around the creek.

A new road was constructed at the upper sections of Fenton Creek to access new logging areas (Site C) (Figure 9). The bridge at this location is twisted and should be stabilized if the road continues to be used. Erosion signs in the surrounding area were present, and this site should be reexamined during higher run offs. At least two old roads, still showing some use, crossed minor creeks with no provisions for water flows. Culverts should be installed at these sites to decrease sedimentation further down stream. In addition, two cutblocks are planned to be logged in the near future (at least one this winter). It is suggested that the areas of Fenton Creek near these cutblocks be reexamined in 1995.

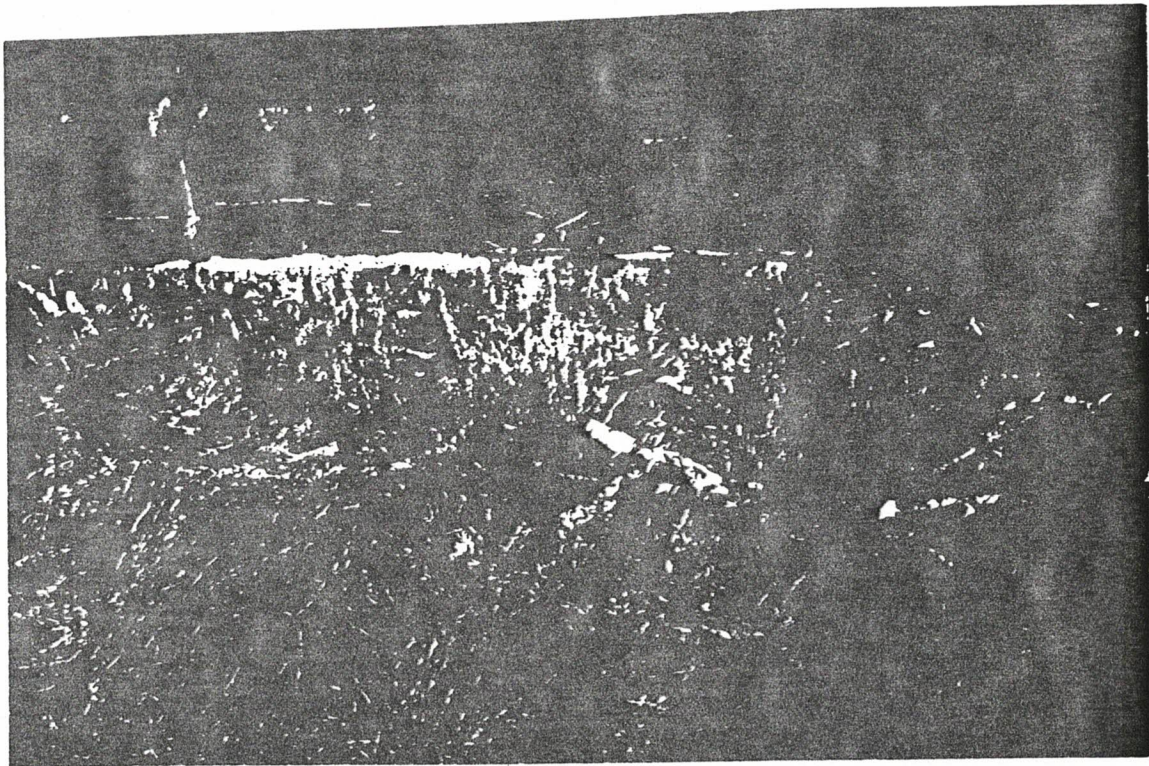
Logging practices have also influenced the tributaries of Owen Creek. Creeks were logged right to the edge in some instances (Figure 10), and riparian vegetation should be replanted at these locations. In addition, in this area, as in others (eg. tributaries to Lamprey Creek), logging close to the edge or into ravines causes an increase in windfalls which in turn increase the debris in the creek. It is suggested that cutblocks remain at least 3m away from the edge or ravines to decrease the likelihood of uprooted trees on steep slopes and soil instability. ←

**Figure 10.** Creek 460-6006-239-433-225. Logging and slash burning around creek. No riparian vegetation remains around the creek. The wetland below has also been impacted by logging and burning.
