34 KM, SUSKWA MAIN FSR

STREAM RESTORATION, CULVERT OUTLET HYDROLOGIC AND GEOMORPHIC ASSESSMENT

(W.C. 46 - 700 - 30-130)

October 30, 1998

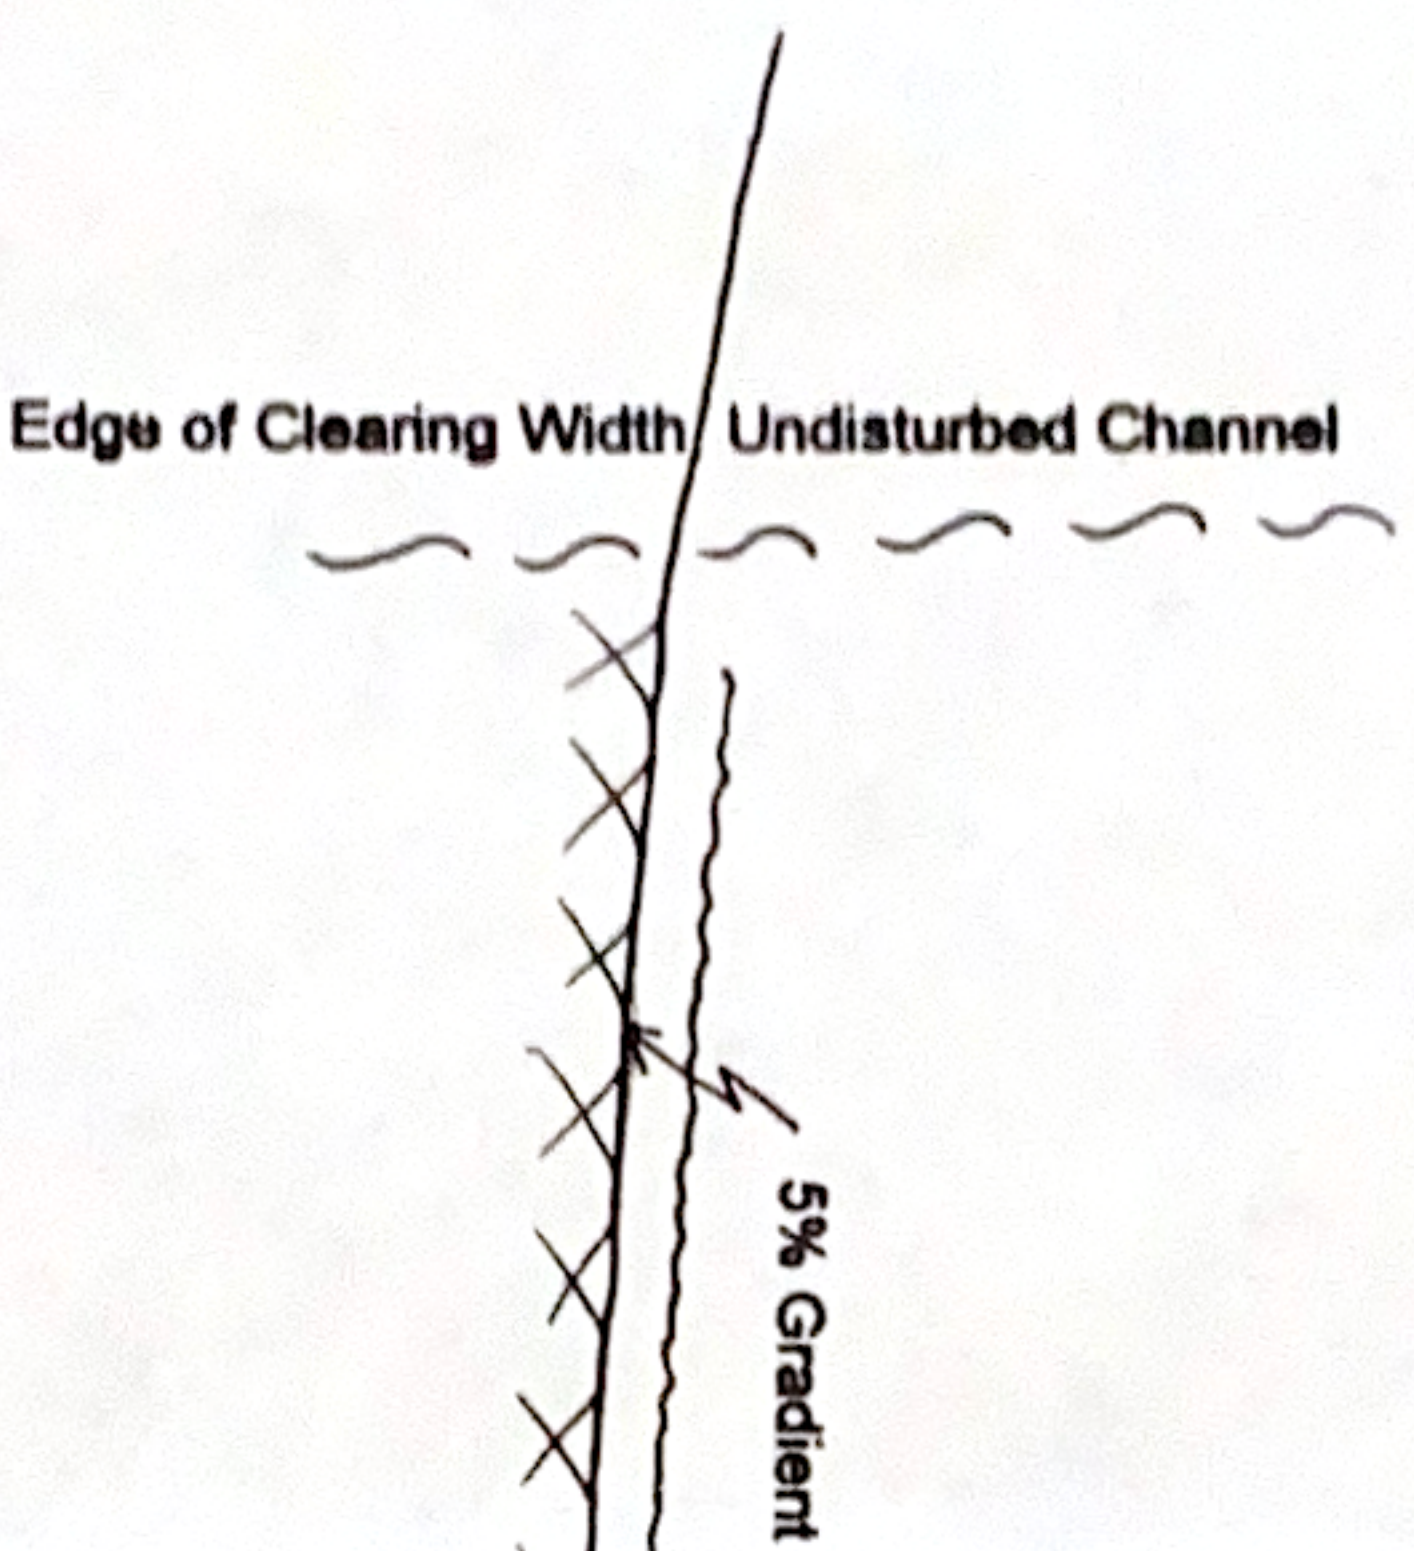
SUSKWA FSR, 34 KM STREAM CROSSING Reconnaissance Profile

Bed material size: $d_{50} = 23 \text{ cm}$

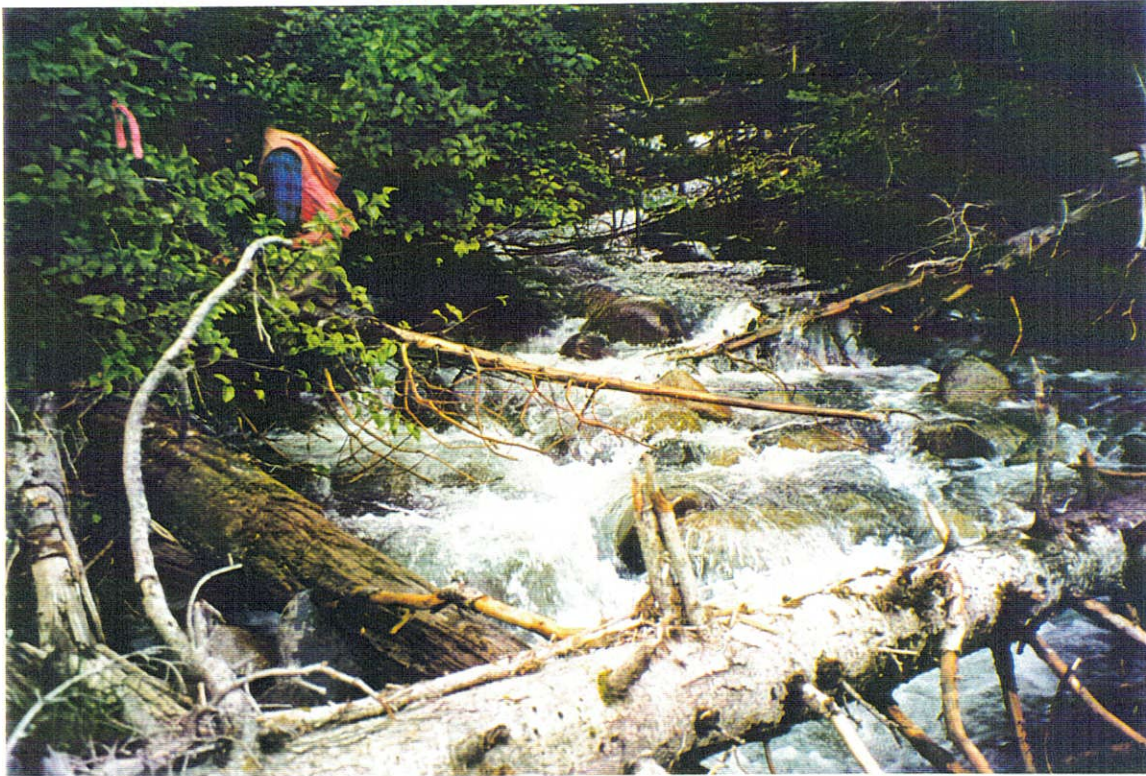
Photo1: Boulder step, 15 m upstream of the culvert; looking upstream; 16/06/98

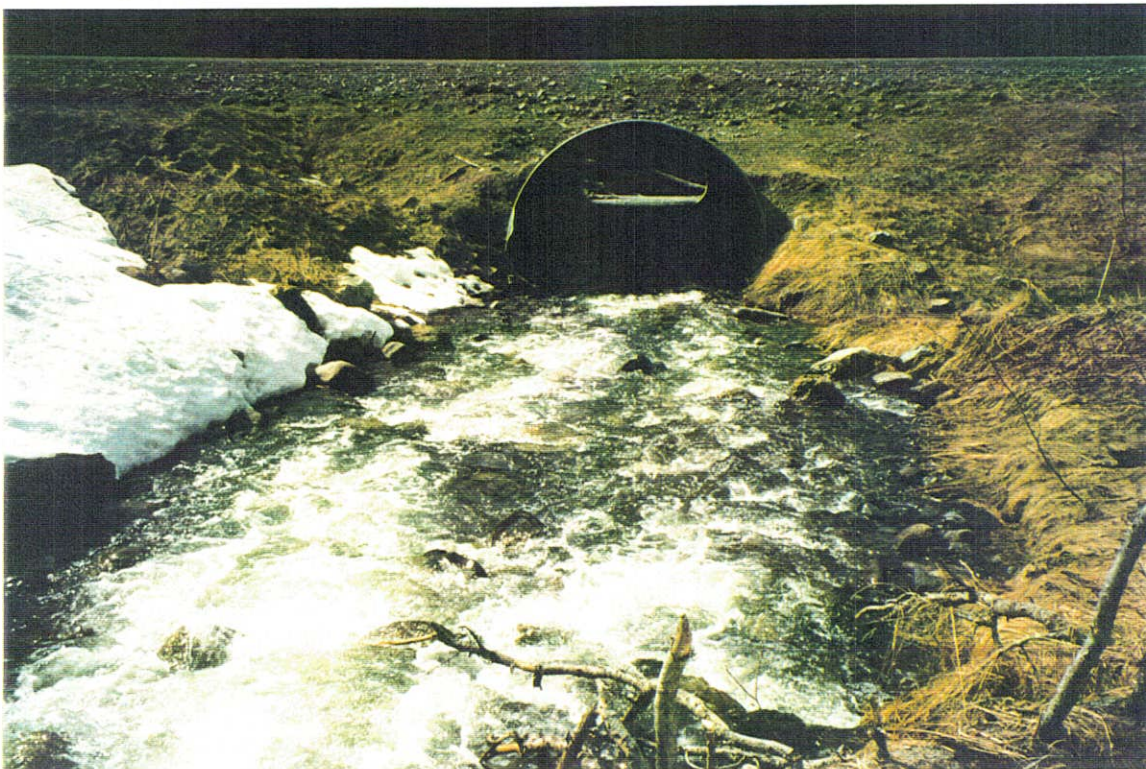
The culvert has a gradient of 5 %, over a length of 21.5 m. It is placed level with the stream bed at the inlet. No sediment or woody debris was deposited in the culvert; however, during the second site visit in June, a 66 x 39 x 29 cm boulder was found inside the culvert near the outlet. This boulder was not there during the site visit in May. This observation is evidence that large size bedload moved through the culvert, possibly during a flood event on May 26, 1998, which affected other streams in the Suskwa Watershed.

Photo 2: Culvert inlet; looking downstream; 17/05/98

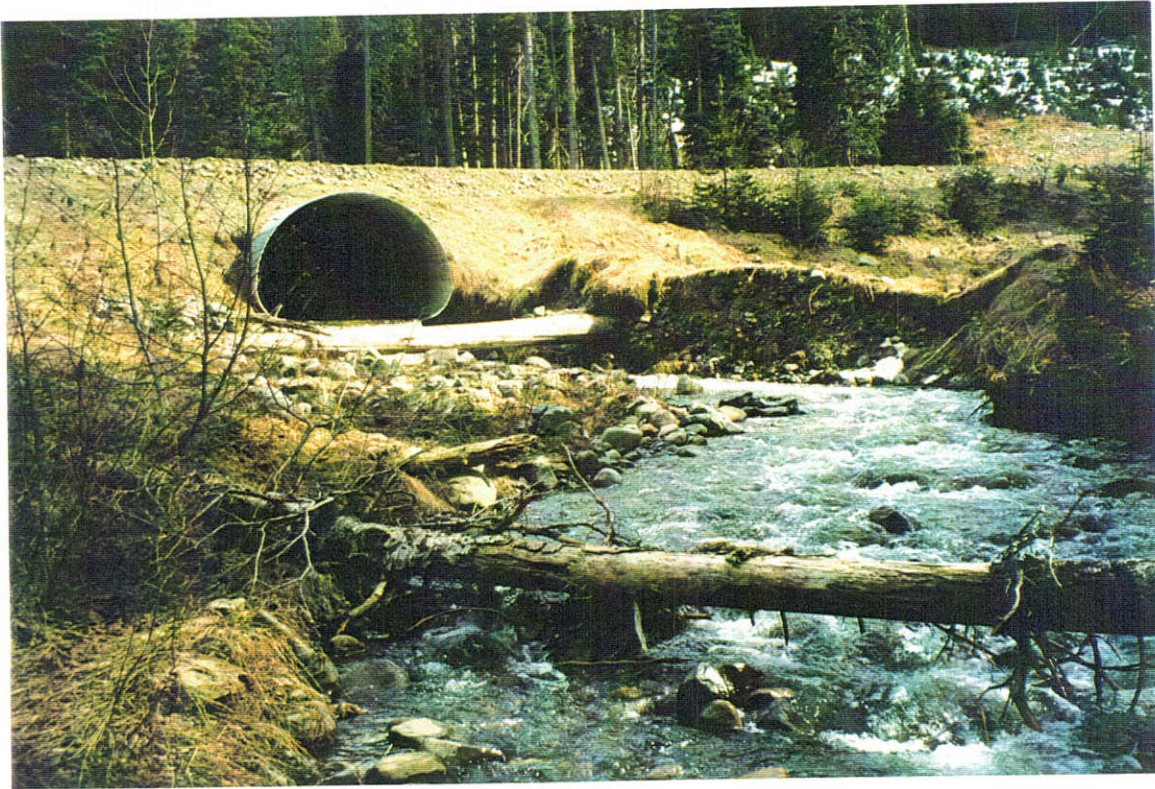
In the 3,890 x 2,690 mm multi plate arch culvert, the natural channel width is reduced to less than 4 m. Flow is accelerated, causing erosion and scour at the outlet of the culvert. Presently, the culvert outlet is .85 m perched above an 0.8 m deep scour pool. Continuing erosion at the outlet slowly enlarges the scour pool, and has caused 0.9 m wide undercutting under the culvert invert. Bedload is mobilized from the 1.5 m high channel banks just below the culvert and is deposited in the gentler channel section in the forest downstream. Two logs were placed perpendicular to the stream flow, 4.5 m downstream of the culvert, spanning the entire channel width. The logs may have been partly embedded in a 5 % channel bed when the culvert outlet was built in 1988. They are now undermined and have approximately 0.7 m clearance above the channel bottom. The down-cut channel section extends over a length of 16 m below the culvert. Downstream of that point, the pre-construction channel banks remain intact. Bank height is 30 to 70 cm.

The culvert presently blocks fish passage because (1) the jump at the outlet is too high ($\pm 0.9 \text{ m}$) and because (2) flow velocity in the culvert is too fast. A recommended height for vertical jumps is 0.15 m for trout and 0.3 m for adult salmon (p. 19, Stream Crossing Guidebook for Fish Streams, BC Ministry of Forests, 1997). Flow velocity measured in the culvert on June 16, 98 was 1.54 m/s during the relatively low discharge of $0.82 \text{ m}^3/\text{s}$. Adult Dolly Varden and Bulltrout require flow velocities less than 0.9 m/s to swim upstream through a culvert for a distance of greater than 18 m (p. 18, Stream Crossing Guidebook for Fish Streams).

Photo 3: Culvert outlet; looking upstream; 17/05/98

In order to restore access to the fish habitat upstream of the culvert, flow velocity in the culvert has to be reduced to 0.9 m/s during fish migration seasons and the jump at the culvert outlet has to be eliminated or reduced to less than 0.3 m.

Reduction of flow velocity through the culvert could be attempted by installing baffles, possibly combined with coarse granular sediment fill between baffles. Sediment may become trapped between baffles naturally. Reduced flow velocities in the culvert will allow fish passage at certain flow levels and will reduce the erosive forces at the culvert outlet. Engineering expertise will be required to evaluate the effectiveness of various baffle types at fish passage flow levels and the reduction in flow velocity that can be achieved. While the culvert appears oversized for the stream, the hydraulic capacity of the altered culvert area with respect to Q_{100} must also be assessed by a Professional Engineer. Pre-fabricated baffles can be ordered from Armtec (pers. communication, Al Harrison). Engineering Section, Prince Rupert Forest Region, may be available to provide engineering expertise (telephone conversation, Don John, 30/10/1998).

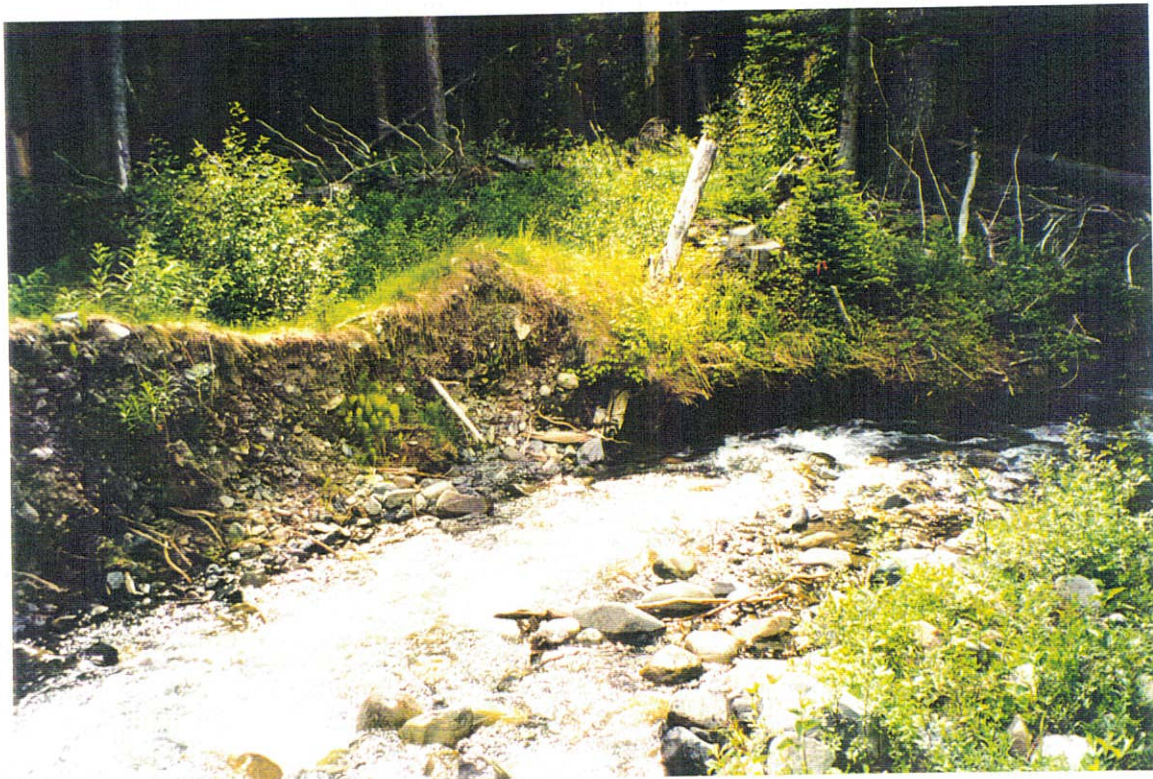
Creating a tailwater effect in the culvert by raising the weir at the culvert outlet is not recommended. Natural, pre-construction channel banks starting 16 - 20 m downstream of the culvert, near the edge of the right-of-way clearing, are low (0.3 to 0.7 m). The start of the low banks sets the limit for the downstream extent of the raised channel bed. The height of the weir required to create a tailwater effect would bring the gradient of the 20 m long, built-up channel section to more than 9 %. This was considered undesirable because the higher flow velocity on the steeper gradient reduces fish passage and the higher erosive force reduces channel bed stability.

Photo 4: Transition from scoured channel bed with high left bank to low pre-construction left channel bank; looking downstream; 16/06/98
