**Summary of Monitoring and Evaluation of In-Stream Works at Sites 14
and 15 in the Kitwanga River South Sub-Basin to March, 1999**

Prepared for the
Gitsegukla Band Council

by
Alan Gilchrist, Ph.D.
Hydroglyphic Terrain Analysts
and
Glenn Grieve, R.P. Bio.
BioLith Scientific Consultants Inc.

March 31, 1999

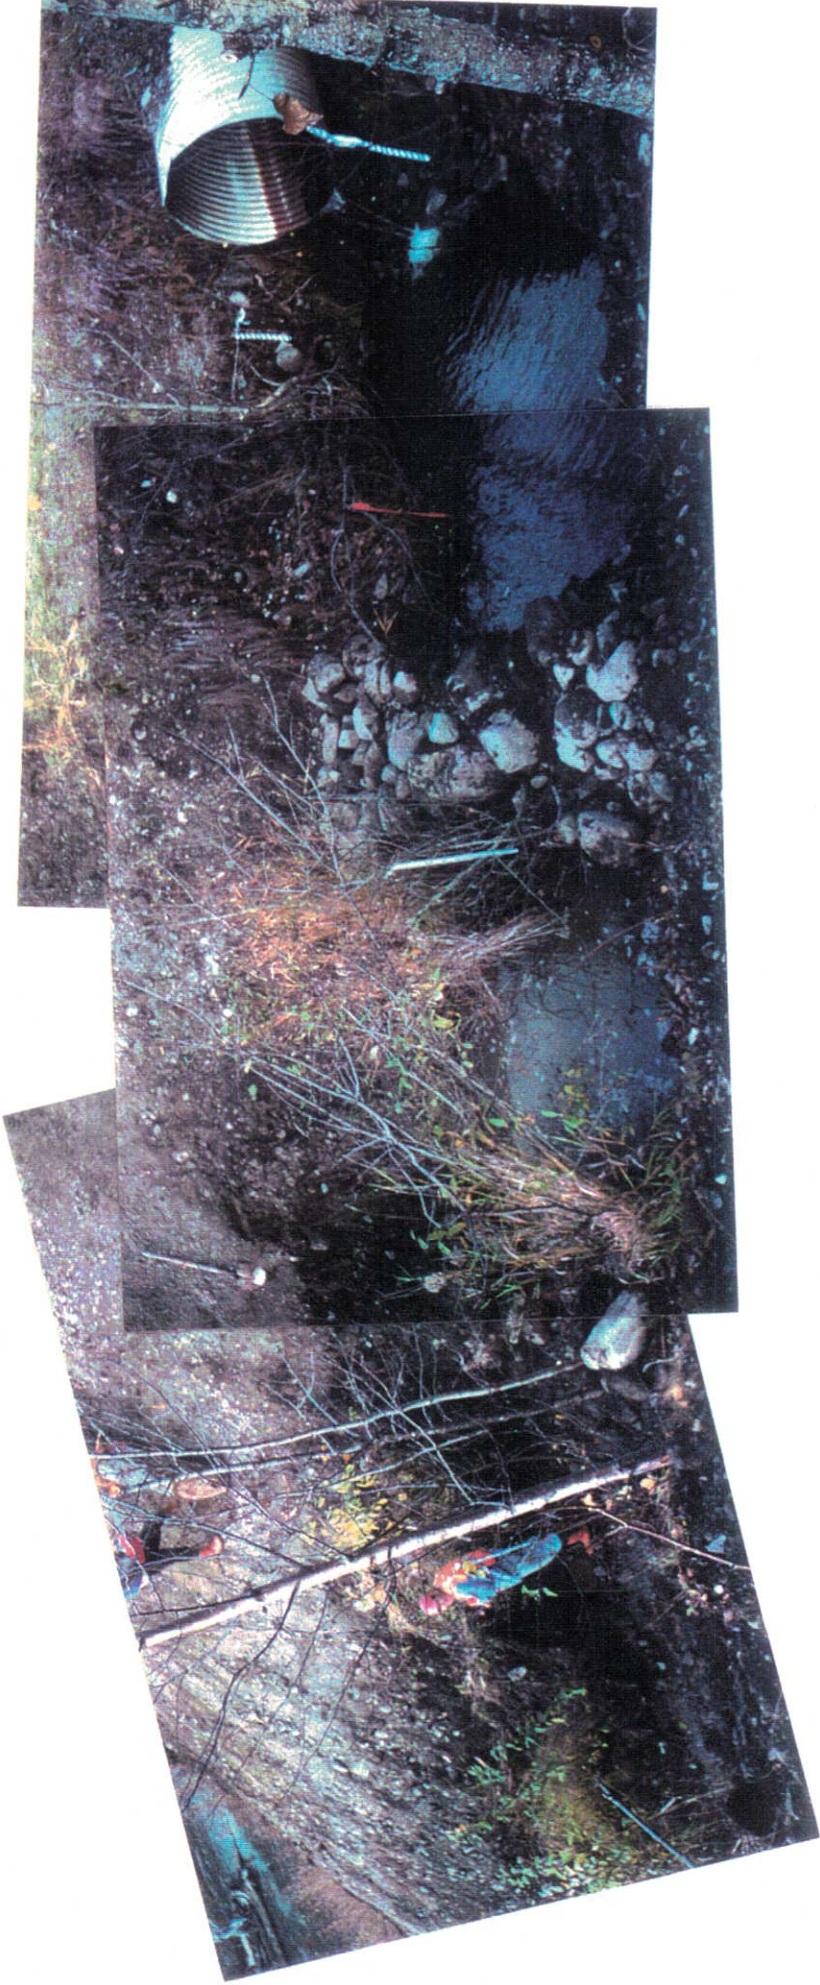
Photo 1. This mosaic looks north during the construction at Site 14. Visible from the perched culvert downstream, are the excavated plunge pool, a small rock weir, another plunge pool and the pulled back bank.

In this letter they expressed concern regarding Site 14 with respect to the pull back of banks, inadequate seeding with grass, loss of low shrub and herb cover, inadequate step pool construction using insufficiently sized and improperly oriented materials and inadequate regulatory agency approvals.

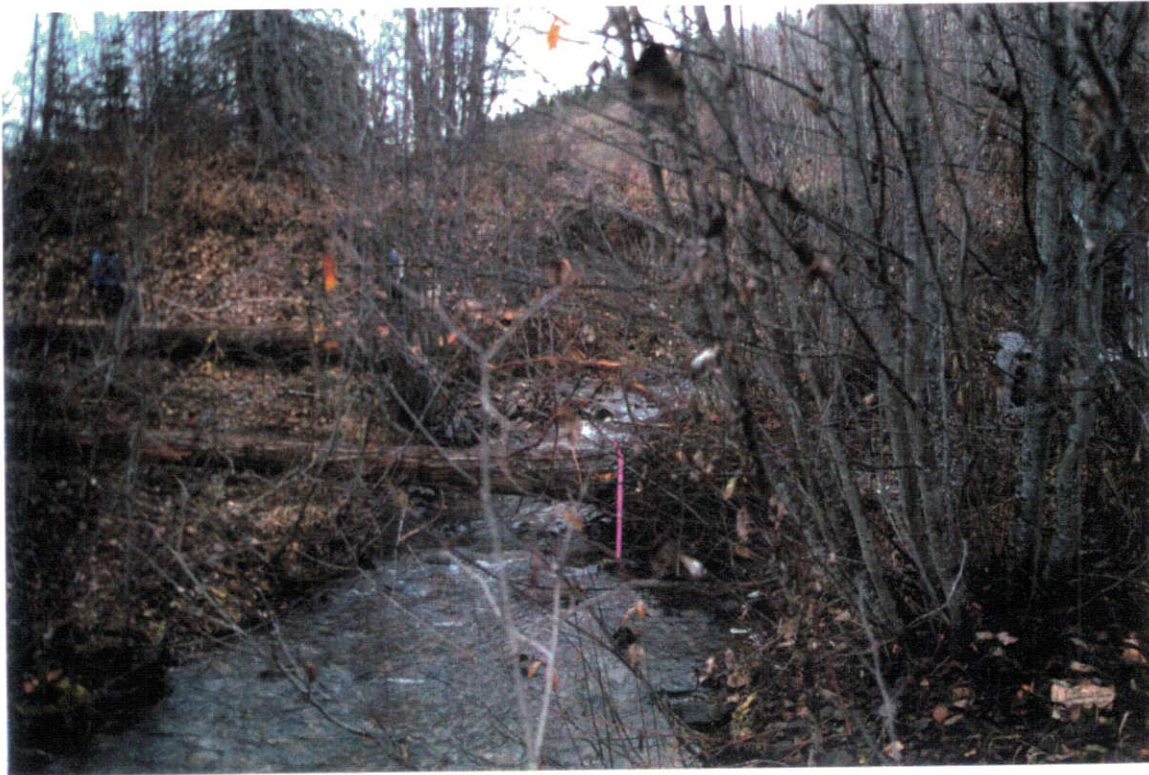
Photo 4. Looking upstream toward the complete tree with root wad attached that was one of two pieces of LWD that were installed across the channel.

With respect to Site 15, they suggested that, although the LWD was of high quality, branches and tops should be left attached. They further suggested that the LWD be anchored. Concerns were expressed over the stability of the debris catchers, possible end scouring around a channel spanning piece of LWD, riparian area degradation by machine use and the channel excavation.

It is recommended that the LWD installed at Site 15 should be anchored to imported boulders >65 cm in their b axis, using steel cable >1.5 cm in diameter epoxied into 15 cm deep holes drilled into the rock using the Hilti Epoxy system. Such boulders may be available along the west Kitwancool Lake FSR.
