**Summary of Stream Restoration Activities at Sites 14 and 15 in the
Kitwanga River South Sub-Basin to March, 1999**

Prepared for the
Gitsegukla Band Council

by
Glenn Grieve, R.P. Bio.
BioLith Scientific Consultants Inc.
Terrace, B.C.

March 31, 1999

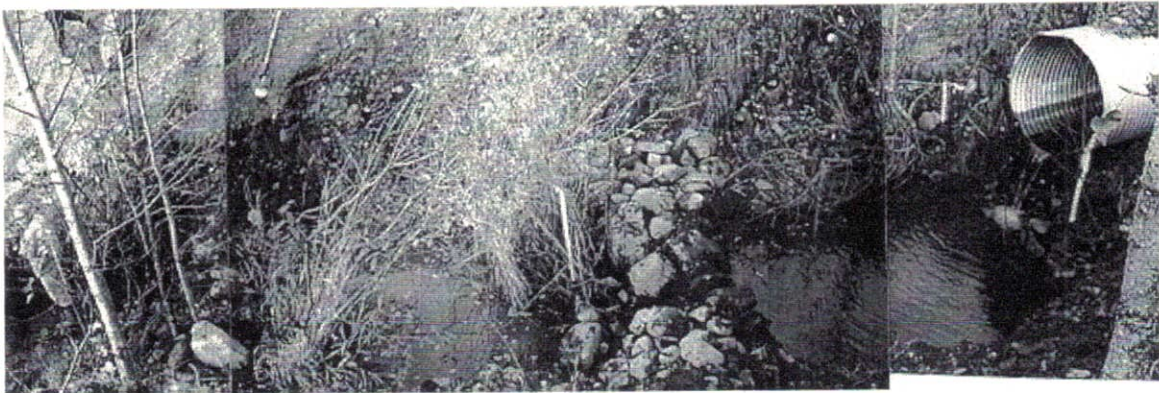
Photo 1. This composite photo looking north shows, from right to left and downstream, the perched culvert, the excavated plunge pool, a rock weir, another plunge pool and the northern pulled back bank.

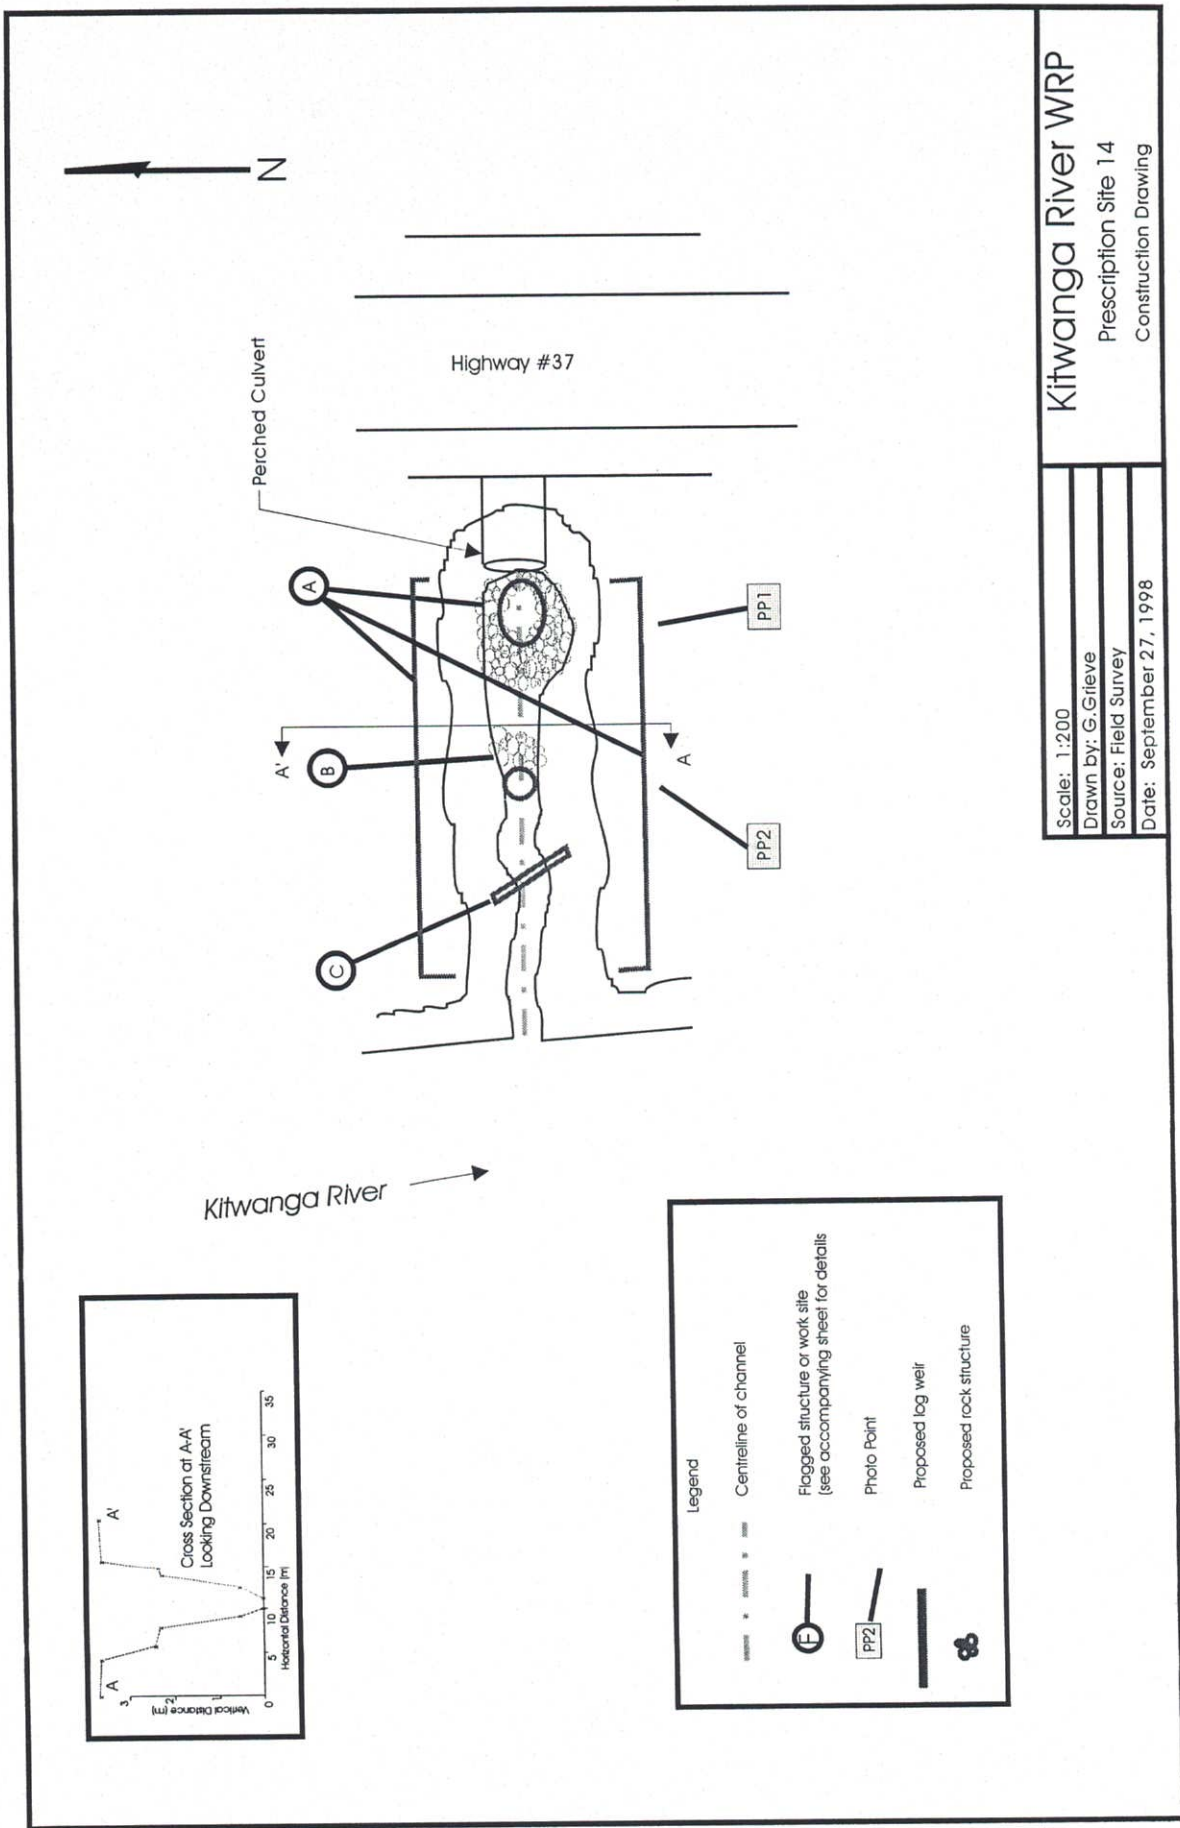
Figure 2. Construction drawing for Site 14, Kitwanga River.

- digging the plunge pool under the culvert deeper,
- the construction of a small rock weir to increase the water depth of the pool,
- a second rock weir further downstream,
- a log placed across the channel and embedded into it and
- the upper third of the bank to be pulled back at the crest of the berms
- waste to be spoiled and seeded on the top of the bank.

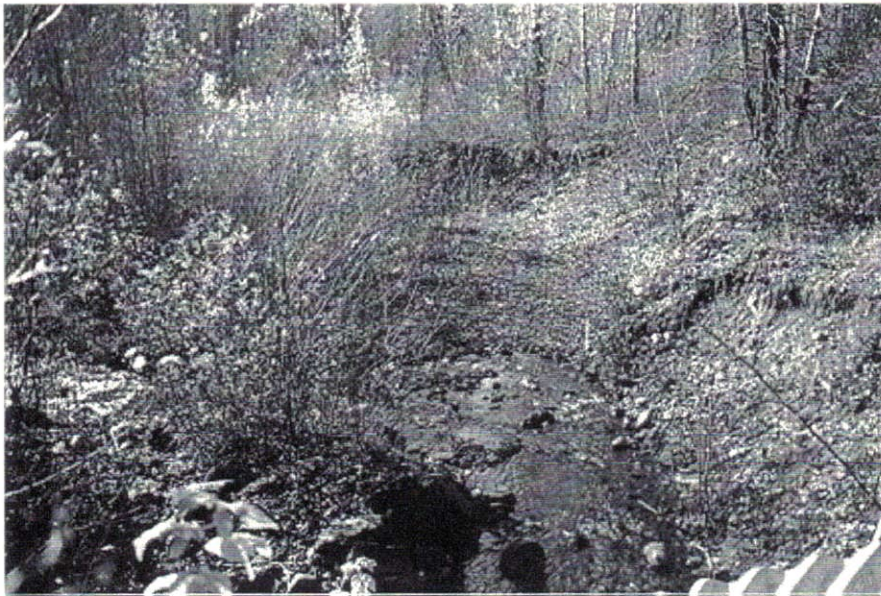
Prescription Site 15 was located on Tributary 18 of the Kitwanga River South Sub-Basin. The project involved the nearly 50 m section of stream below the southern access road into Gitanyow (Kitwancool) Village. The stream was characterized by a large, perched culvert under the access road that was a barrier to fish, some bank erosion on both sides of the stream, some channel instability in the lower section of the stream, a lack of woody debris, few deep pools and limited variety of habitat types (see Photo 2) .

Photo 2. Looking downstream from atop the perched culvert before construction.

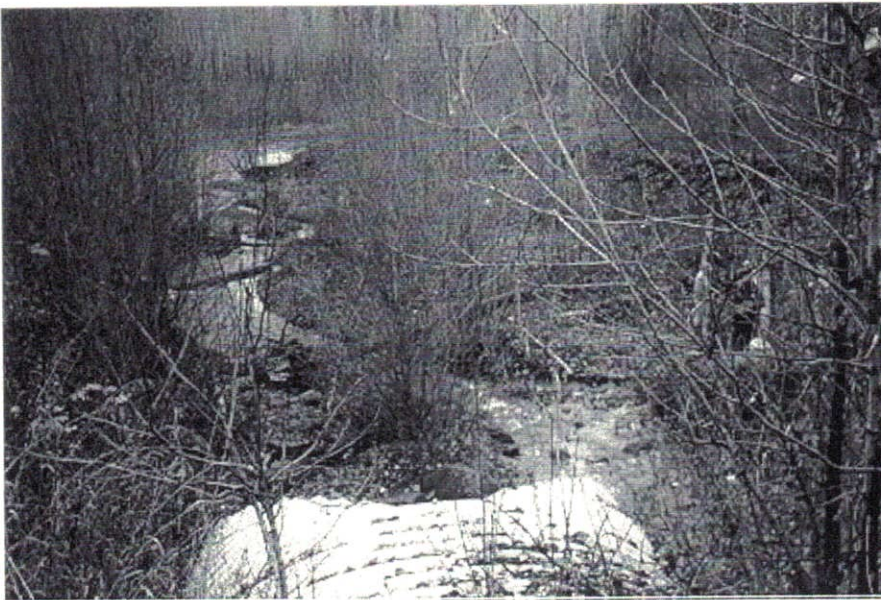
Photo 3. Looking downstream . The two technicians are standing on the LWD placed closest to the culvert.

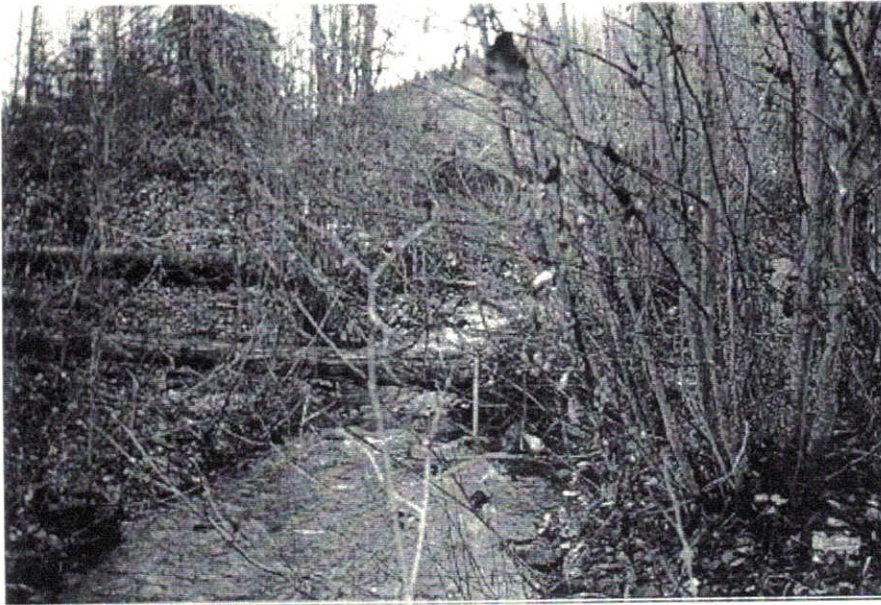
Photo 4. Looking upstream toward the uppermost channel spanning LWD. This was a modification from the original plan.
