# **Project Completion Abstract**

# Fish Passage Culvert Inspections, Telkwa River Watershed, Northern Interior Forest Region

Project Number: 2502002 Fiscal Year: 2006 – 2007

West Fraser Mills Ltd., PIR Division, Smithers, BC. Skeena Stikine Forest District / NIFR.

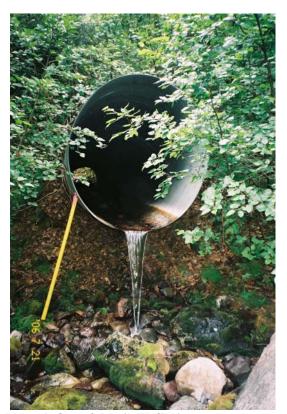
Photo 1. One of the six FPCI sites.
