**BULKLEY/FULTON WATERSHED
FISH PASSAGE CULVERT ASSESSMENT PROGRAM**

January 12, 2010

Ecofor Consulting Ltd.
PO Box 1270
Fort Saint James, BC
VOJ 1P0
(250) 996-2151

EPN 2009-2029-001

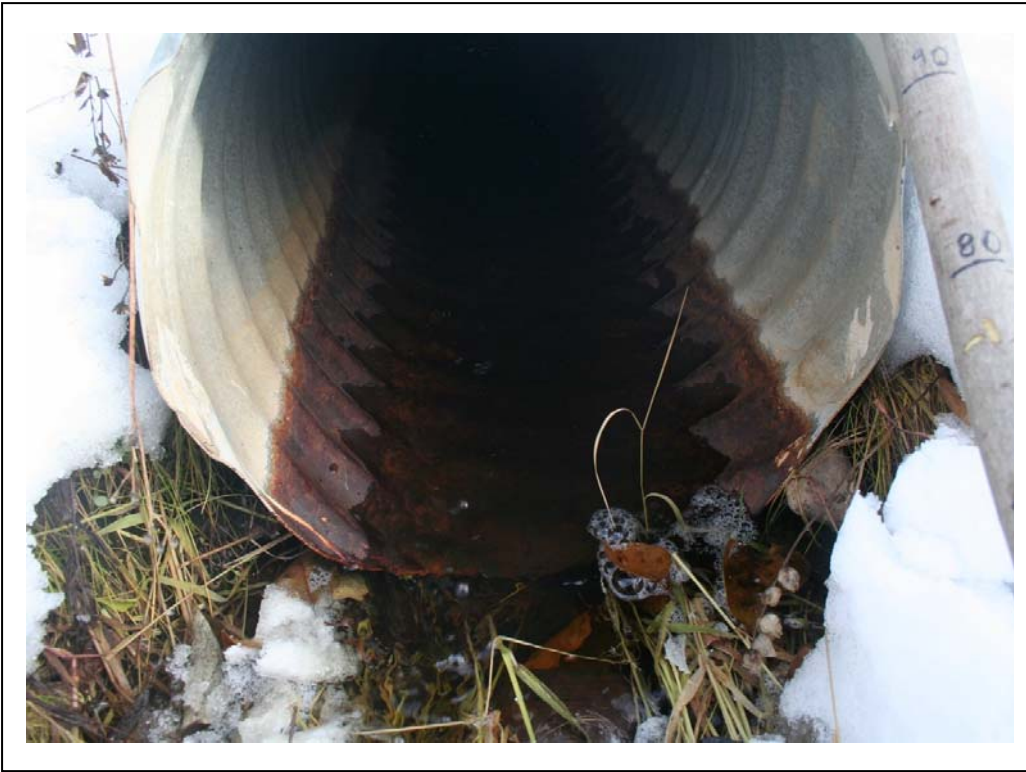
View of the culvert inlet.

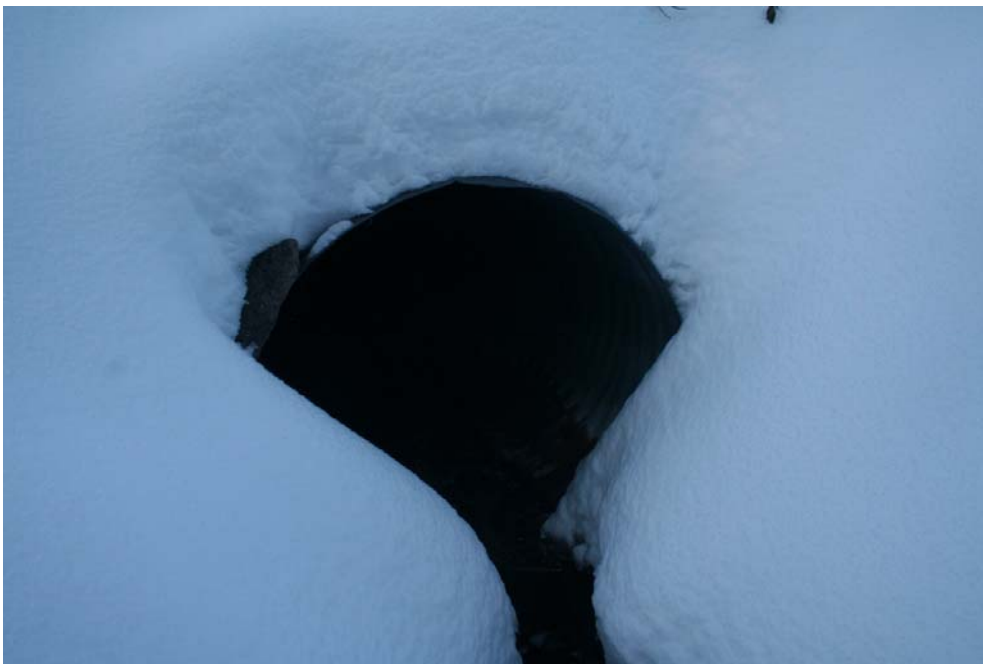
Representative habitat found upstream of the culvert.

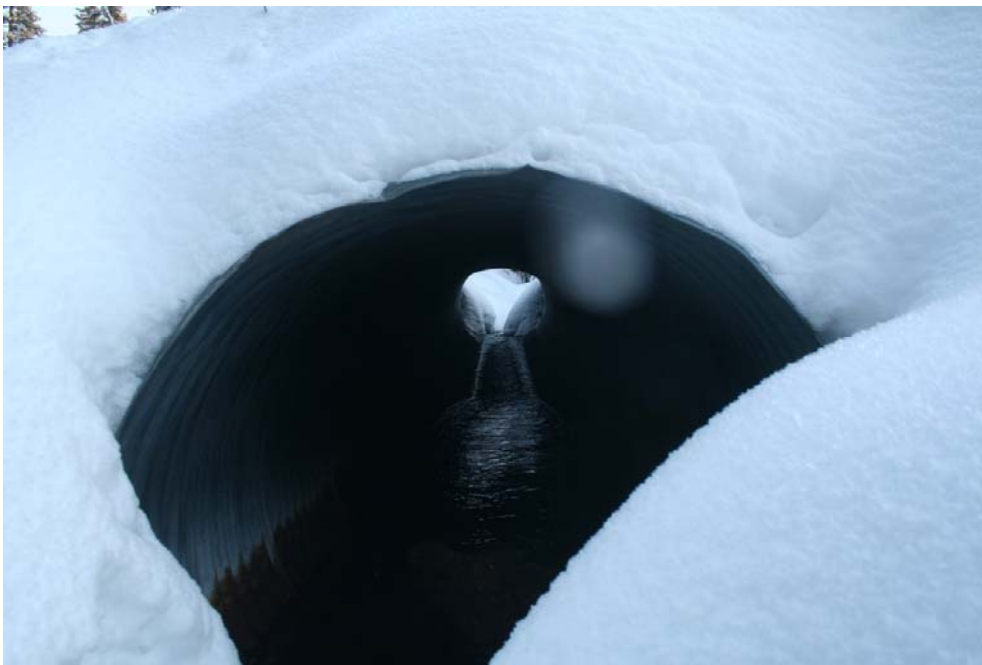
Representative habitat found downstream of the culvert.

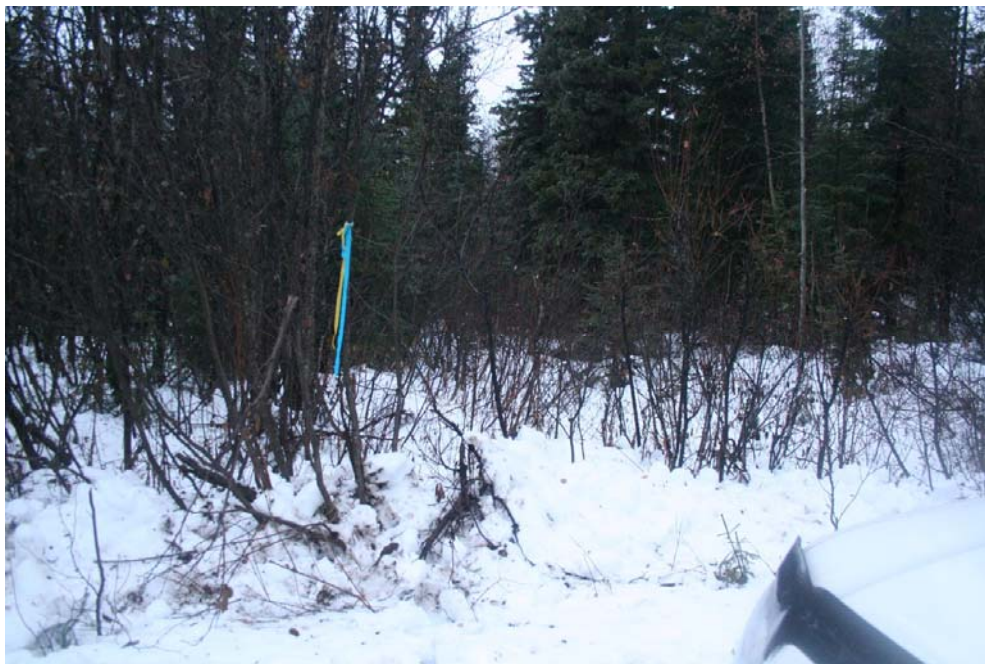
View downstream. No culvert found at this location.

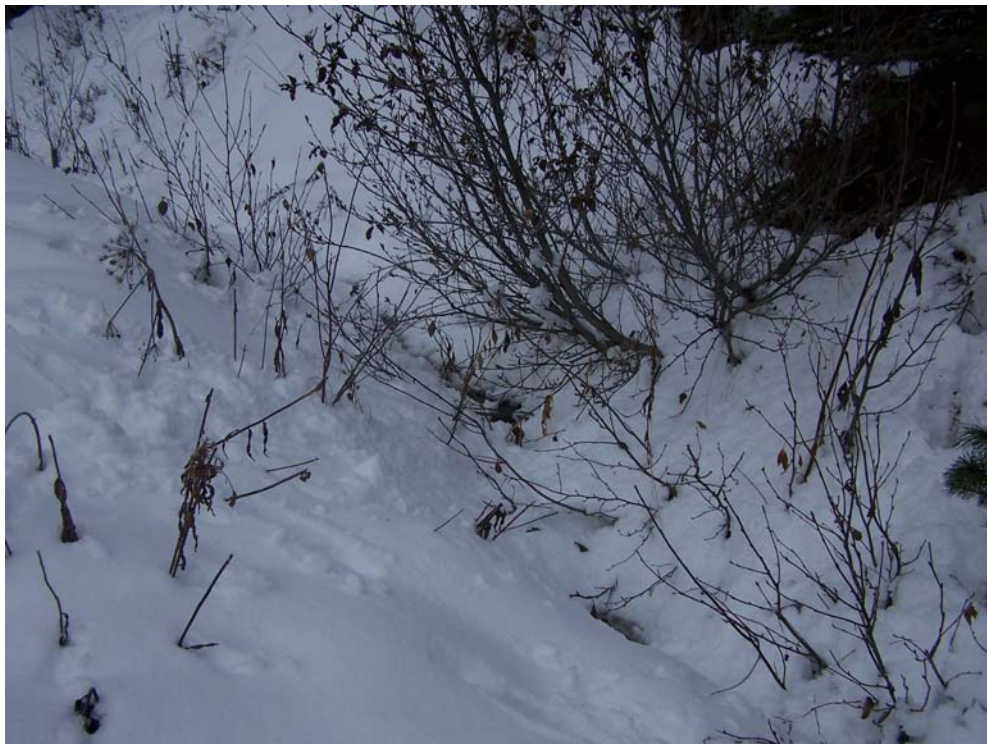
This is a mixed forest with some wet areas with a cover of willow/spruce that contribute limited amounts of run-off.

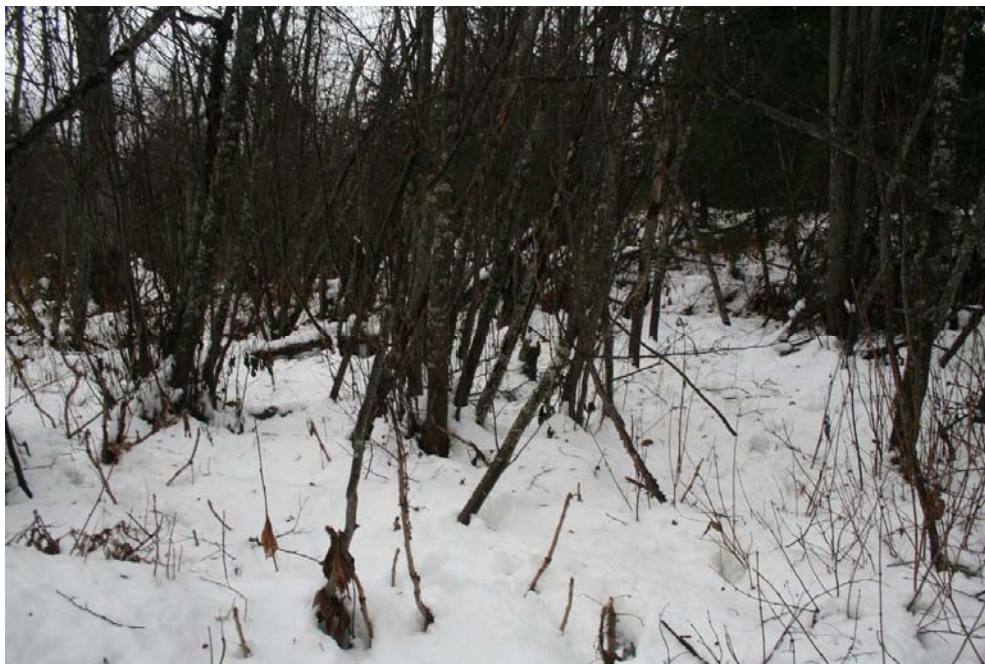
View downstream. Culvert found but no stream NVC.

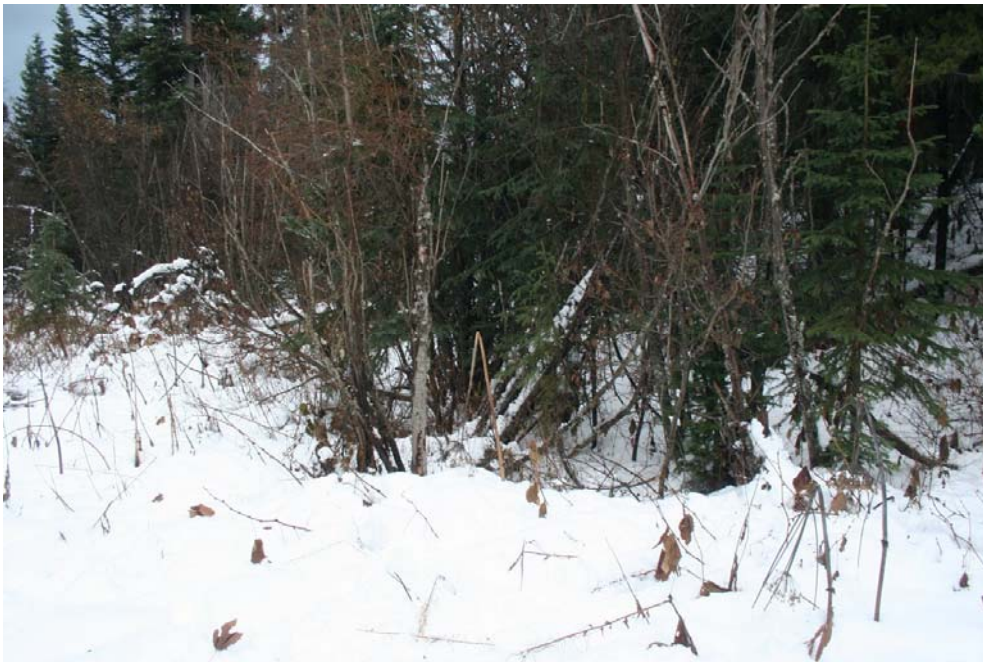
View downstream. No culvert found at this location.

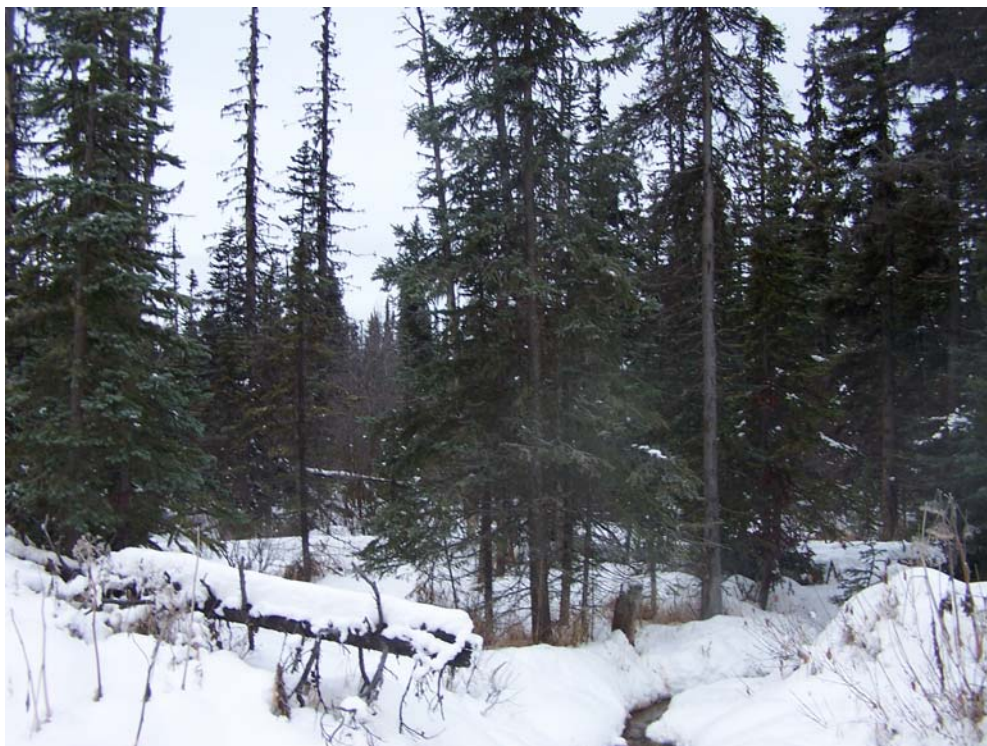
Upstream of the culvert there is a mixed spruce/sub-alpine fir forest that contribute some seepage, but there is no continuous scoured stream channel at this location.

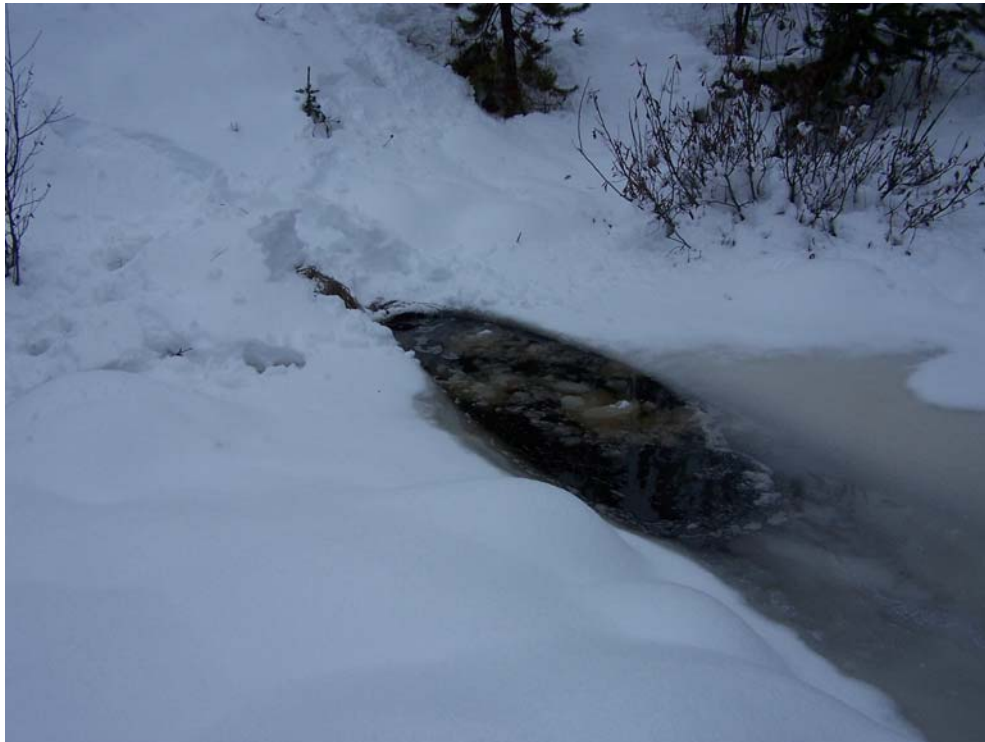
Downstream view of culvert inlet, upstream water flows gather in pool before entering into culvert. No inlet drop noted.

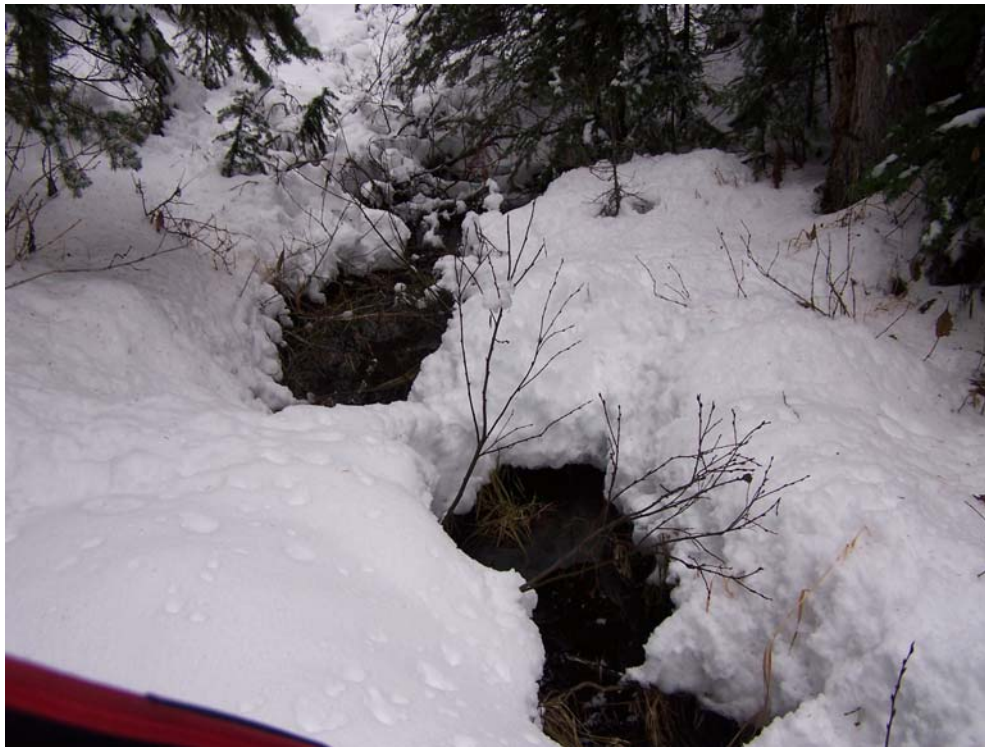
Upstream view of culvert outlet; no outfall drop as the outfall pool extends up into culvert (difficult to tell how far water extends through pipe, it was too dark to see inside of culvert at time of sampling). Large outfall pool approximately 2m by 5m (ground estimate).

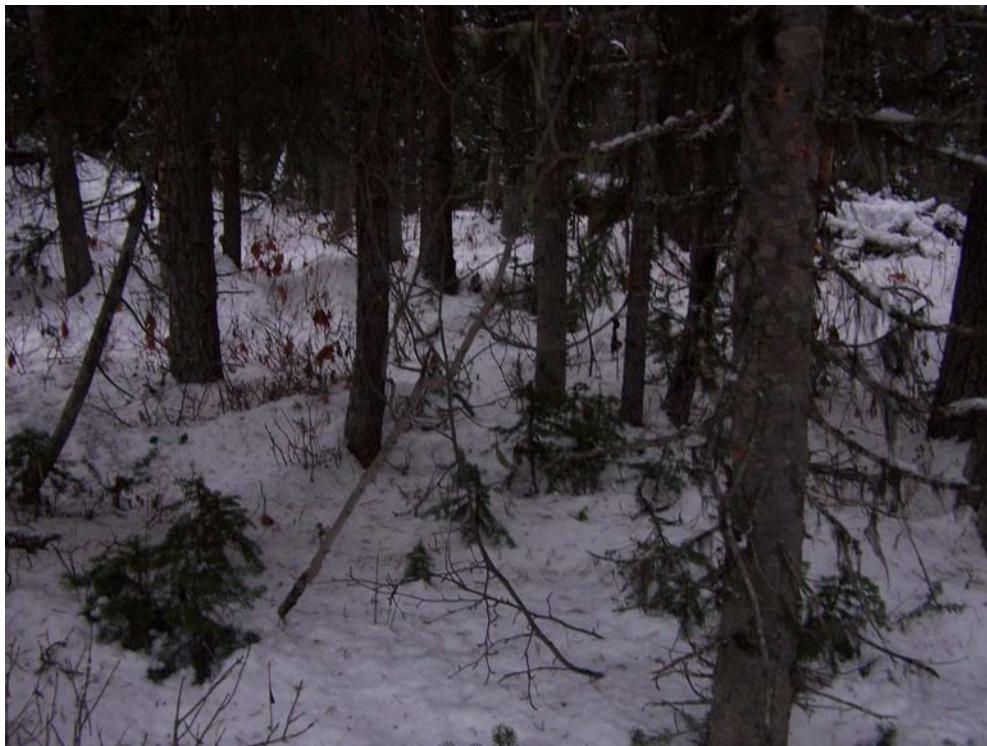
Opposite of the culvert inlet there is a wet alder/willow swale that contributes run-off, but there is no stream at this location.

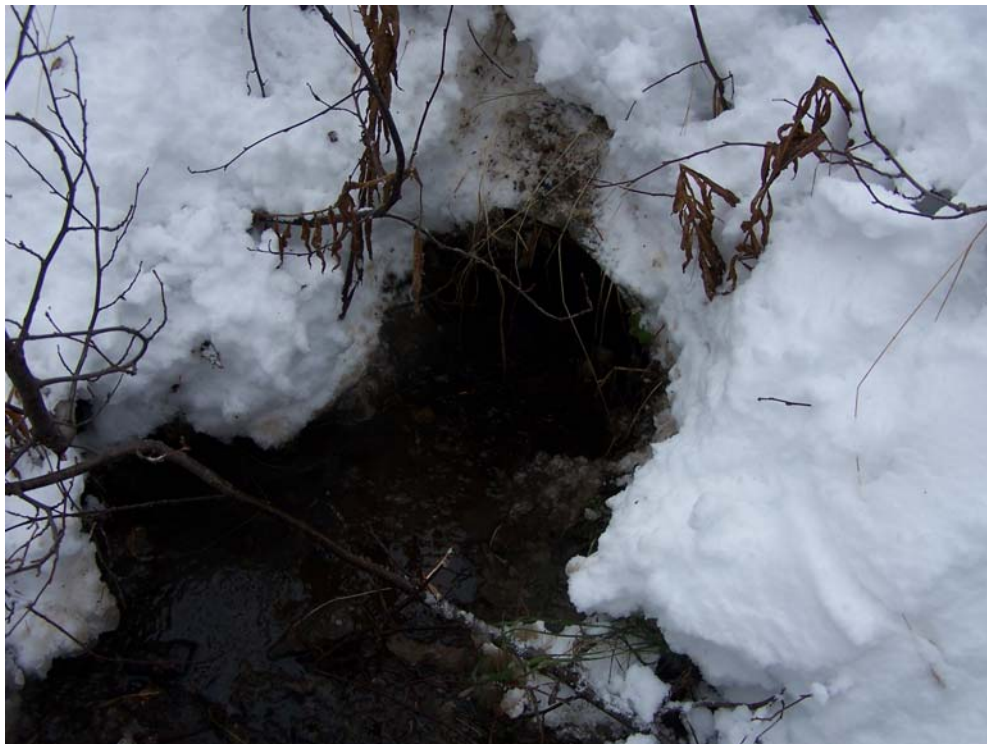
Downstream view of culvert inlet; there are minimal water flows entering into this overgrown culvert inlet.

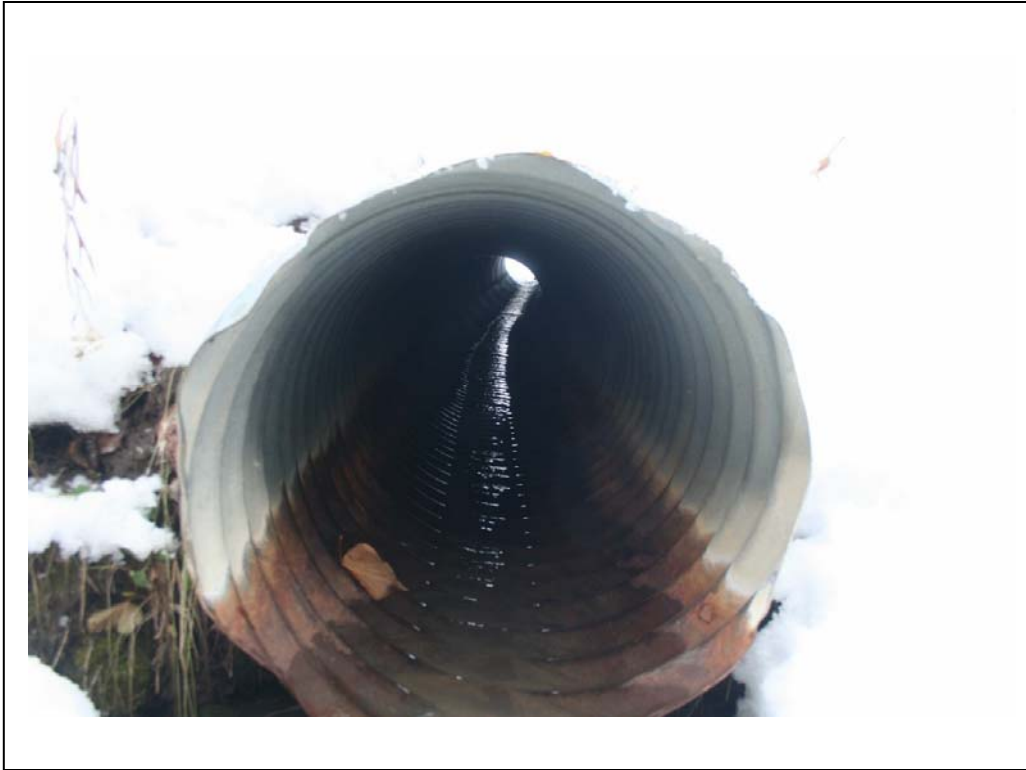
View of the culvert inlet.

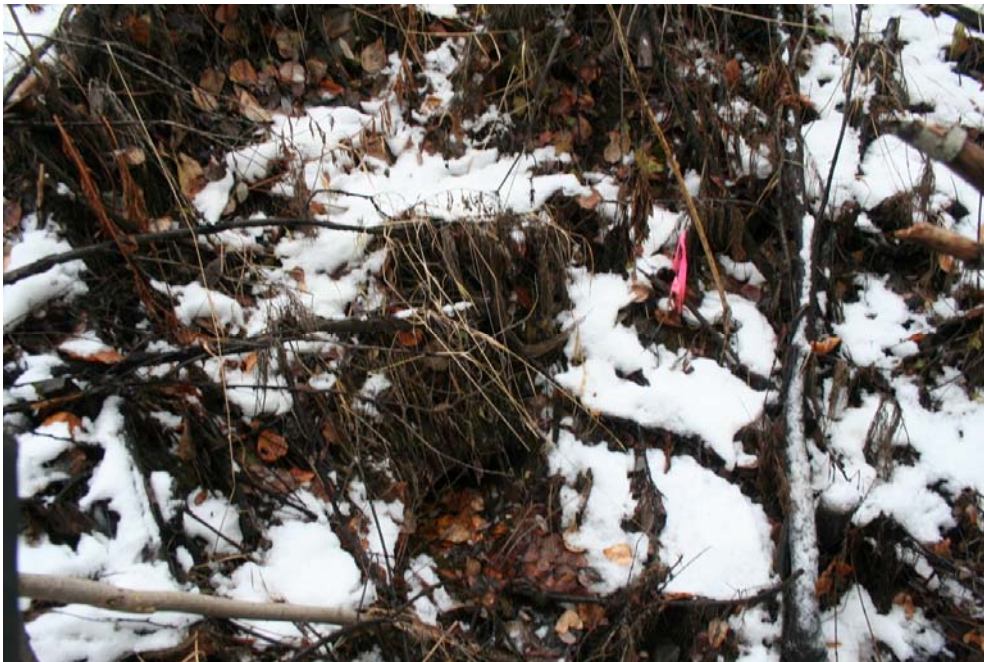
Representative habitat found upstream of the road crossing. Stream may dissipate 100m u/s.

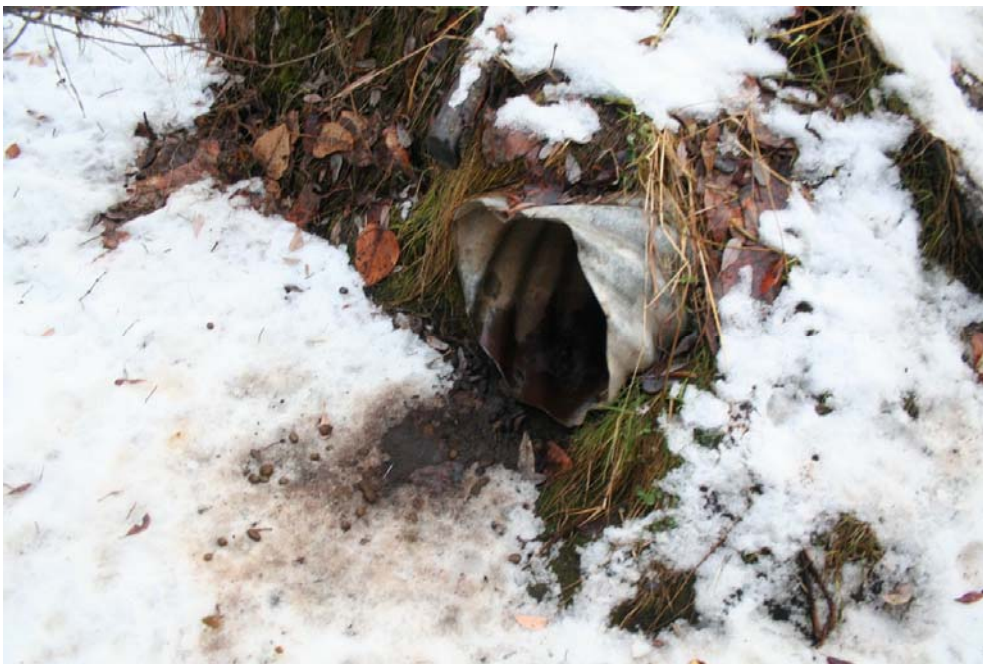
View downstream. Culvert found but no stream NVC.

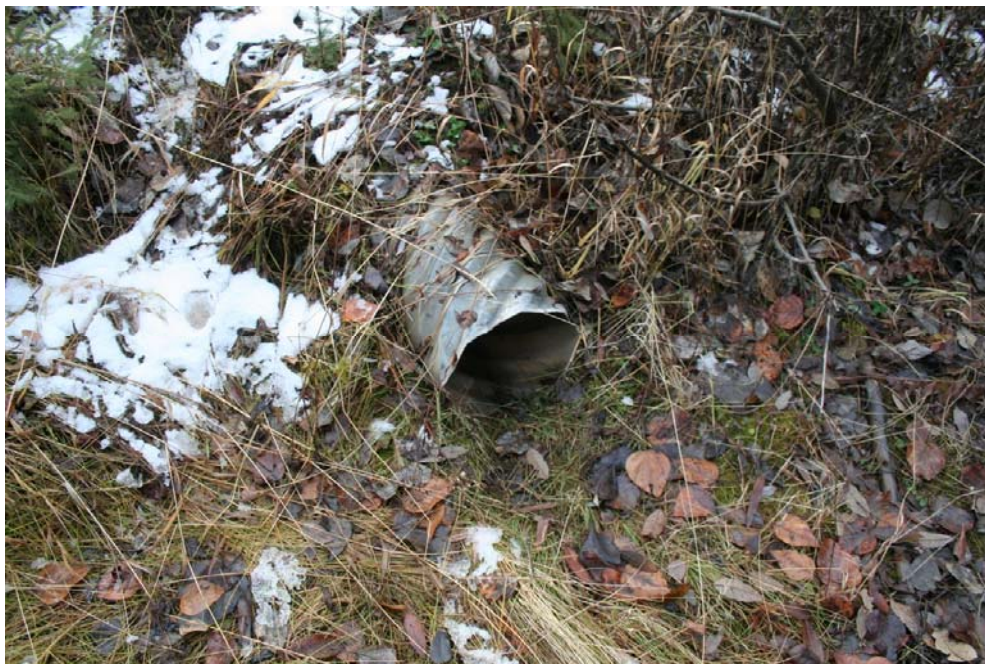
View downstream. Culvert found but no stream NVC.
