Level 1 Fish Habitat
Assessment Procedure
of Selected Sub-Basins
Within the Taltapin
Watershed

T. Roy, H. Liebe-McGinnis Carmanah Research Ltd. 1556-6th Ave. Prince George BC V2L 5B5

March 1998

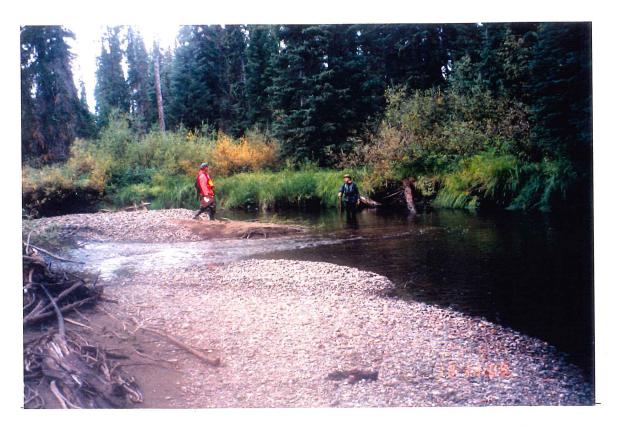
Plate #1: Typical pool section in Pinkut Creek Reach 6. Note elevated mid channel bar and sand in substrate.

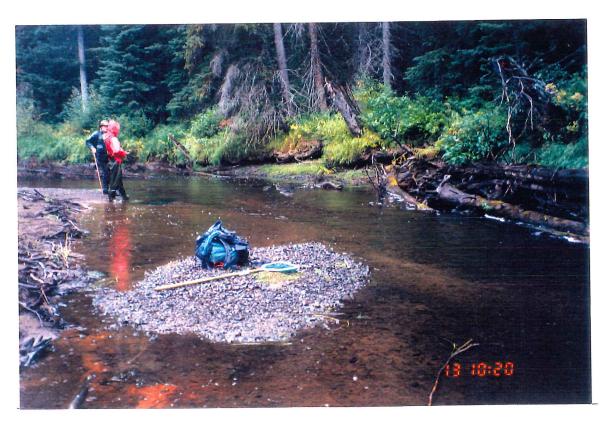
Plate #2: Typical glide section in Pinkut Creek Reach 6. Note sand and silt in substrate.

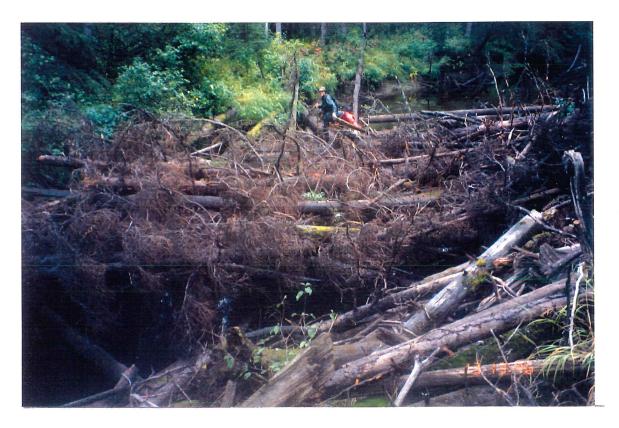
Plate #4: LWD jam in middle of Pinkut Creek Reach 6.

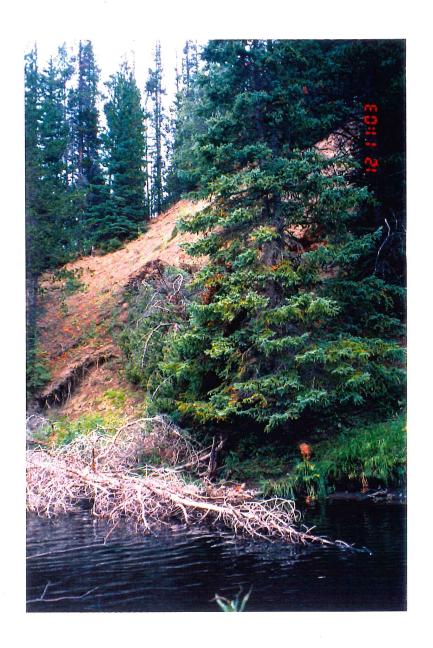
Plate #5: Natural slope failure on Pinkut Creek Reach 6 (Site #3).

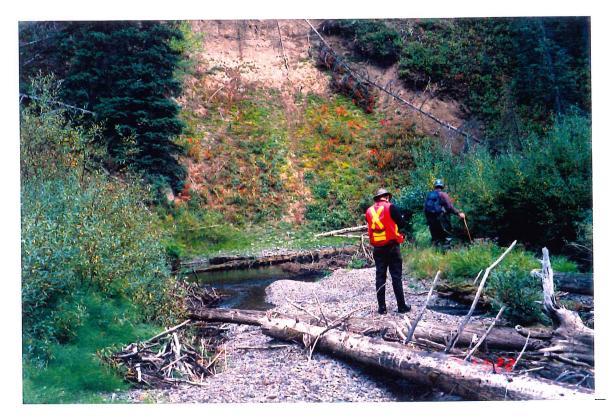
Plate #6: Natural slope failure on Pinkut Creek Reach 6. Note revegetation on lower half (Site#4).

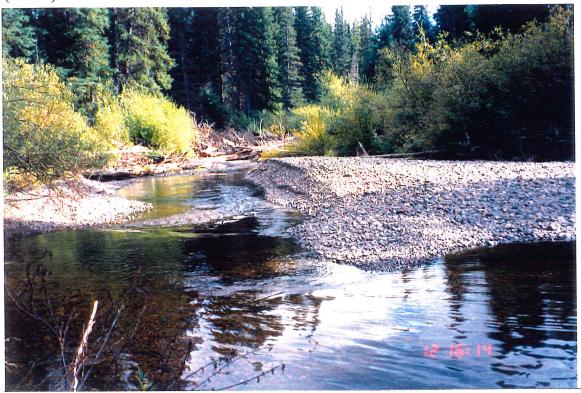
Plate #7: Typical riparian growth along Pinkut Creek Reach 6. Note elevated mid channel bar.

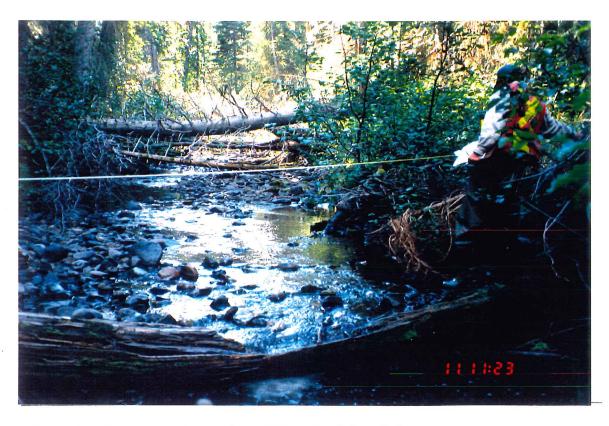
Plate #11: LWD accumulation along Pinkut Creek Reach 6.

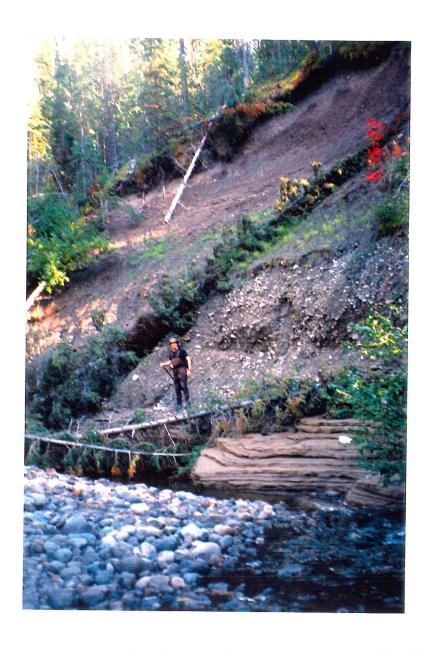
Sites 6, 7 and 8 are large slumps measuring (height X width) approximately 30m X 100m (Appendix B; Plate 12), 10m X 20m (Appendix B; Plate 14) and 20m X 40m (Appendix B; Plate 13), respectively. All three are actively eroding fines and larger substrates into the system and have not yet reached their angles of repose. Sites 7 and 8 are adjacent to an old cutblock at the 26km mark of the Augier Main road. A riparian reserve zone has been maintained, and regeneration of the block appears to be successful. There is a slight possibility that these slumps were caused by a change in hydrological patterns associated with the harvesting activity in the area.

Plate #12: Natural slope failure on Lord's Creek Reach 1 (Site #6).

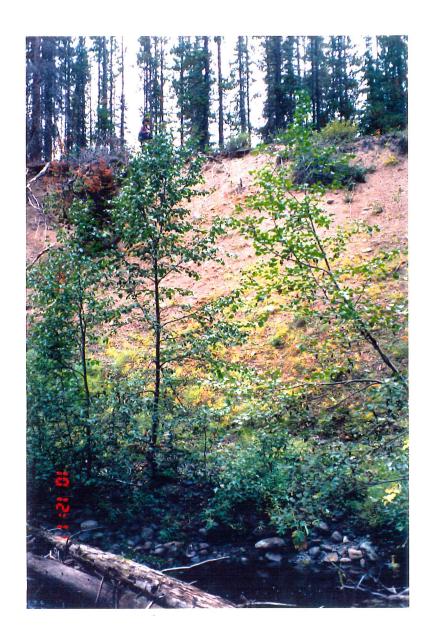
Plate #13: Natural slope failure on Lord's Creek Reach 1 (Site #8).

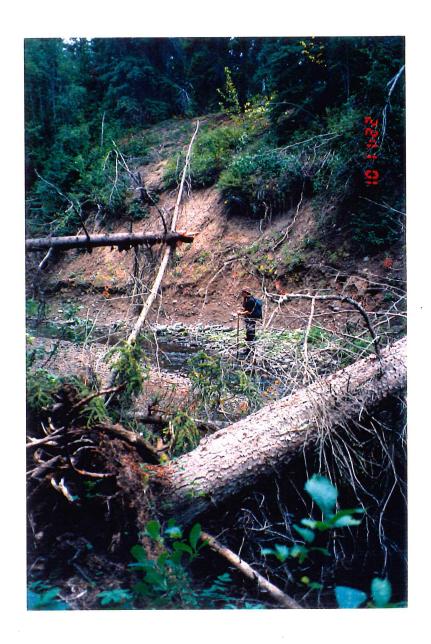
Other indicators of channel instability include elevated mid-channel bars and multiple channels caused by eroding banks (Appendix B; Plate 14) and associated LWD jams.

Plate #14: Eroding banks on Lord's Creek Reach 1 (Site #7).

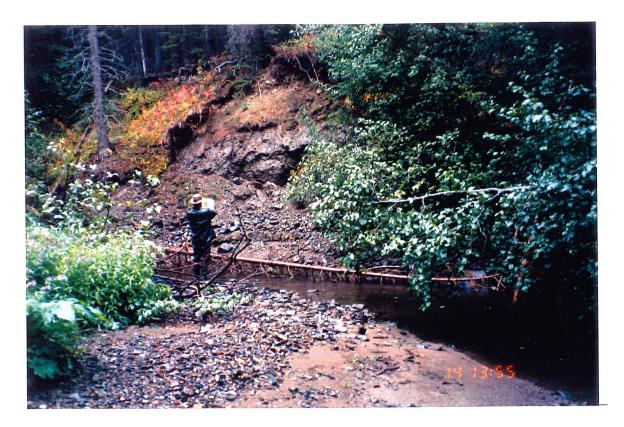
Plate #19: Natural slope failure on on Henrietta Creek Reach 4 (Site #10).

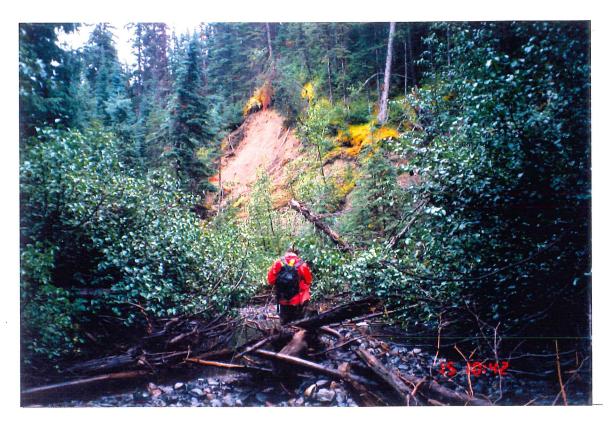
Plate #20: Natural slope failure on Henrietta Creek Reach 4 (Site #11).

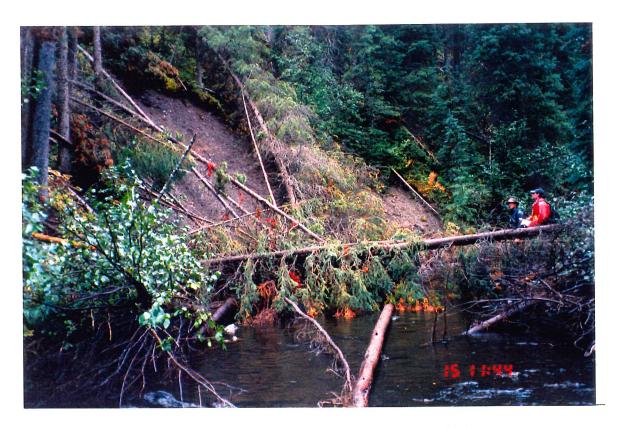
Plate #21: Natural slope failure on Henrietta Creek Reach 4 (Site#12).

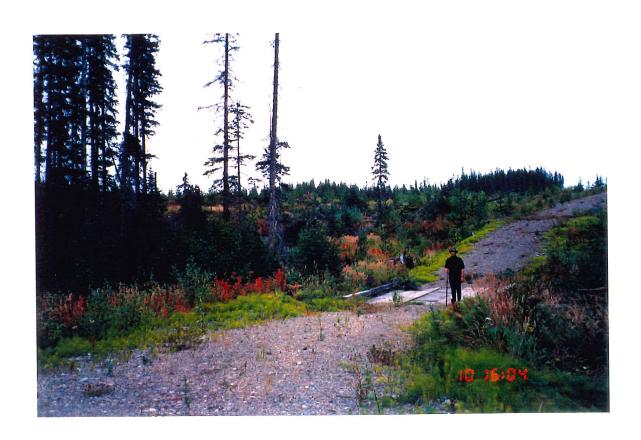
Plate #23: Logging bridge on Lord's Creek Reach 1 (Site #5).

- Reduce the amount of LWD below first logging bridge (Site 5).
- It is recommended that slope stabilization measures be implemented. Stabilization of slumping banks could improve gravel quality for spawning fish. However, the effects of this work would not be immediate, and considerable time would be required until natural flushing of existing fine sediment deposits occurs.

- Replanting of mixed riparian vegetation along edge of creek adjacent to first logging bridge is recommended.

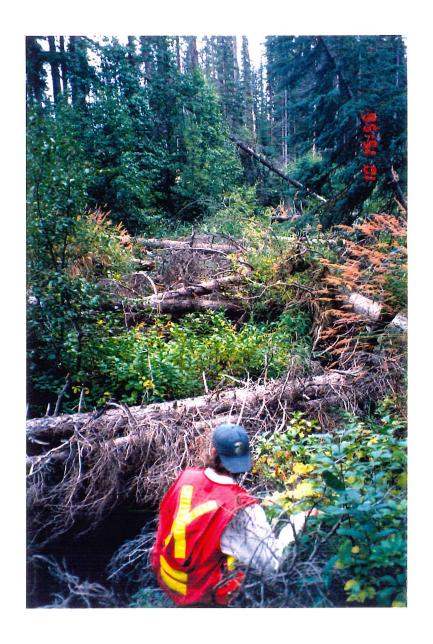
Plate #24: Blowdown in Riparian Reserve Zone on Lord's Creek Reach 1 (Site #5).

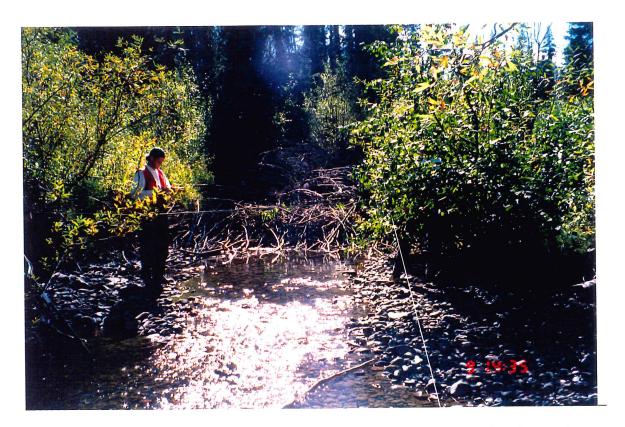
Lord's Creek electroshocking results are in Appendix E. They confirm the suggestions of the 1996 OFHAP that resident rainbow trout inhabit the reach. They also indicate that beaver activity has prevented spawning kokanee from accessing upstream habitat. At the time of assessment a large, well established dam approximately 1050m upstream of the confluence with Pinkut Creek was the upper limit of spawning kokanee migration. The value of the inaccessible habitat upstream of Reach 1 is not known. Further investigation is warranted, as large numbers of spawning kokanee were observed up to the base of the dam.

Plate #25: Impassable beaver dam on Lord's Creek Reach 1. Upper limits of spawning kokanee (Site #9).

- Although beaver dams are impeding fish passage, the ponds also act as settling ponds and therefore improve the quality of downstream spawning gravel. They also produce much needed pool rearing habitat. Only dams shown to be impassable and impeding access to high quality spawning sites should be considered for removal.
- Note: Techniques described in Tech. Circ. 9 are not recommended in this case due to lack of access for heavy machinery.
