Skeena Region

Region 6

UTM (NAD 83) zones, northings and eastings; watershed codes and waterbody identifiers for aquatic rehabilitation projects for Region 6, Skeena.

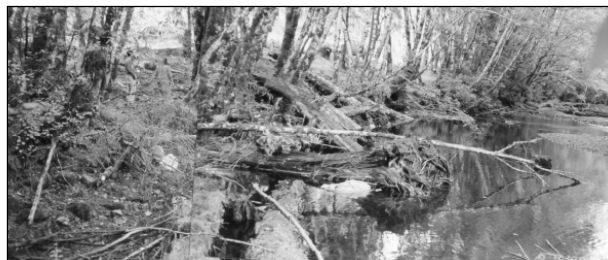
Figure 6-1. In Copper River mainstem, rocks attached by cable and epoxy ballasted the structures.

The two sites (sites 3 and 4) selected for instream work in 1999 were located approximately 600 m apart. Both sites were located within 20 m of the South Bay Mainline. At site 3, eight large red cedar and cypress (*Chamaecyparis nootkatensis*) logs, 4 with rootwads attached, and six spruce stumps were used to create a structure on an outside bend. Most of the stems had one end attached to live trees on the bank while the other end on the riverbed was ballasted with rocks attached by cable and epoxy (Fig. 6-1).

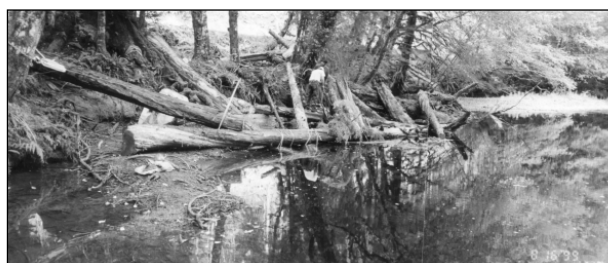
Figure 6-2. The triangulated structures were formed by using a series of triangles with the logs pinned together using rebar.

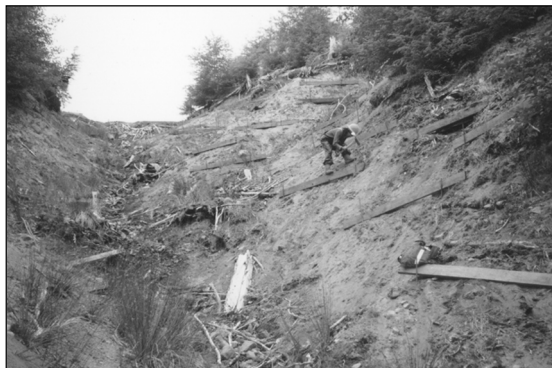
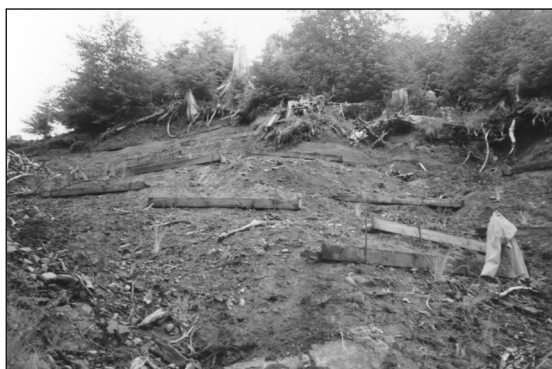
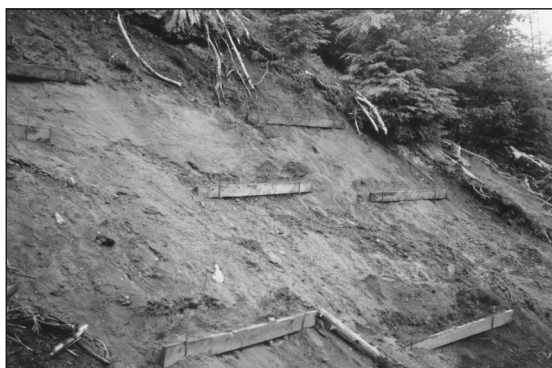
The slides have created logjams and sediment wedges in the creek. The slide paths have not revegetated and fine sediment continues to be deposited into the creek.

Figure 6-3. Construction view of bioengineered landslide.

Figure 6-4. Construction view of bioengineered landslide.

Figure 6-5. Construction view of bioengineered landslide.

- The spur road above the slides was deactivated in 1998. During the deactivation, logging debris was pulled back from the break in the slope below the road.
- Rebar, boards, Sitka alder (*Alnus sinuata*) plugs and fertilizer were carried to the slides. Willow was not used because it is scarce in this area.
- Modified Brush Layers (MBL) were rebarred into place on the steeper sections of the slide (Figs. 6-3, 6-4 and 6-5). The brush layer consisted of Sitka alder plugs that were planted 30 cm apart. Sitka alder plugs were also planted on the slope between the MBLs. Live gully breaks were not used. The MBLs were extended into the gullied section of the slide to prevent further gully development. The MBL in the gullied section contained only cobbles to allow water passage.

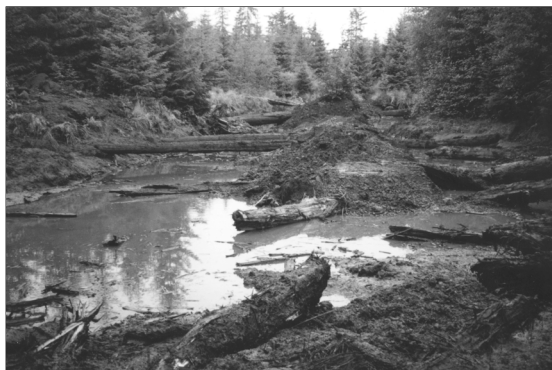
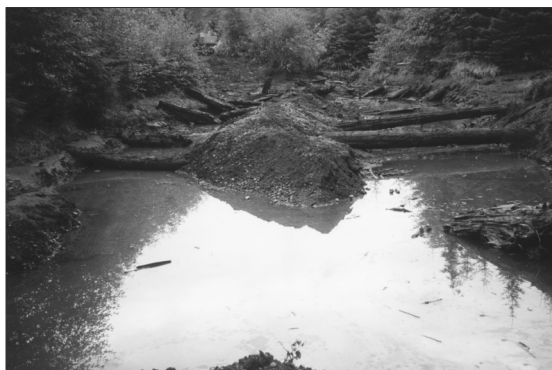
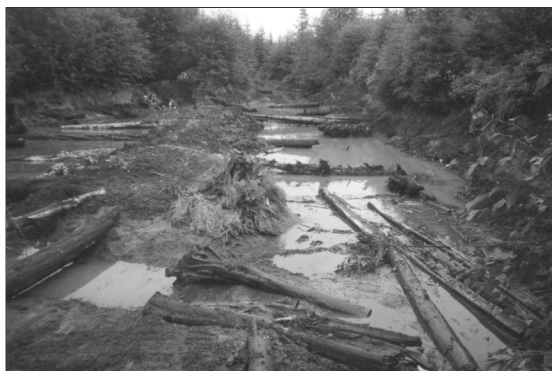
The pond is tidal; U-shaped, 250-m long and 18-m wide. The pond is shallow with a low water depth averaging less than 40 cm and no overhead cover. Coho fry, stickleback (*Gasterosteus spp.*) and sculpin have been fish-

trapped. Summer water temperatures have exceeded 25°C resulting in coho fry mortality.

Figure 6-6. Post-construction view of off-channel pond (prior to dam removal).

Figure 6-7. Post-construction view of off-channel pond (prior to dam removal).

Figure 6-8. Post-construction view of off-channel pond (prior to dam removal).

The pond was excavated to a depth of between 1.5 and 2 m below the low water mark (Figs. 6-6, 6-7 and 6-8). The two ends of the pond were left at a depth of 40 cm to provide a variety of habitat depths. Three long slender islands were built to increase the edge area in the pond. The side slopes on the pond excavation have 1 horizontal to 1 vertical slope in an attempt to provide bank stability. Fifteen rootwads and 60 logs were placed in the pond for cover. Small trees and branches collected from a previous tree spacing project were added to the pond as cover. Following the excavation the exposed soils were grass seeded.

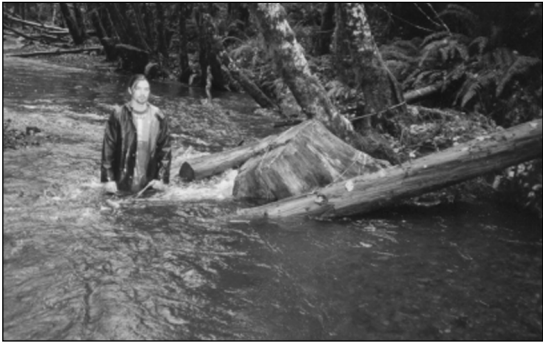
Figure 6–9. Placing instream structures in Weeping Willow Creek is expected to increase the scour and cover for fish.

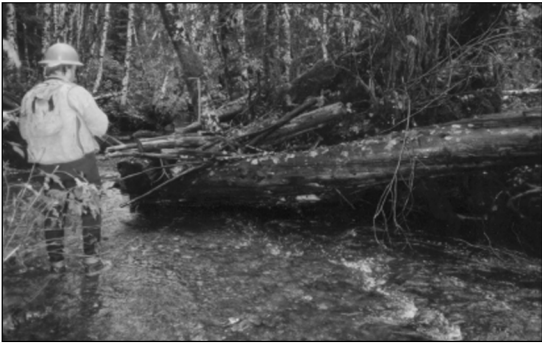
Figure 6–10. V-shaped lateral LWD spurs were placed in 11 locations in Weeping Willow Creek.

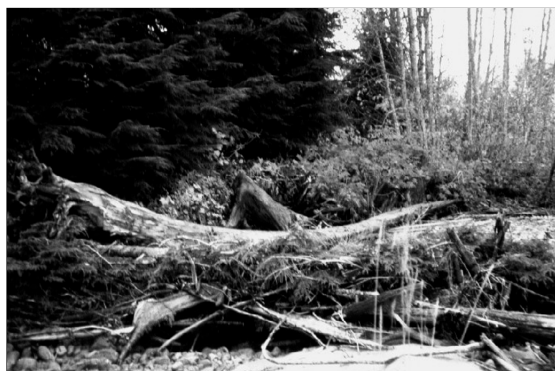
Figure 6-11. Complexing at Glacier Creek in progress.

LWD was placed at approximately 16 locations along the lower part of the creek fan. A EX200 excavator was utilized in the placement of the LWD. After the wood was put in place they were then pinned together with 5/8-inch rebar and tied together with biodegradable (manila) rope. The completed project has created pools for fish habitat.

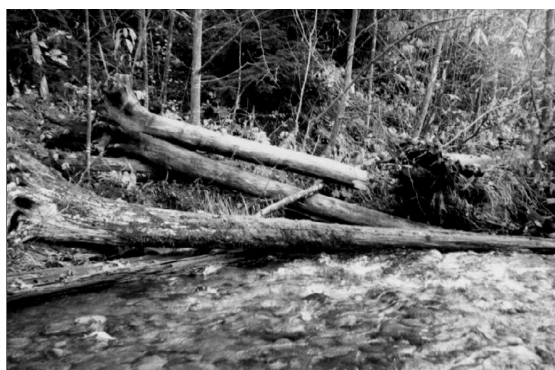
Stabilizing the lower part of Glacier Creek has created more diversity and habitat conditions (Fig. 6–12). It also provides more water depth during low flow periods. The works will be monitored over an extensive period of time by taking photographs of the area. The pools will provide holding cover for spawners and rearing habitat for juvenile and resident salmonids.

Figure 6-12. Placement of LWD at Glacier Creek.

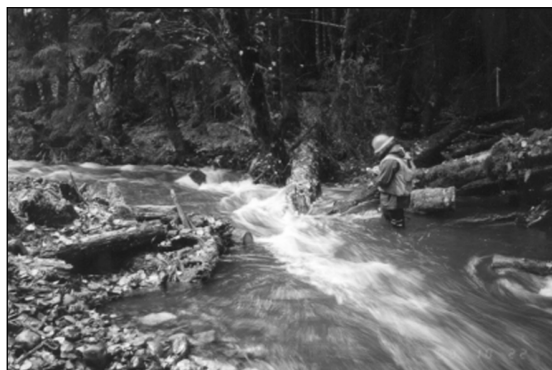
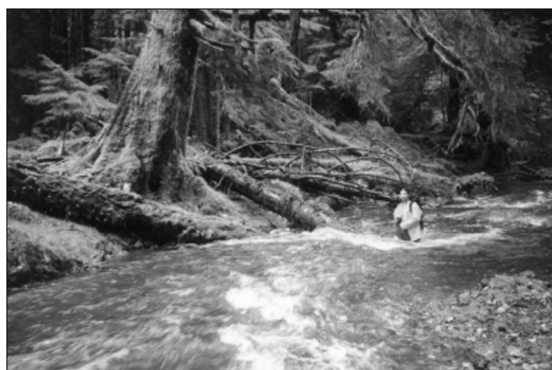
Figure 6–13. View looking upstream at a typical V-shaped log spur on Clew Creek.

Figure 6–14. View looking upstream at a typical V-shaped log spur on Clew Creek.

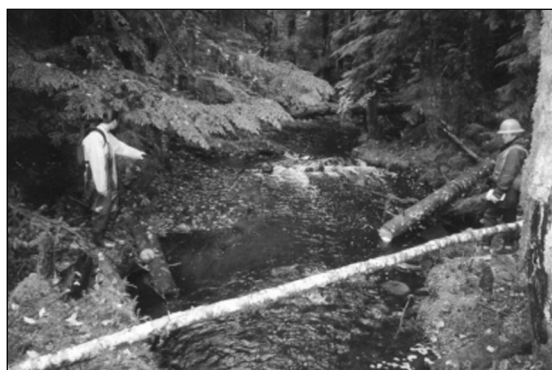
Figure 6–15. View looking upstream at a rock riffle and two LWD structures constructed by hand in Tributary 2.0 LB.

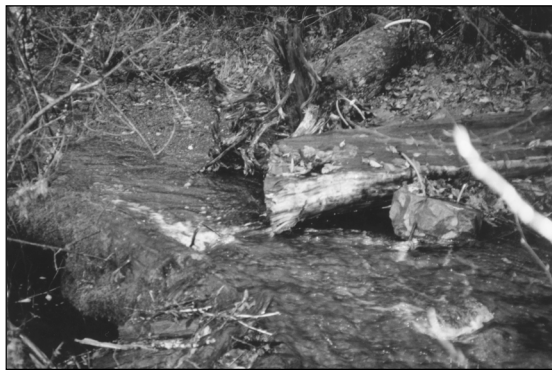
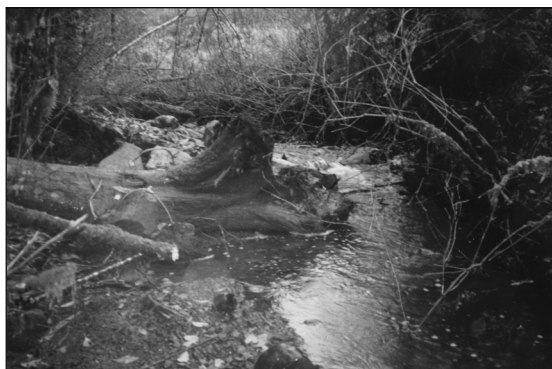
Figure 6-16. Post-construction view of a triangular logjam.

Figure 6-17. Post-construction view of a triangular logjam.

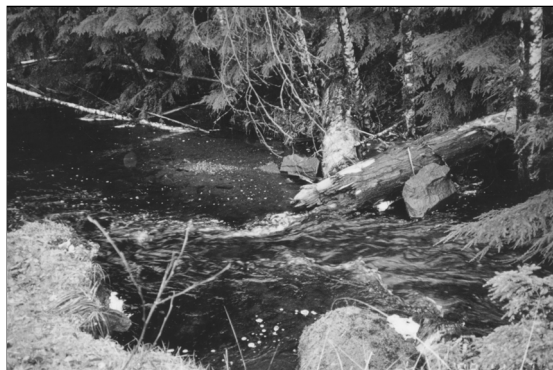
Figure 6-18. Post-construction view of a triangular logjam.

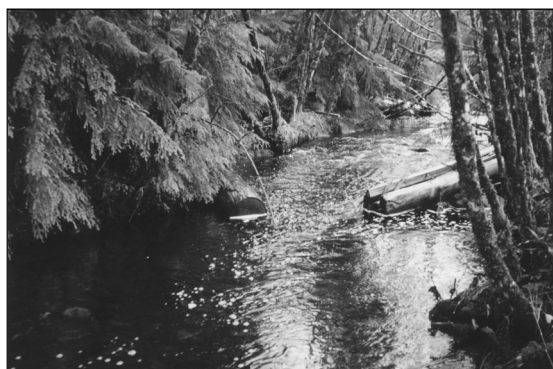
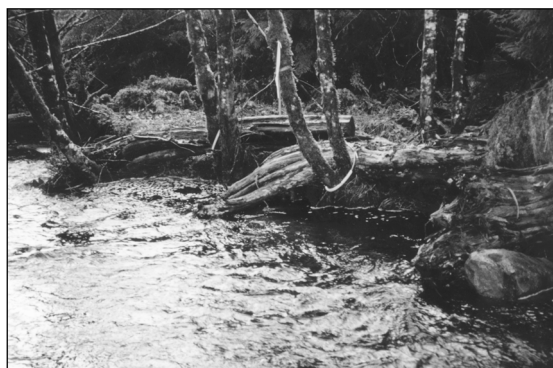
Figure 6-19. Post-construction view of log deflectors.

Figure 6-20. Post-construction view of log deflectors.

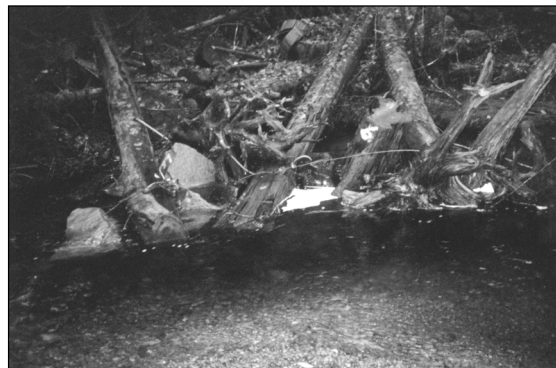
Figure 6-21. Post-construction view of a triangular logjams.

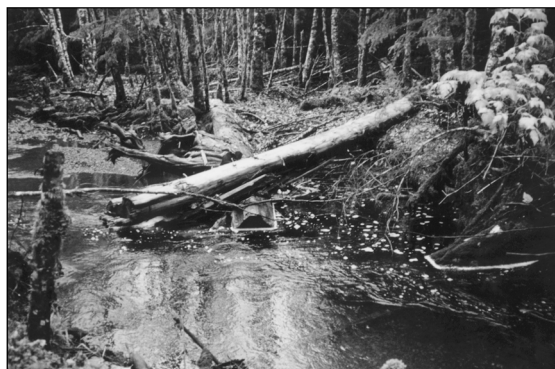
Figure 6-22. Post-construction view of a logjam.

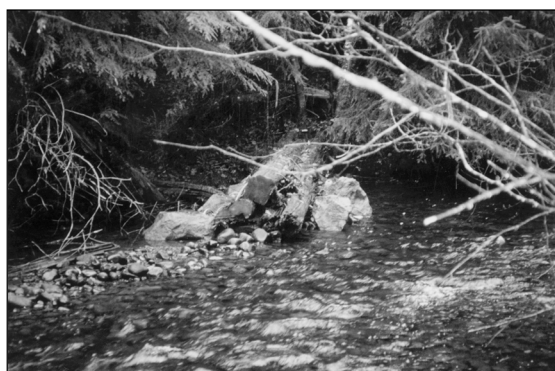
Figure 6-23. Post-construction view of a log deflector.

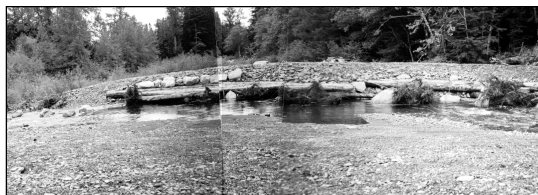
Figure 6-24. Post-construction view of Site 17, Greenville Creek.

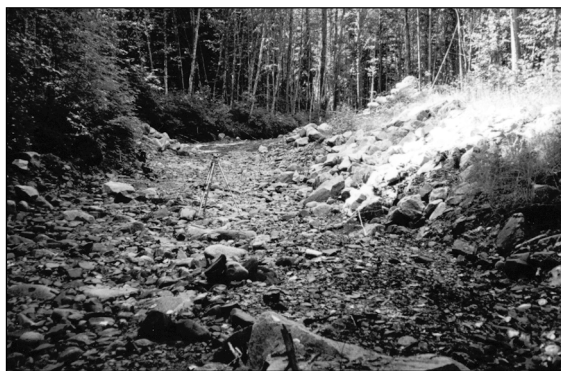
Figure 6-26. Downstream, pre-construction view from chainage 0+850 m at riffle crest site 1 (crest at 0+836 m) and riffle crest site 2 (crest in photo background at 0+791 m).

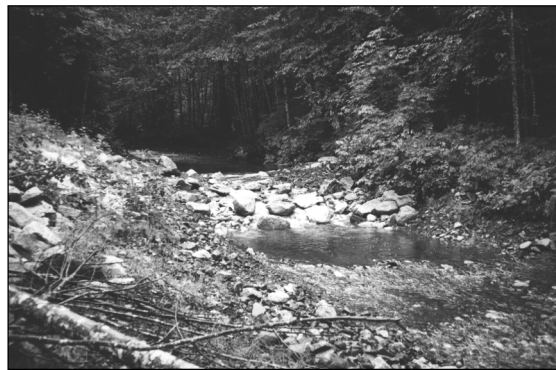
Figure 6-27. Upstream view of riffle and pool sequence at Site 1. Riffle crest is at chainage 0+836 m.

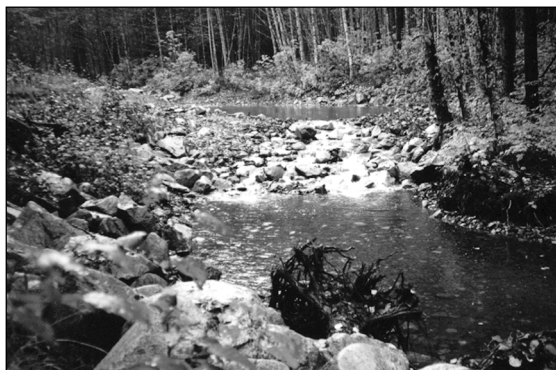
Figure 6-28. Upstream view of riffle and pool sequence at Site 2. Riffle crest is at chainage 0+791 m.

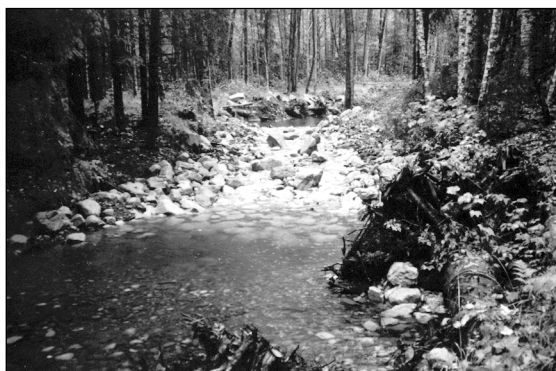
Figure 6-29. Upstream view of riffle and pool sequence at Site 3. Riffle crest is at chainage 0+746 m.

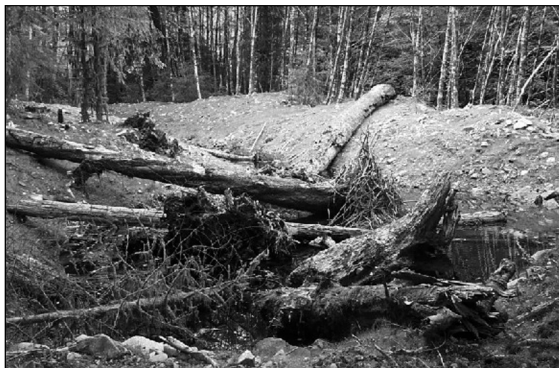
Figure 6-30. The downstream end of Off-channel #1. Depth in this area is approximately 1.5 m.

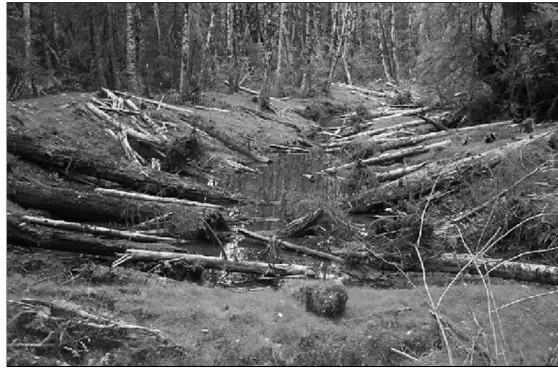
Figure 6-31. The upstream end of Off-channel #1. Any trees knocked down during construction were utilized to provide cover.

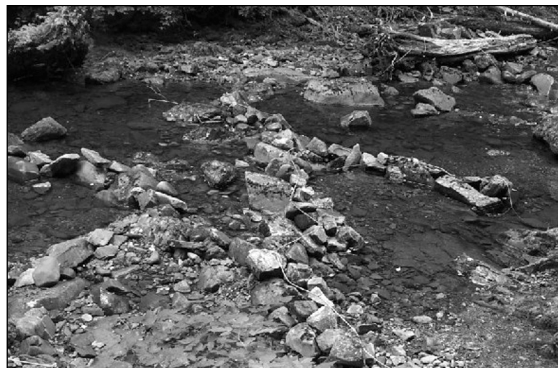
Figure 6-32. This boulder weir was constructed in reach 3. The main objective is to capture gravel moving downstream, however low velocity rearing habitat has also been created. The majority of the weirs were cabled together for much needed stability.

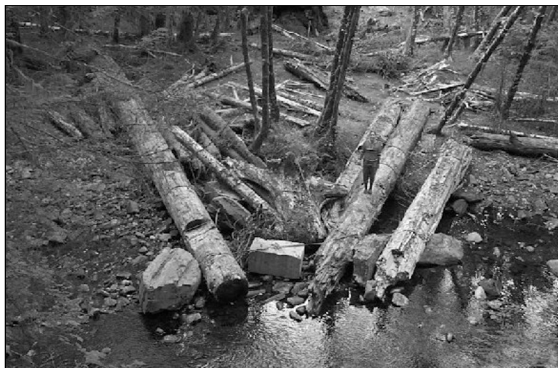
Figure 6-33. This LWD structure was constructed in reach two, 375 m upstream of the mouth.

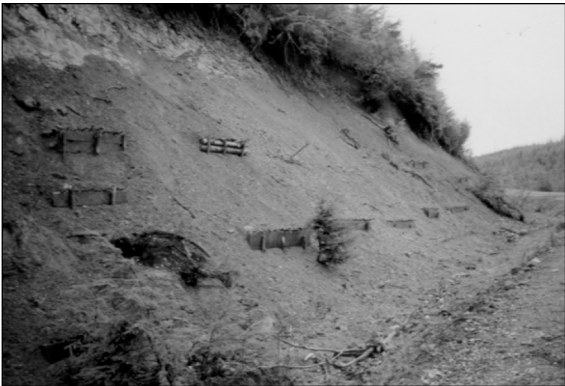
In general, Clay Creek downstream of the ditchline is subject to high degrees of sedimentation and aggradation resulting from the erosion of lacustrine soils within the ditchline. The ditchline is highly prone to perennial surface and rill erosion, as evidenced by the numerous sediment wedges found throughout the downstream portion of Clay Creek. To that end, this site was proposed for rehabilitative works during the 1999/2000 field season.

Figure 6-34. Panoramic view of Clay Creek (Y-1900) debris slump pre-work, August, 1999.

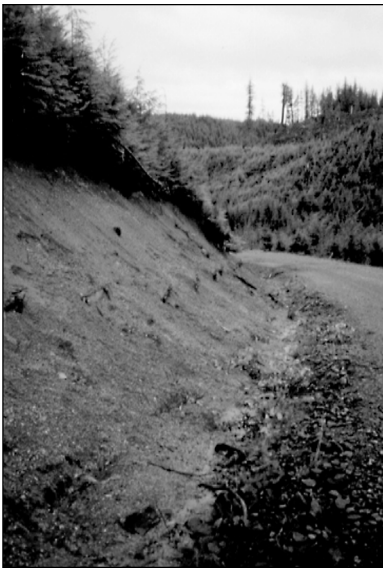
Figure 6-35. Panoramic view of Clay Creek (Y-1400) ditchline post-construction, December, 1999.

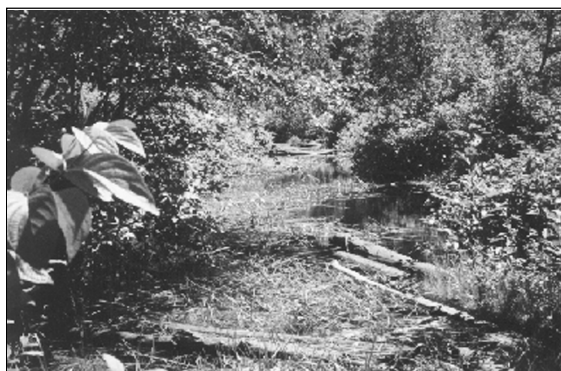
Figure 6-36. Isolated off-channel slough located upstream of perched culverts at 28 km.

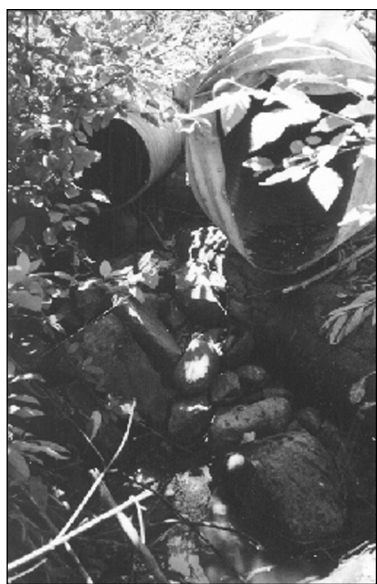
of juvenile coho were observed holding in the slack water below the culvert outfall during high runoff with no access to the off-channel habitat. Minnow trapping in the slough captured several coho smolts (160 to 180 mm in length) which were likely 3 years old and not able to exit the slough due to dispersed flow through the roadbed and perched culvert inlet. In addition to the metal culverts, an obstructed wooden box culvert was found during excavation, which dispersed water into the roadbed and prevented fish movement.

Figure 6-37. Outlet of two culverts perched 50 cm above the bed and only accessible at high flood river flows (inlet to left culvert buried).

In August of 1999, we replaced the two perched culverts with a 1500 mm culvert that ensured up and downstream fish passage and removed the box culvert to maintain adequate water depth in the slough upstream (Figs. 6-38, 6-39).

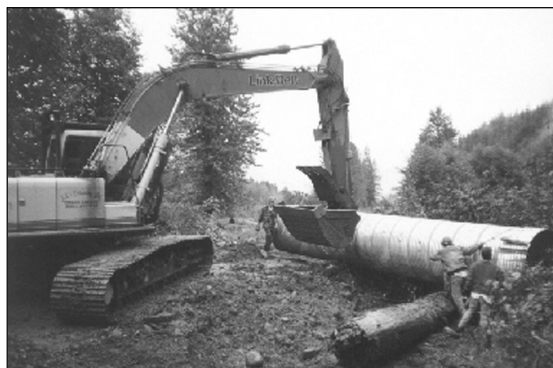
Figure 6-38. Installation of new 1500 mm culvert.

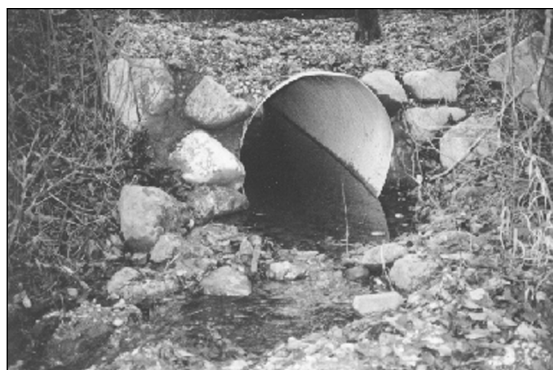
Figure 6-39. The new culvert provides upstream access to off-channel habitat and enables downstream migration of smolts.

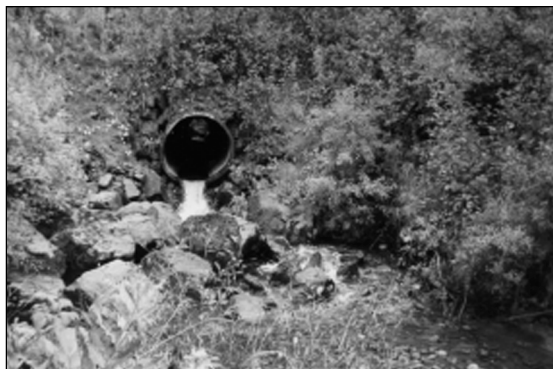
Figure 6-40. "Before" photo of 1960s constructed wooden stave culvert creating a full fish passage barrier on lower Fenton Creek.

The wooden stave culvert on lower Fenton Creek was removed and replaced with a large arch culvert during a compressed two–week implementation schedule. The entire flow of Fenton Creek had to be rerouted around the deactivation and construction site for approximately 100 m upstream and downstream of the site for the construction period. Fish in the immediate project area were salvaged and placed downstream of the construction site. The arch culvert was placed on embedded concrete footings that allowed the natural stream bed to be re-established at the appropriate gradient (Figs. 6–41, 6–42).

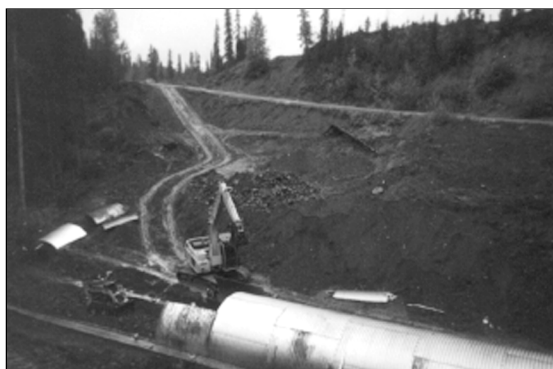
Figure 6-41. Placement of new arch culvert on concrete footings.

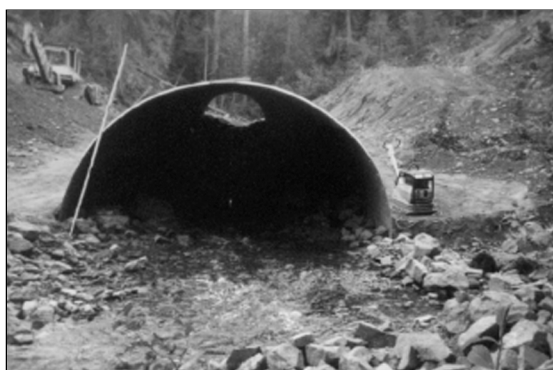
Figure 6-42. Arch culvert installed with flows re-established. The final construction stage was to replace road fill over the arch.
