**Annual Compendium Of Aquatic Rehabilitation Projects
For The Watershed Restoration Program
1998 - 1999**

Watershed Restoration Project Report No. 13

Watershed Restoration Program
Ministry of Environment, Lands and Parks
2204 Main Mall, UBC
Vancouver, BC V6T 1Z4

1999

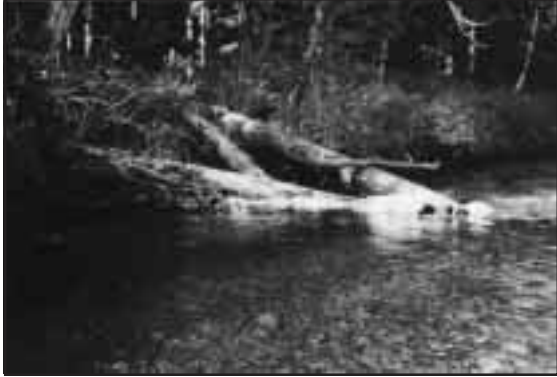
Figure 1-18. Lateral debris jam, located along the Wolfe Creek restoration section, placed to scour pool habitat and provide protective cover habitat.

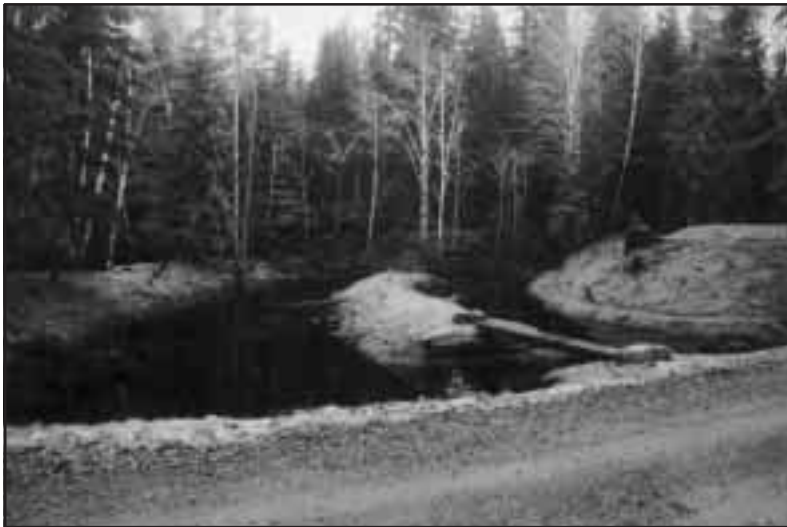
Figure 1-23. Off-channel ponds at the upper Keogh River. The lower pond (center) was excavated within the old cut-off river flood channel, and the upper “flooded” pond (left edge of photo) was created by constructing a berm with material excavated from the lower pond.

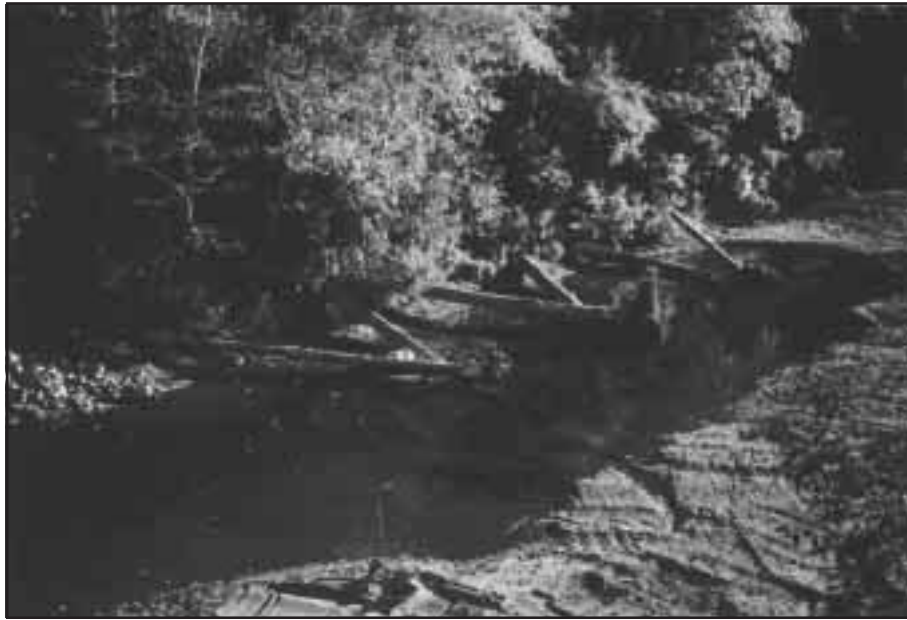
Figure 1-47. Three LWD triangles at Site 13, Reach 20, South Sarita River. Photo taken at extreme low flows.

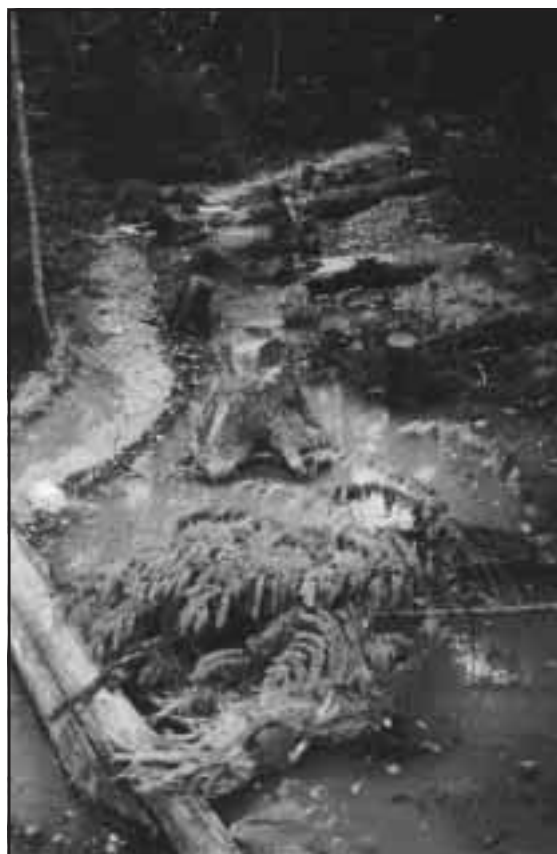
Figure 2-7. Logs placed in channel which followed an unused skidder road.

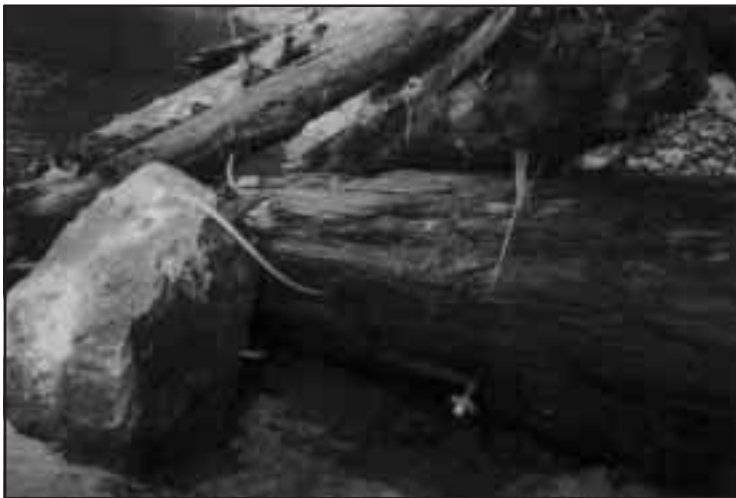
Figure 2-10. Various techniques used to anchor LWD structures. Some slack was left in the cable to accommodate shifting in high flows.

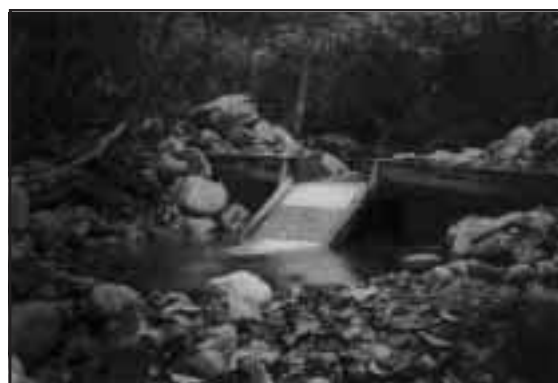
Figure 2-12. Installed and functioning intake designed by Rheal Finnigan, P. Eng. Creek water is diverted through the opening behind the ramp to the head of the new channel via a buried pipe to the right of the intake.

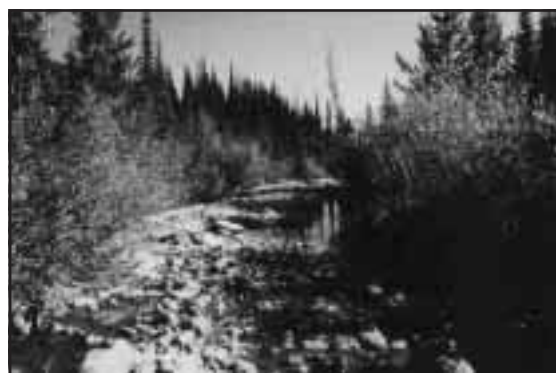
Figure 3-1. Pre-construction conditions in Arrastra Creek.

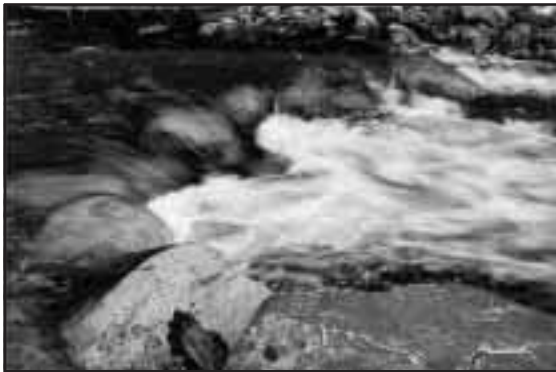
Figure 3-36. Properly functioning boulder vortex weir, installed in 1997.

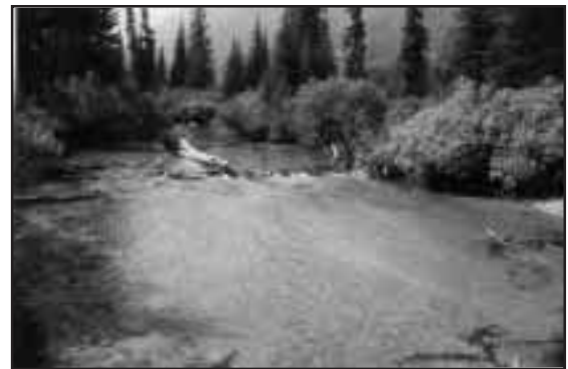
Figure 4-17. Typical perpendicular LWD limiting substrate migration, existing conditions.

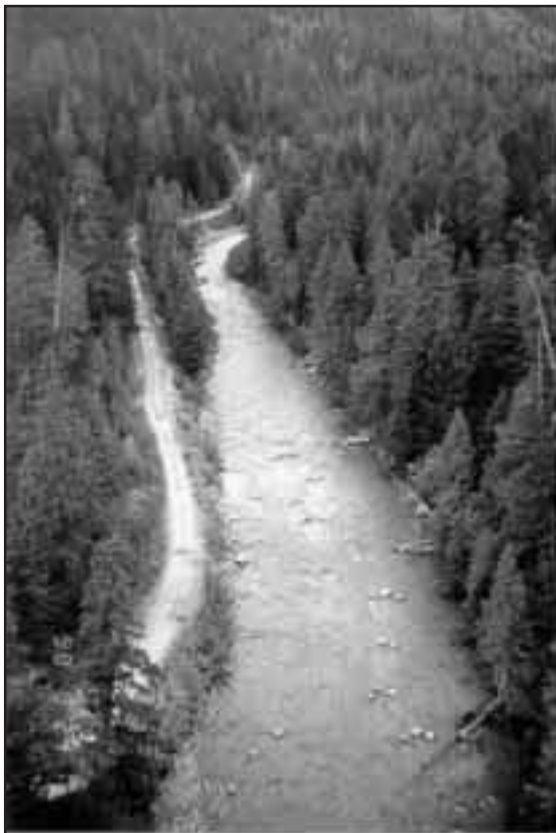
Figure 4-44. Post-project conditions. Note boulder clusters and three lateral log jams.

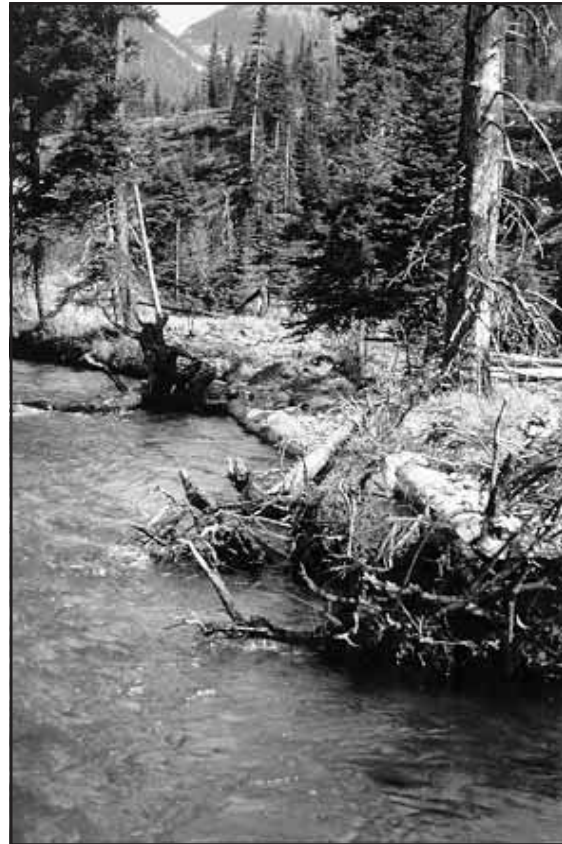
Figure 4-66. Whole tree revetment to protect eroding bank. Note energy dissipation along bank margin.

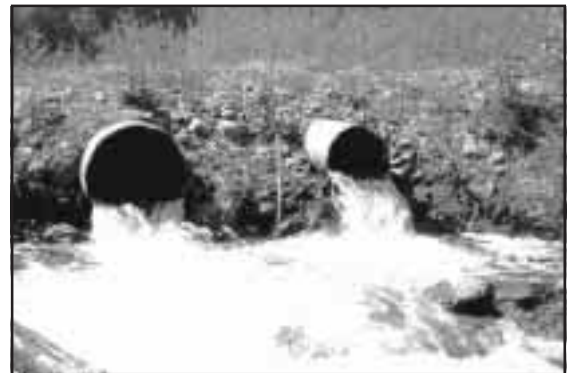
Figure 5-5. Culverts prior to replacement.

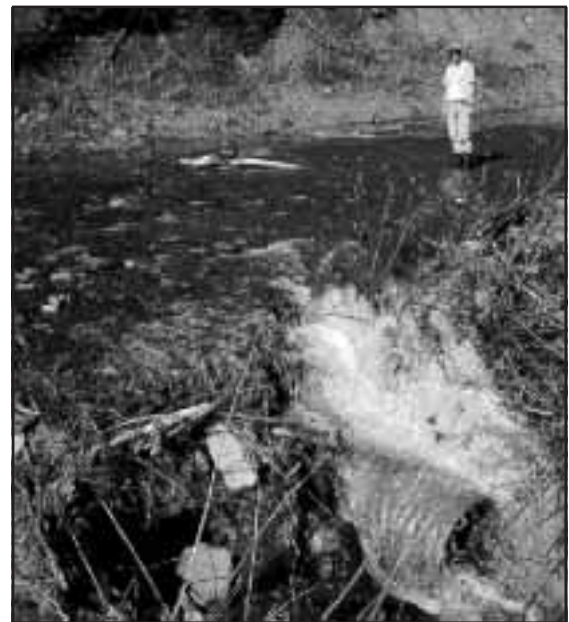
Figure 5-16. Culvert prior to replacement.

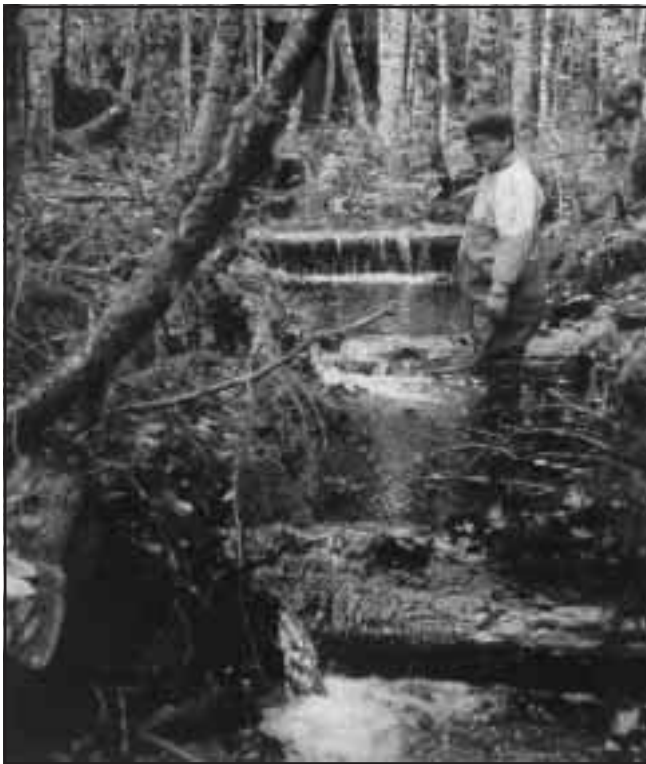
Figure 6-4. Reach 5D view from upstream looking downstream at the downstream rock riffle.

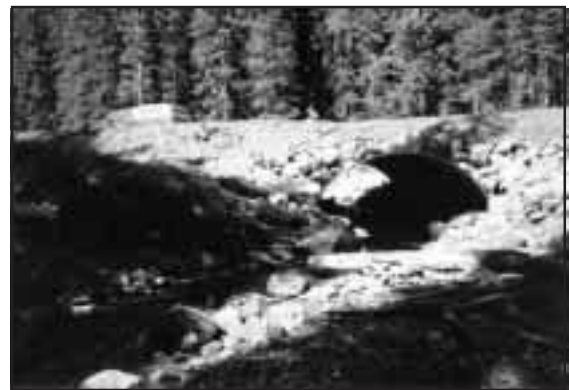
Figure 7-17. Downstream view of crossing #2 following replacement with a bottomless arched culvert.

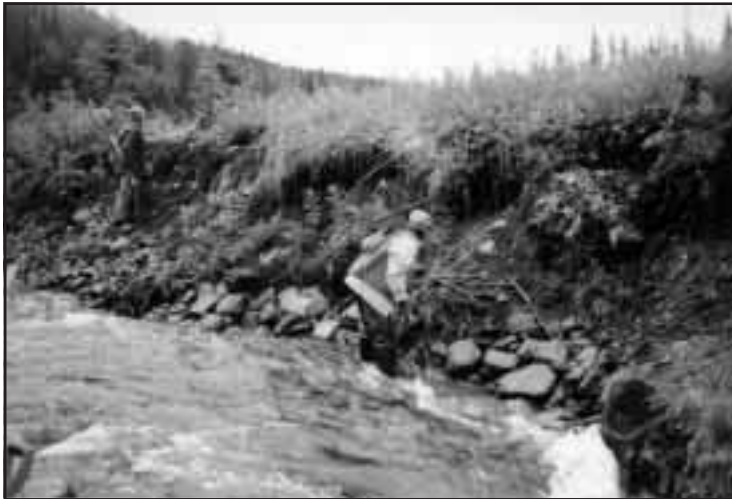
Figure 7-20. Horizontal willow staking of an eroding cutbank on Blue Grave Creek.
