Watershed Restoration Program
Ministry of Environment, Lands and Parks
and Ministry of Forests

**Annual Compendium Of Aquatic Rehabilitation Projects
For The Watershed Restoration Program
1998 - 1999**

Watershed Restoration Project Report No. 13

1999

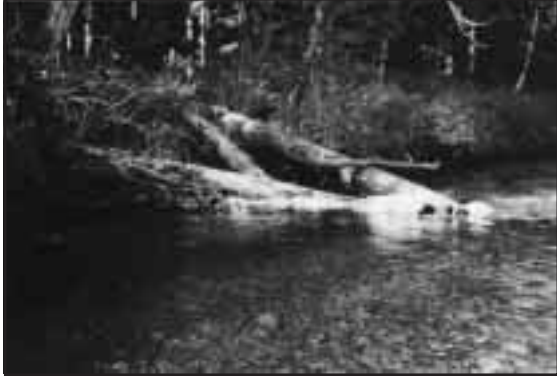
Figure 1-18. Lateral debris jam, located along the Wolfe Creek restoration section, placed to scour pool habitat and provide protective cover habitat.

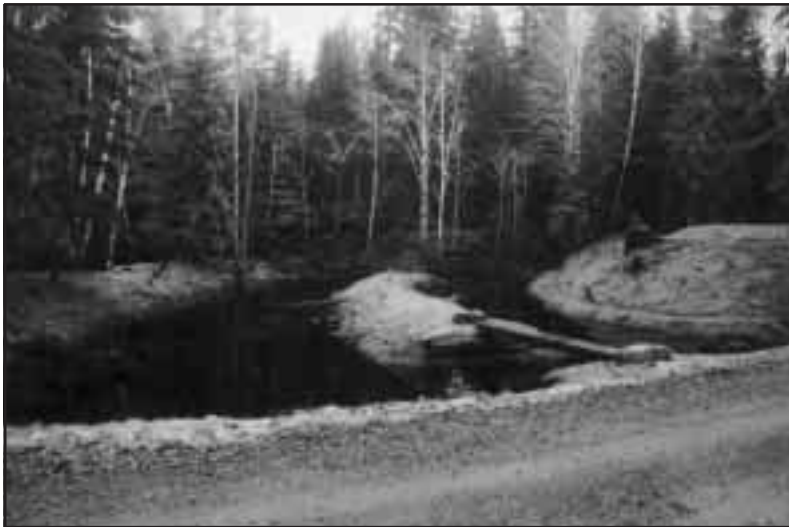
Figure 1-23. Off-channel ponds at the upper Keogh River. The lower pond (center) was excavated within the old cut-off river flood channel, and the upper “flooded” pond (left edge of photo) was created by constructing a berm with material excavated from the lower pond.

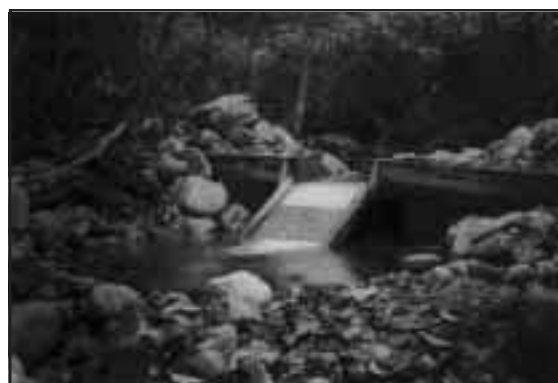
Figure 2-12. Installed and functioning intake designed by Rheal Finnigan, P. Eng. Creek water is diverted through the opening behind the ramp to the head of the new channel via a buried pipe to the right of the intake.

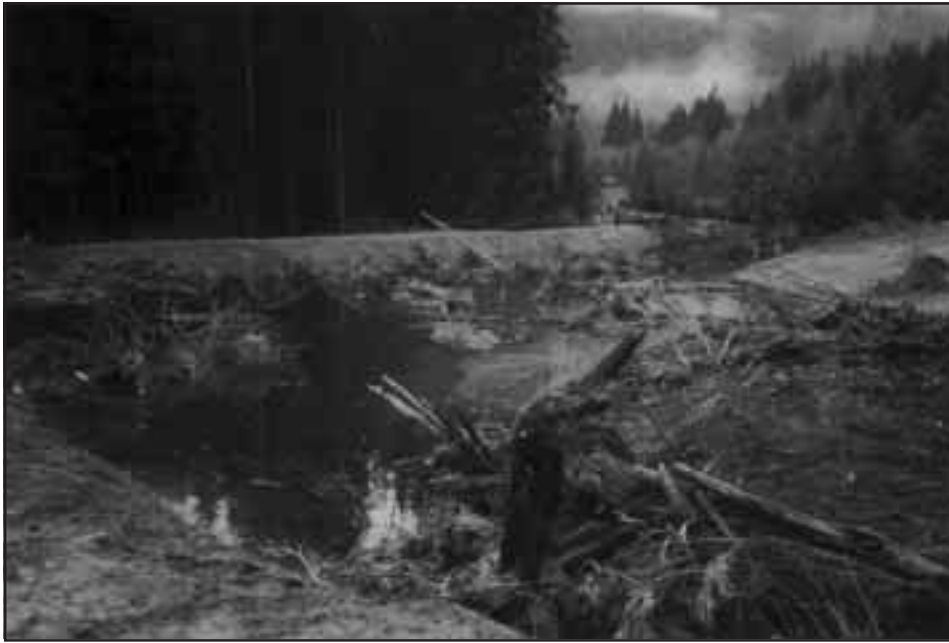
Figure 2-13. Newly excavated pond prior to replanting. Pond depth ranges from >3 m along the berm to the left to 0.3 m to the right. Overflow is located where the person is standing on the berm.

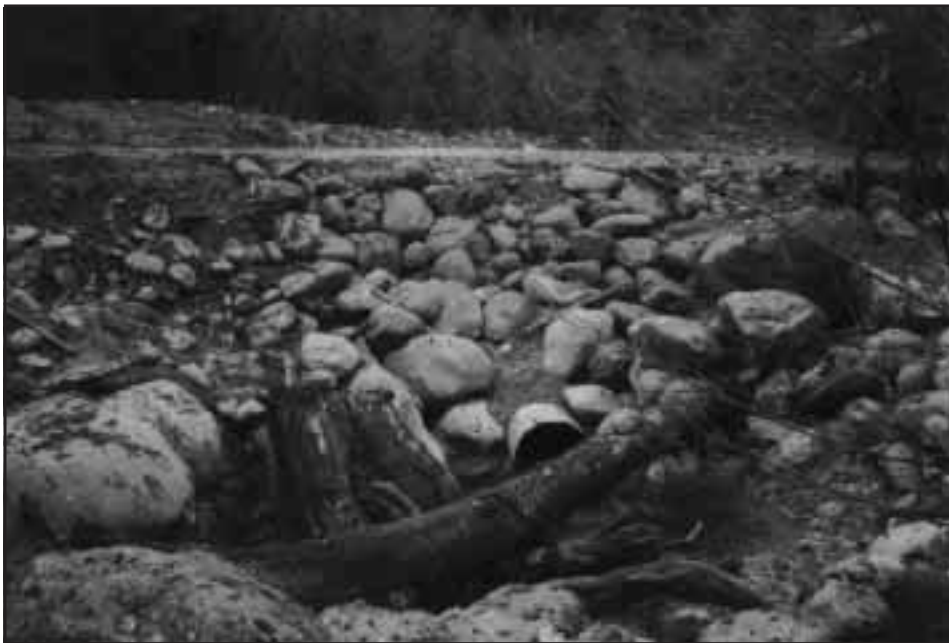
Figure 2-14. New 18 m x 800 mm culvert installed under the Statlu Forest Service Road. Culvert was installed at 0% gradient and submerged to facilitate perennial fish access from Statlu Creek to the new habitat.

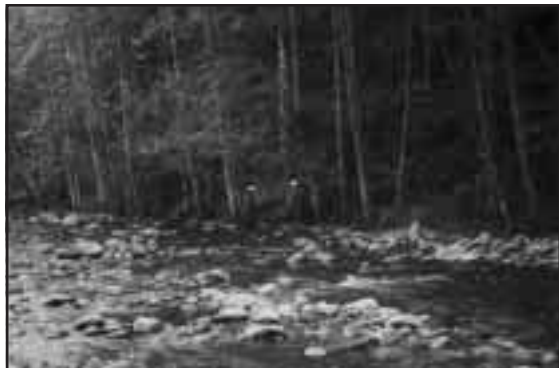
Figure 2-32. Typical view of the Coquitlam River indicating very little habitat and hydraulic diversity in the channel.

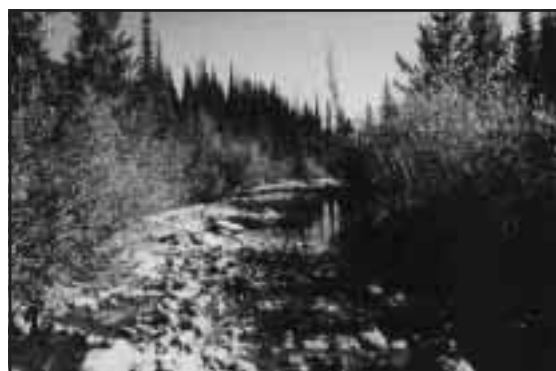
Figure 3-1. Pre-construction conditions in Arrastra Creek.

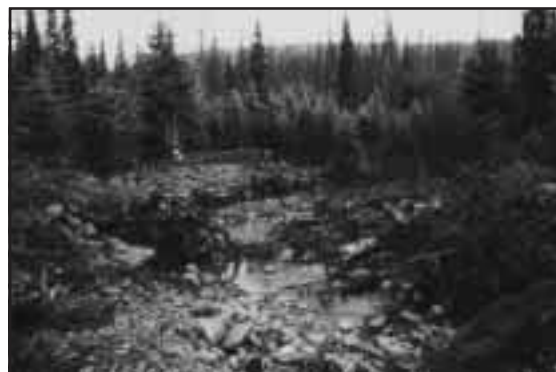
Figure 3-2. Large woody debris placement to stabilize the Arrastra Creek mainstem channel.

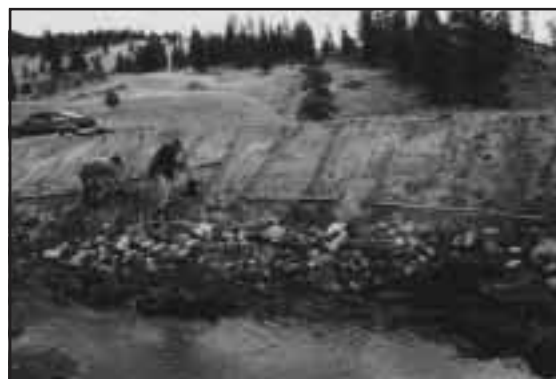
Figure 3-23. Live pole placement and bank stabilization on Shingle Creek.

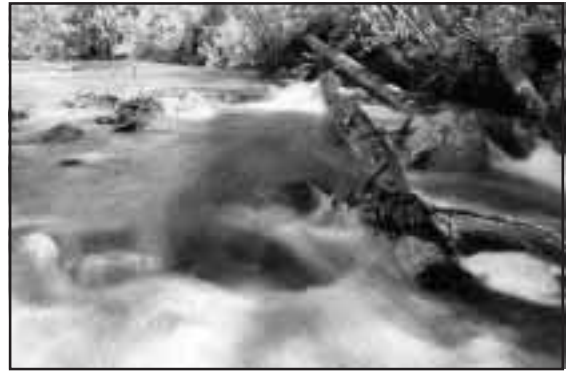
Figure 3-38. Failed diagonal LWD weir. Inadequate ballast/anchoring on left side, installed in 1997.

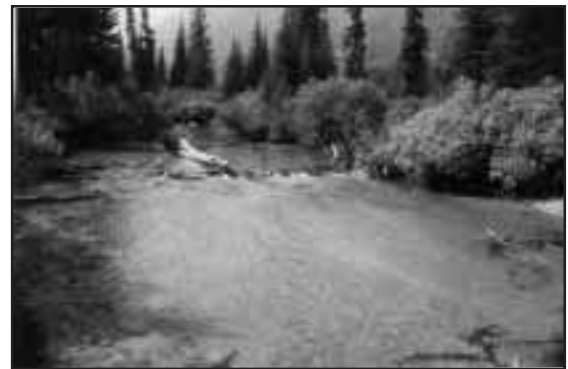
Figure 4-17. Typical perpendicular LWD limiting substrate migration, existing conditions.

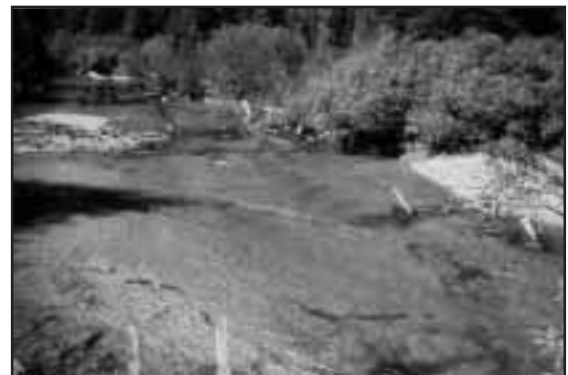
Figure 4-18. Perpendicular LWD post-notch log prescription. Note: increased local velocity and active down-cutting under base flow conditions.

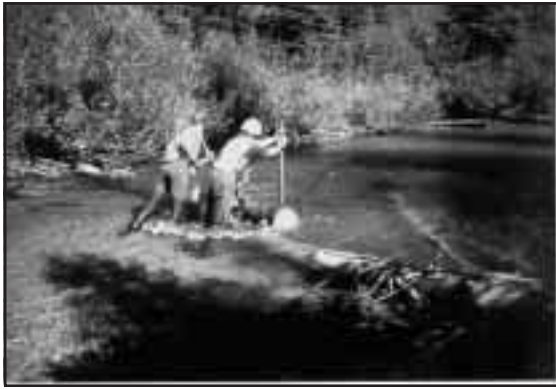
Figure 4-19. Notch log prescription. Work crew removing mid-portion of problem LWD.

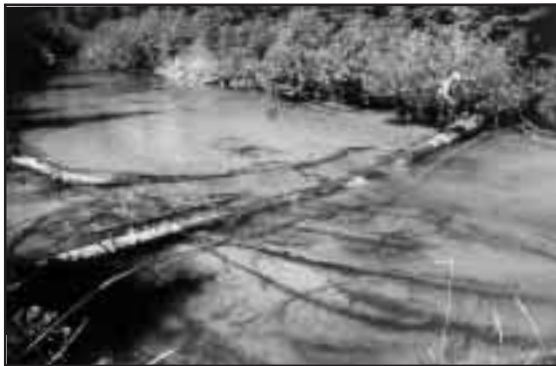
Figure 4-20. Relic beaver dam across channel, existing conditions.

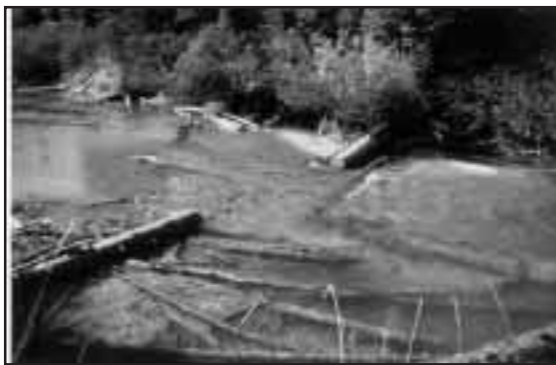
Figure 4-21. Relic beaver dam after partial removal. Note: channel down-cutting, shifted substrate and newly exposed LWD.

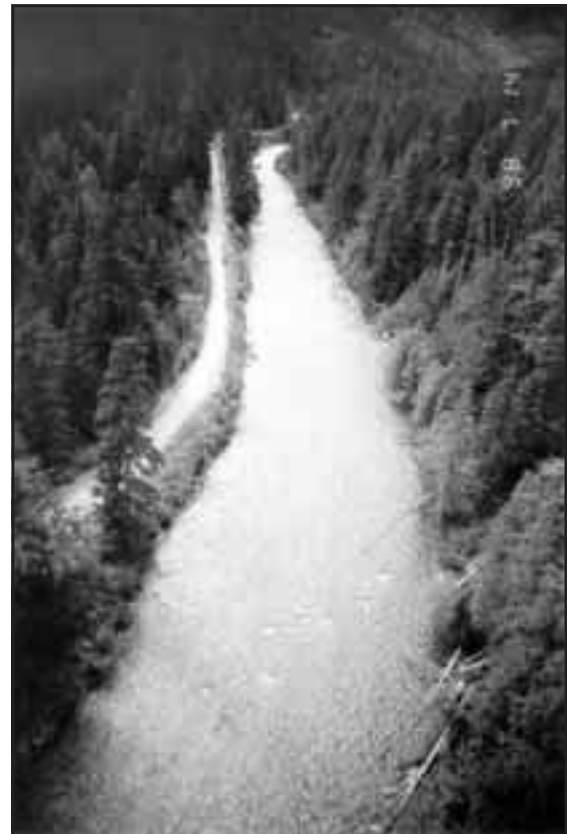
Figure 4-42. Pre-project conditions. Note the lack of complexity and instream cover.

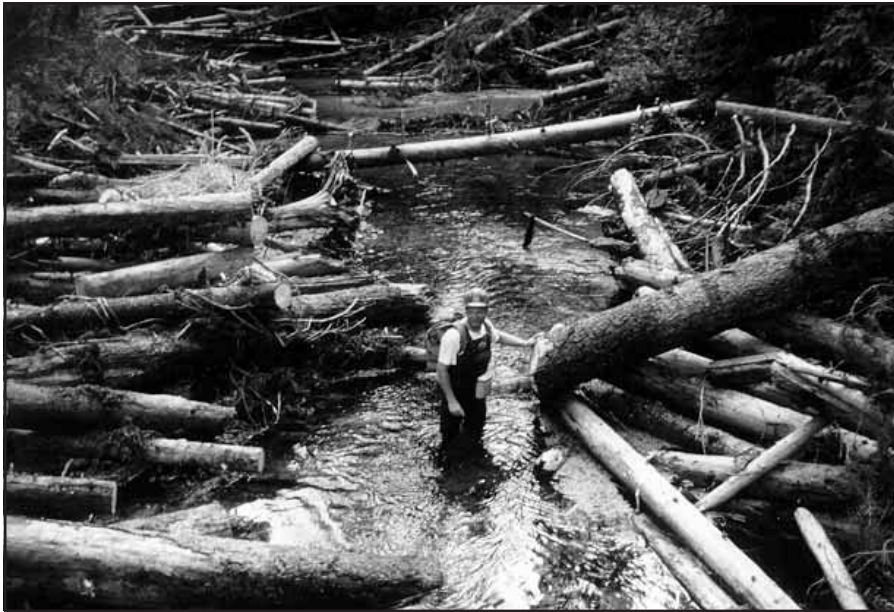
Figure 4-58. The partial removal of blowdown on Sanca Creek has been completed.

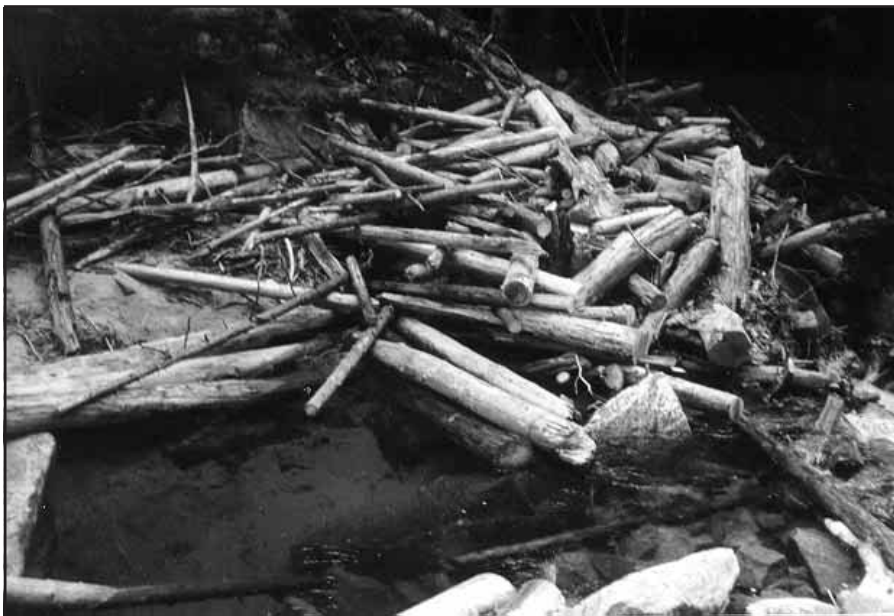
Figure 4-59. The channel of Sanca Creek is opened but logs were left in and above the pool to provide cover for trout.

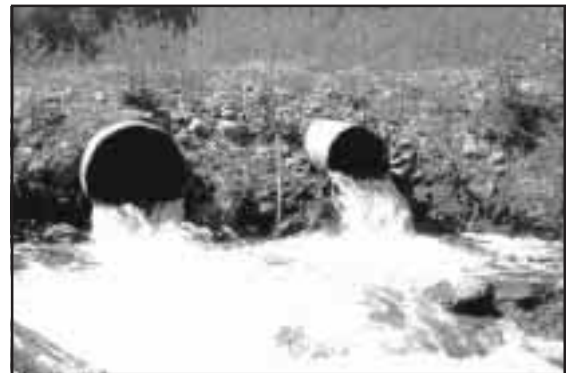
Figure 5-5. Culverts prior to replacement.

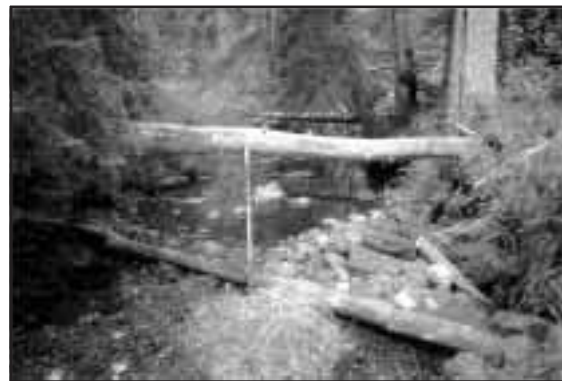
Figure 5-13. Site 8 on Marjorie Creek at extreme low flows during August 1998 installation (above) and approaching bankfull conditions on November 12, 1998 (below).

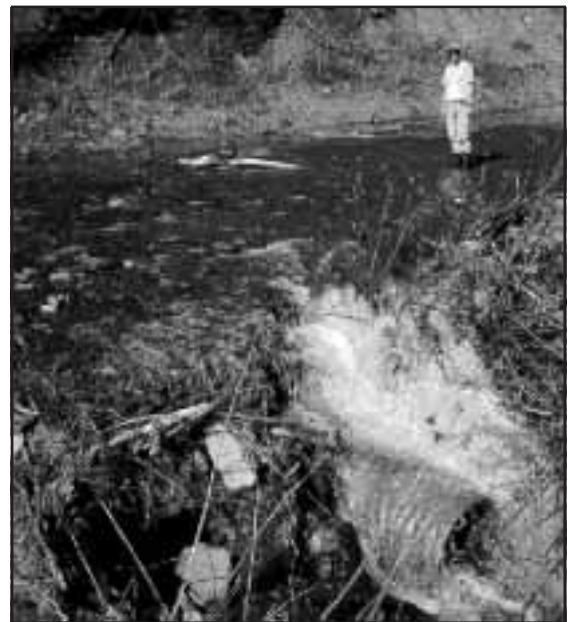
Figure 5-16. Culvert prior to replacement.

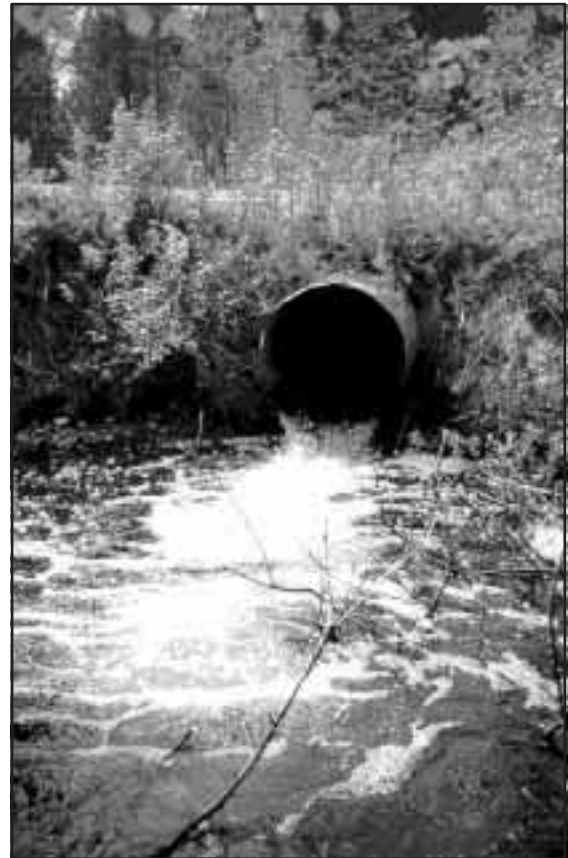
Figure 5-19. Culvert prior to replacement.

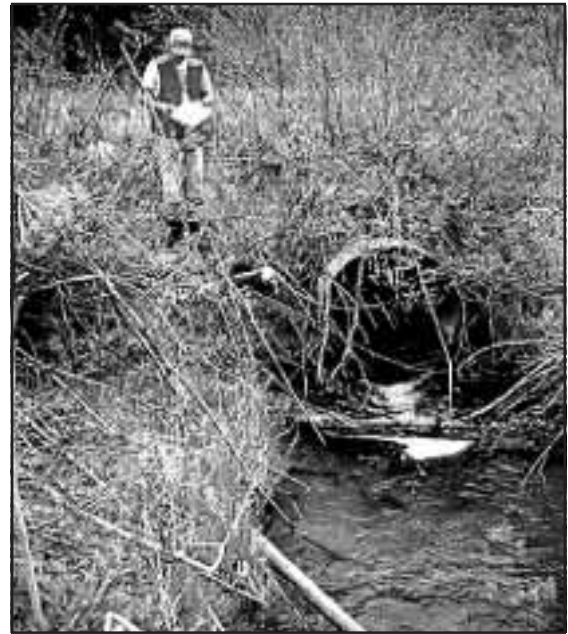
Figure 5-21. Culvert prior to replacement.

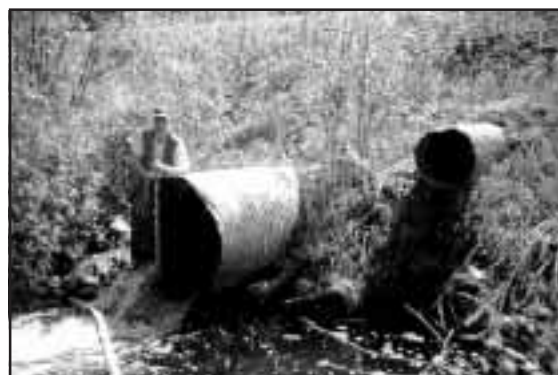
Figure 5-24. Culverts prior to replacement.

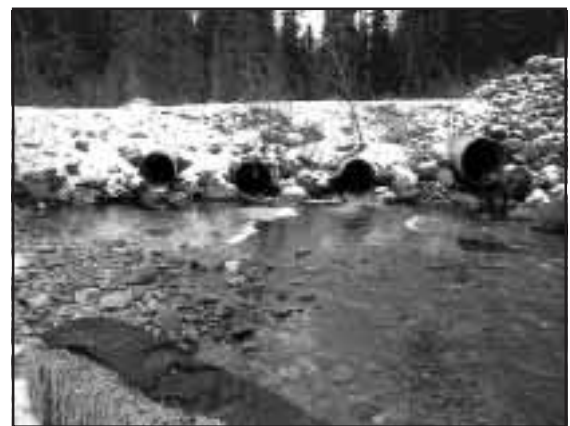
Figure 5-31. Culverts prior to replacement.

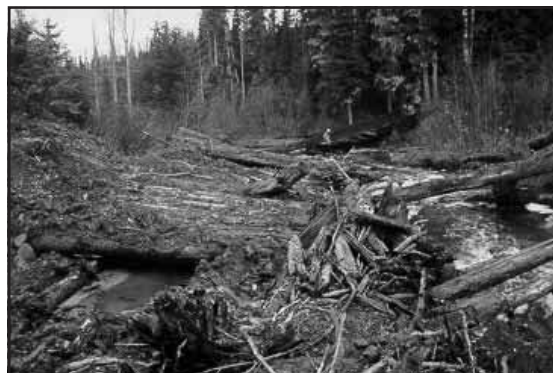
Figure 6-8. Downstream view of Site 3 on a tributary of the Kitsequecla River. Photo was taken prior to pull back of a failed bridge and channel rehabilitation.

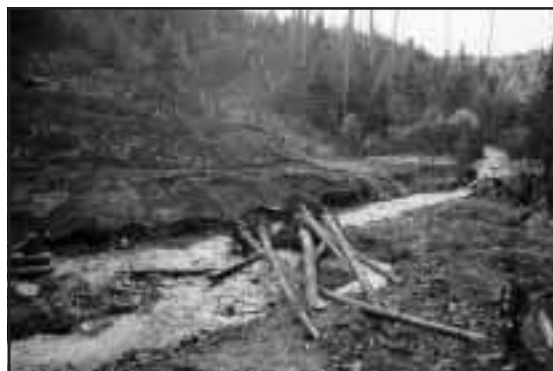
Figure 6-9. Upstream view of Site 3 showing the site immediately after the bridge pull back. The banks were seeded and LWD was placed in the channel to later be dispersed in prescribed locations downstream.

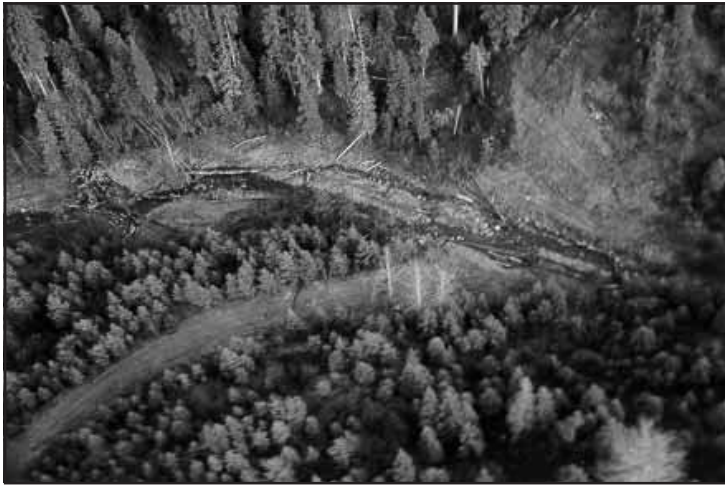
Figure 6-10. Aerial view of Site 3. Note high quality second growth for future long-term recruitment of LWD. To address short-term LWD deficiencies logs were placed parallel to the stream flow to encourage bank and mid-channel bar stabilization.

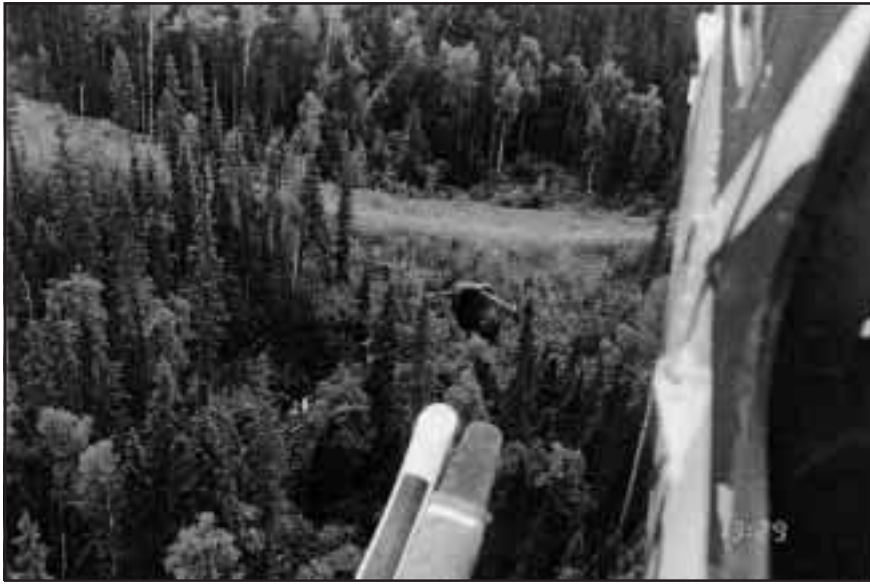
Figure 7-13. Aerial view of the box culvert crossing on Stubby Creek.

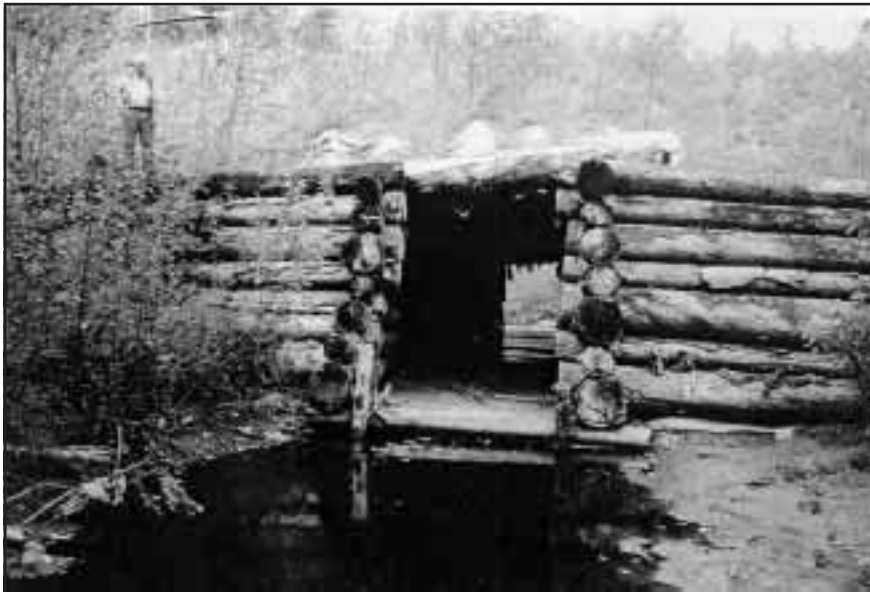
Figure 7-14. A view of the outlet of the box culvert crossing on Stubby Creek.

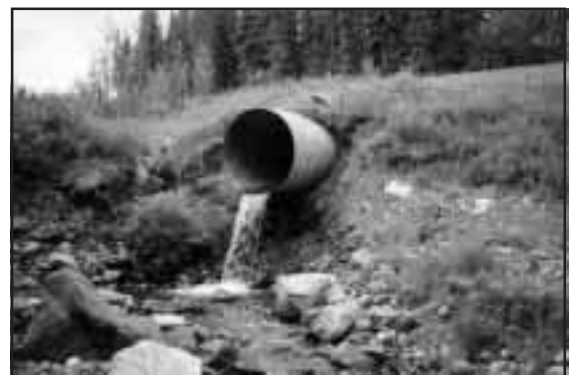
Figure 7-18. Upstream view of crossing #4 before restoration. Note the 1.5 m drop at the outfall.

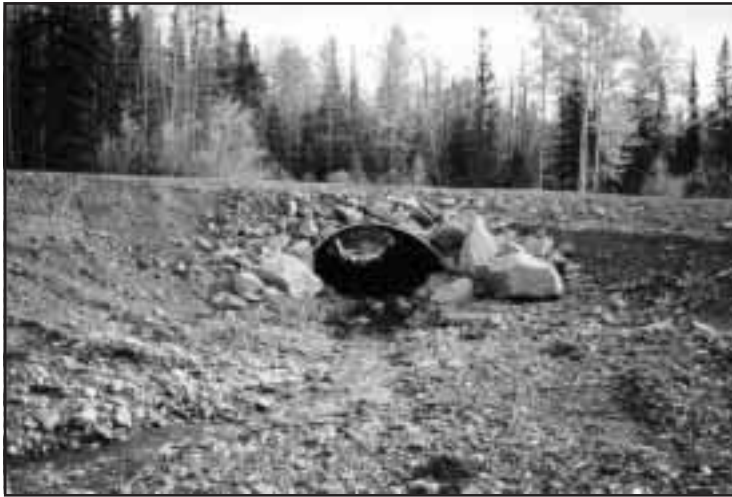
Figure 7-19. Downstream view of crossing #4 following replacement with a bottomless arched culvert and recontouring of the streambed.
