## **Exchamsiks Fish Ladder Repairs Construction Summary Report**

## Exchamsiks Fishway Repair Prescription

EXCHAMSIKS FISHWAY  
REPAIR  
PLAN, PROFILE, AND NOTES

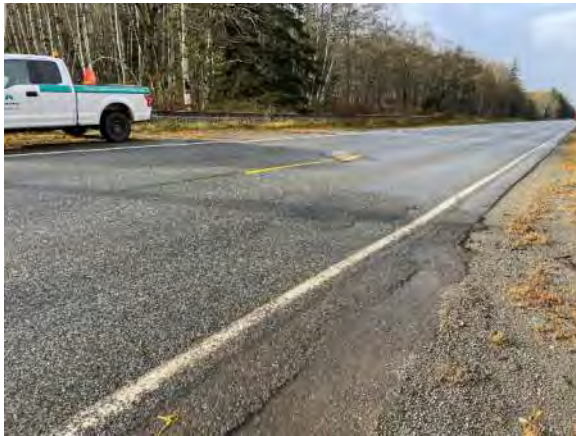
During the inspection it was noted that some degradation has occurred to the asphalt road section within this area, a detailed review this was not part of the scope, and therefore no work is proposed to be completed for the culvert section under the road.

*Photo 7 - Road Damage*

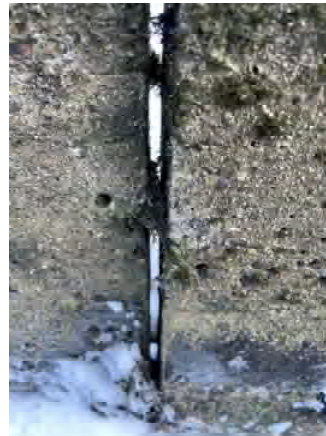
After review of the fish ladder, it appears that the individual boxes have shifted positions, causing gaps to form between the boxes (see photo 3, 8 & 11). The overall location of the ladder does not appear to have changed. Large amounts of material around the boxes have been eroding away causing large gaps between the concrete boxes and the adjacent ground (see photo 3 & 4). The material under the culvert into the ladder has been completely eroded away causing the pipe to be suspended between the road fill material and the concrete boxes. It is recommended to disconnect the boxes from each other (see photo 12 for bolt connection) and lift the individual boxes out of the way in order to re-establish the base materials. Since the overall elevation of the boxes doesn't appear to have changed much it is assumed the support rails under the boxes are still in good condition and have not moved. Therefore, only the base material will only require repair, but a review of the rails and base should be inspected to confirm this upon removal of the boxes. Upon re-installing the boxes, Con Seal CS-102 Butyl Rubber (product information is attached) sealant (or approved fish friendly equivalent) should be placed on all joints prior re-bolting the boxes securely together. After the boxes have been put back into place, they should be backfilled with an approved granular material to match the existing ground with a minimum 2% grade away from the boxes to reduce the potential for additional erosion. Care should be taken when backfilling around the culvert to ensure that compacted material is established underneath the pipe. Within the locations that the backfill is within the water, Class 50 kg riprap should be used to prevent erosion specifically in the location of the left side of section B on the drawings between the boxes and the railway grade, as depicted in photo 10 where water continues to flow during low flow periods.

*Photo 8 - Displacement between Boxes*

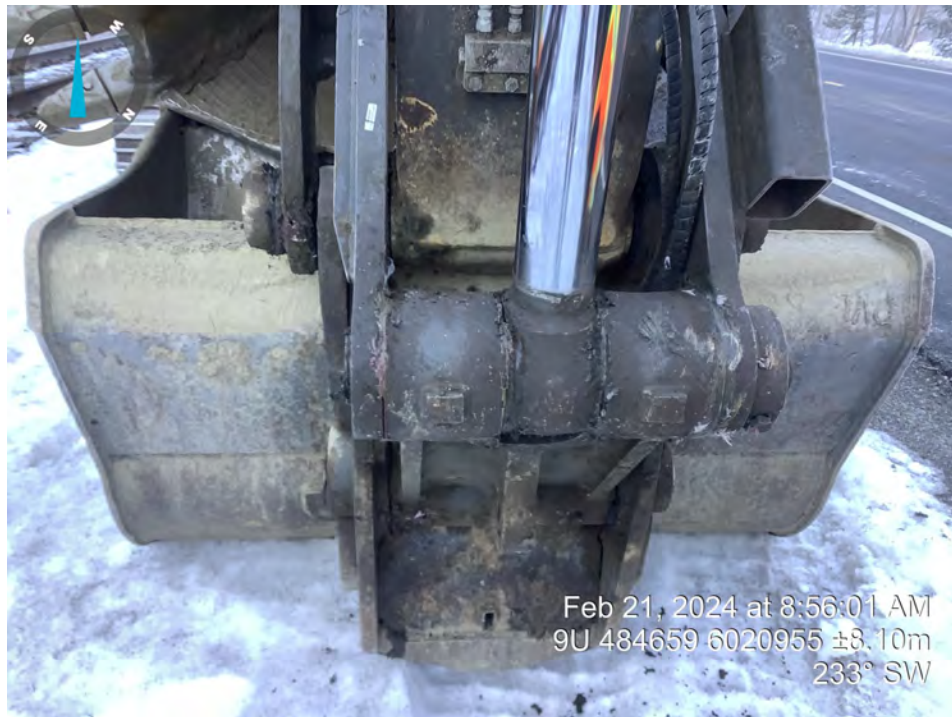
- Excess grease observed on excavator during mobilization inspection. PVL supervisor notified and the excess grease was promptly cleaned up.
- Spill barrel on site and adequately stocked

- 3 Excess grease on bucket cleared up.

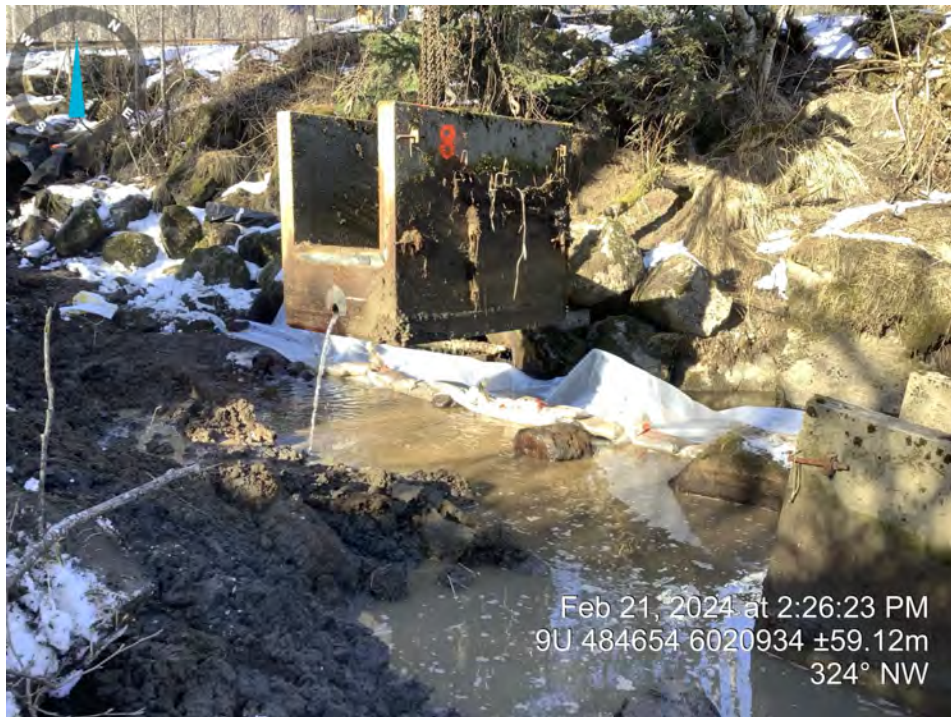
- sandbag berm did not fully contain water and sediment. Sediment plume occurred as PVL removed the last two fishway boxes which were partially in the water. Additional sandbags will be placed on this berm tomorrow.

- 7 Fishway boxes being drained over water immediately after removal. Sandbag berm installed.

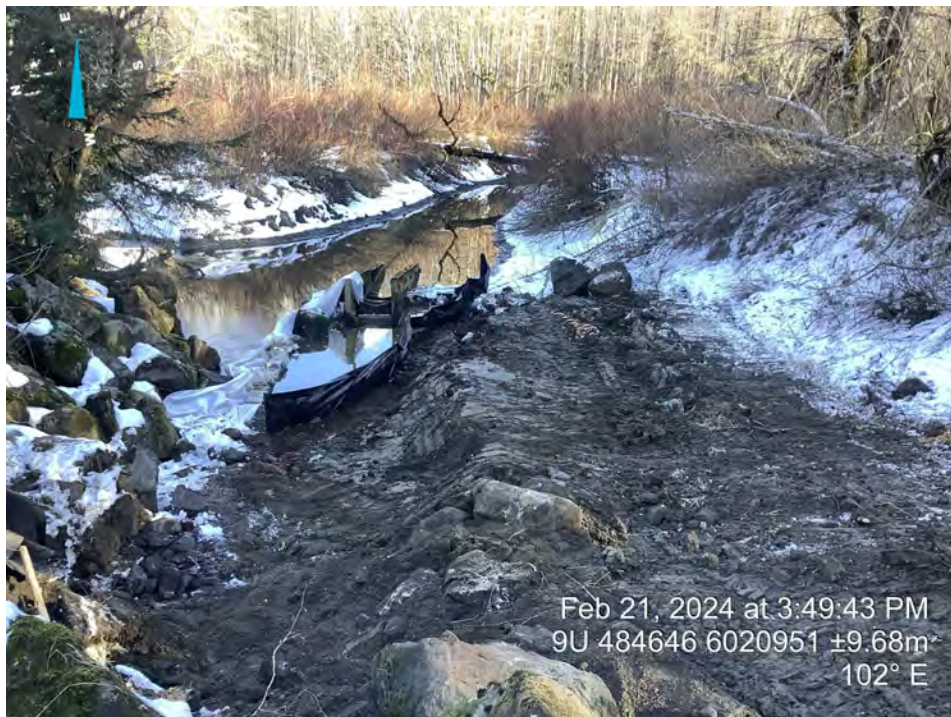
- 8 Sediment fencing installed at the end of the day.

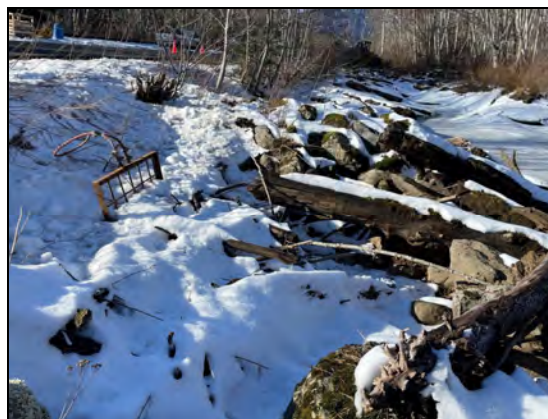
Photo 2 – upstream side of the highway, debris accumulated on the outlet pipe

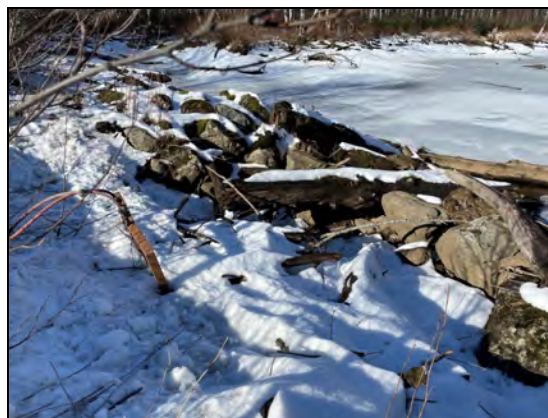
Photo 4 – the culvert inlet is set on the grade seal. Fish were observed at the toe, in the open water.

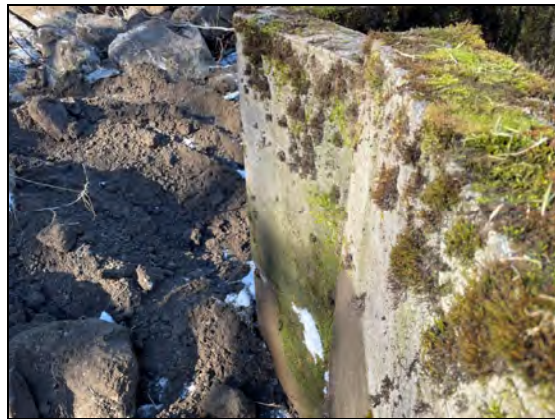
Photo 10 – ground conditions outside the top box of the fishway, gravels with riprap.

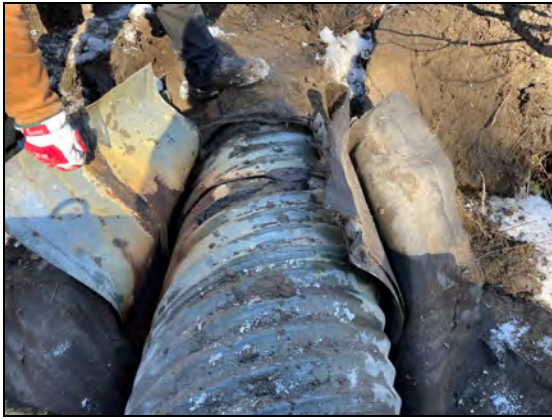
Photo 11 – collar at the culvert stub incorporated a sealer product as well as filter cloth

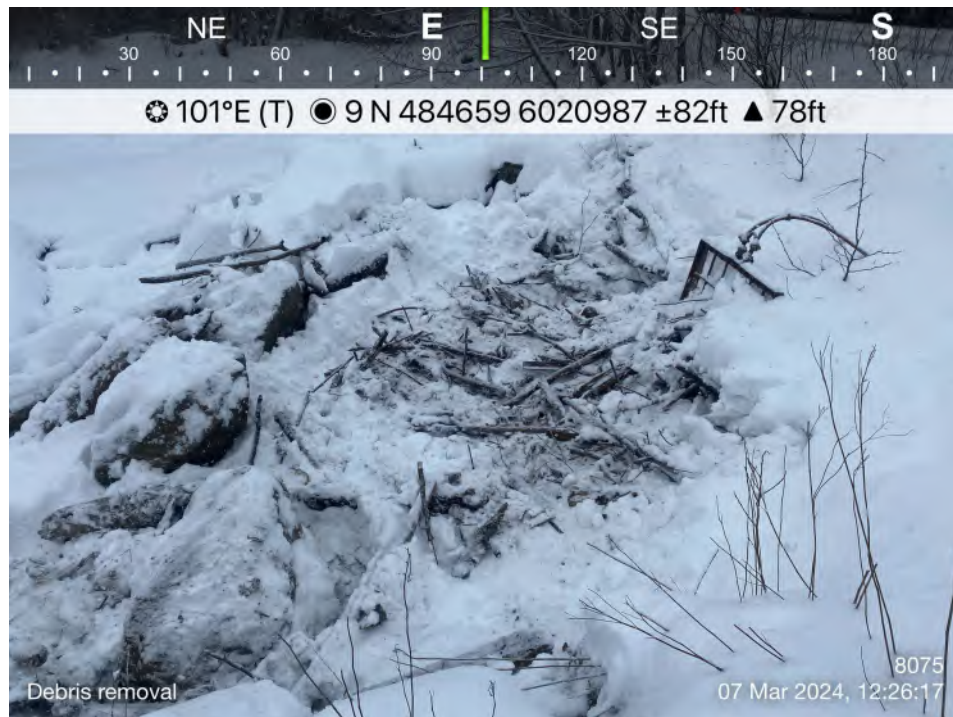
- 1 Fine woody debris remains after excavator clean up. Hand work required to complete task.

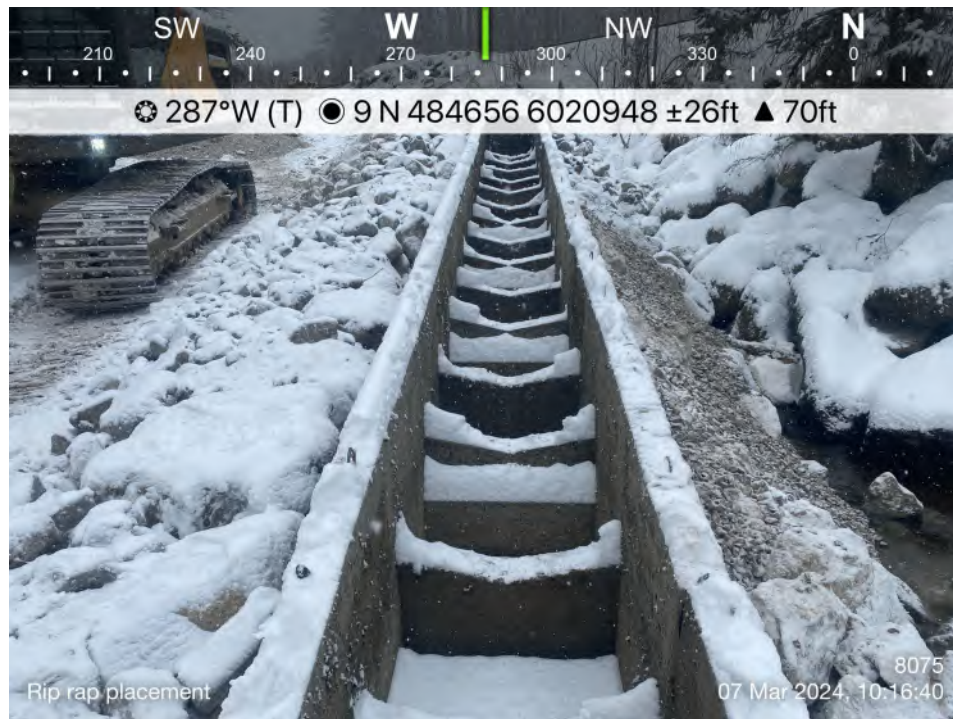
7 Fishway after completion of installation.
