Fish Passage Assessment of Kispiox Forestry Road Stream Crossings

Ken Rabnett & Tim Wilson
Gitksan Watershed Authorities
January 2007

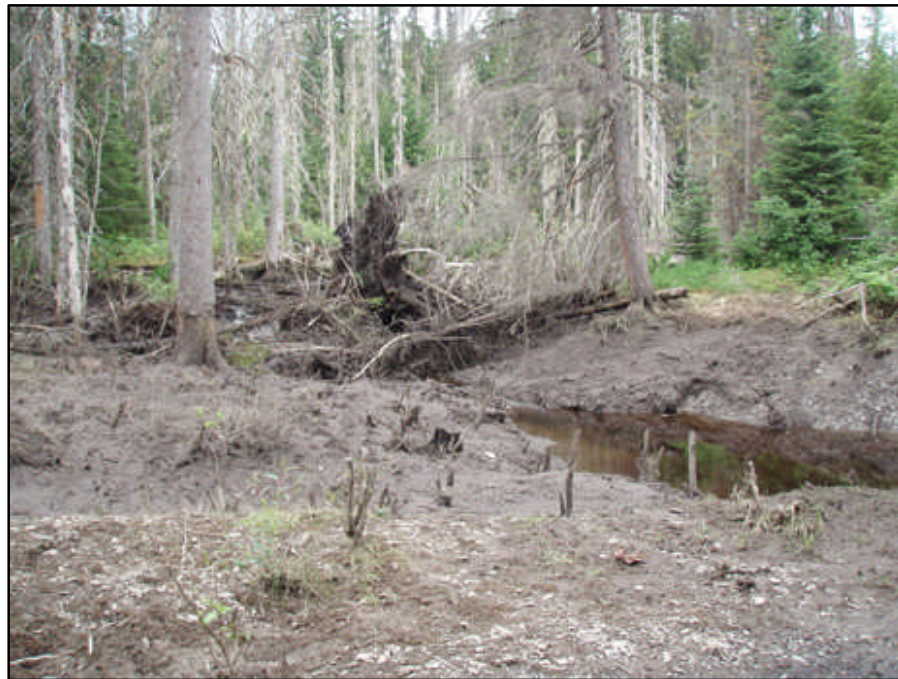
Figure 3. Typical ponded area following beaver dam failure. Site 132 located on a tributary to Ironside Creek.

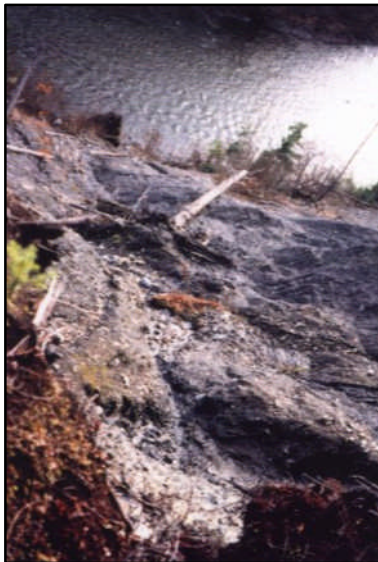
Figure 7. Cutblock slumping into Sweetin River

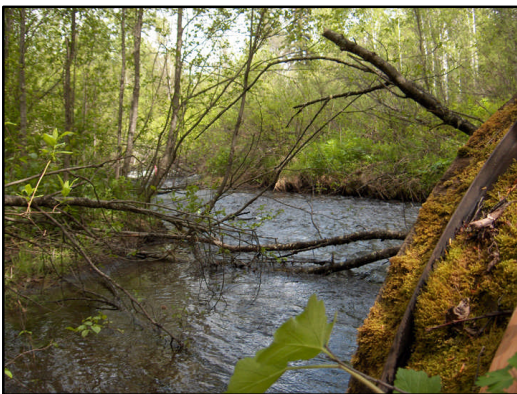
**Figure 12. Clifford Creek culvert inlet
View upstream from inlet.**

Clifford Creek culvert restoration is rated High Priority with a matrix score of 46. A concrete bridge is recommended to restore suitable flows, ease fish passage, and provide low maintenance efforts. The original channel, with an average gradient of 1% and several bedrock outcrops controlling base levels, should be reestablished.

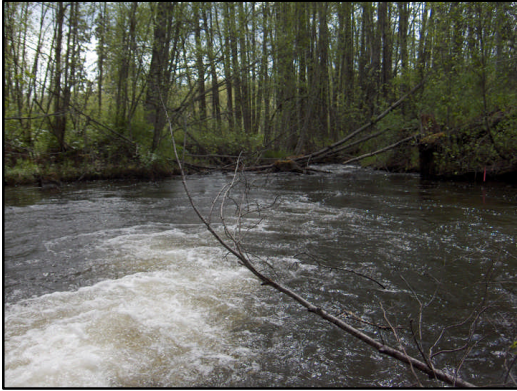
**Figure 13. Clifford Creek culvert outlet.
View downstream from outlet.**

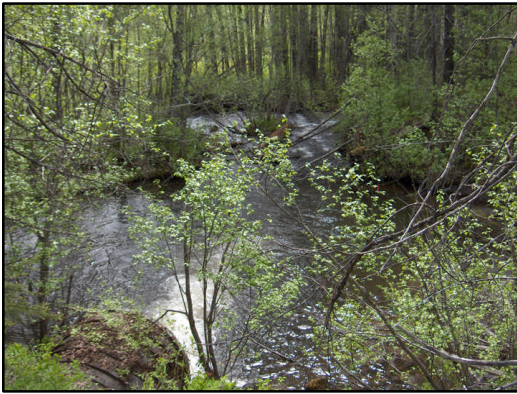
**Figure 14. Clifford Creek culvert outlet.
View downstream from outlet.
Original channel is to the right of photo.**

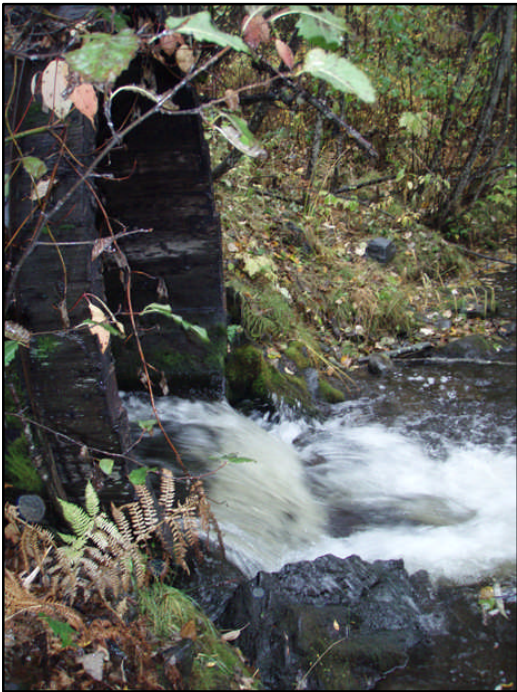
**Figure 15. Clifford Creek outlet.
Side view shows culvert discharge onto boulders.**

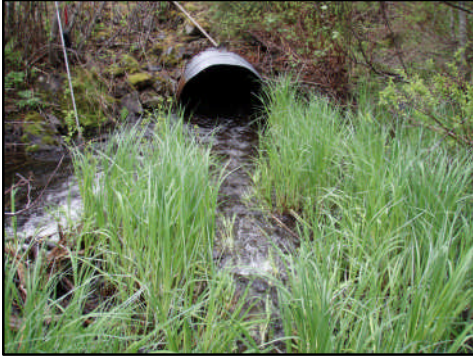
**Figure 26. Hodder Creek culvert inlet.
View downstream to inlet.**

The Hodder Creek culvert supports the Kispiox Trail at approximately 88 km. The culvert controls access to high value spawning and rearing fish habitat in the lake and about 8.3 km of tributaries upstream of Hodder Lake. Bedrock limits the culvert outlet pool depth and the downstream gradient is 6%, which together do not allow a backwater solution. The culvert is undersized to adequately pass a 100 year high flow event and is 23 m downstream of a beaver dam that could potentially fail or be breached. Excess culvert velocity (0.95 m/s average on moderate flows), an outfall drop barrier at some flows, and low in-culvert water depth along with insufficient outlet pool depth limit fish passage. Hodder Creek culvert restoration is rated a High Priority Restoration site with a matrix score of 46. An open bottom arch or open bottom structure is recommended.

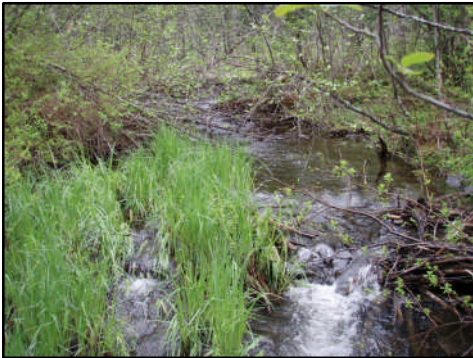
**Figure 27. Hodder Creek culvert inlet.
View upstream from inlet.**

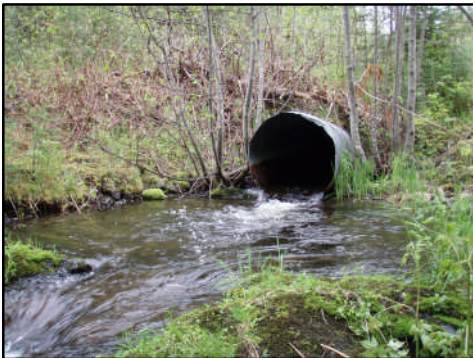
**Figure 28. Hodder Creek culvert outlet.
View upstream to outlet.**

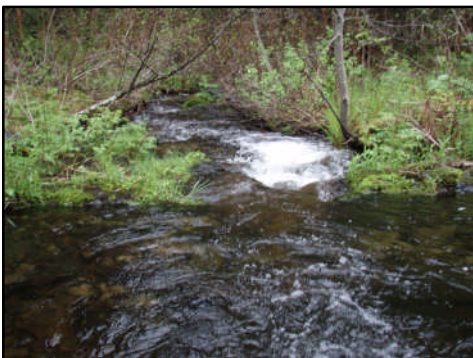
**Figure 29. Hodder Creek culvert outlet.
View downstream from outlet.**

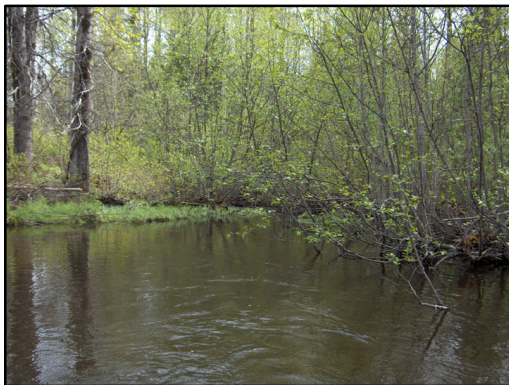
**Figure 30. Kline Creek culvert outlet.
View downstream from outlet.**

Kispiox Trail crosses Kline Creek culvert at 51 km. The culvert has historically been a fish passage problem primarily due to beaver activity with debris accumulations, dam failures, and screens on the inlet. The 500 CMP overflow culvert is crushed and dysfunctional. The 1100 main culvert is undersized for 100 year flood events, and more particularly, for beaver impoundments outbursts. The culvert is a velocity barrier for juvenile fish. Kline Creek culvert is rated medium priority with a matrix score of 42. An open bottom arch or open bottom structure is recommended.

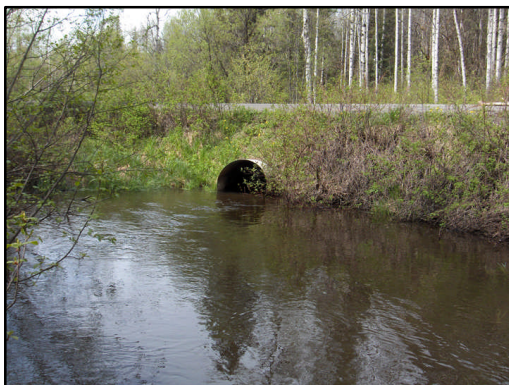
**Figure 31. Kline Creek culvert outlet.
View upstream to outlet.**

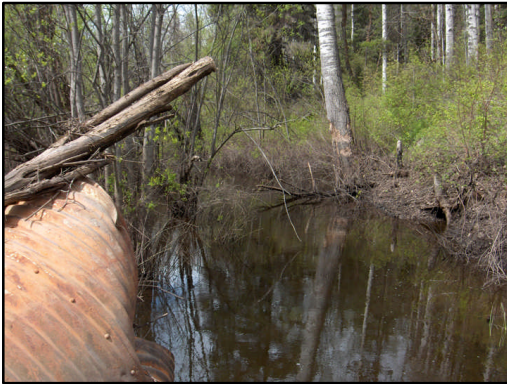
**Figure 32. Kline Creek culvert inlet.
View downstream of inlet.**

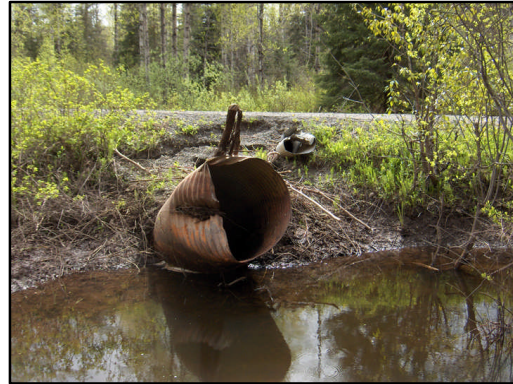
**Figure 33. Kline Creek culvert inlet.
View upstream from inlet.**

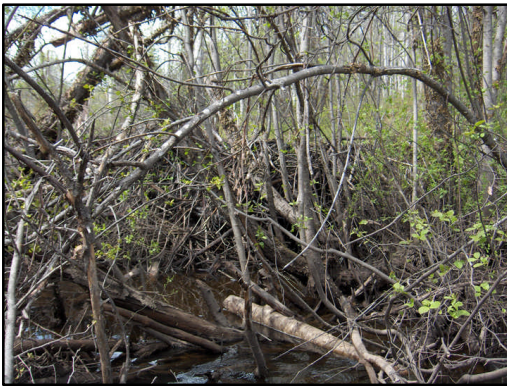
**Figure 34. Kline Creek culvert inlet.
View to beaver dam 29 m upstream.**

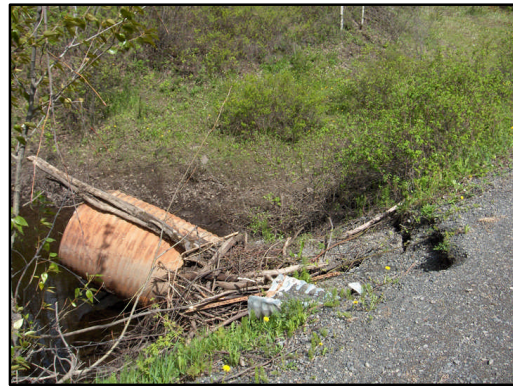
**Figure 35. Kline Creek culvert inlet.
View shows failure in road shoulder**

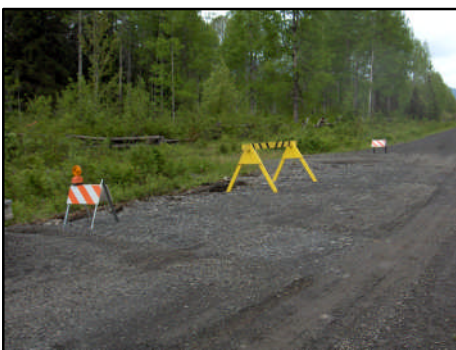
**Figure 36. Kline Creek
View shows erosion where Kline flowed over Kispiox Trail**

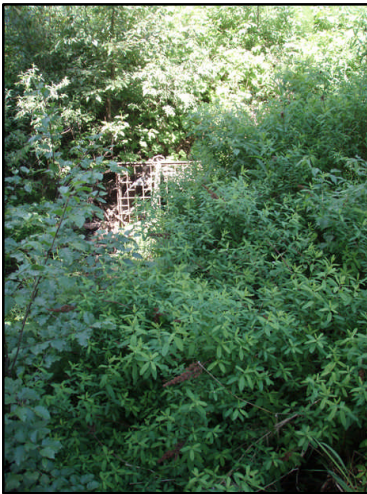
**Figure 41. Site 240 culvert inlet.
View downstream to inlet**

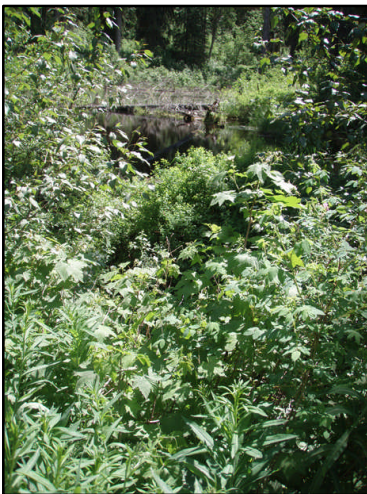
**Figure 42. Site 240 culvert inlet.
View upstream from inlet.**

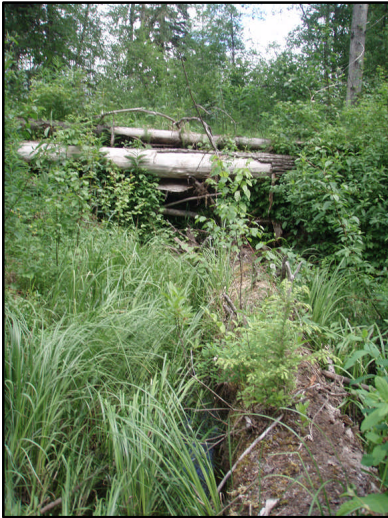
**Figure 46. Site 239 culvert inlet.
View downstream to inlet.**

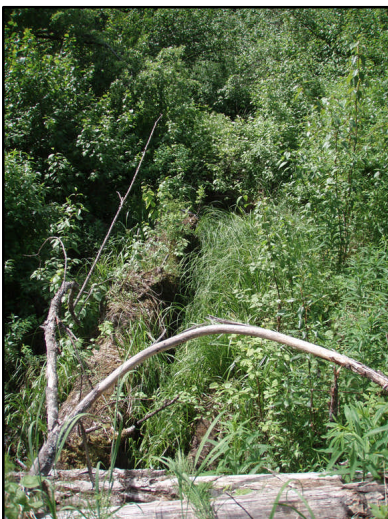
**Figure 47. Site 239 culvert inlet.
View upstream from inlet.**

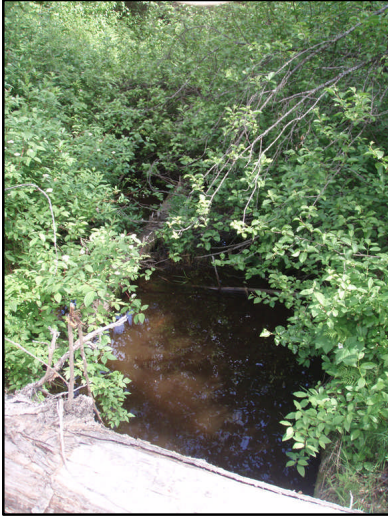
**Figure 48. Site 239 culvert outlet.
View downstream from outlet.**

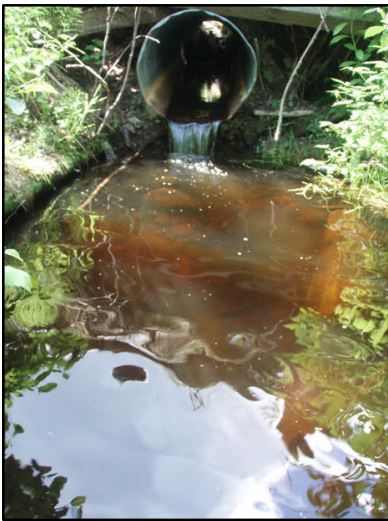
**Figure 49. Site 239 culvert outlet.
View upstream to outlet.**

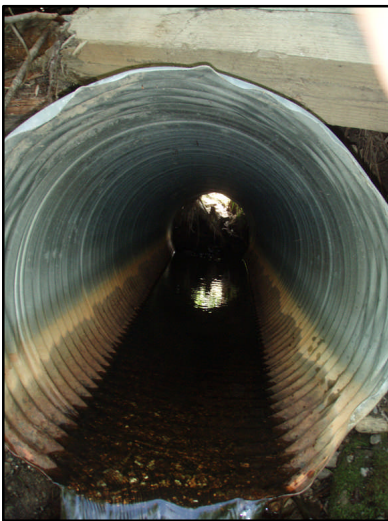
**Figure 50. Site 239 culvert.
View upstream through culvert.**

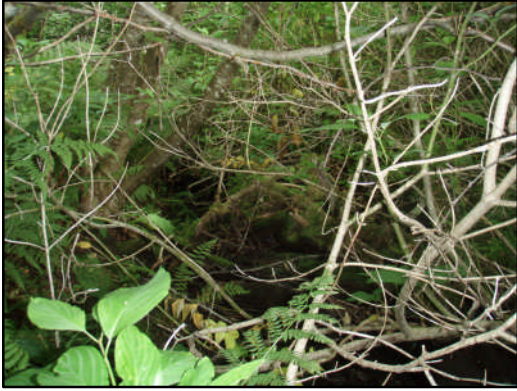
**Figure 53. Site 390 culvert outlet.
View downstream from outlet.**

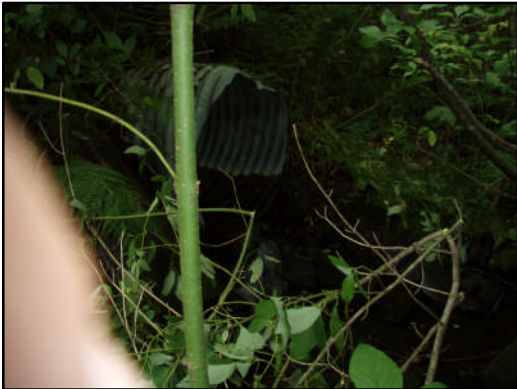
**Figure 54. Site 390 culvert outlet.
View upstream to outlet.**

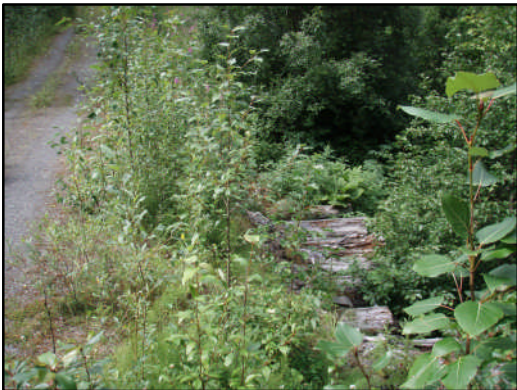
Figure 55. Site 390 Corduroy and road bed.
