**Detailed Fish Habitat, Riparian and
Channel Assessment
for
Select Central Bulkley River Tributaries**

Greg Tamblyn
Resource Management Consultant
Smithers, BC.

Matthew Jessop
British Columbia Conservation Foundation
Smithers, BC.

February 29, 2000

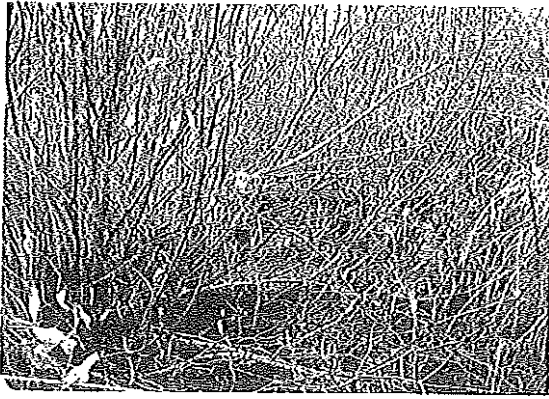
A: Upstream view of typical channel and riparian vegetation in wetland near the confluence with Robin Creek.

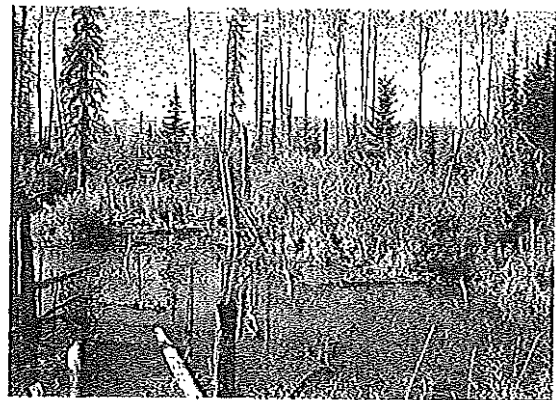
F: Downstream view of beaver pond and dam at 1+830 m.

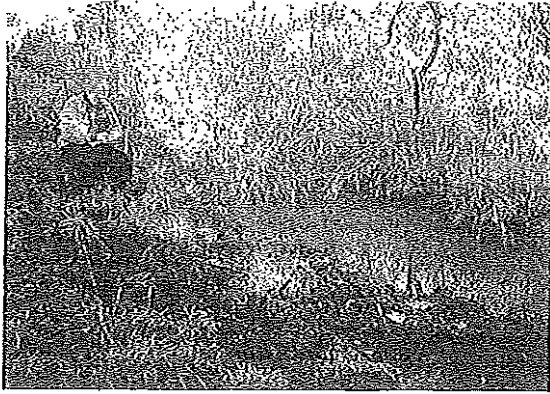
A: Cross-channel view of cattle watering impacts at pool sampled at 0+183.

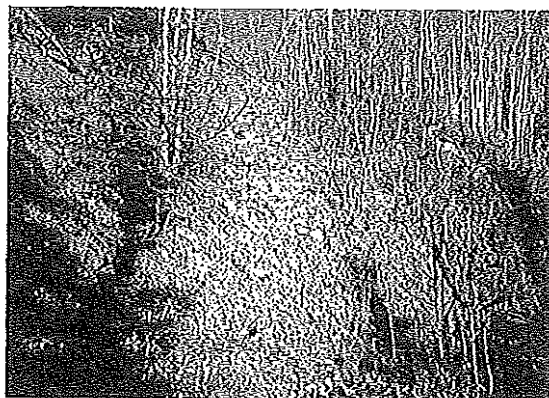
E: View of small revegetating slump or slope failure at 2+730 m. An access road is located at the top of the gully.

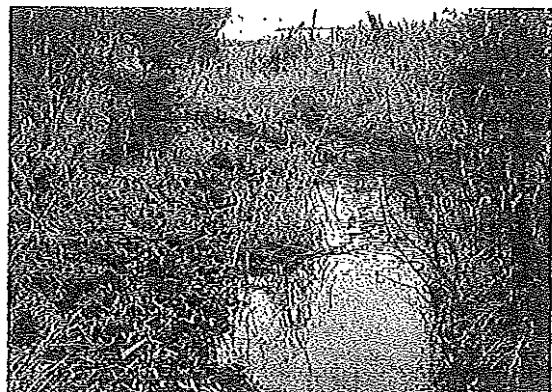
F: Upstream view of cattle impacts to the channel downstream at 1+260 m near the upper reach break.

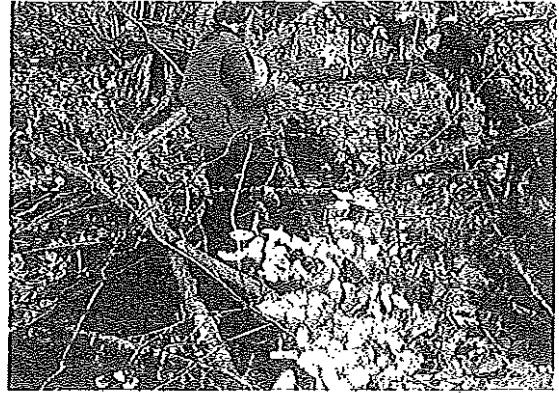
B: View of typical channel conditions at 0+185 m. Note the abundant nonfunctional LWD spanning the channel.

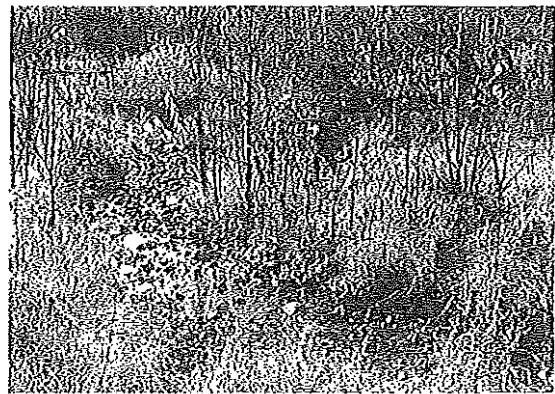
D: Downstream view of impacted channel and riparian habitat at 1+160 m. Note the braided channel and aggradation upstream of the road crossing.

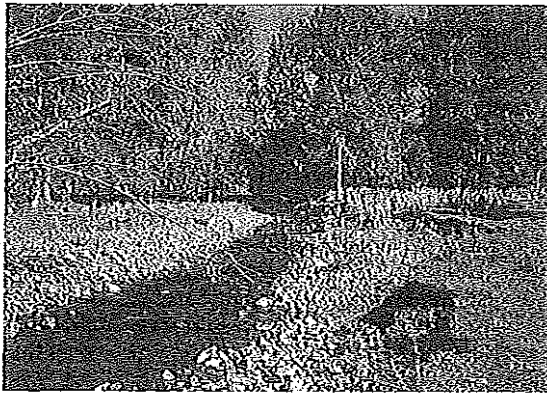
H: Upstream view of channel and riparian impacts at 6+325 m. Note the lack of riparian vegetation and LWD and the poor condition of the banks.

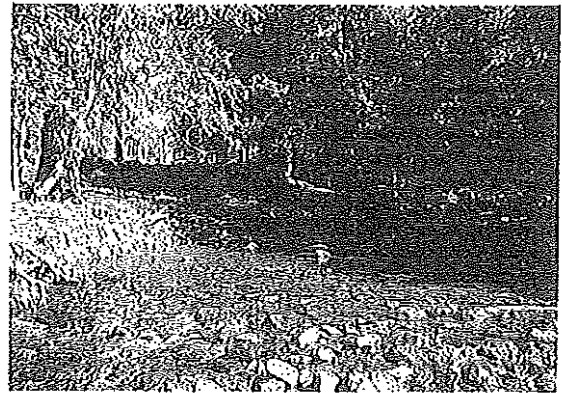
I: View of a well used cattle watering area and ford at 6+435. Note the exposed soil and poor bank structure.

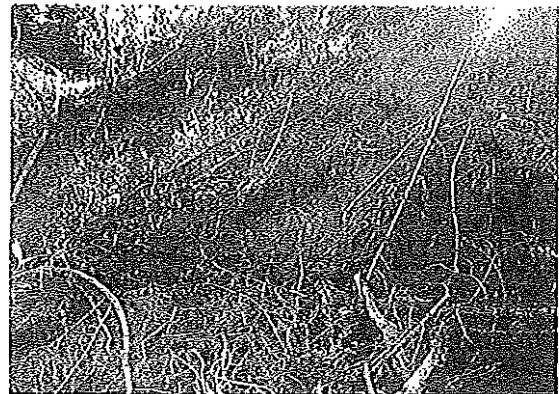
J: View of a hydraulic failure of a clay bank at 6+540 m. This is a source of fine sediments and SWD.

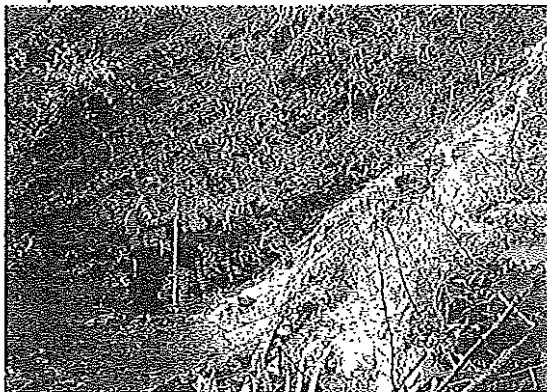
C: View of a hydraulic failure of a clay bank at 0+375 m. Note the clay flowing into the channel.

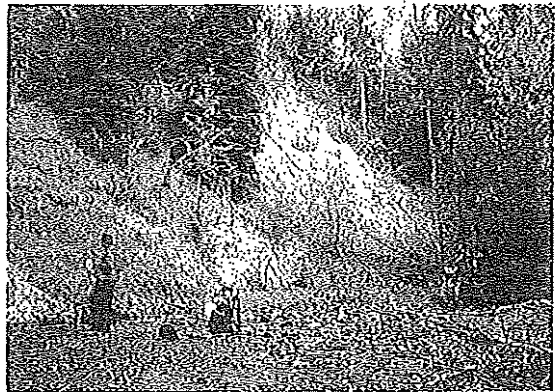
D: View of slope failure and slump of clay bank into the channel at 1+120 m. This slope is a source of LWD recruitment.

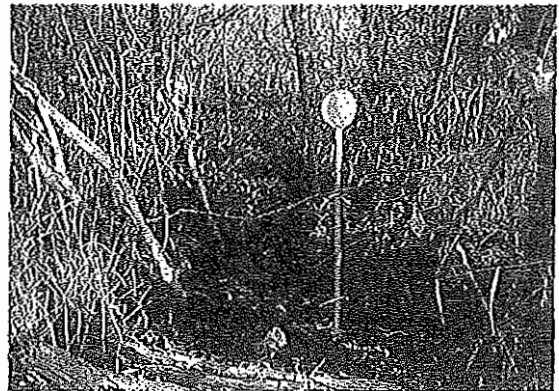
D: Upstream view of the dry channel at 4+557 m. This was the main channel prior to the stream diversion at the reach 1/2 break.

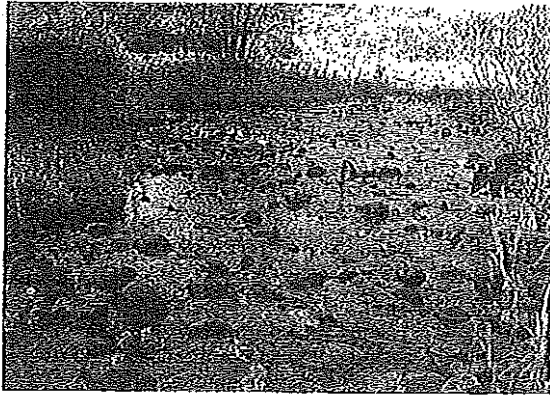
A: View of degrading channel under the power line crossing at 0+850 m. The channel is 15 m wide at this point.

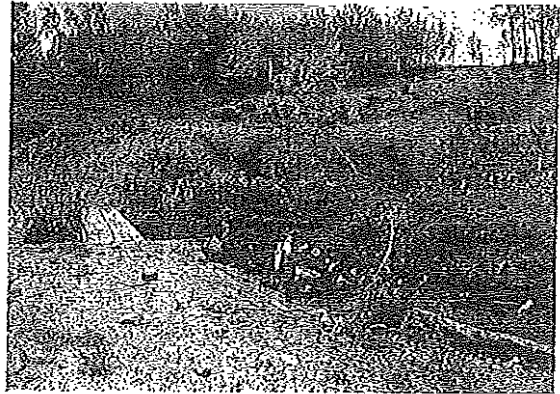
B: View of bridge and cattle watering area at 1+415 m.

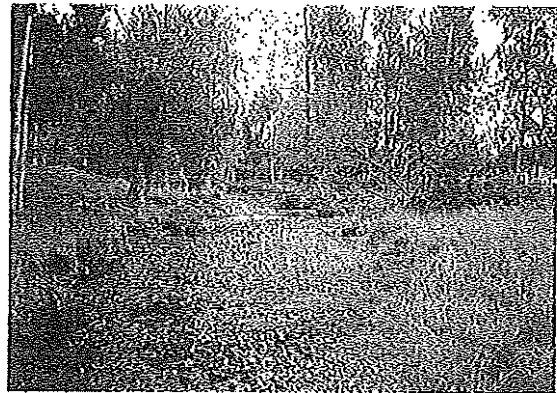
D: Upstream view of aggrading channel caused by cattle trampling and watering at 5+334 m.

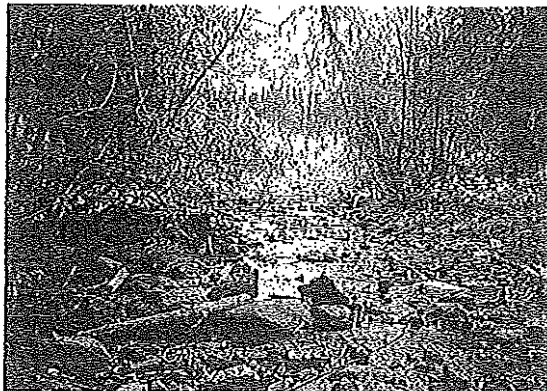
C: Upstream view of channel and forest harvest at 1+337 m. Note the debris and widened channel caused by multiple bridge washouts and channel fording.

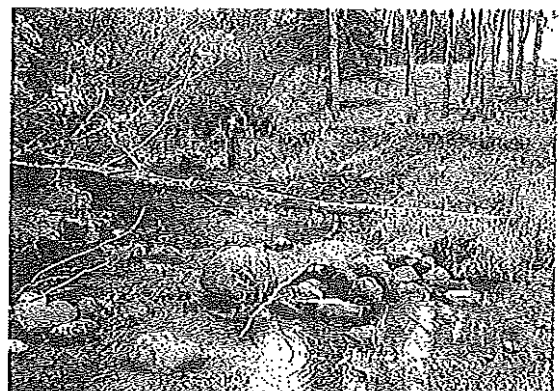
D: Upstream view of bank shear and trampling at 2+077 m. Note the relatively intact riparian vegetation at photo left.

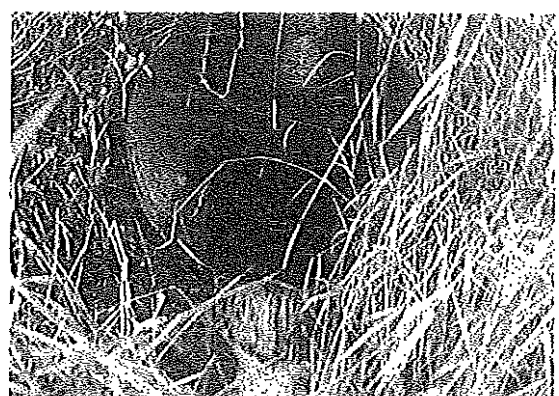
F: Upstream view of culvert under McNeil Road at 4+149 m. The culvert is perched 20 cm and has no plunge pool below it.

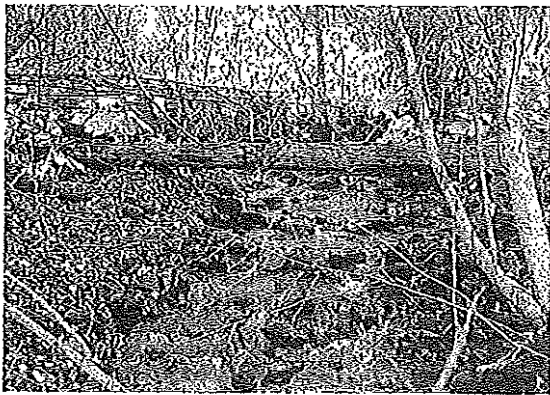
B: View of a potential temporary barrier to fish migration, 60 cm high, at 0+215 m. This feature was typical of the reach.

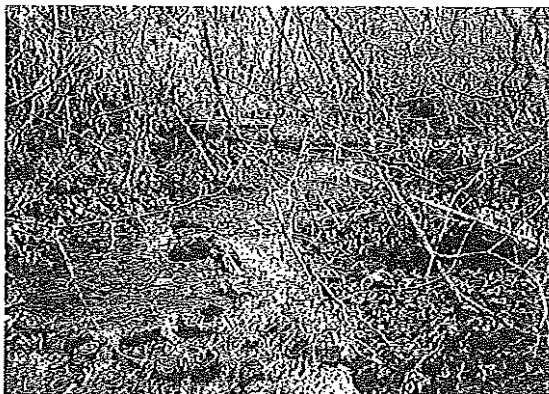
D: View of the road crossing under the power lines at 0+684 m. This is a frequently used vehicle and cattle crossing.

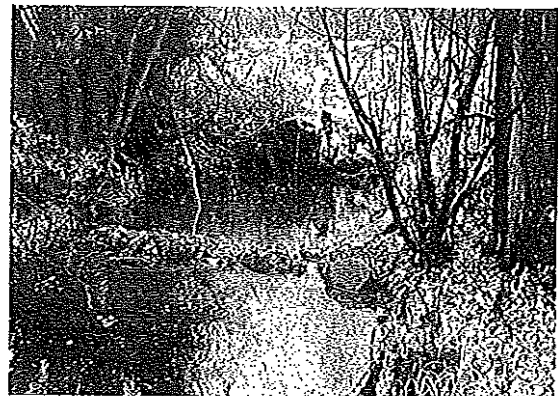
F: Upstream view of culvert under Victoria Dr. at 0+270 m in reach 2. This culvert is perched 75 cm during most flow conditions.
