1st Avenue Culvert Replacements (Lakelse Lake)

Stream Crossings 2 to 4

Environmental Monitoring Report

March 2004

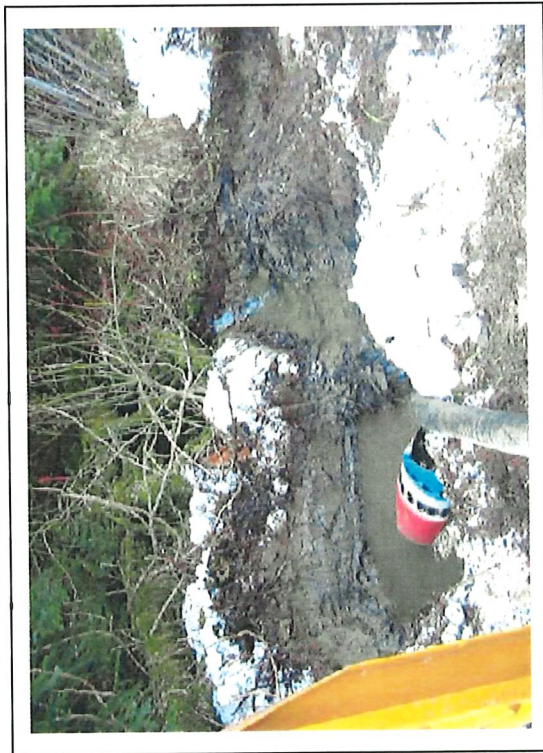
Inlet sump and stream flow diversion ditch.

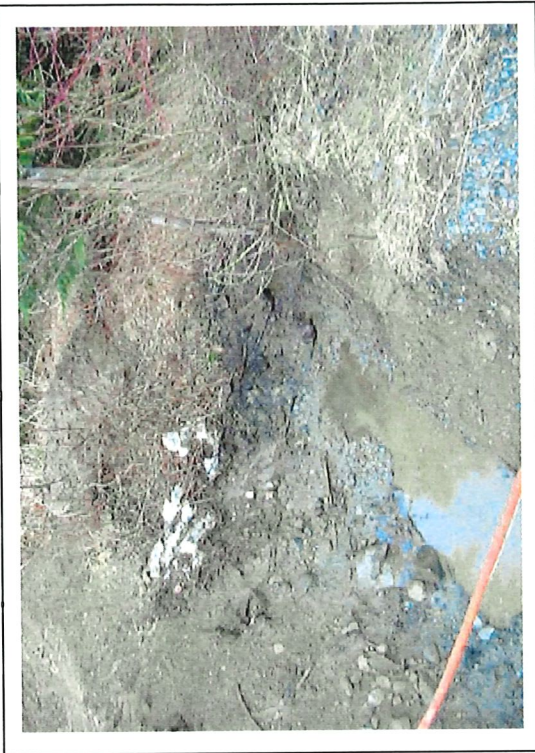
Sump located at the downstream end of the culvert excavation.

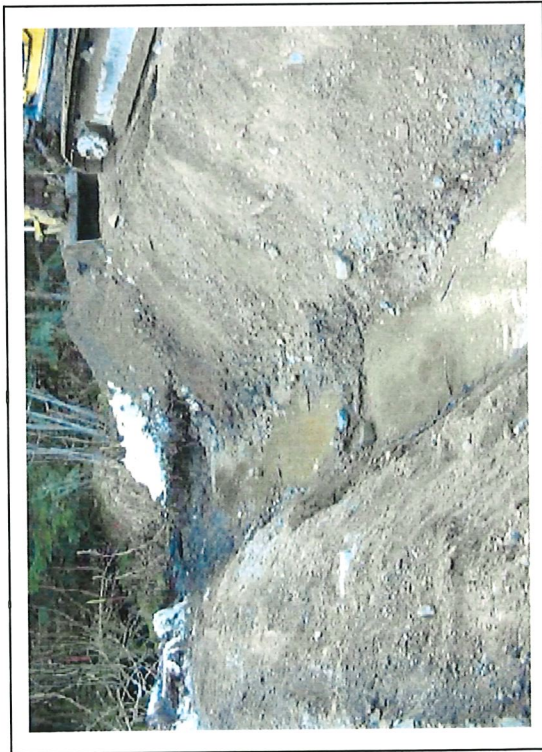
Culvert excavation.

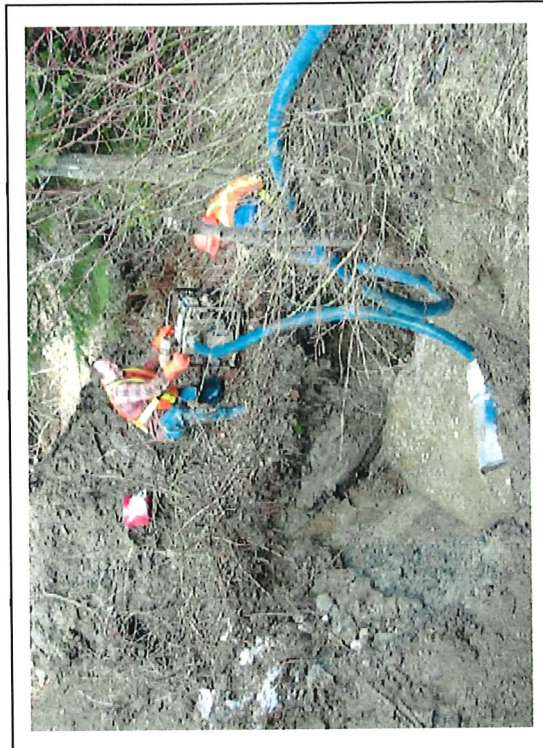
Downstream sump.

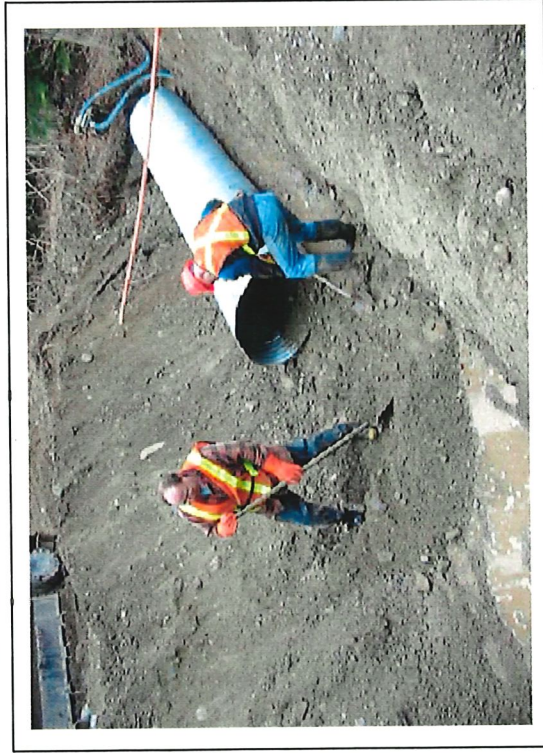
Culvert was infilled with gravel and cobble substrates.

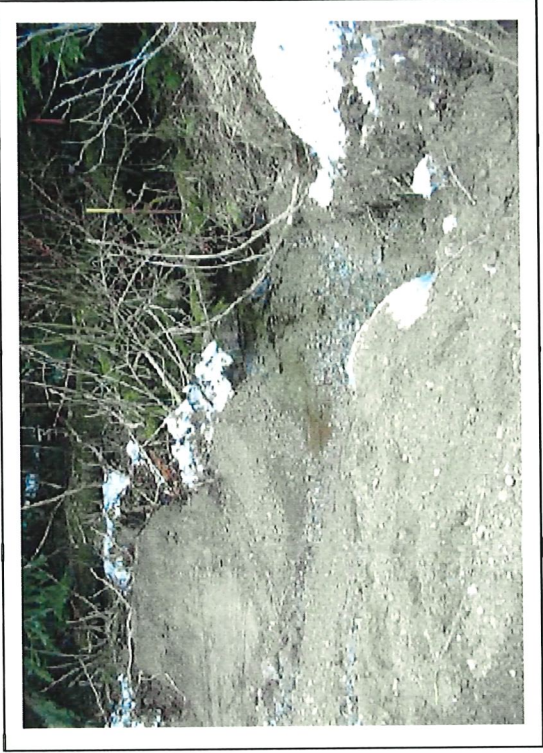
Culvert inlet post construction.

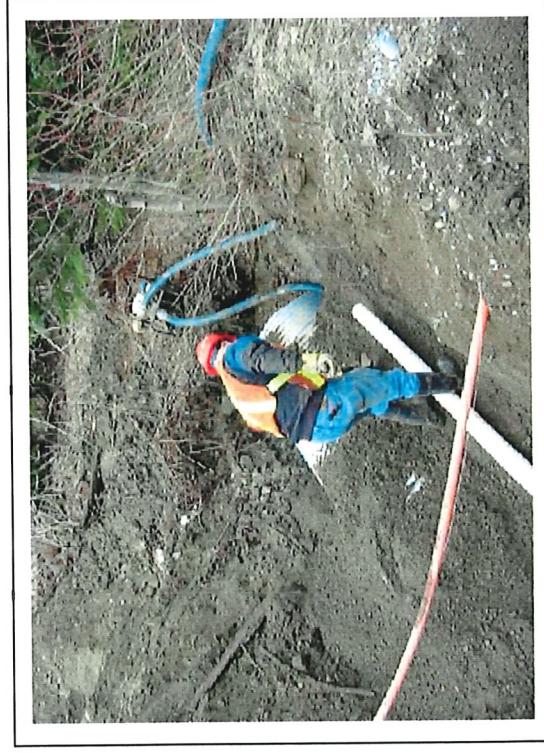
Culvert was backfilled with gravel material.

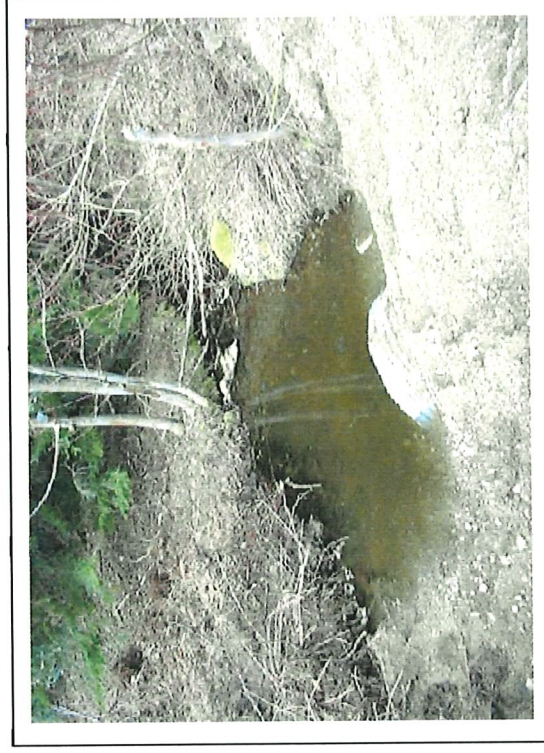
Culvert outlet post construction.

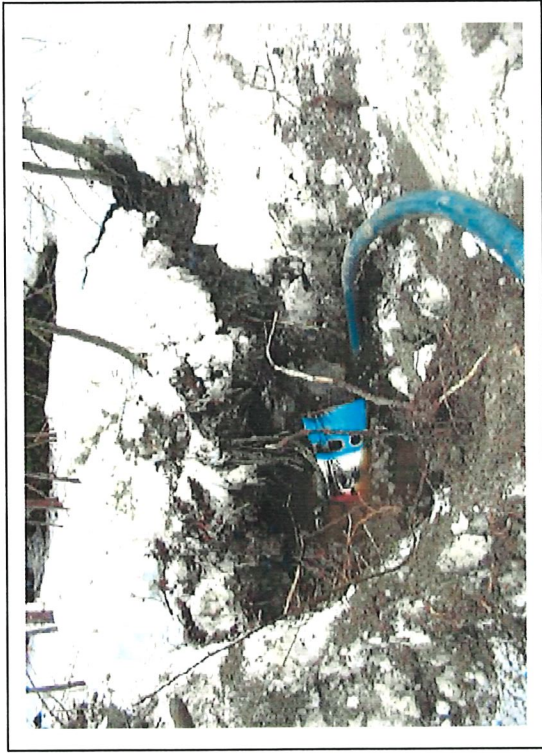
Inlet sump and stream flow diversion ditch.

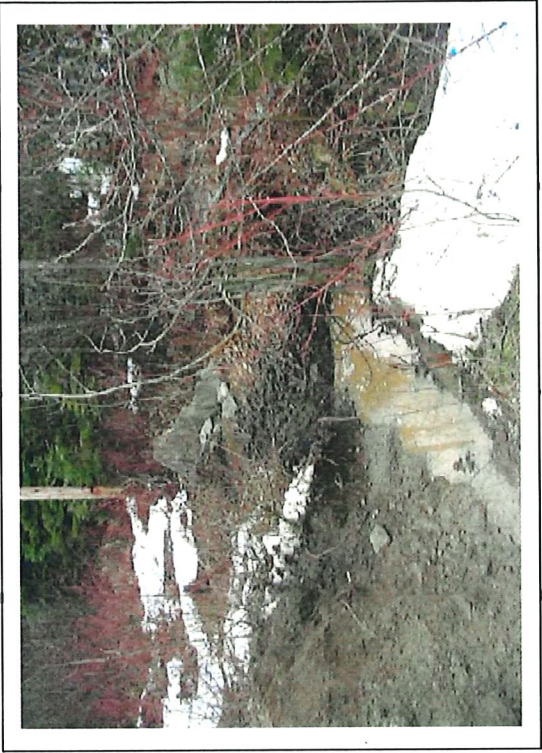
Downstream sump was excavated to collect sediment-laden water.

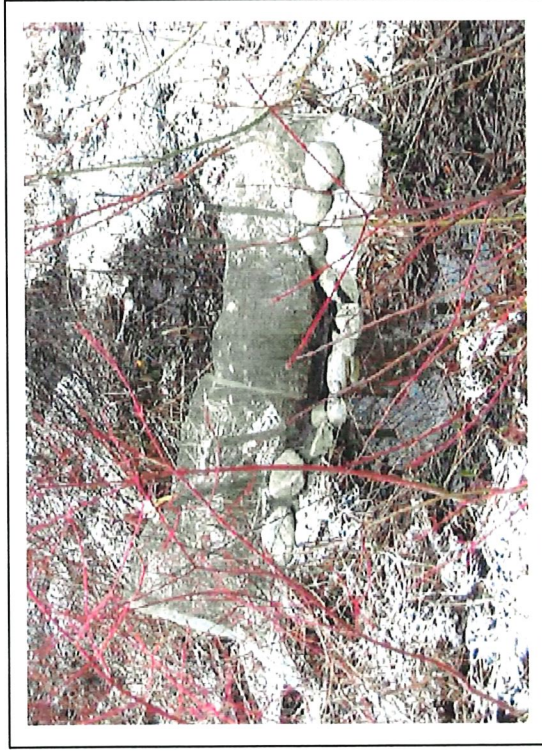
Downstream fish isolation fence.

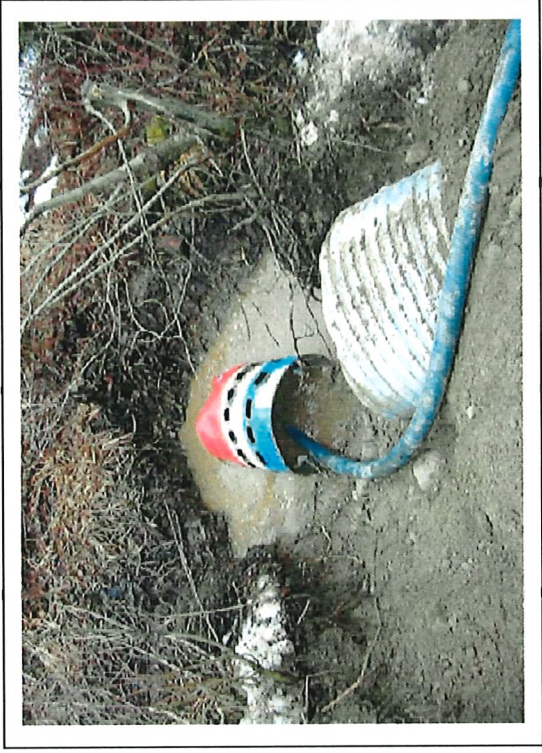
Downstream sump.

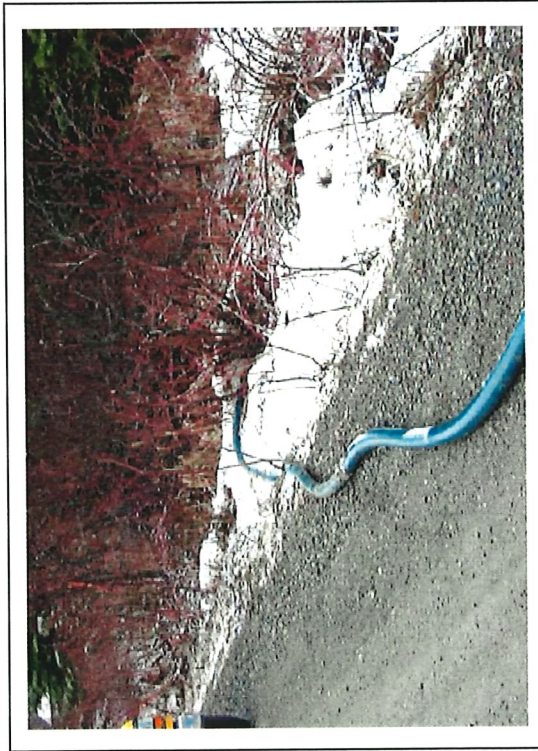
Sediment laden water was pumped into vegetated areas for settling.

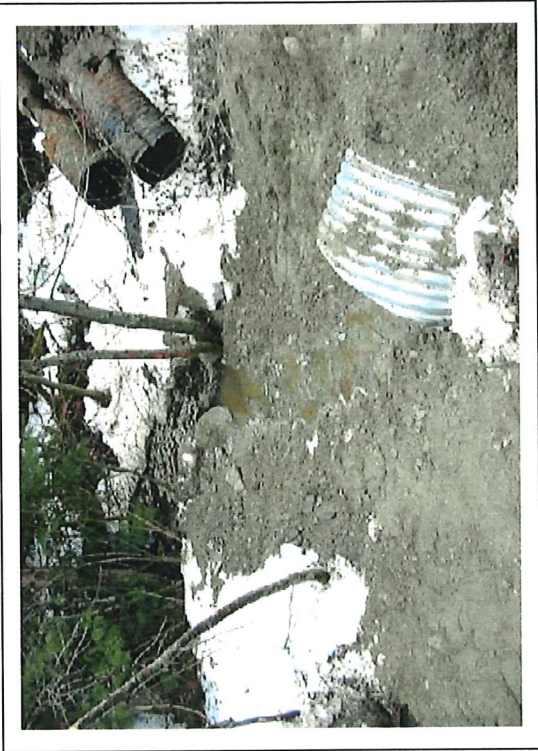
Culvert inlet post construction.

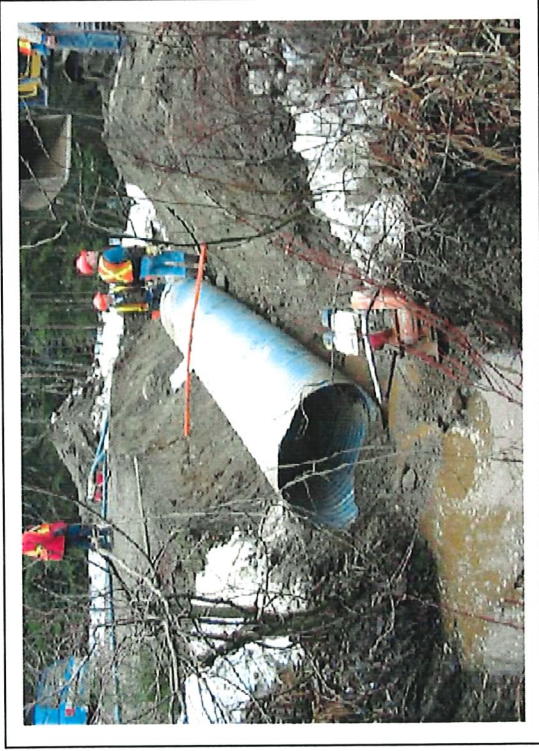
Culvert was embedded to allow fish passage.

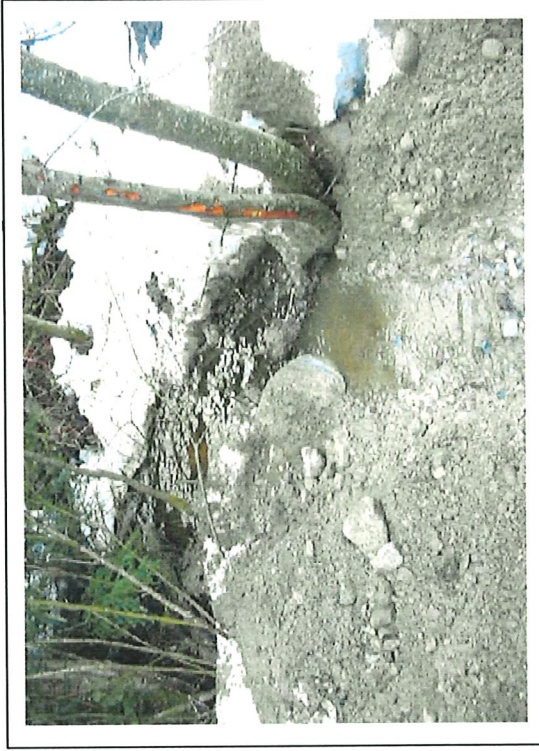
Culvert inlet post construction.

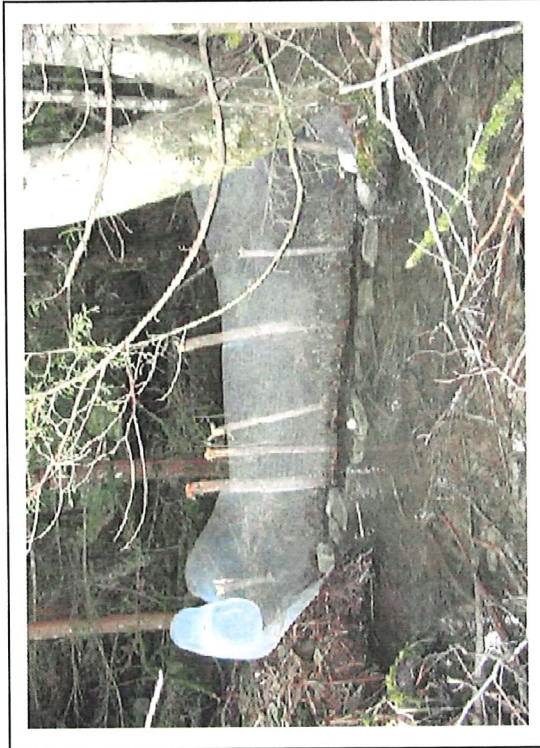
Downstream fish isolation fence.

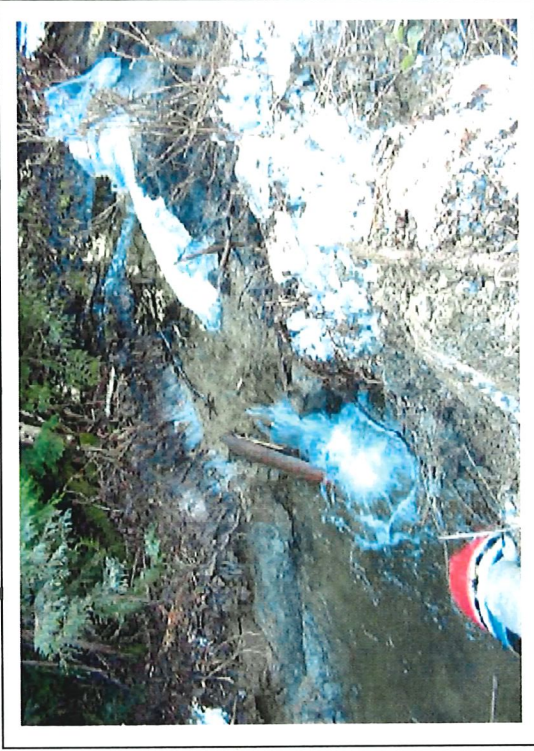
Stream flow was diverted into upstream sump.

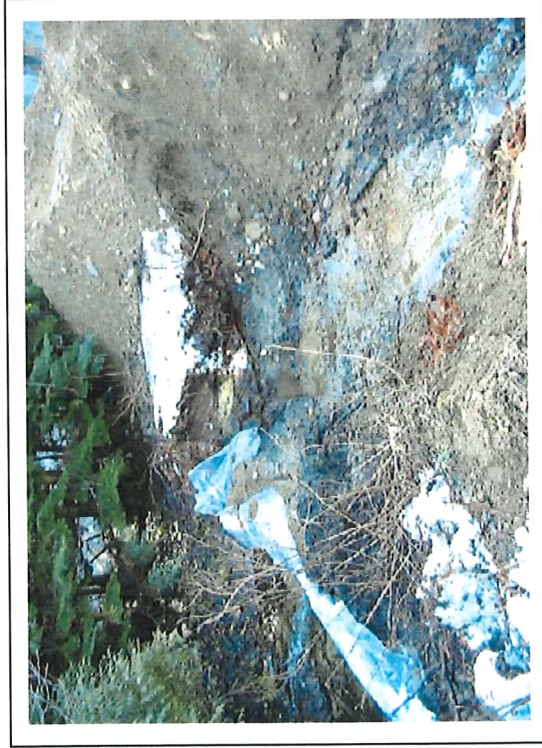
Stream diversion dam located upstream of the work site.

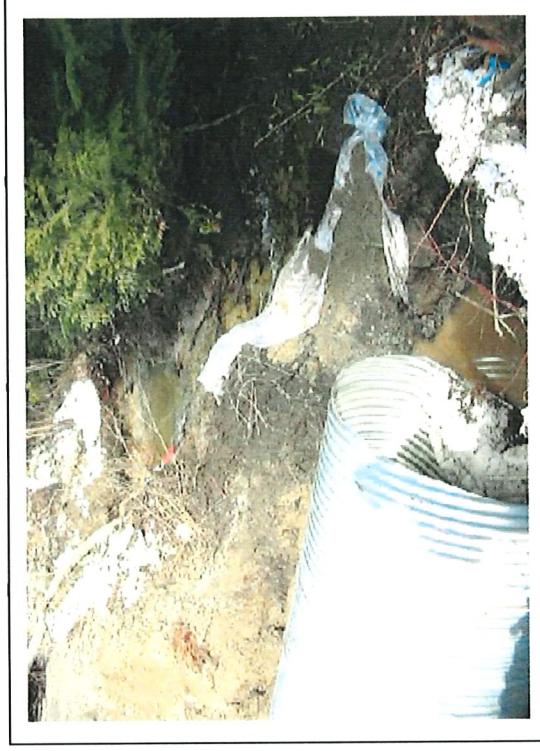
Culvert inlet prior to backfilling.

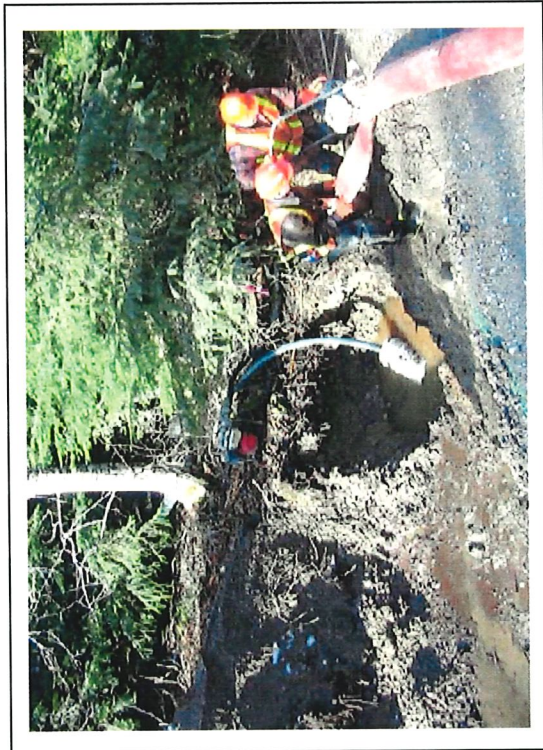
Downstream sump prior to culvert placement.

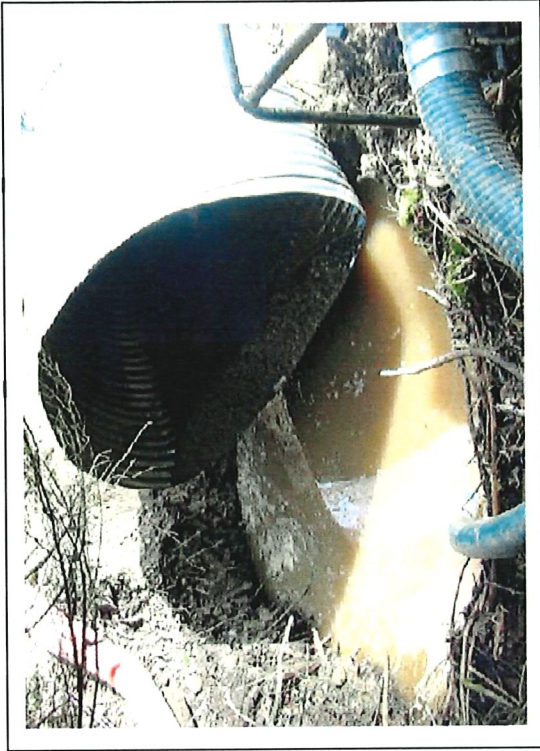
Infill substrates were flushed with water prior to re directing stream flow through the new culvert.

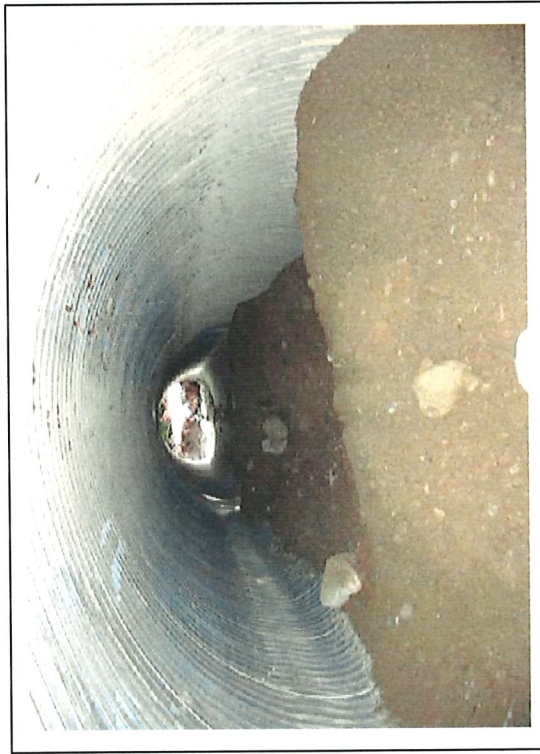
Culvert was filled with gravel and cobble substrates.

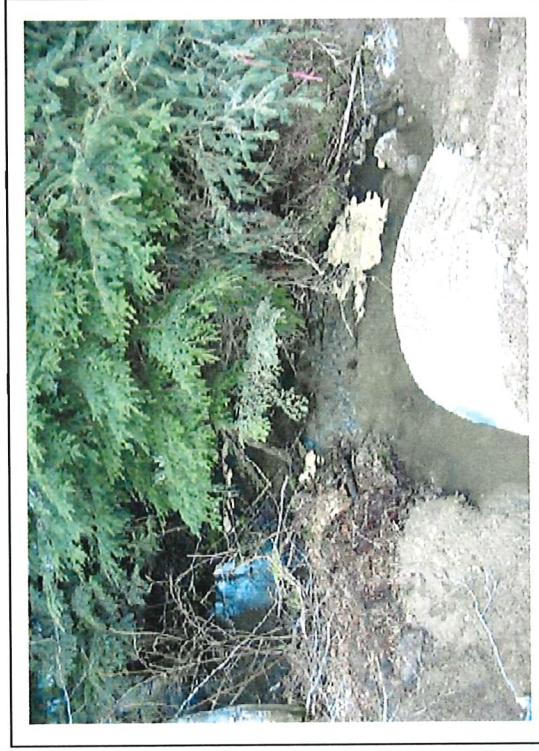
Culvert outlet post construction.
