1st Avenue Culvert Replacements (Lakelse Lake)

Environmental Monitoring Report

TRITON
ENVIRONMENTAL CONSULTANTS LTD.

January 2004

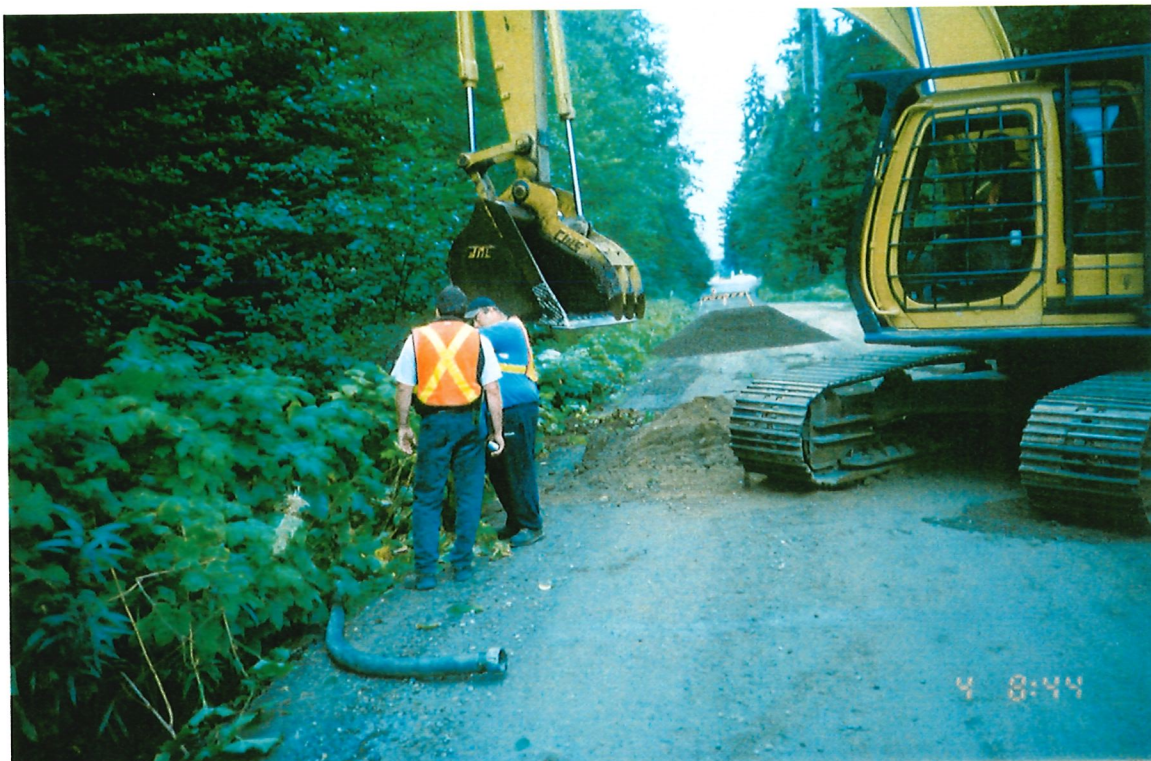
Photo 6-1 Crew deciding on upstream sump location.

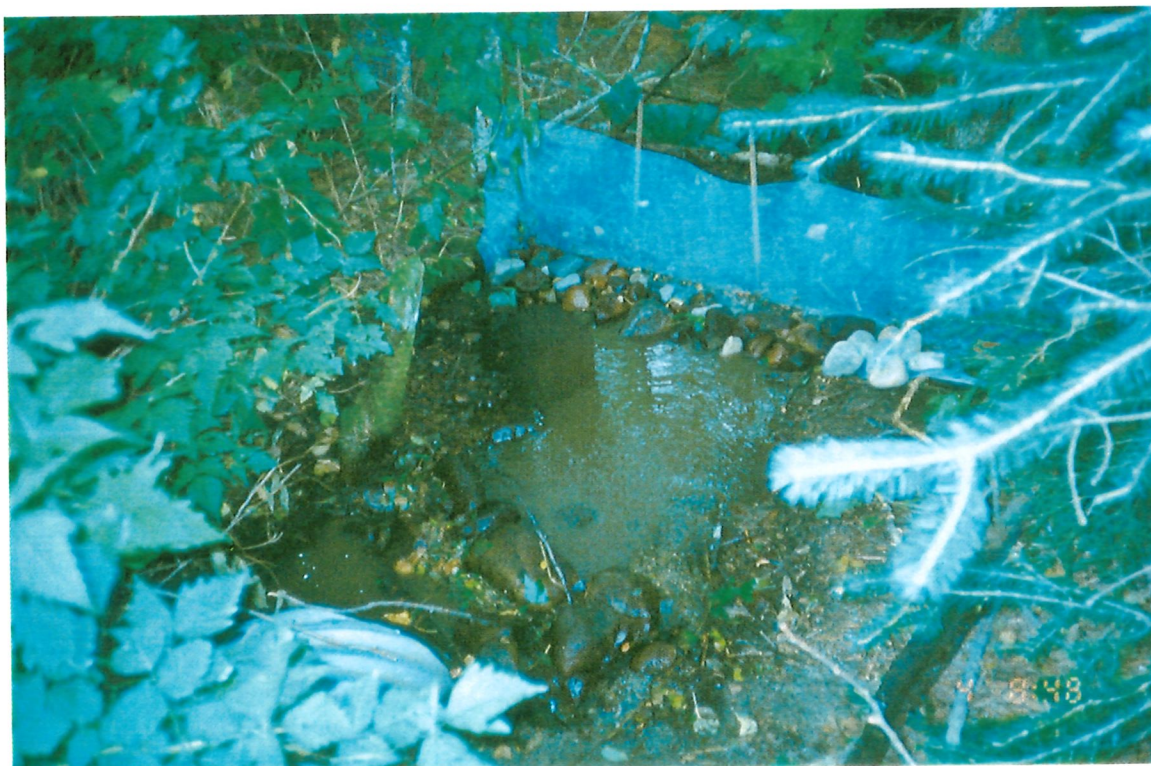
Photo 6-2 Downstream photo towards downstream stop net.

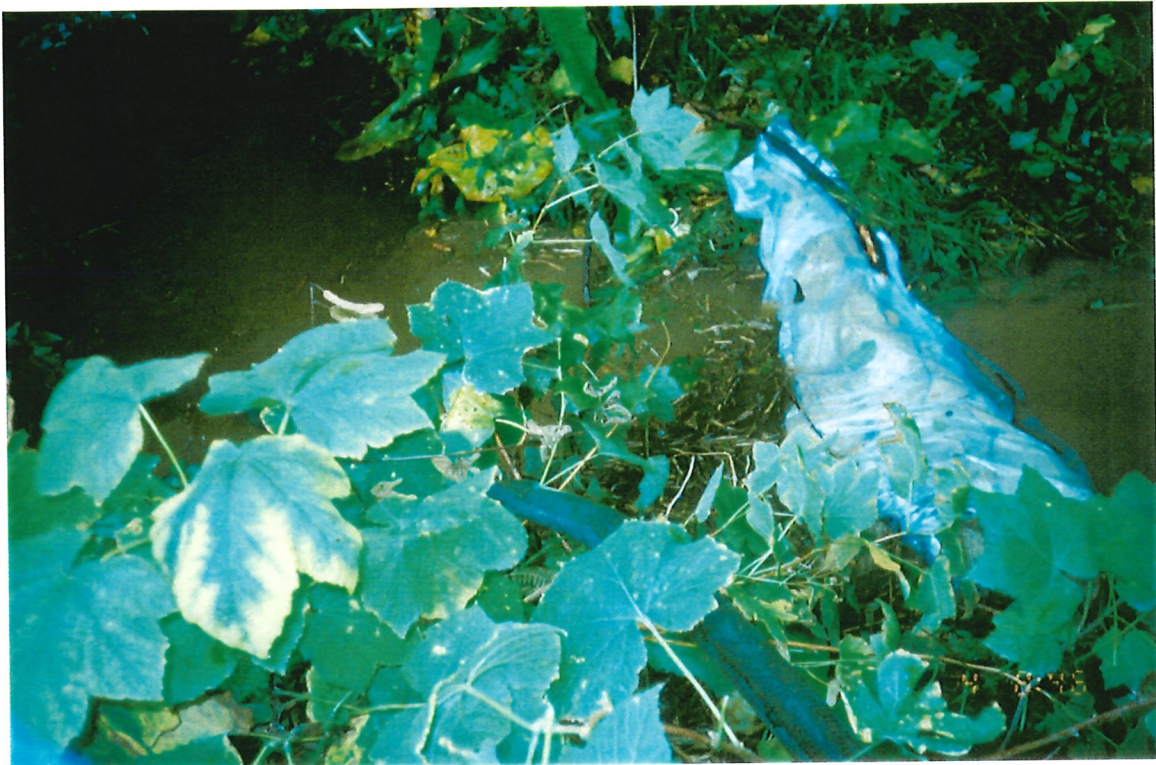
Photo 6-3 Upstream sandbag / poly plastic dam.

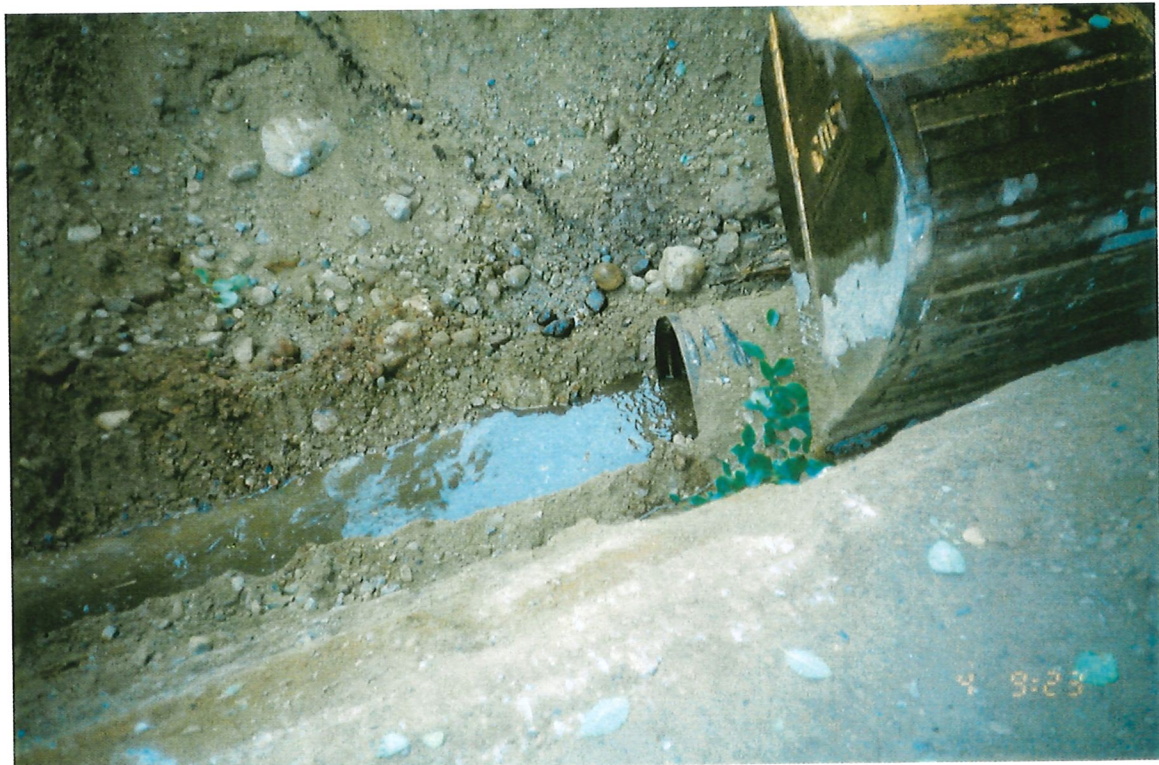
Photo 6-4 Excavating existing culvert.

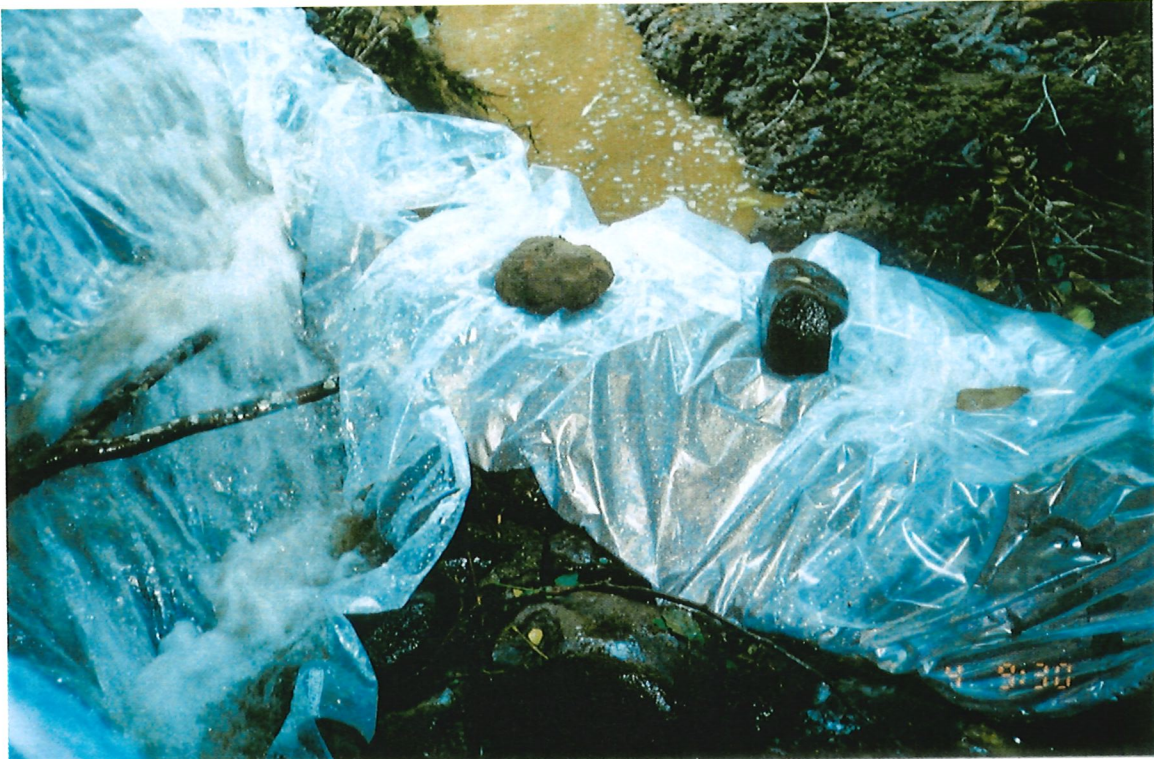
Photo 6-5 Photo of downstream sandbag / poly plastic weir and isolated dirty water within trench after culvert removal. Poly / boulder diffuser at left of picture.

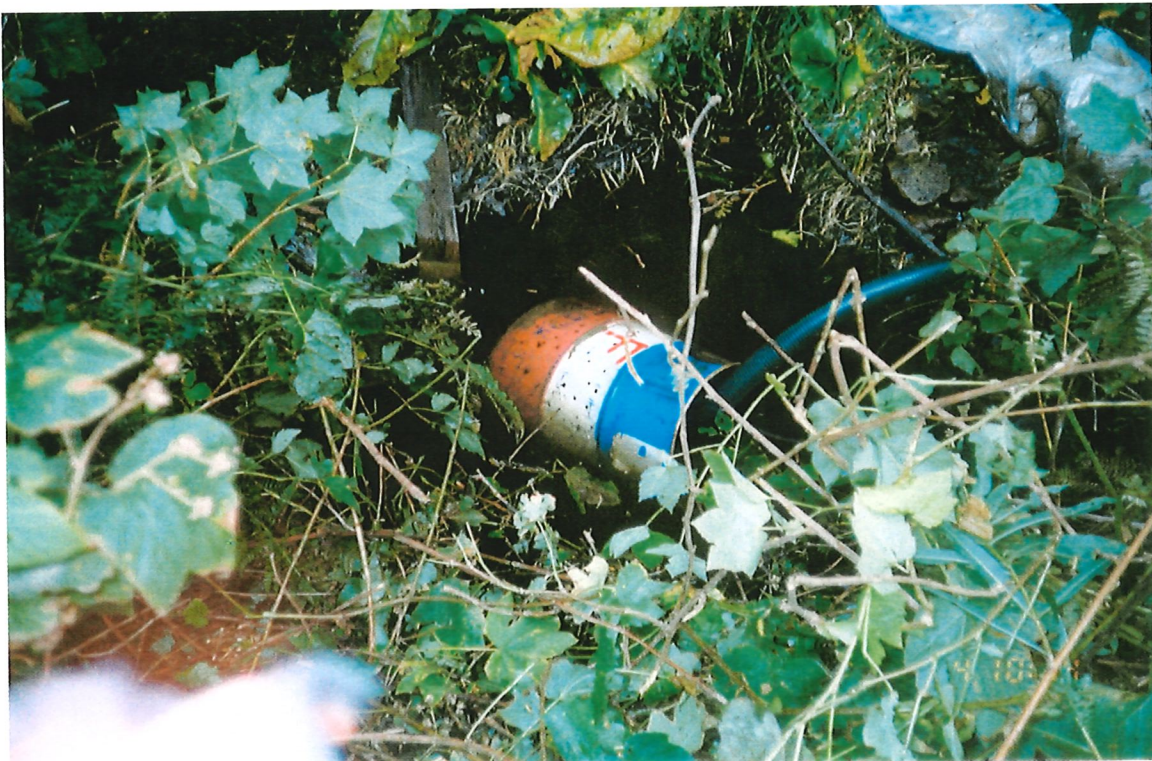
Photo 6-6 Photo at upstream end of diversion.

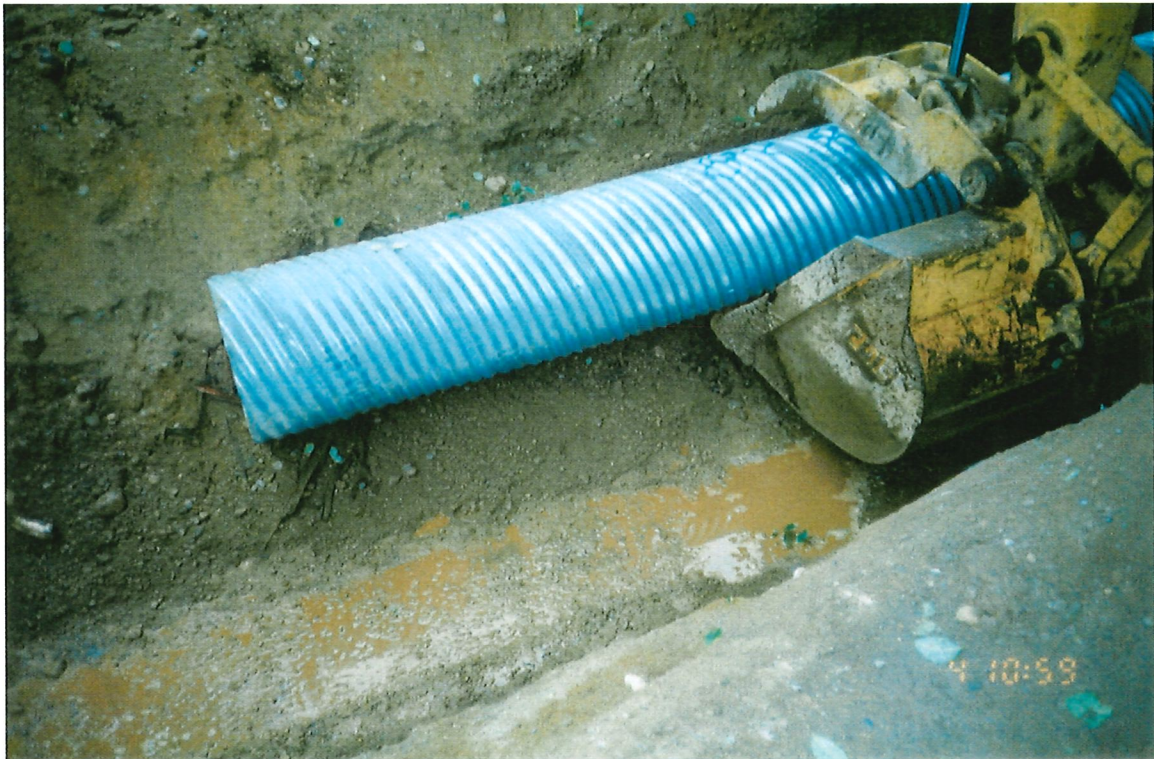
Photo 6-7 Laying new section of culvert in trench.

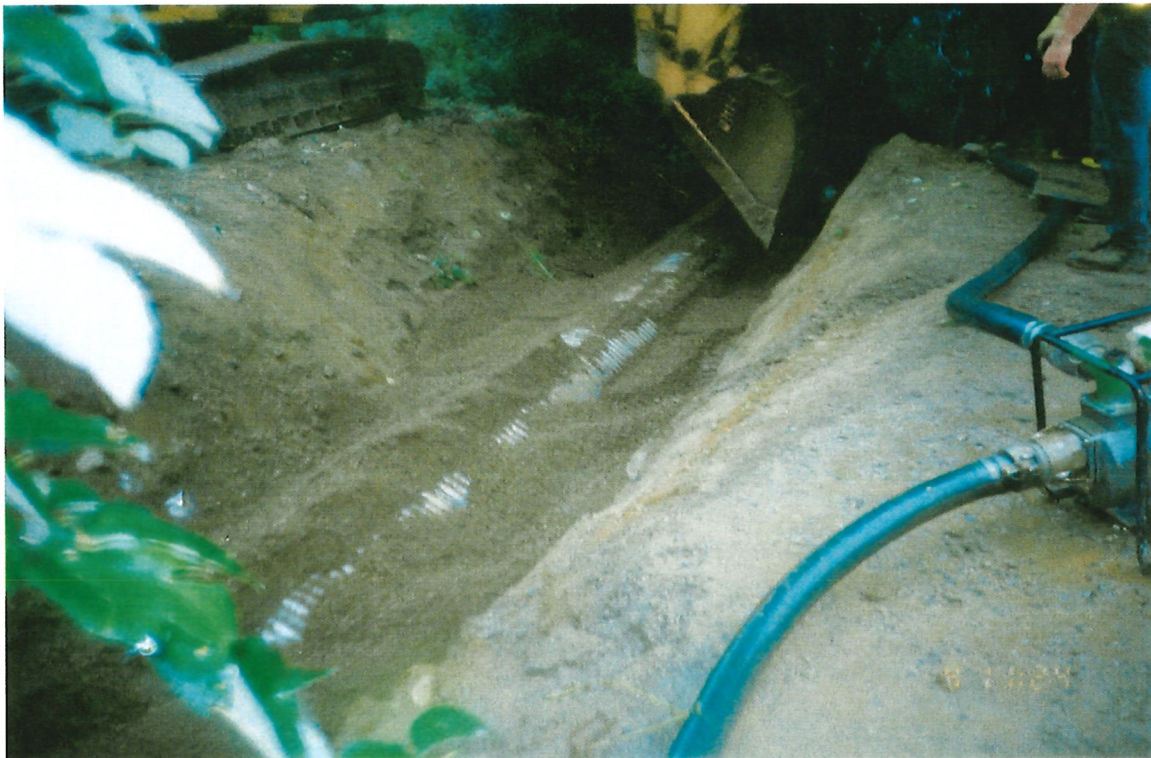
Photo 6-8 Back-filling new culvert.

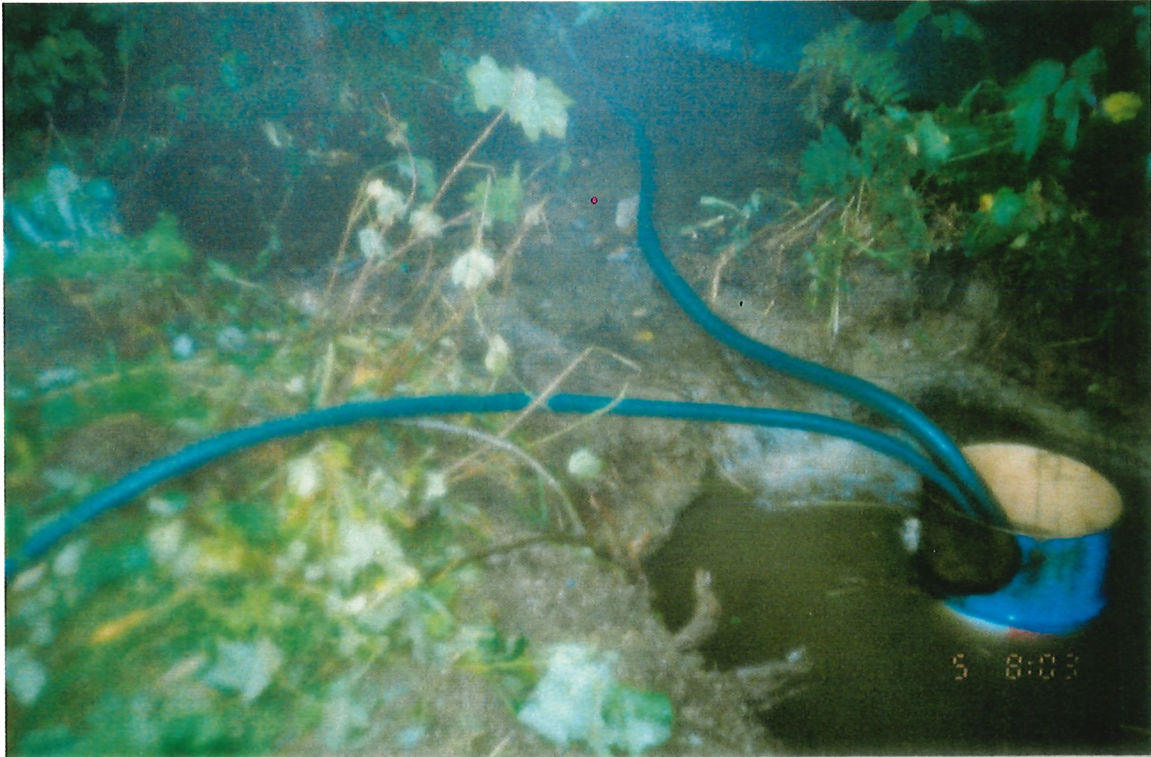
Photo 6B-1 Partially filling sump at upstream end of culvert for cleansing prior to diversion around site.

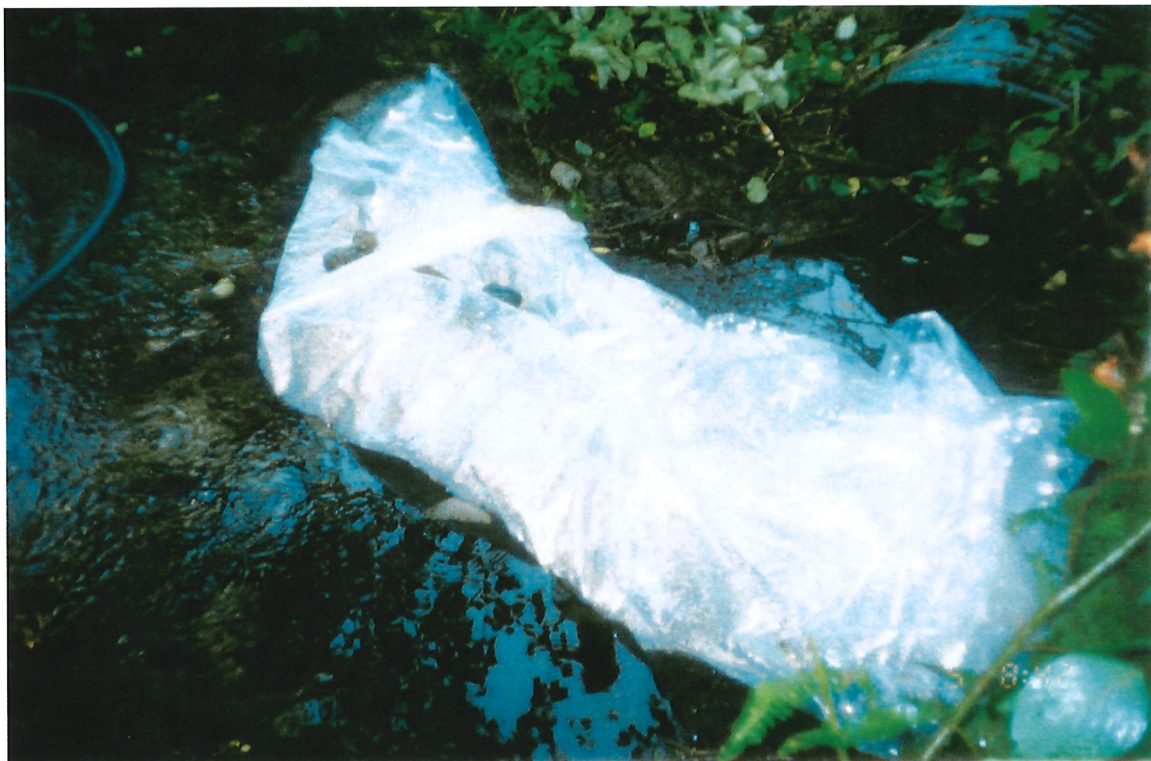
Photo 6B-2 Sandbag / poly weir at upstream end of culvert.

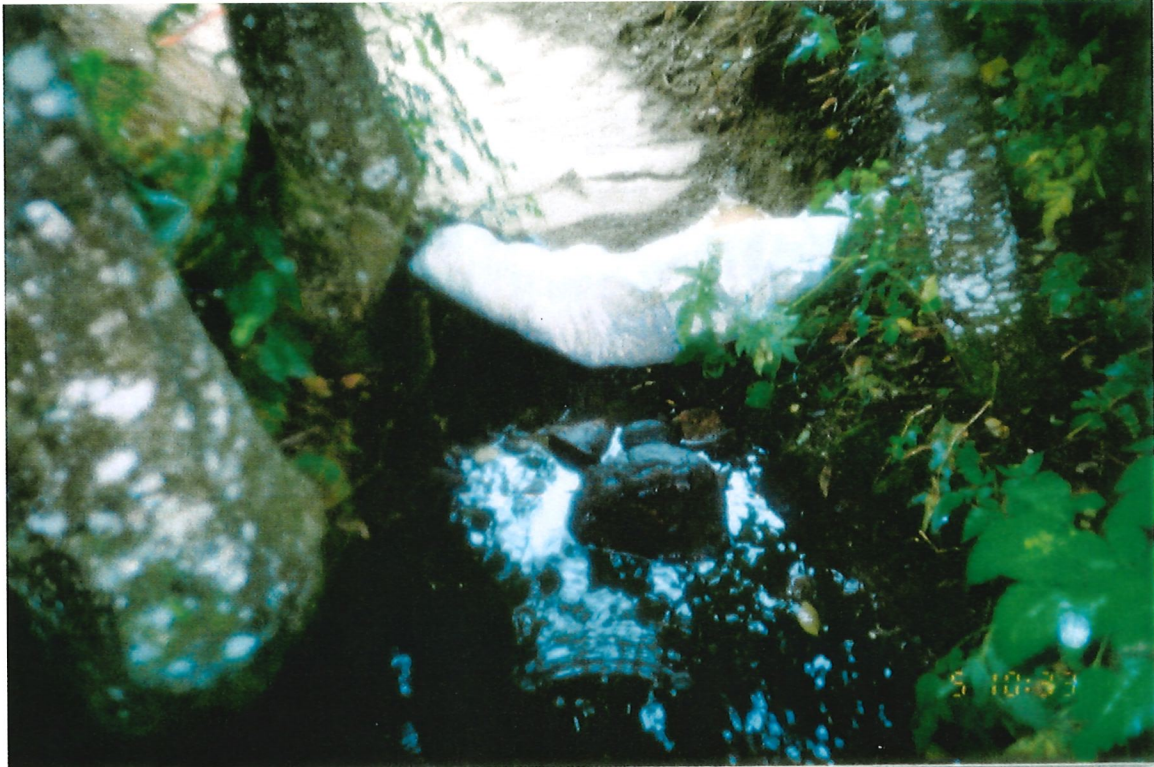
Photo 6B-3 Sandbag / poly weir at downstream end of site.

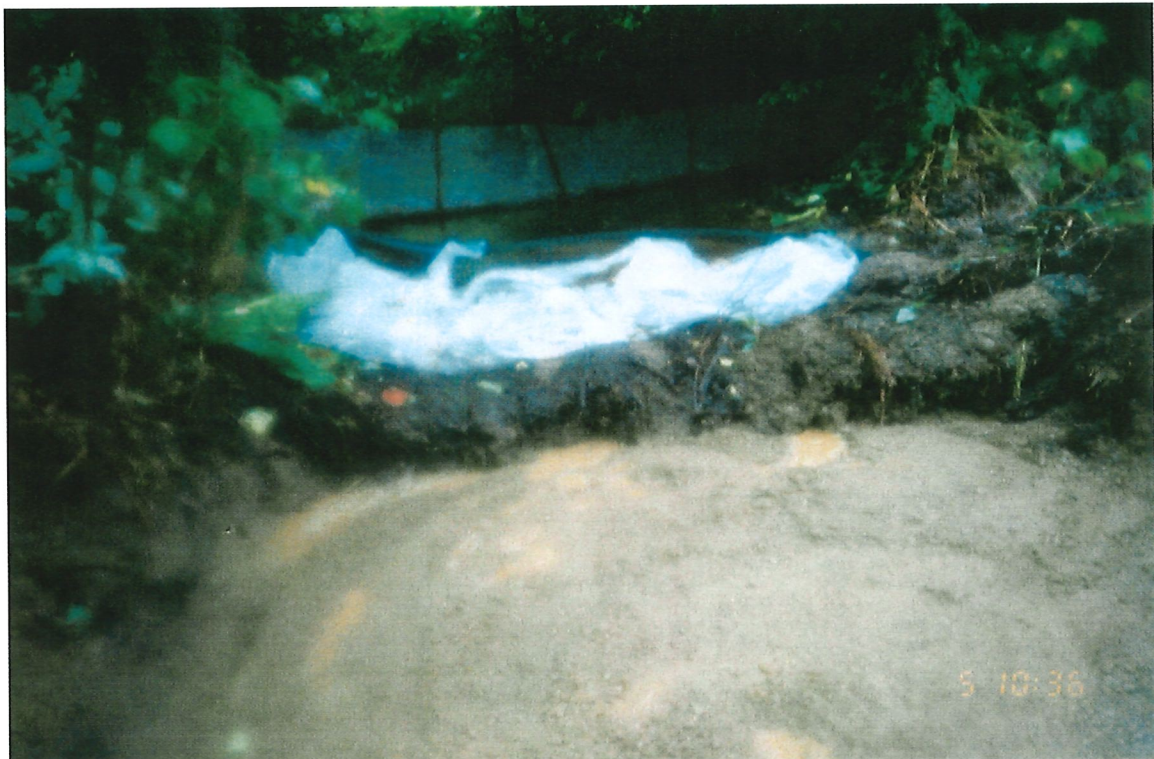
Photo 6B-4 Sandbag / poly weir at upstream end of site and fish exclusion fence in background.

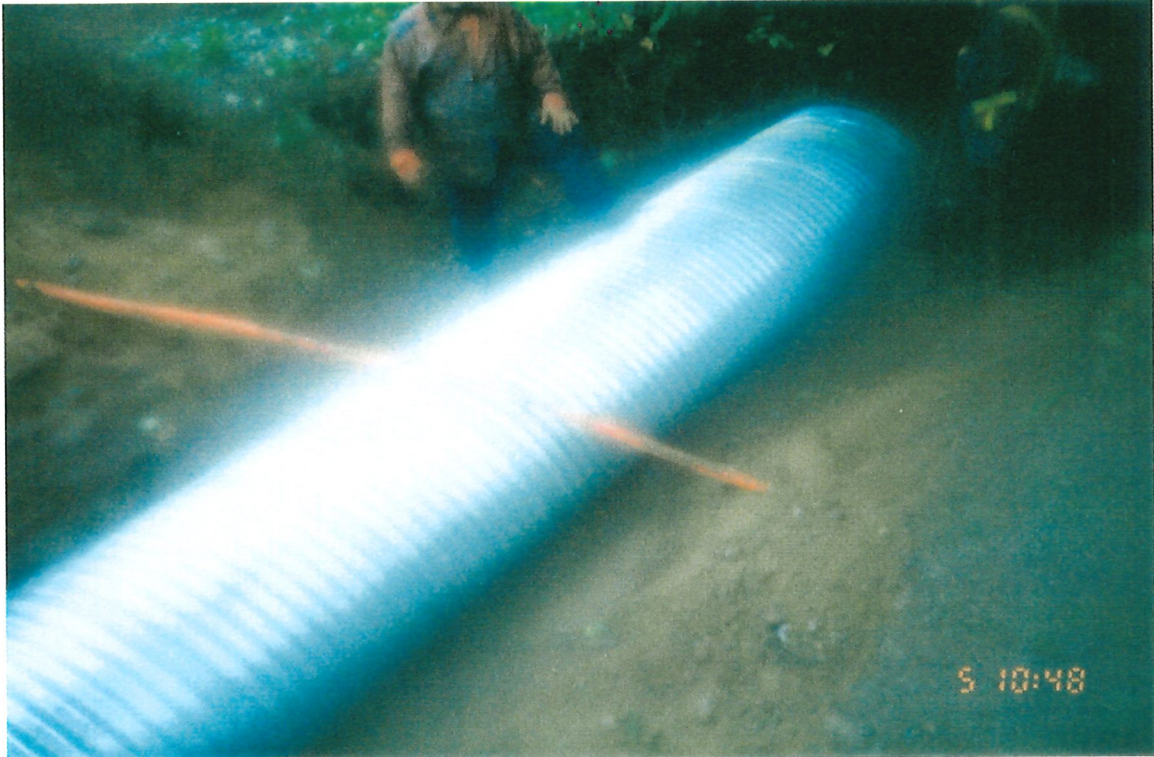
Photo 6B-5 Placing culvert under natural gas line.

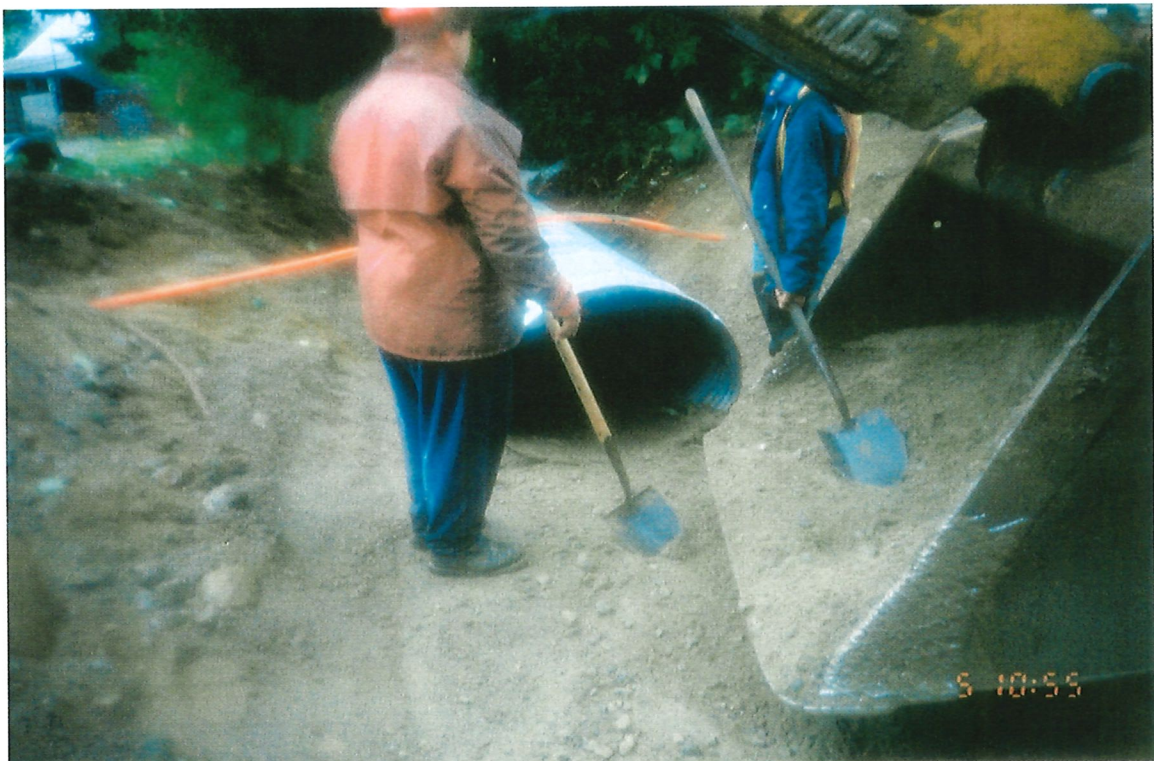
Photo 6B-6 Crew filling culvert with approved fisheries gravel.

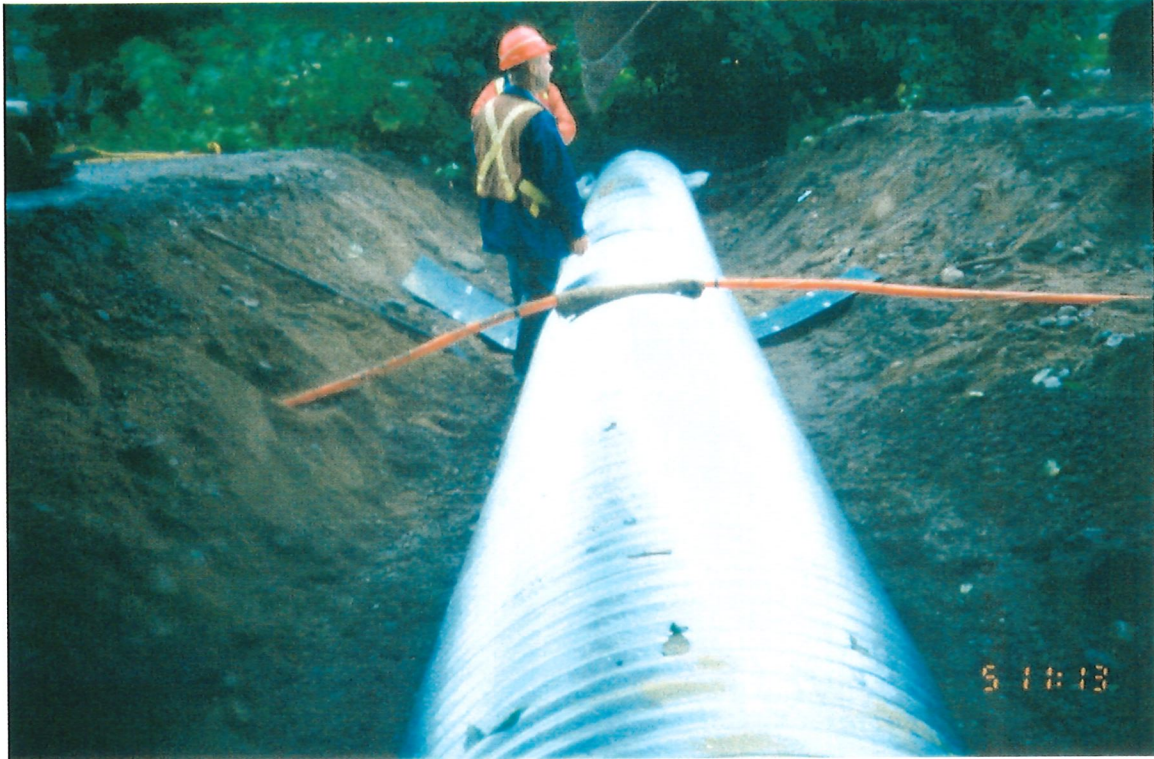
Photo 6B-7 Crew collaring culvert and wrapping natural gas line prior to backfilling.

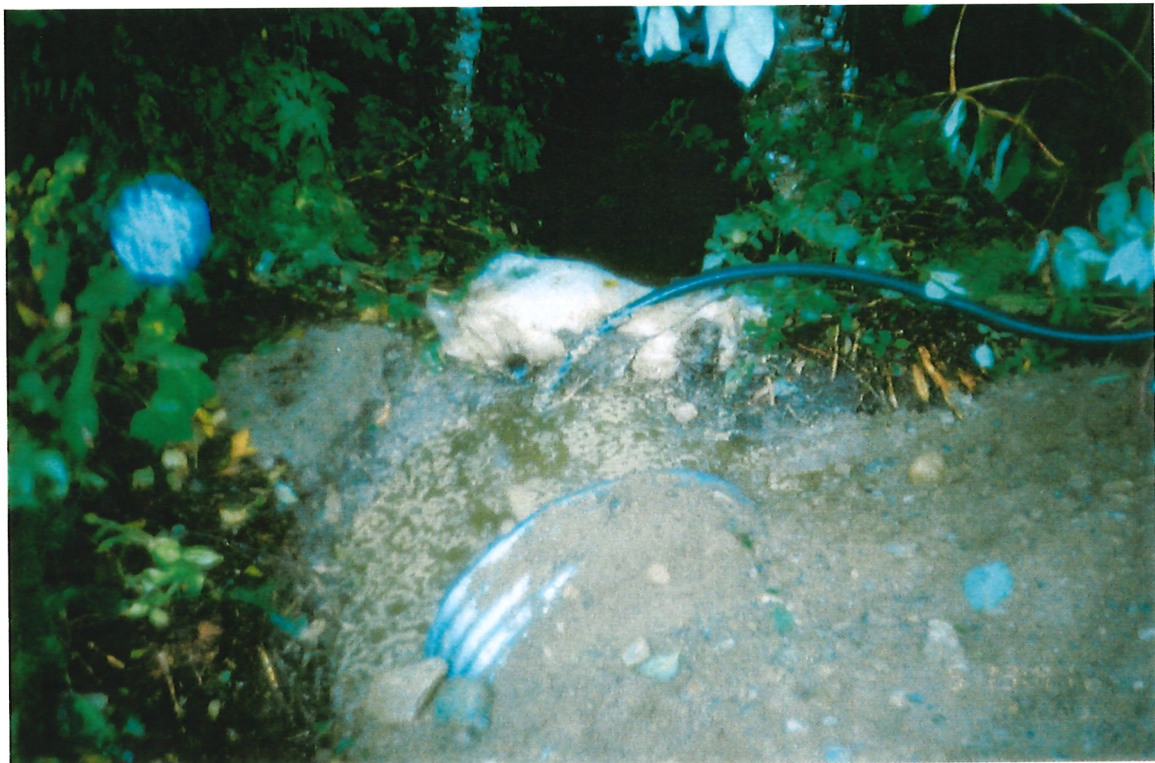
Photo 6B-8 Flushing of culvert to remove fines from fill materials. Dirty water was pumped into adjacent vegetation.

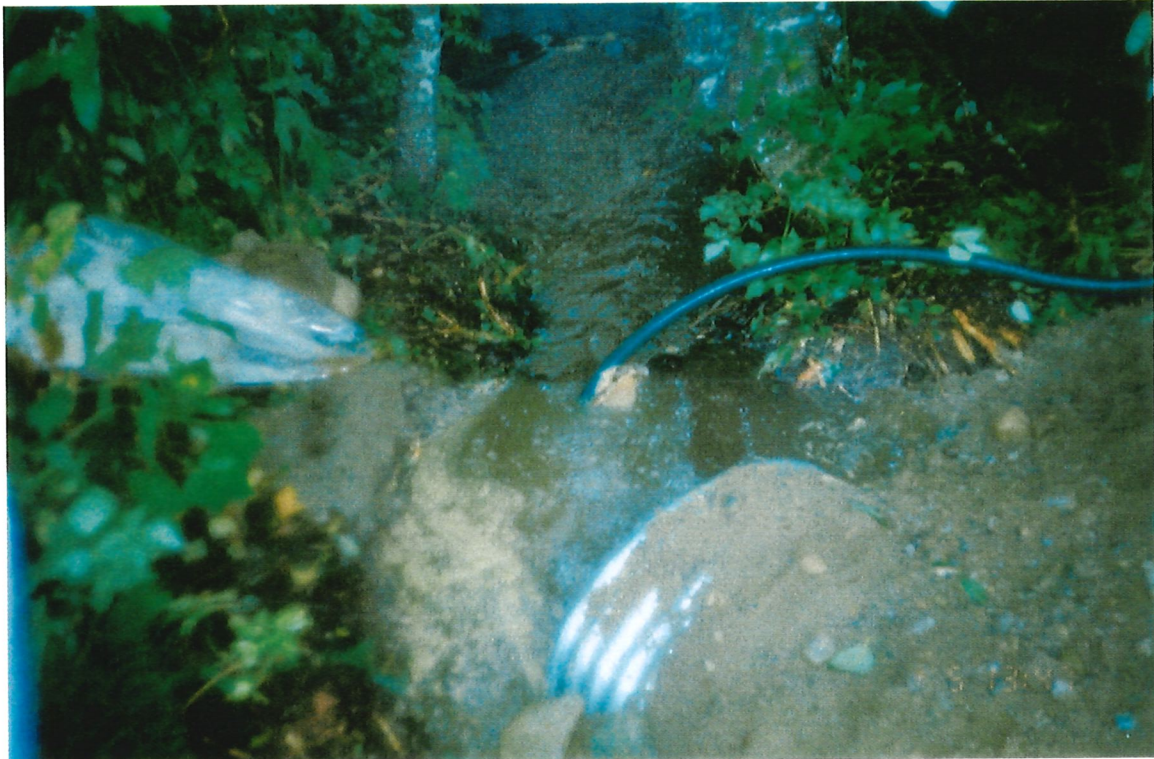
Photo 6B-9 Full breach of upstream weir and removal of downstream weir.

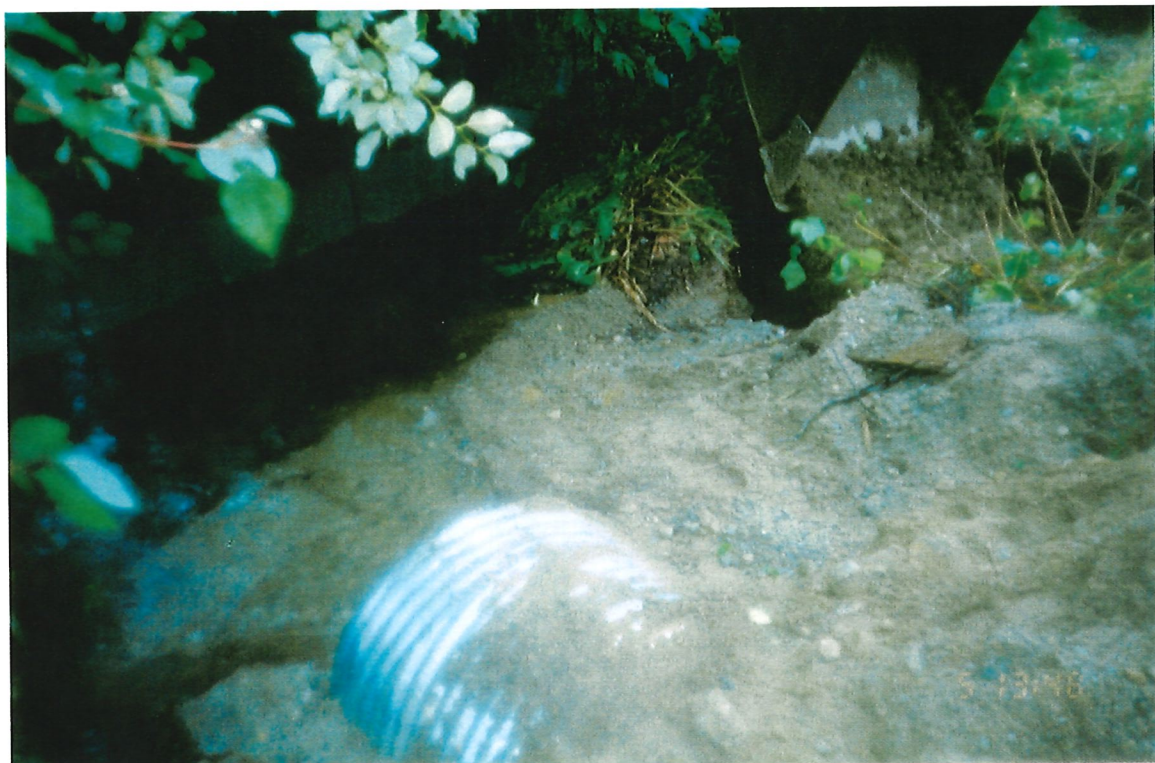
Photo 6B-10 Backfilling upstream sump.

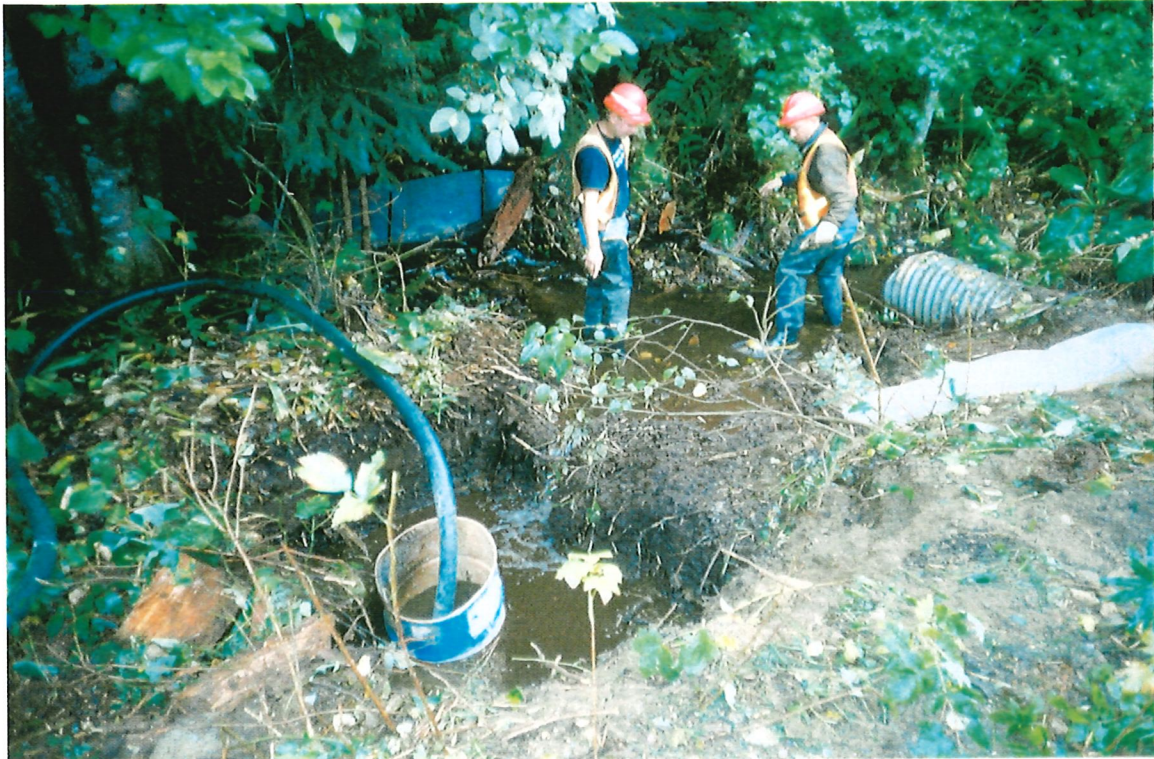
Photo 5-1 Crew filling sump at upstream end of culvert.

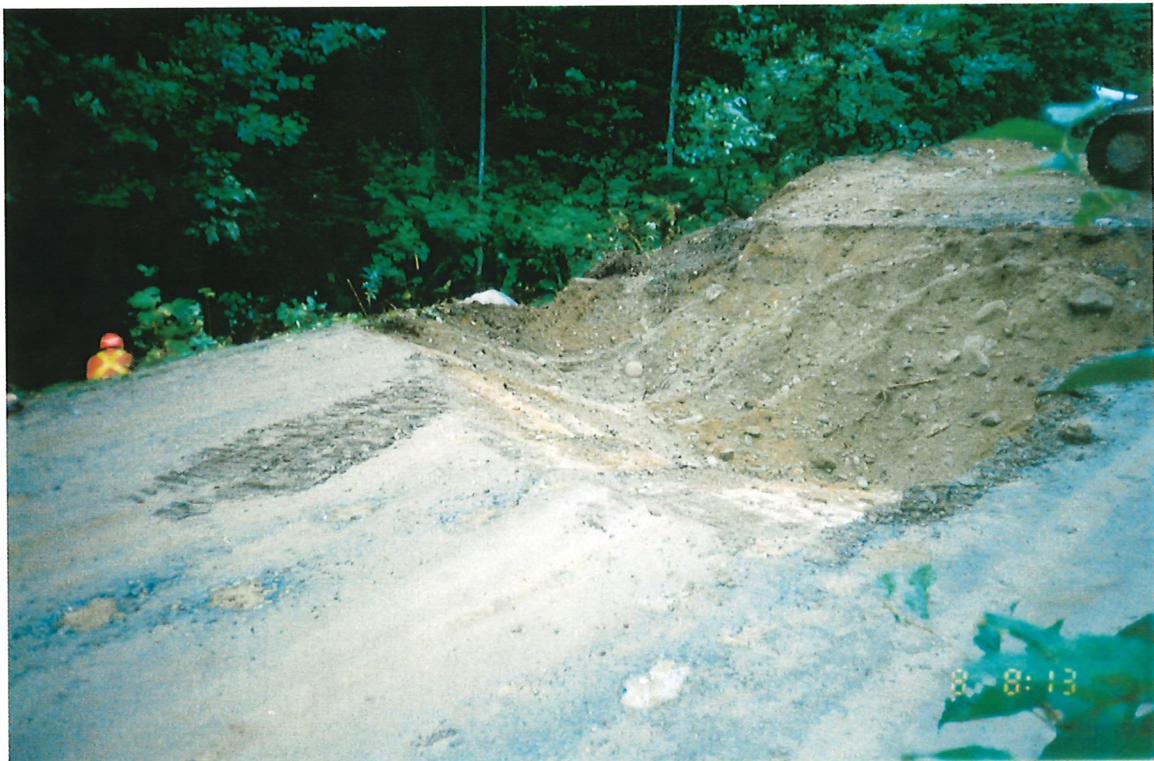
Photo 5-2 Excavating roadbed.

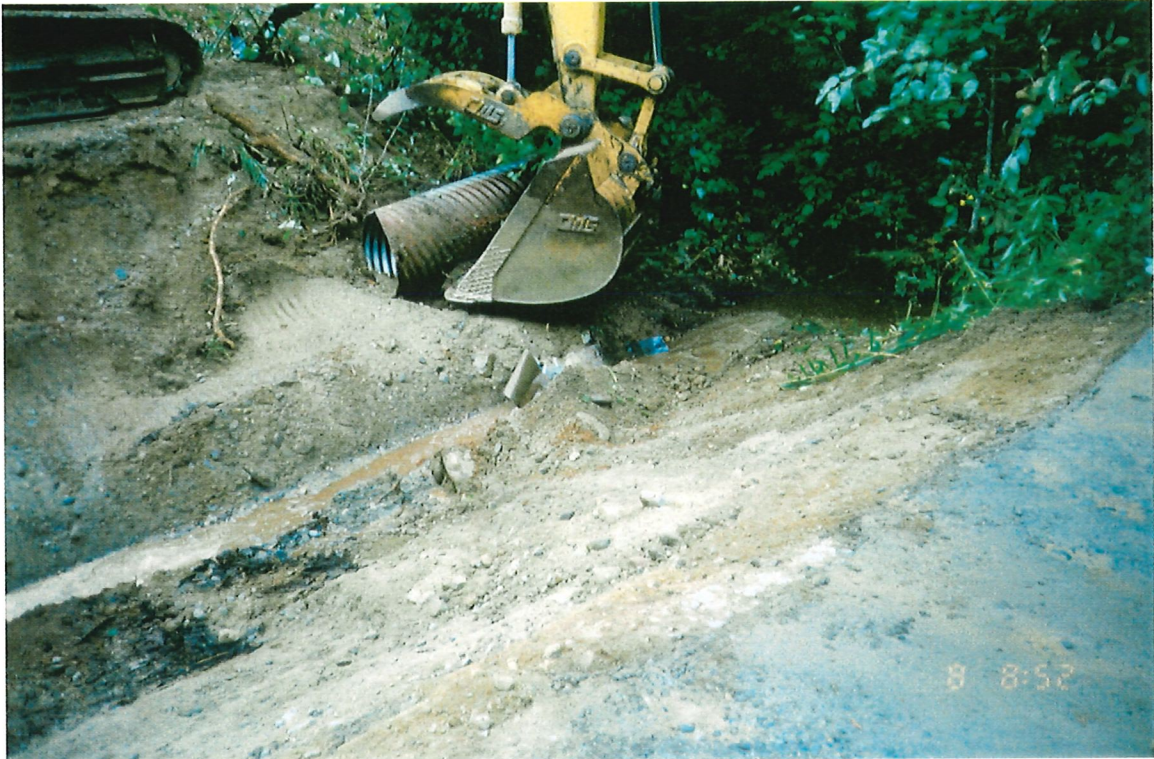
Photo 5-3 Removing existing culvert from trench.

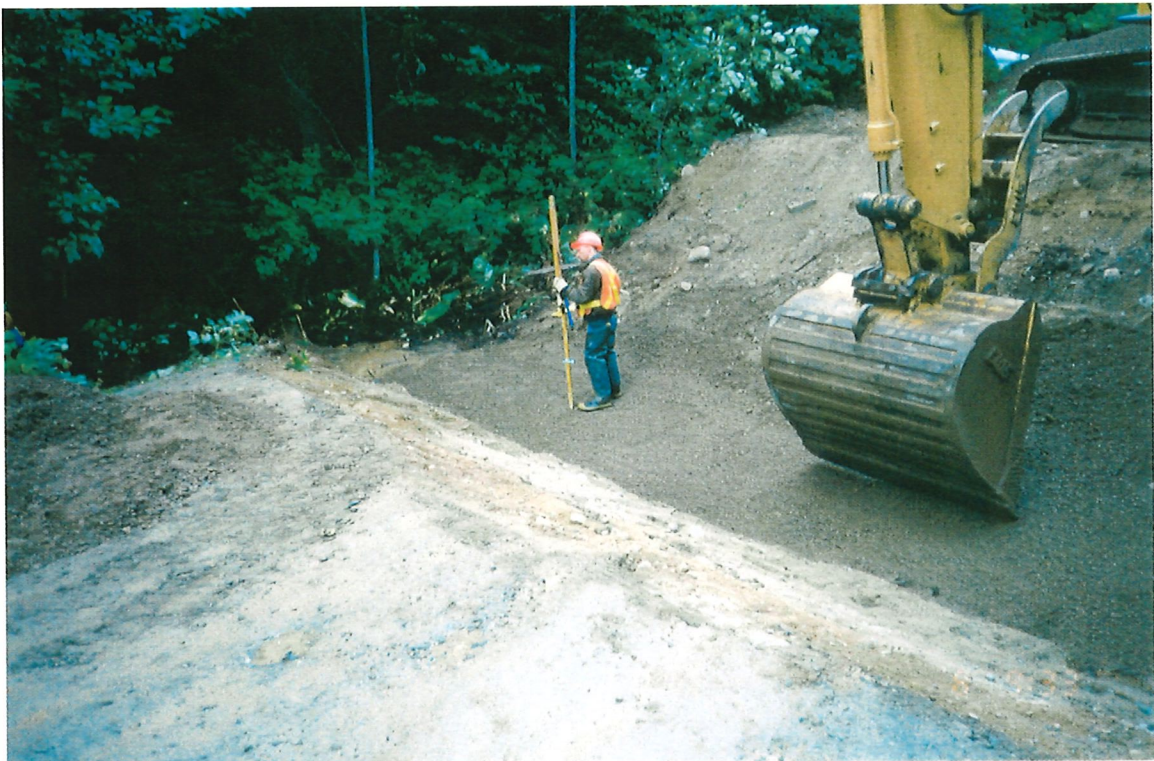
Photo 5-4 Leveling culvert bed to grade.

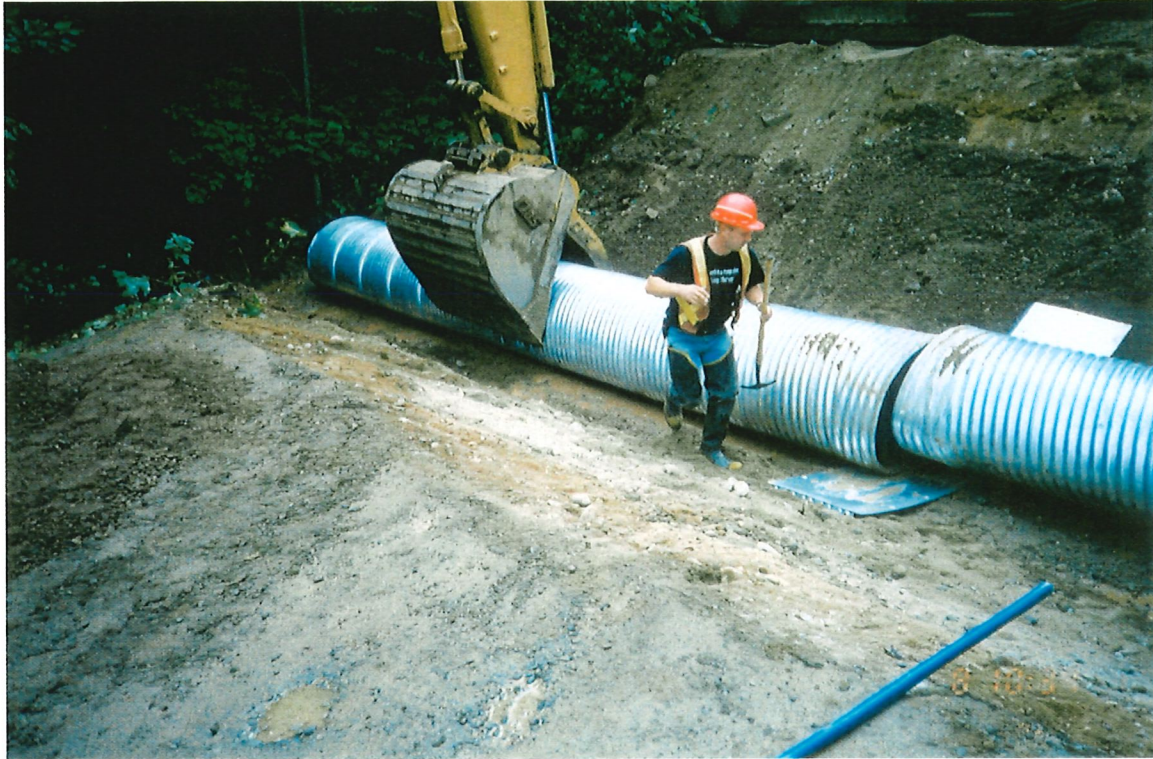
Photo 5-5 Aligning upper and lower sections of culvert prior to collaring.

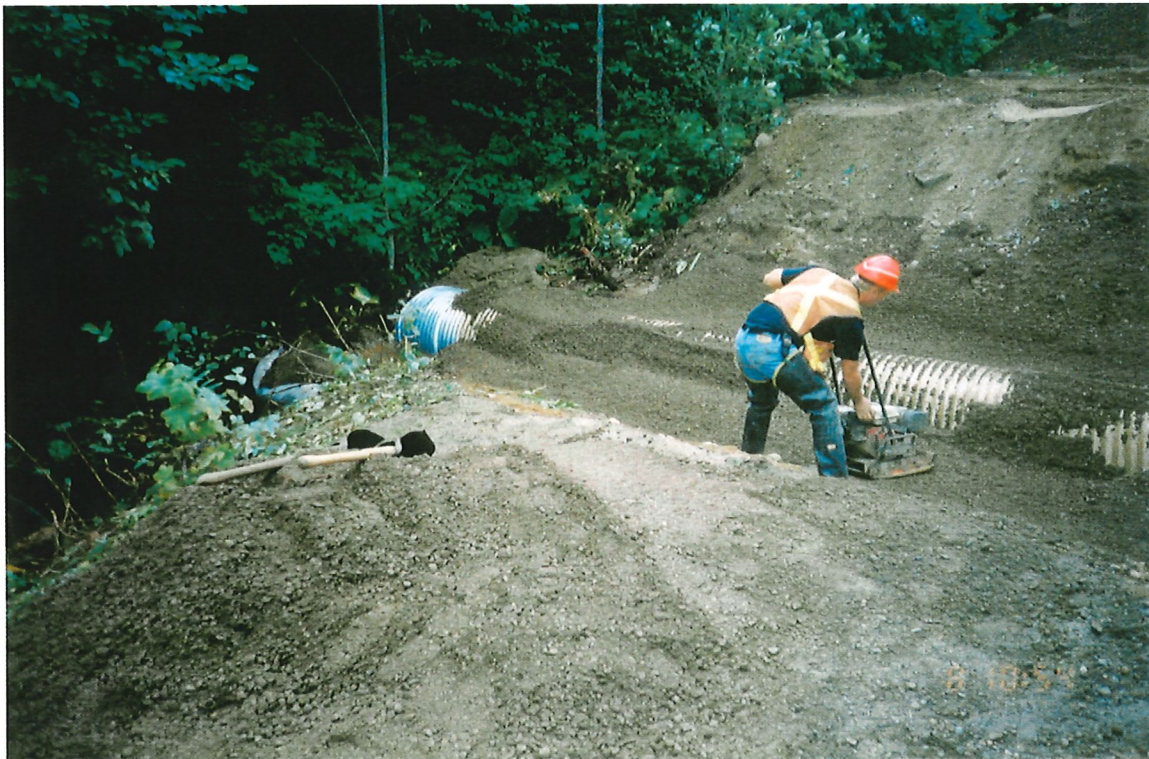
Photo 5-6 Compacting fill around culvert.

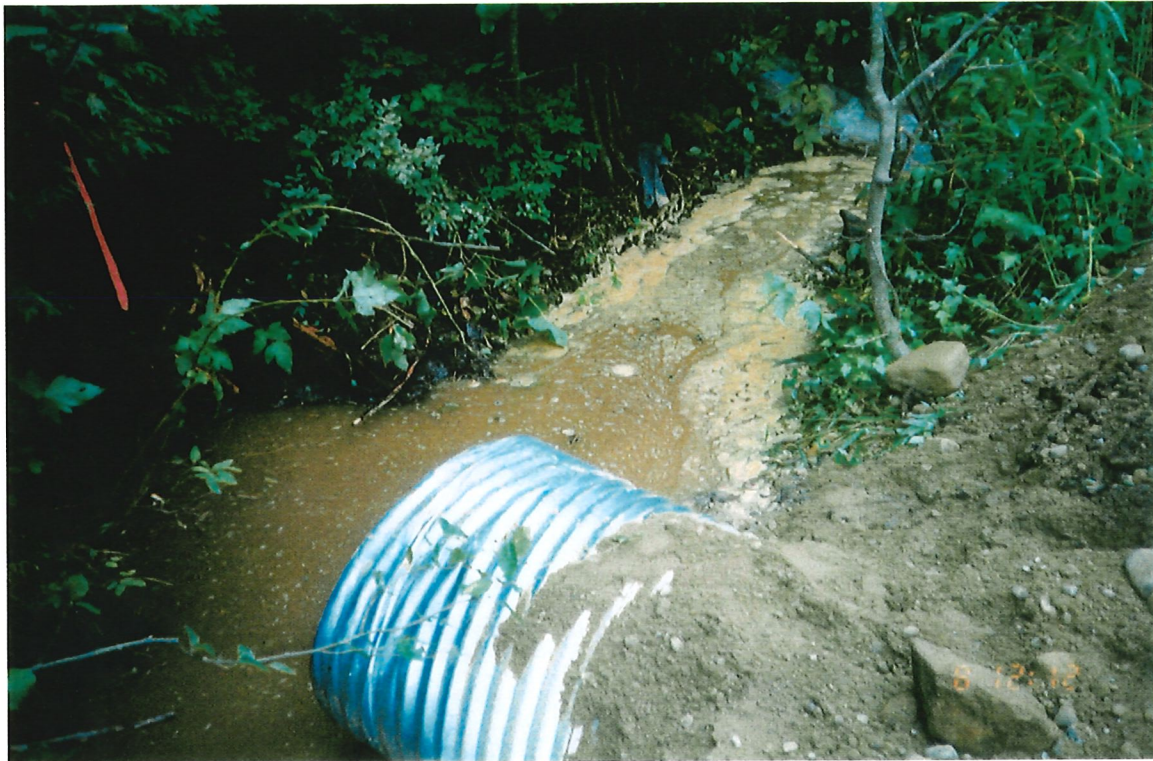
Photo 5-7 Flushing of culvert to remove fines from culvert infill materials. Dirty water pumped into adjacent vegetation.

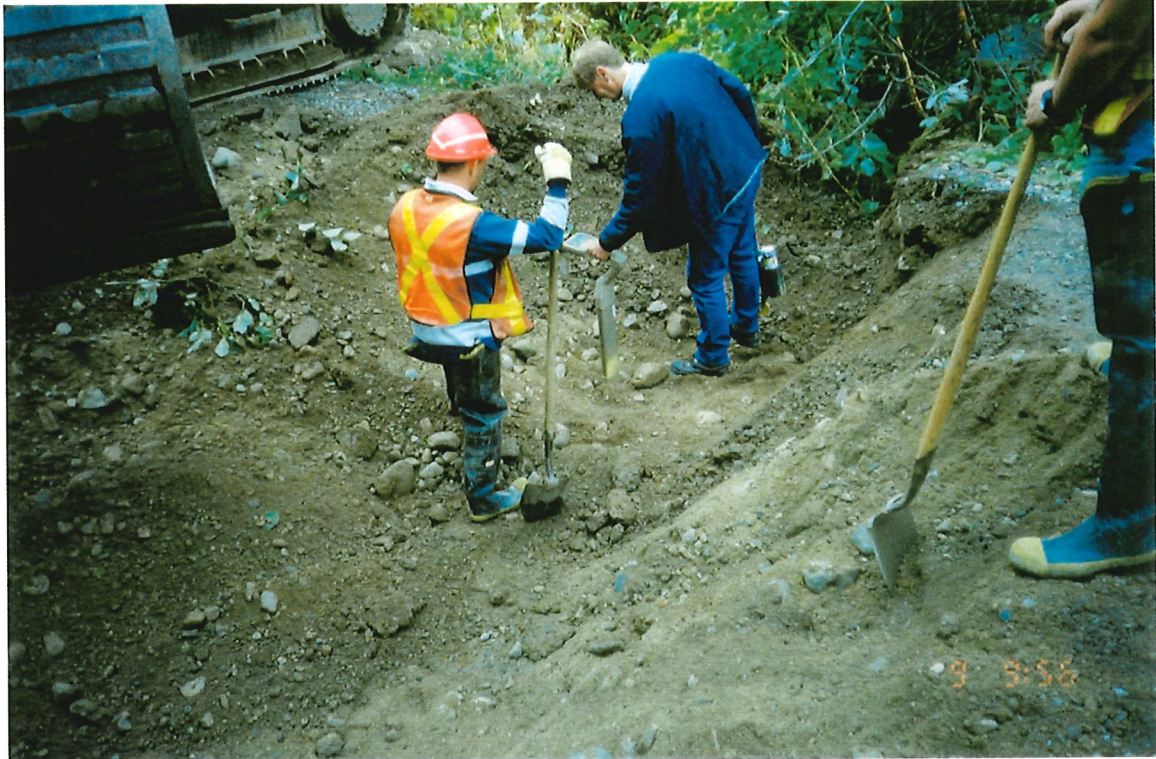
Photo 9-1 Searching for natural gas line.
