1st Avenue Culvert Replacements (Lakelse Lake)

Environmental Monitoring Report

TRITON
ENVIRONMENTAL CONSULTANTS LTD.

January 2004

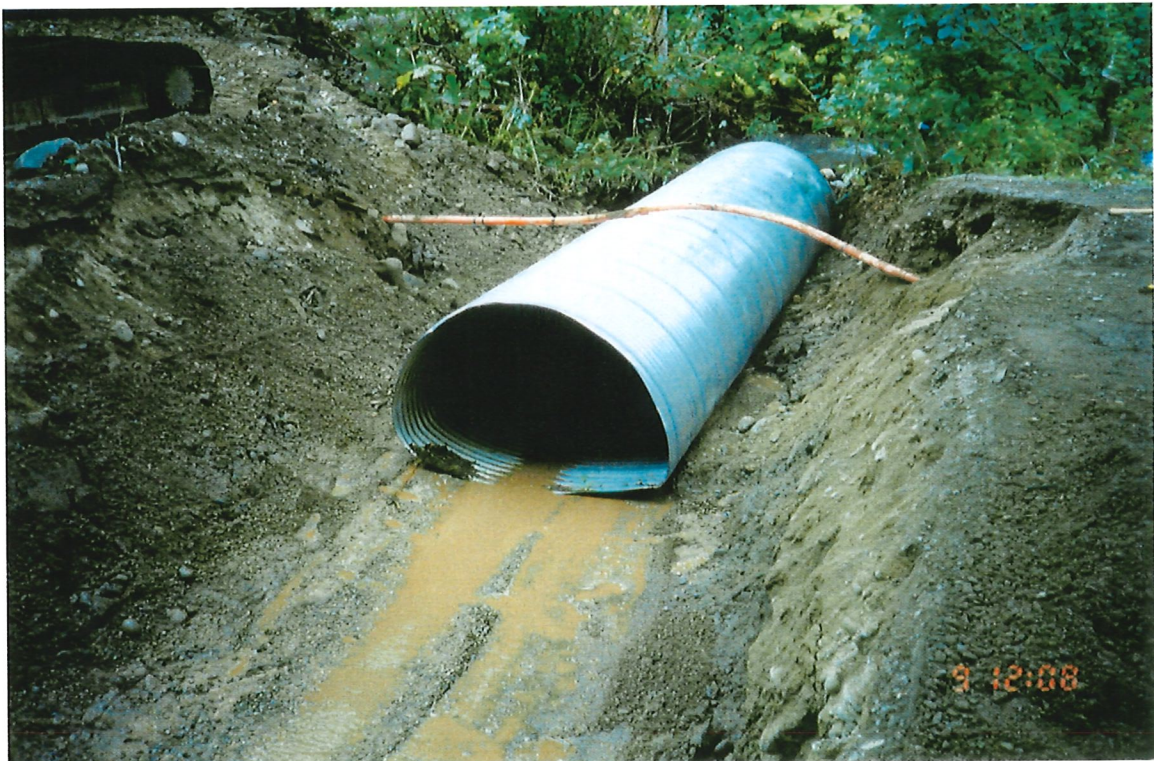
Photo 9-2 Downstream section of culvert being installed under natural gas line.

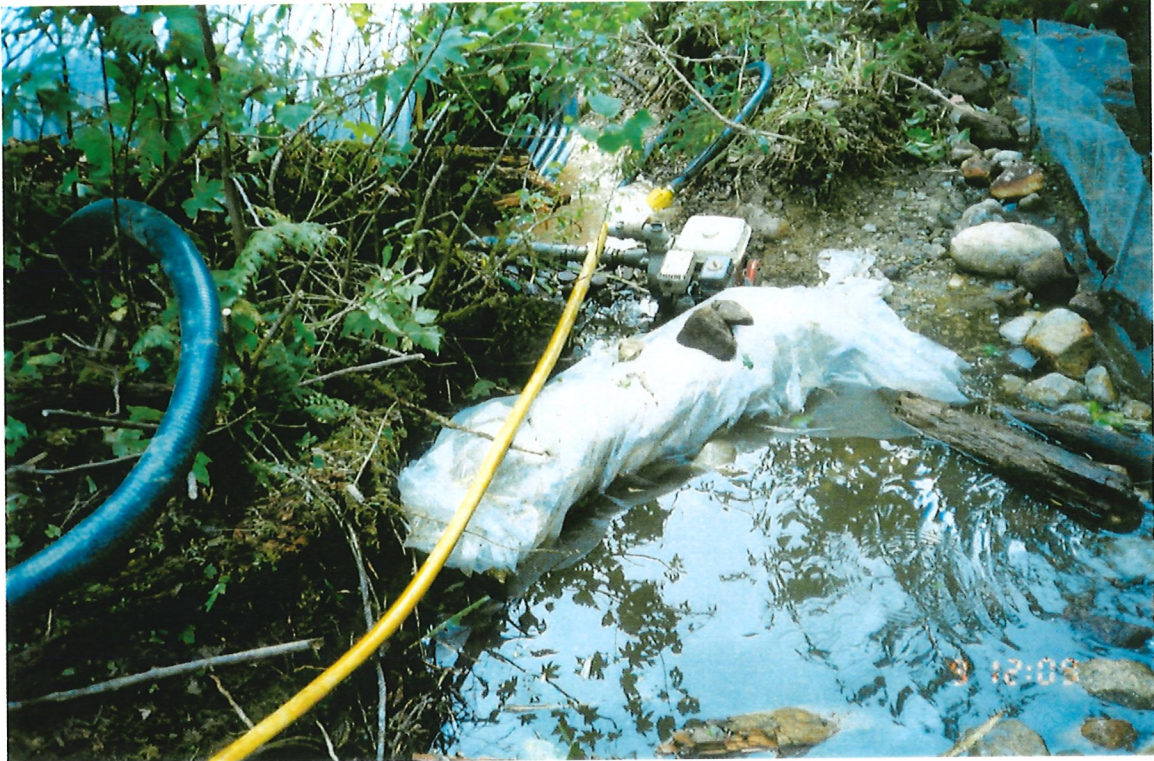
Photo 9-3 Sump with pump and sandbag / poly weir at outlet of culvert.

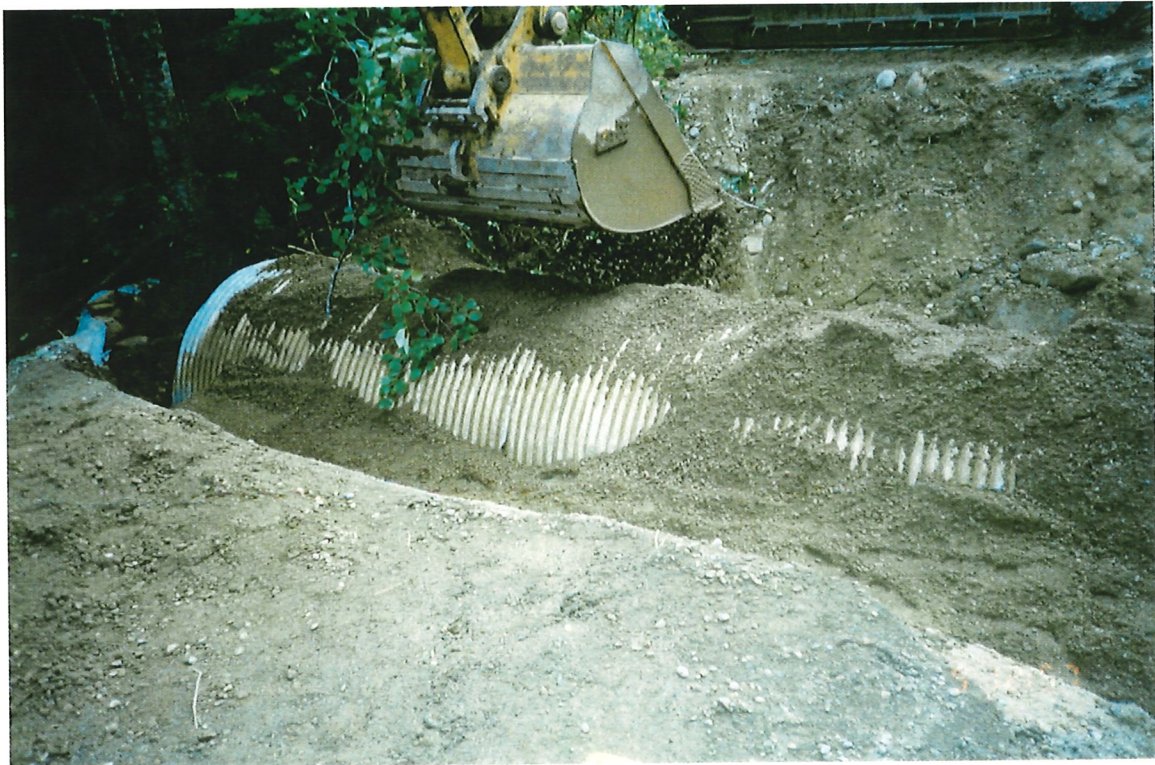
Photo 9-4 Backfilling around culvert.

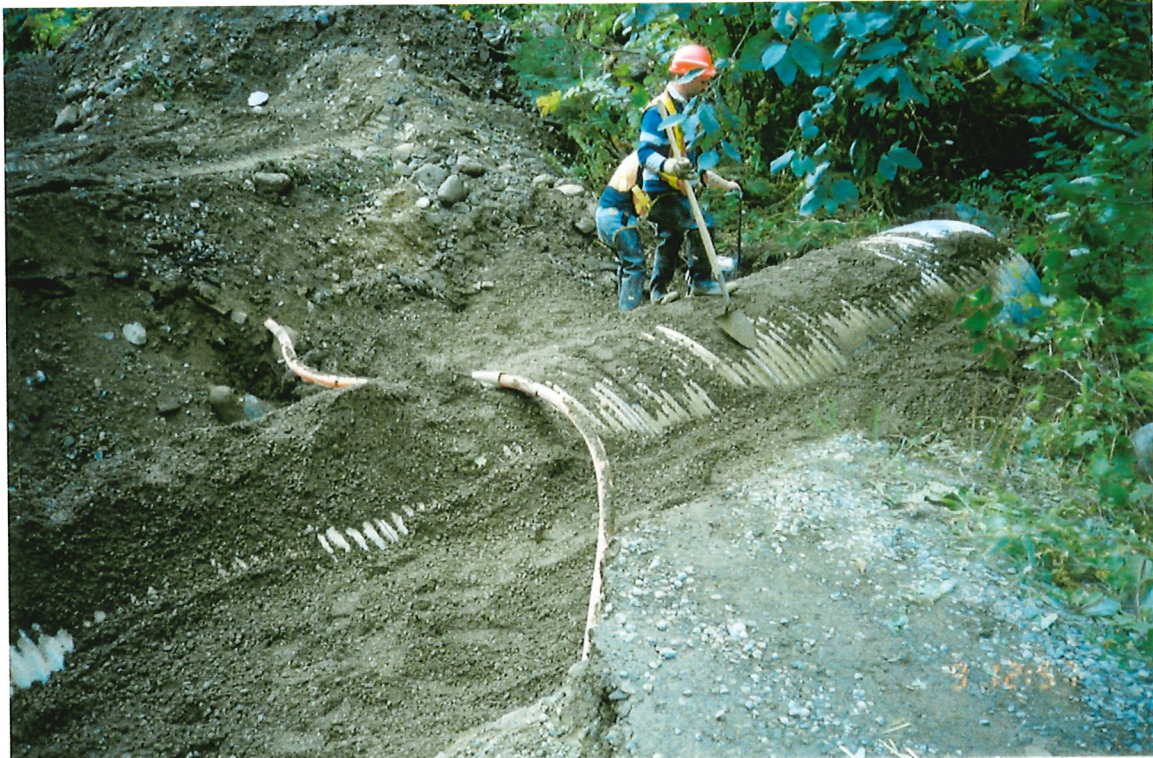
Photo 9-5 Compacting gravel around culvert.

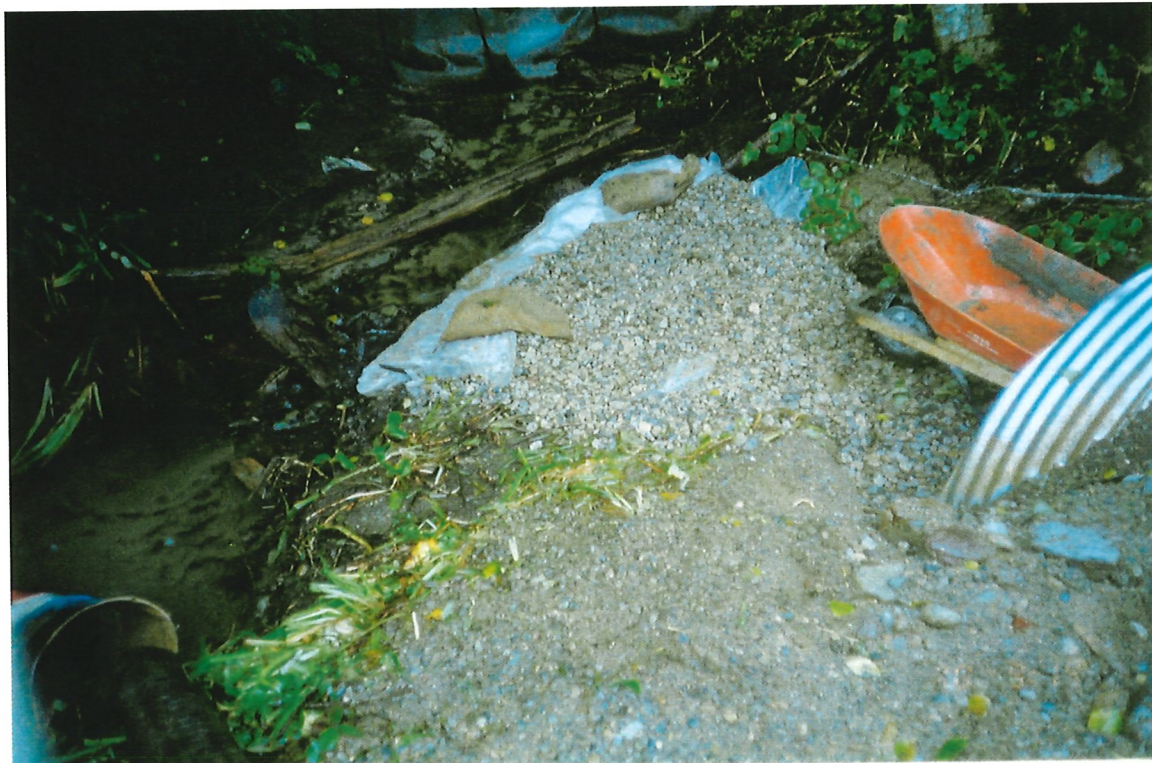
Photo 9-6 Upstream sandbag / poly weir with fisheries gravel for culvert infill.

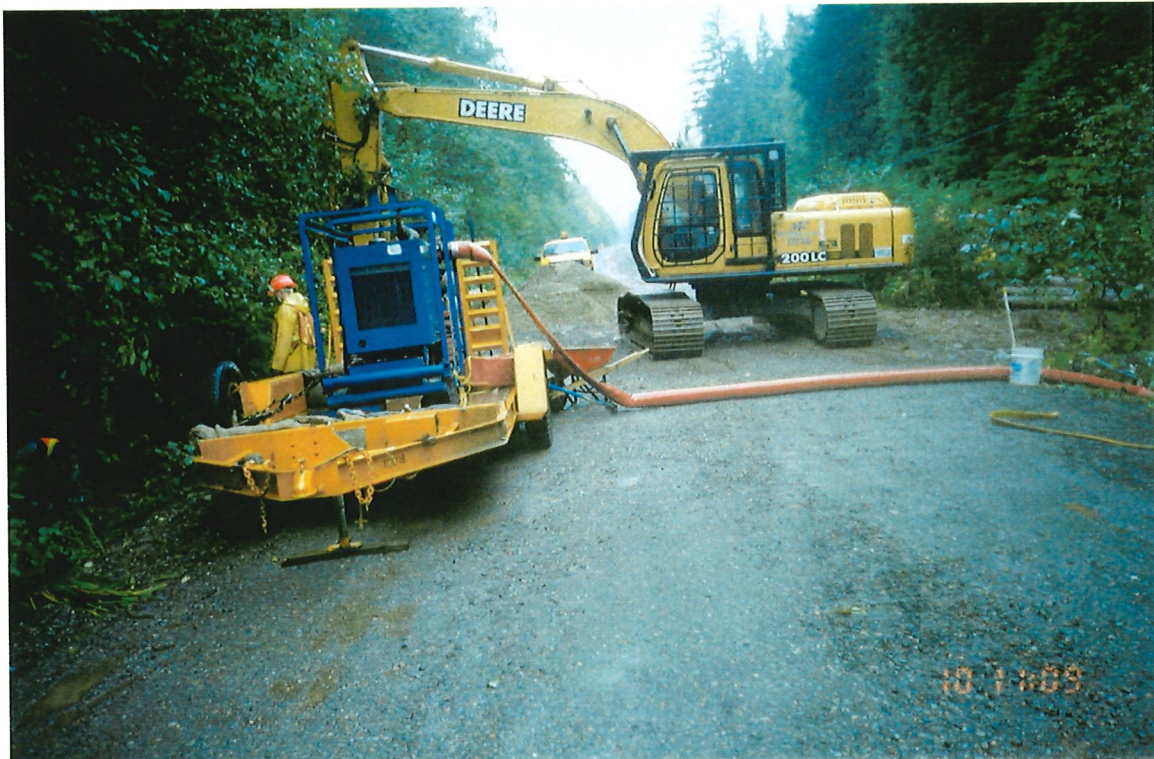
Photo 9-7 Flight pump and excavator used for 1st Avenue installations.

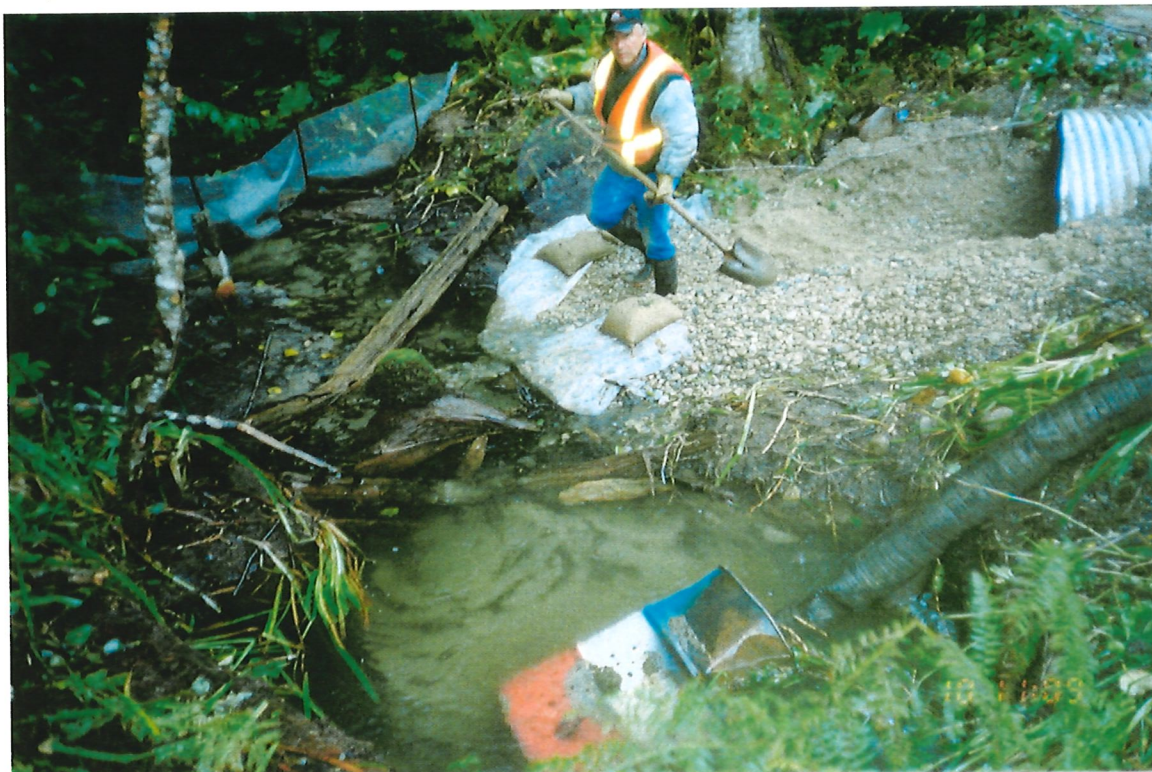
Photo 9-8 Partial breach of upstream weir for culvert cleanse.

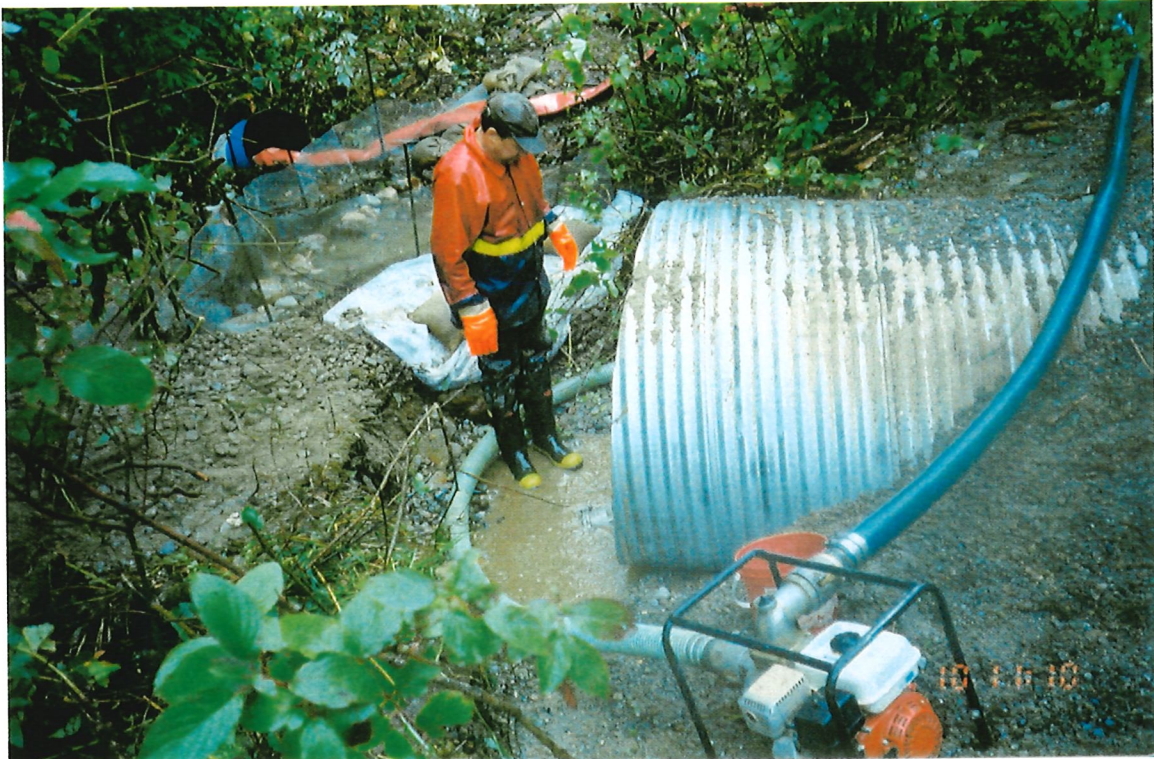
Photo 9-9 Removing dirty water from lower sump during culvert cleanse.

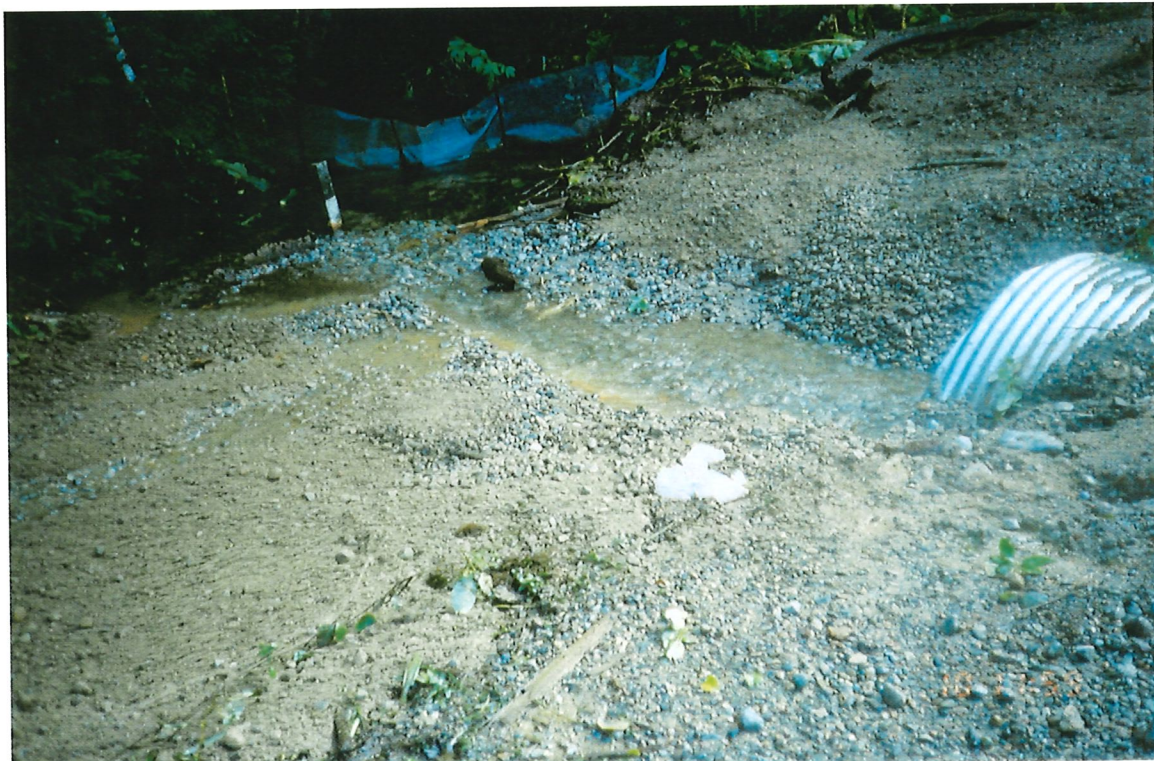
Photo 9-10 Photo of culvert inlet after full breach and sump infill.

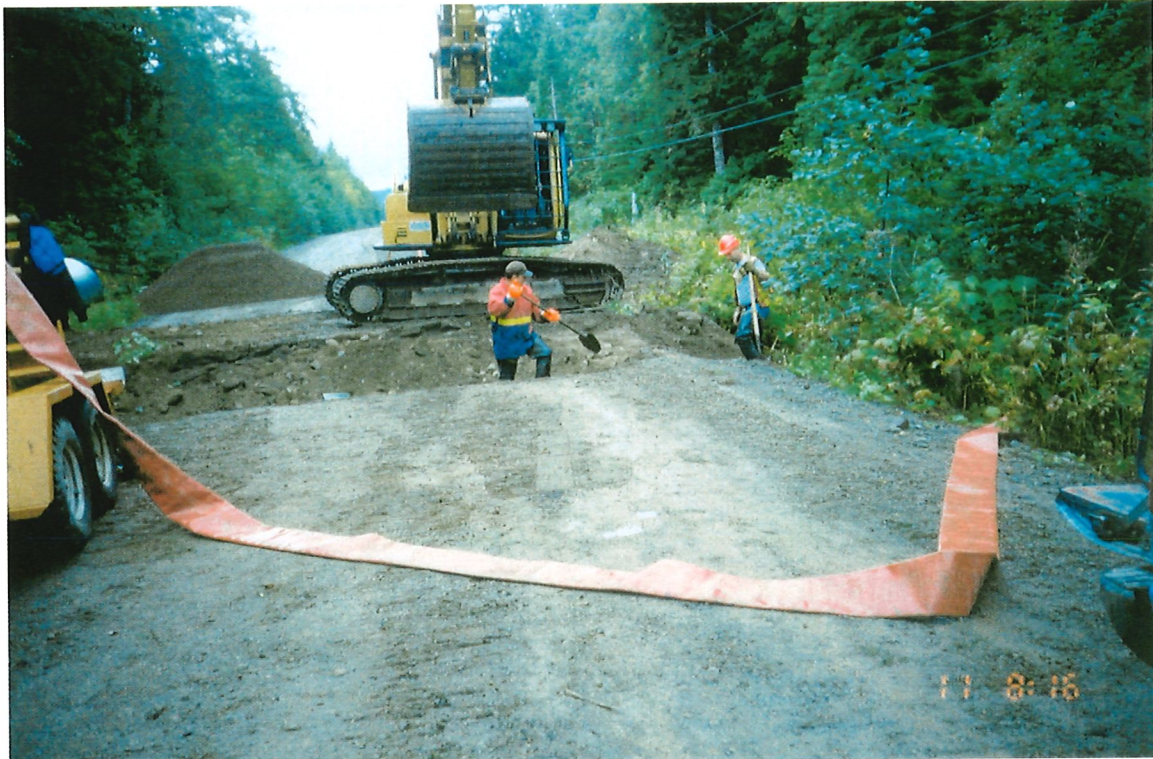
Photo 10-1 Excavating around natural gas line.

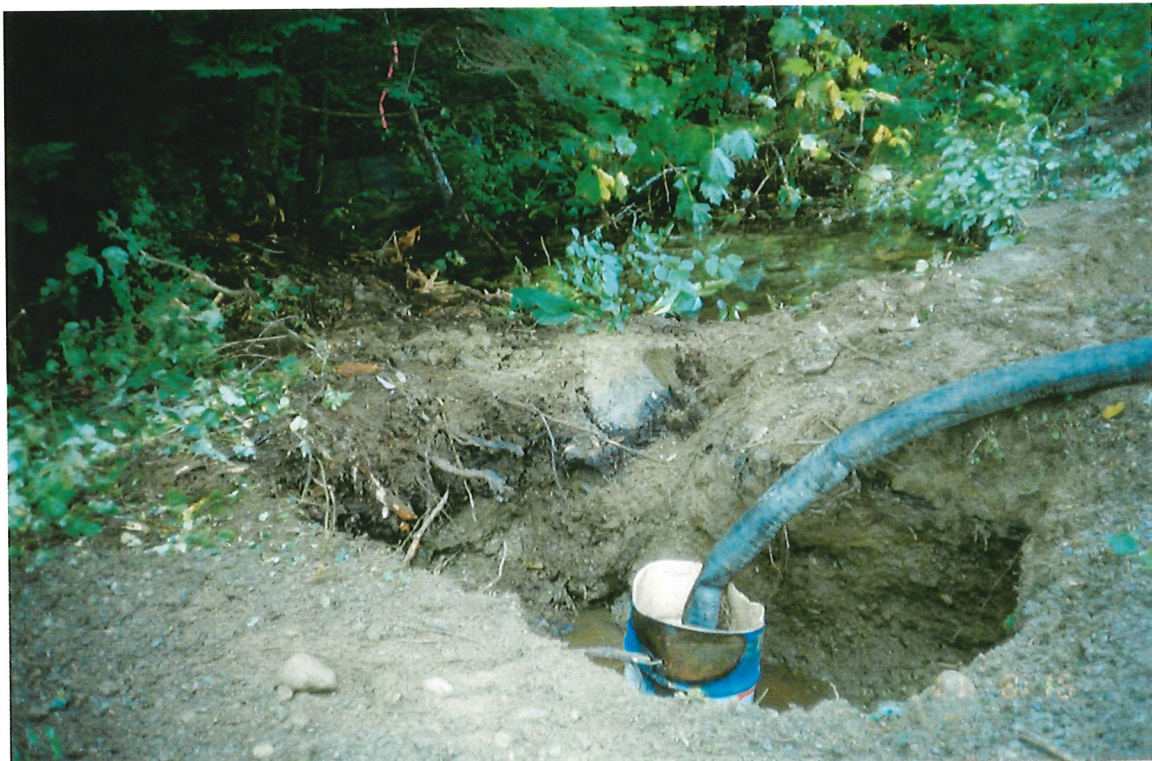
Photo 10-2 Sump at upstream end of culvert prior to filling.

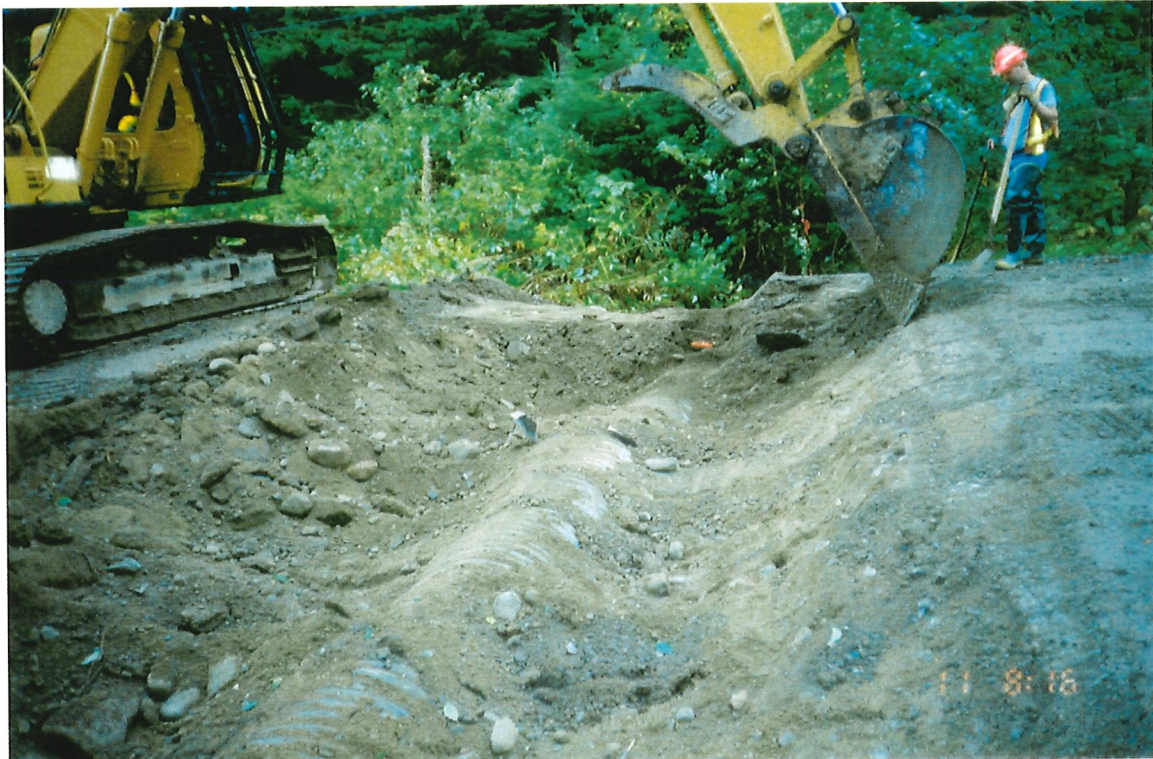
Photo 10-3 Excavating around natural gas line.

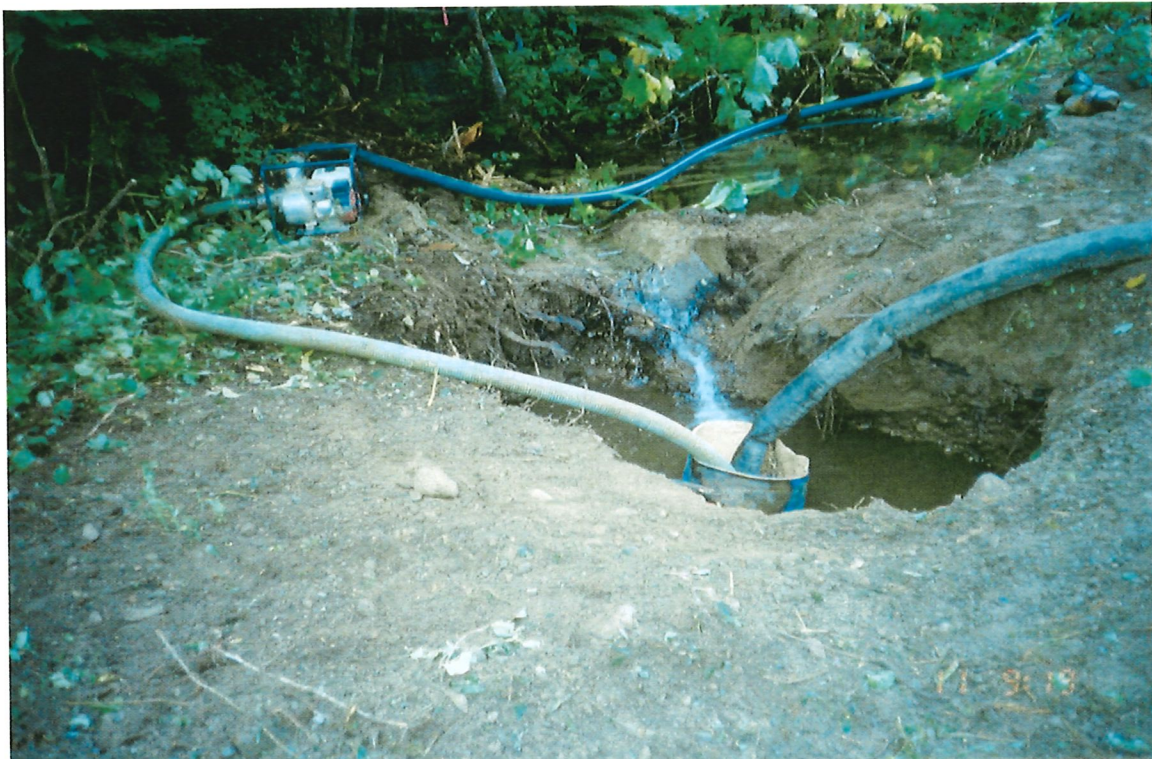
Photo 10-4 Filling upstream sump prior to diversion. Note 3" pump for removing dirty water

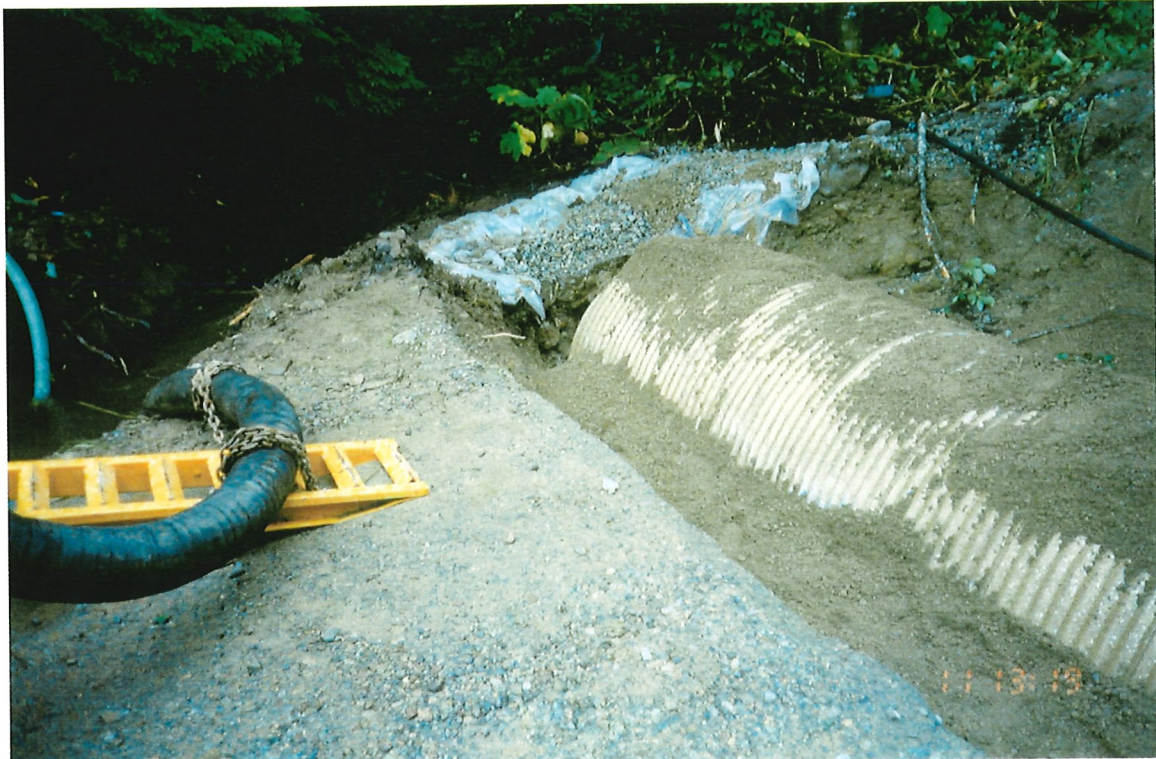
Photo 10-5 Backfilling around culvert.

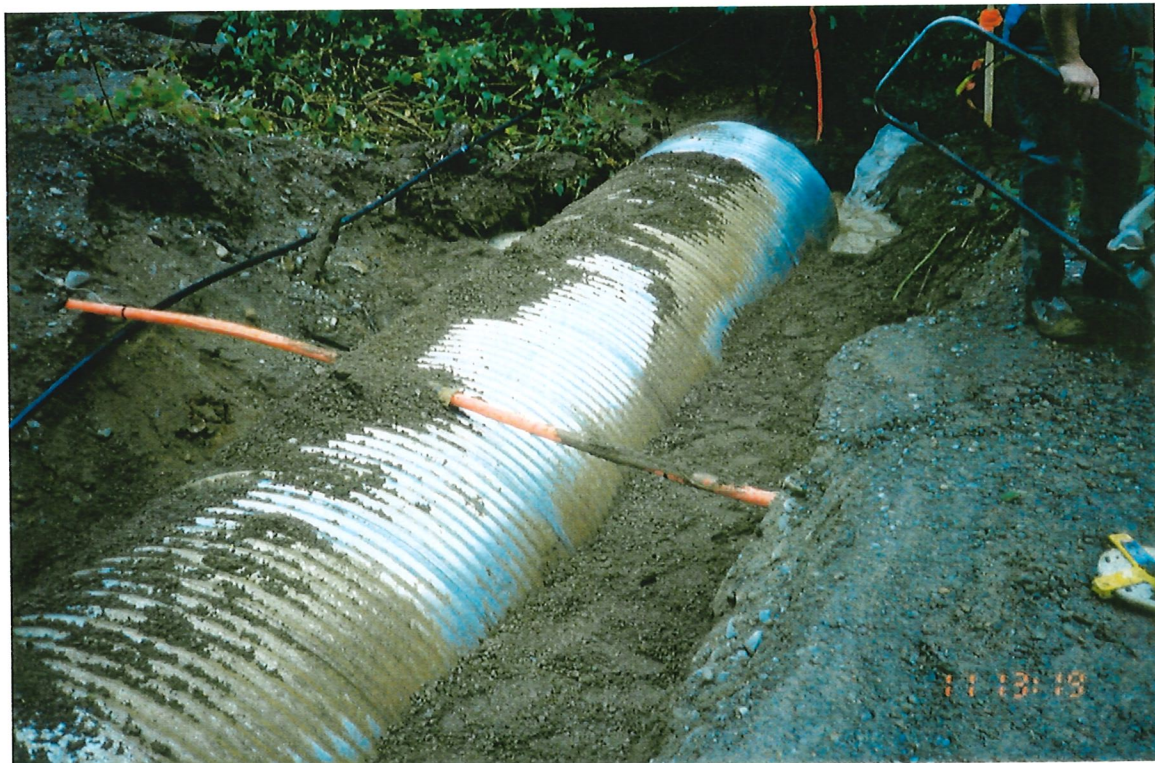
Photo 10-6 Backfilling and compacting around culvert.

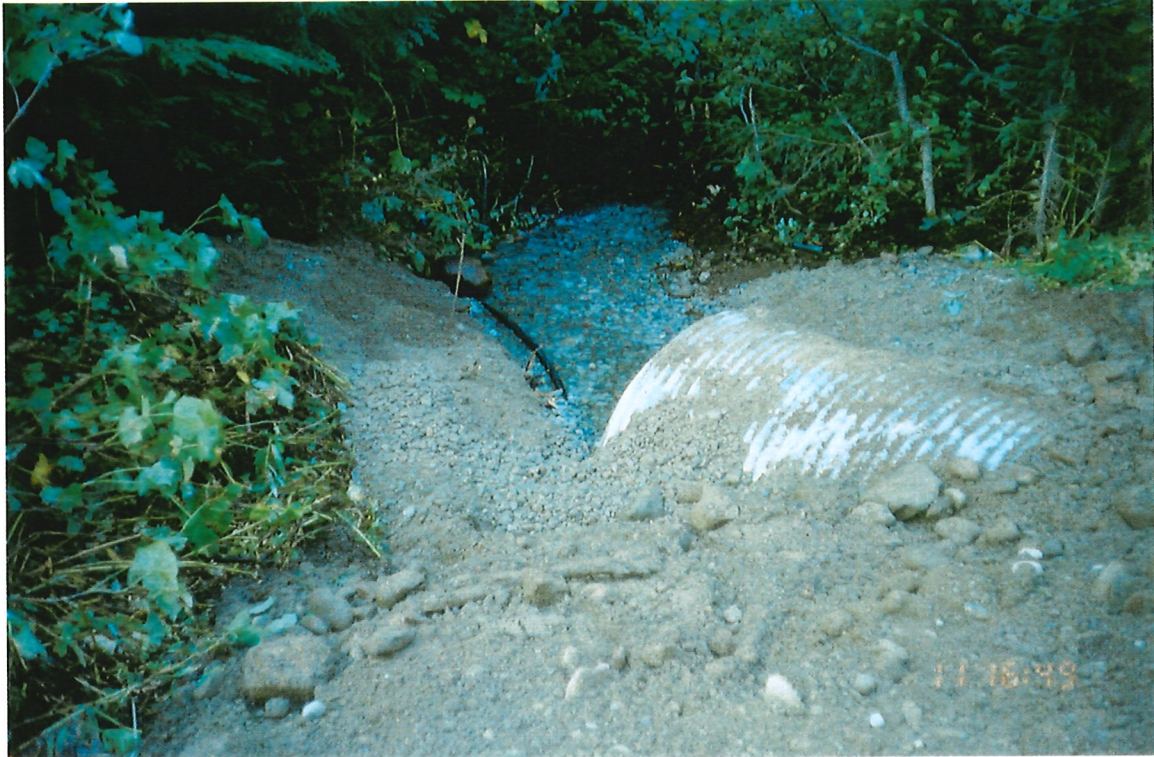
Photo 10-7 Inlet of culvert showing distribution of gravel substrates. Note local water intake adjacent to right bank.

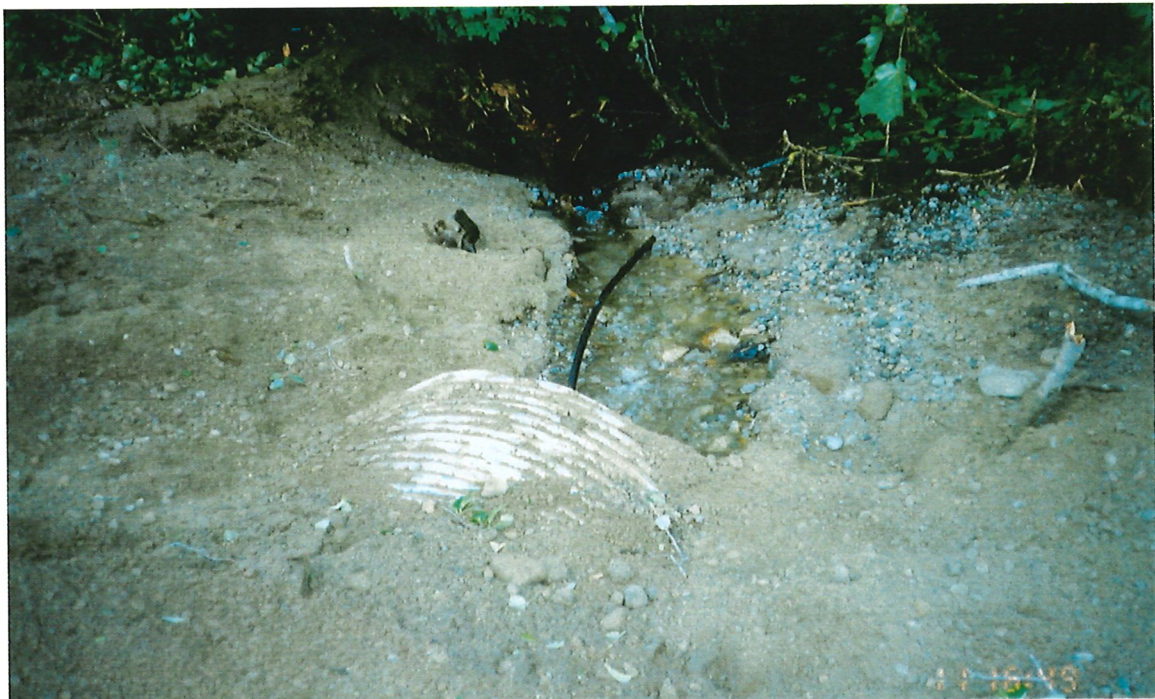
Photo 10-7 Outlet of culvert showing local water intake hose running up and through culvert.

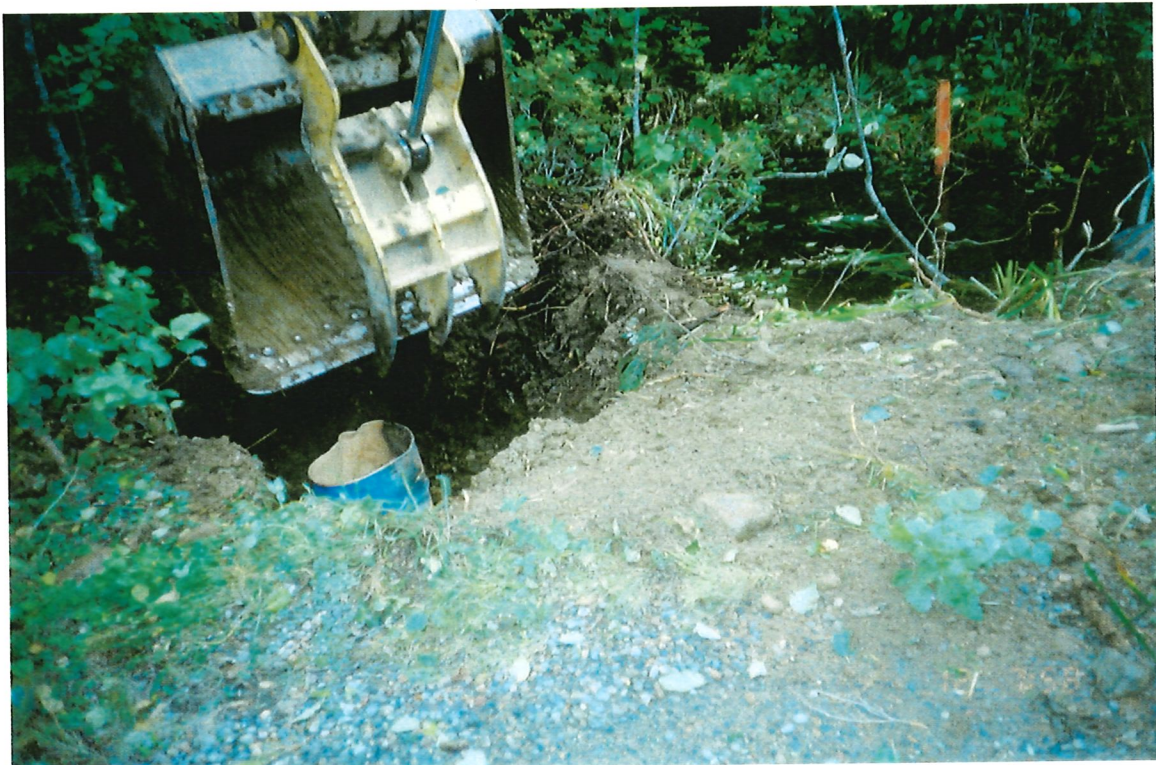
Photo 12-1 Placing sump adjacent to stream.

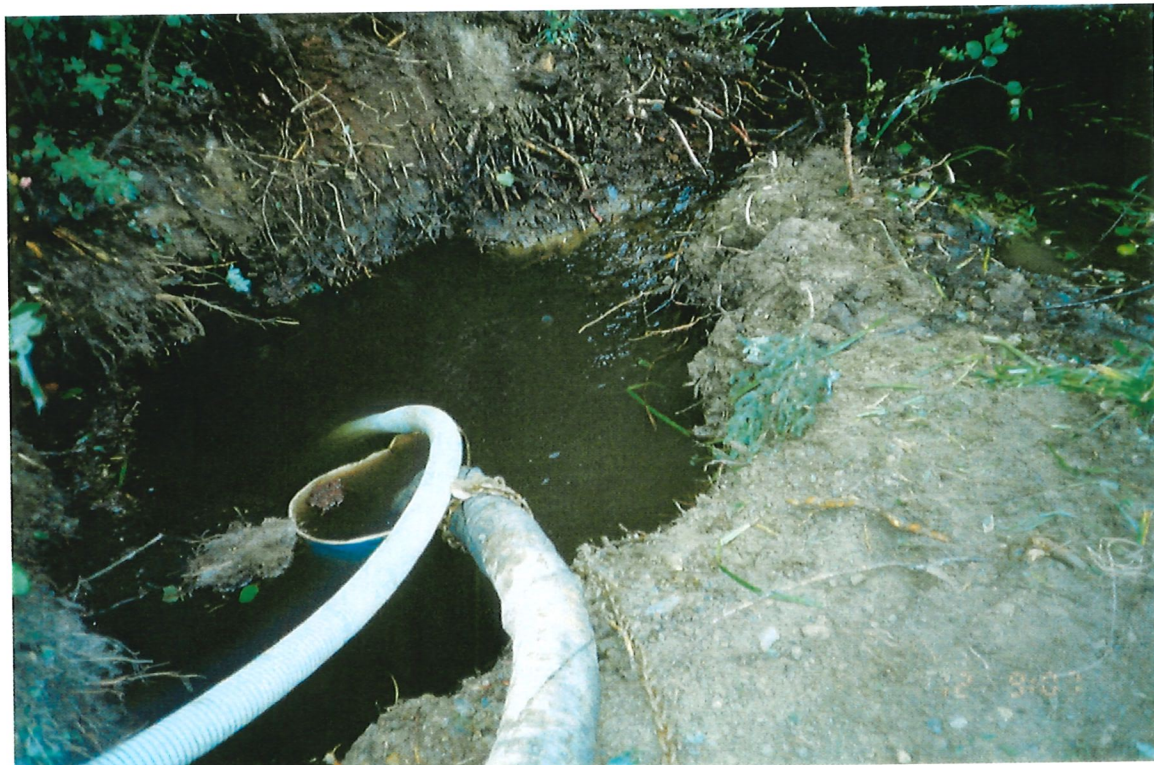
Photo 12-2 Filling upstream sump prior to diversion. Note 3" pump for removing dirty water

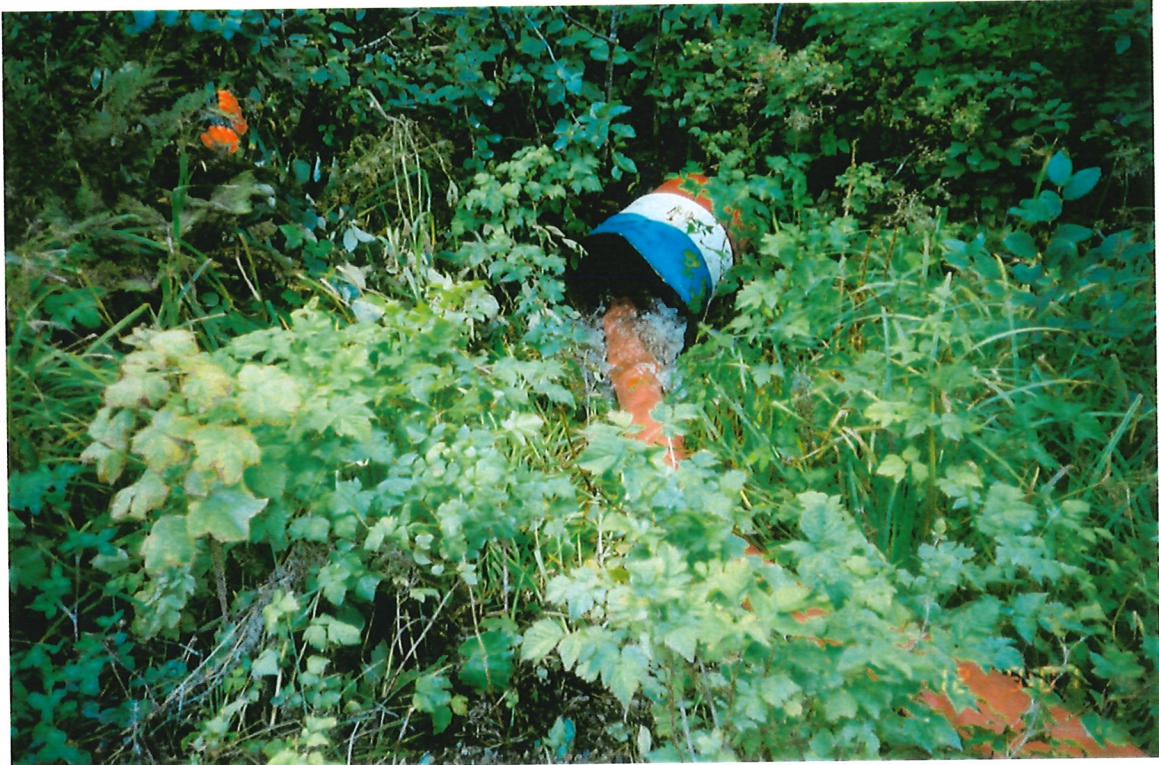
Photo 12-3 Diffuser at end of diversion hose.

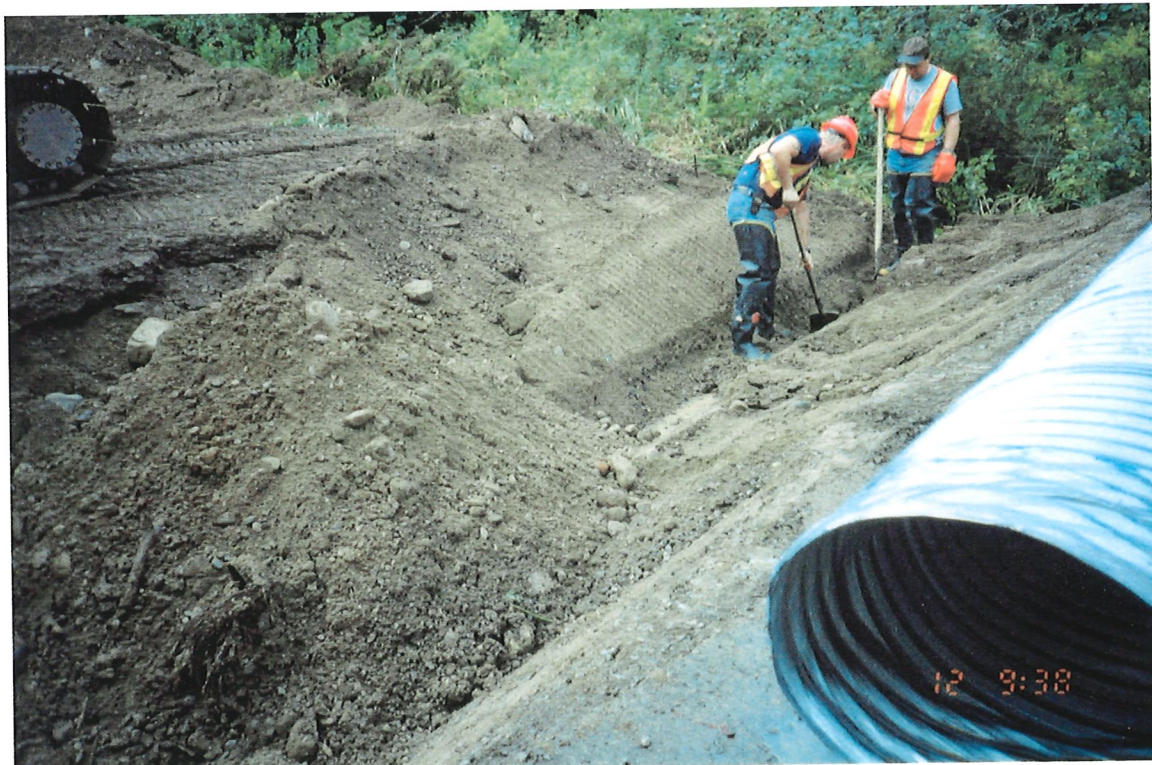
Photo 12-4 Crew searching for gas line in culvert trench.

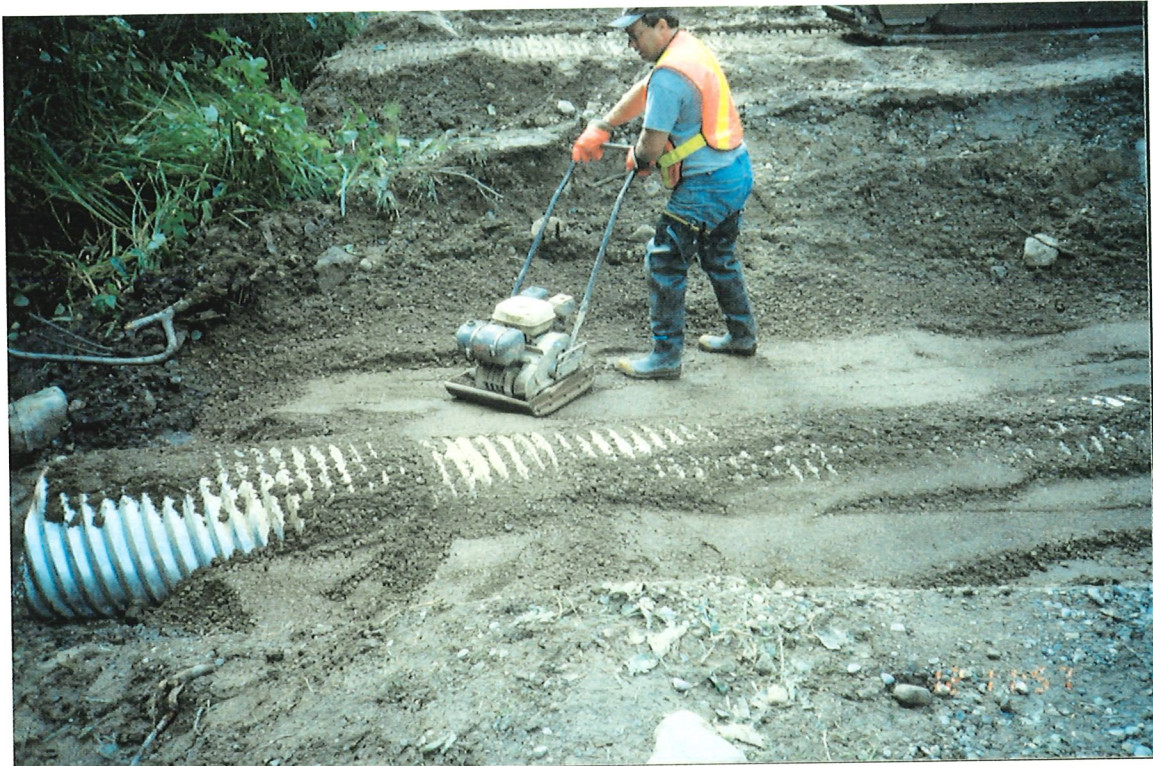
Photo 12-5 Compacting gravel around culvert.

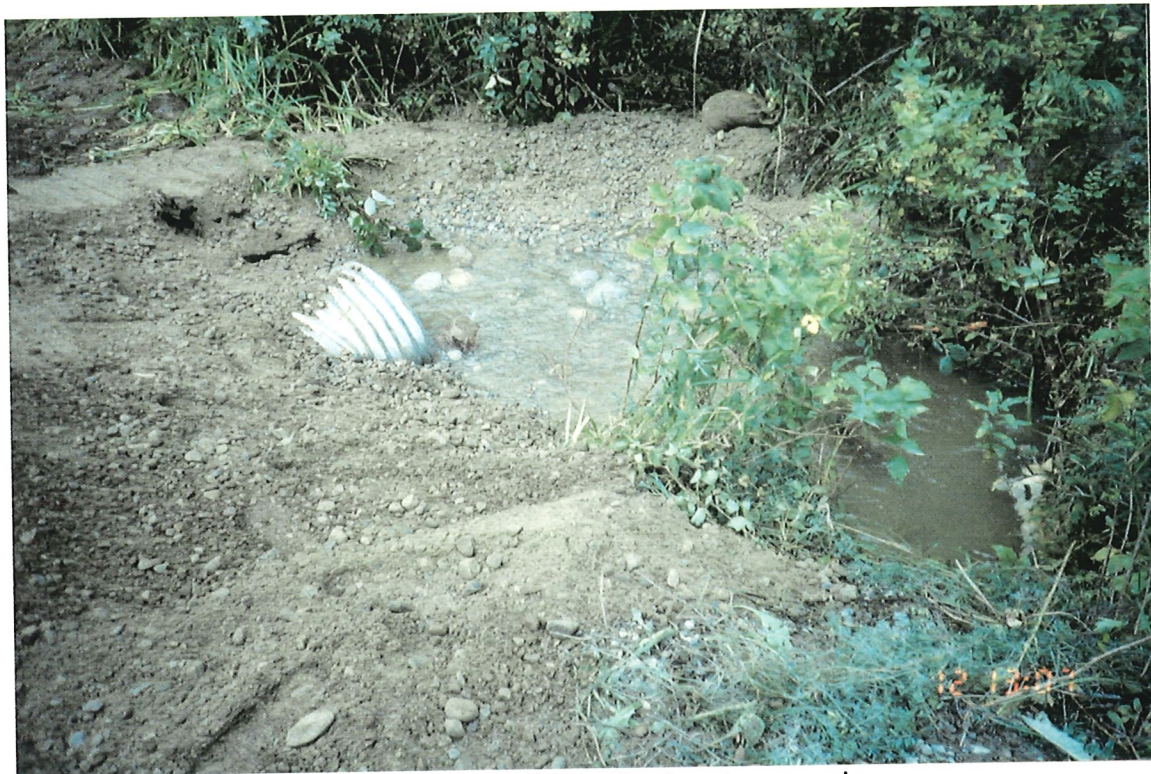
Photo 12-6 Water out of culvert after full breach of upstream weir.

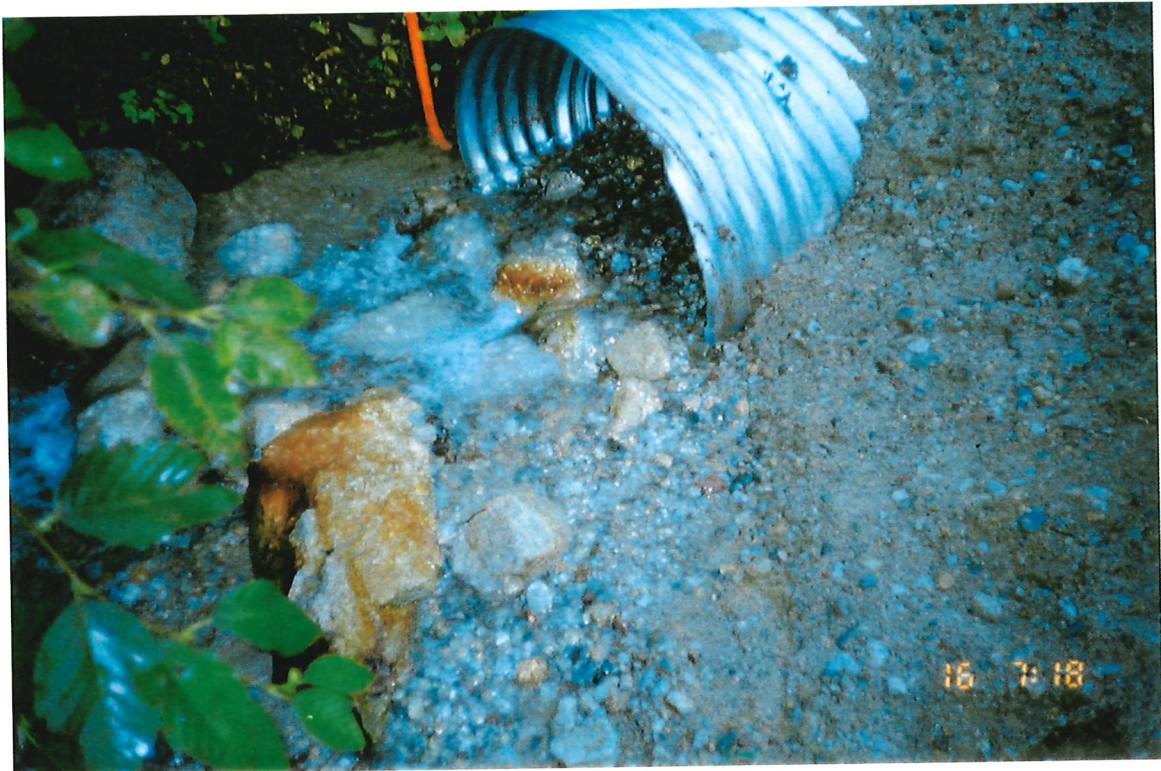
Photo 14-1 Culvert outlet.

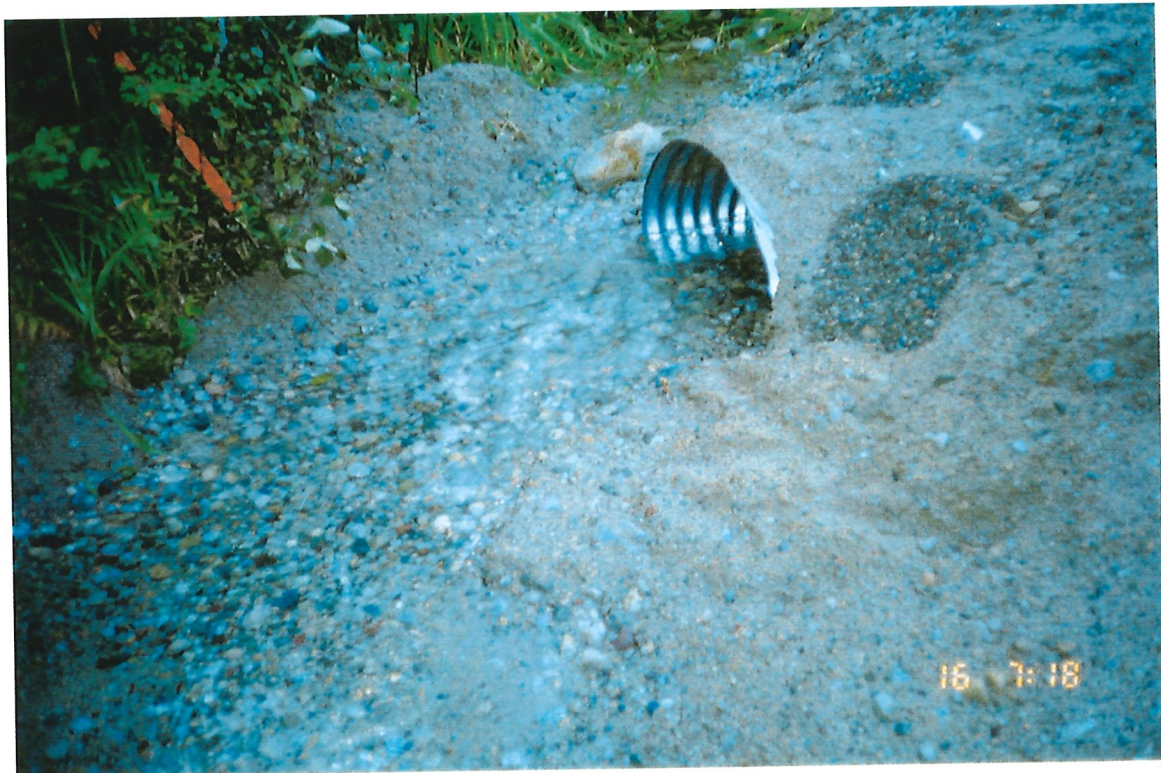
Photo 14-2 Culvert inlet.

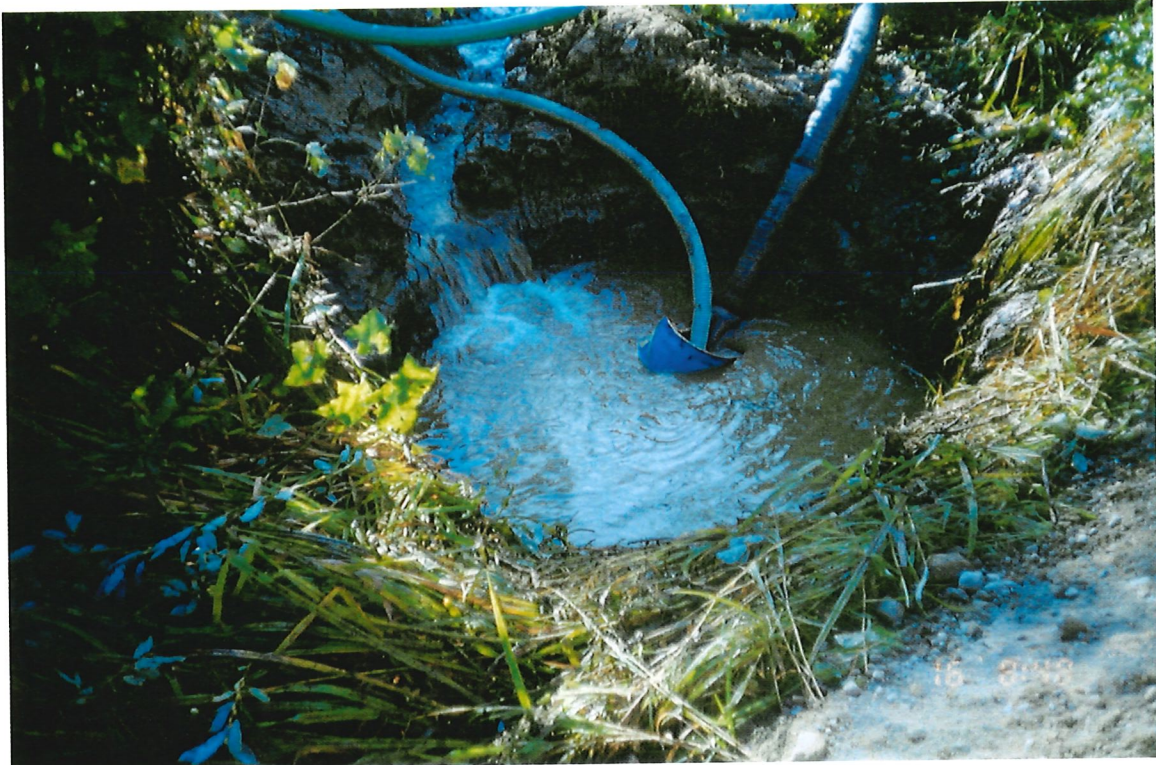
Photo 16-1 Filling upstream sump prior to diversion.
