1st Avenue Culvert Replacements (Lakelse Lake)

Environmental Monitoring Report

TRITON
ENVIRONMENTAL CONSULTANTS LTD.

January 2004

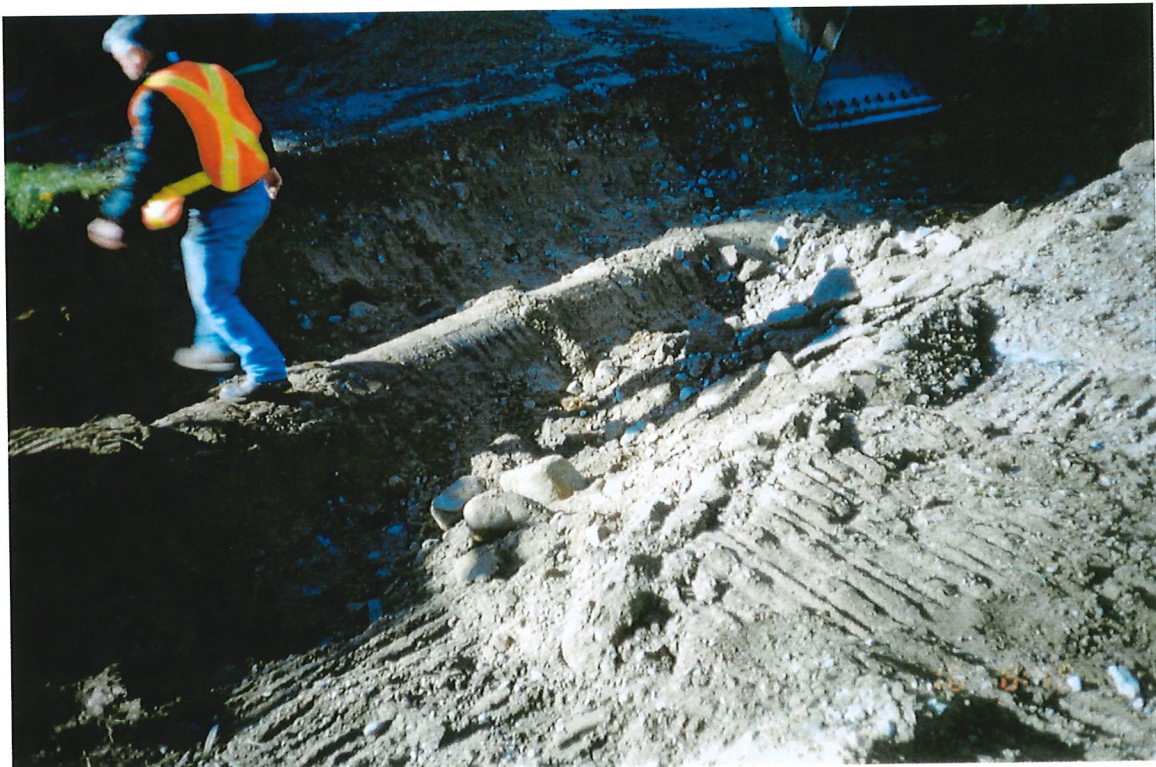
Photo 16-2 Excavating down to existing culvert.

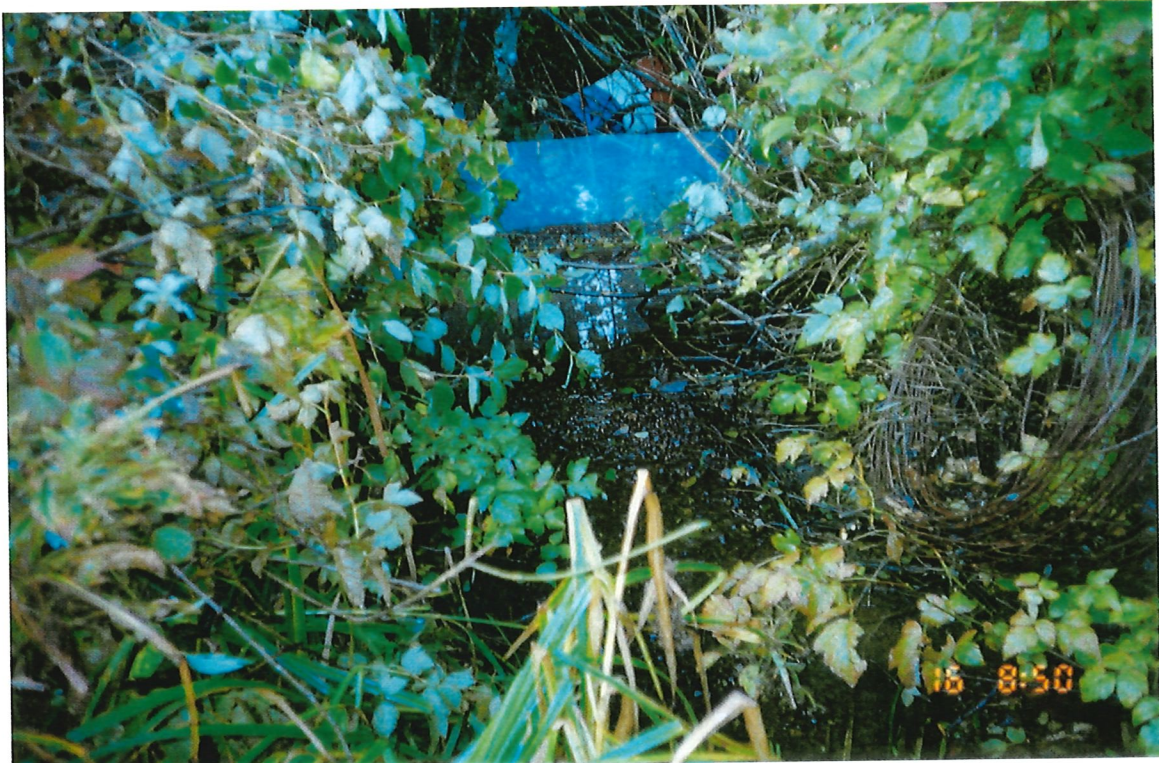
Photo 16-3 Downstream stop-net and diffuser for diversion hose.

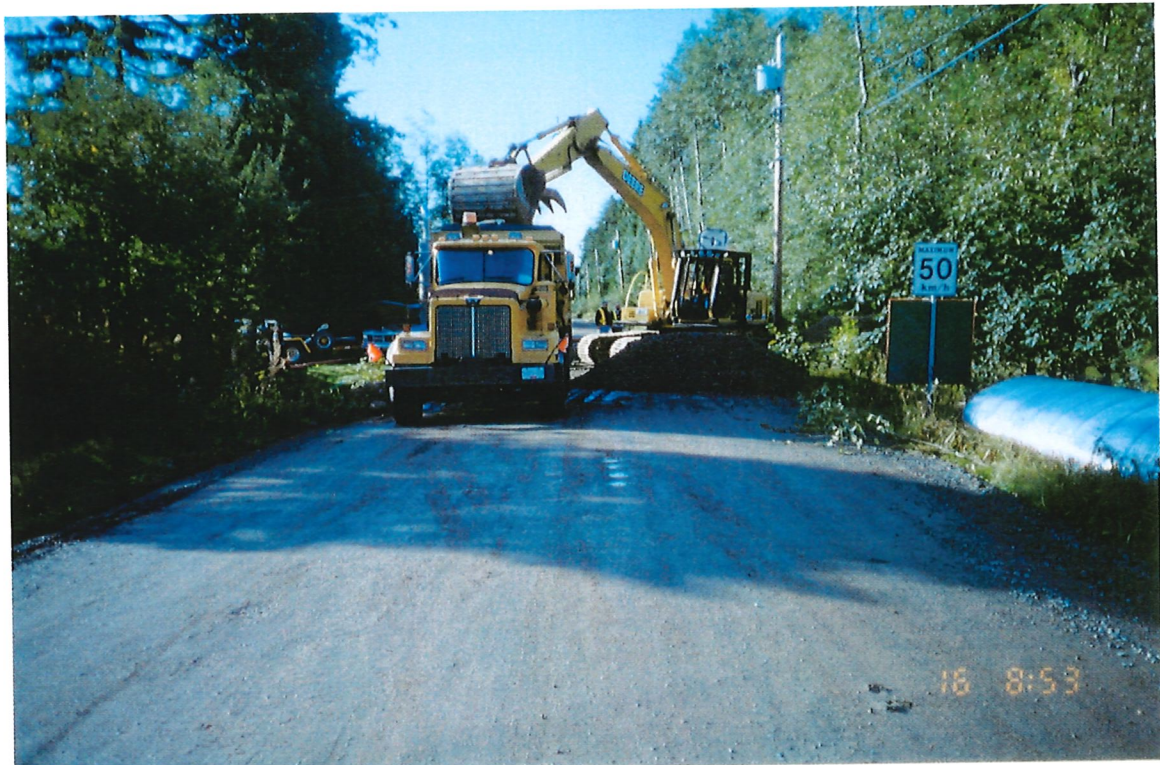
Photo 16-4 Removing waste materials from site.

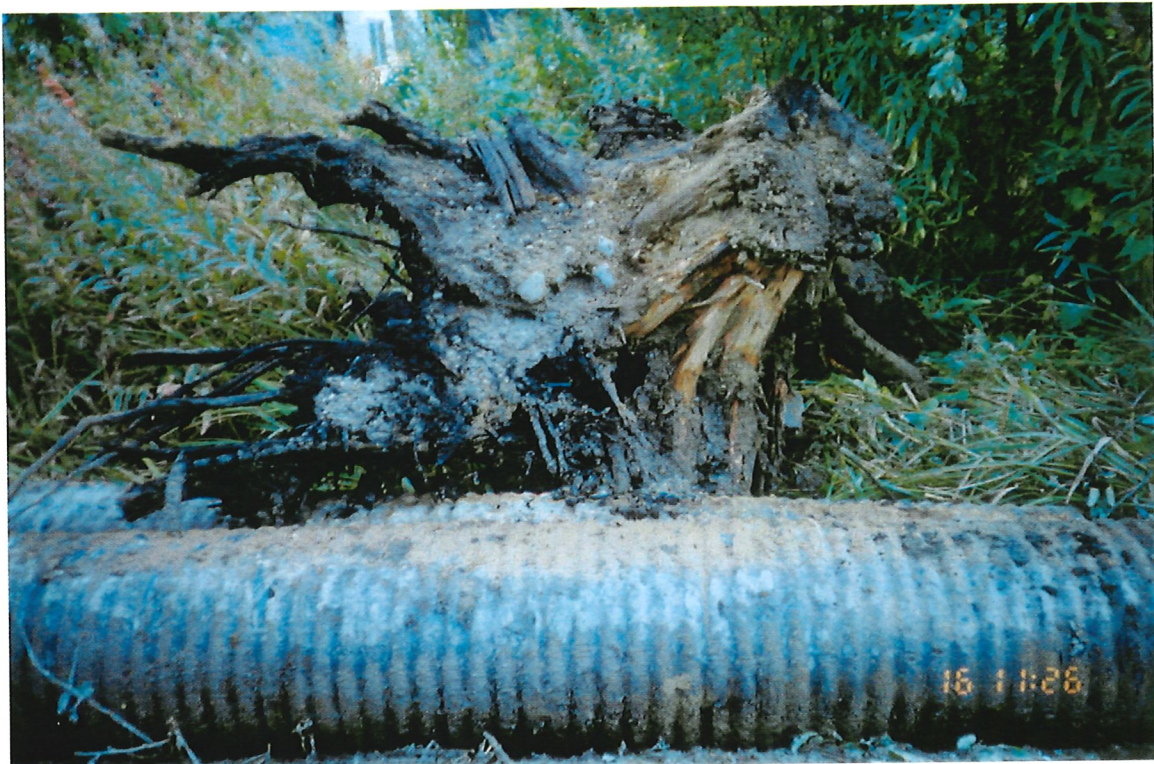
Photo 16-5 Example of material found throughout road grade.

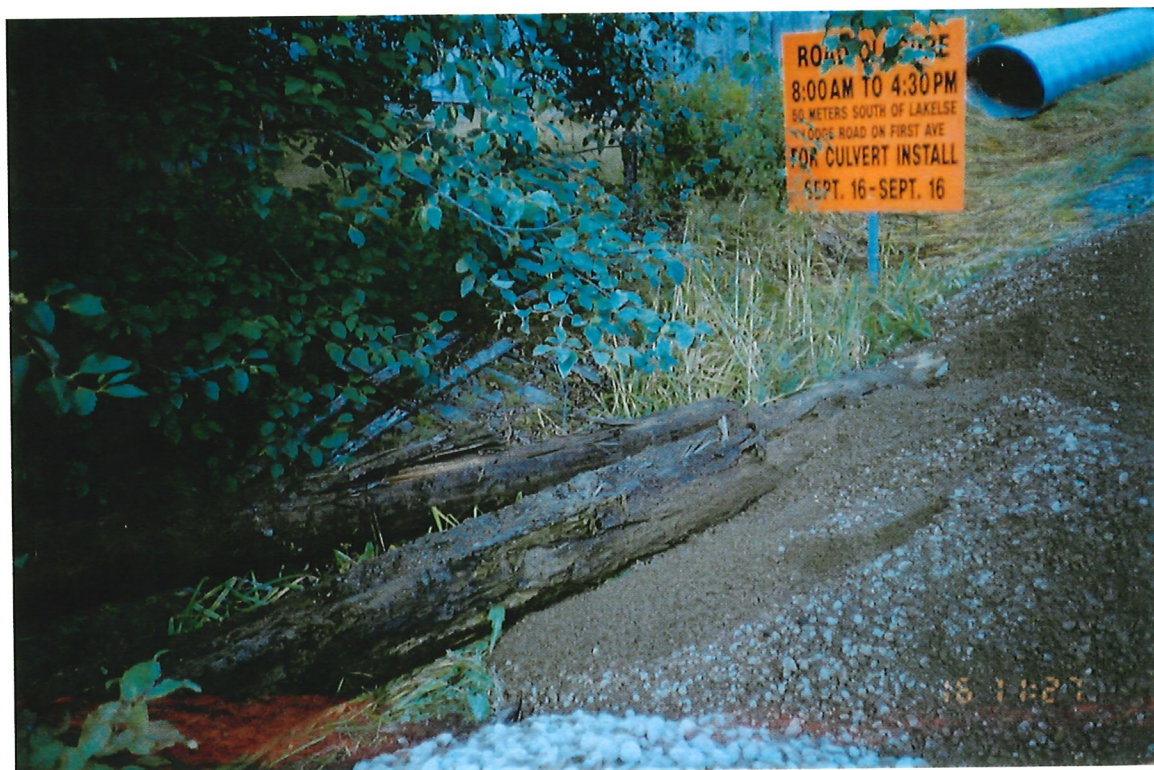
Photo 16-6 Signage letting resident know of road closures.

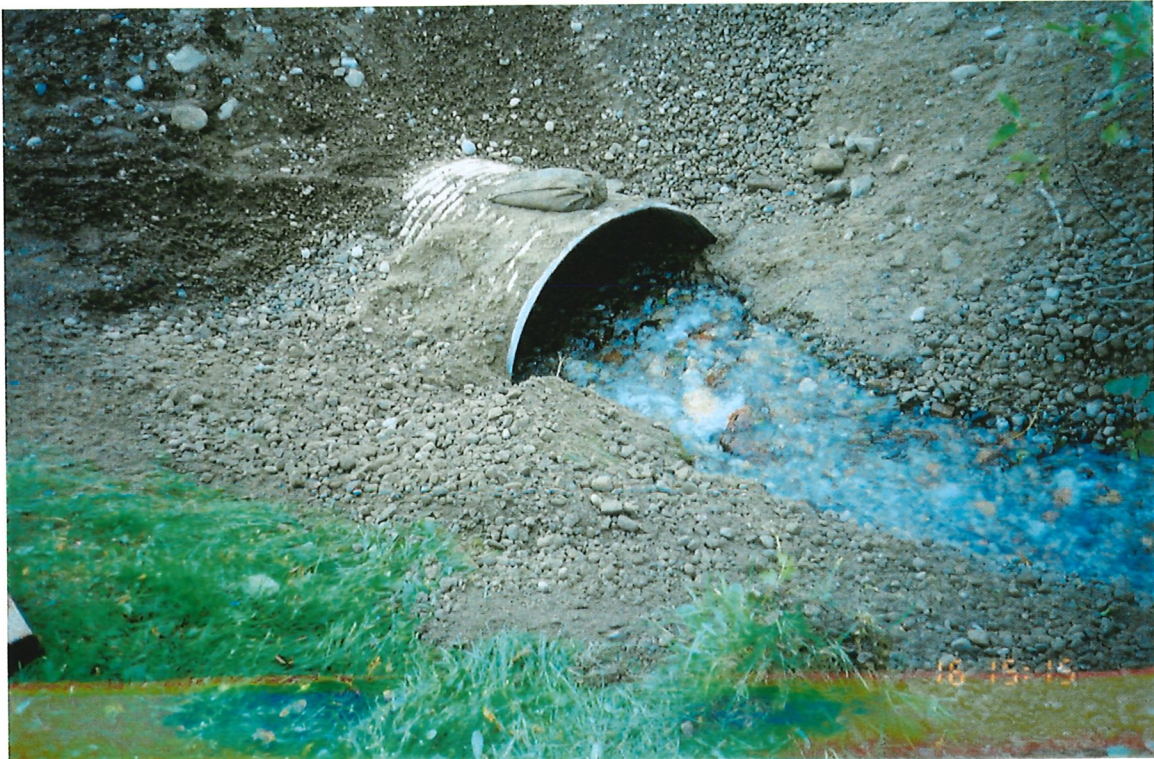
Photo 16-7 Photo of inlet immediately after breach of upstream weir.

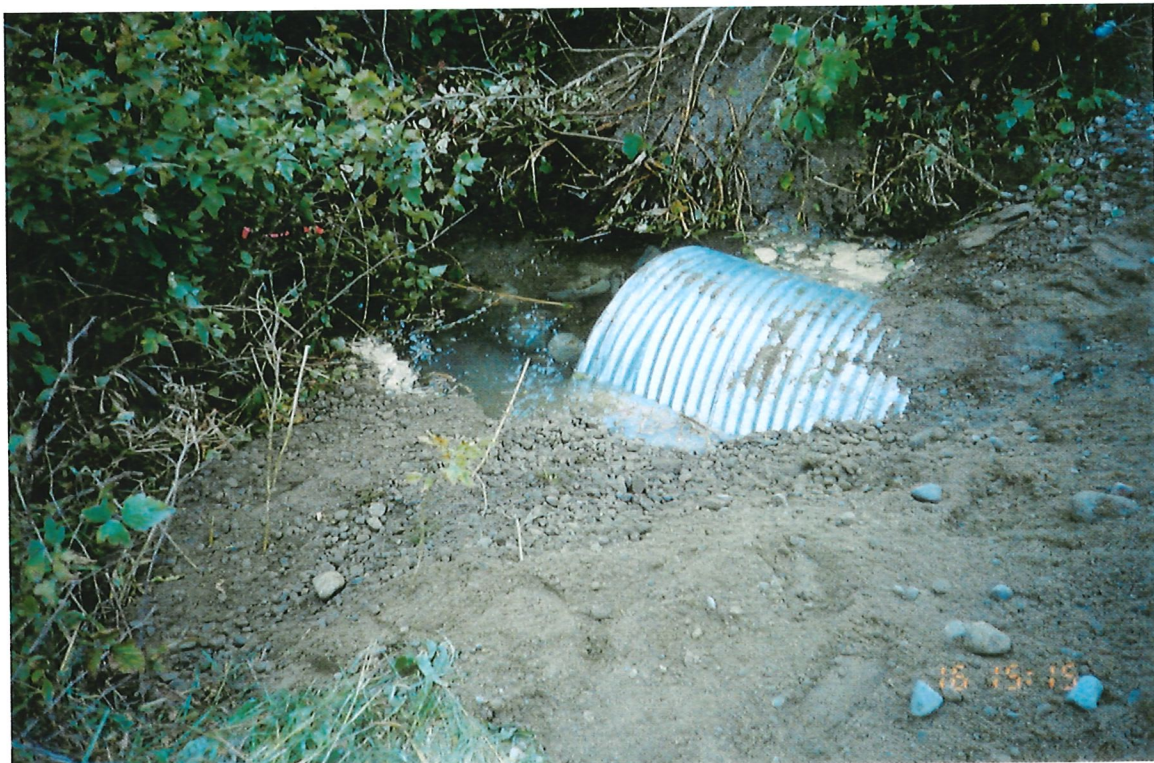
Photo 16-8 Photo of outlet immediately after breach of upstream weir.
