Environmental Mitigation Plan

Strimbold Bridge Maxan Creek Deactivation

November 2015

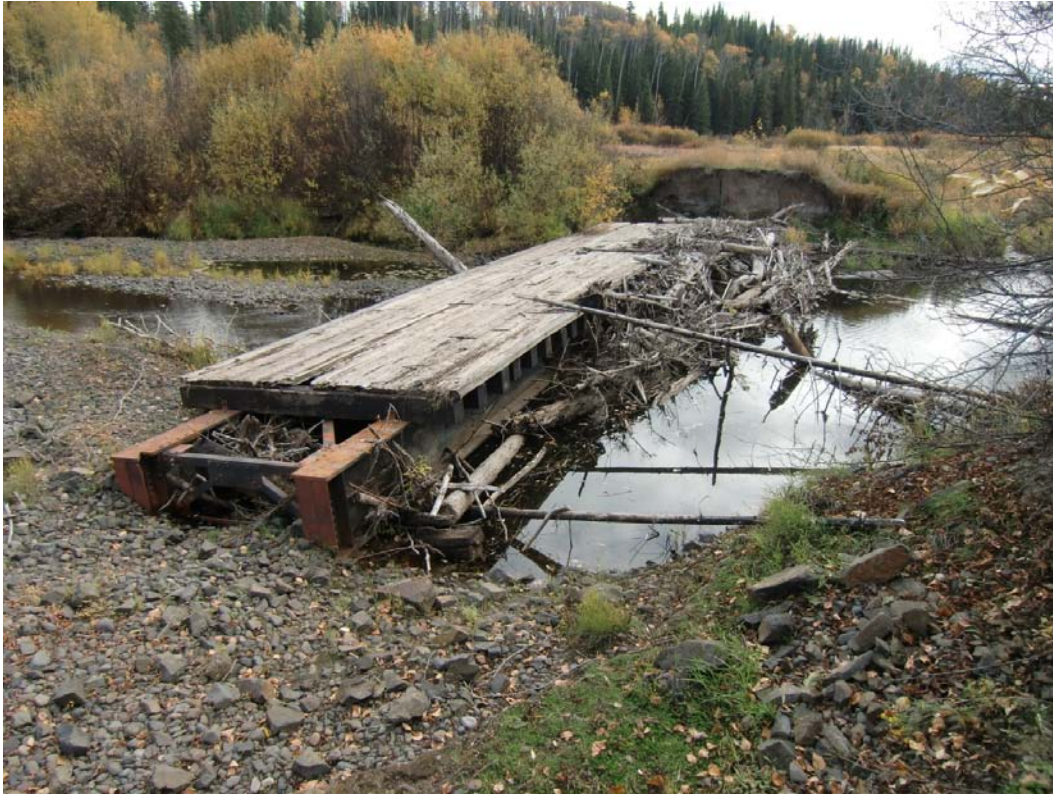
The bridge is constructed of steel railroad cars with a wooden deck and no apparent abutments. The running surface is 12m long x 3.3m wide and was likely never constructed to forestry standard. This portion of Maxan Creek (WSC 460-924300) is downstream of Maxan Lake and approximately 2km upstream of the outlet at Bulkley Lake. Several fish species are known in this section of Maxan Creek according to Habitat Wizard including Chinook Salmon, Coho Salmon, Sockeye Salmon, Steelhead, Rainbow Trout, Dolly Varden, Mountain Whitefish, Lamprey, Longnose Sucker, Prickly Sculpin and Lake Chub. This section of Maxan Creek is over 10m wide with a low gradient, characterized by meandering riffle-pool morphology and frequent beaver dams. MFLNRO staff observed a Chinook salmon redd immediately downstream of the site.

Photo 1. Strimbold Bridge, September 29, 2015.

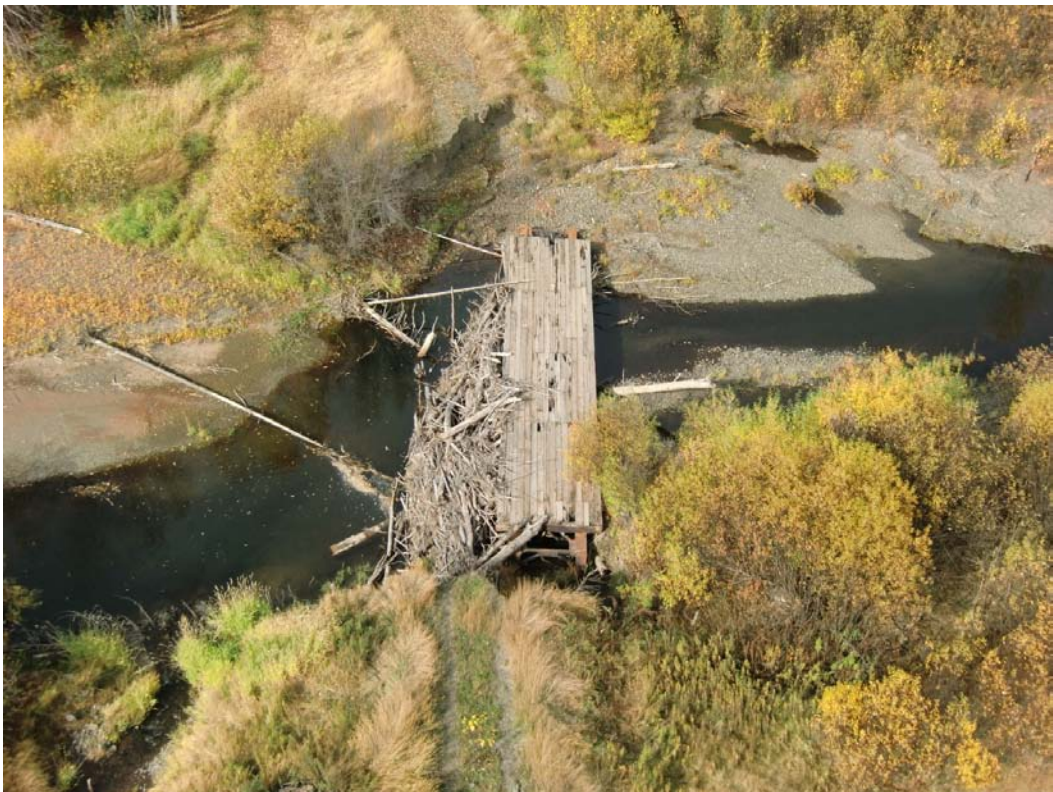
Photo 2. Strimbold bridge on Maxan Creek, debris on upstream side, known Chinook spawning on downstream side, September 29, 2015.

3. **Fish at Site:** Chinook Salmon were observed by MFLNRO staff immediately downstream of the site on September 29, 2015. Eggs would stay in the gravels until May or June of the following year depending on temperatures. Resident fish are expected to congregate under the bridge and within the accumulated debris on the upstream side of the bridge. Works could result in death to fish at the site.

5. **Remove upstream debris:** Some of the upstream debris will have to be removed in order to wrap the bridge with cables for lifting or skidding. The excavator will sit on the gravel bar to reach the debris, which will be put on top of the streambank above the high water mark. Only the excavator bucket and thumb should be in the water (ie., no greased joints). Debris left in the stream is not an environmental concern according to correspondence with MFLNRO and DFO staff.

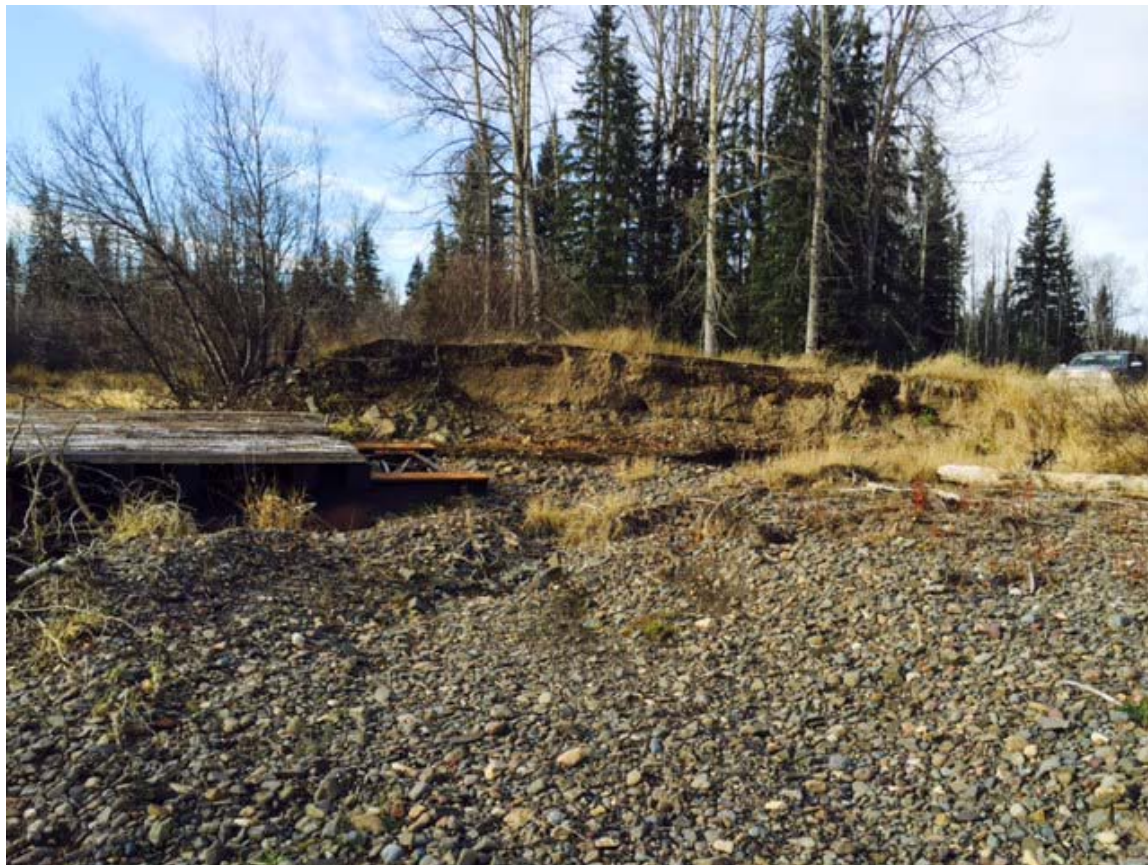
4. **Access:** Access roads from the southeast are partially deactivated and include a gasoline crossing and cattleguard that may not support a heavy equipment crossing. Access roads from the northwest are private and the last portion is not maintained. The crossing approaches have been washed out and there are oversteepened banks on each side of the bridge now.

Photo 3. Oversteepened bank on northwest side, November 11, 2015.

4. **Build access ramps:** The northwest bank is oversteepened and will be pulled back to create a ramp and place the surplus material along the sides of the approach road. If any material needs to be brought below the high water mark for access, geotextile should be put down underneath so that the fill can be completely removed afterwards.

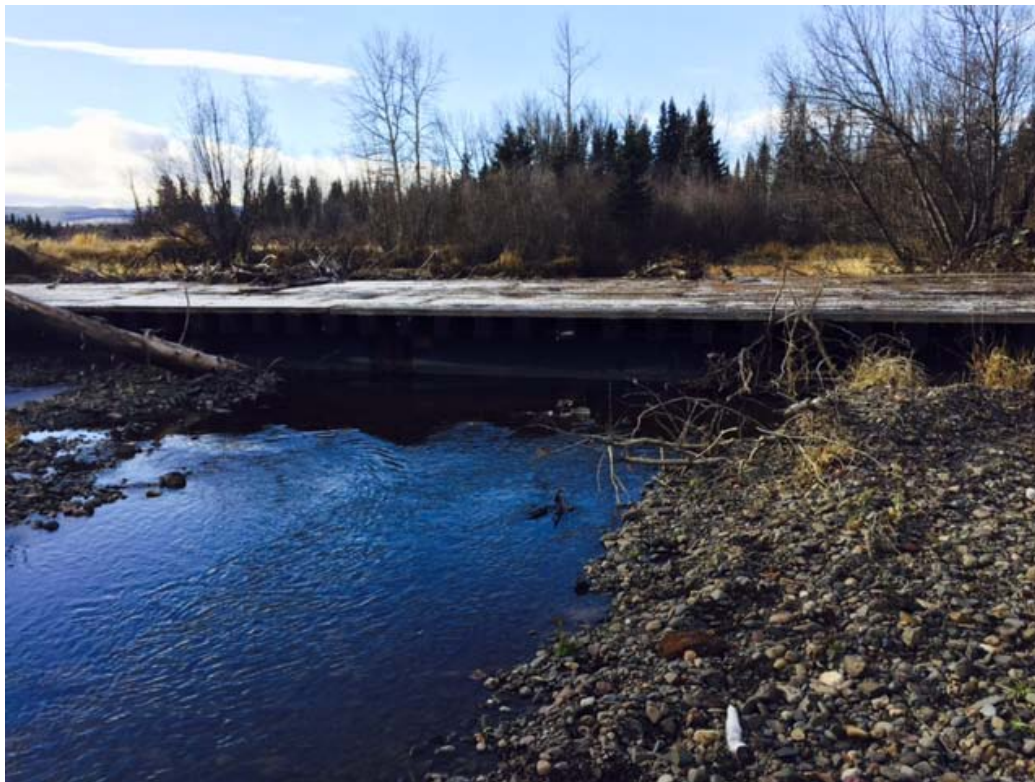
6. Aquatic Habitat Features: The bridge and debris have created an upstream pool with rearing and overwintering potential. Spawning gravels are present immediately downstream of the bridge. Removal of the debris and bridge will drain the pool and remove cover. Spawning potential may also decrease both by potentially filling in the gravels with fines and by losing the adjacent deeper water that could be used as a holding area.

Photo 4. Downstream spawning substrate, November 11, 2015.

Downstream spawning gravels could be filled in by the suspended sediment at a time of year when they would not be flushed prior to spawning activities.

2. **Monitor downstream spawning gravels:** As per BC Water Quality Guidelines for aquatic life, spawning gravels should not exceed (by volume) 10% <2mm, 19% <3mm and 28% <6.35mm. Measure downstream streambed substrate composition at the redds immediately downstream of the site before and after works, 2mm, 3mm and 6.3mm sieves will be required. If streambed substrate composition immediately downstream negatively changes as a result of the works, the redds may be washed using a pump from the upstream pool. This is especially important since there would likely be no increased flows before salmon arrive to the site to spawn.

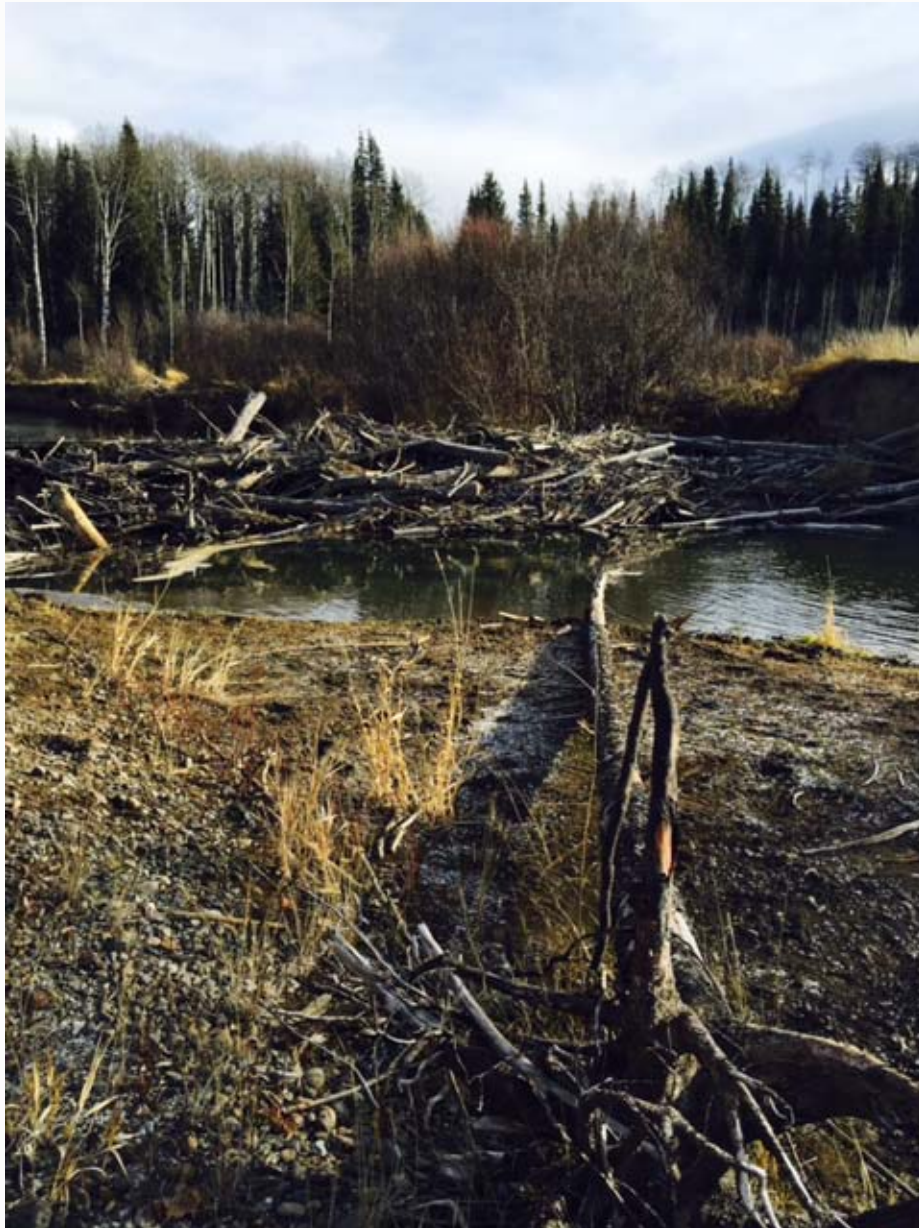
8. Woody Debris Accumulation: While the debris accumulation provides fish habitat, it is a safety concern as the bridge will need to be cabled for removal.

Photo 5. Debris accumulation, November 11, 2015.

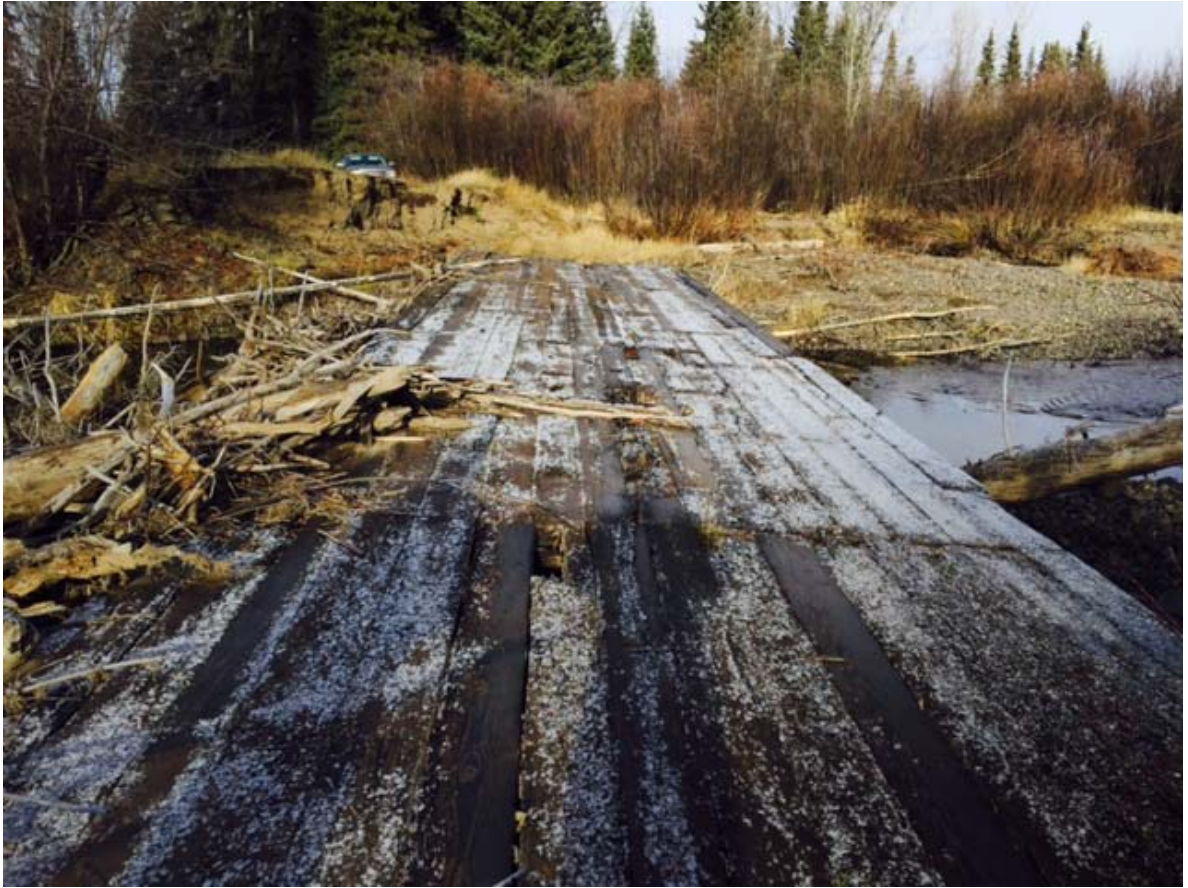
Photo 6. Decking and upstream debris, November 11, 2015.

6. **Remove ties and deck.** IF the bridge is to be lifted out of the stream, ties and decking will be removed while it is still in the stream. The untreated rotten deck will be pulled/cut off exposing tie bolts. Then the bolts will be cut with a torch (about 15 per side). The ties will not be cut over the stream to prevent any creosote from entering the stream. If the bridge is to be skidded out of the stream, the decking and ties will be removed after the bridge is skidded up onto the gravel bar, again without cutting the ties to ensure that any creosote debris would not enter the stream at high water.
