Fish Habitat Assessment and Selected Rehabilitation Prescriptions within the Zymoetz Watershed

Terrace Salmonid Enhancement Society
Terrace, B.C.

Ministry of Environment, Lands and Parks Watershed Restoration Program

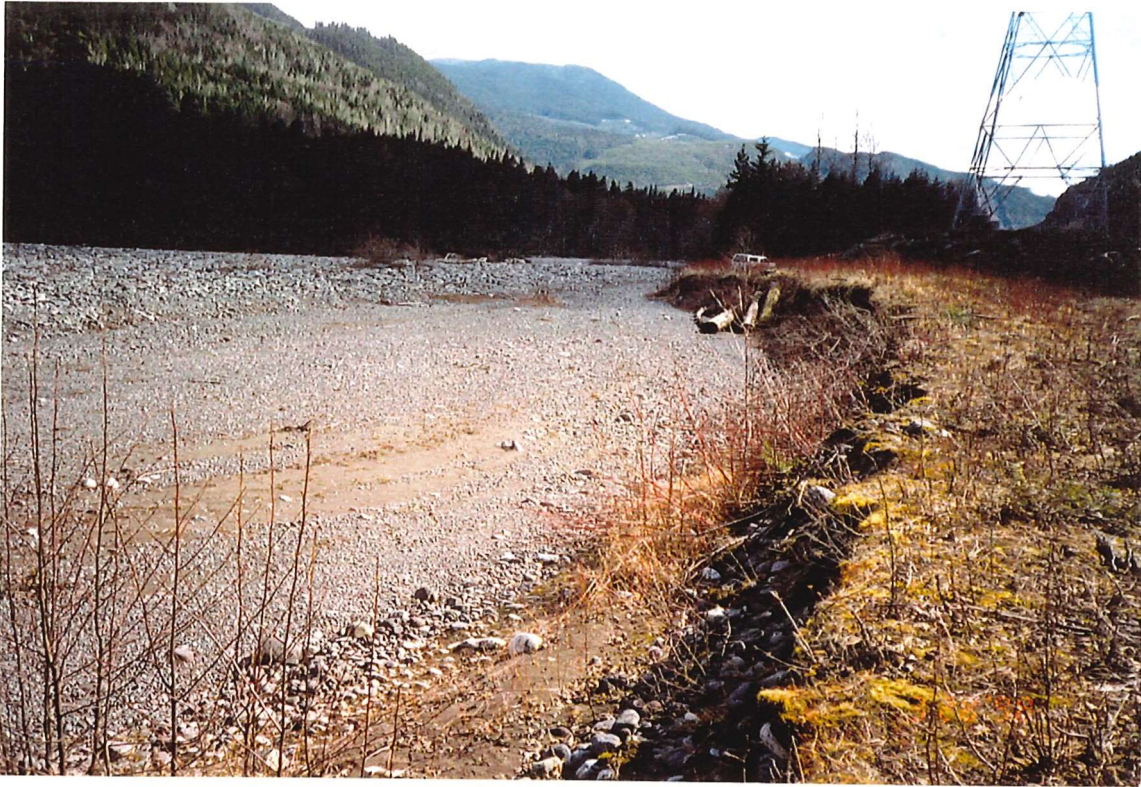
On November 14, 1997, one minnow trap set in an isolated pool yielded 2 juvenile coho with fork lengths of 60 mm and 65 mm. Two days previous, two coho redds were observed in a ground water pond at the west end of the channel (photo 5). On December 2, 1997, a pH reading of 8.6 was taken. The relative abundance of fish at this site is 0.02. Four test holes were dug on March 31, 1998, by a rubber tired back hoe (photo 6 and 7). At the first hole, 100 m from the Zymoetz River, water was reached at 1.5 m and flowed faster than the back hoe could bucket it out. Water was reached at slightly less than 2 m for the second hole, 200 m from the Zymoetz. Water from the third hole, 300 m from the river, was found at a depth of 2.2 m. Water was found at just over 1 m in the fourth hole, 400 m from the river; there was excellent flows at hole one and four. At the time of digging, the Zymoetz River was within a few centimeters of the lowest seasonal flow seen in 20 years.

Photo 2: Looking upstream in the dry channel.

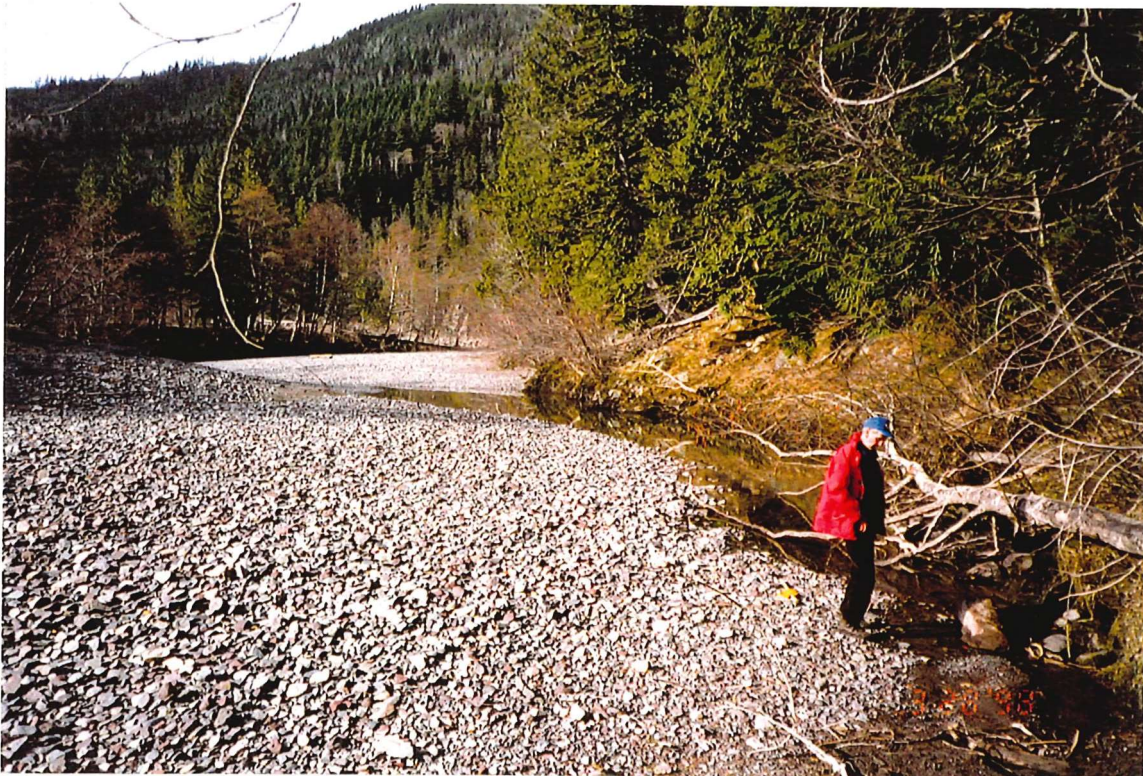
There was 1 coho redd found in this site close to the top of the channel. Two minnow traps revealed no fish on November 12, 1997.

Photo 13: Top side of the channel.

Complexing with LWD to provide shelter and protection for juveniles is necessary in the pool areas. Aside from the placement of boulders in key scattered locations, LWD (20 to 50 cm) should be assembled in clusters at each pool location. To anchor key logs, trenches should be excavated in the gravel bars to bury root wads and logs. The intent is that no extensive cabling of logs should take place. After key logs are dug into the gravel, loose or floating logs can be cabled to the key logs in a way that the cable is hidden as much as possible and used only where necessary.

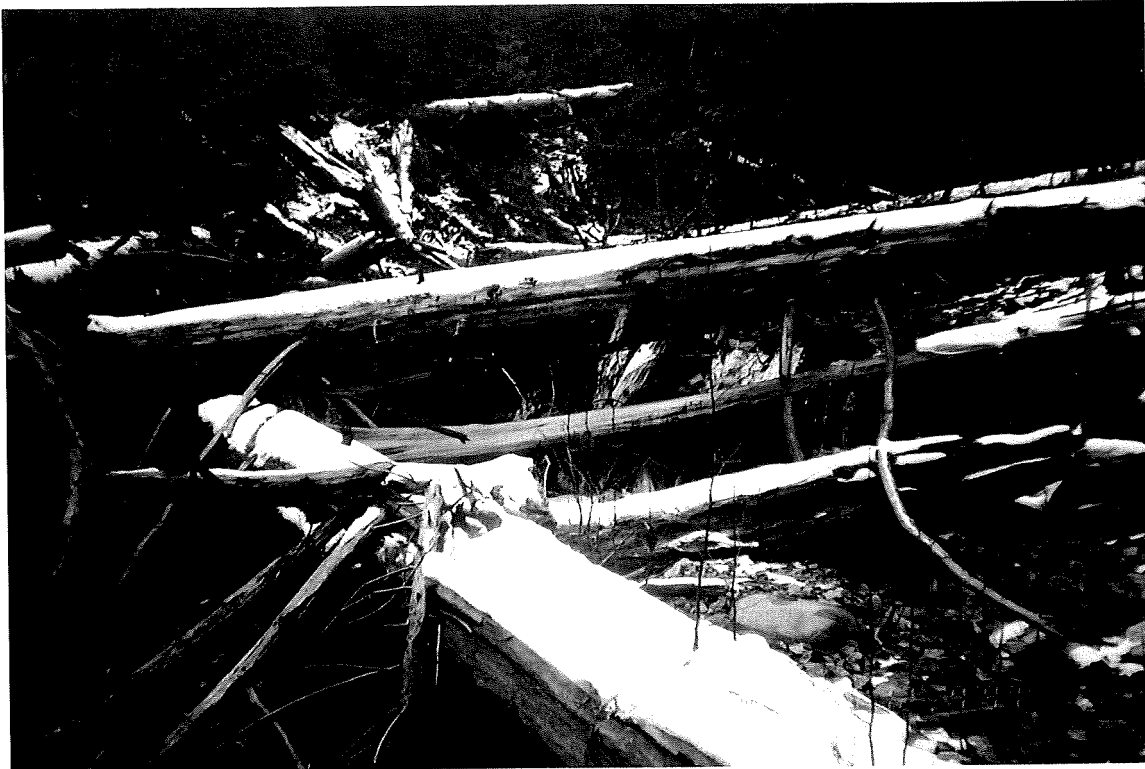
The old bridge is located 100 m above the Zymoetz River on a small stream with an estimated average gradient of 50% from the bridge up, 12% from the bridge down and an average channel width of 5.5 m. The bridge has missing upright posts and the cribbing and cross braces are sagging. Midway between the Zymoetz River and the bridge lies a log jam that is a probable barrier to anadromous fish migration (photo 15). The stream has high over-wintering and rearing habitat value. Collapse of the bridge material could alter the habitat and possibly deposit a large amount of fines into the Zymoetz River.

Photo 15: This log jam is a probable barrier to anadromous fish migration.

The old bridge needs to be removed. However, this is an up slope responsibility that should be handled by the Ministry of Forests, the lead proponent for the Zymoetz up slope restoration work. We recommend this be done using a large track type excavator to scrape off as much gravel and debris from the surface as possible. Then, the rotten decking needs to be removed followed by the stringers being pulled apart by the excavator over to the west side. It is possible that the stringers may break apart and fall into the creek along with other debris. This would only cause a temporary disturbance until the pieces are removed. All the materials should be burned or spread over the bank of the road in a number of locations to blend in with the natural surroundings.

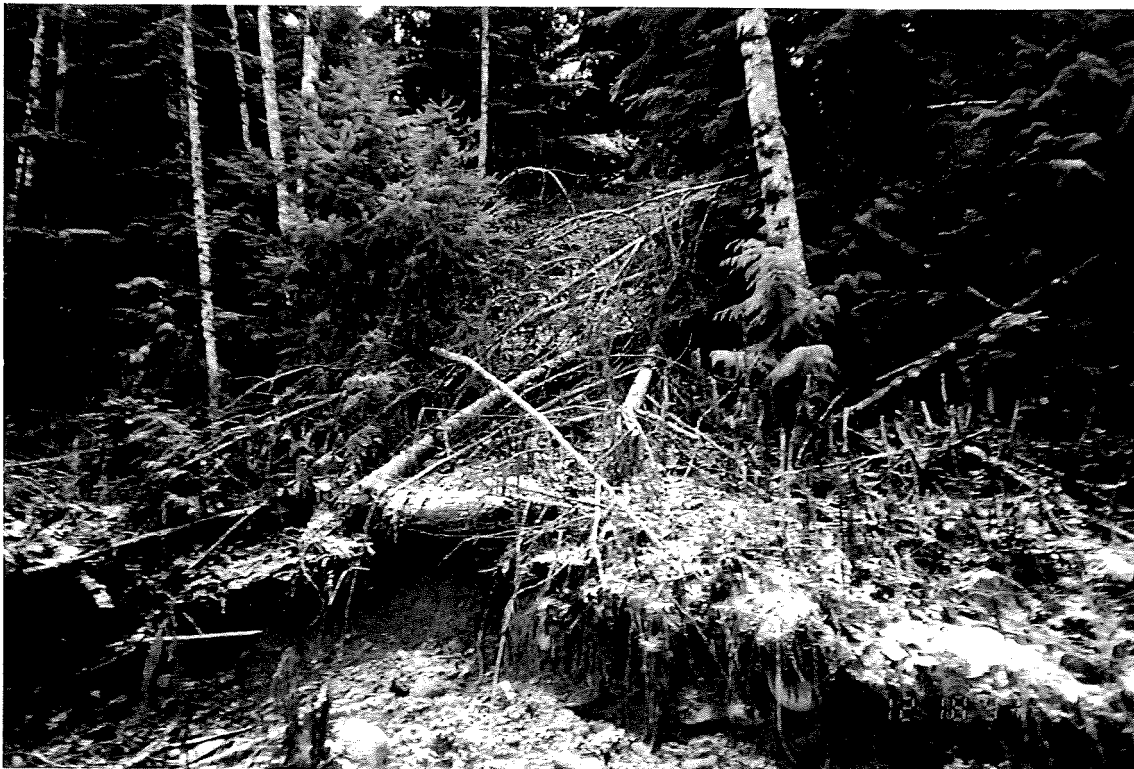
The erosion in a number of spots along this site has caused two small creeks flowing through to transport material. The bank needs to be stabilized as there is a high potential for a slump or serious erosion to take place above the road. There are a minimum of five separate bank locations above the road, two of which have had intermittent flow of water through them that could slump onto the road or continue to erode in a more insidious, slower manner and eventually slump or erode. Further up the slope a second eroded bank is indicating that slumping may have begun. This secondary erosion may have been caused by the construction of the PNG pipeline.

Photo 18: Slumped bank caused by road construction.

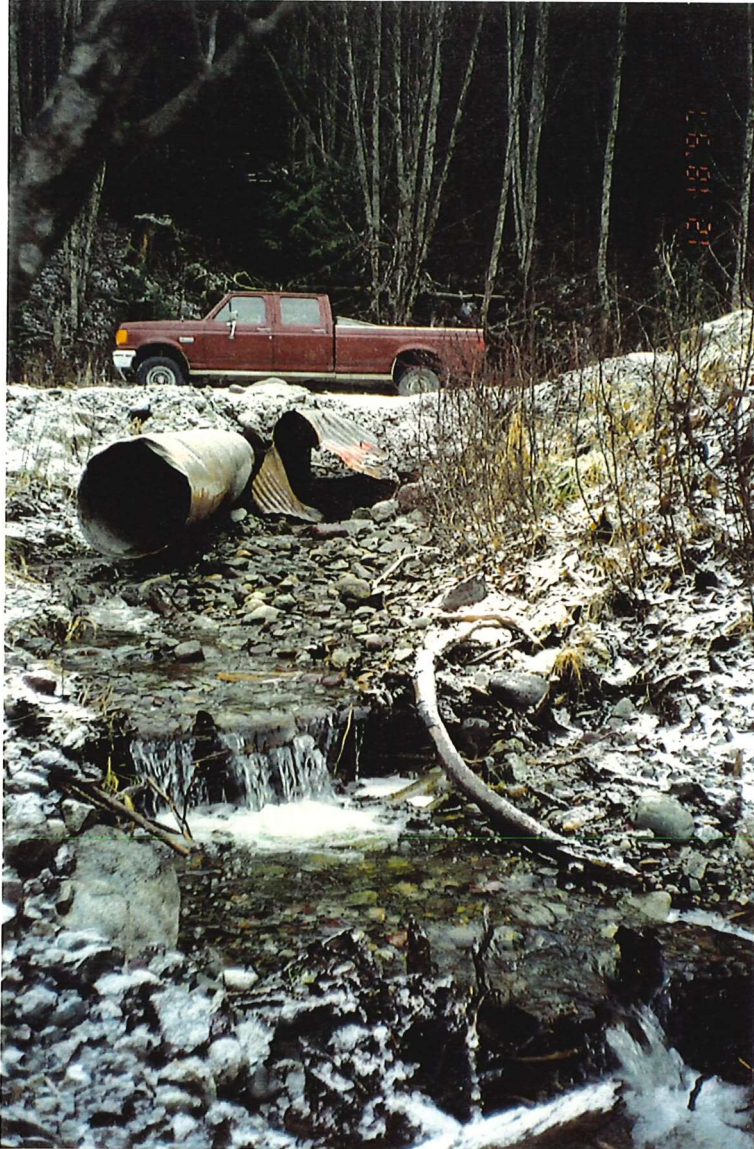
A pH of 9.3 was recorded January 6, 1998. The drop from the culvert to the creek is too high for juveniles to migrate through. The site has good potential for rehabilitation of the micro habitat below the road.

Photo 27: Kaluha Creek below the Copper FSR. These culverts are in poor condition and need to be replaced with a single box culvert.

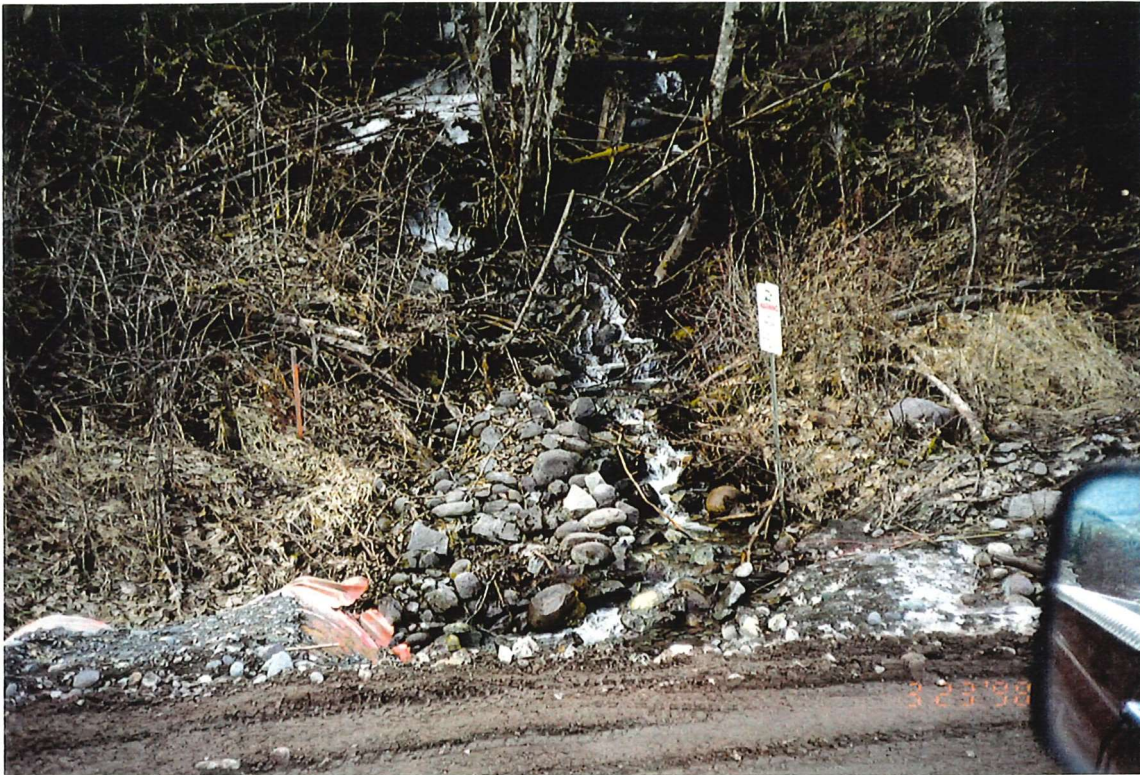
Photo 28: Kaluha Creek above the Copper FSR.

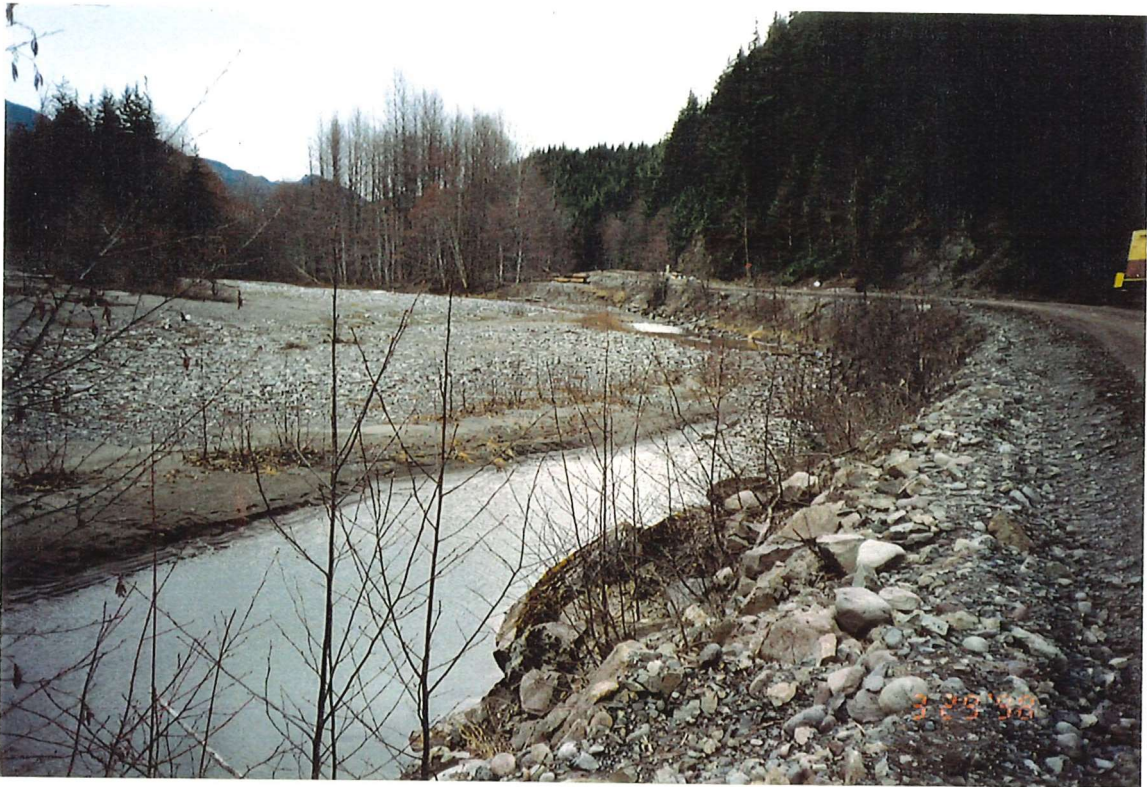
Photo 29: Looking upstream on 16 Km side channel.

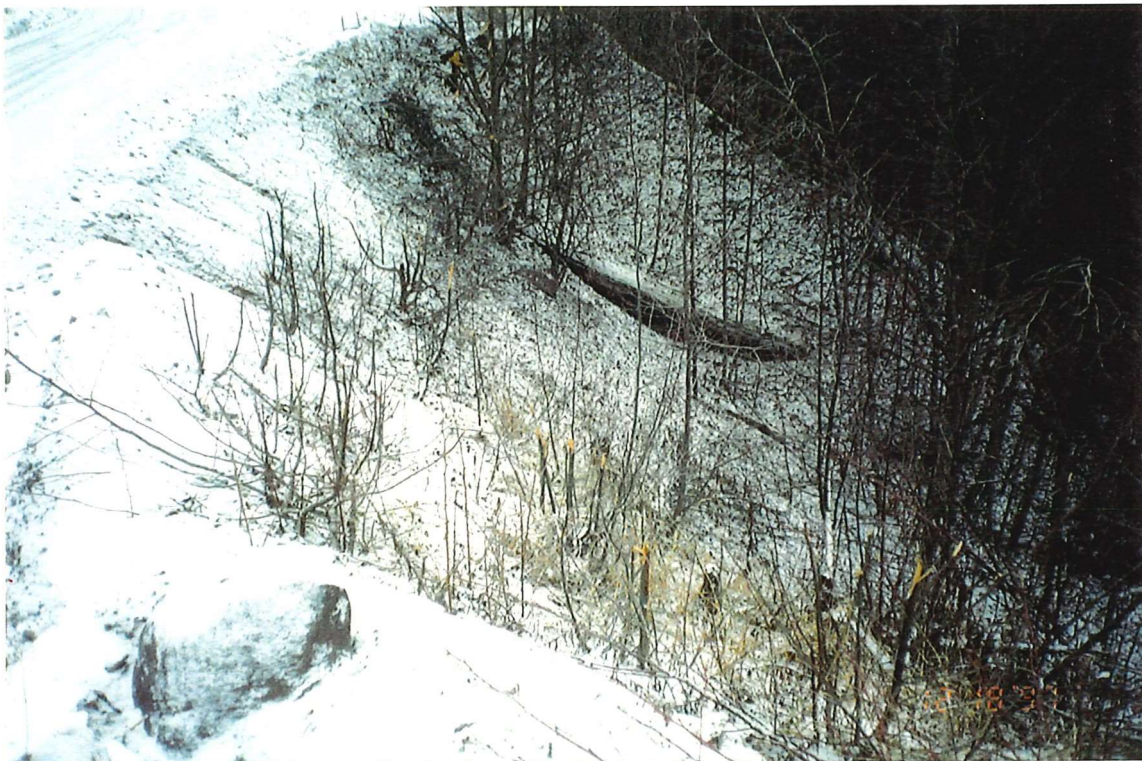
The bank currently poses no impact on the Zymoetz River below, but is precarious and threatens future damage if it collapses.

Photo 31: This steep bank failure has potential to impact rearing and spawning habitat in the Zymoetz River.

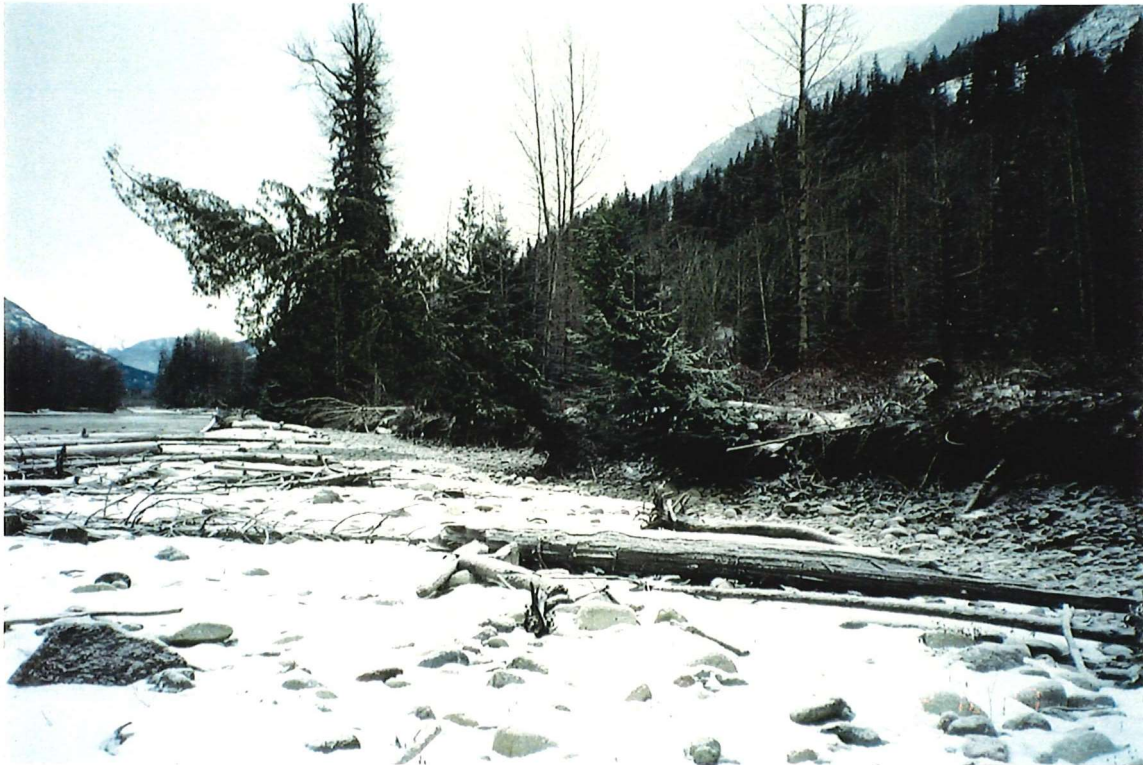
The side channel was dry every time the site was observed. It appears, after close examination, that water velocities through the channel are extensive.

Photo 32: Eroded band and disappearing riparian zone between the Copper FSR and the Zymoetz River

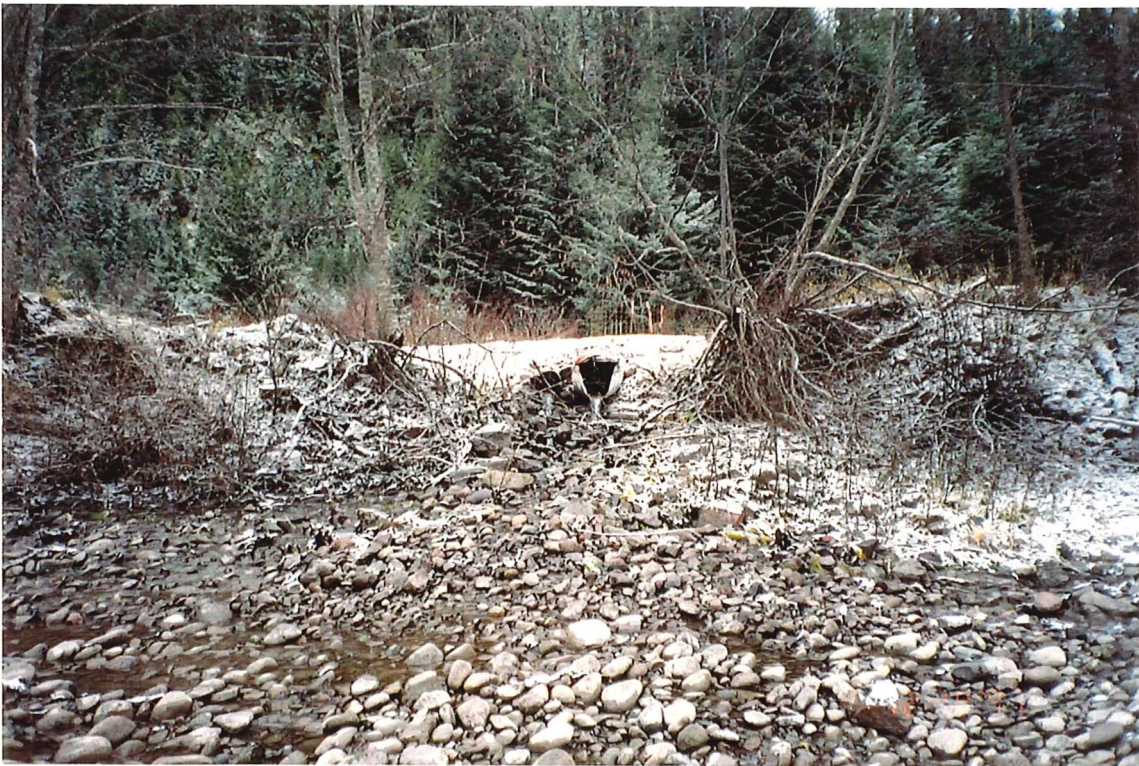
Minnow trapping above the culvert on December 2, 1997, yielded no fish. This could be, in part, due to the cold water temperatures or to the short trapping time of 4 hours. No water was observed flowing through the culvert or under it during a field trip on March 9, 1998 (photo 34).

Photo 33: This poorly installed culvert provides poor access for salmonids during all water flows (November 1997).

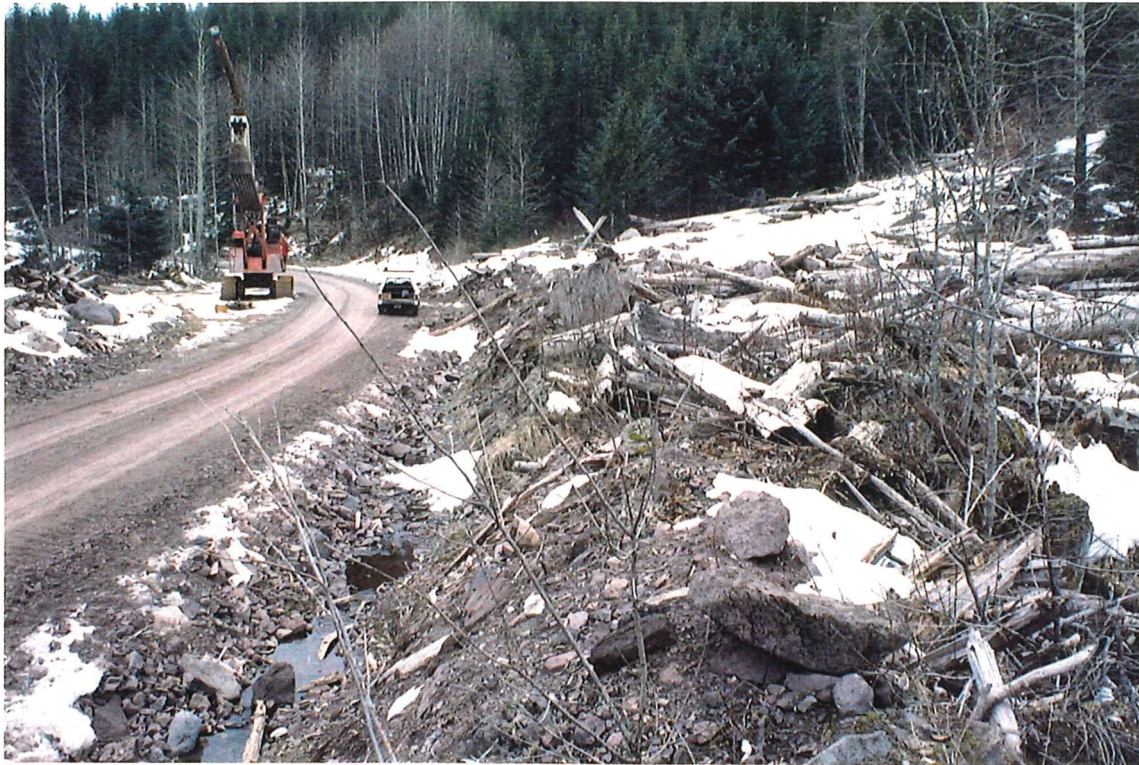
One minnow trap was set on either side of the road; no fish were caught. One possible reason for lack of juveniles on the south side of the road was the presence of four large char spawning in the gravel each 30 to 40 cm long. A second factor could be that the beaver dam on the north side is impassable or a culvert could be blocked. The trap on the north side was set below the beaver dam. A trap set under the 30 km bridge revealed 1 cutthroat, with a fork length of 120 mm, on November 14, 1997. There were two spawning char observed on the north side of the FSR. The relative abundance calculated here is 0.04. There is extensive evidence of past logging throughout this stream. Examples include large stumps within the wetted portions, clear-cut areas adjacent to the stream and live trees within the creek suggesting flow diversion. Logging damage including the road construction and maintenance has been extensive. During the field trip on March 9, 1998, no water was flowing through the creek channel and most of the beaver ponds had dried up. The water flowing through the alluvial fan was flowing into a logging spur road ditch and draining away into the gravel substrate.

Photo 45: Alluvial fan caused by debris torrent, water flowing into ditch.

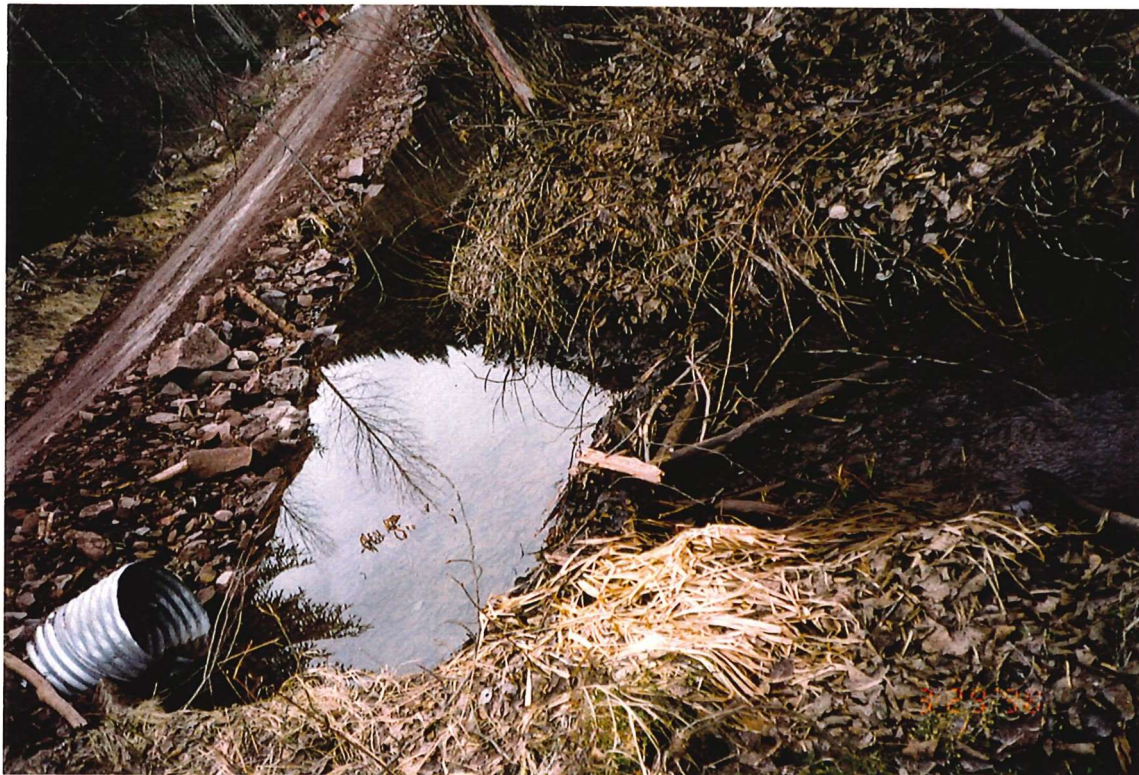
Photo 46: All of Swan Creek flowing into ditch.

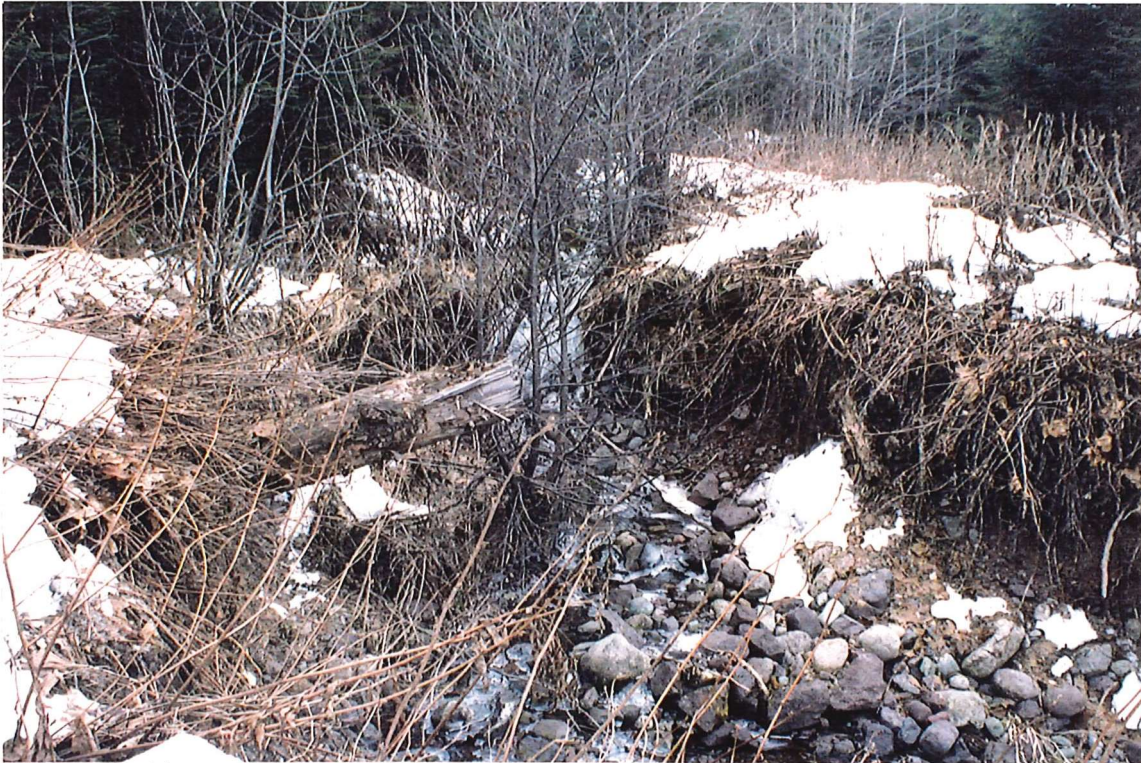
Photo 54: Above the Copper FSR, eroded bank and small water fall.

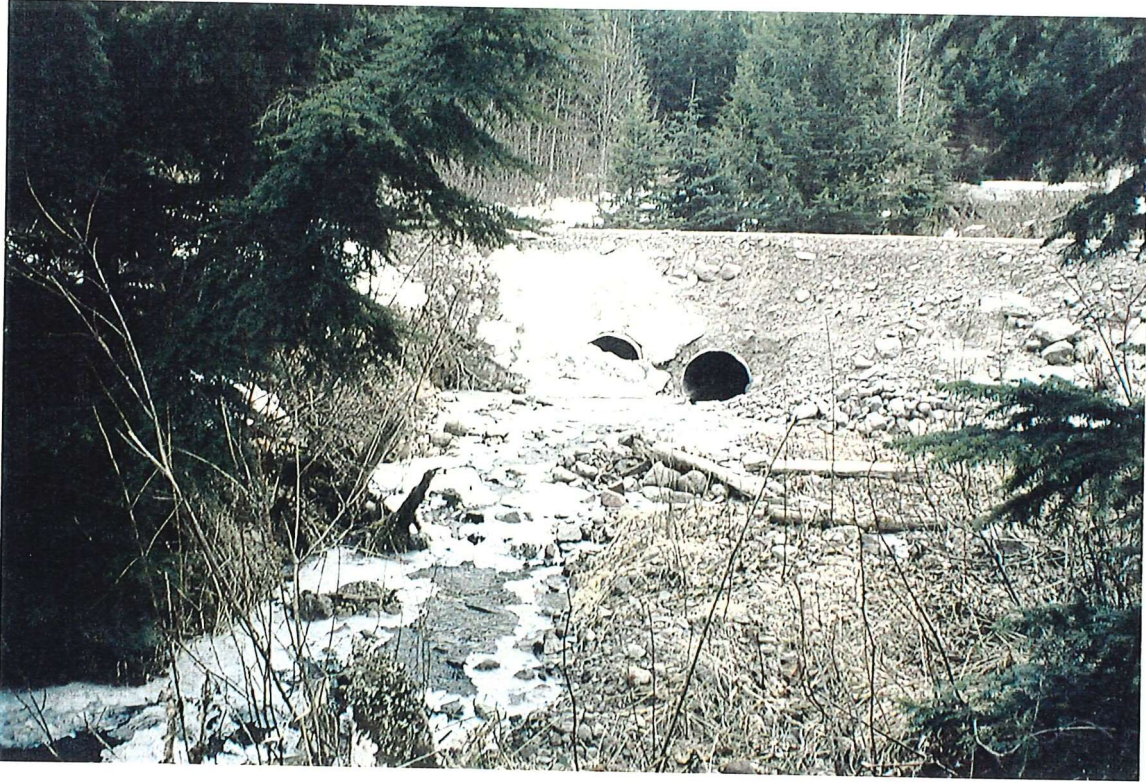
Upon examination, the culvert was found to be partially plugged due to road grading (photo 55). The bottom section of site 99B consists of large, spaced rocks of high gradient. The suspicions of impassability were substantiated with the trapping results of November 14, 1997. The minnow trap set above both questionable sections produced no fish making either one or both likely a problem. A pH of 8.6 was recorded.

Photo 55: Degraded creek below the road.

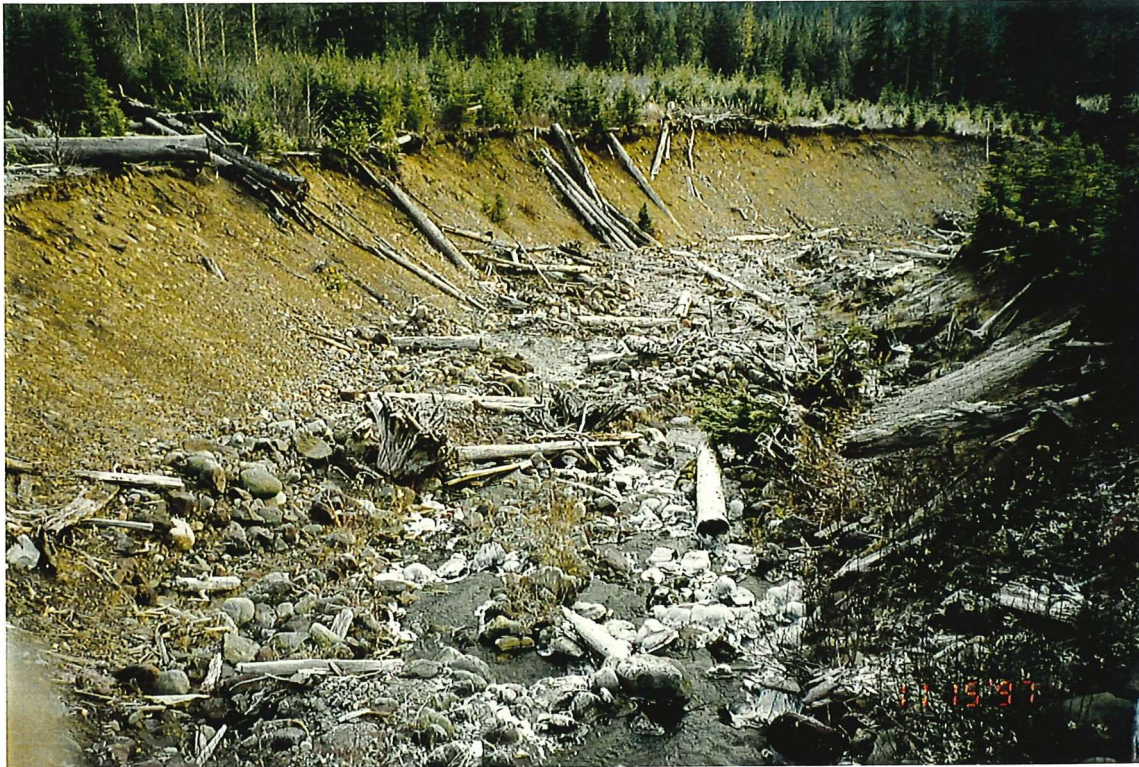
This area appears to have been logged to the creek's edge. This is apparent from large cables tied around stumps (photo 65) and bare, collapsed slopes adjacent to the creek. It also appears that the creek torrented during the 1978 flood event causing major riparian damage, widening of the channel and flood plain. A lot of scouring and debris transport has also taken place. The trapping results of November 17, 1997 yielded no fish from any of three traps over a 24 hour period. A pH of 8.1 was recorded.

Photo 62: Top of the tormented gully.

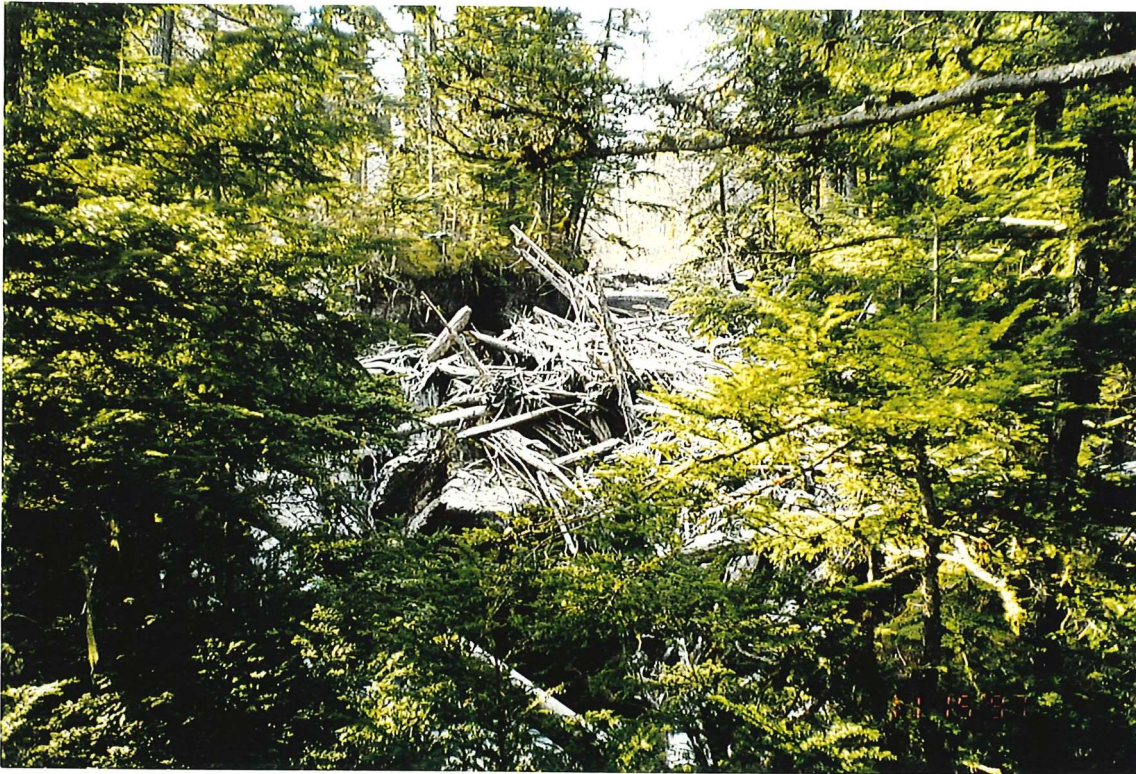
Photo 77: This log jam directly behind the falls has made fish migration impossible.
